STATE OF TENNESSEE DEPARTMENT OF ENVIRONMENT AND CONSERVATION DIVISION OF MINERAL AND GEOLOGIC RESOURCES

Mining Facility Inspection Report

NPDES permit number: TN0070408 NPDES Permit type: Individual

Inspection type: Compliance Evaluation Inspection (non-sampling) (CEI)

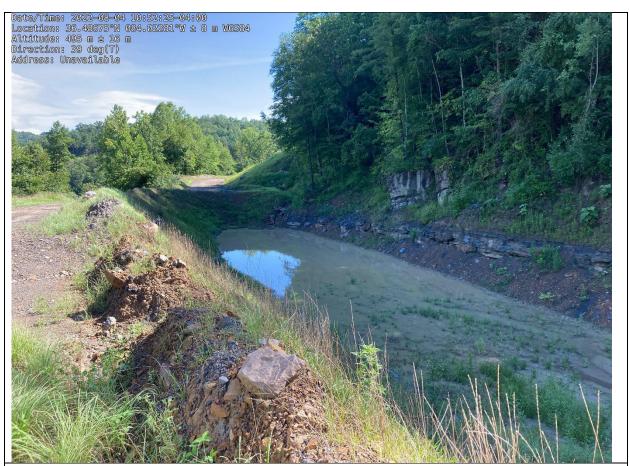
36.48675 -84.02281 39.23709468223087 2022/08/04 10:52:25

Photo 1: Photo of pond 100. The pond was receiving storm water at the time of inspection but not discharging.

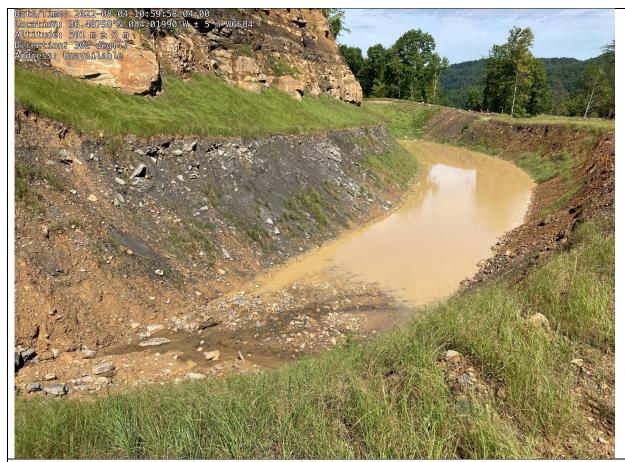
36.48758 -84.0199 301.746632996633 2022/08/04 10:59:58

Photo 2: Photo of Pond 103. This pond was receiving inflow but not discharging at the time of inspection.

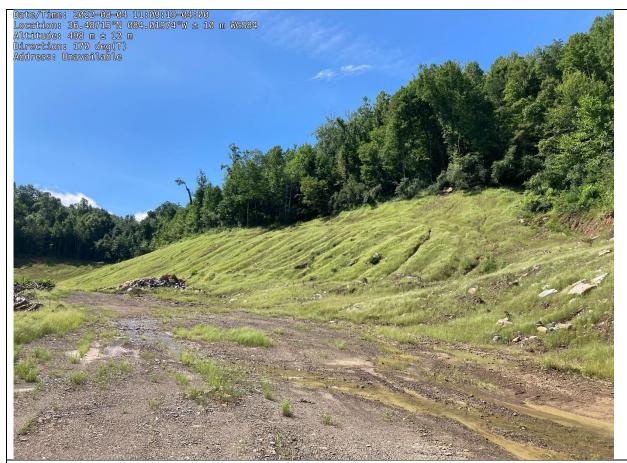
36.48714 -84.01974 169.68148781530567 2022/08/04 11:09:19

Photo 3: Photo showing the reclaimed highwall southeast of pond 103. The highwall has been regraded and seeded.

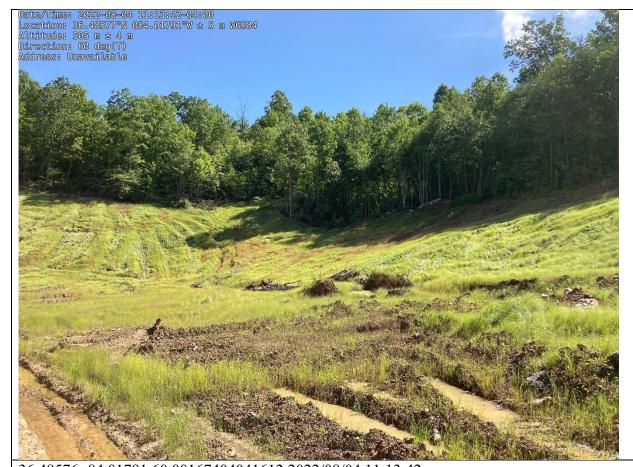
36.48576 -84.01791 60.00167404041612 2022/08/04 11:13:42
Photo 4: Additional photo showing the coninuation of the reclaimed highwall along the bench.

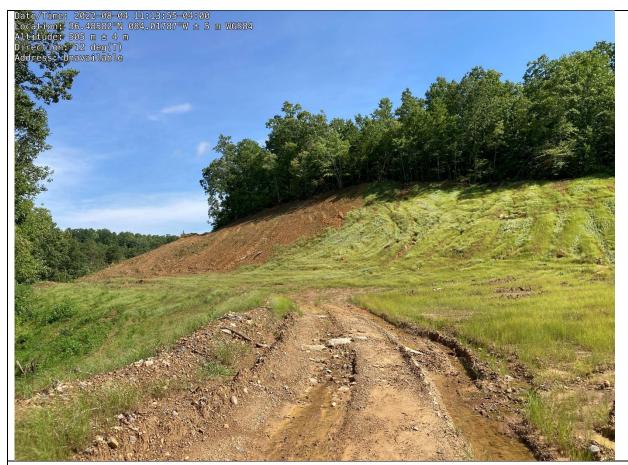
36.48583 -84.01787 11.700095540419762 2022/08/04 11:13:55 Photo 5: Final photo of the continuation of highwall reclamation.

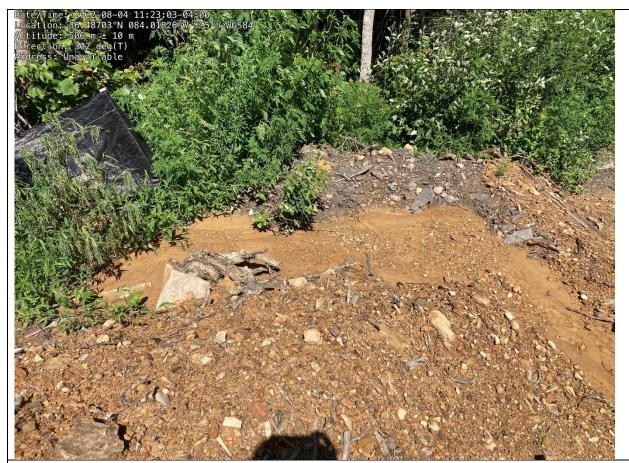
36.48703 -84.01826 301.86252771618626 2022/08/04 11:23:03

Photo 6: Sump at the end of the highwall to be cleaned. This sump receives a small ammount of drainage from the dirt haulroad.

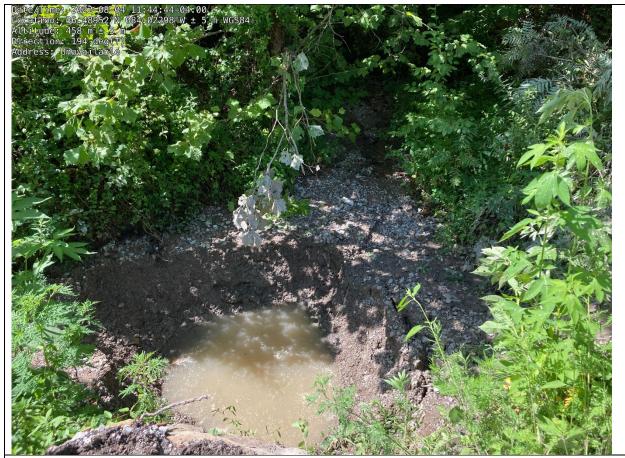
36.48952 -84.02298 193.52649191299497 2022/08/04 11:44:44

Photo 7: Photo of one of several sumps that have been cleaned out along the haulroad.
