**RE: Site Assessment Report
Individual Construction Permit TN0081949
Jasper Highlands
ADE Project No. 16161**

**JASPER HIGHLANDS
Site Assessment Report
Marion County, TN**

**Photo Log for
Site Assessment**

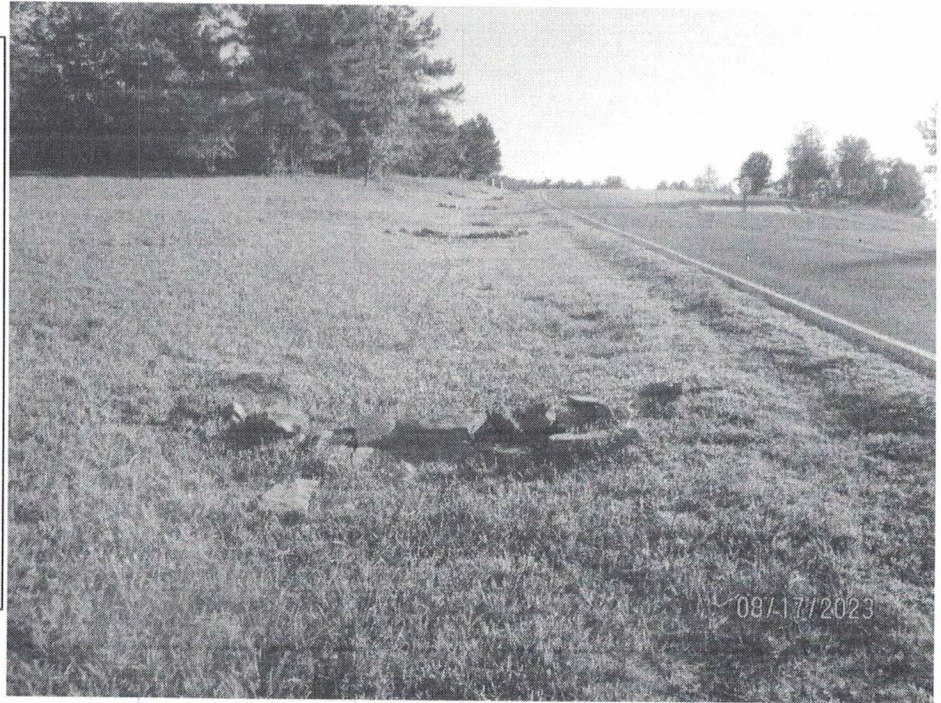
Photo 1:

Outfall S59

Rock check dams have been installed in a roadside ditch and appear to be functioning properly.

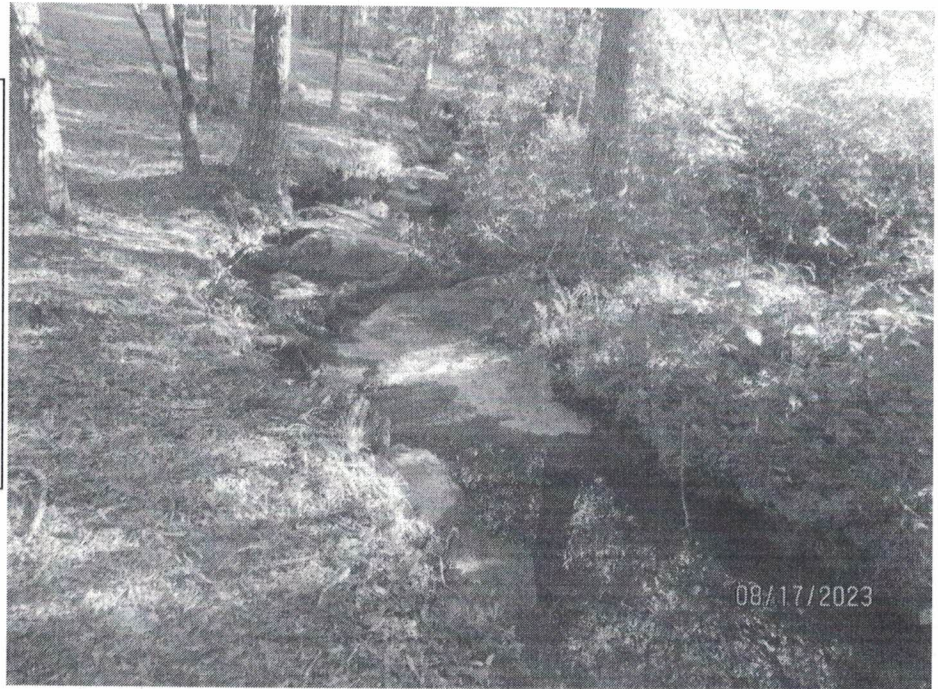
Photo 2:

- Currently the disturbed area within outfall S66 consists of one home being constructed totaling approximately 0.40 acres of disturbance.
- The outfall sampling location was observed, and no sign of sediment discharge were observed (see photo 2).
- The stormwater basin has been installed and appears to be stabilized.

Outfall S66

The outfall sampling location was observed. No signs of sediment discharge were observed.

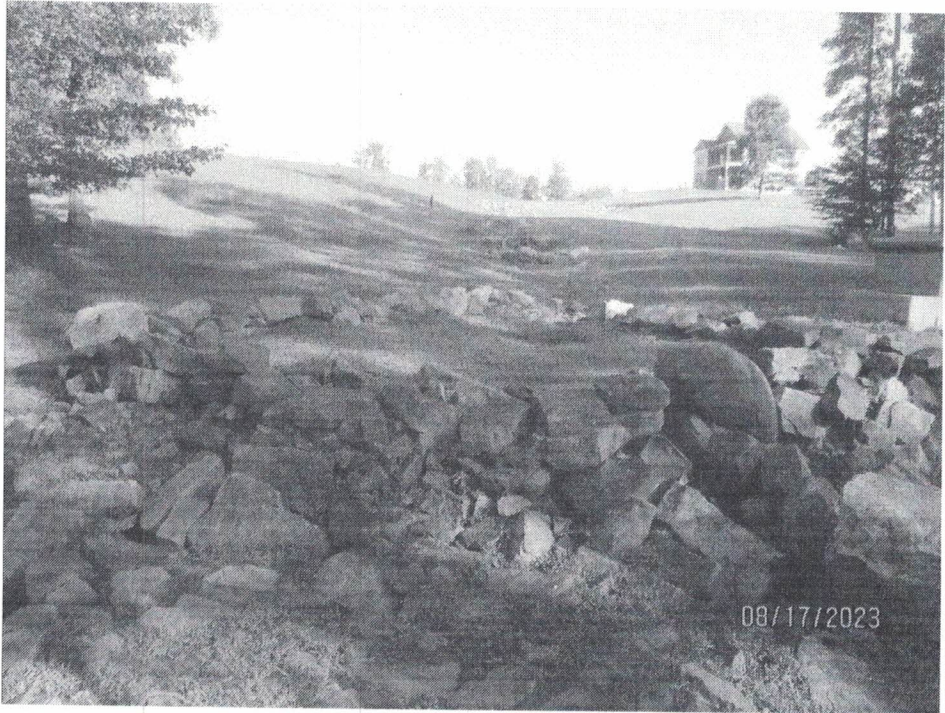
- Currently the disturbed area within outfall S98 consists of two homes being constructed totaling approximately 0.60 acres of disturbance.
- The individual lot-level erosion controls were observed and appeared to be functioning properly.
- Rock check dams were observed along a roadside ditch and appeared to be functioning properly (see photo 3).

Photo 3:
Outfall S98
 Rock check dams have been installed in a roadside ditch and appear to be functioning properly.
 Photo Taken 8/17/2023

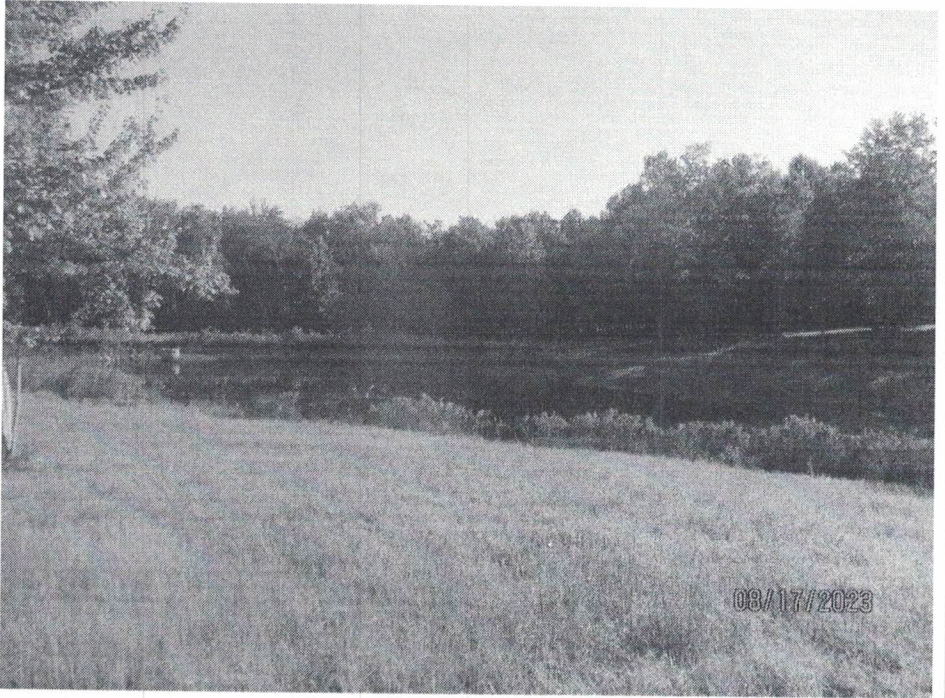
- Currently the disturbed area within outfall S153 consists of six home construction sites. The disturbed area within the outfall S153 drainage basin is approximately 3.0 acres.
- The individual lot-level erosion controls were observed and appeared to be functioning properly.
- The stormwater basins have been installed and appear to be stabilized (see photo 4).

Photo 4:
Outfall S153
 A stormwater basin has been installed and appears to be functioning properly.
 Photo Taken 8/17/2023

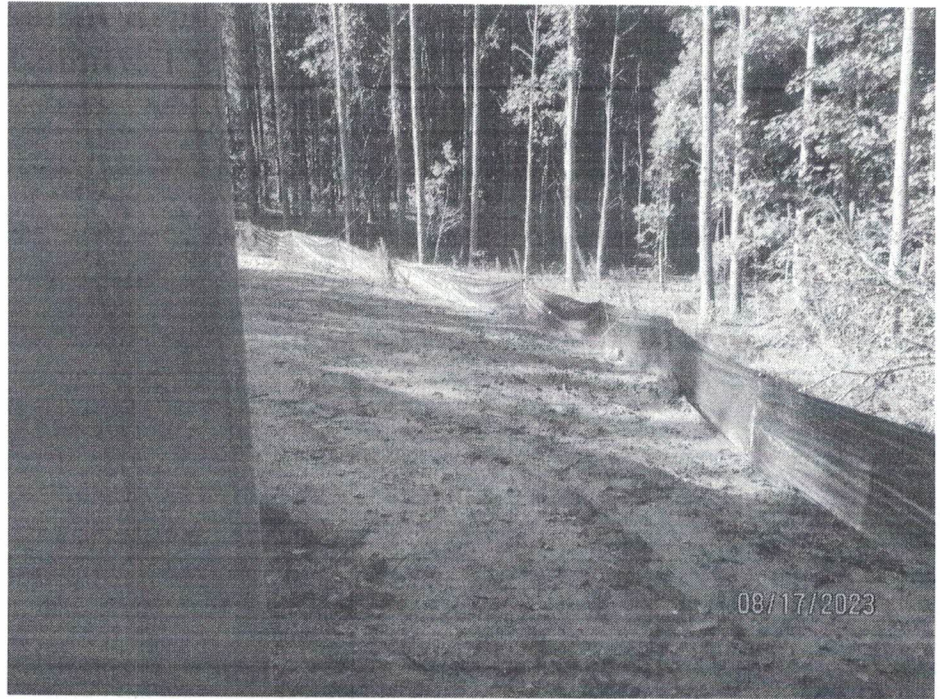
Photo 5:

- Currently the disturbed area within outfall S201 consists of three home construction sites. The disturbed area within the outfall S201 drainage basin is approximately 1.2 acres.
- The individual lot-level erosion controls were observed and appeared to be functioning properly (see photo 5).
- The stormwater basins have been installed and appear to be stabilized.

Outfall S201

The individual lot level erosion controls have been installed and appear to be functioning properly.

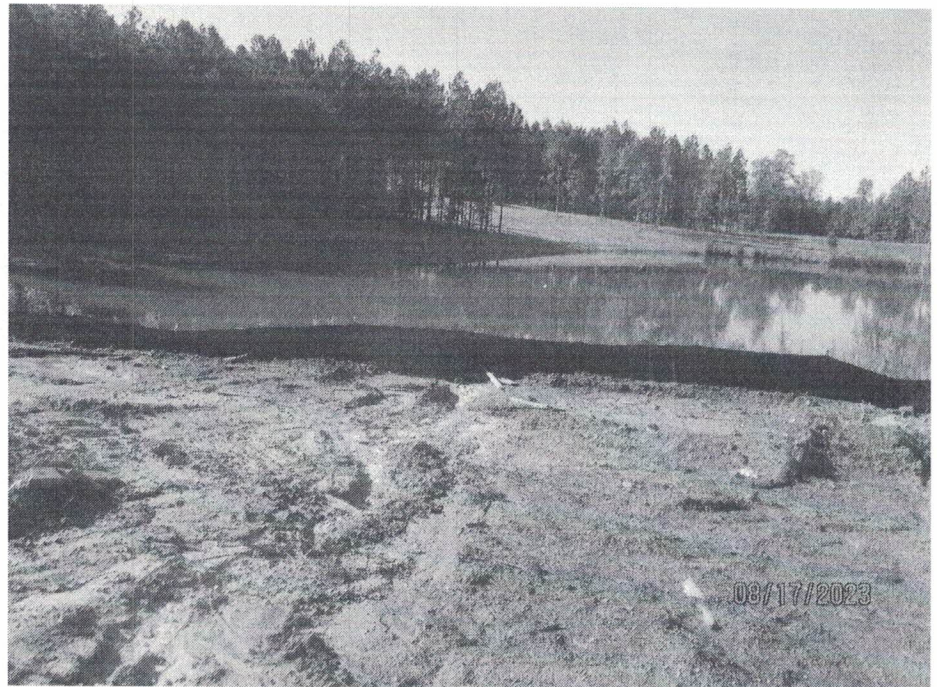
Photo 6:

- Currently the disturbed area within outfall S208 consists of 2 home construction sites, roadway construction, and utility installation along the roadway. The disturbed area within the outfall S208 drainage basin is approximately 2.0 acres.
- The stormwater basins have been installed and appear to be stabilized.
- The individual lot-level erosion controls were observed and appeared to be functioning properly (see photo 6).

Outfall S208

The individual lot level erosion controls have been installed and appear to be functioning properly.

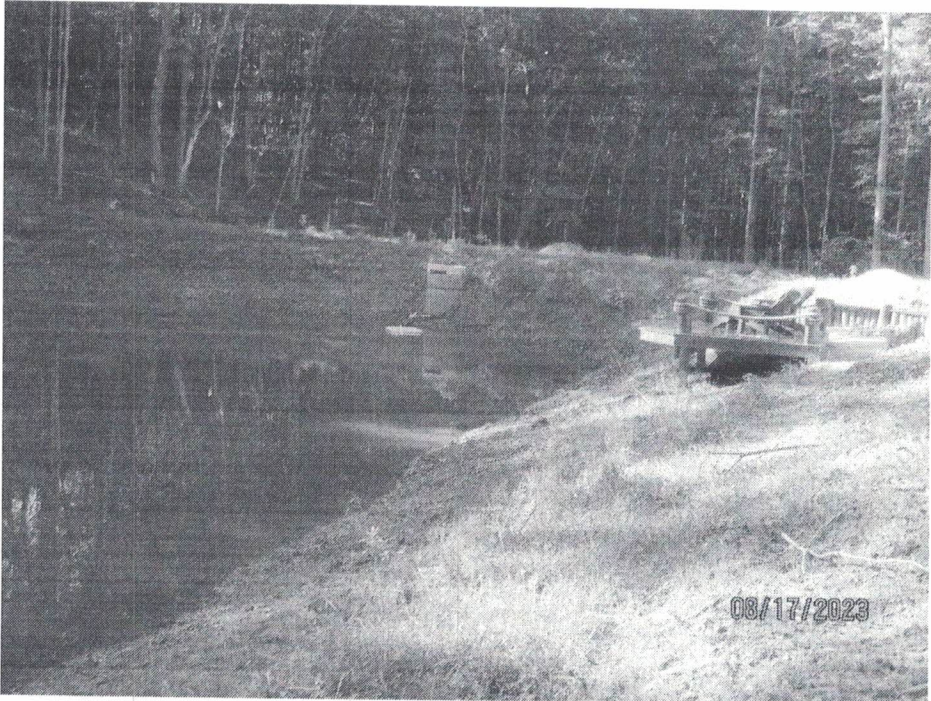
- Currently the disturbed area within outfall S218 consists of 7 home construction sites, roadway construction, and utility installation along the roadway. The disturbed area within the outfall S218 drainage basin is approximately 2.5 acres.
- Rock check dams have been installed in the roadside ditch and appear to be functioning appropriately.
- The stormwater basins have been installed and appear to be stabilized (see photo 7).

Photo 7:
Outfall S218
 A stormwater basin has been installed and appears to be functioning properly.
 Photo Taken 8/17/2023

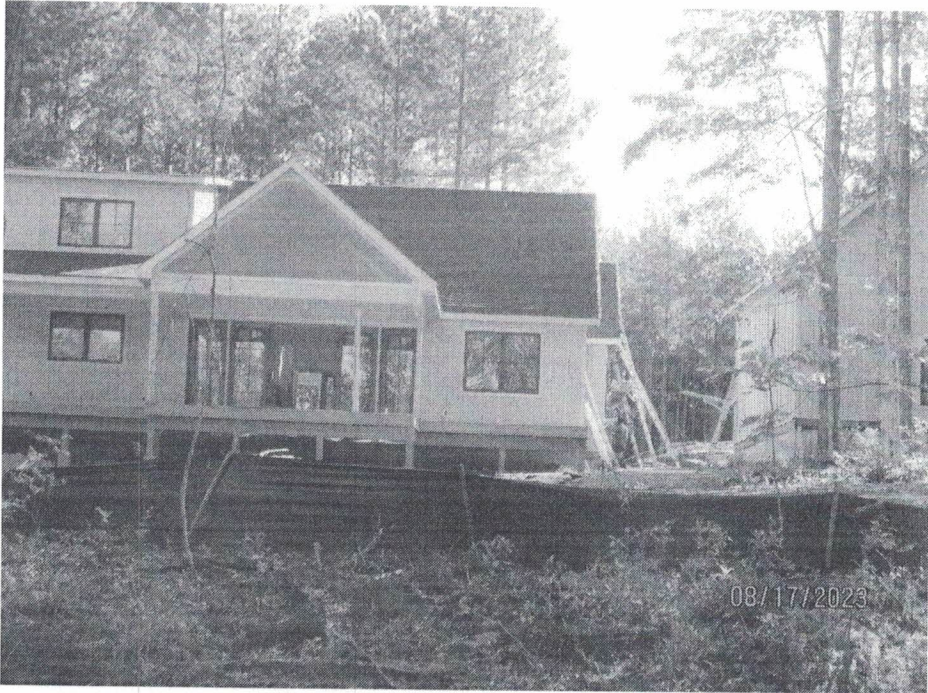
Photo 8:
Outfall S275
 The individual lot level erosion controls have been installed and appear to be functioning properly.
 Photo Taken 8/17/2023

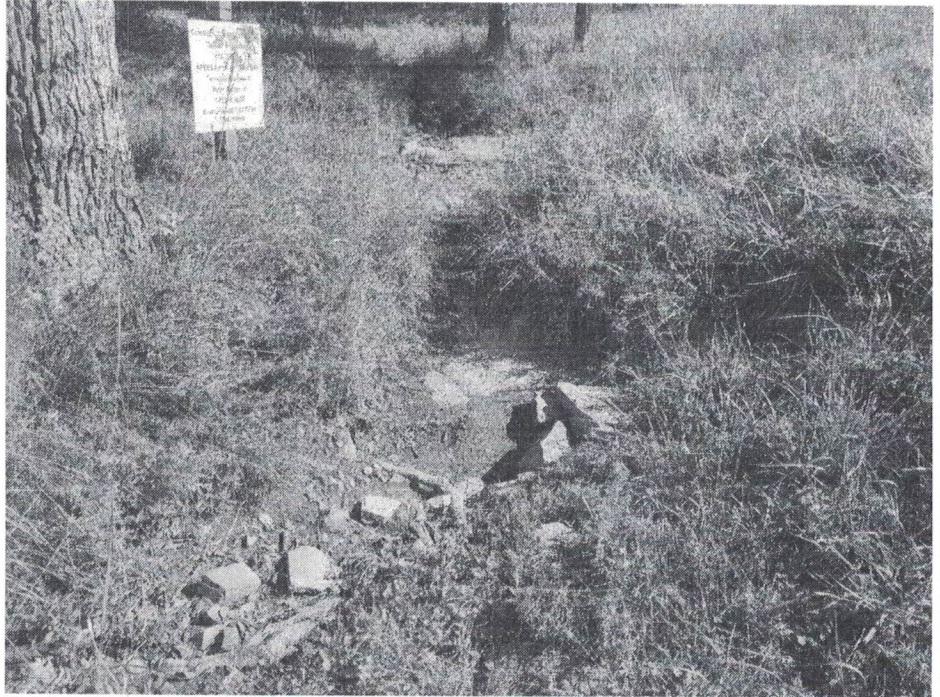
The outfall sampling location was observed. No runoff was present, and no signs of sediment discharge were observed.

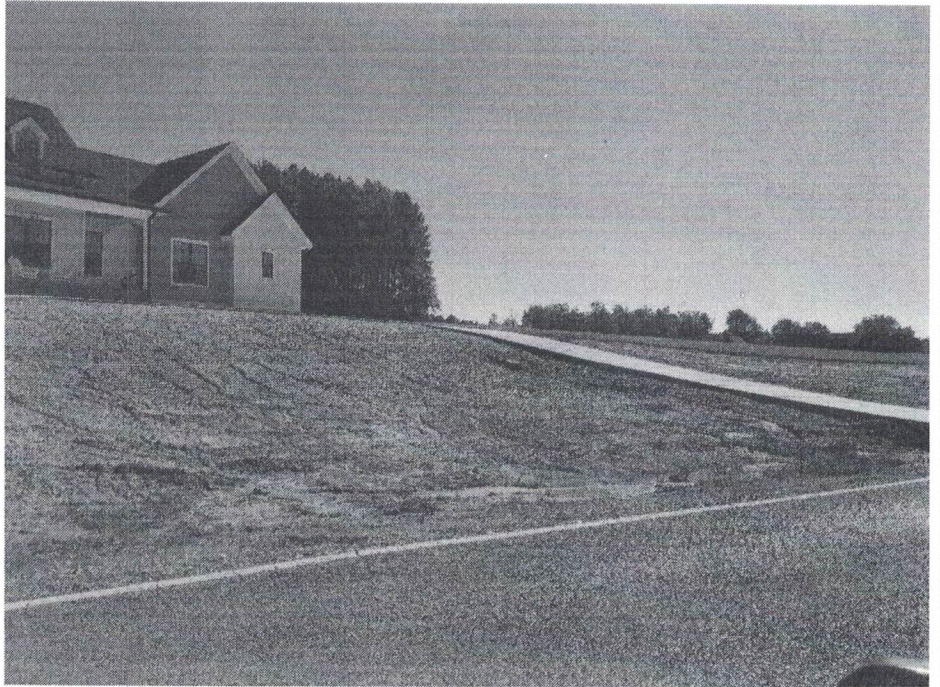
Photo 2:

- Currently the disturbed area within outfall S66 consists of one home being constructed totaling approximately 0.4 acres of disturbance.
- An individual home construction site was observed. Silt fence should be installed downstream of disturbances. Areas that have reached final grade should be stabilized (see photo 2).

Outfall S66

An individual home construction site was observed. Silt fence should be installed downstream of disturbances. Areas that have reached final grade should be stabilized.

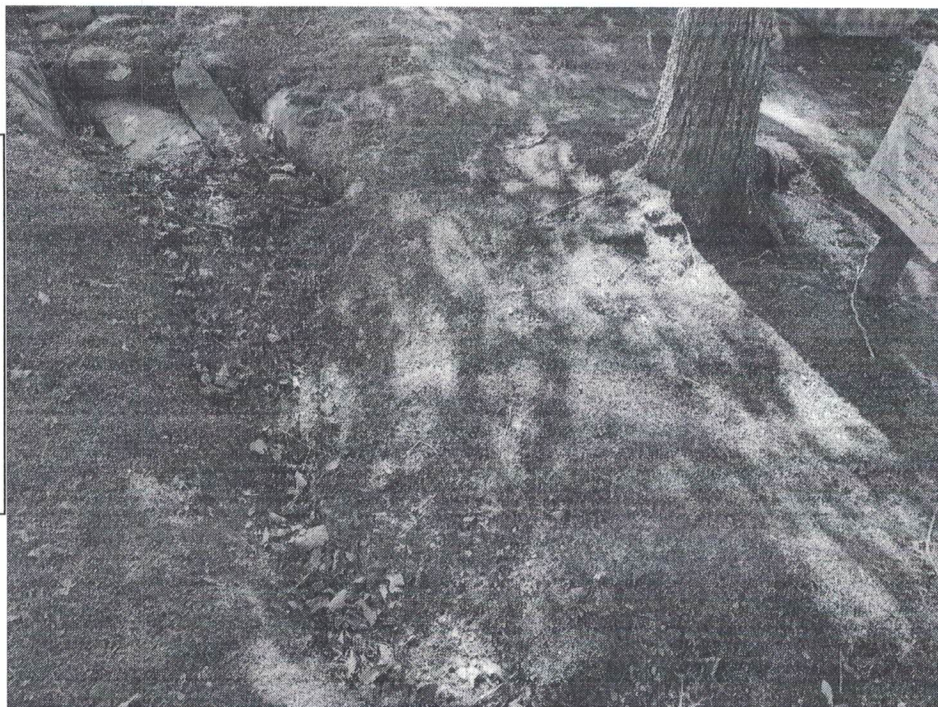
- Currently the disturbed area within outfall S98 consists of two homes being constructed totaling approximately 0.6 acres of disturbance.
- The outfall sampling location was observed, and no signs of sediment discharge were observed (see photo 3).

The outfall sampling location was observed. No runoff was present, and no signs of sediment discharge were observed.

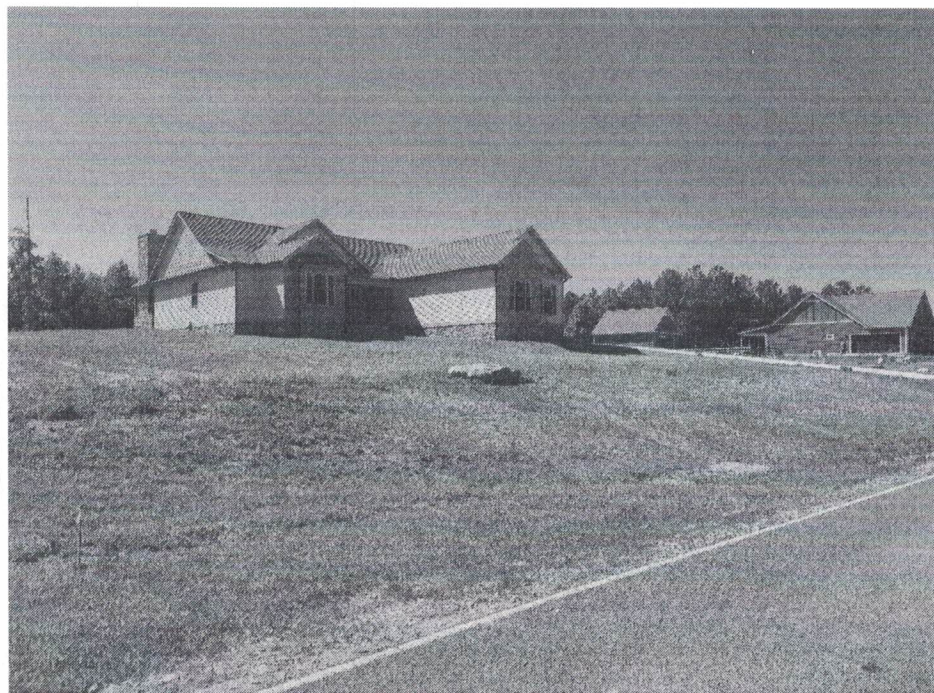
Photo 4:

- Currently the disturbed area within outfall S153 consists of six home construction sites. The disturbed area within the outfall S153 drainage basin is approximately 3.0 acres.
- An individual home construction site was observed. Grass is beginning to grow in previously disturbed areas (see photo 4).
- The outfall sampling location was observed, and no signs of sediment discharge were observed.

Outfall S153

An individual home construction site was observed. Grass is beginning to grow in previously disturbed areas.

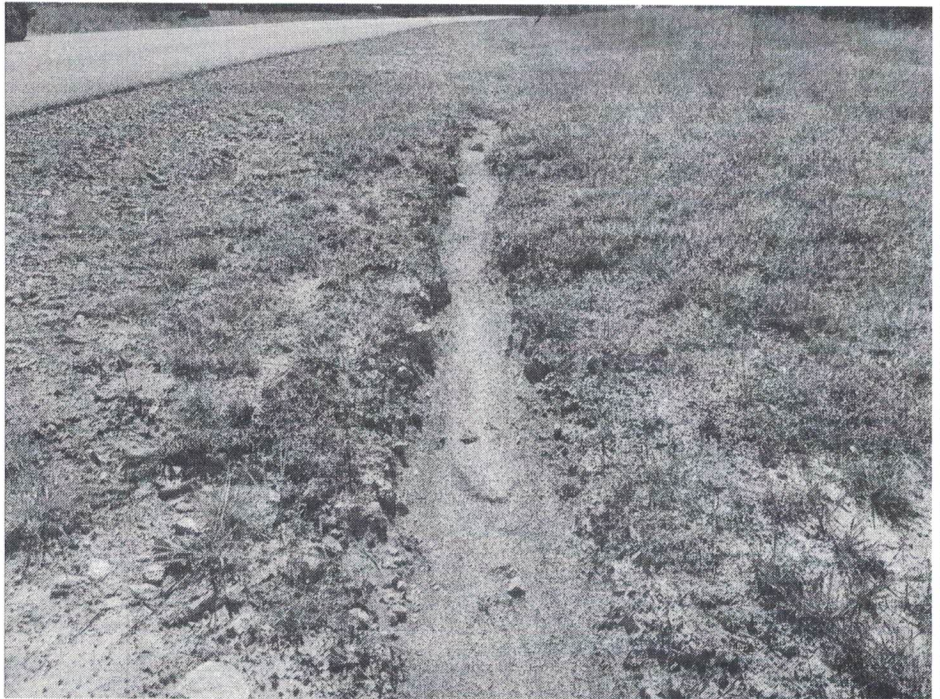
- Currently the disturbed area within outfall S201 consists of three house construction sites. The disturbed area within the outfall S201 drainage basin is approximately 1.2 acres.
- A roadside swale was observed. The swale should be stabilized with grass, matting, rock, or other means to prevent washout. Check dams may be needed to capture sediment until the swale is stabilized (see photo 5).

Photo 5:
Outfall S201
 A roadside swale was observed. The swale should be stabilized with grass, matting, rock, or other means to prevent washout. Check dams may be needed to capture sediment until the swale is stabilized.
 Photo Taken 8/31/2023

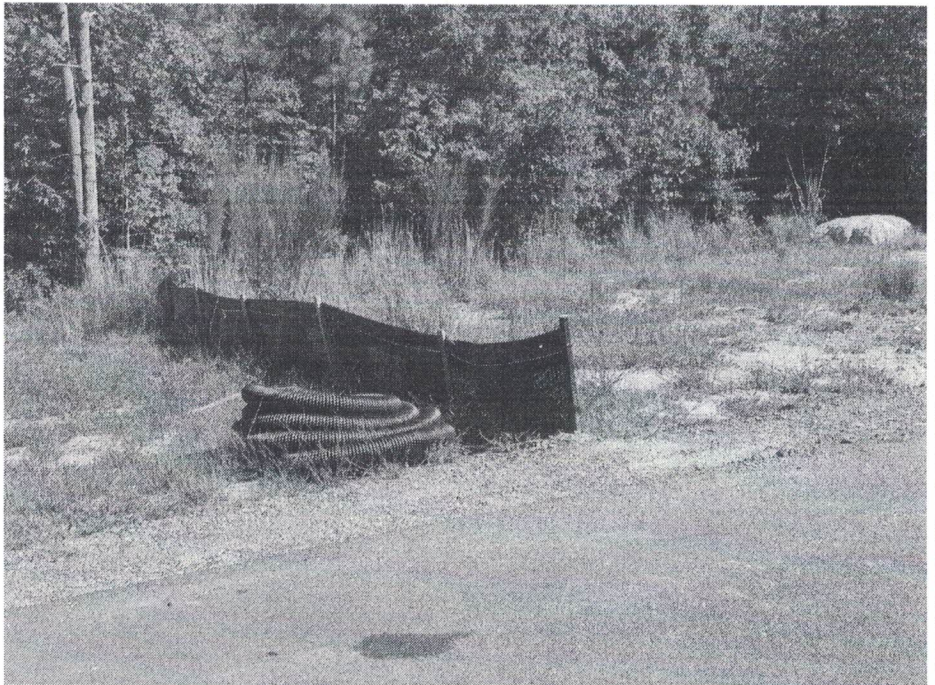
- Currently the disturbed area within outfall S208 consists of the construction of 2 home construction sites, roadway construction, and utility installation along the roadway. The disturbed area within the outfall S208 drainage basin is approximately 2.0 acres.
- An individual home construction site was observed, and erosion control measures appeared to be in place and functioning properly (see photo 6).

Photo 6:
Outfall S208
 An individual home construction site was observed, and erosion control measures appeared to be in place and functioning properly.
 Photo Taken 8/31/2023

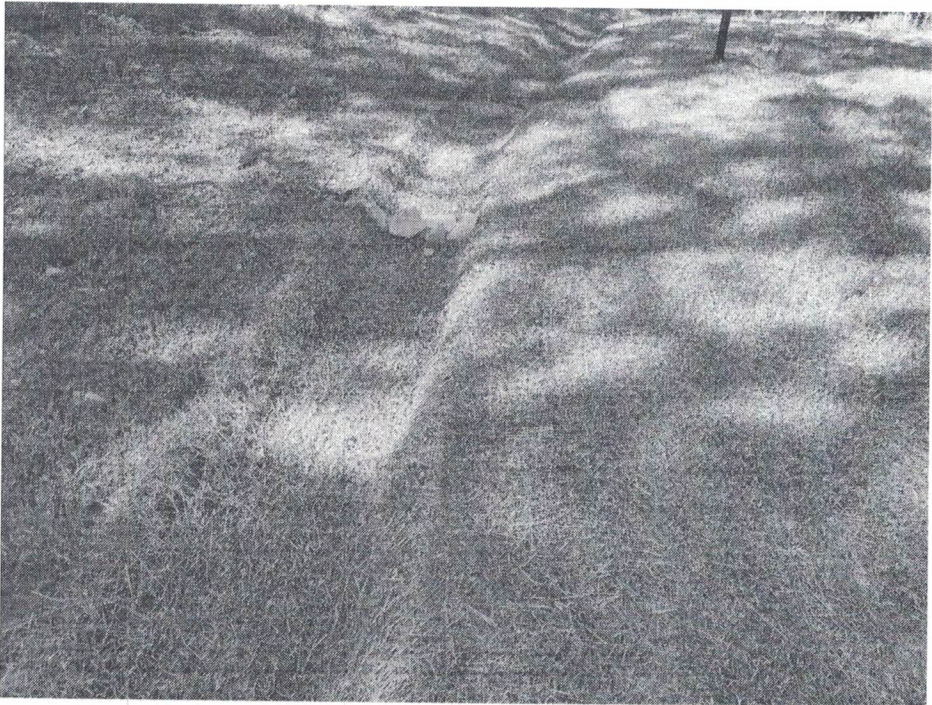
- Currently the disturbed area within outfall S218 consists of 7 home construction sites, roadway construction, and utility installation along the roadway. The disturbed area within the outfall S218 drainage basin is approximately 2.5 acres.
- A roadside swale was observed. The swale has recently been stabilized with grass, matting, and rock check dams (see photo 7).

Photo 7:
Outfall S218
 A roadside swale was observed. The swale has recently been stabilized with grass, matting, and rock check dams.
 Photo Taken 8/31/2023

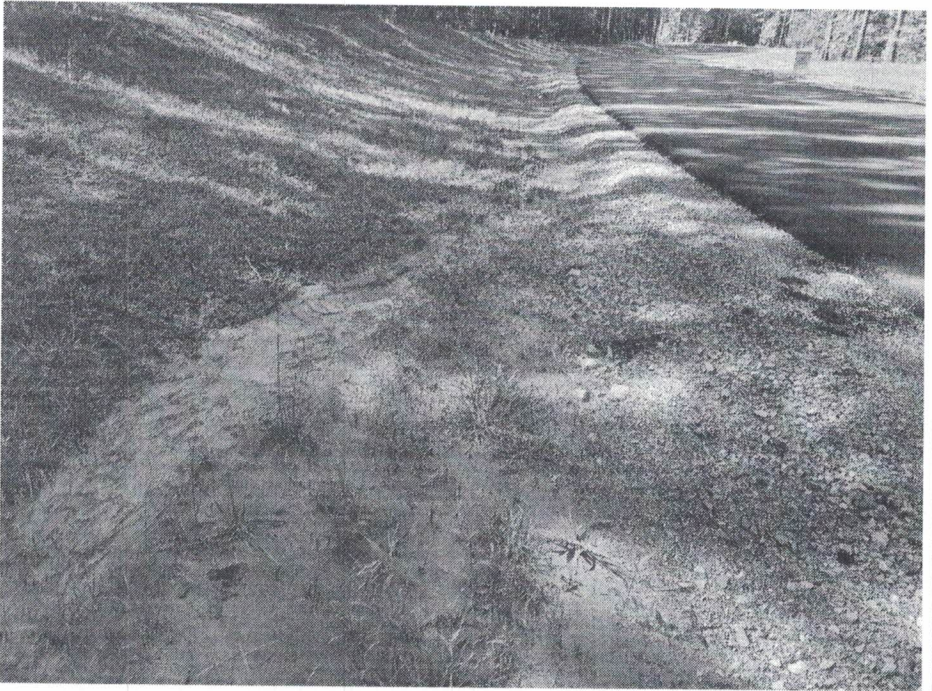
Photo 8:
Outfall S275
 Areas recently disturbed for utility installation should be stabilized. Rock check dams may be needed in roadside swales to control sediment.
 Photo Taken 8/31/2023
