RE: **Notice of Violation and Compliance Review Meeting**  
Compliance Evaluation Inspection (CEI);  
City of Celina Sewer Treatment System, NPDES # TN0063886

The City of Celina Wastewater Treatment Plant (NPDES # TN0063886), July 28, 2022; Clay County

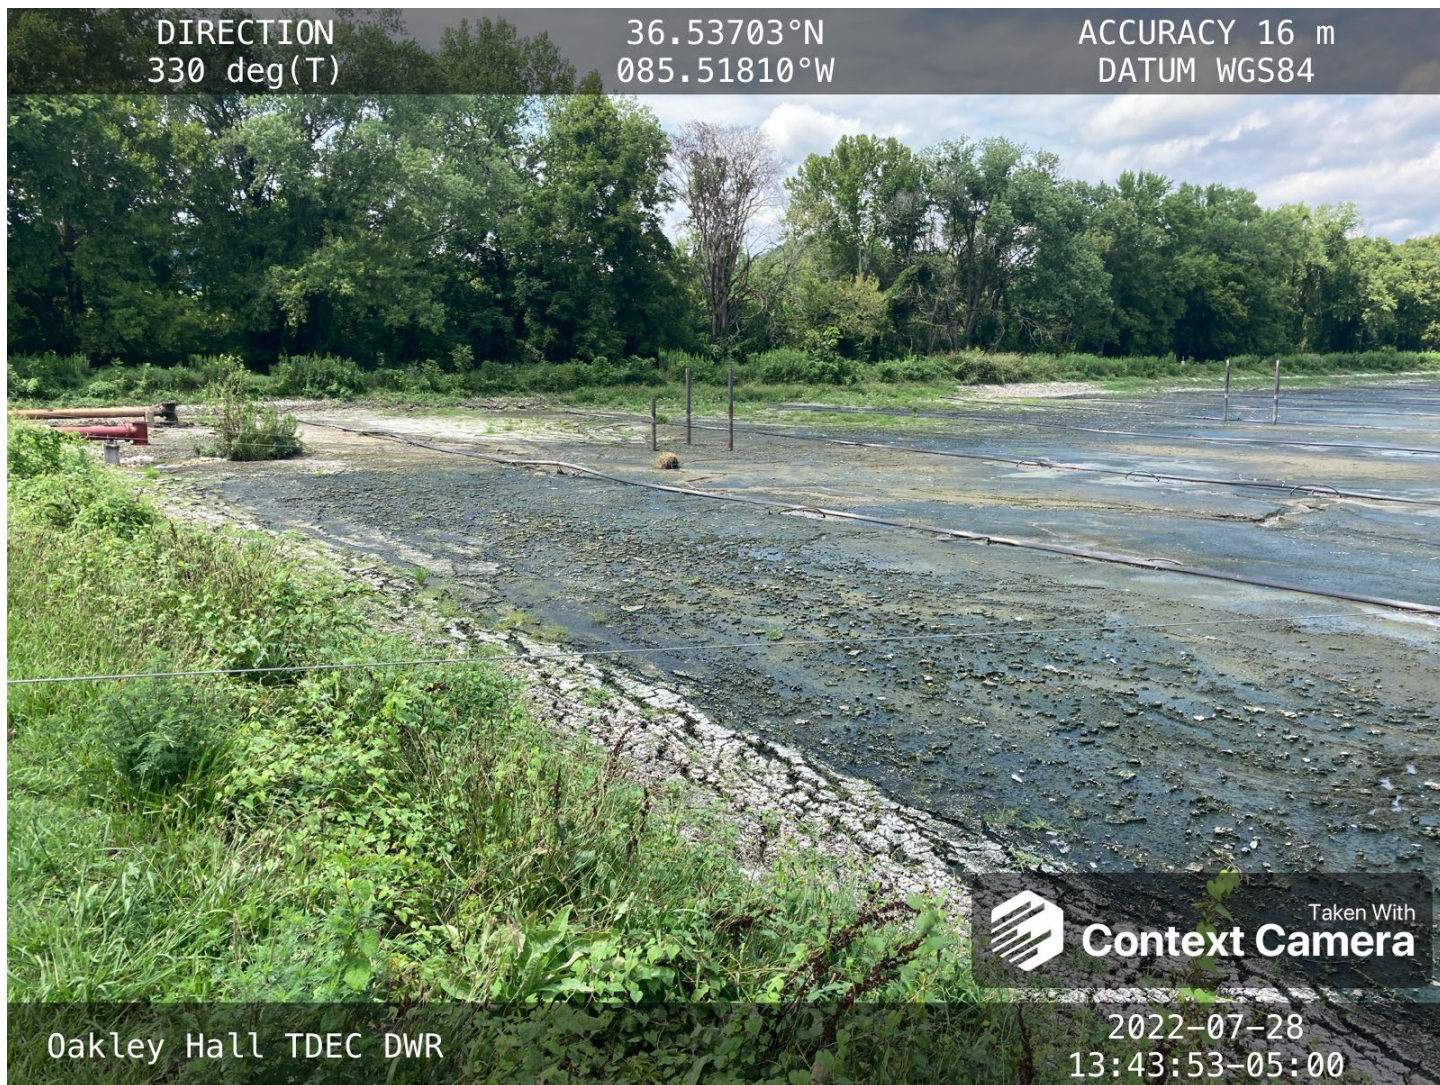
The first in the series of three ponds is pictured. It was drained in order to place the concrete pedestal for the new influent pipe support. Heavy solids were visible in this first pond. It was heavily laden with fibers from hygiene products.

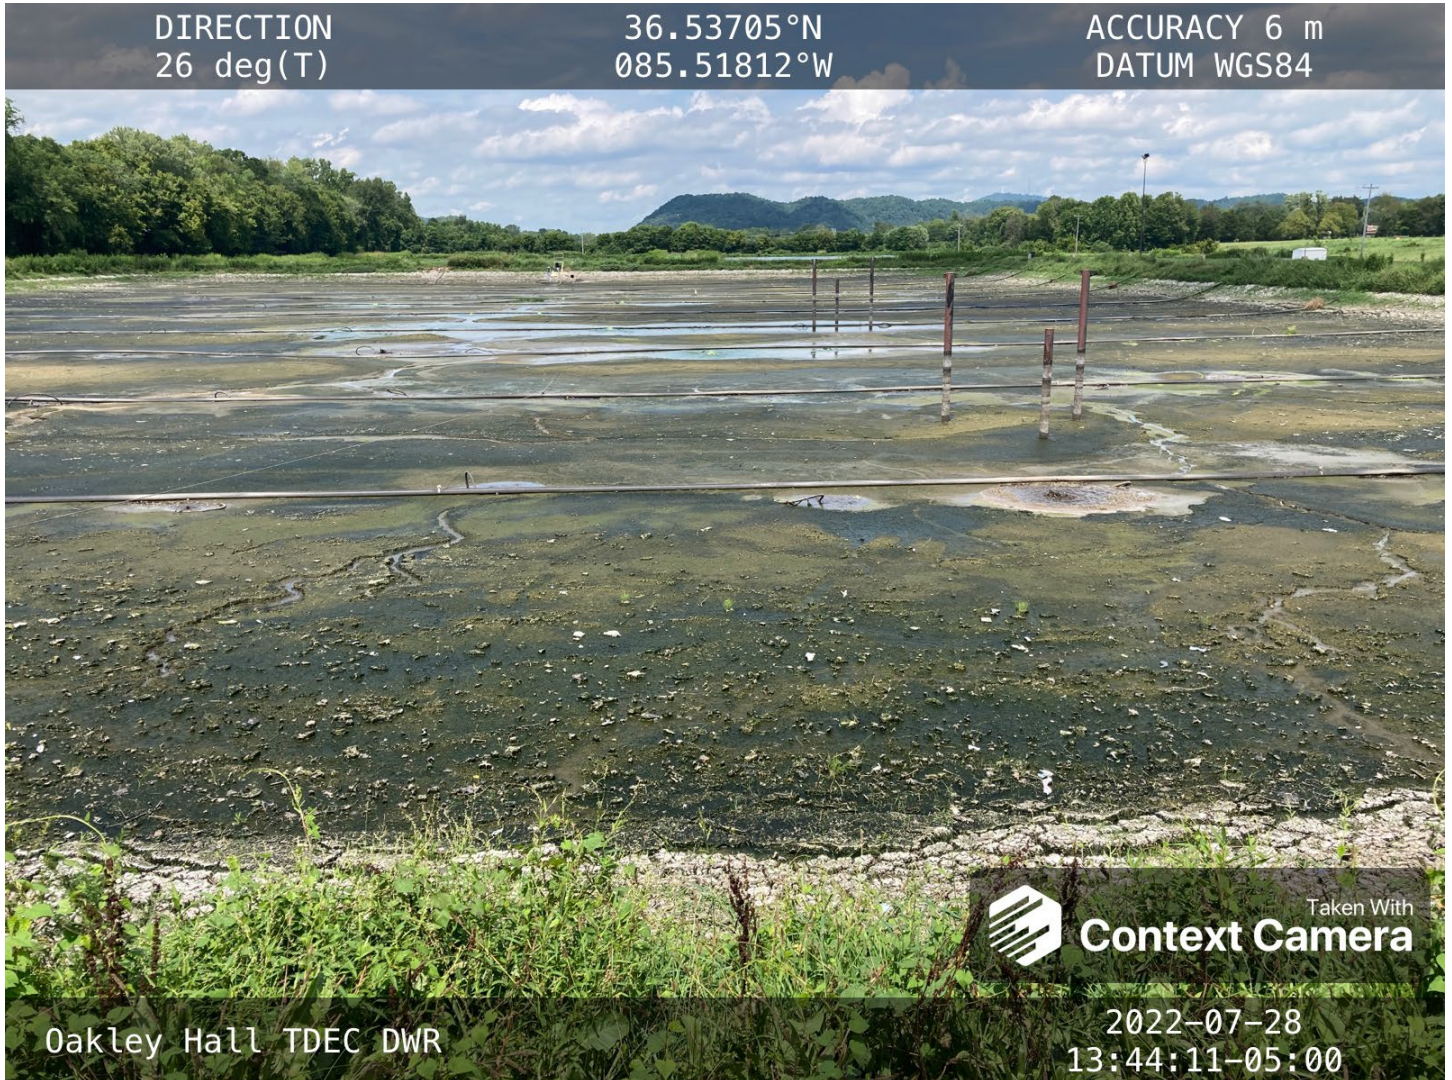
Heavy solids are distributed across the pond. Since the headworks were never properly operational and repairs unsuccessful, hygiene products of fiber and plastic have not been properly removed. The sludge in this pond has not been removed under a maintenance schedule. Solids from unscreened septic hauler's waste has contributed to the problem.

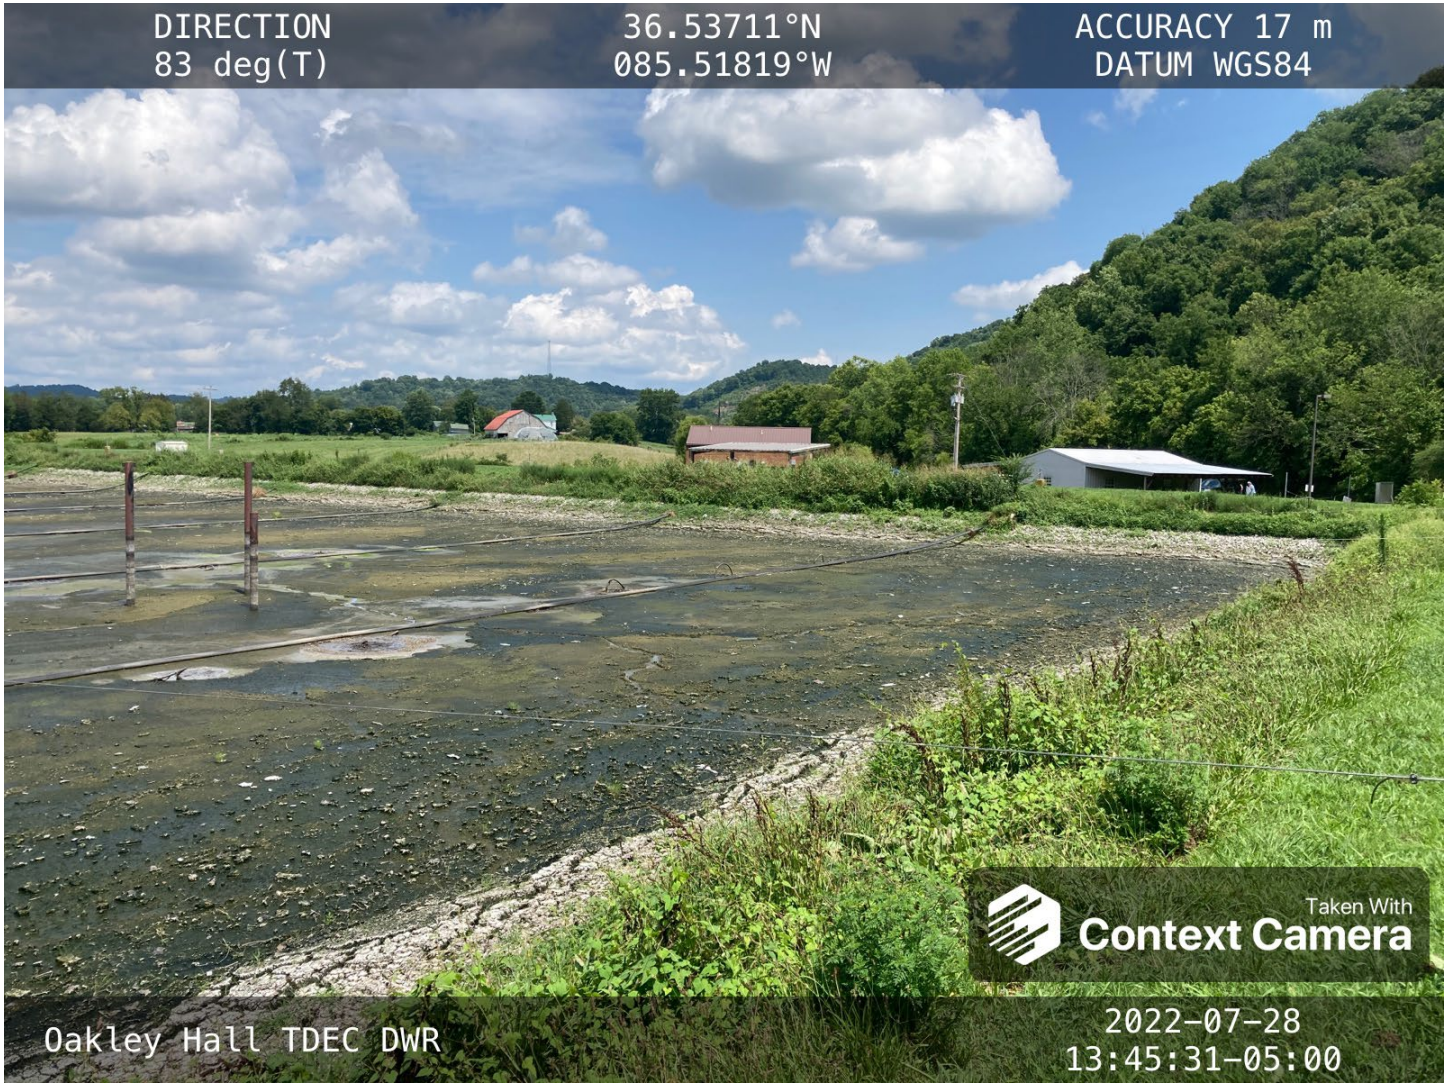
The sludge buildup in the ponds has likely affected the efficiency of the aeration unit(s).

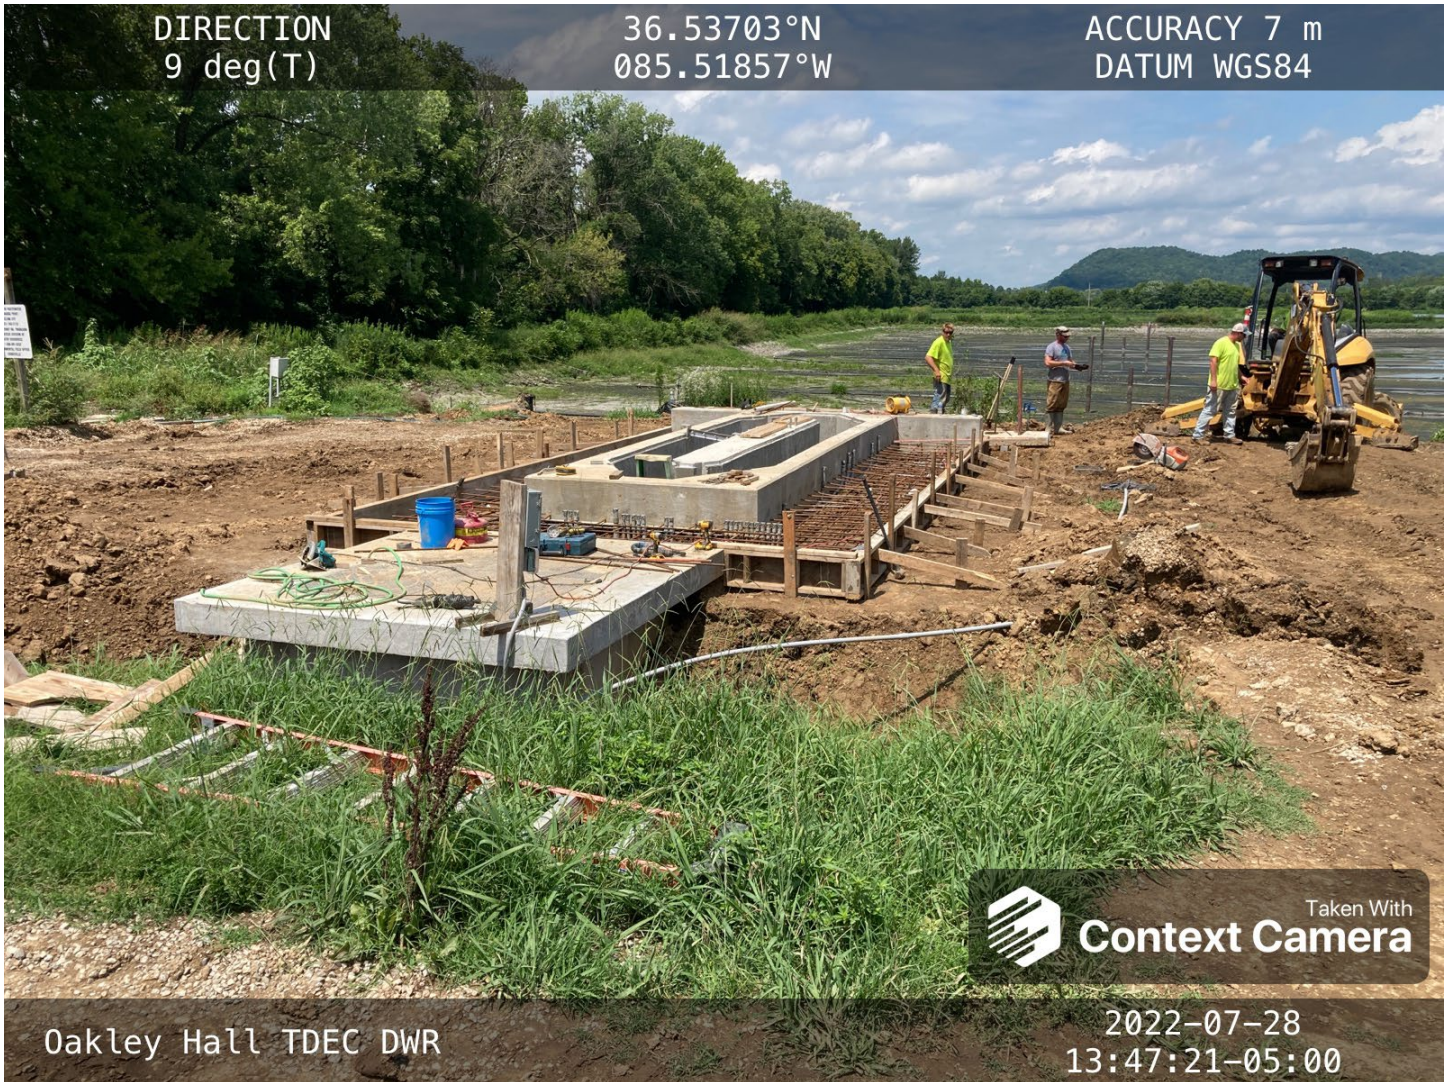
The third iteration in headworks is being constructed for this sewer treatment system.

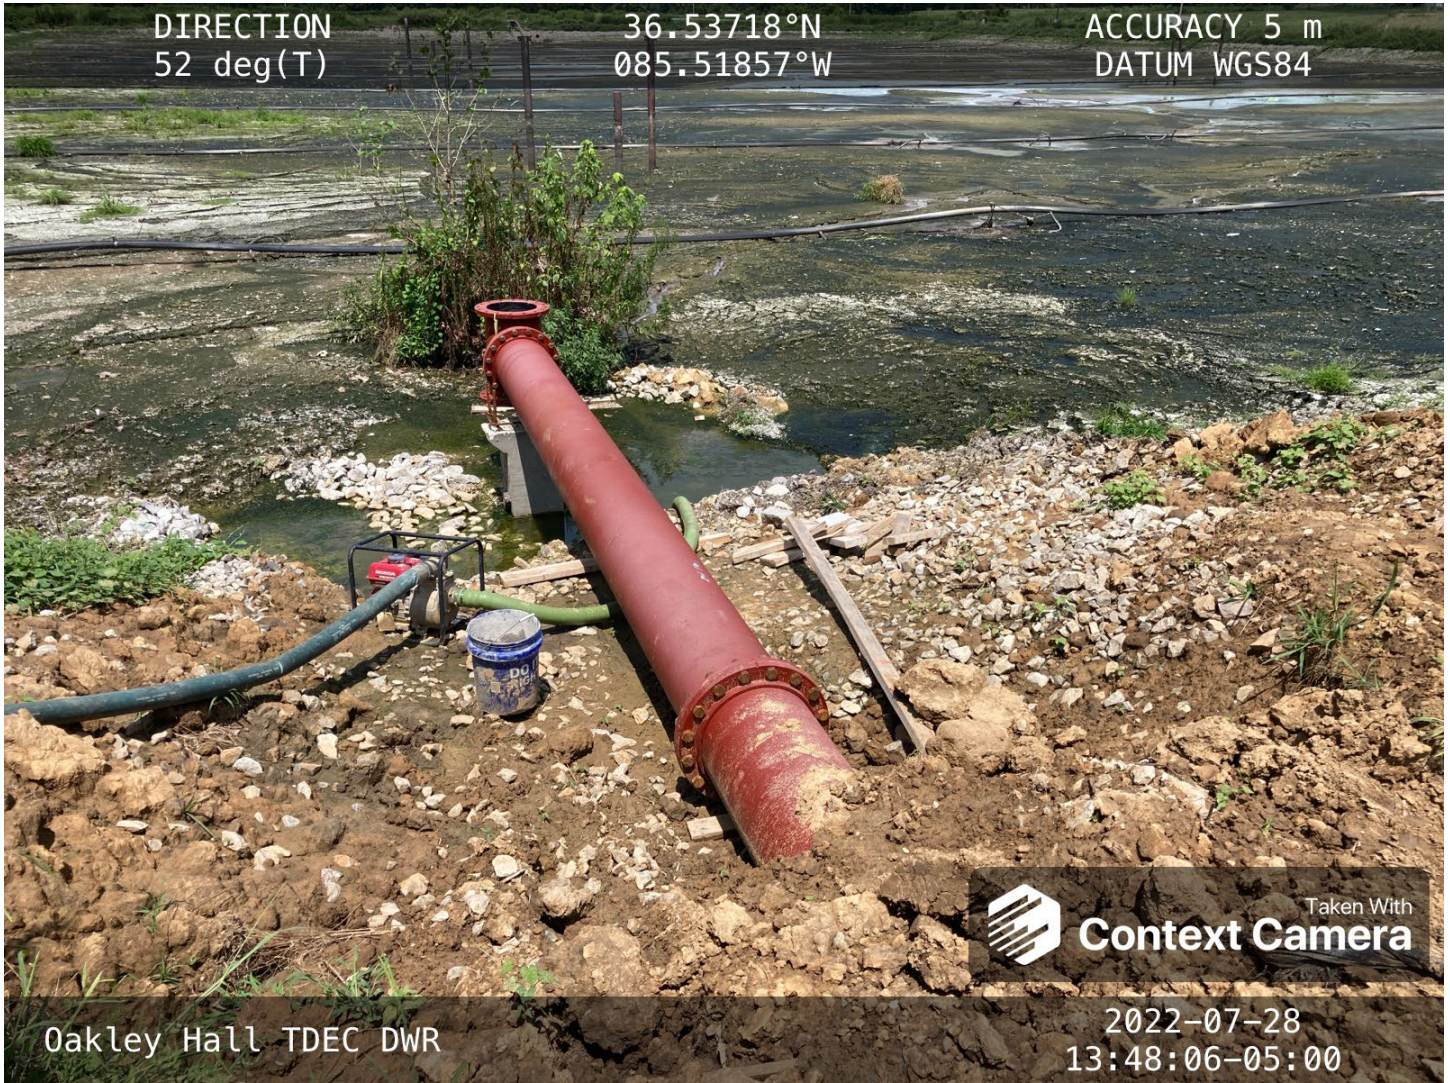
Heavy thick solids are visible in the first pond as the pedestal for the new inlet pipe is constructed. Vegetation is growing on the surface of the sludge. Talking to the Operator, a thin layer of clay may have been used for the lining of the pond. The operator was asked to immediately record photos of the pond in order to assess the removal of these observed solids.

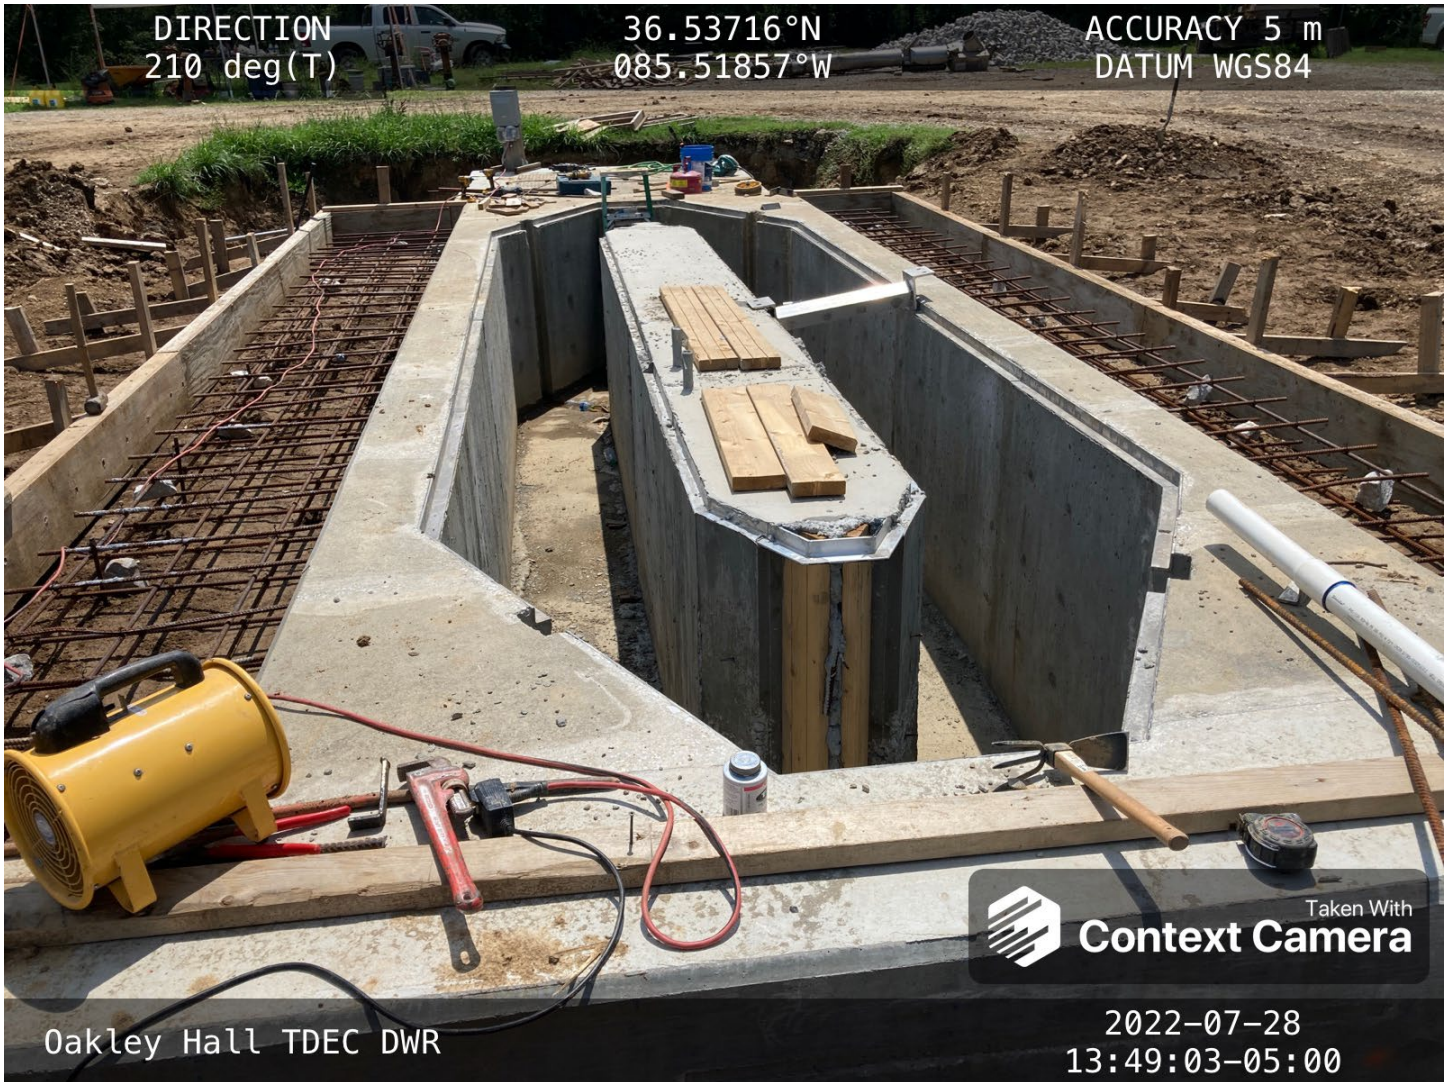
The concrete form for the new headworks is pictured. Some piping issues have come to light with the as built plans. The piping issues had to be discussed with engineering personnel.

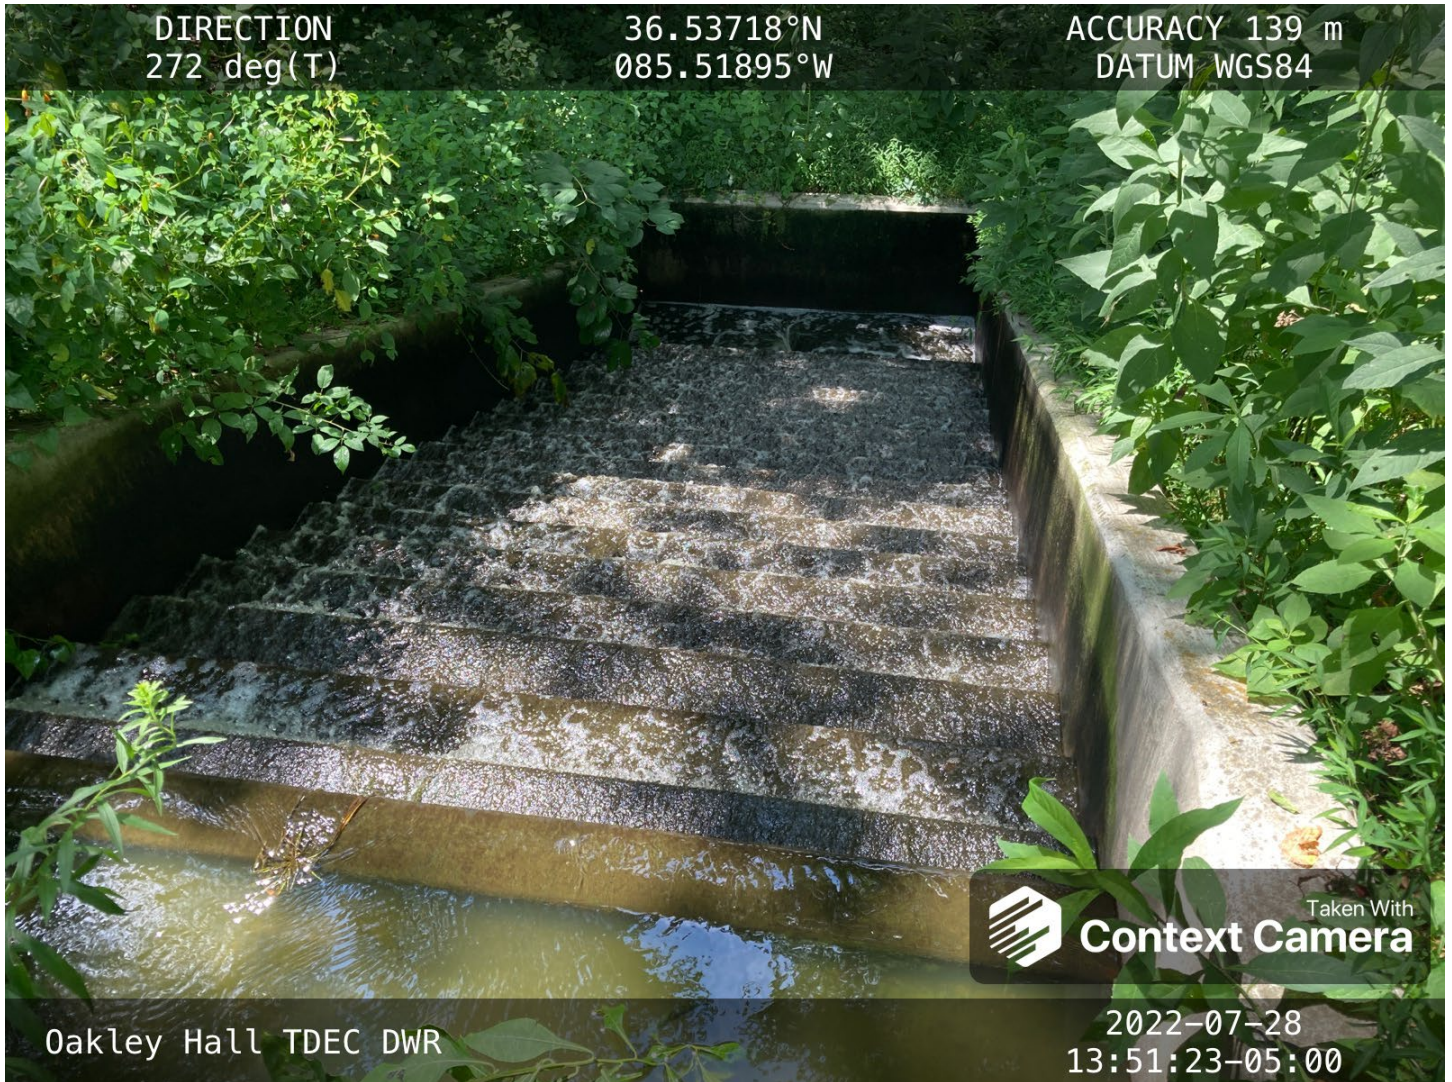
The effluent discharge is pictured. This is with the first pond bypassed. The Operator stated that he had a couple of violations while removing the first pond from service. The Operator and City will need to develop a plan for the removal of the sludge solids from at least the first pond. It will need to be done next year after the new headworks system is on-line.

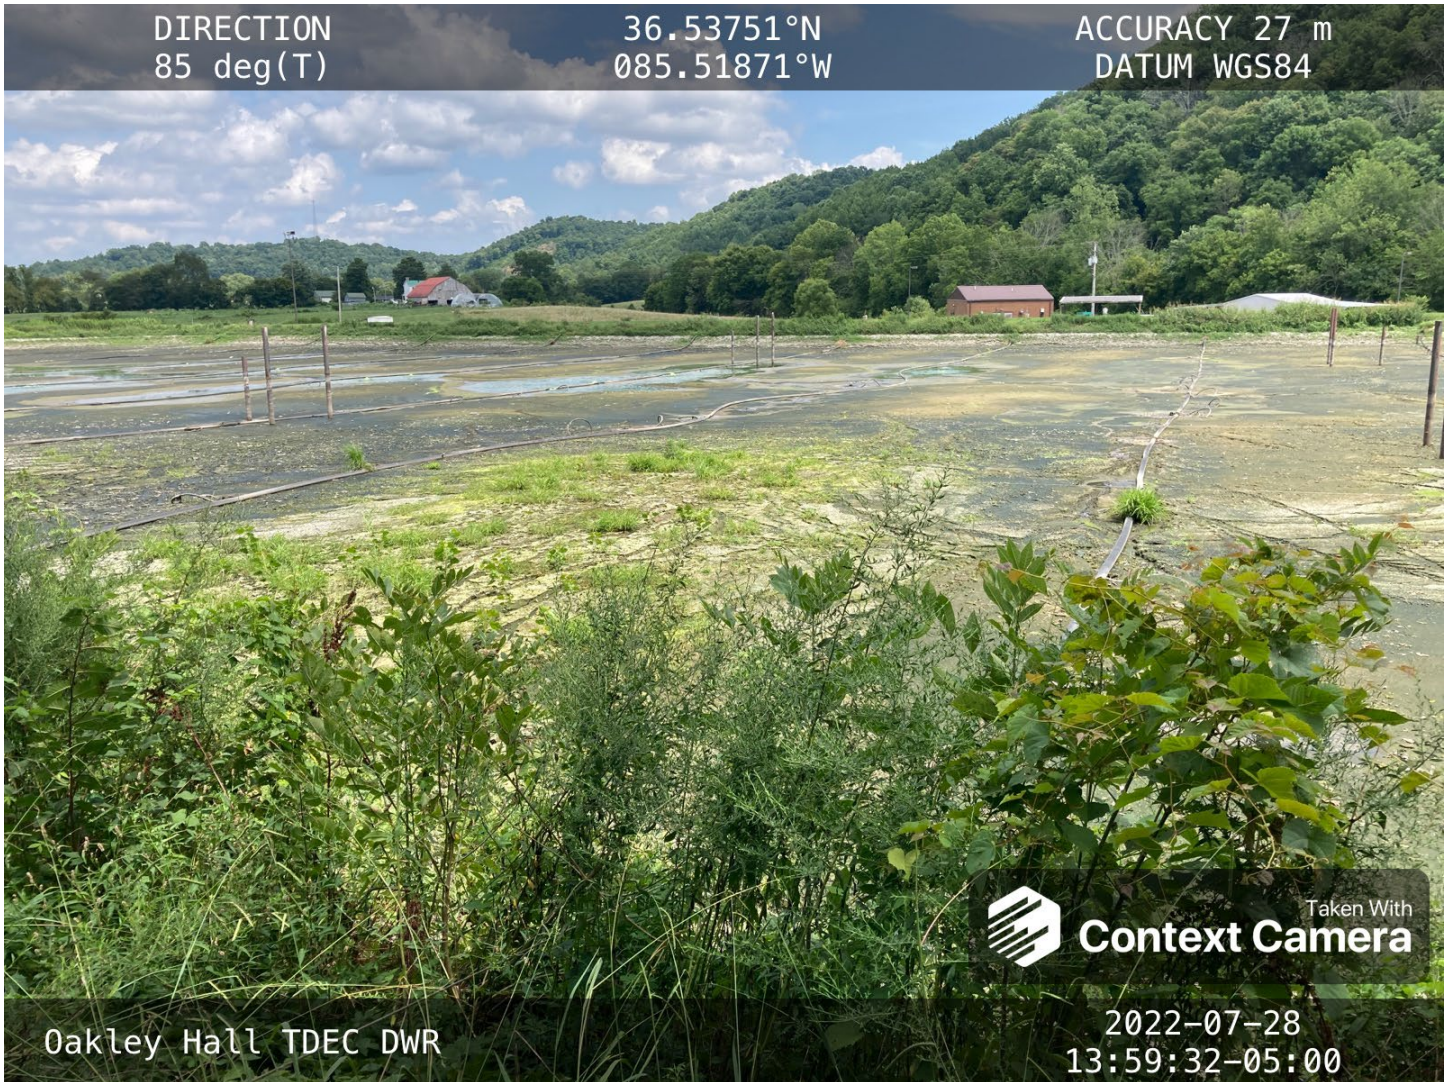
The first pond is pictured. Note the solids delta with vegetation in the forefront of the picture. This material should have never been allowed to build up in the pond. This is due to a lack of proper maintenance by periodically removing the solids.

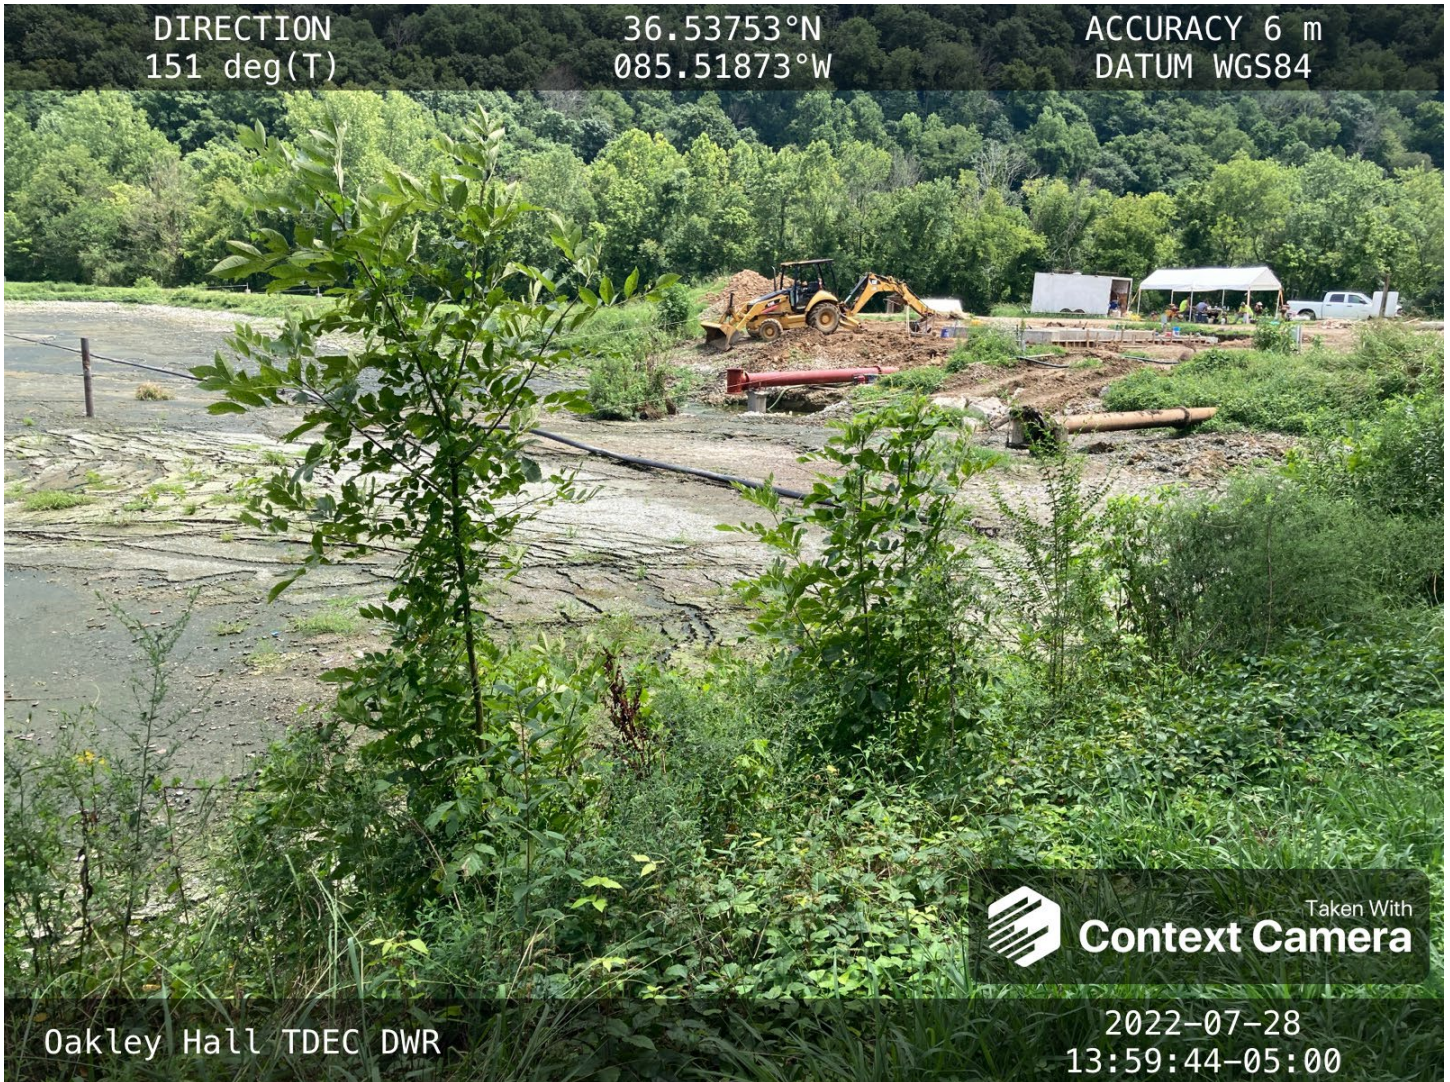
The construction area of the new headworks is pictured. Note the heavy solids in the first treatment pond.

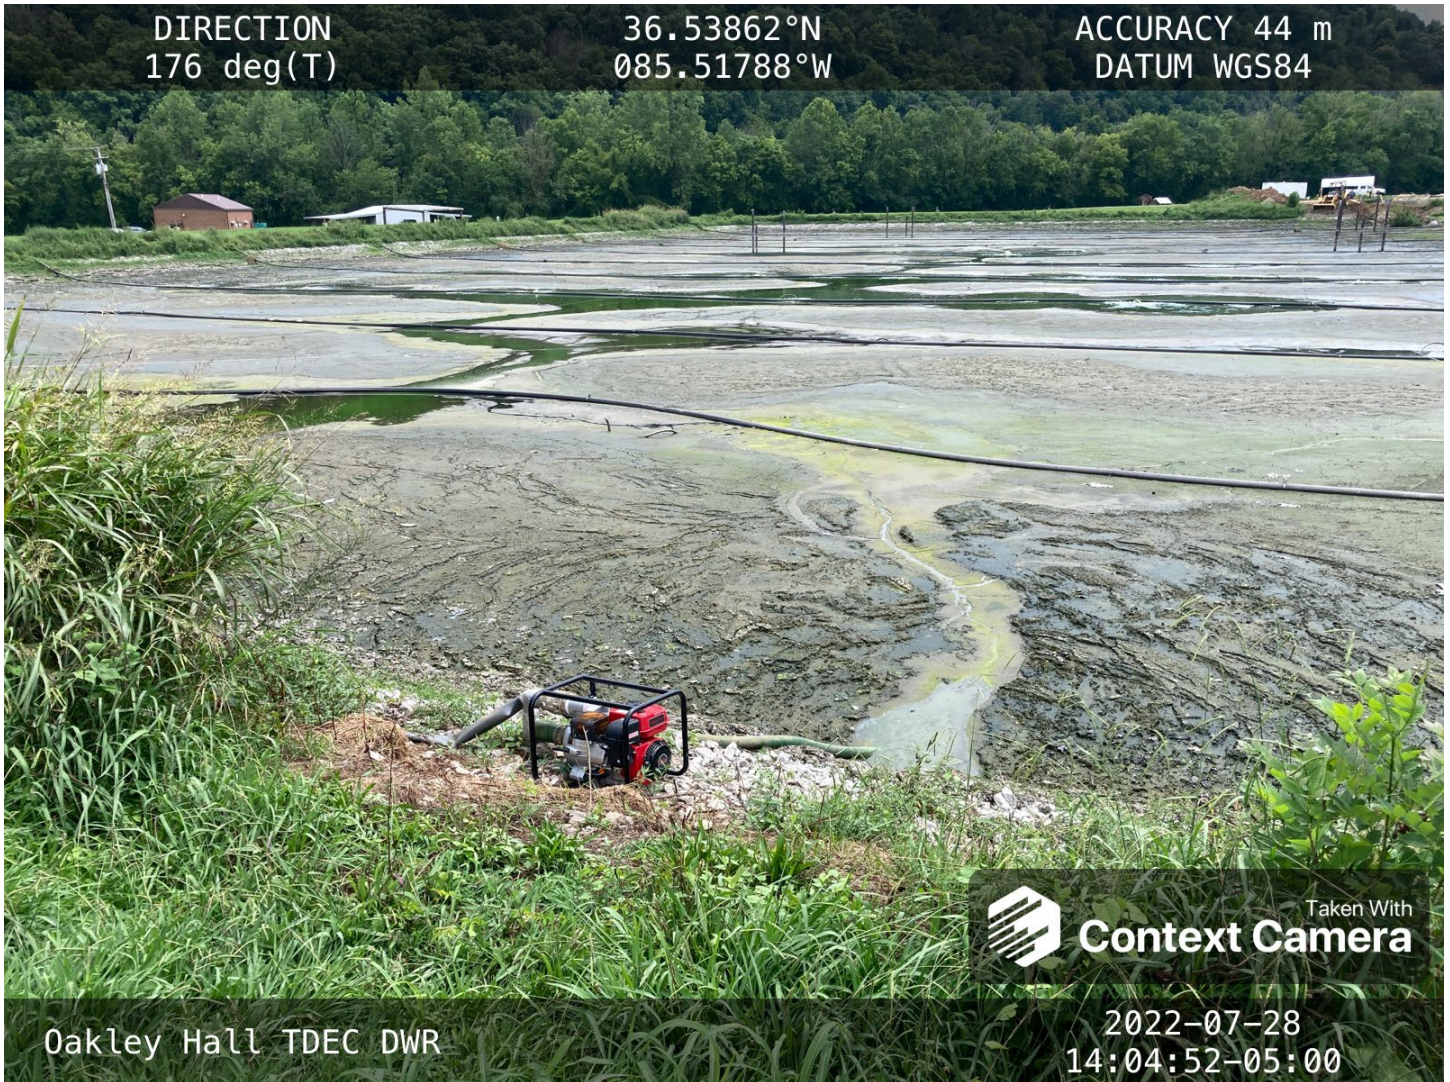
Two pumps are being used to assist draining the first pond as it is bypassed.

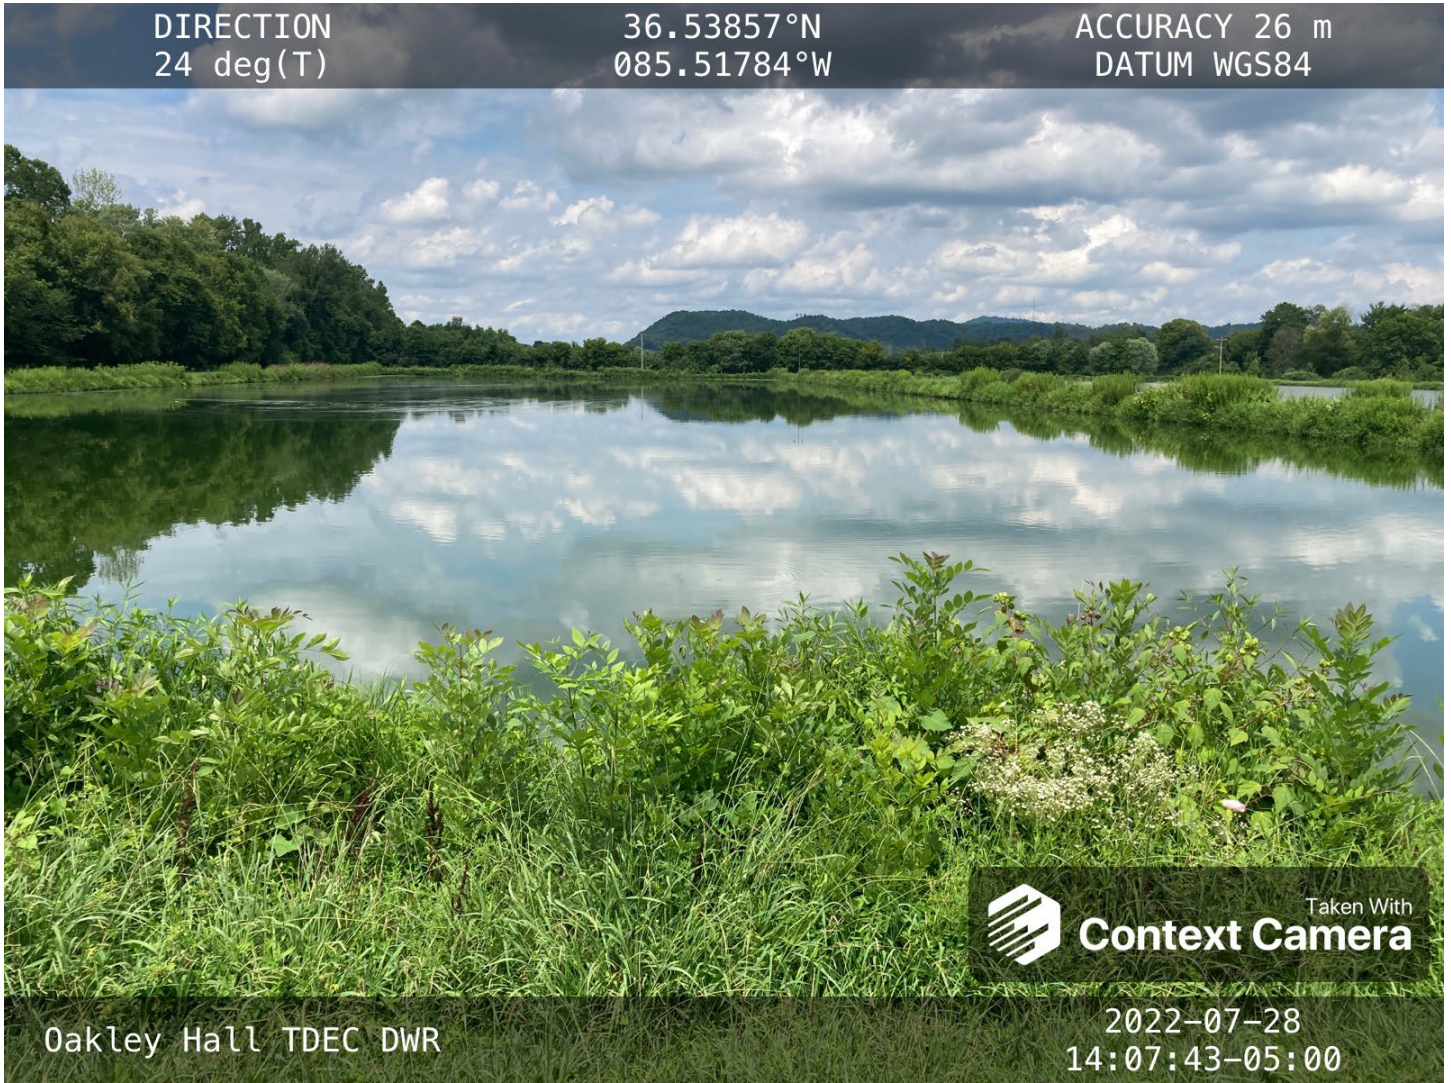
The second pond is pictured. The solids level in this pond will need to be determined.

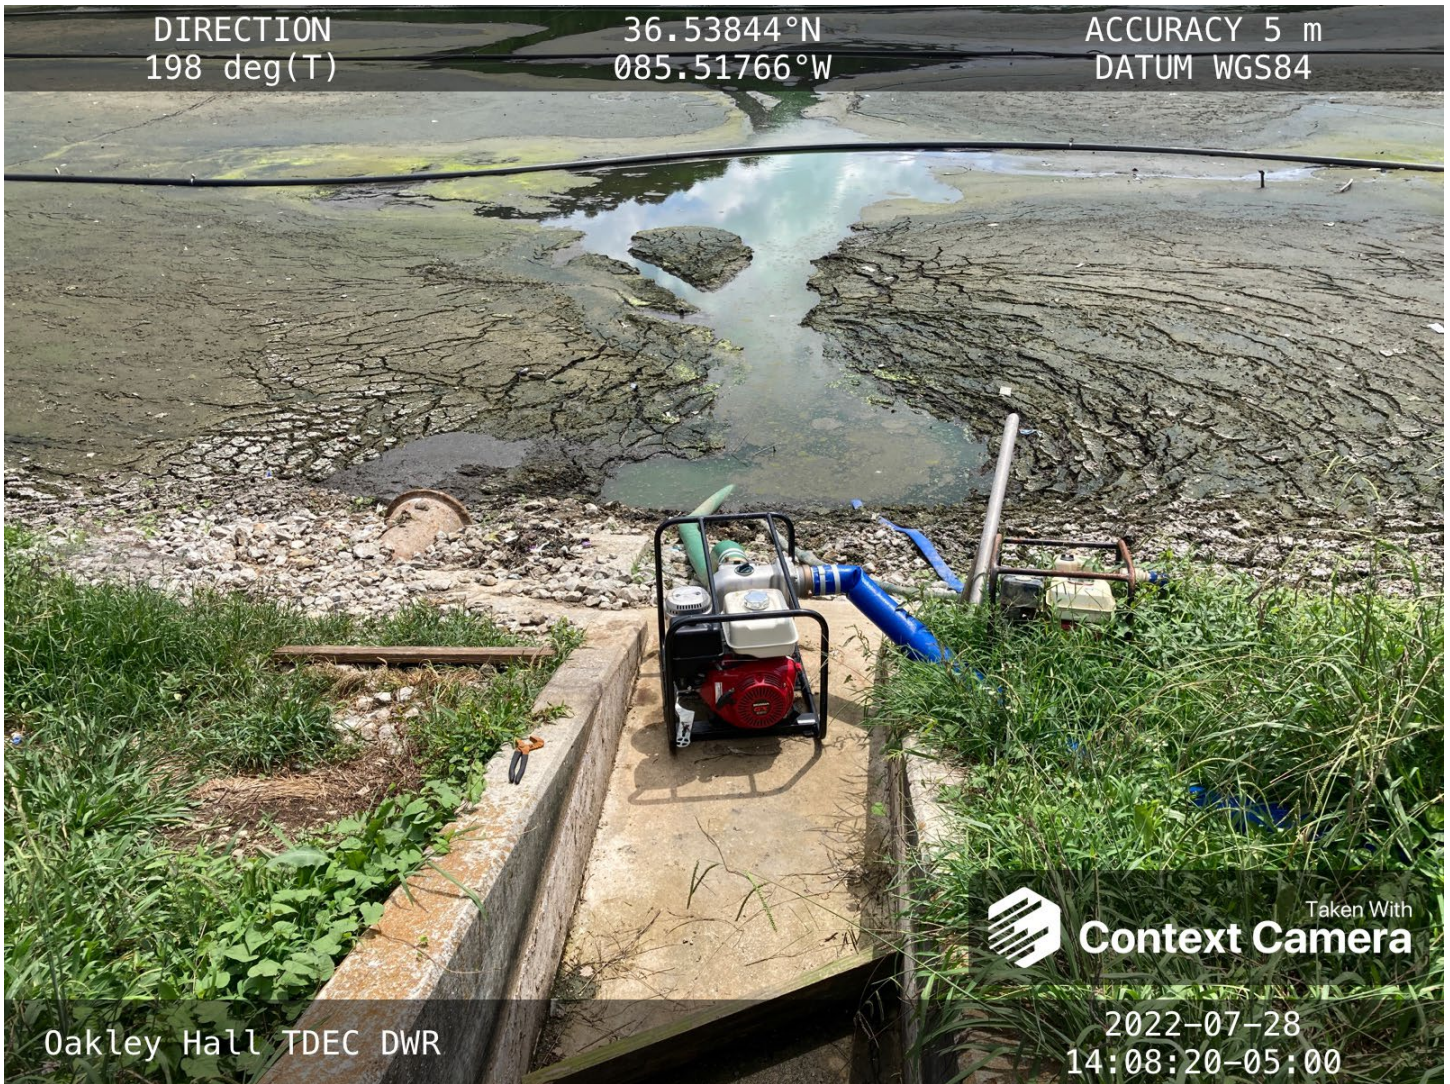
The second of two pumps is being used to assist in draining the first pond as it is bypassed. This pond was bypassed with an existing bypass line. The valve had to be gently worked to get it to move and open. The valves need to be worked.

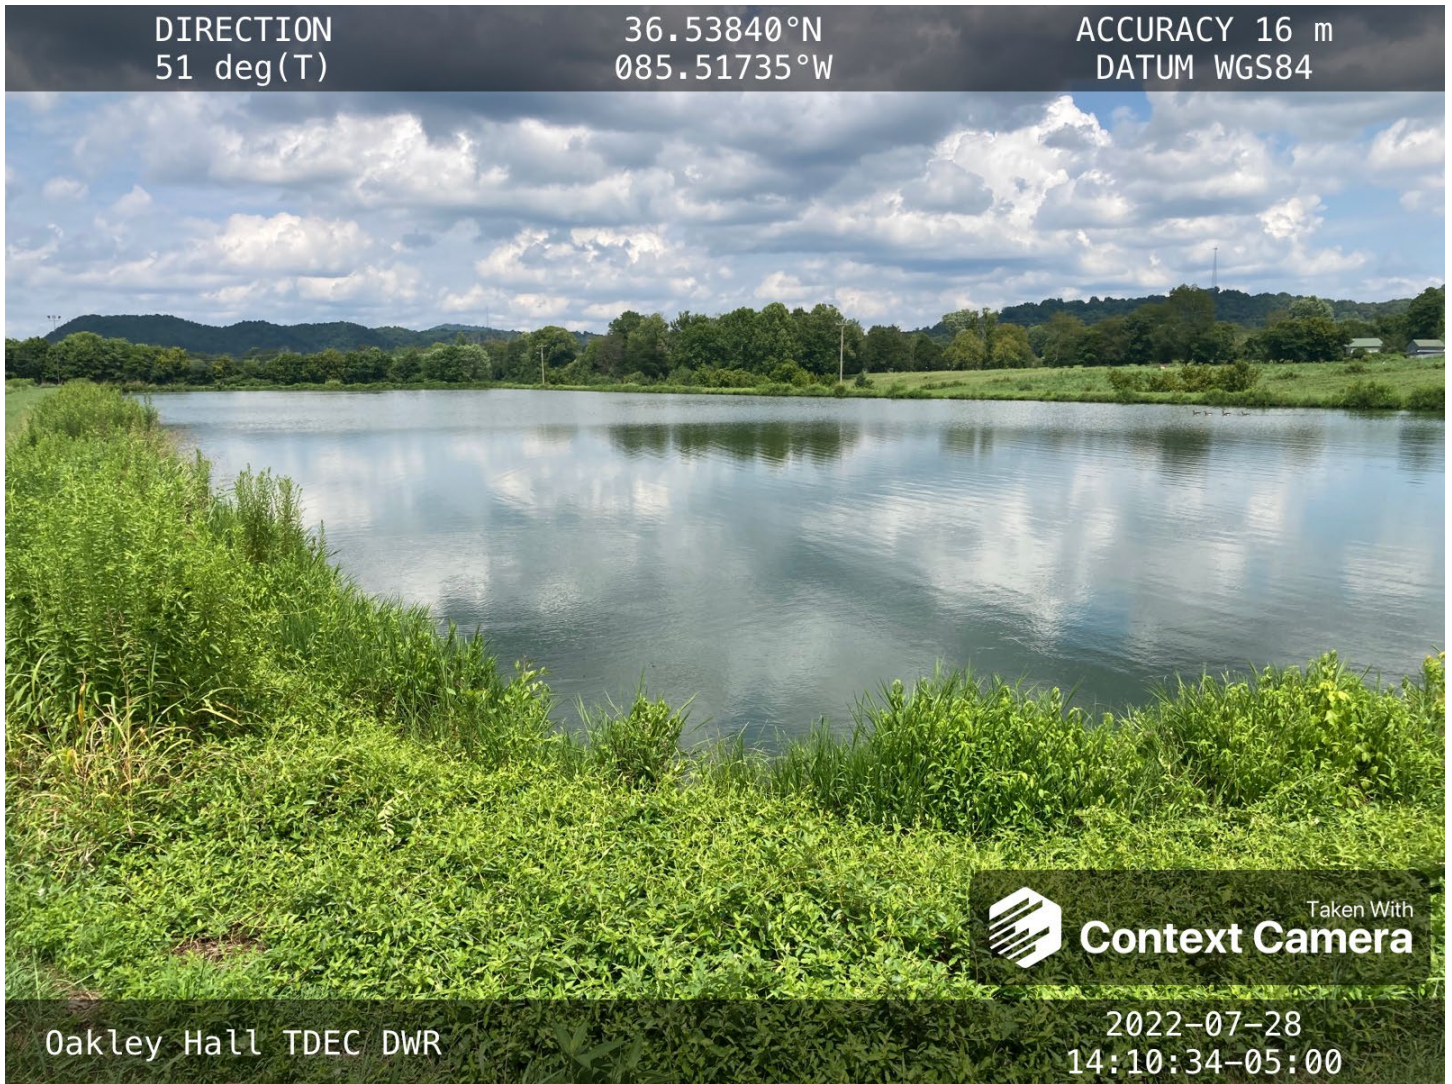
The third and final pond is pictured. Vegetation is high around the periphery of the pond. This may be in this condition to protect wild bird nests. The discharge from this pond is treated with bleach before discharged to the Cumberland River. The Operator stated that while the first pond is filling, (when the headworks are complete) he is going to drain the bleach contact chamber and perform required maintenance. This system has an approximate 30-day detention time.
