MICHAEL B. ERP, P.E.
116 WILDWOOD DRIVE
SOMERSET, KENTUCKY 42503
PHONE: (606) 875-4271

May 12, 2022

RE: NPDES Permit for Alden Resources, LLC. Area #6, Campbell County, TN
NOV Response for NPDES #TN0070408, OSM #3340

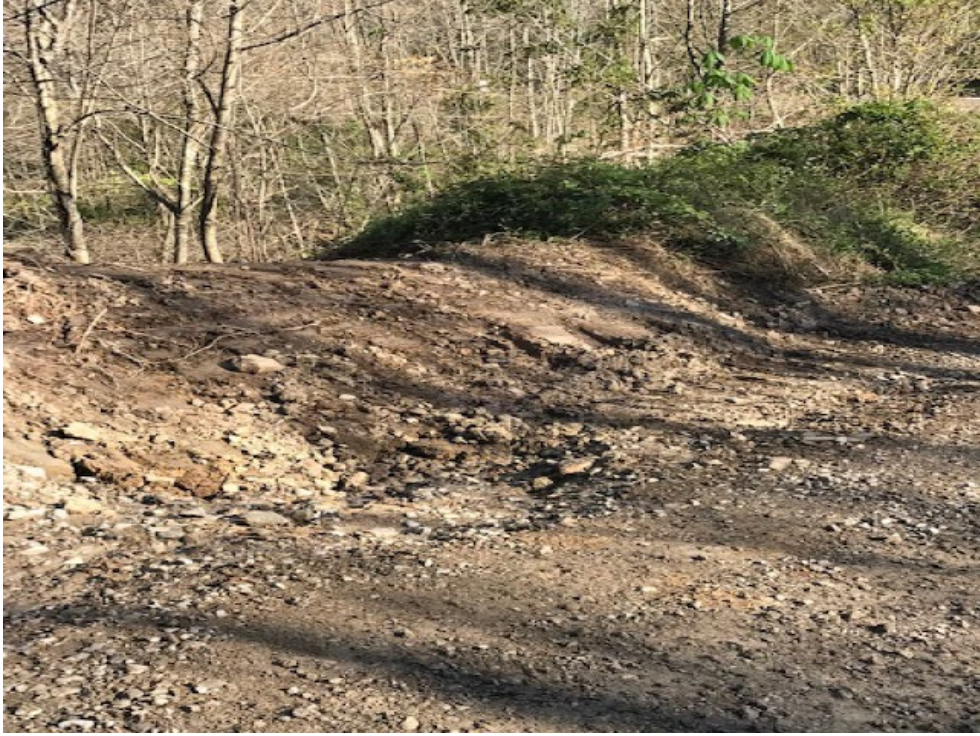
Pic. 1 Haulroad Berm Repair

1. Drainage windows in the haul road berm have been closed up and road drainage has been confined to outlets that have sumps installed prior to discharge. (See Pics 1-3)
2. Pond #100 has been lined with claylike shale and is beginning to impound water, this feature will continue to be monitored to see if any additional leaks are present
3. Auger holes on the inside of pond #100 have been packed with claylike shale for sealing, the auger holes and high wall miner holes within the pond #103 watershed have likewise been packed with claylike shale
4. The diversion ditches to pond #100 have been re-graded and modified to provide the proper minimum depth and configuration per approved designs
5. Pond #103 has been constructed and "as built" certification materials (OSM submittal) have been included to document the certification. The previously submitted materials for the pond 100

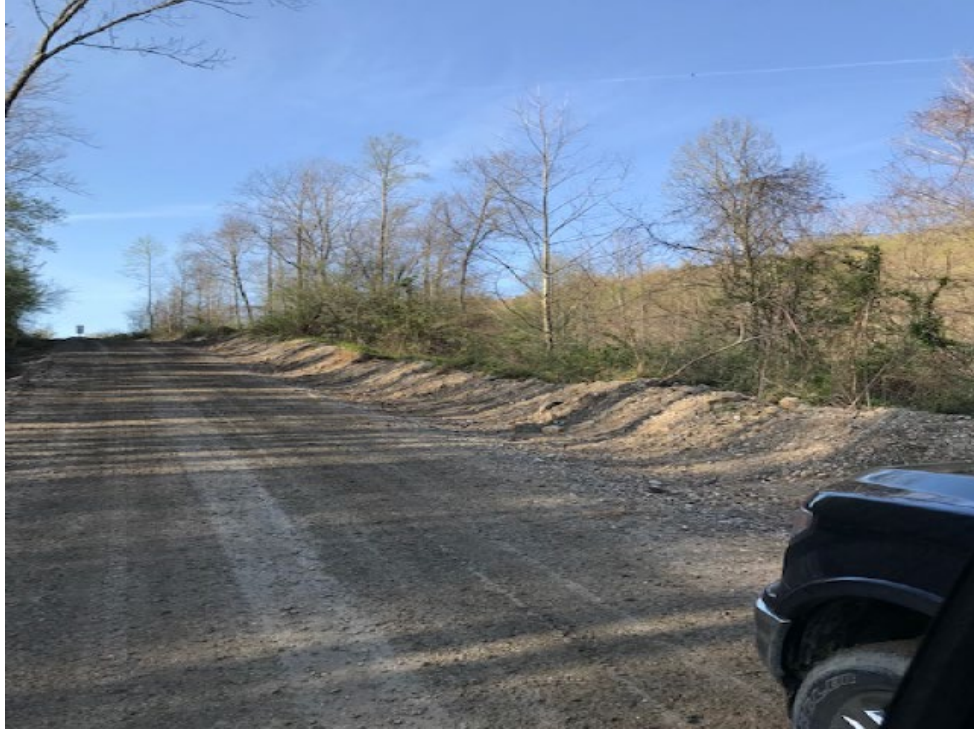
Pic. 2 Haulroad Berm Repair near top

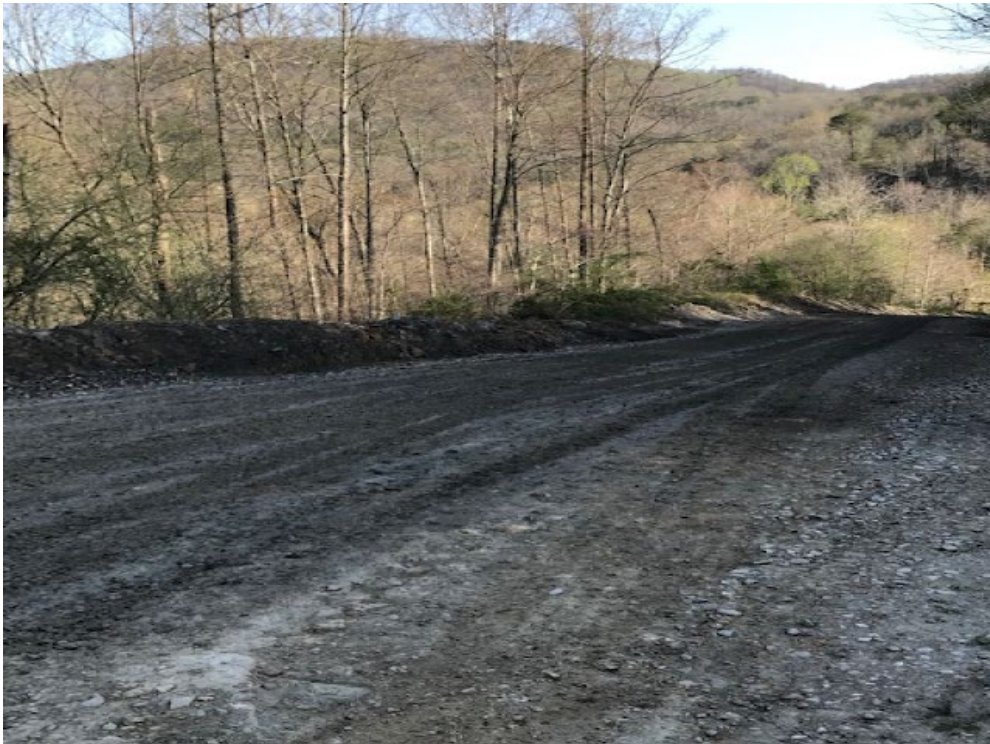
Pic. 3 Haulroad Berm Repair looking down

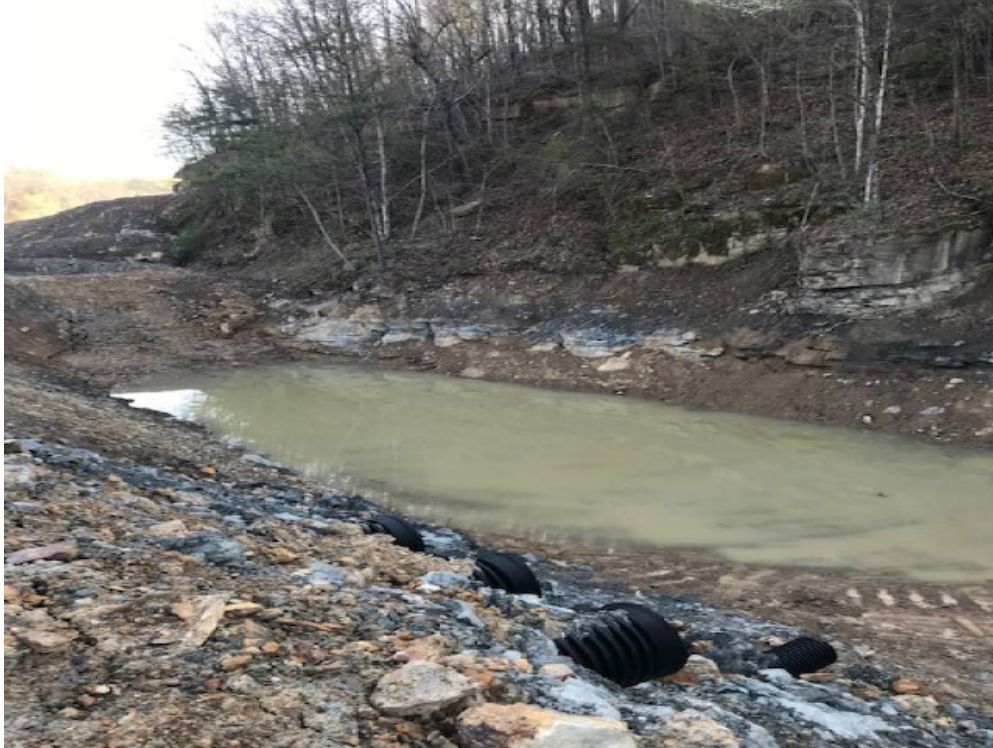
Pic 4 Pond 100 Sealed and Auger Holes Plugged (above white rock line in back)

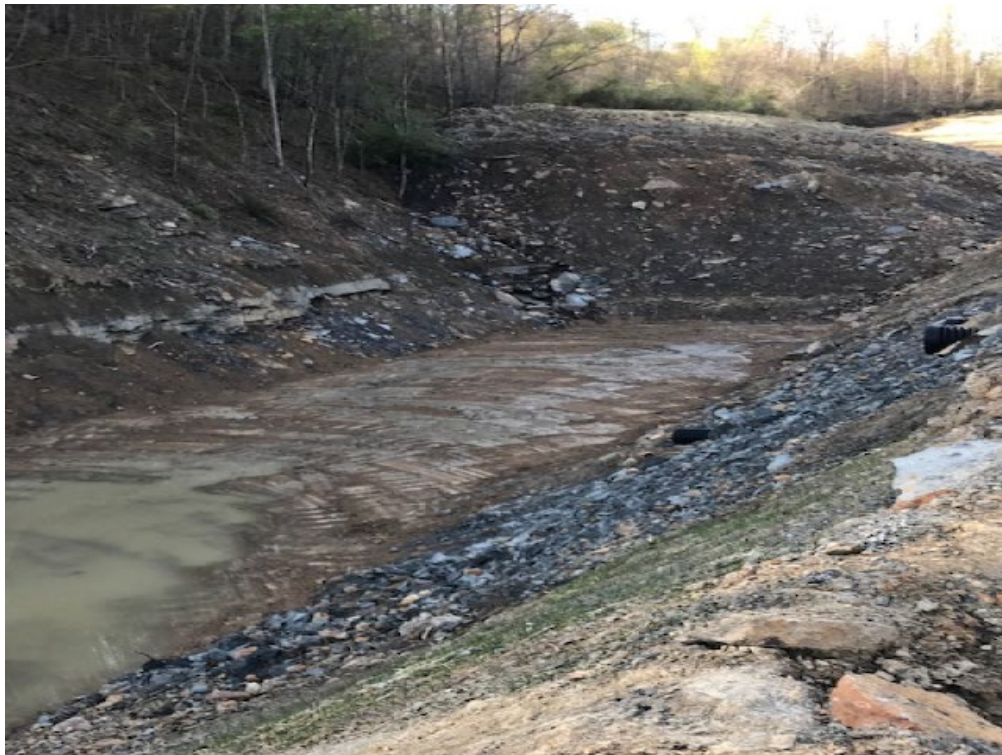
Pic 5 Pond 100 bottom seal and auger hole seal (background)

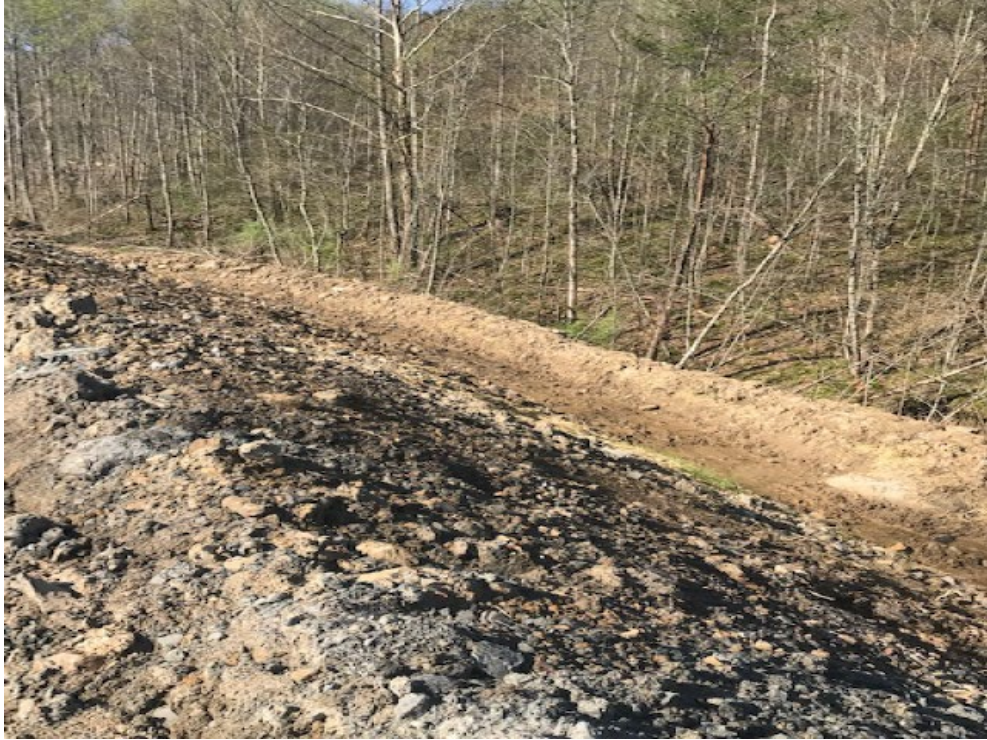
Pic 6 Re-Worked Ditch to pond 100

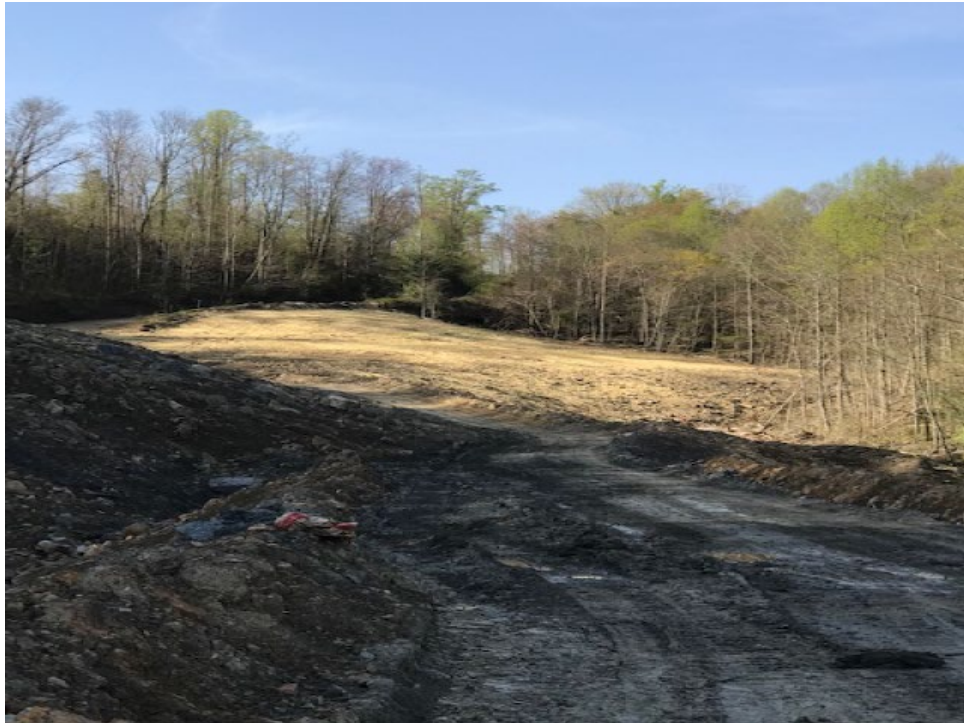
Pic 7 Upslope of Pond 100 (was supplemented with hydro-seeding after this 4/22/22)

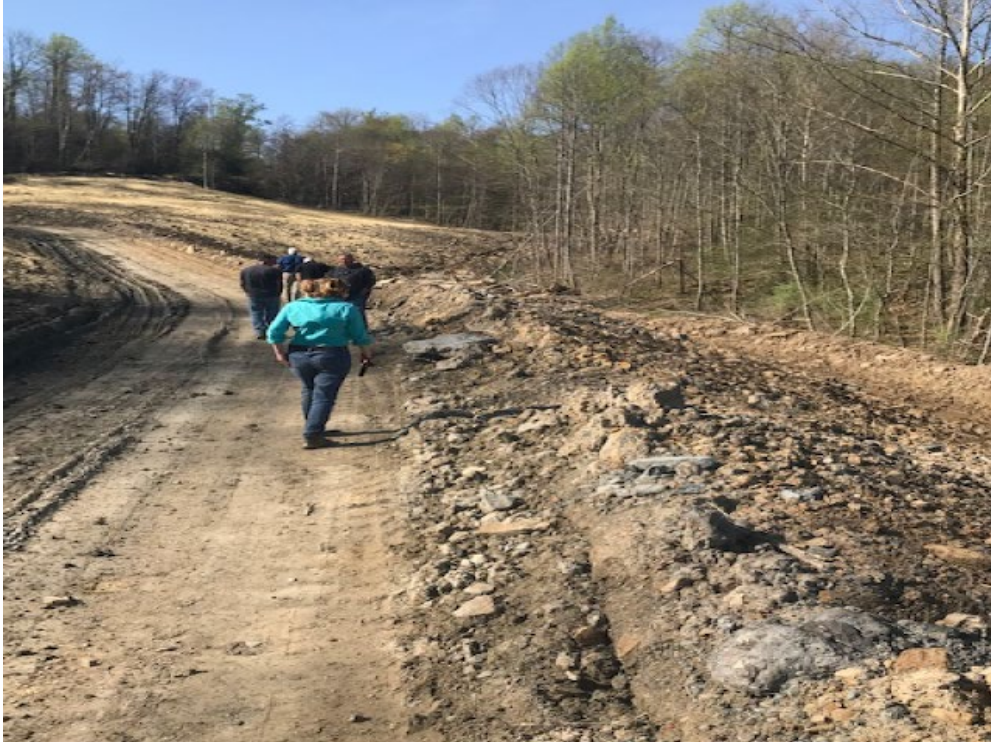
Pic 8 Field walk of Pond 100, upslope ditch, upslope area (4-22-22)

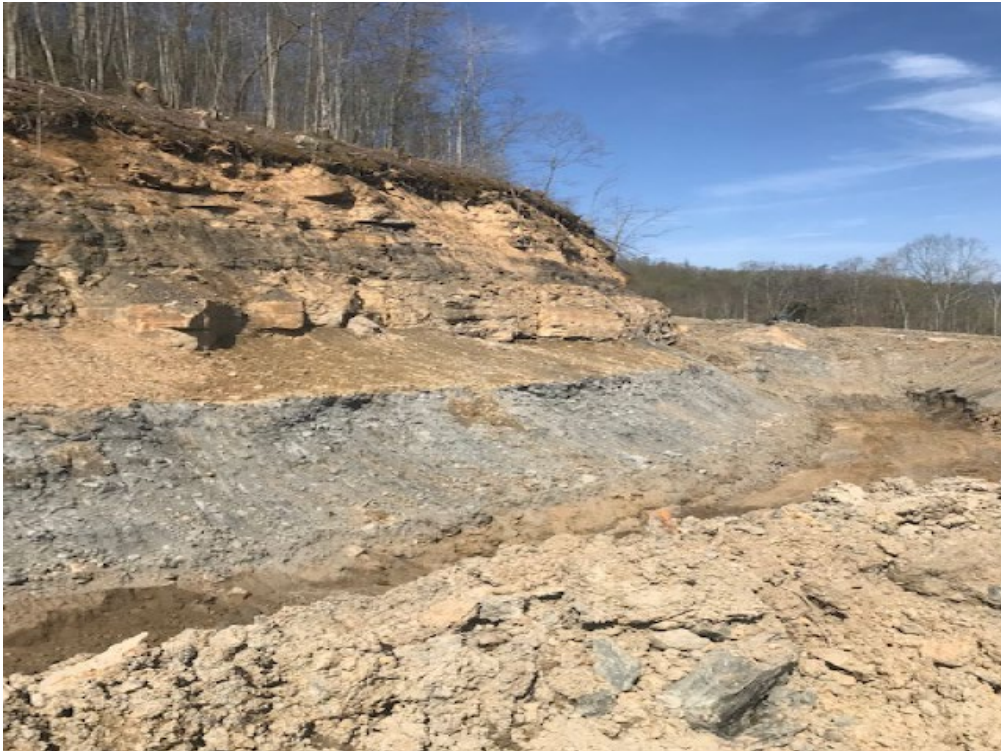
Pic 9 Pond 103 during construction and sealed auger holes above gray shale line

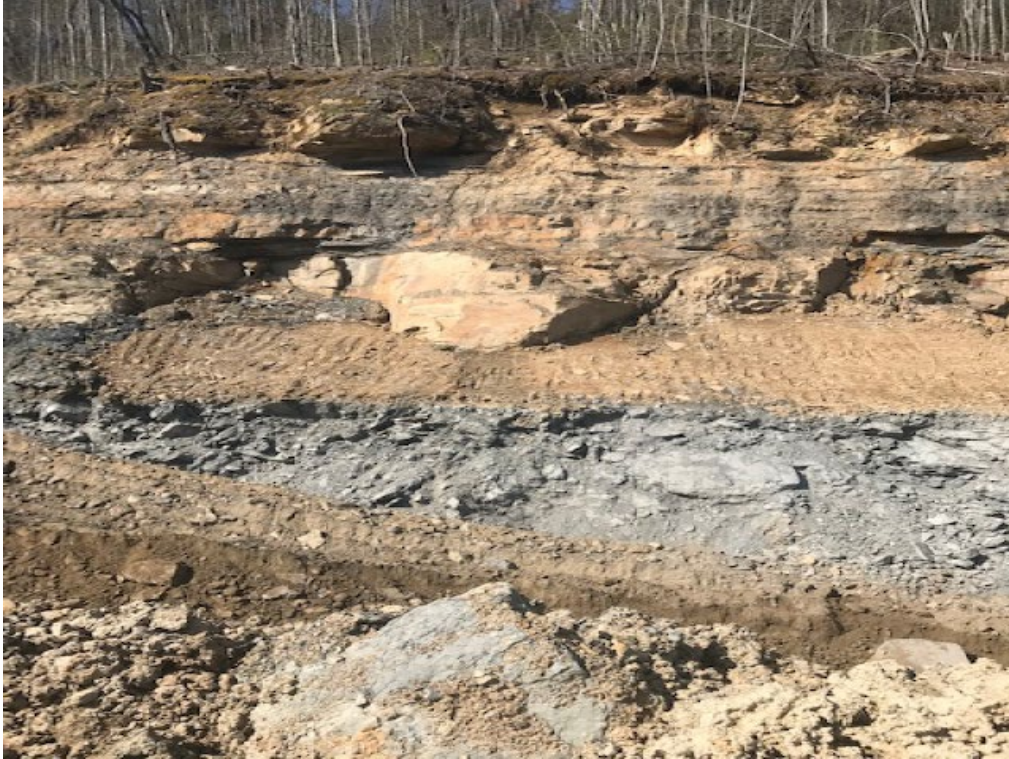
Pic 10 Sealed auger holes above pond 103 location

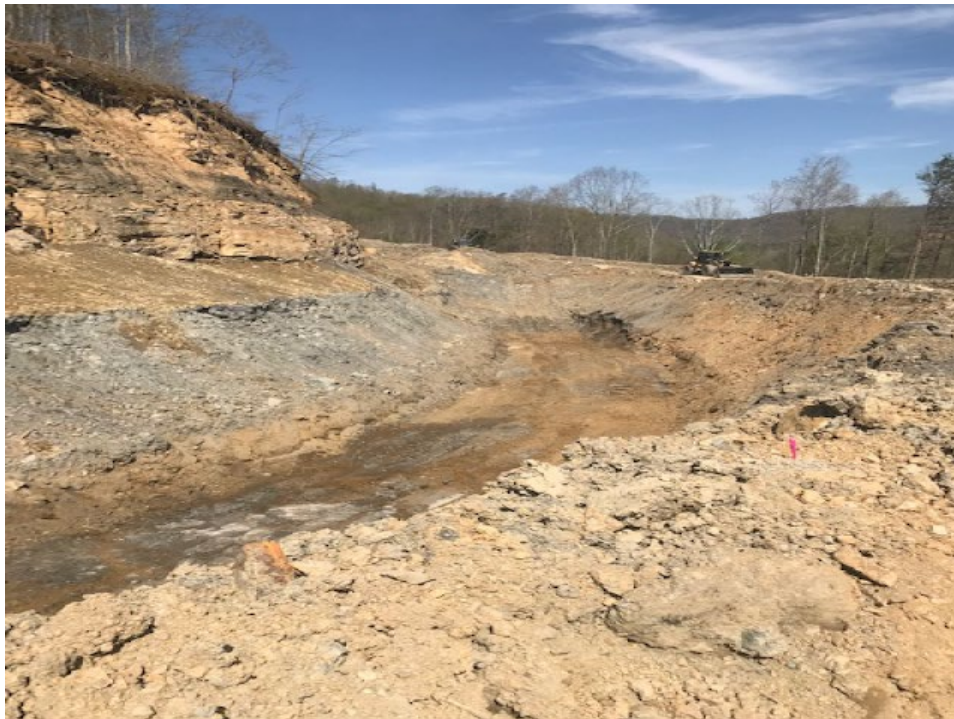
Pic 11 Pond 103 during construction with initial clay liner material being placed (4-22-22)

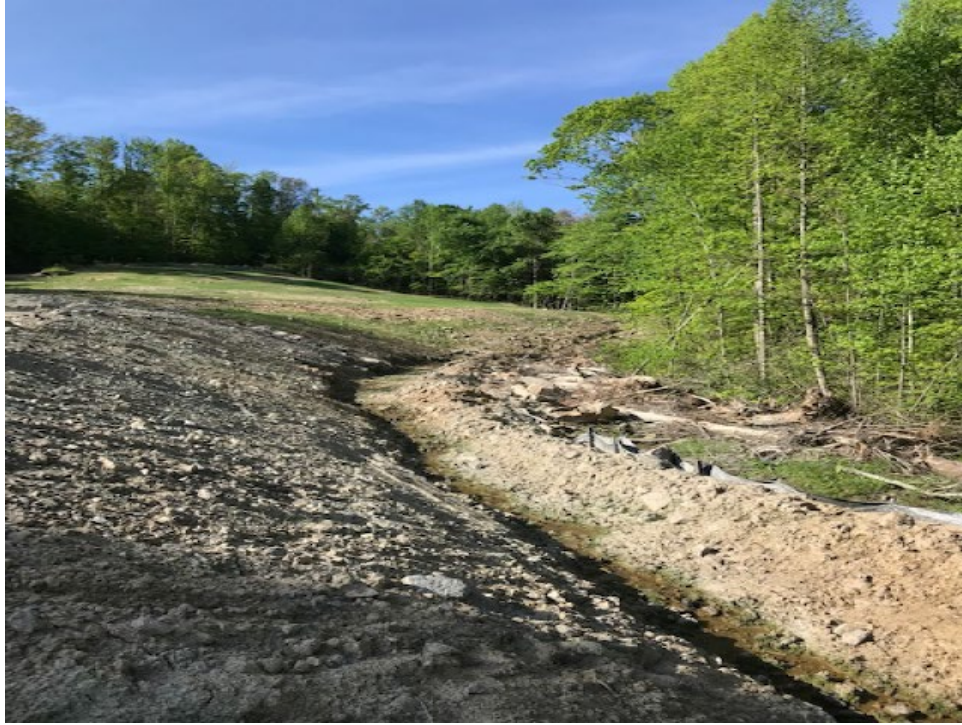
Pic. 12 Vegetative Growth on Hydro seeded areas-ditch repair(5-5-22)

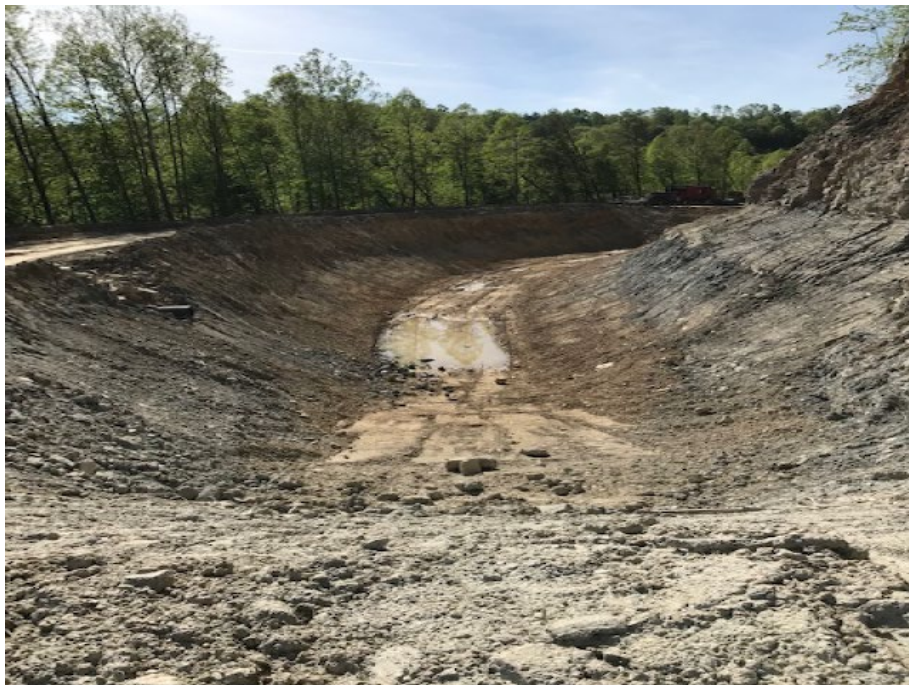
Pic 13 Final Grade Pond 103 with Principal Spwy Installed (Emergency un-finished in order to

remove highwall miner from site. (5-5-22)

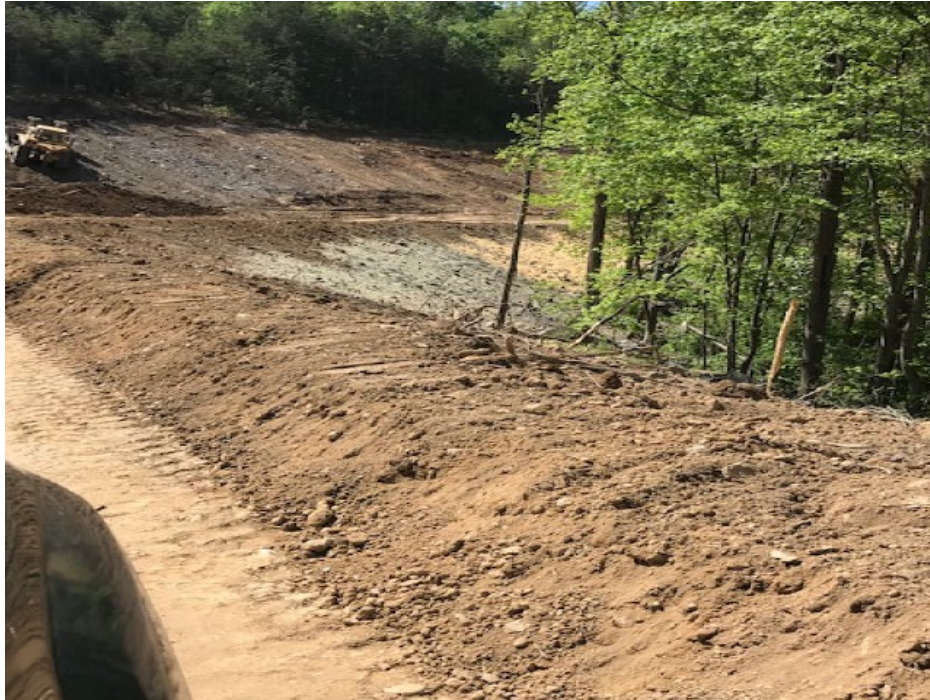
Pic 14 Berm at closing end of job-timber separated and hydro seeded (5-5-22) Ditch to 103

6. Windrowed timber has been separated from the outside berm in all areas including those viewed with TDEC on 4-22-22.
7. Overall reseeding and hydroseed application to reclaimed areas, berms, etc. has been accomplished with some final backslope seeding/mulching yet to accomplish. This will be done in timely manner consistent with overall re-grading and backfilling reclamation of the area.

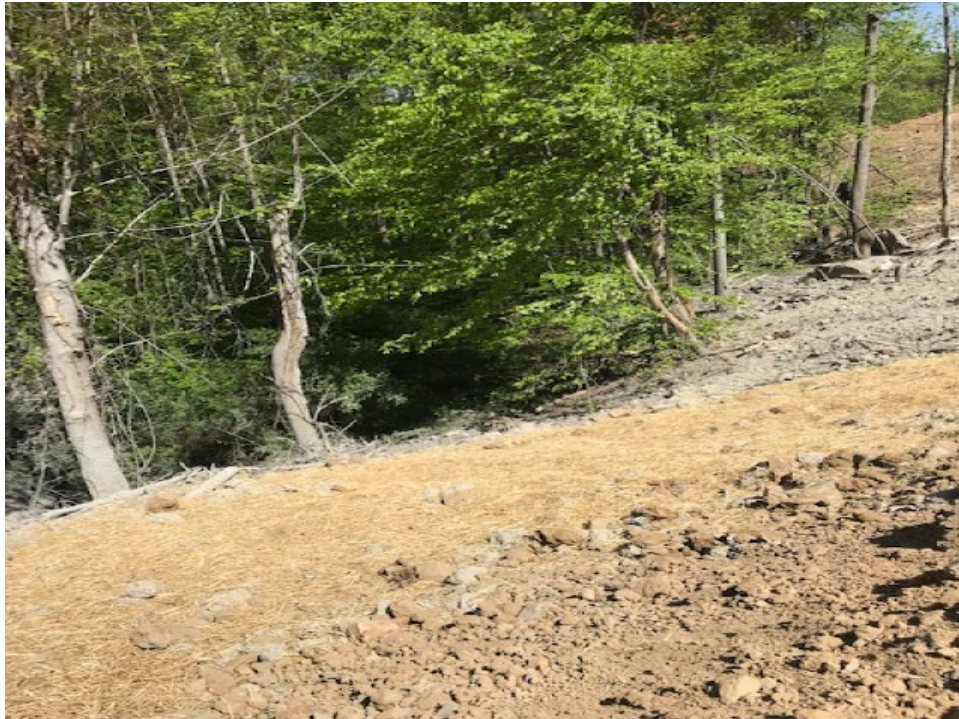
Pic 15 Berm graded, timber separated view toward end of job (5-5-22)

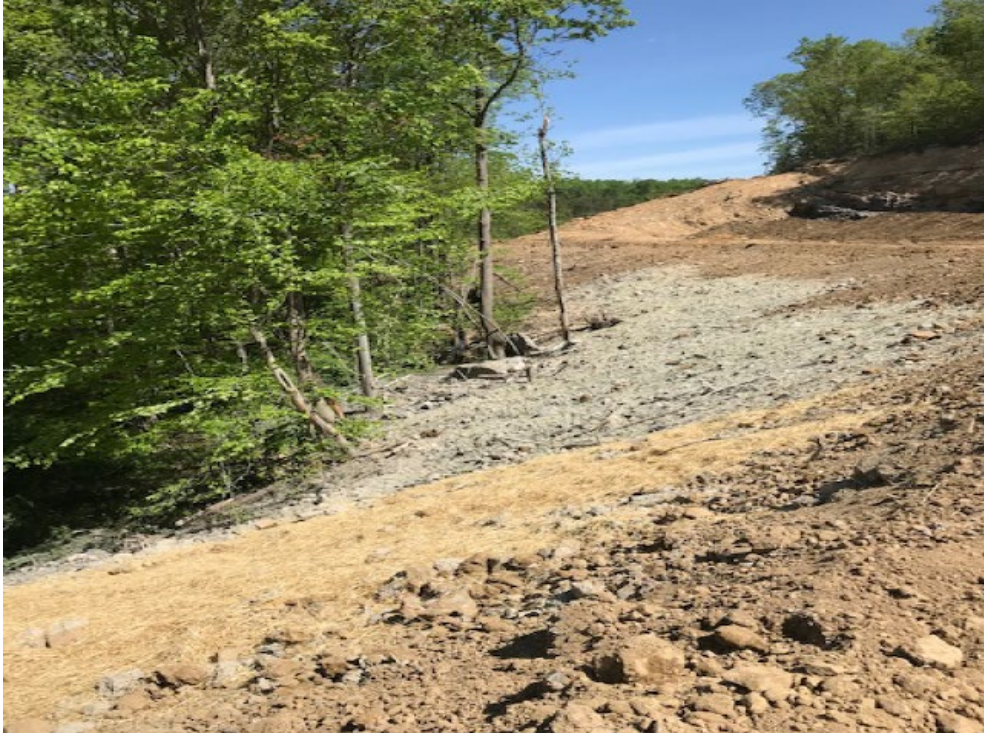
Pic 16 Berm, ditch, timber separated with one spot left to seed near very end of job (5-5-22)
