Mining Facility Inspection Report

Inspection start date and time: September 26, 2022 9:45 AM

NPDES permit number: TN0063606

INSPECTION RESULTS: In Compliance

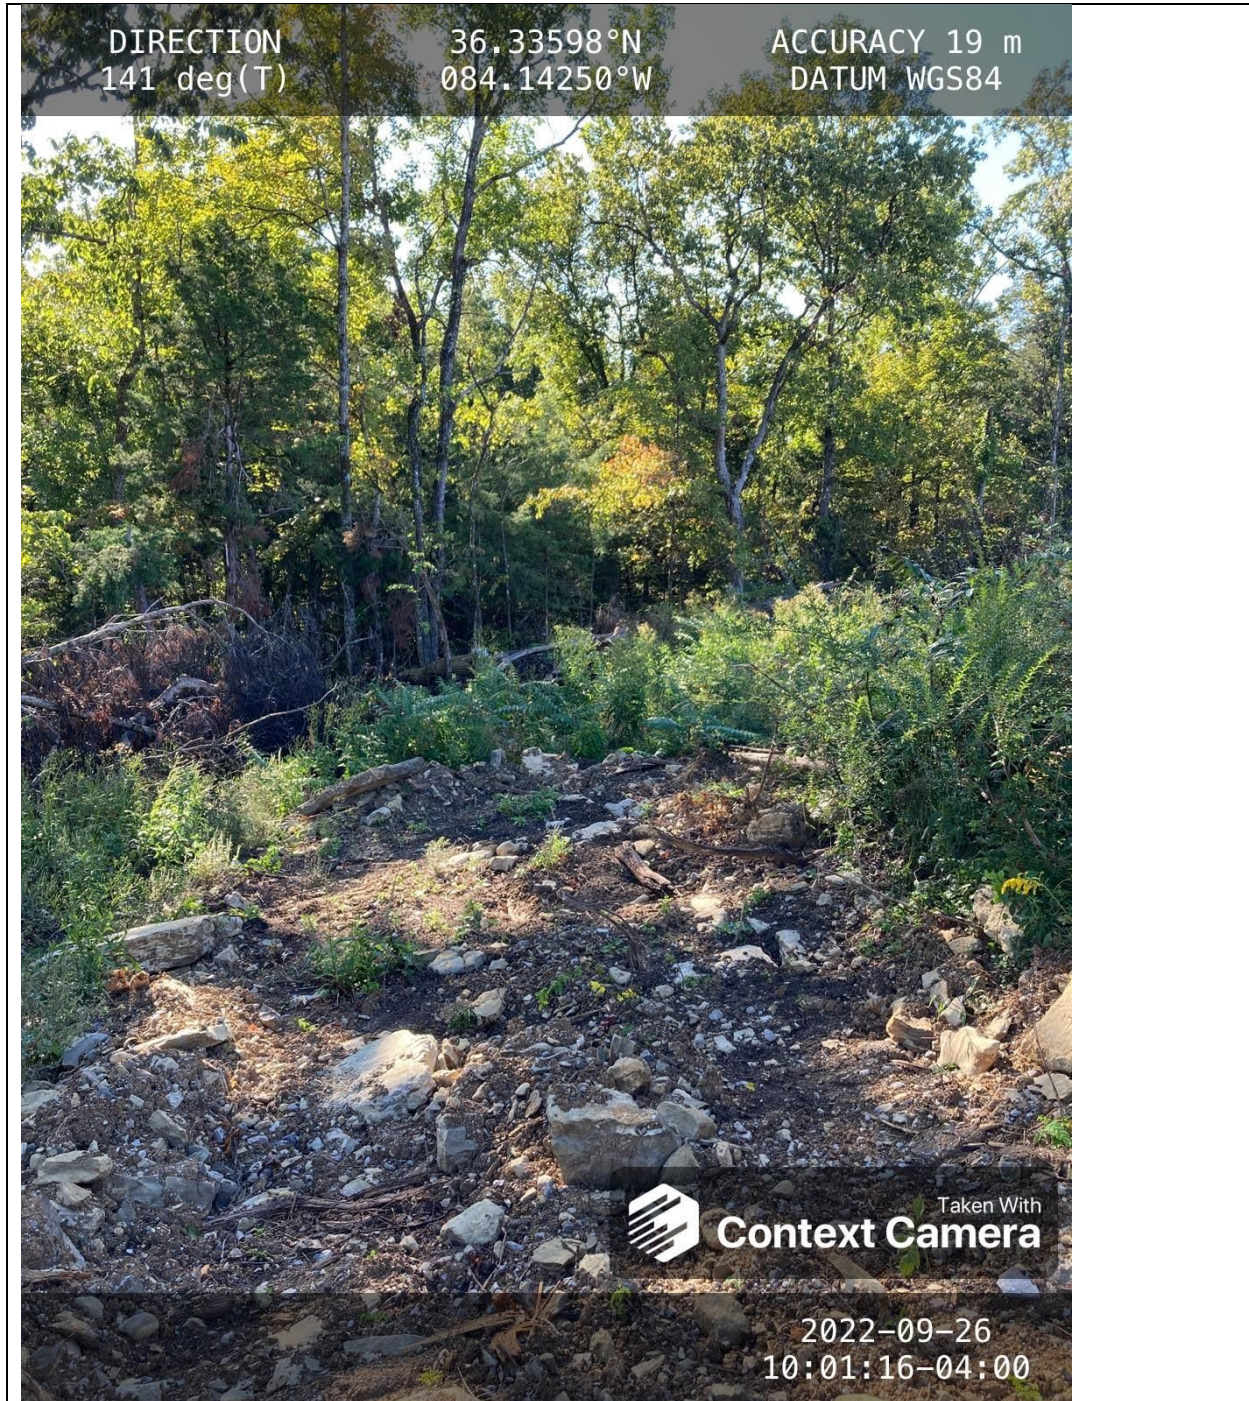
Taken With Context Camera 2022-09-26 09:54:01-04:00		
36.33658 -84.14432 17.2227465785748 2022/09/26 09:54:01		
Item 1:View of the area that has been clear cut. The area slopes away from the pit and thus needs stabilization measures such as seed/straw, mulch,rock, etc. Brush berms are not approved BMPs. Temporary BMPs should be installed such as silt fences until more permanent BMPs are installed.

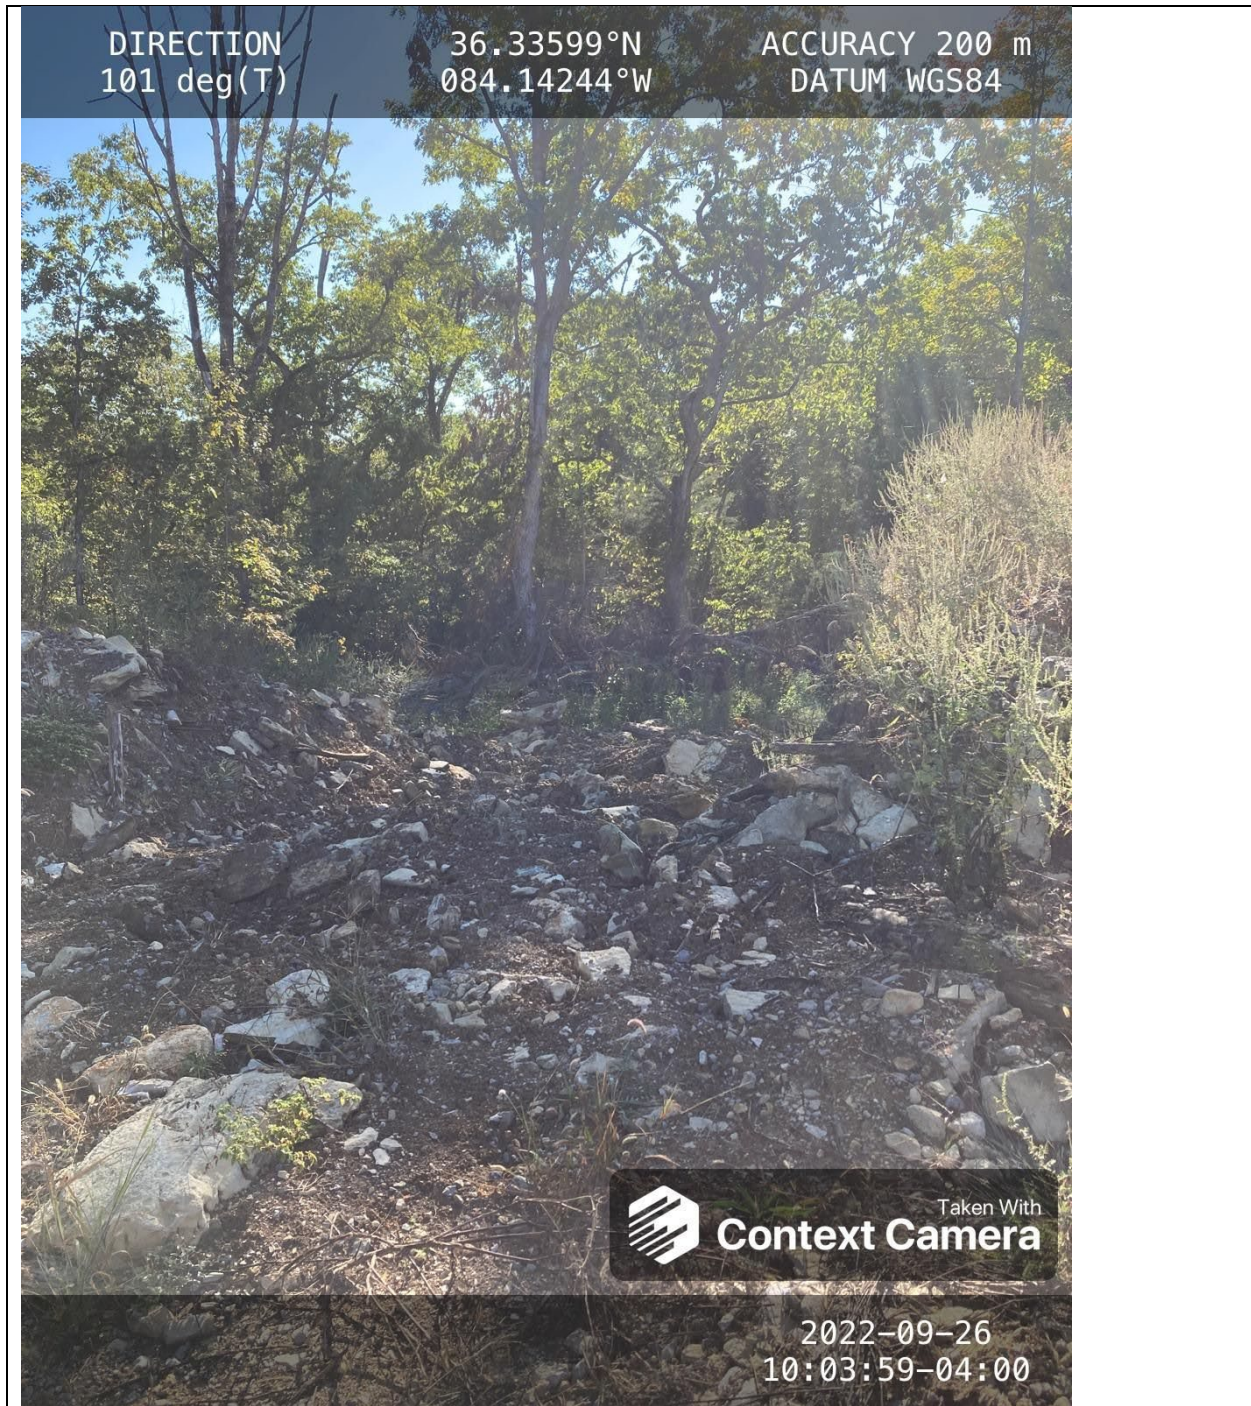
Item 2: Road behind the back haul road that is on the back slope area. Again, brush berms are not approved BMPs. This area should have more stabilization efforts for the loose material in the area/dirt within the road.

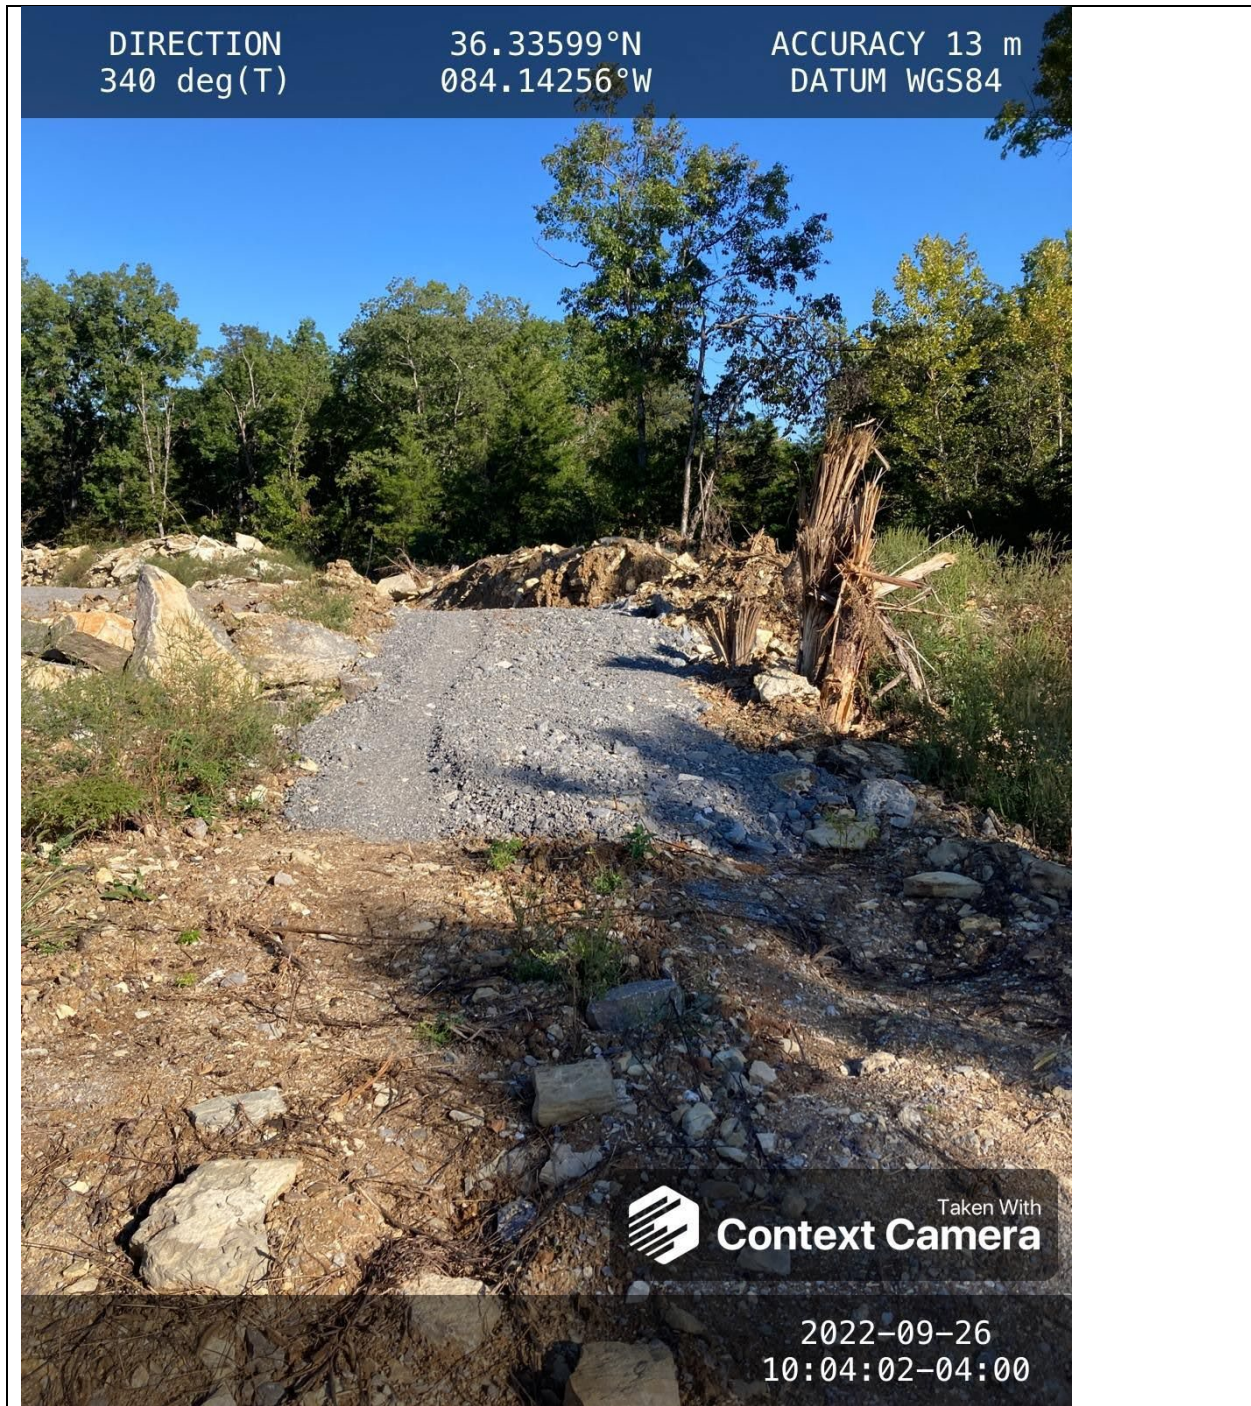
Item 3: Another view of the back slope area that needs additional stabilization measures.

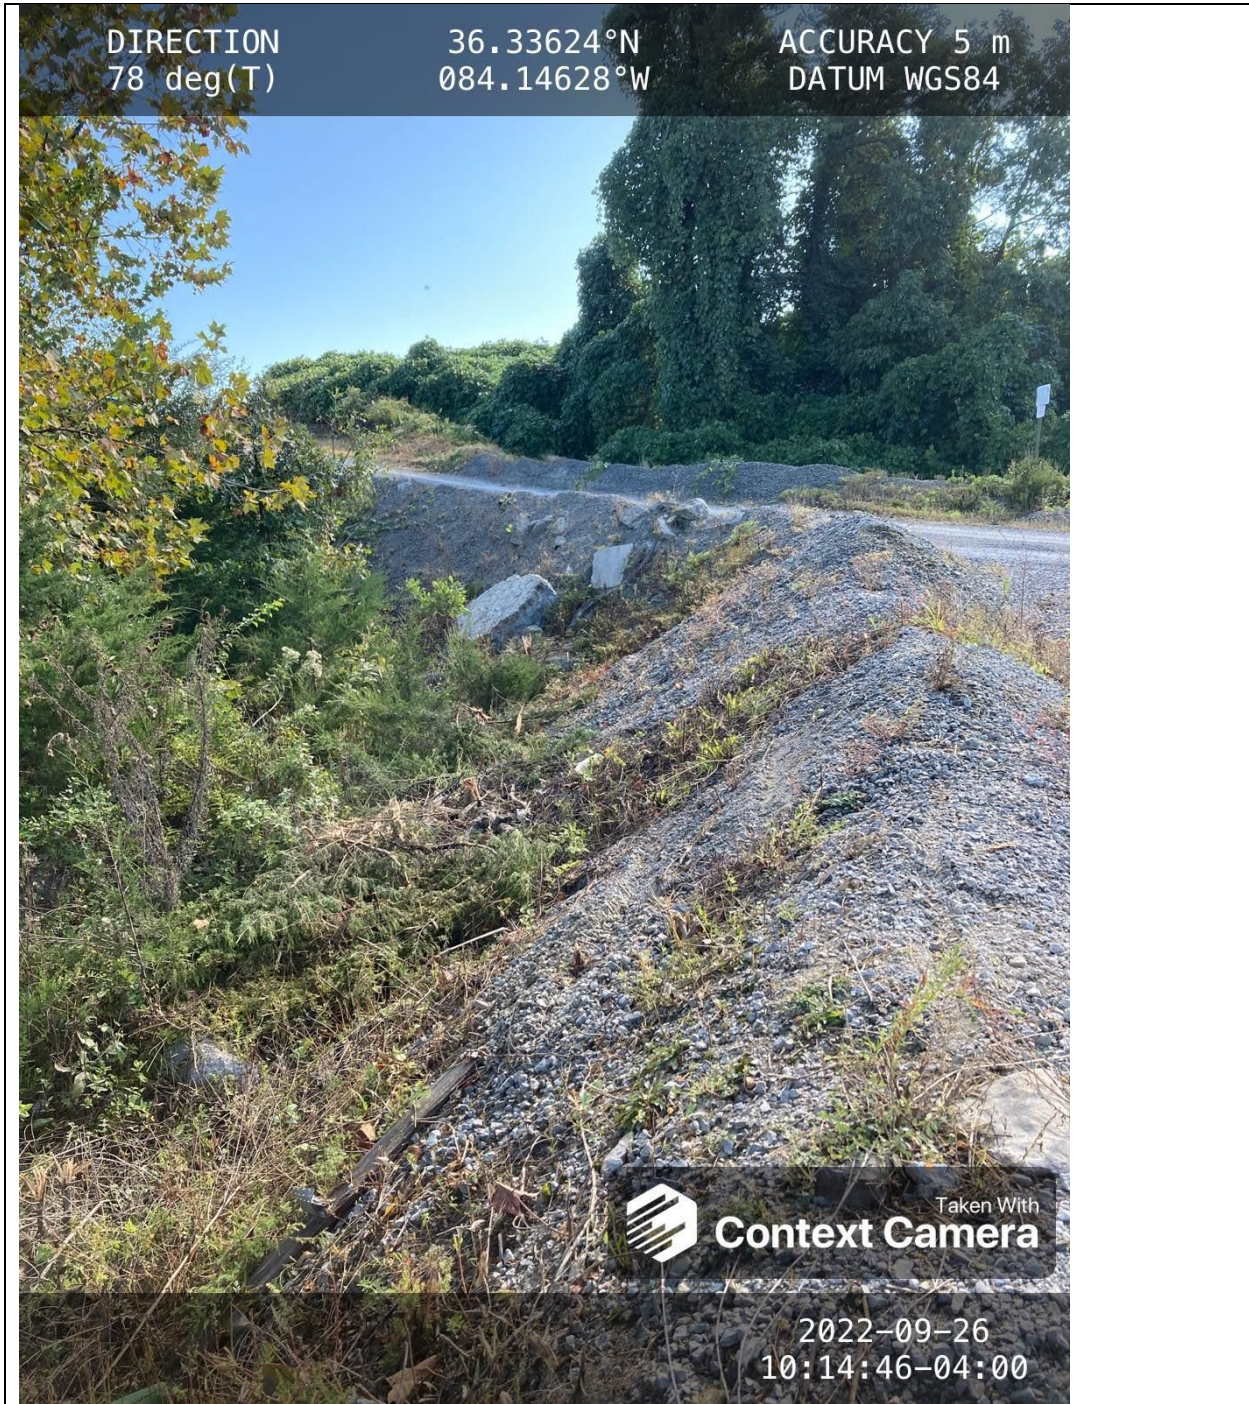
Item 6: Pond 002 area according to the map. Water from the pit gets pumped to it, and the pumps were not running at the time of inspection. This pond should be cleared out and more clearly defined on site with the defined outfall point to ensure adequate monitoring can be conducted.

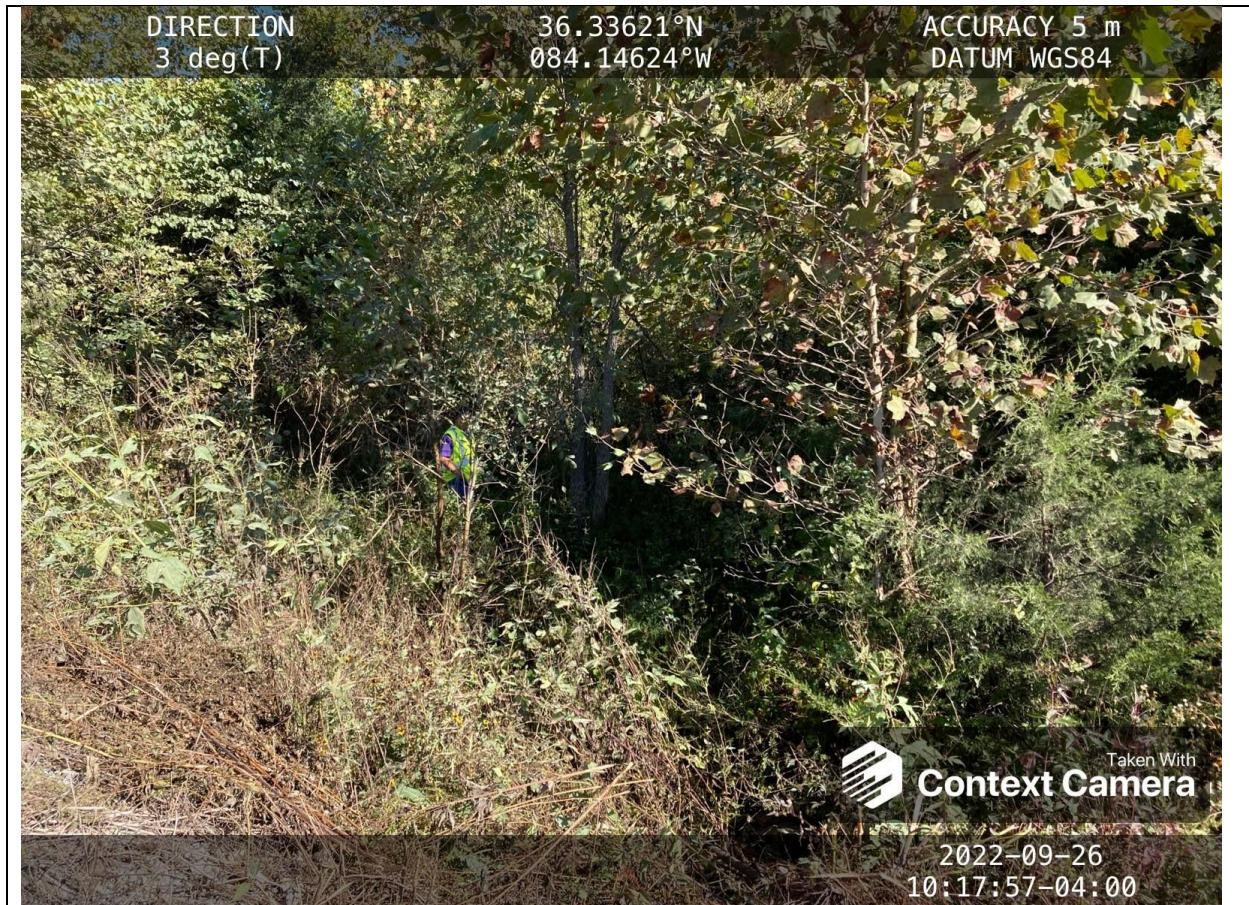
Item 7: Culvert area that gets water from the quarry pit when water is pumped out.

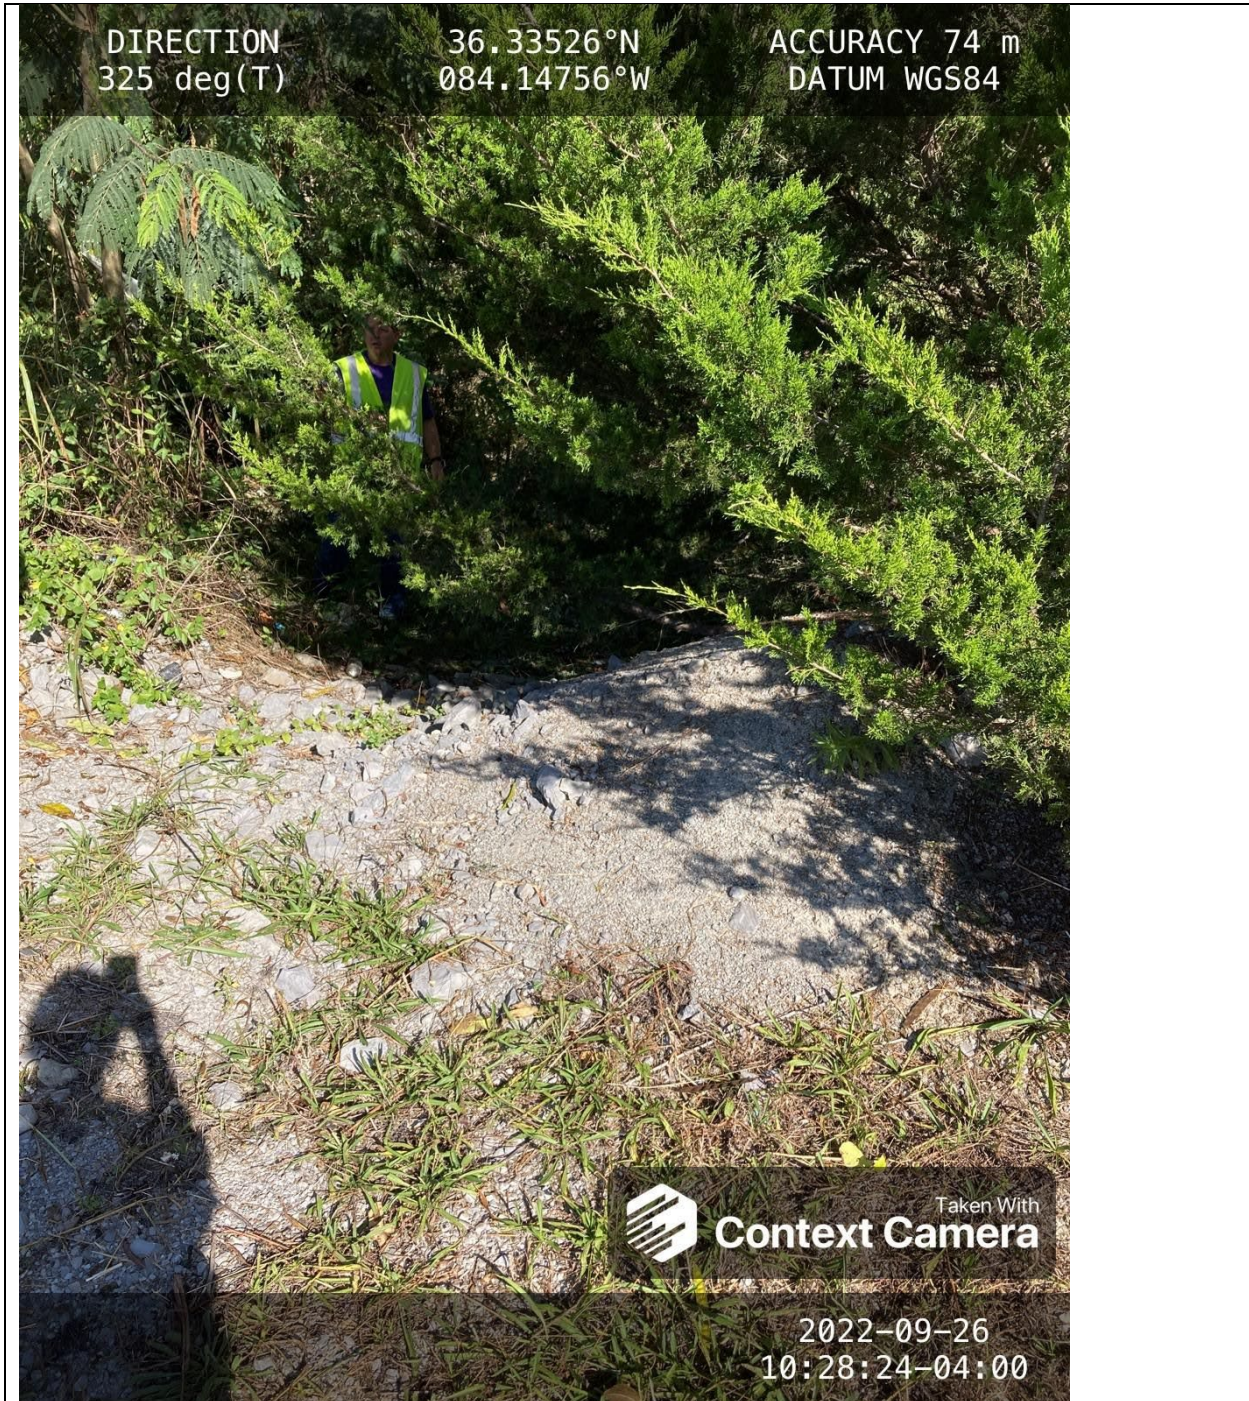
Item 10: Water from the parking area makes it to Pond 001 through this hole in the berm.

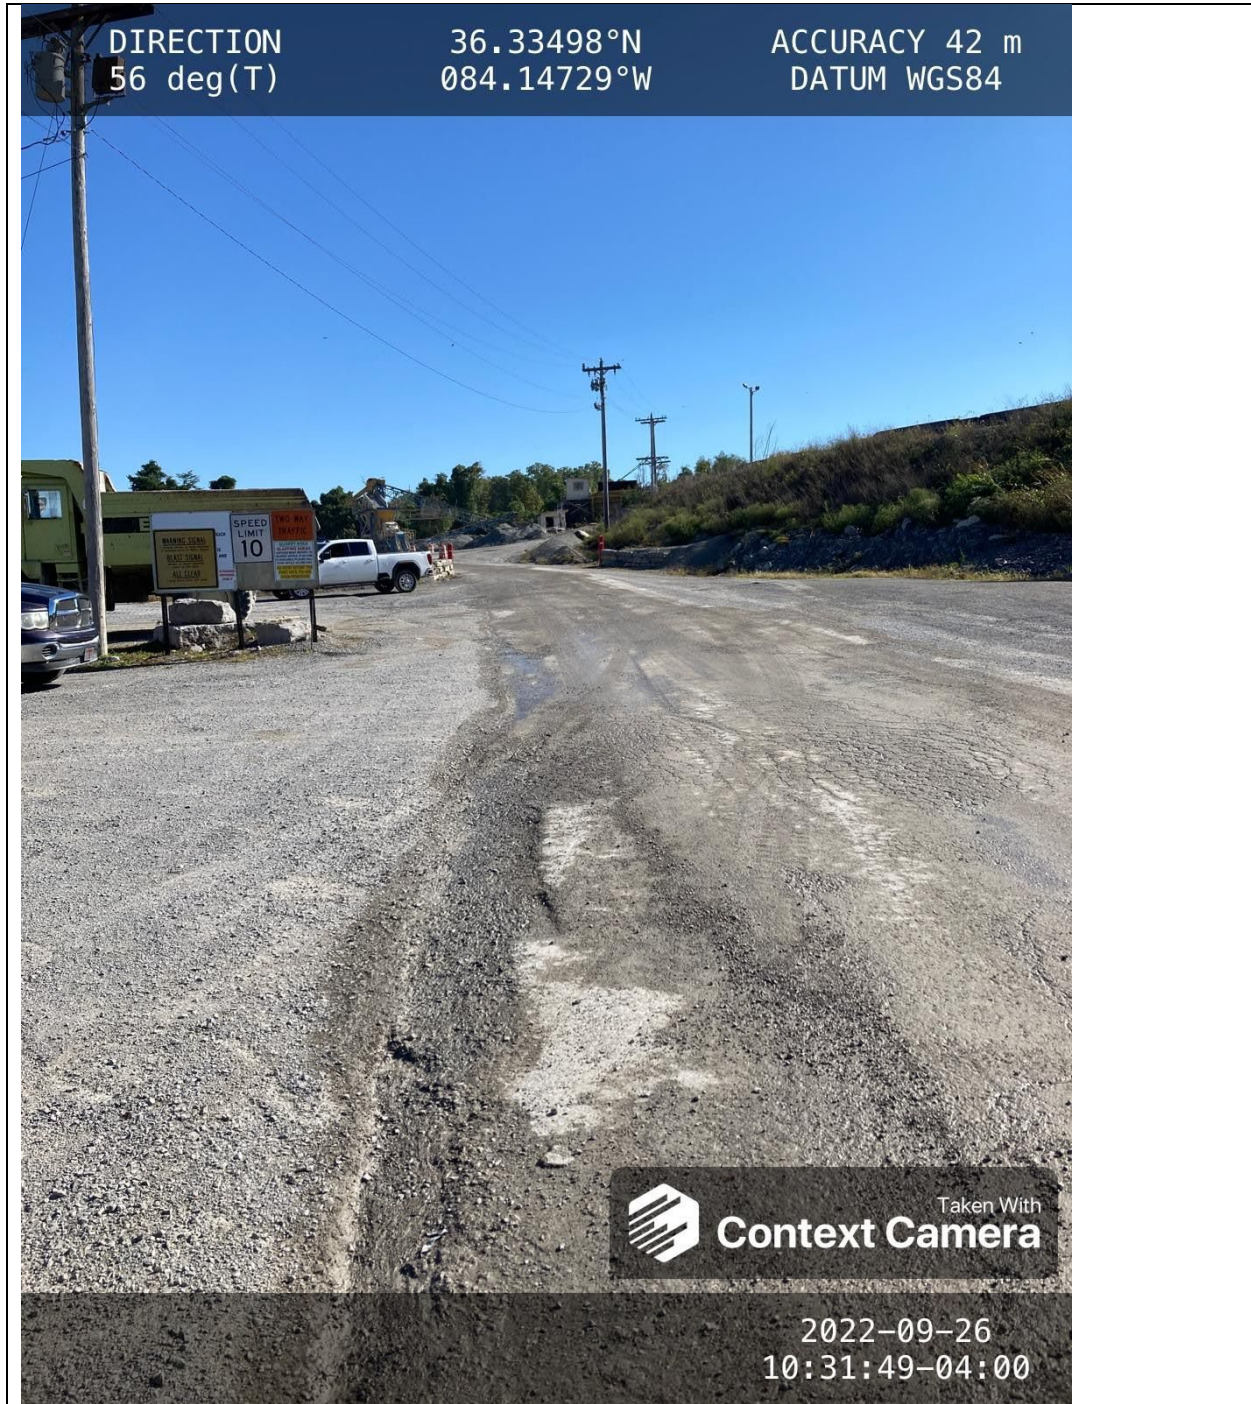
Item 11: Another view at a way water gets to Pond 001. The Pond 001 size/location was not clearly defined. This pond needs to be cleaned out and more clearly defined with an outfall point.

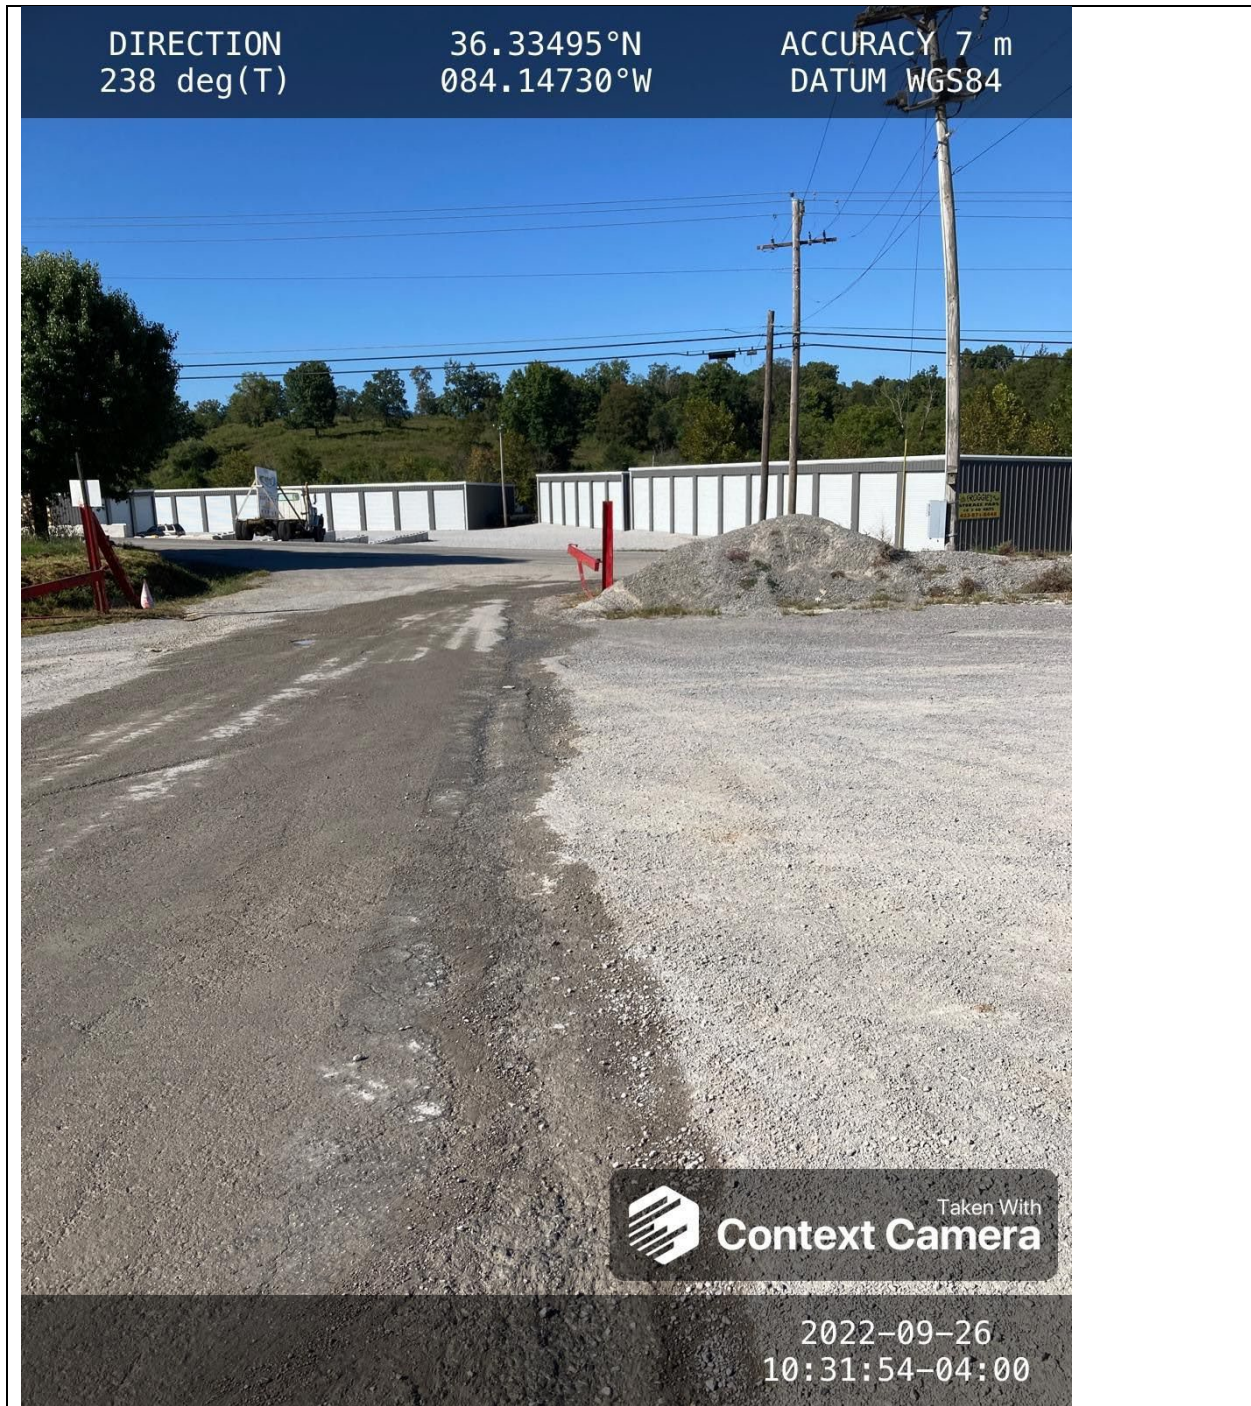
Item 12: View of the entry/exit road that has evidence of dust suppression water flowing on it.

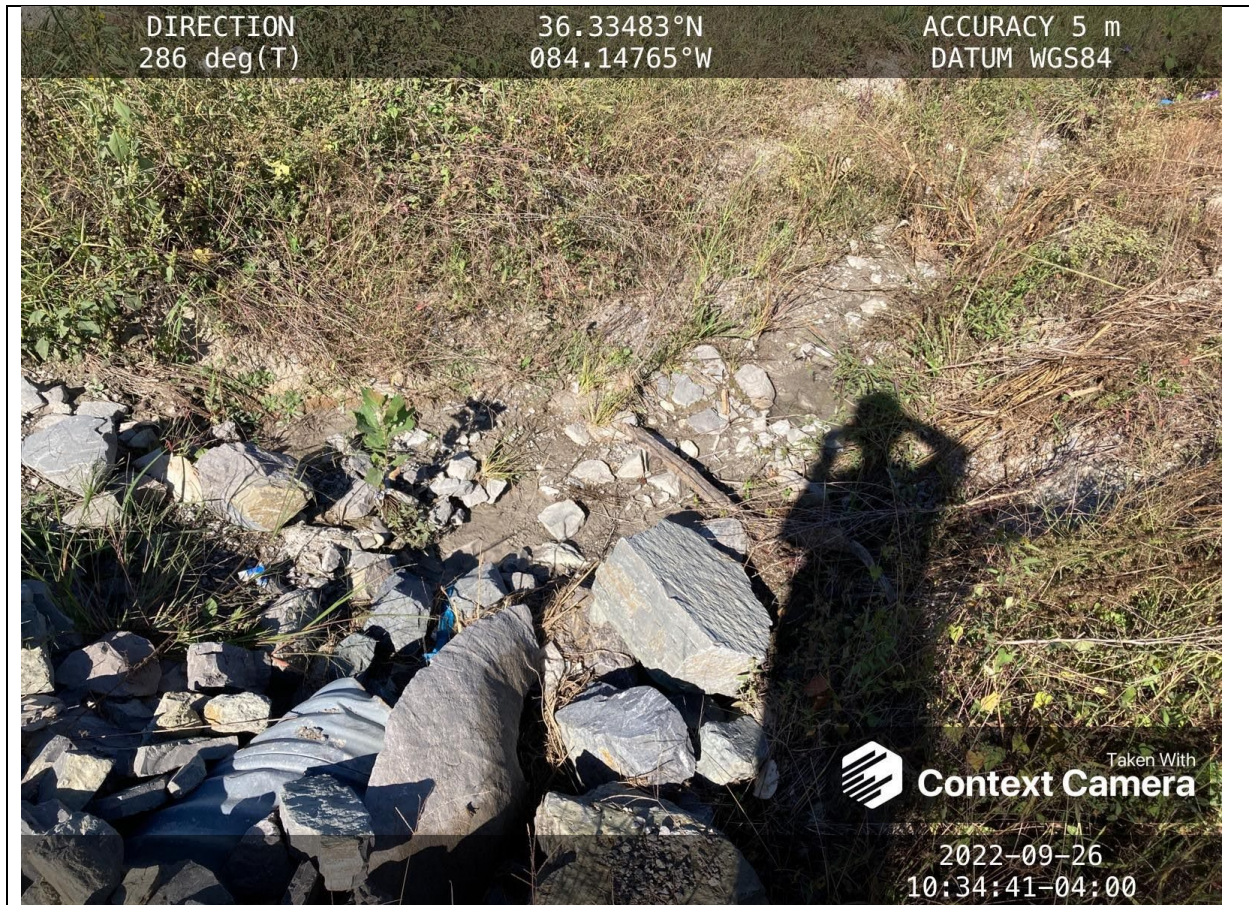
Item 15: Picture showing the water making it offsite and to a ditch at the public road.

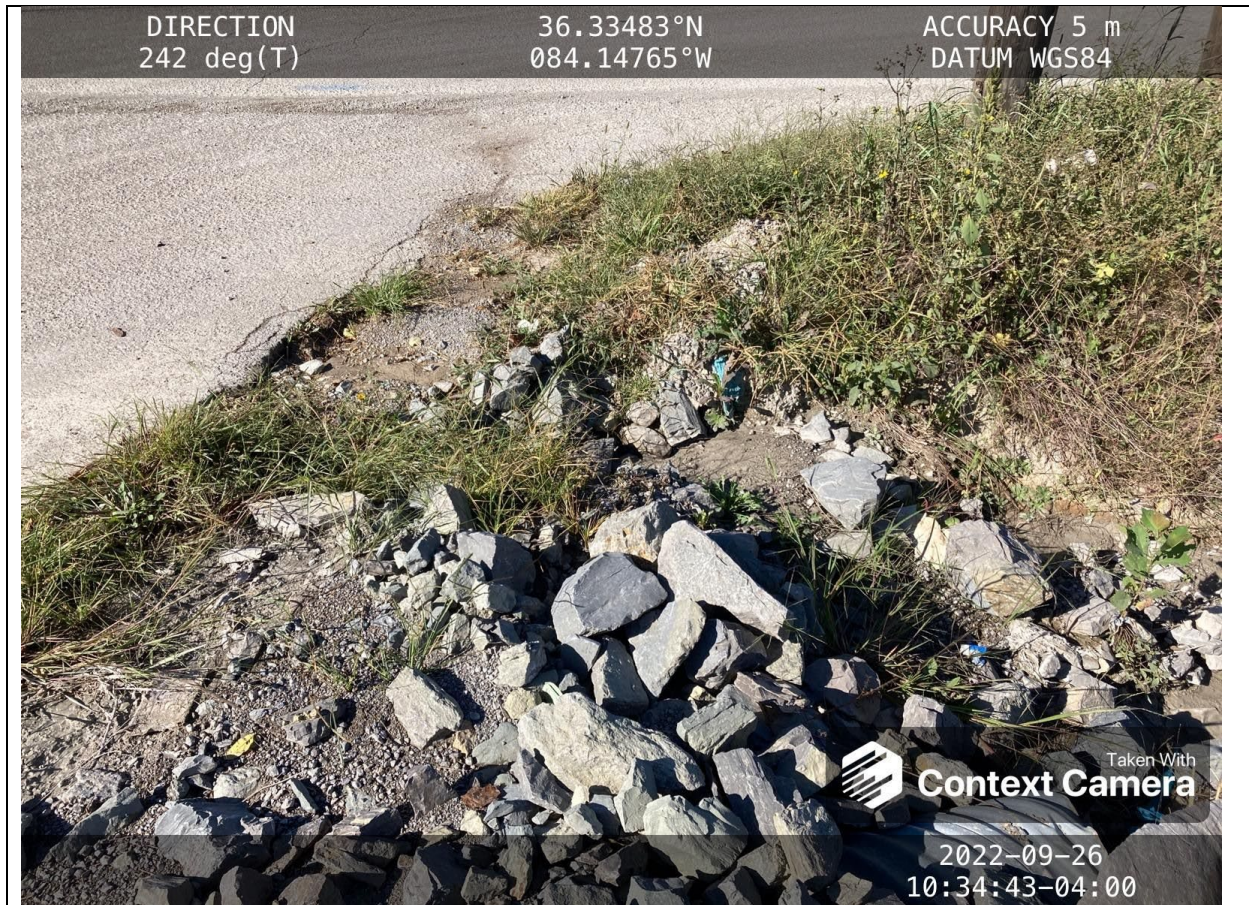
Item 16: View of the ditch. Sediment can be seen within the ditch that migrated there in the dust suppression water and/or stormwater from the site.

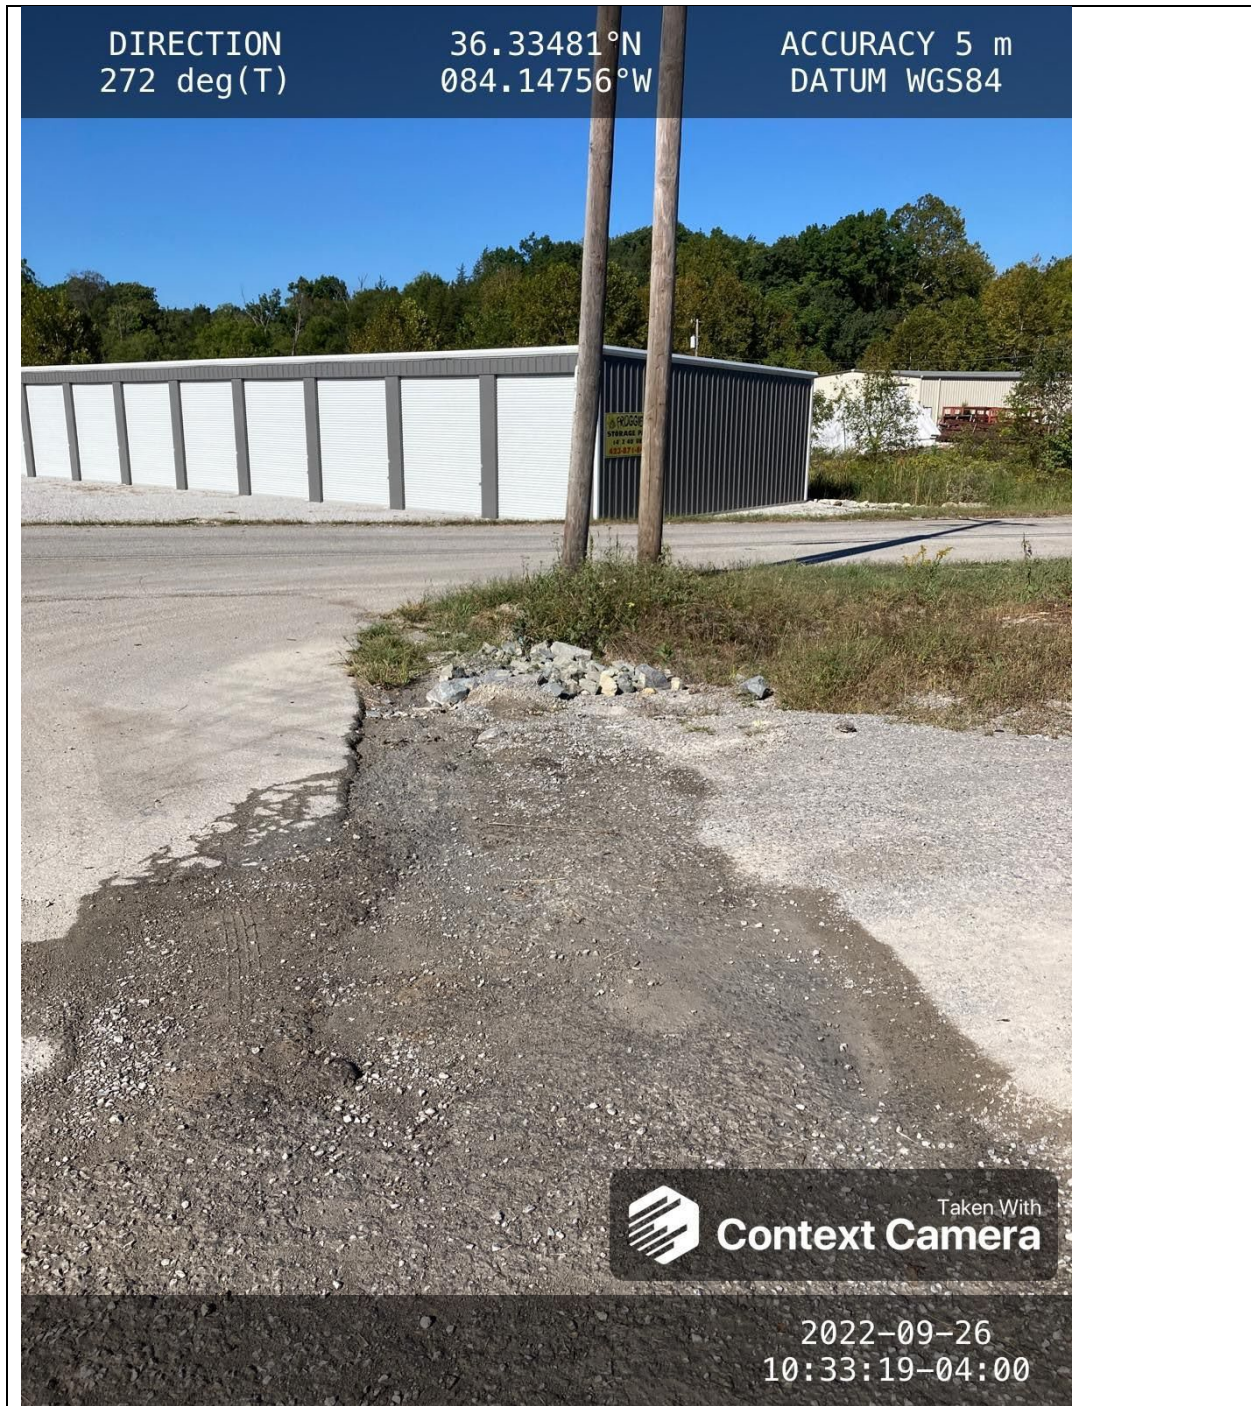
Item 17: Another view of the place the water makes it to from the entry/exit road. Sediment is clearly visible in the culvert. This water should be monitored prior to making it offsite.
