Construction Stormwater Inspection Certification (Twice-Weekly Inspections)

Site or Project Name: Jasper Highlands		NPDES Tracking Number: TNR 112089
Primary Permittee Name: John Thornton		Date of Inspection: 09/06/2023
Current approximate disturbed acreage: 17-20	Has rainfall been checked/documented daily? <input checked="" type="checkbox"/> Yes <input type="checkbox"/> No	Name of Inspector: Tyler Jeffrey, CPESC
Current weather conditions: Partly Cloudy, 84 degrees		Inspector's Training Certification Number: 135506

537 Market Street, Ste 202 Chattanooga, TN 37402 Phone (423) 266-3501	Date: 9/21/2023
	JASPER HIGHLANDS Site Assessment Report Marion County, TN	Photo Log for Site Assessment

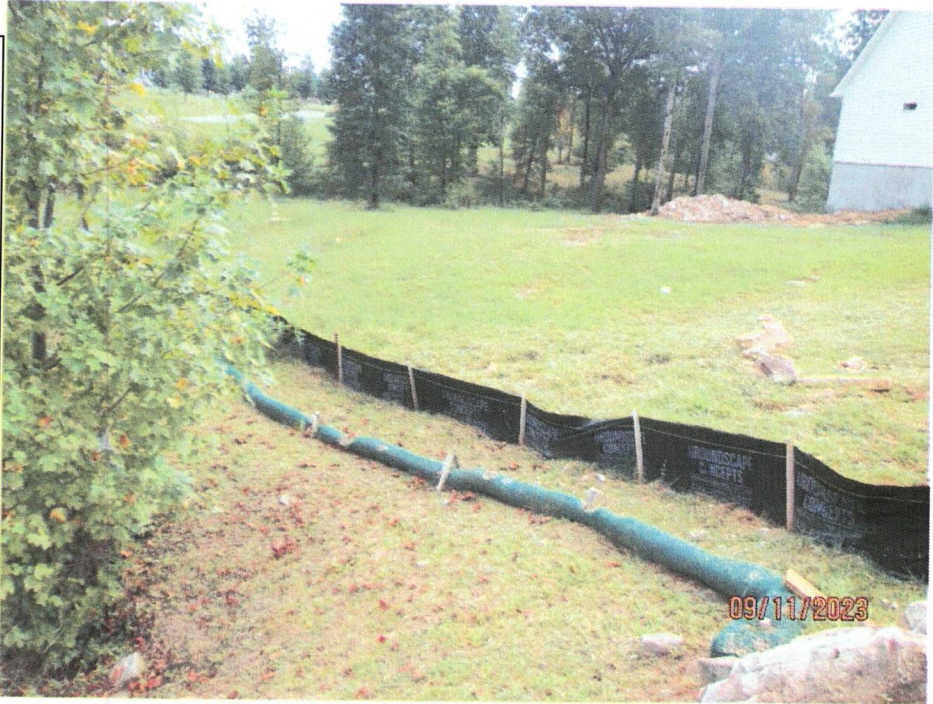
- Currently the disturbed area within outfall S59 consists of a laydown and borrow pit area used for construction, and three homes being constructed totaling approximately 1.5 acres of disturbance. The laydown area drains into a stormwater conveyance swale containing several rock check dams before reaching a sediment basin.
- The individual lot-level erosion controls were observed and appeared to be functioning properly (see photo 1).
- The outfall sampling location was observed, and no signs of sediment discharge were observed.

Photo 1:
Outfall S59
 The individual lot level erosion controls have been installed and appear to be functioning properly.
 Photo Taken 9/11/2023

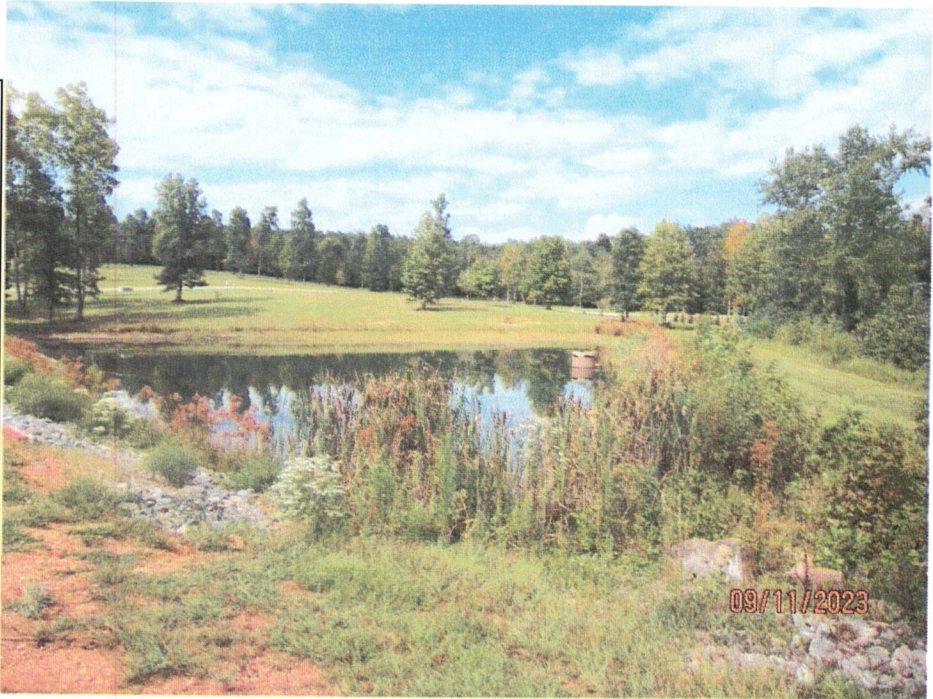
- Currently the disturbed area within outfall S66 consists of one home being constructed totaling approximately 0.40 acres of disturbance.
- The outfall sampling location was observed, and no sign of sediment discharge were observed.
- The stormwater basin has been installed and appears to be stabilized (see photo 2).

Photo 2:
Outfall S66
 A stormwater basin has been installed and appears to be functioning properly.
 Photo Taken 9/11/2023

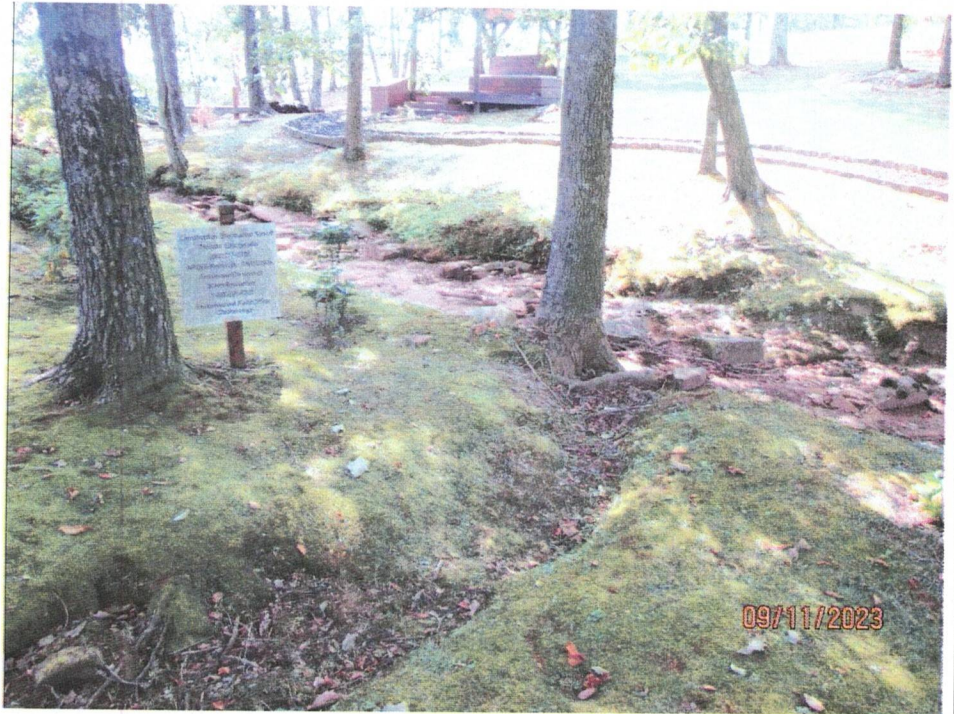
- Currently the disturbed area within outfall S98 consists of two homes being constructed totaling approximately 0.60 acres of disturbance.
- The individual lot-level erosion controls were observed and appeared to be functioning properly.
- The outfall sampling location was observed, and no sign of sediment discharge were observed (see photo 3).

The outfall sampling location was observed. No signs of sediment discharge were observed.

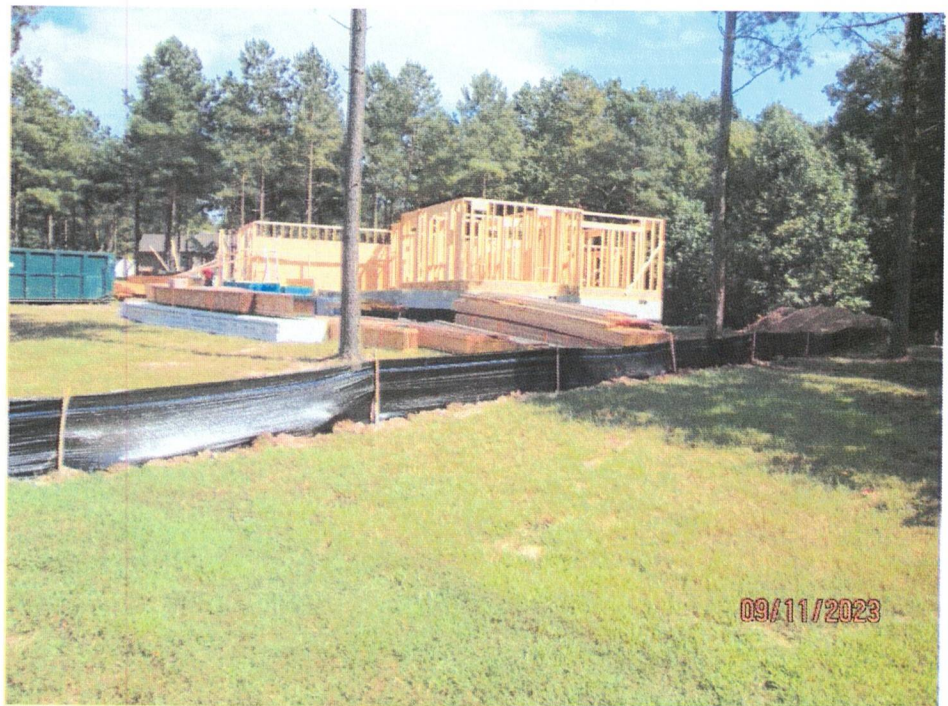
Photo 4:

- Currently the disturbed area within outfall S153 consists of six home construction sites. The disturbed area within the outfall S153 drainage basin is approximately 3.0 acres.
- The individual lot-level erosion controls were observed and appeared to be functioning properly (see photo 4).
- The stormwater basins have been installed and appear to be stabilized.

The individual lot level erosion controls have been installed and appear to be functioning properly.

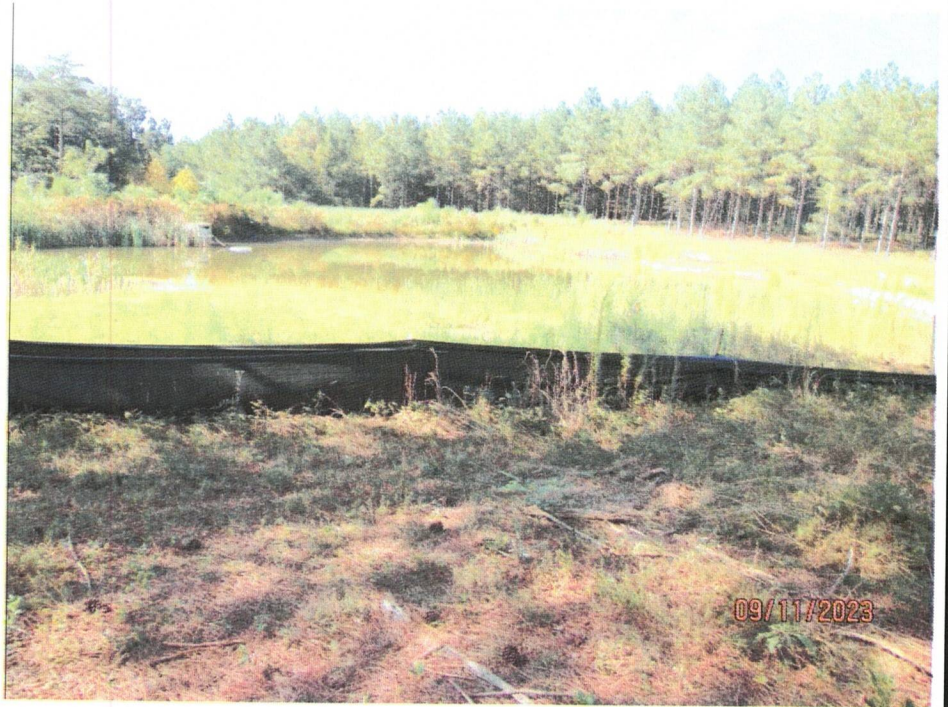
- Currently the disturbed area within outfall S201 consists of three home construction sites. The disturbed area within the outfall S201 drainage basin is approximately 1.2 acres.
- The individual lot-level erosion controls were observed and appeared to be functioning properly (see photo 5).
- The stormwater basins have been installed and appear to be stabilized.

The individual lot level erosion controls have been installed and appear to be functioning properly.

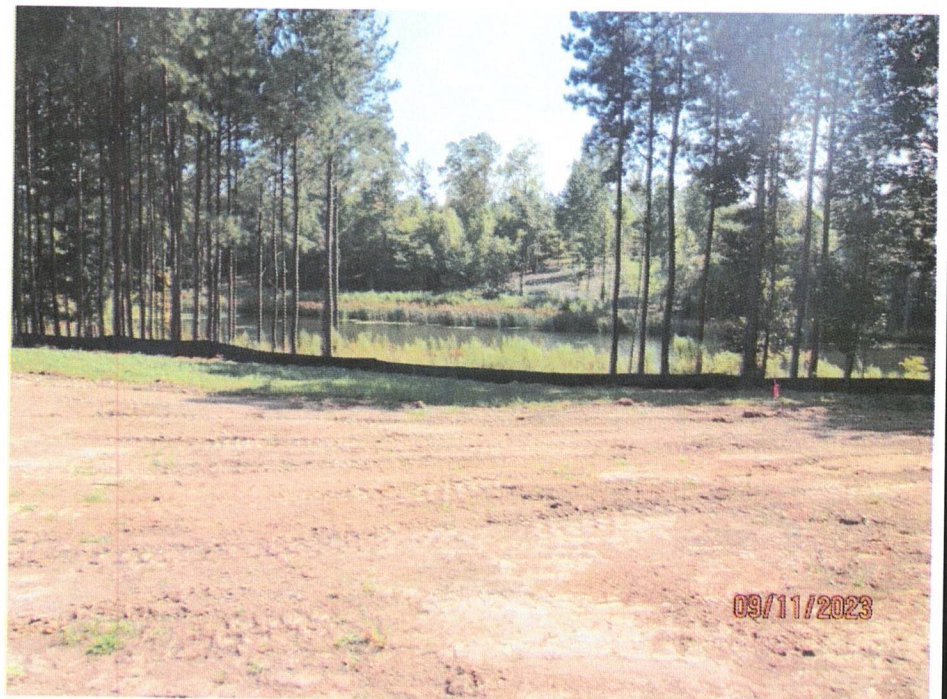
Photo 6:

- Currently the disturbed area within outfall S208 consists of 2 home construction sites, roadway construction, and utility installation along the roadway. The disturbed area within the outfall S208 drainage basin is approximately 2.0 acres.
- The stormwater basins have been installed and appear to be stabilized.
- The individual lot-level erosion controls were observed and appeared to be functioning properly (see photo 6).

The individual lot level erosion controls have been installed and appear to be functioning properly.

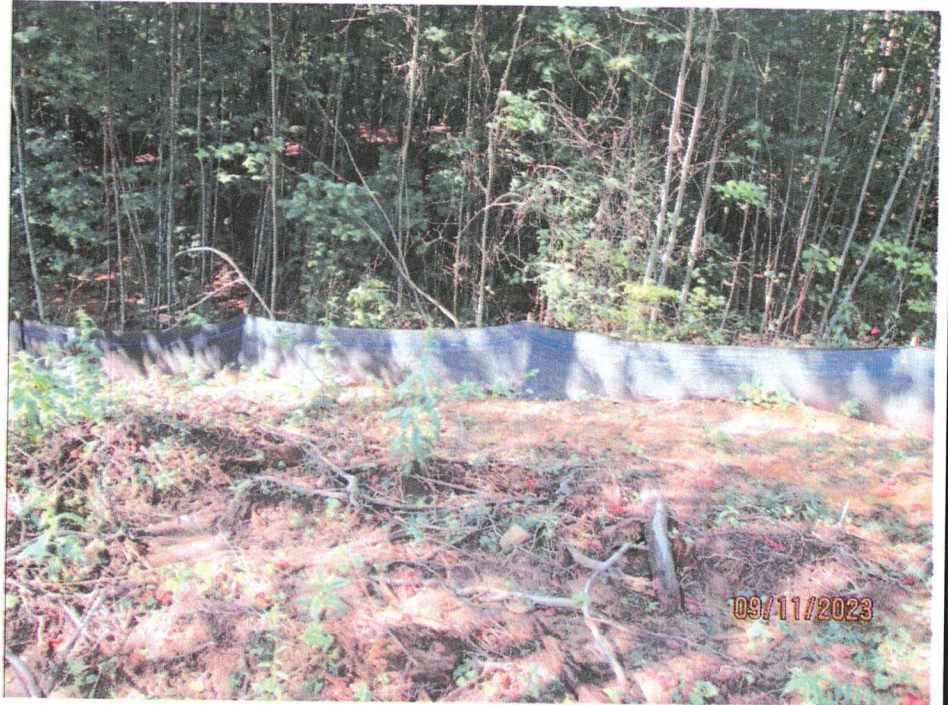
- Currently the disturbed area within outfall S218 consists of 7 home construction sites, roadway construction, and utility installation along the roadway. The disturbed area within the outfall S218 drainage basin is approximately 2.5 acres.
- Rock check dams have been installed in the roadside ditch and appear to be functioning appropriately.
- The individual lot-level erosion controls were observed and appeared to be functioning properly (see photo 7).

The individual lot level erosion controls have been installed and appear to be functioning properly.

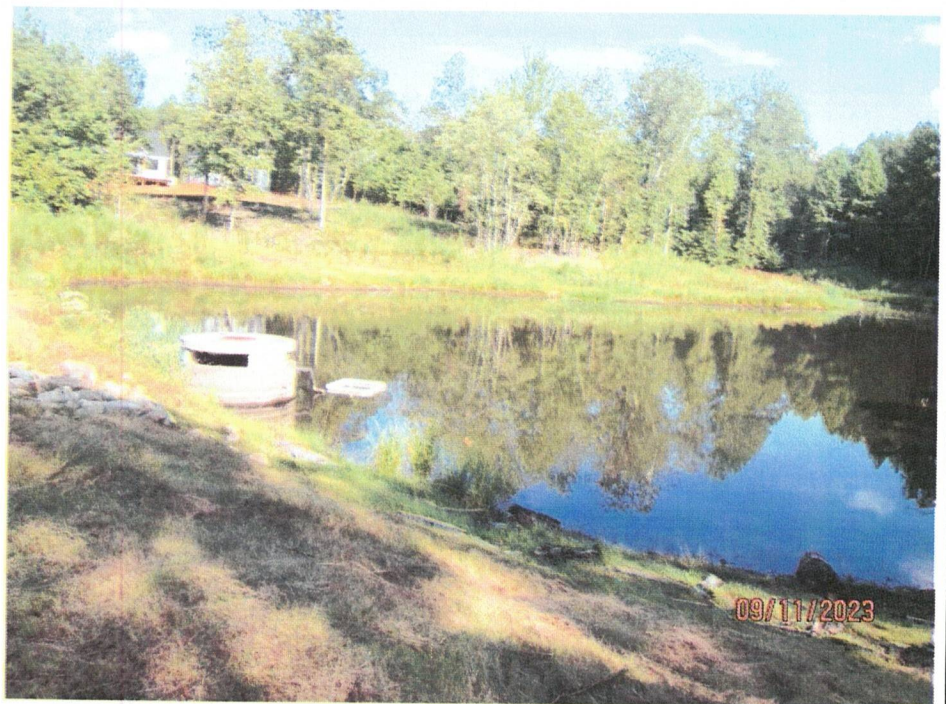
Photo 8:

- Currently the disturbed area within outfall S275 consists of roadway construction, 1 home construction site and utility installation along the roadway. The disturbed area within the outfall S275 drainage basin is approximately 0.75 acres.
- The individual lot-level erosion controls were observed and appeared to be functioning properly.
- The stormwater basins have been installed and appear to be stabilized (see photo 8).

A stormwater basin has been installed and appears to be functioning properly.

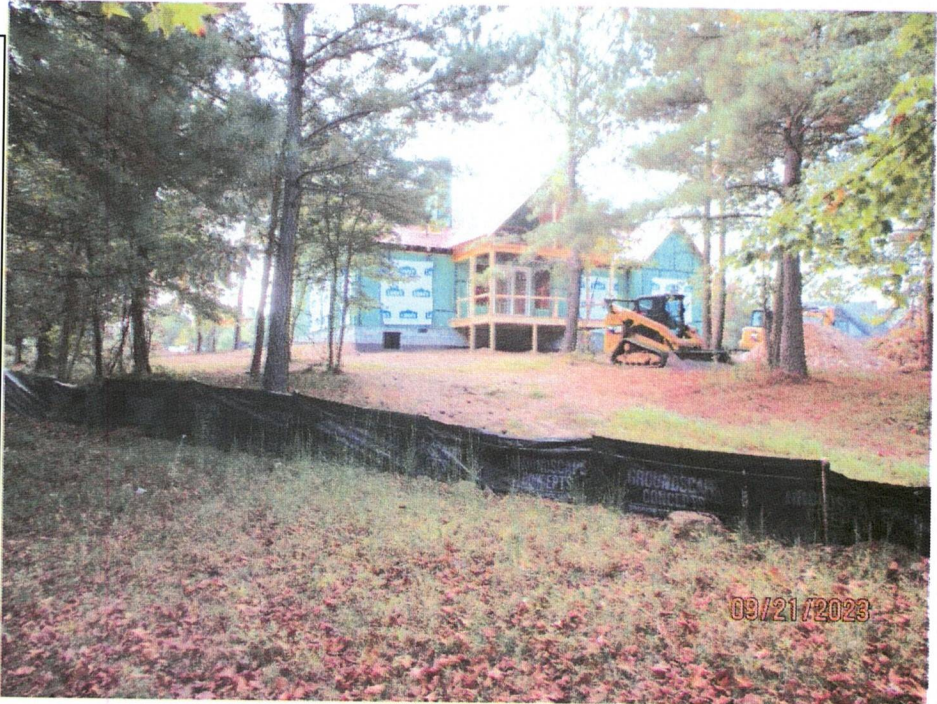
- Currently the disturbed area within outfall S59 consists of two homes being constructed totaling approximately 1.0 acres of disturbance.
- The individual lot-level erosion controls were observed and appeared to be functioning properly (see photo 1).
- The outfall sampling location was observed, and no signs of sediment discharge were observed.

Photo 1:
Outfall S59
 The individual lot level erosion controls have been installed and appear to be functioning properly.
 Photo Taken 9/21/2023

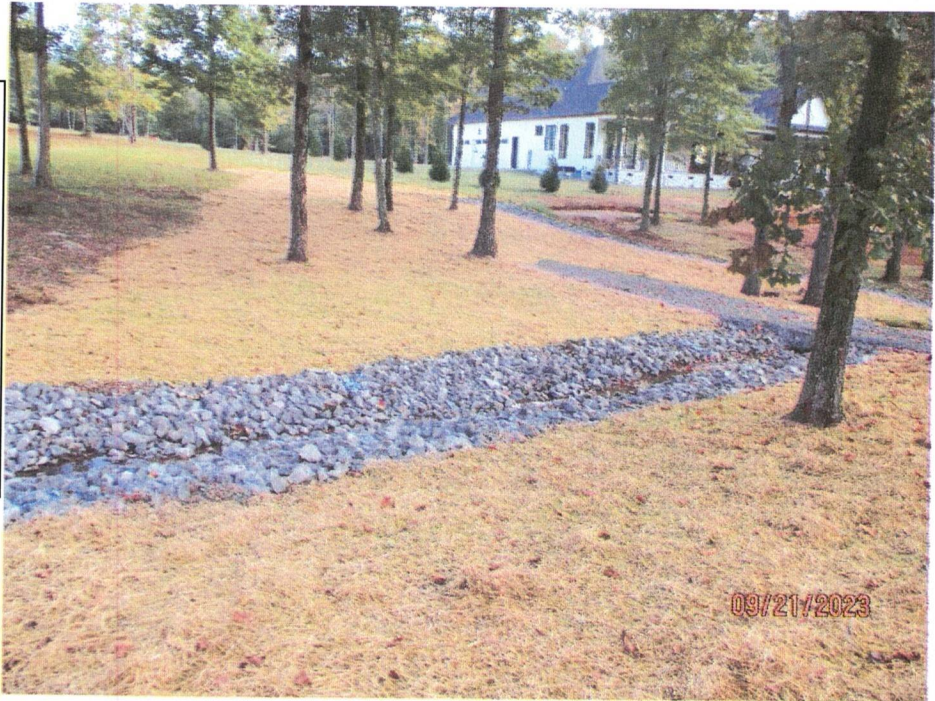
- Currently the disturbed area within outfall S66 consists of one home being constructed totaling approximately 0.40 acres of disturbance.
- The outfall sampling location was observed, and no sign of sediment discharge were observed.
- The individual lot-level erosion controls were observed and appeared to be functioning properly (see photo 2).

Photo 2:
Outfall S66
 The individual lot level erosion controls have been installed and appear to be functioning properly.
 Photo Taken 9/21/2023

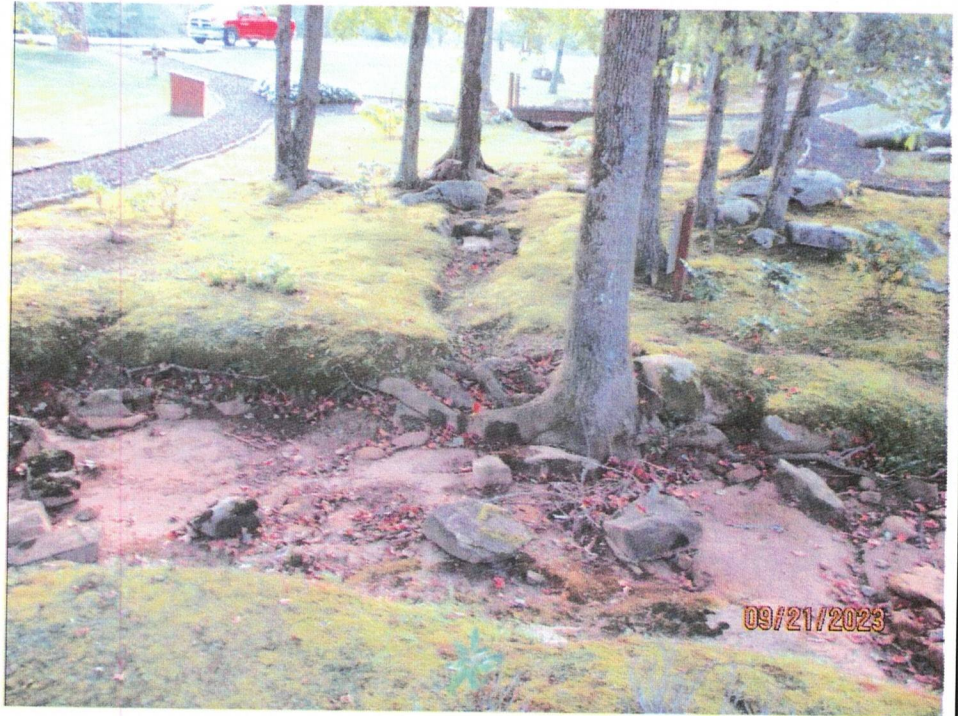
Photo 3:

- Currently the disturbed area within outfall S98 consists of two homes being constructed totaling approximately 0.60 acres of disturbance.
- The individual lot-level erosion controls were observed and appeared to be functioning properly.
- The outfall sampling location was observed, and no sign of sediment discharge were observed (see photo 3).

The outfall sampling location was observed. No signs of sediment discharge were observed.

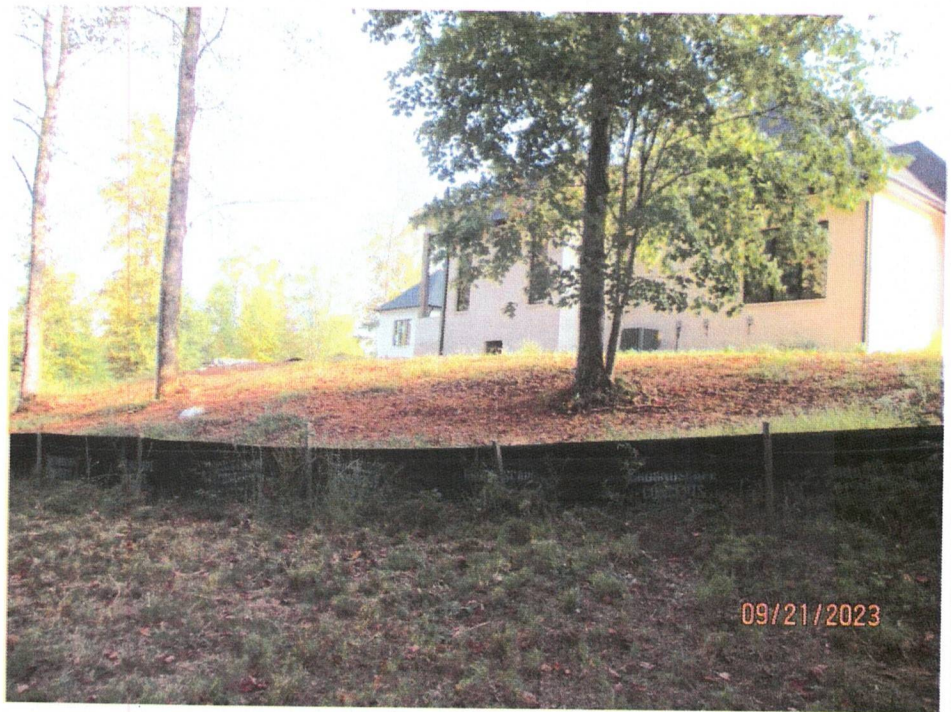
Photo 4:

- Currently the disturbed area within outfall S153 consists of six home construction sites. The disturbed area within the outfall S153 drainage basin is approximately 3.0 acres.
- The individual lot-level erosion controls were observed and appeared to be functioning properly (see photo 4).
- The stormwater basins have been installed and appear to be stabilized.

The individual lot level erosion controls have been installed and appear to be functioning properly.

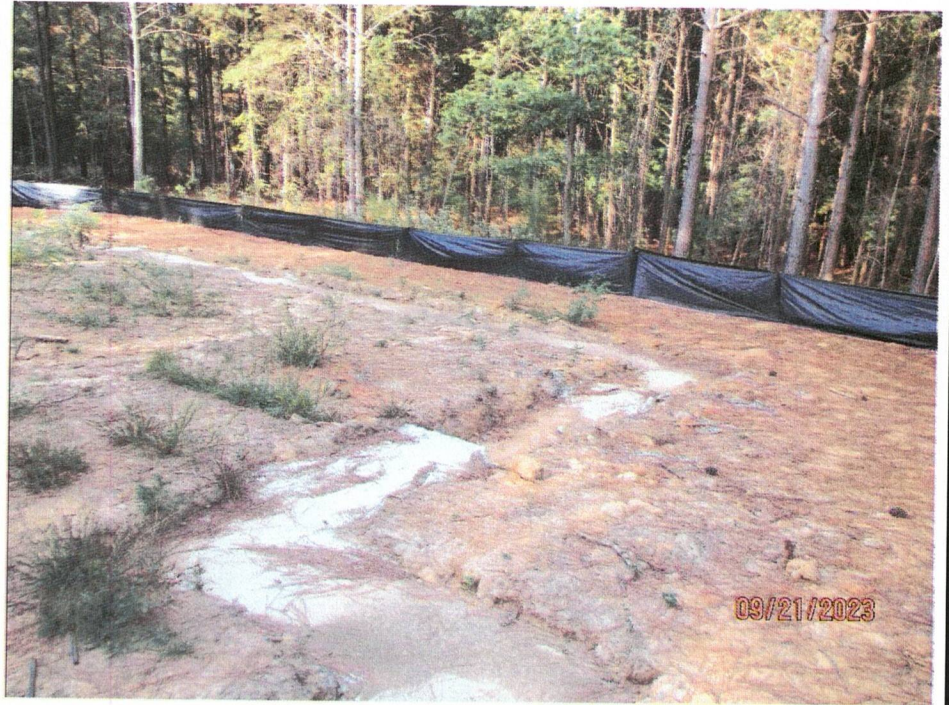
- Currently the disturbed area within outfall S201 consists of three home construction sites. The disturbed area within the outfall S201 drainage basin is approximately 1.2 acres.
- The individual lot-level erosion controls were observed and appeared to be functioning properly (see photo 5).
- The stormwater basins have been installed and appear to be stabilized.

The individual lot level erosion controls have been installed and appear to be functioning properly.

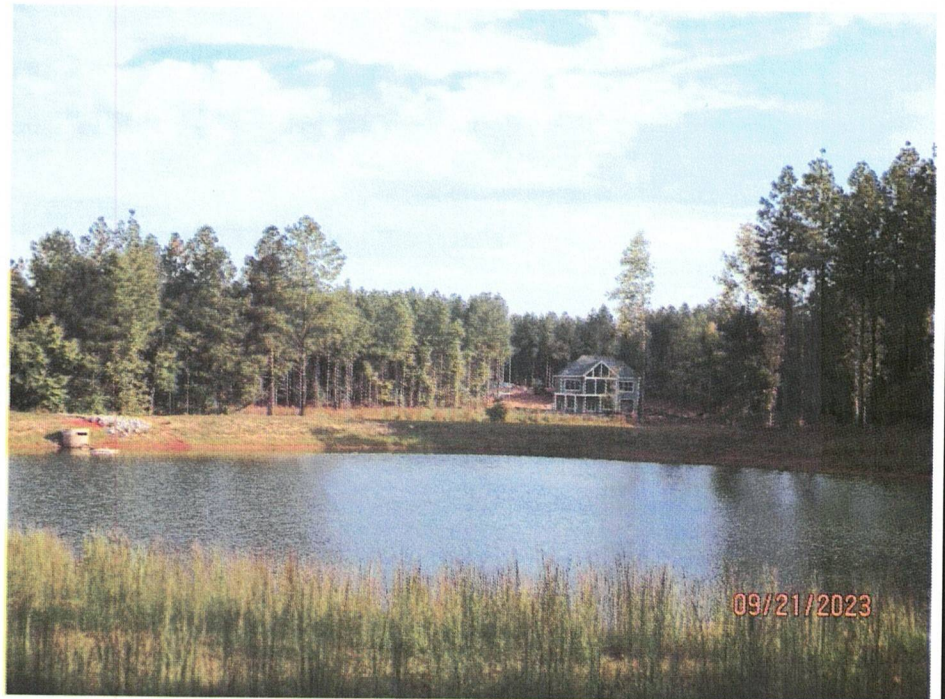
Photo 6:

- Currently the disturbed area within outfall S208 consists of 2 home construction sites, roadway construction, and utility installation along the roadway. The disturbed area within the outfall S208 drainage basin is approximately 2.0 acres.
- The stormwater basins have been installed and appear to be stabilized (see photo 6).
- The individual lot-level erosion controls were observed and appeared to be functioning properly.

A stormwater basin has been installed and appears to be functioning properly.

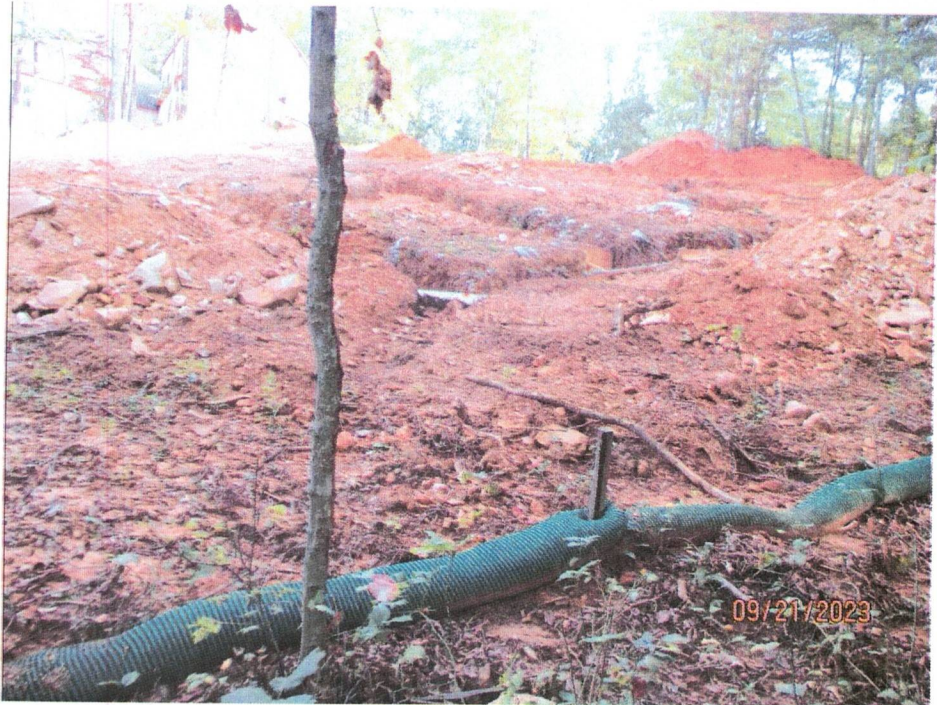
- Currently the disturbed area within outfall S218 consists of 7 home construction sites, roadway construction, and utility installation along the roadway. The disturbed area within the outfall S218 drainage basin is approximately 2.5 acres.
- Rock check dams have been installed in the roadside ditch and appear to be functioning appropriately.
- The individual lot-level erosion controls were observed and appeared to be functioning properly (see photo 7).

Photo 7:
Outfall S218
 The individual lot level erosion controls have been installed and appear to be functioning properly.
 Photo Taken 9/21/2023

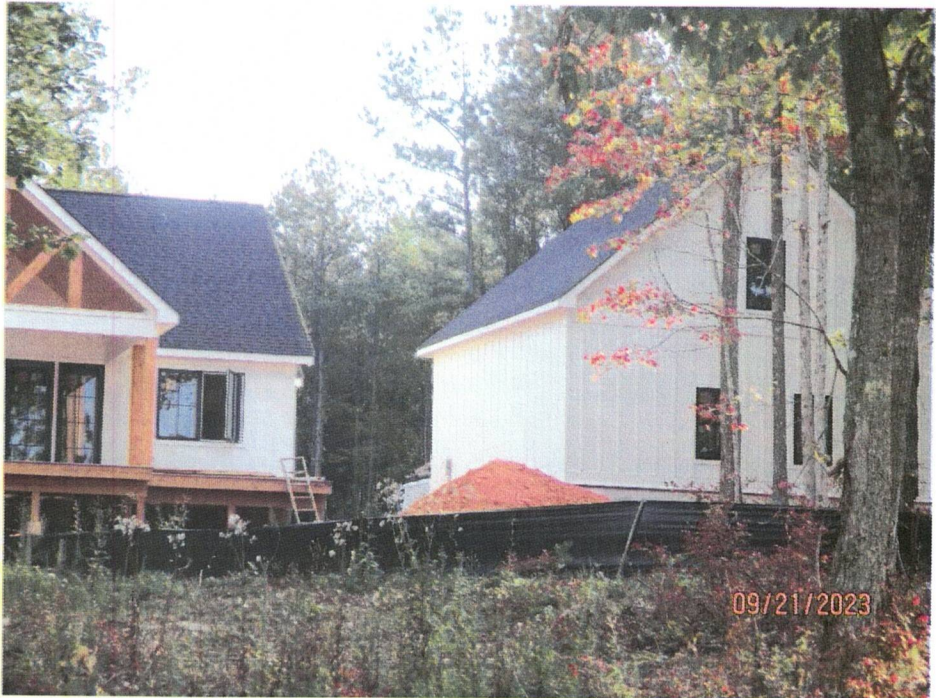
- Currently the disturbed area within outfall S275 consists of roadway construction, 1 home construction site and utility installation along the roadway. The disturbed area within the outfall S275 drainage basin is approximately 0.75 acres.
- The individual lot-level erosion controls were observed and appeared to be functioning properly (see photo 8).
- The stormwater basins have been installed and appear to be stabilized.

Photo 8:
Outfall S275
 The individual lot level erosion controls have been installed and appear to be functioning properly.
 Photo Taken 9/21/2023
