RE: Safety Inspection  
Reedy Creek Dam  
I.D. # 09-7032  
Carroll County

**INSPECTION REPORT  
DAM AND APPURTENANT WORKS**

**Name of Structure:** Reedy Creek Dam **I.D.:** 09-7032  
**Owner:** Carroll County Watershed Authority **County:** Carroll  
**H.P.C.:** 1 **Weather:** Clear, 70°s **Date:** May 17, 2022  
**Last Inspection Date:** May 13, 2021 **Lake Level:** 4'-5' > NPL  
**Emergency Spillway Capacity: Required:** PMP **Existing:** PMP  
**Persons Present at Inspection:** Stephen Miller & Will Little - TN Safe Dams Program; John Bowling - JEFO DWR

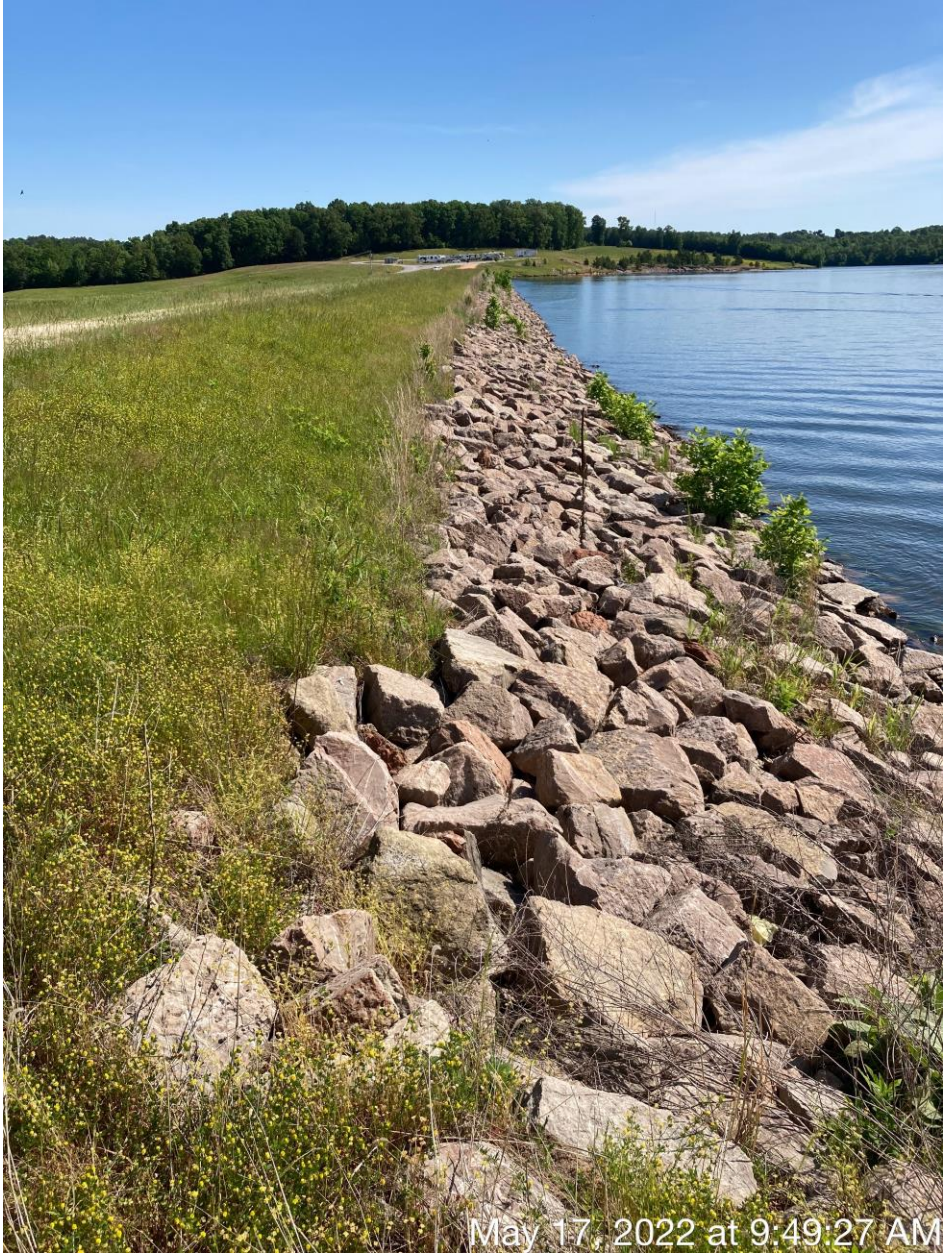
Grass and weeds. Small trees/bushes are scattered in the rip rap.

<b>Description</b> North side of upstream slope. Scattered trees/bushes in rip rap.

Spray/remove any vegetation in the rip rap on a routine basis so that the rip rap remains free of vegetation.

Spray/control the vegetation in all rip rapped areas so that the rip rap remains free of any vegetation.

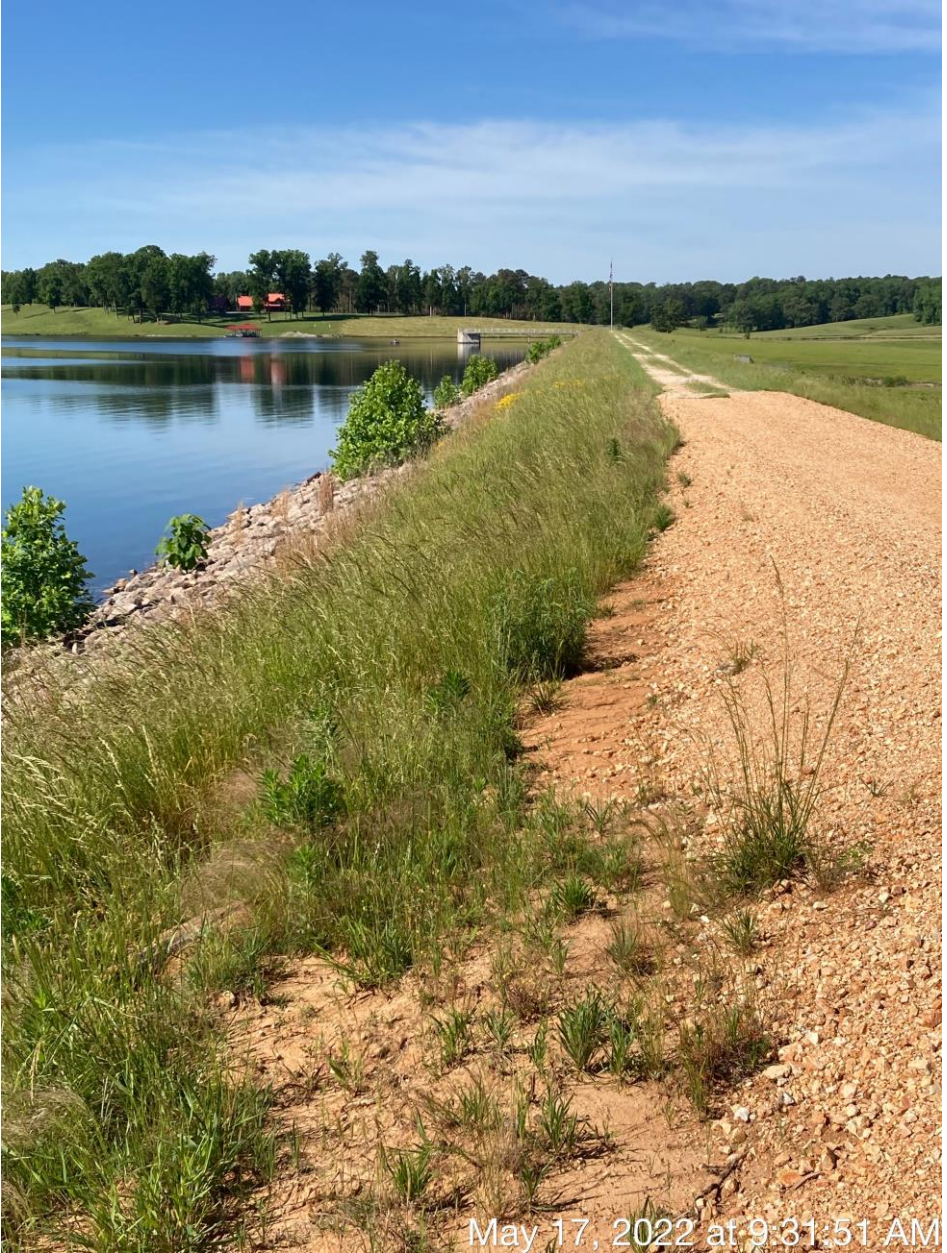
2	5/17/2022		
Description			
Photo of north end of dam taken from near the right abutment. Trees/bushes in rip rap.			
		May 17, 2022 at 9:31:51 AM

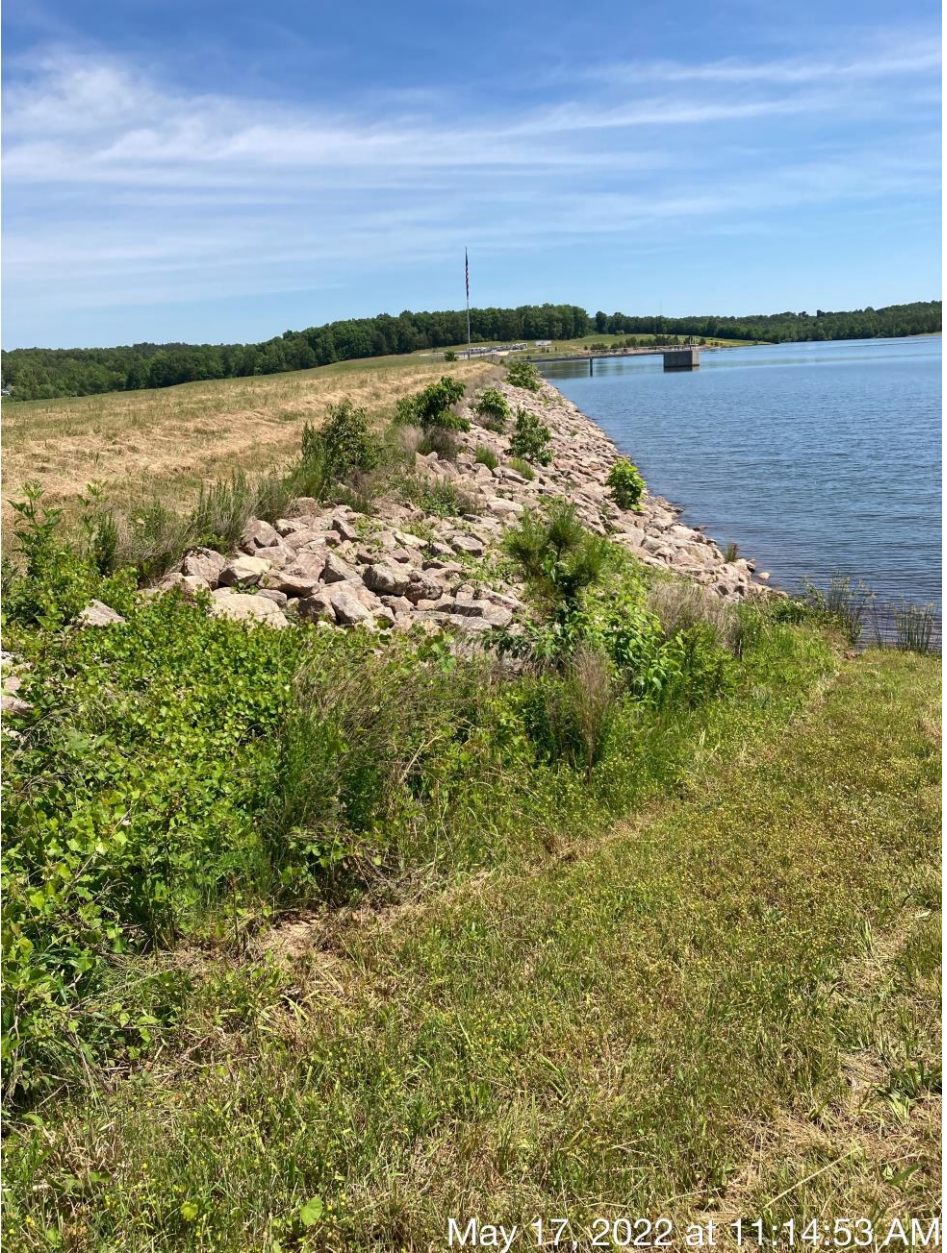
<b>Description</b> South end of upstream slope. Scattered trees/bushes in rip rap.

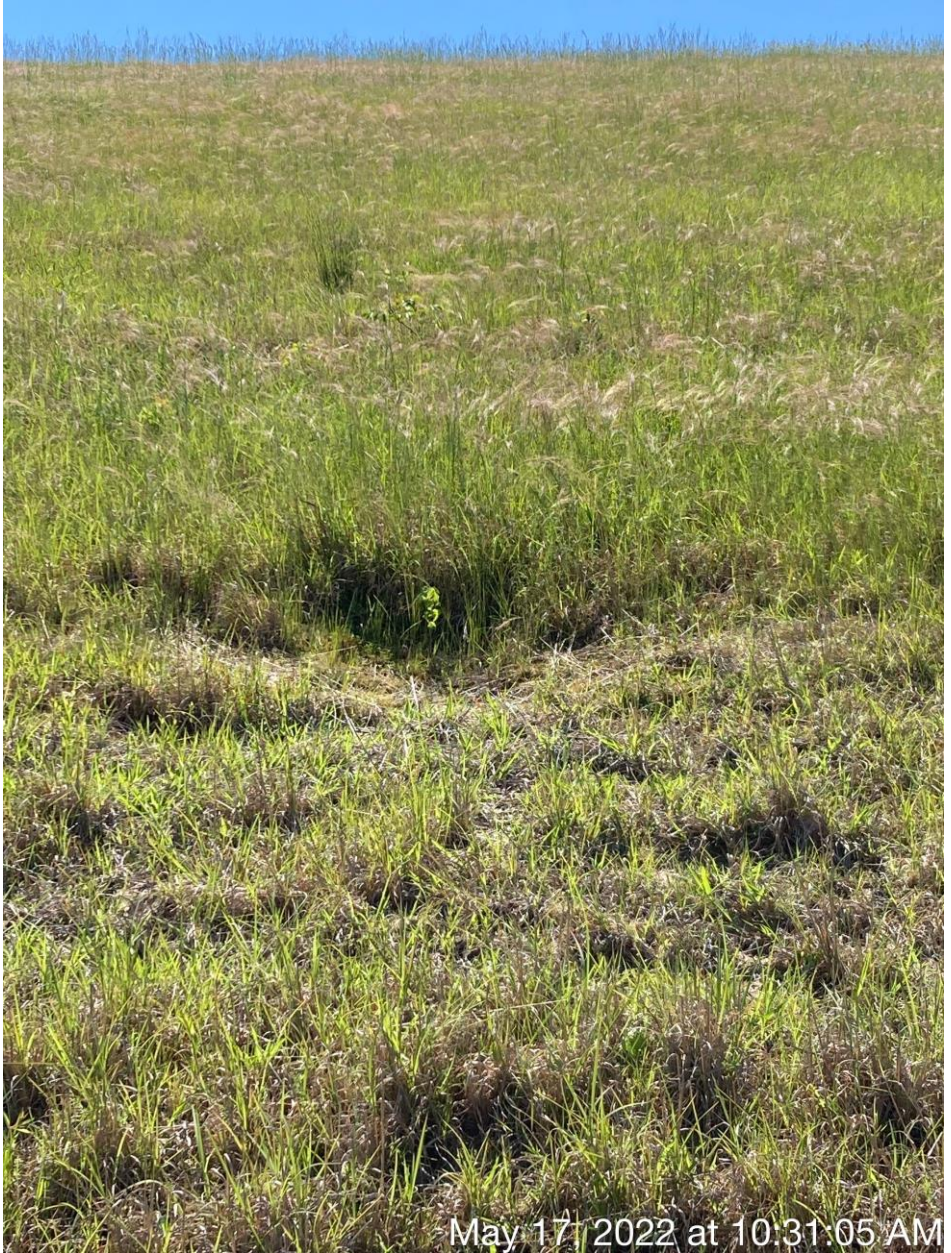
<p>May 17, 2022 at 10:31:05 AM</p>	
<b>Description</b> North side of dam on downstream slope. Past noted bare area is now more vegetated.

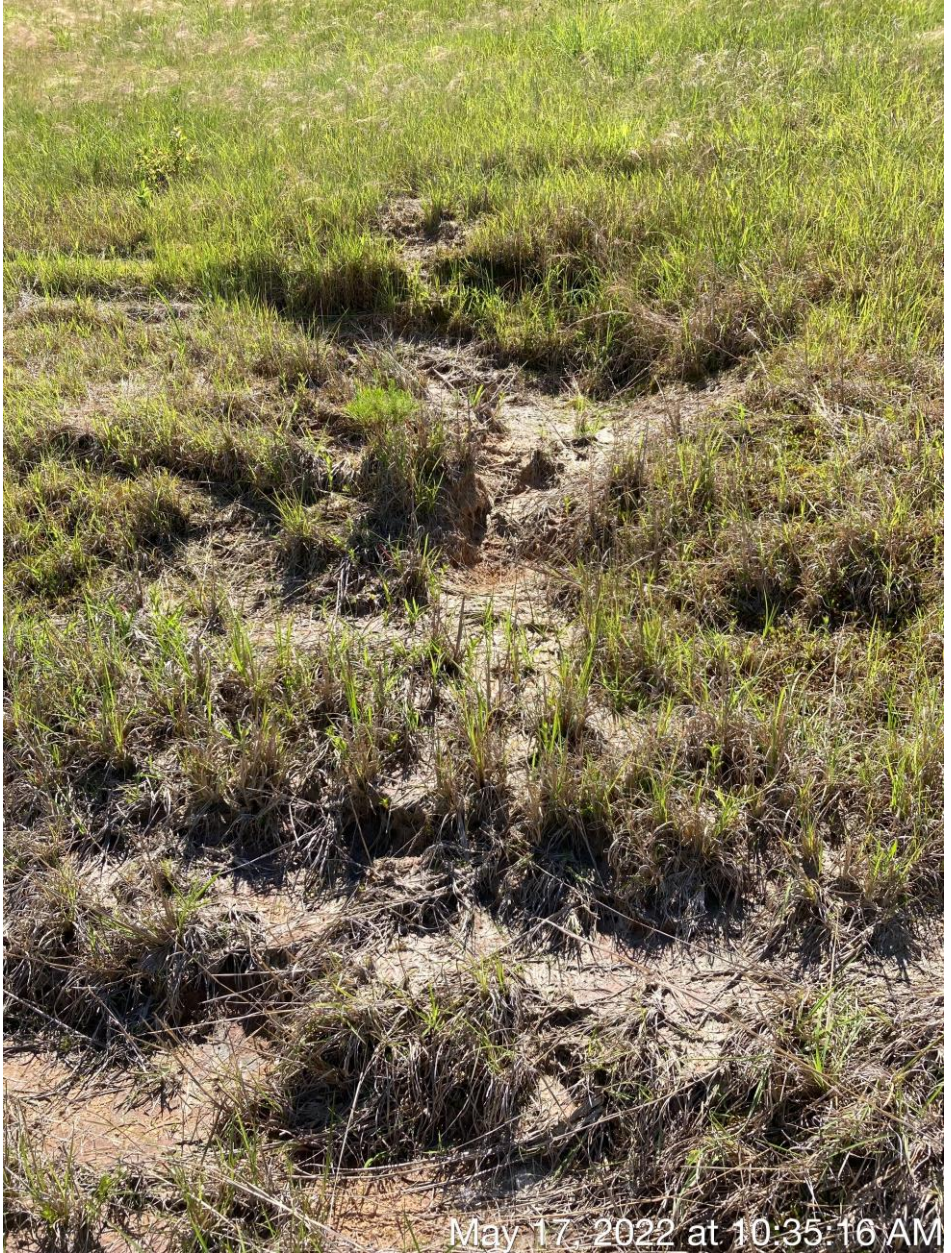
A few small bare areas are present about 20% up the slope on the north side. These areas do not appear to have gotten worse since the last inspection but should be repaired/stabilized.

<p>May 17, 2022 at 10:35:16 AM</p>	
<b>Description</b> North side on downstream slope. Bare area with minor erosion.

Continue to improve the grass cover on the downstream slope to help with the erosion issues on the slope.

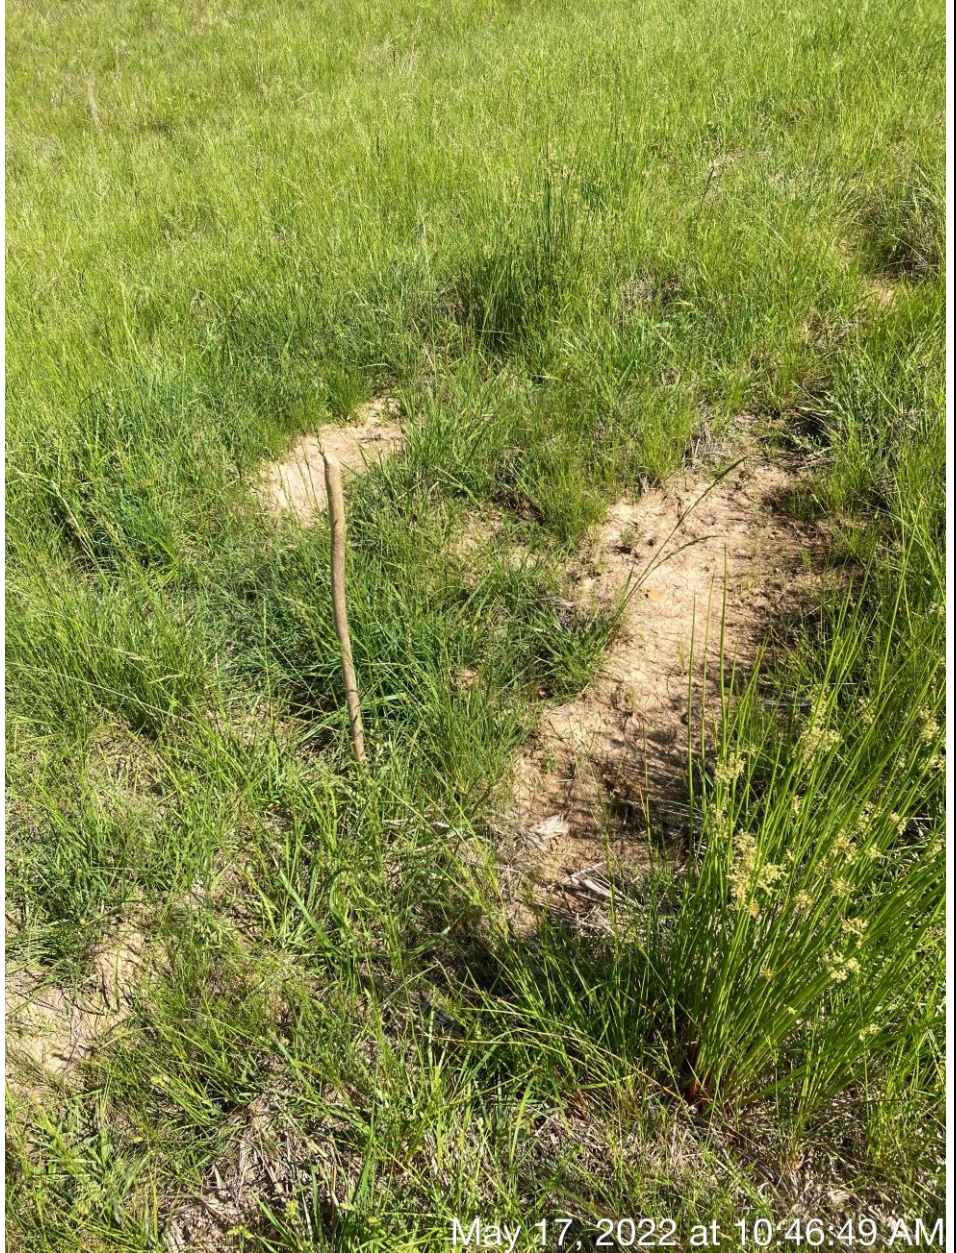
A small hole is present ~90' north of the concrete chute about  
a third of the way up the slope.

<b>Description</b> The stick is marking a small hole ~90' north of the concrete chute about a third of the way up the downstream slope.

Fill the hole observed ~90' north of the concrete chute about a third of the way up the downstream slope with soil.

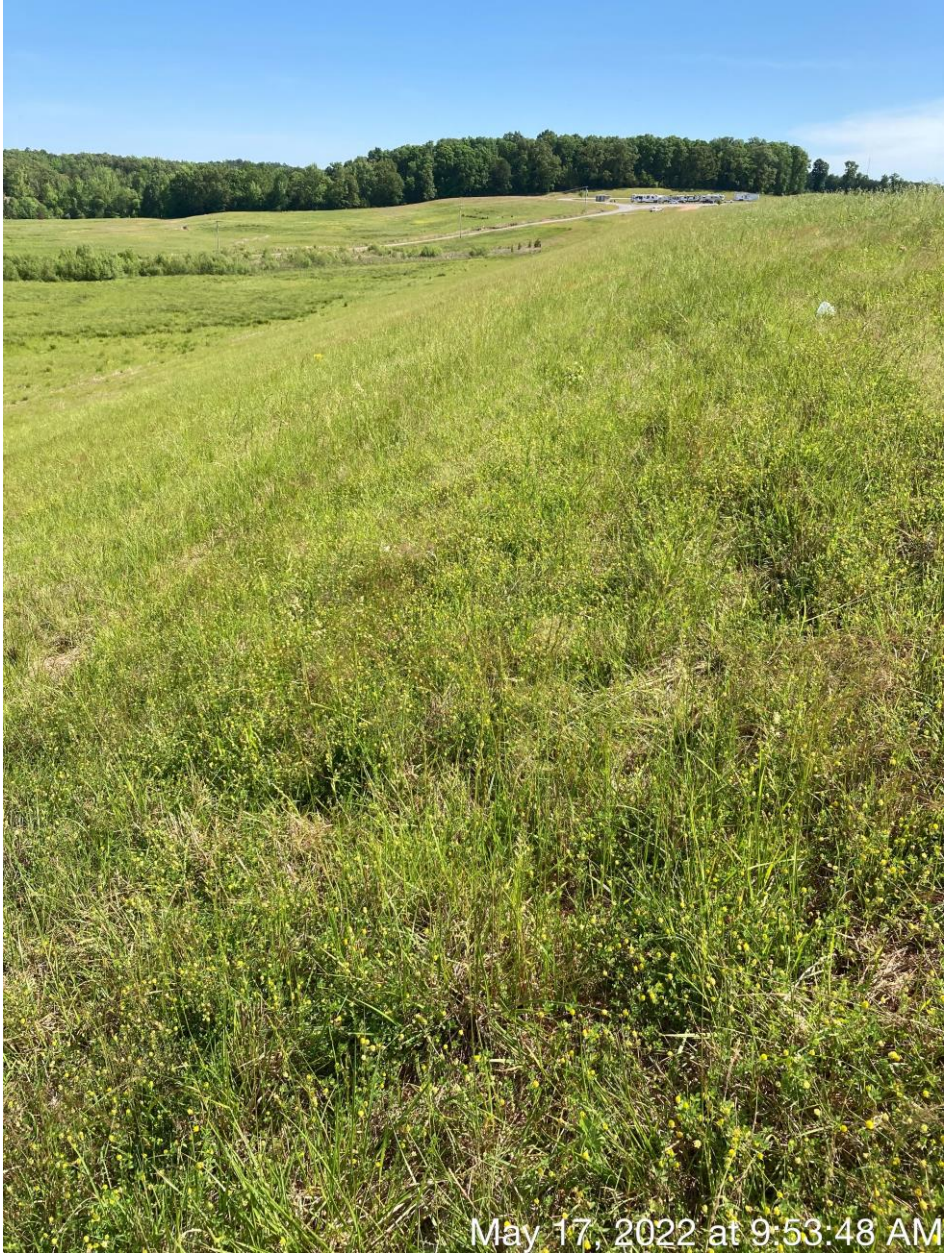
<p>May 17, 2022 at 9:53:48 AM</p>	
<b>Description</b> Downstream slope north of the concrete chute.

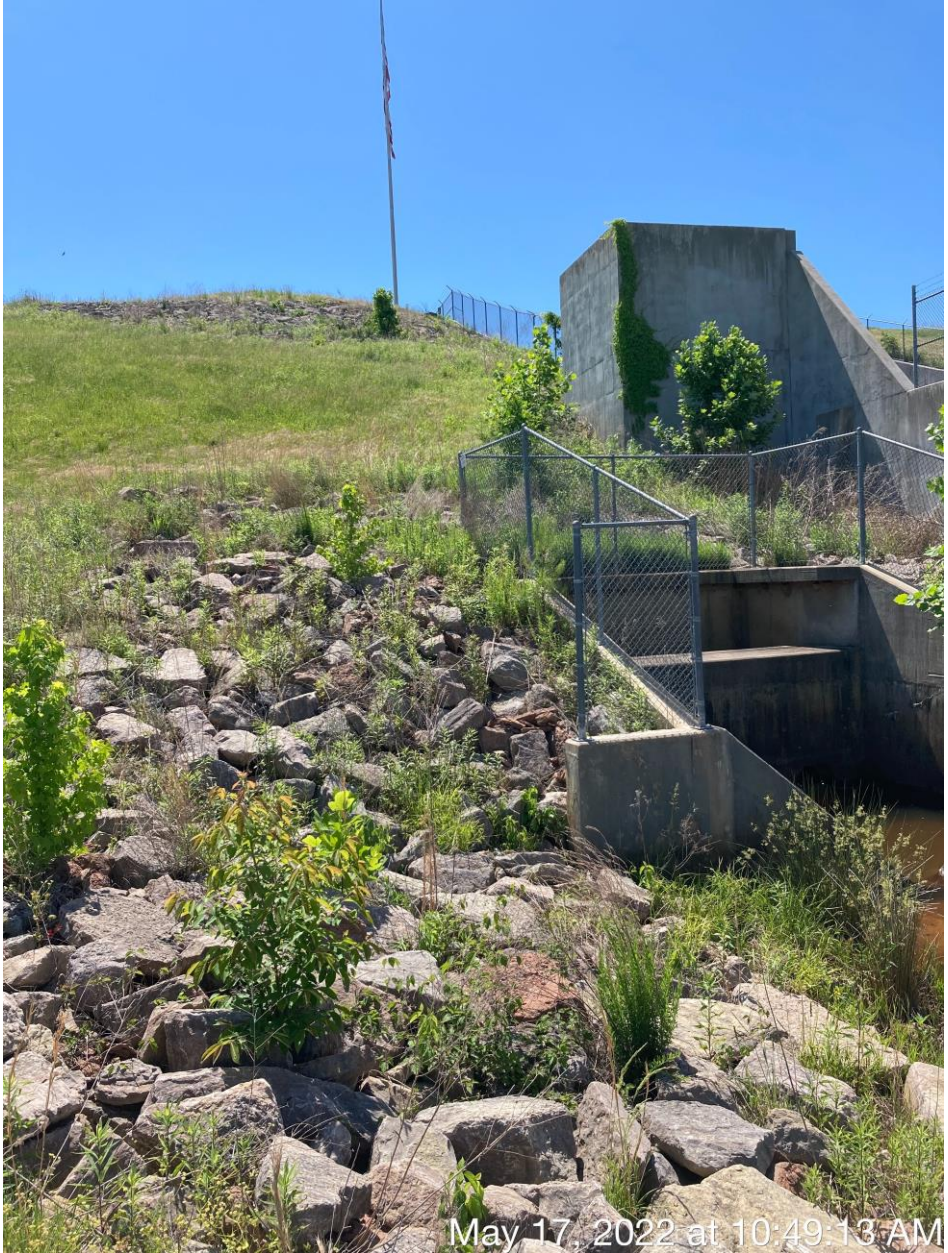
<p>May 17, 2022 at 10:49:13 AM</p>	
<b>Description</b> Photo of rip rap along concrete chute. Trees/bushes present in rip rap.

Spray/control the vegetation in all rip rapped areas.

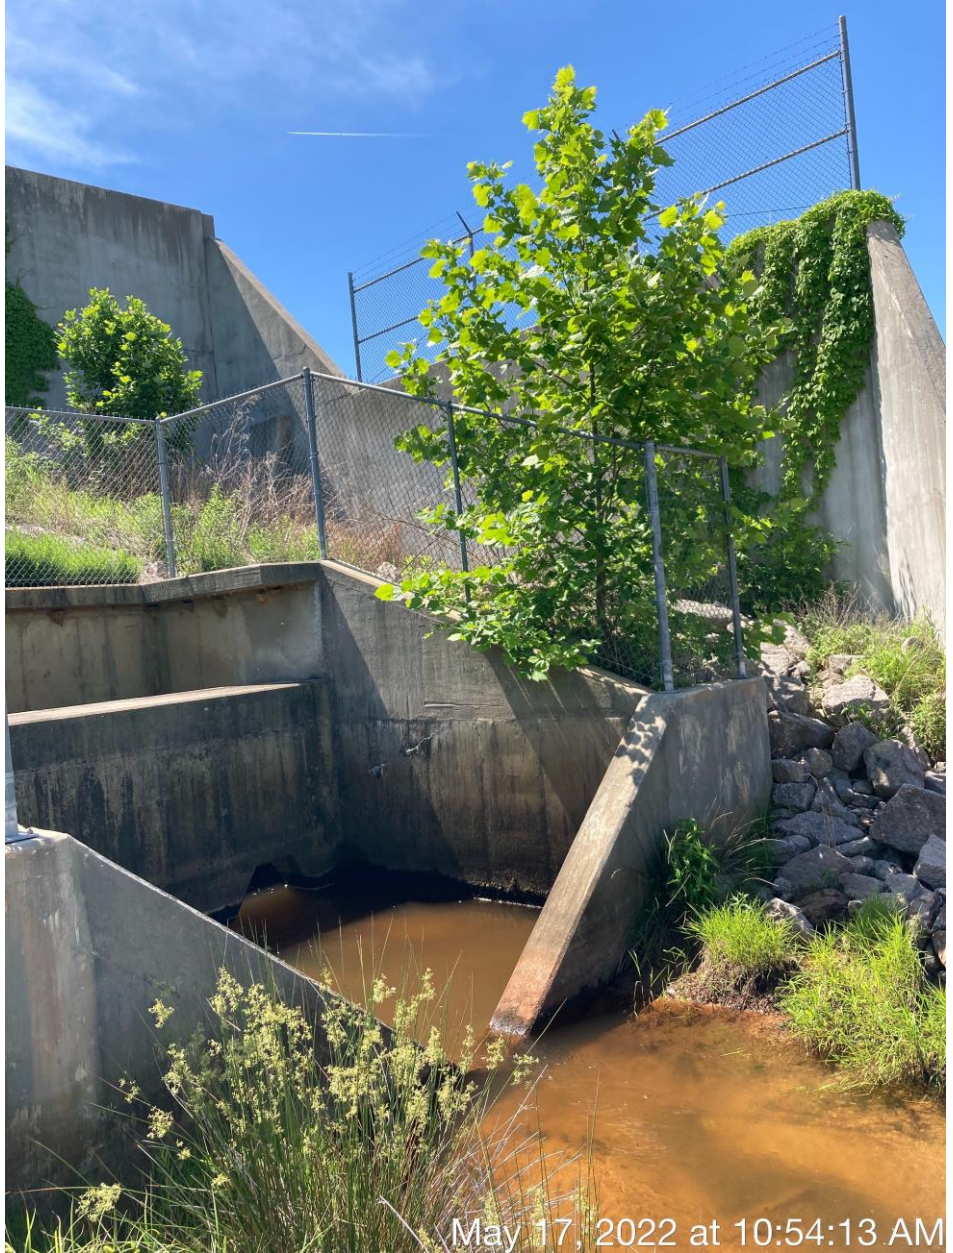
<b>Description</b> Photo of area along concrete chute. Trees/bushes and vines present in rip rap and along chute.

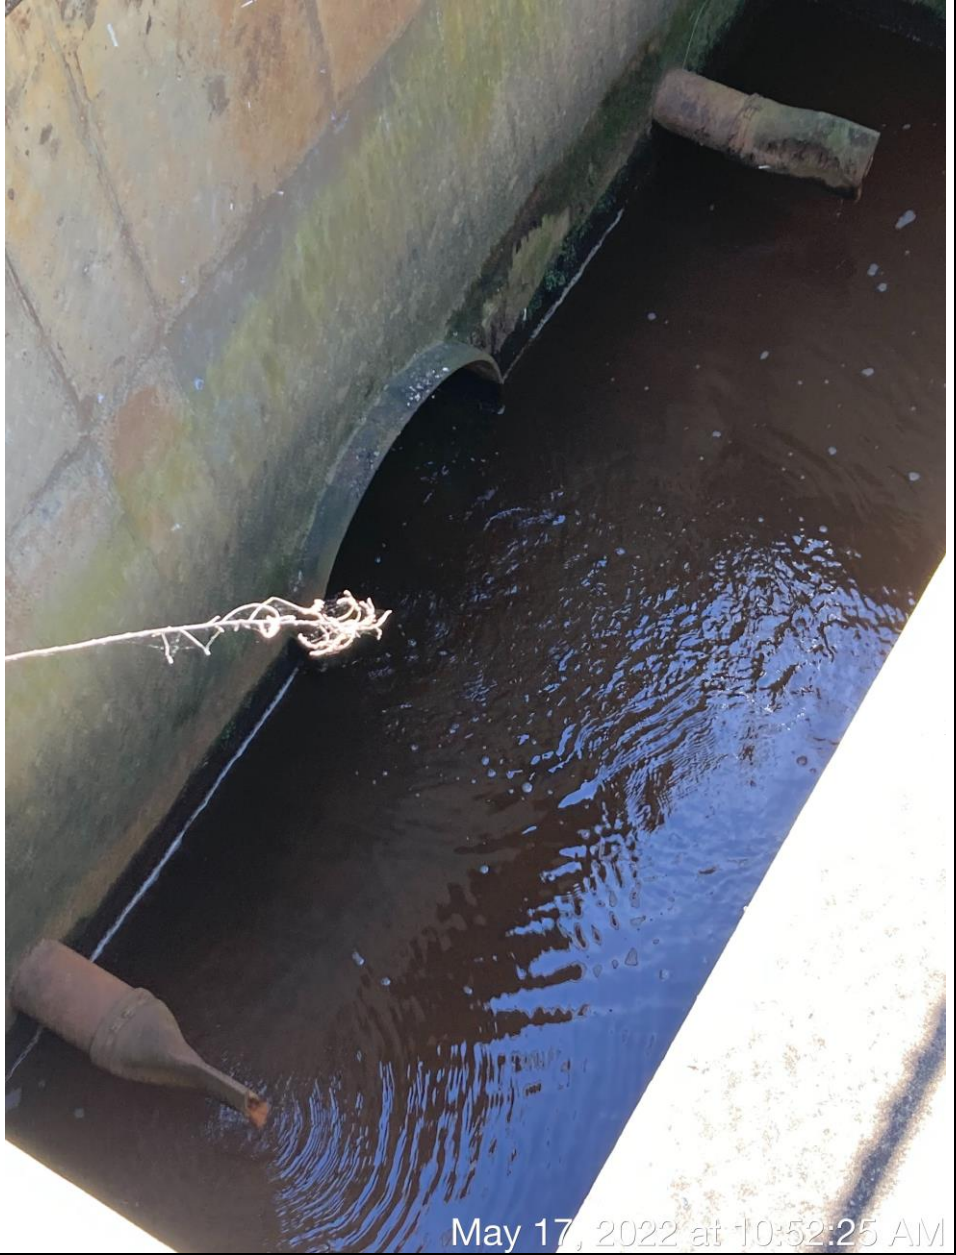
6' X 6' concrete box culvert into a concrete box impact basin.

Ok.

<b>Description</b> Principal spillway outlet
