Re: Compliance Evaluation Inspection
 Madeline Farms (LaGrange Point) State Operating Permit: SOP-07038
 Piperton, Fayette County, Tennessee

Compliance Inspection for State Operating Permits

Facility Name: Madeline Farms Subdivision	Tracking Number: SOP-07038
Permit Effective Date: September 01, 2022	Permit Expiration Date: August 31, 2027
Date of Inspection: October 11, 2022 Time of Inspection: 9-10:30	Inspectors: Ginna McWhirter, Courtney Driver
Official Contact Person: Richard Mills, Piperton Public Works Director	
Address: 3570 Hwy 196 Piperton, TN 38017	Phone Number: (901) 221-7806
	Email: rmills@pipertontn.com

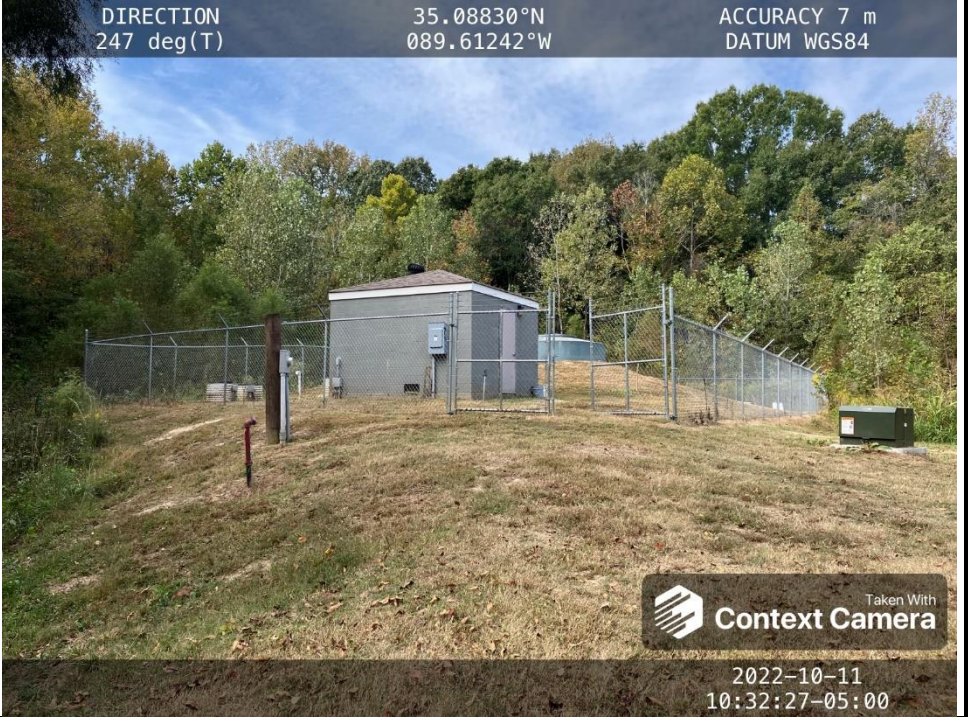
The system consisted of residential septic tanks, an equalizer tank, recycle tank, bio cleres, disposal tank, pump house, and the drip fields. The equalizer tank, recycle tank, bio cleres, disposal tank, and pump house were in an enclosure to the west of the drip field (Photo 1). All equipment appeared to be maintained well and in good condition. The equipment in the field house, such as the water meter and filter system, also appeared in good condition. The water meter calibration logs were observed in the pump house and calibrations occur once a year.

Description			
View southwest of pump house, bio cleres, and treatment tanks. Area was fenced in and locked upon arrival to the site.

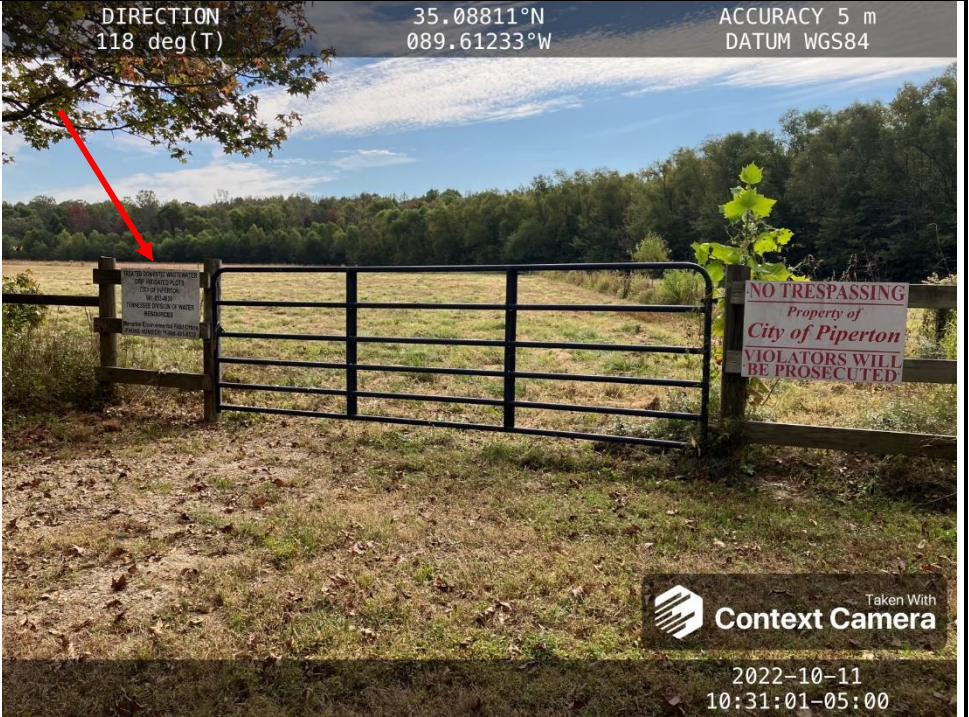
Description			
View southeast of the drip field entrance. Proper signage was observed at the site (red arrow).

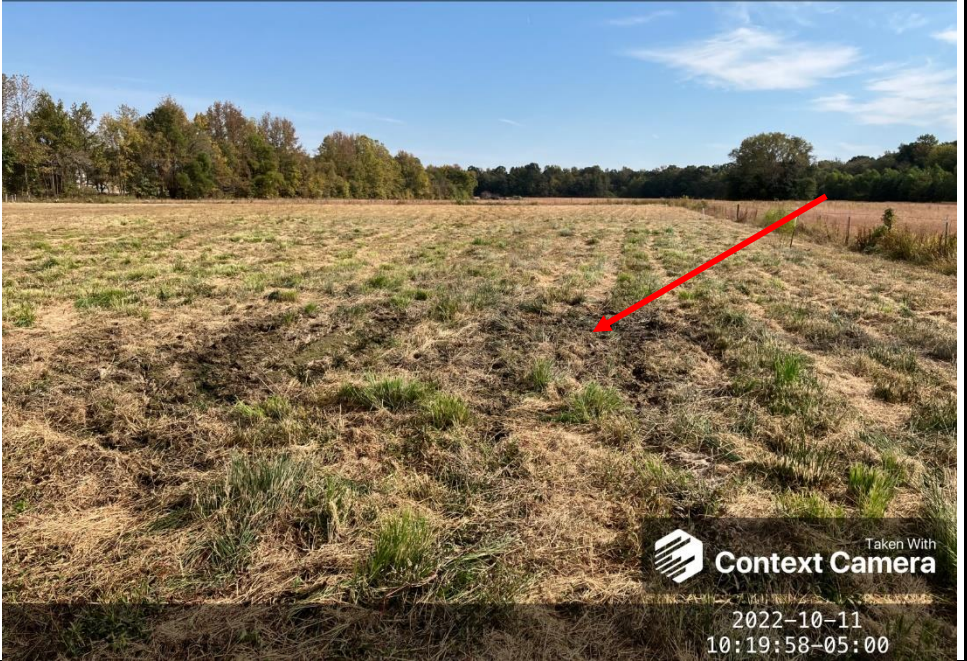
The drip field is split into five zones and cycles through each zone to distribute the wastewater. Air relief pipes are located on the northwestern edge of the field. The field was mowed at the time of the inspection. The fence around the drip field was at least four feet high, barbed wire, and appropriate signage was observed (Photo 2). Two locations that contained standing water were observed during the inspection. According to Mr. Harville, the wet area located in the mid-southeastern edge of the drip field (Photo 3) has been an ongoing leak they have been attempting to locate and fix for approximately a year. Recently, they determined the leak location and fixed the issue. Mr. Harville indicated they are keeping the spot under observation for any additional leaks. The other wet area observed near the northeastern fence line (Photo 4) was found during the inspection. Mr. Harville indicated they will determine the location of the leak and fix the issue.

Project: Madeline Farms (LaGrange Pointe) Subdivision Wastewater Treatment Facility		Site Location: Madeline Farms Subdivision, Piperton, Fayette County		Permit No.: SOP-07038
Photo No. 3	Date 10-11-2022	DIRECTION 42 deg(T)	35.08761°N 089.61113°W	ACCURACY 4 m DATUM WGS84
Description View along the southeastern fence line of the wet area where a leak was located and fixed. This area is under observation for additional leaks.
