RE: COMPLIANCE EVALUATION INSPECTION

NOTICE OF VIOLATION

CITY OF DYERSBURG LANDFILL

SOLID WASTE INSPECTION REPORT

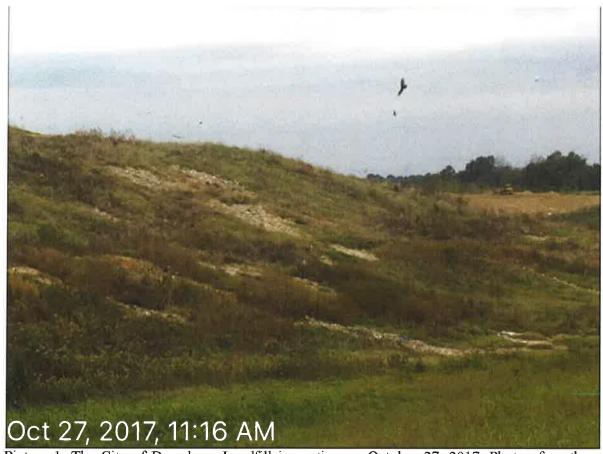
Washout of Solid Waste – During the October 27, 2017 inspection of the City of Dyersburg Municipal Landfill, several small areas of exposed waste were noted to have washed out on the internal slopes. However, the more concerning issue was the northern slope where several very large areas of the slope had eroded and waste was exposed in long stretches down the slope following mostly a rill pattern. Here, some waste had washed down the slope and possibly past the liner. It was noted during this inspection that the landfill had received 5.7 inches of rain October 9-11, 2017 with several smaller periodic rain events after that leading up to the October 27, 2017 inspection.

Inadequate erosion control – During the October 27, 2017 inspection, it was noted that erosion control measures had not been implemented to adequately control erosion and prevent washout of waste, especially on the northern slope. This violation is paired with the above violation, "Washout of solid waste". The northern slope had several large areas where the intermediate cover had eroded due to lack of maintenance. This type of soil is prone to easily erode even with a healthy stand of established vegetative cover. However, regular maintenance and installing adequate erosion control measures to slow run-on and run-off were recommended by the inspector.

Unsatisfactory intermediate cover – During the October 27, 2017 inspection, the inspector found the northern slope to have unsatisfactory intermediate cover due to the extensive amount of erosion the slope had sustained during recent heavy rainfall and areas of exposed waste that were now present. Several small areas were also noted on the internal slopes.

Unsatisfactory stabilization of cover – During the October 27, 2017 inspection, the inspector noted several very large areas of unsatisfactorily stabilized cover on the northern slope. Areas of the intermediate cover had eroded and waste was exposed in long stretches down the slope, mostly following a rill pattern. Small areas noted on the

Picture 1. The City of Dyersburg Landfill inspection on October 27, 2017: Photo of northern slope with erosion, washout of solid waste, unsatisfactory intermediate cover, and unsatisfactory stabilization of cover.

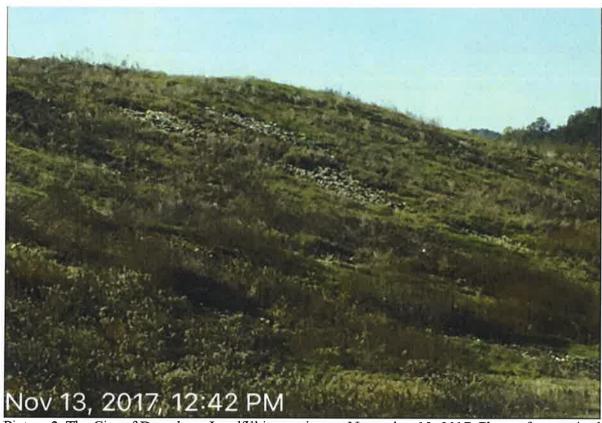
During the November 13, 2017 inspection, it was noted that repair work had been done at the landfill. All of the smaller areas of exposed waste on the inner slopes noted during the October 27, 2017 inspection had been corrected. However, the larger washed areas on the northern slope remained non-compliant as observed previously. Certified Operator - Greg Wilson stated that the northern slope was too dangerous at the present time to operate equipment due to wet conditions within that area. The inspector advised the operator to (without delay and when safe for landfill staff to proceed) repair the northern slope washout areas to a compliant condition. Although leachate is a concern due the size of the areas of exposed waste, there was no visible leachate.

During the November 13, 2017 inspection, no progress had been made on the northern slope to bring erosional issues into compliance due to the aforementioned safety reasons. However, landfill staff worked all weekend on the internal slopes to repair erosion rills and areas of exposed waste. The inspector noted the repaired slopes were now compliant. Also, repair work on the southernmost slope that faces the demolition landfill area was performed with soil placement to eroded areas. This area has been seeded with wheat, blown with straw and straw bale anchors placed at intervals across the top of the slope. The area will need to be watched closely and maintained to mitigate any further erosion.

Violation 8270: The large areas of waste that had washed out on the previous inspection (10-27-2017) have not been fixed due to the slope being too wet to put equipment on. As soon as the slope is dry enough to safely support equipment, the plan is to fix these areas. There is a sand pit at the toe of the slope that prevents any leachate from leaving the cell.

Picture 2. The City of Dyersburg Landfill inspection on November 13, 2017: Photo of unrepaired northern slope with erosion, washout of solid waste, unsatisfactory intermediate cover, and unsatisfactory stabilization of cover.

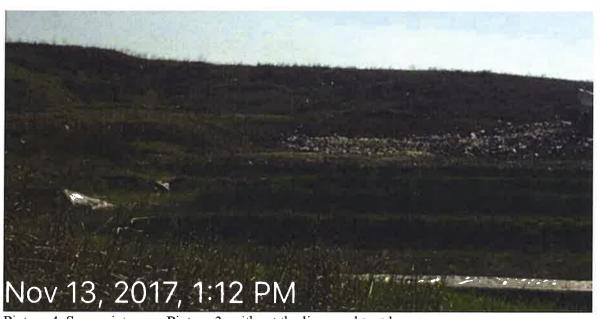
During the November 13, 2017 inspection, the inspector noted repairs were made to all of the smaller areas of unsatisfactory intermediate cover on the inner slopes. These areas in violation on the October 27, 2017 inspection were corrected. However, the larger areas on the northern slope remained non-compliant.

During the November 13, 2017 inspection, all of the smaller areas of unsatisfactory intermediate cover on the inner slopes that were noted during the October 27, 2017 inspection had been patched and will need to be stabilized to minimize further erosion. The larger areas on the northern slope remained non-compliant.

Some of the cover repair work that brought inner slopes back into compliance.

Two red lines denote the "L-

Shaped" previous fill area interface with the current

fill area.

Picture 3. The City of Dyersburg Landfill inspection on November 13, 2017: Photo of repaired inner slopes that were observed with erosion, washout of solid waste, unsatisfactory intermediate cover, and unsatisfactory stabilization of cover on the October 27, 2017 inspection.
