General NPDES Permit for Stormwater Discharges from Construction Activities (CGP)

RE: Site Assessment Report Individual Construction Permit TN0081949 Jasper Highlands ADE Project No. 16161

JASPER HIGHLANDS Site Assessment Report Marion County, TN

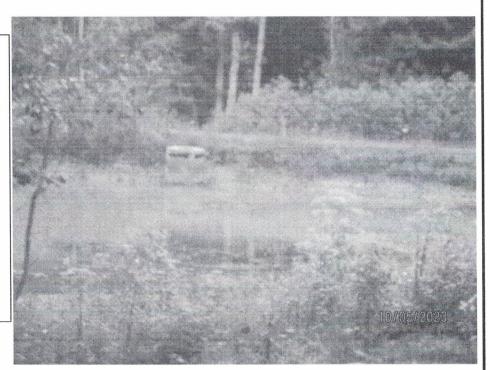
Photo 1:

- Currently the disturbed area within outfall S59 consists of two homes being constructed totaling approximately 1.0 acres of disturbance.
- A stormwater basin has been installed and appears to be functioning properly (see photo 1).
- The outfall sampling location was observed, and no signs of sediment discharge were observed.

Outfall S59

A stormwater basin has been installed and appears to be functioning properly.

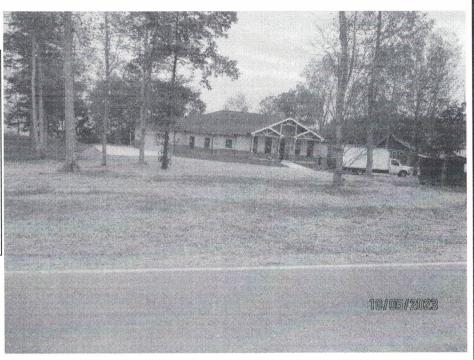
Photo 2:

- Currently the disturbed area within outfall S98 consists of two homes being constructed totaling approximately 0.60 acres of disturbance.
- The individual lot-level erosion controls were observed and appeared to be functioning properly (see photo 2).
- The outfall sampling location was observed, and no sign of sediment discharge were observed.

Outfall S98

The individual lot level erosion controls have been installed and appear to be functioning properly.

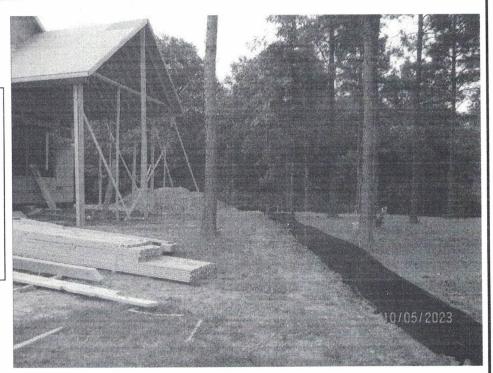
Photo 3:

- Currently the disturbed area within outfall S153 consists of six home construction sites. The disturbed area within the outfall S153 drainage basin is approximately 3.0 acres.
- The individual lot-level erosion controls were observed and appeared to be functioning properly (see photo 3).
- The stormwater basins have been installed and appear to be stabilized.

Outfall S153

The individual lot level erosion controls have been installed and appear to be functioning properly.

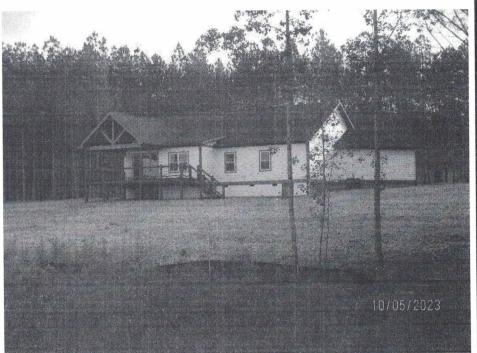
Photo 4:

- Currently the disturbed area within outfall S201 consists of three home construction sites. The disturbed area within the outfall S201 drainage basin is approximately 1.2 acres.
- The individual lot-level erosion controls were observed and appeared to be functioning properly (see photo 4).
- The stormwater basins have been installed and appear to be stabilized.

Outfall S201

The individual lot level erosion controls have been installed and appear to be functioning properly.

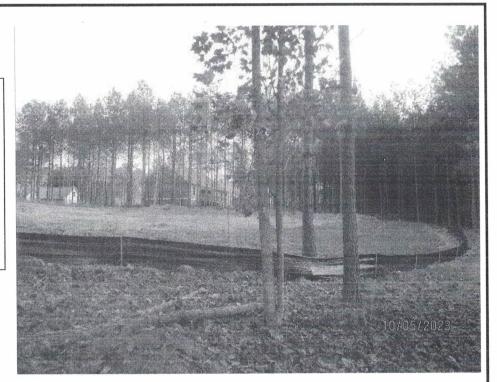
Photo 5:

- Currently the disturbed area within outfall S208 consists of 2 home construction sites, roadway construction, and utility installation along the roadway. The disturbed area within the outfall S208 drainage basin is approximately 2.0 acres.
- The stormwater basins have been installed and appear to be stabilized.
- The individual lot-level erosion controls were observed and appeared to be functioning properly (see photo 5).

Outfall S208

The individual lot level erosion controls have been installed and appear to be functioning properly.

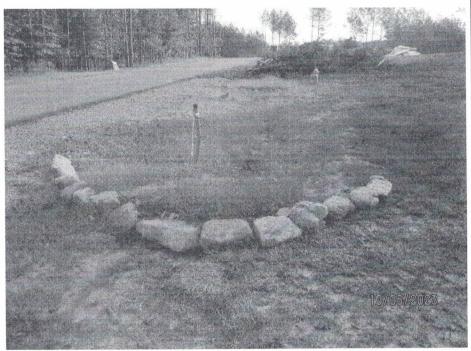
Photo 6:

Outfall S218

Rock check dams have been installed along a roadside ditch and they appear to be functioning properly.

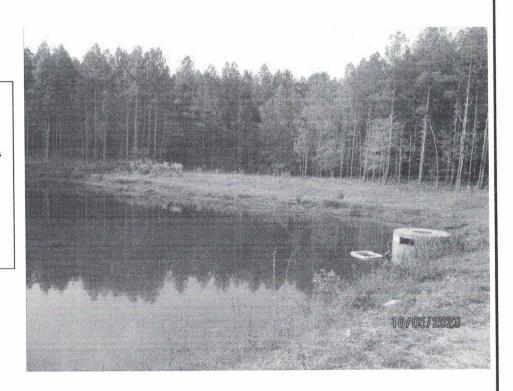
Photo 7:

- Currently the disturbed area within outfall S275 consists of roadway construction,
 1 home construction site and utility installation along the roadway. The disturbed area within the outfall S275 drainage basin is approximately 0.75 acres.
- The individual lot-level erosion controls were observed and appeared to be functioning properly.
- A stormwater basin has been installed and appears to be stabilized (see photo 7).

Outfall S275

A stormwater basin has been installed and appears to be functioning properly.

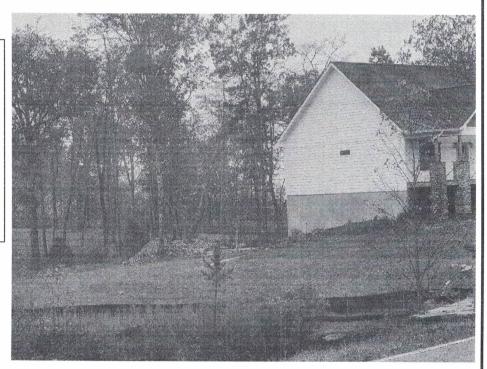
- Currently the disturbed area within outfall S59 consists of two homes being constructed totaling approximately 1.0 acres of disturbance.
- The outfall sampling location was observed. No runoff was present, and no signs
 of sediment discharge were observed.
- Individual home construction sites were observed, and erosion control measures appeared to be in place and functioning properly (see photo 1).

An individual home construction site was observed, and erosion control measures appeared to be in place and functioning properly.

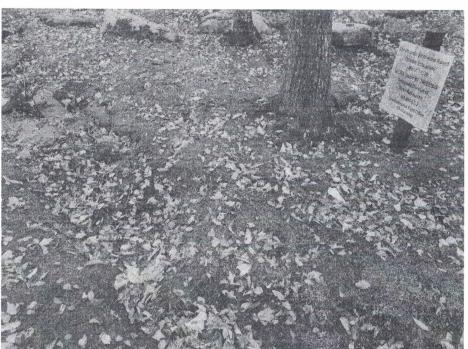
Photo 2:

- Currently the disturbed area within outfall S98 consists of two homes being constructed totaling approximately 0.6 acres of disturbance.
- The outfall sampling location was observed, and no signs of sediment discharge were observed (see photo 2).

Outfall S98

The outfall sampling location was observed. No runoff was present, and no signs of sediment discharge were observed.

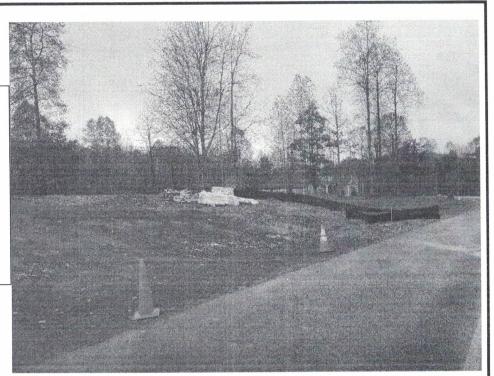
- Currently the disturbed area within outfall S153 consists of six home construction sites. The disturbed area within the outfall S153 drainage basin is approximately 3.0 acres.
- An individual home construction site was observed, and erosion control measures appeared to be in place and functioning properly (see photo 3).
- The outfall sampling location was observed, and no signs of sediment discharge were observed.

An individual home construction site was observed, and erosion control measures appeared to be in place and functioning properly.

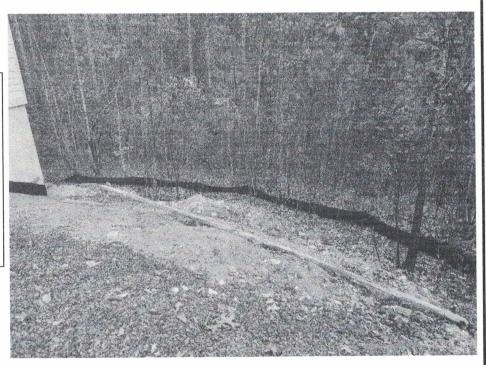
Photo 4:

- Currently the disturbed area within outfall S201 consists of three house construction sites. The disturbed area within the outfall S201 drainage basin is approximately 1.2 acres.
- An individual home construction site was observed, and erosion control measures appeared to be in place and functioning properly (see photo 4).

Outfall S201

An individual home construction site was observed, and erosion control measures appeared to be in place and functioning properly.

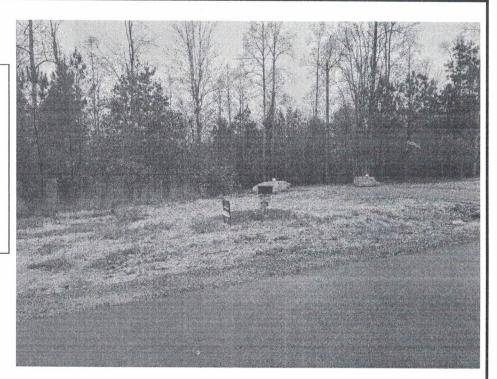
- Currently the disturbed area within outfall S208 consists of the construction of 2 home construction sites, roadway construction, and utility installation along the roadway. The disturbed area within the outfall S208 drainage basin is approximately 2.0 acres.
- An individual home construction site was observed, and seed and straw have covered a previously disturbed area (see photo 5).

An individual home construction site was observed, and seed and straw have covered a previously disturbed area.

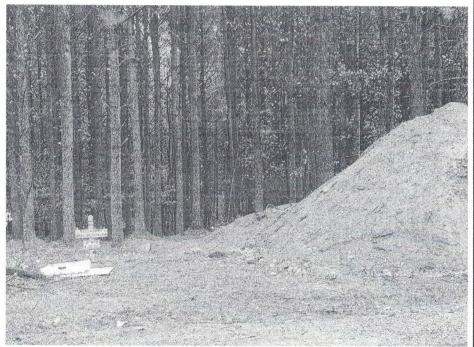
Photo 6:

- Currently the disturbed area within outfall S218 consists of 7 home construction sites, roadway construction, and utility installation along the roadway. The disturbed area within the outfall S218 drainage basin is approximately 2.5 acres.
- A new individual home construction site was observed. Erosion control measures should be installed below disturbed areas (see photo 6).

Outfall S218

A new individual home construction site was observed. Erosion control measures should be installed below disturbed areas.

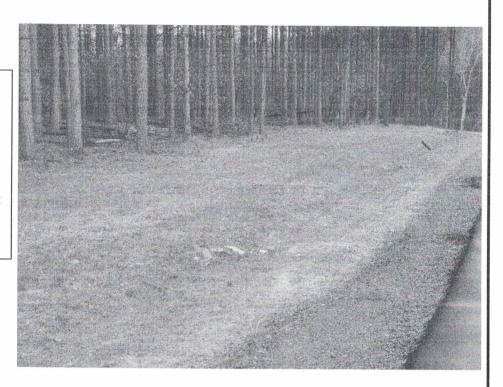
- Currently the disturbed area within outfall S275 consists of roadway construction, utility installation along the roadway, and one home construction site. The disturbed area within the outfall S275 drainage basin is approximately 0.75 acres.
- A roadside swale was observed. The swale has recently been stabilized with grass, matting, and rock check dams (see photo 7).

A roadside swale was observed. The swale has recently been stabilized with grass, matting, and rock check dams.
