Compliance Inspection for Concentrated Animal Feeding Operation (CAFO)

INSPECTION TYPE									
Routine	<input type="checkbox"/>	Comprehensive	<input checked="" type="checkbox"/>	Complaint	<input type="checkbox"/>	Follow Up	<input type="checkbox"/>	Termination	<input type="checkbox"/>
Facility Name:	William Thompson dba Cypress Creek Farm				County(ies):	Obion			
Street Address or Location:	238 Red McCorkle Road Union City, Obion County, TN				Latitude (dd.dddd):	36.350000			
					Longitude (-dd.dddd):	-88.956900			
Official Contact:	William Thompson		Email: htwn@frontiernet.net		Contact Phone: 731-571-3429				
Address:	238 Red McCorkle Road		City: Union City		State: TN		Zip: 38261		
Inspection Date: 6-25-2020			Entry Time: 12:15		Exit Time: 15:15				
Weather Conditions: Mostly Sunny				Inspector(s): Kevin Smith					
PERMIT									
Permit Number:	TN0081779		<input checked="" type="checkbox"/> copy available on site						
Issuance Date	August 2, 2017		Expiration Date	August 31, 2022

PHOTOLOG

Subject: Inspection Pictures from Cypress Creek Farm 6-25-2020 CAFO Inspection

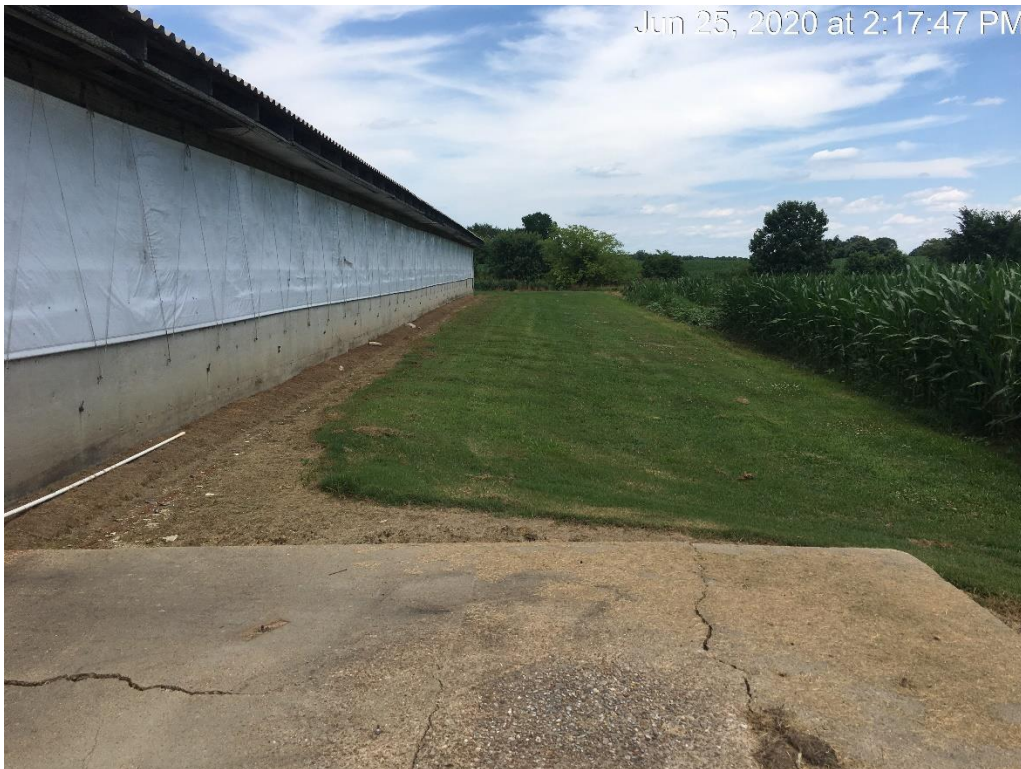
Picture 1

Date of Photo: 6/25/20. Photo taken by: Kevin Smith. Location/Site Name: Cypress Creek Farms / TN0081779. TDWR personnel Present: Kevin Smith. Remarks: Picture is of southern side of the older hog barns. Area was well vegetated. Picture was taken on southwest side of southern hog barn facing east.

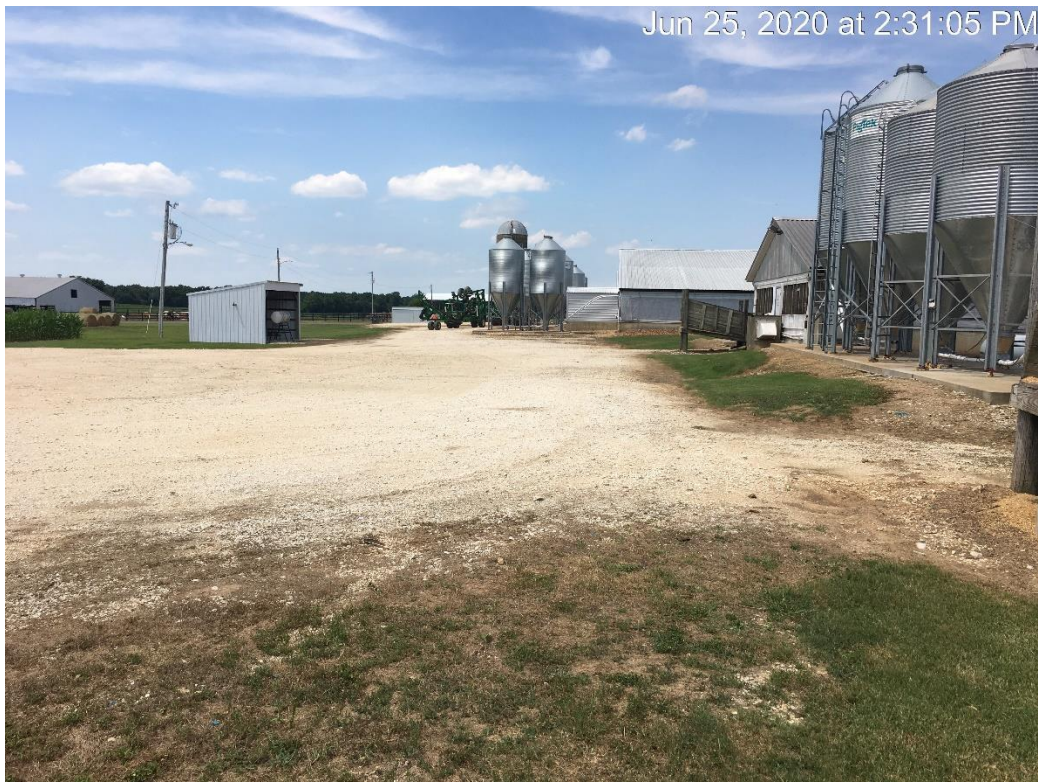
Picture 2

Date of Photo: 6/25/20. Photo taken by: Kevin Smith. Location/Site Name: Cypress Creek Farms / TN0081779. TDWR personnel Present: Kevin Smith. Remarks: Picture is of west side of hog barns. Picture was taken standing near southwest corner of the southern hog barn facing north.

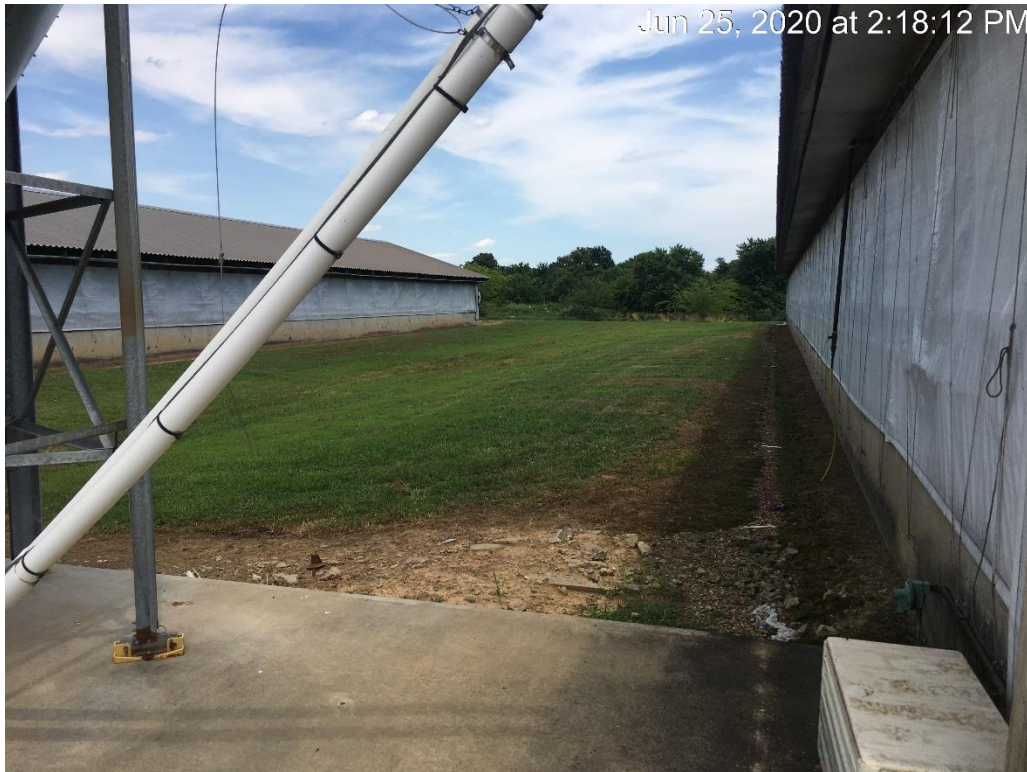
Picture 3

Date of Photo: 6/25/20. Photo taken by: Kevin Smith. Location/Site Name: Cypress Creek Farms / TN0081779. TDWR personnel Present: Kevin Smith. Remarks: Picture is of vegetated area between the older southern hog barns. Picture was taken standing on west side of barns facing east.

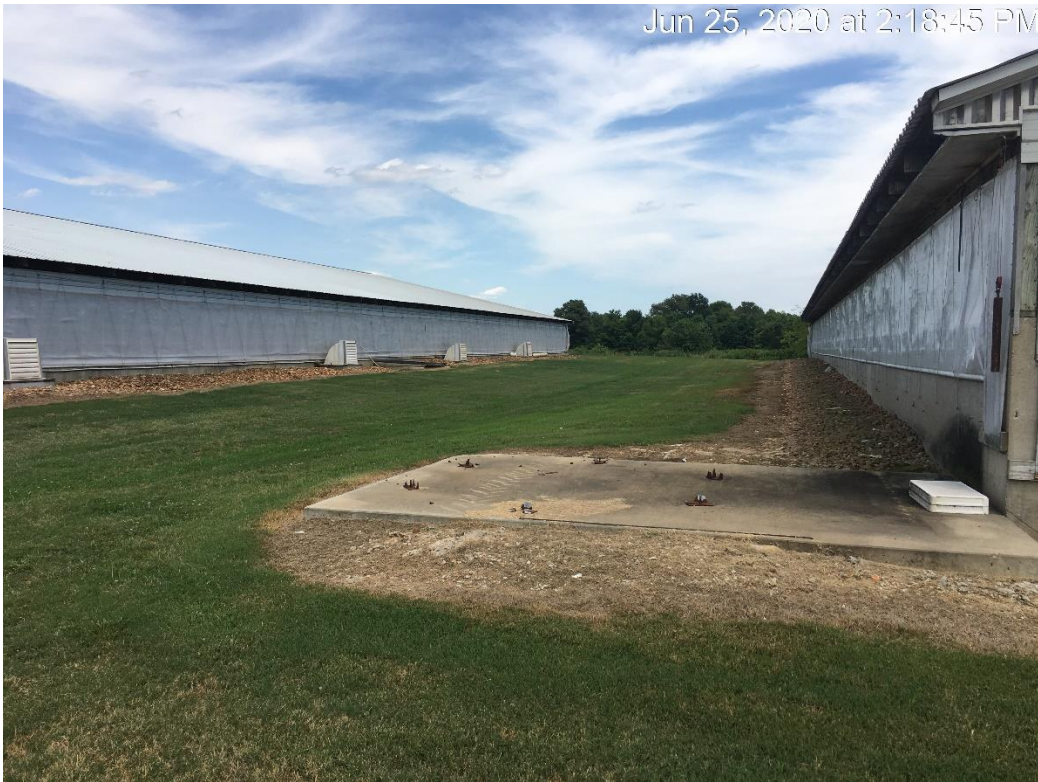
Picture 4

Date of Photo: 6/25/20. Photo taken by: Kevin Smith. Location/Site Name: Cypress Creek Farms / TN0081779. TDWR personnel Present: Kevin Smith. Remarks: Picture is of vegetated area between the new and old hog barns. Picture was taken standing on west side of barns facing east.

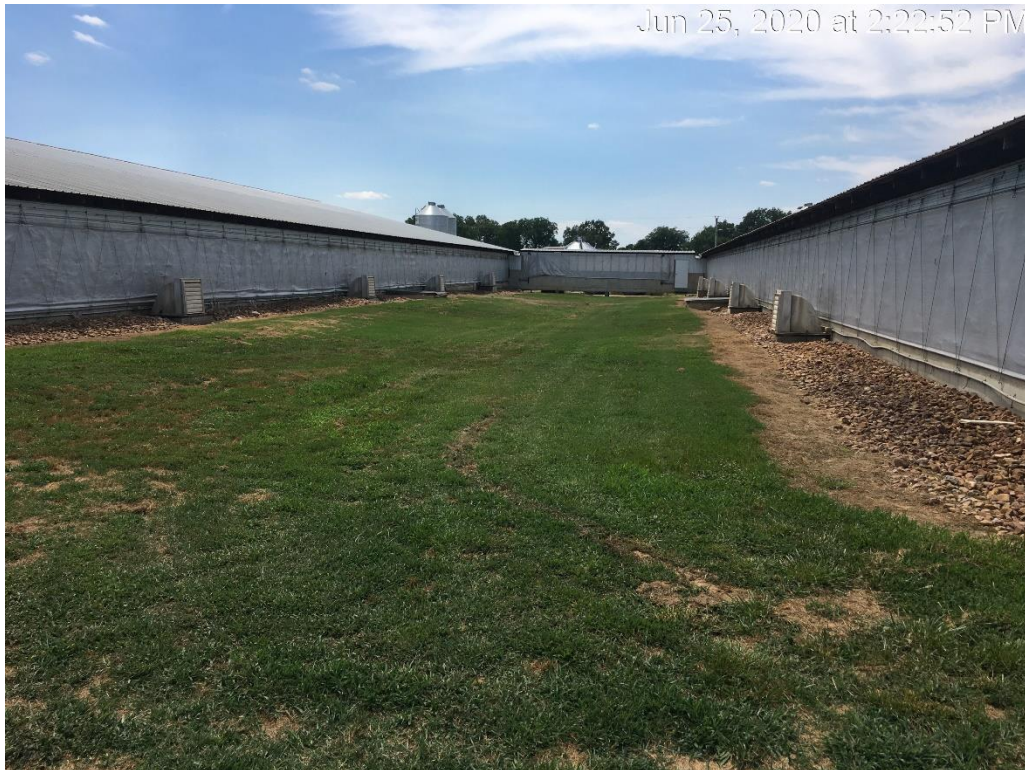
Picture 5

Date of Photo: 6/25/20. Photo taken by: Kevin Smith. Location/Site Name: Cypress Creek Farms / TN0081779. TDWR personnel Present: Kevin Smith. Remarks: Picture is of vegetated area between the new barns. Picture was taken on east side of barns facing west.

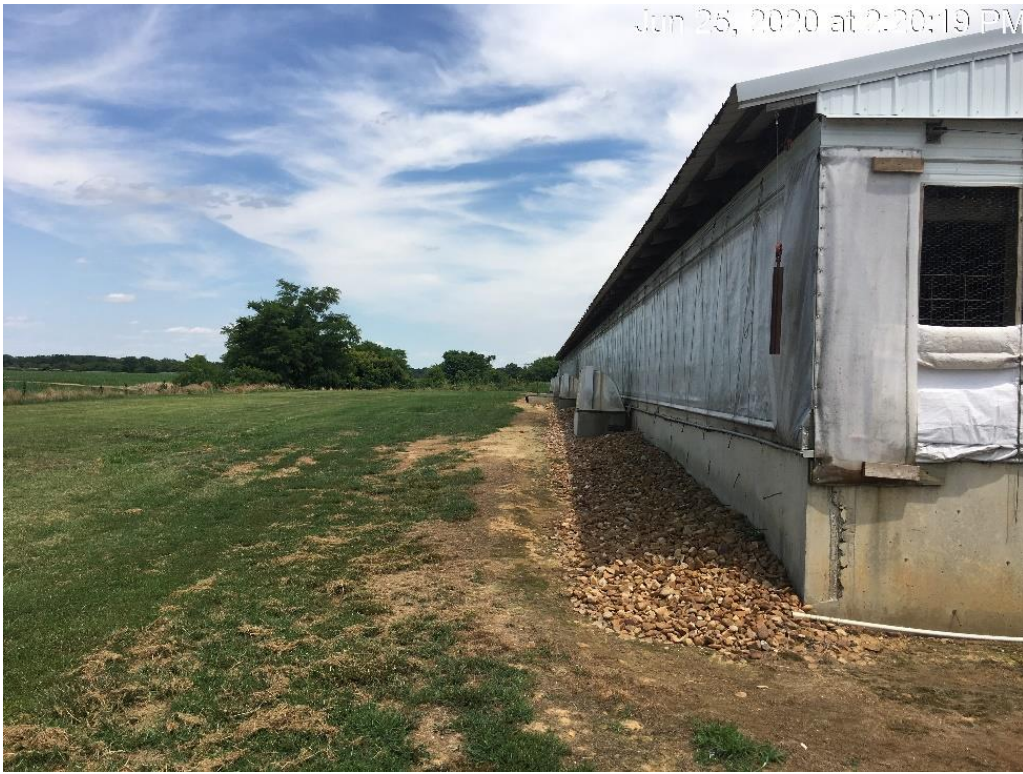
Picture 6

Date of Photo: 6/25/20. Photo taken by: Kevin Smith. Location/Site Name: Cypress Creek Farms / TN0081779. TDWR personnel Present: Kevin Smith. Remarks: Picture is of area north of the northernmost hog barn. Picture was taken standing at northwest corner of northernmost hog barn facing east.

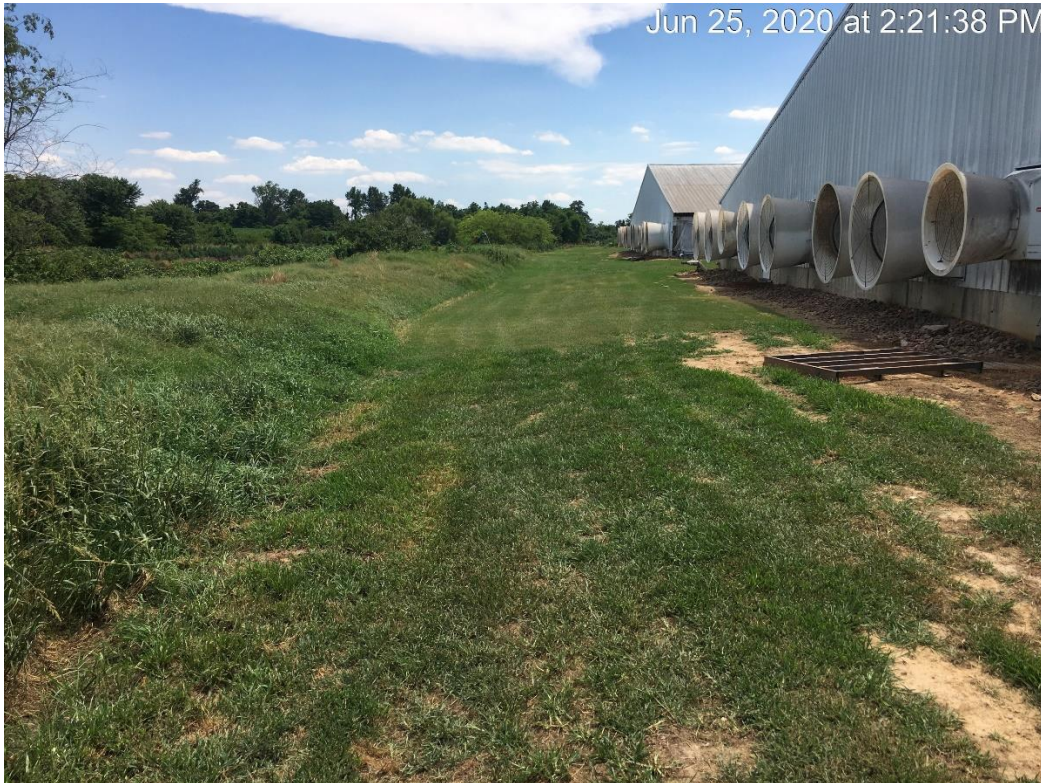
Picture 7

Date of Photo: 6/25/20. Photo taken by: Kevin Smith. Location/Site Name: Cypress Creek Farms / TN0081779. TDWR personnel Present: Kevin Smith. Remarks: Picture is of the eastern side of the hog barns. Picture was taken standing near northeast corner of northern most hog barn facing south.

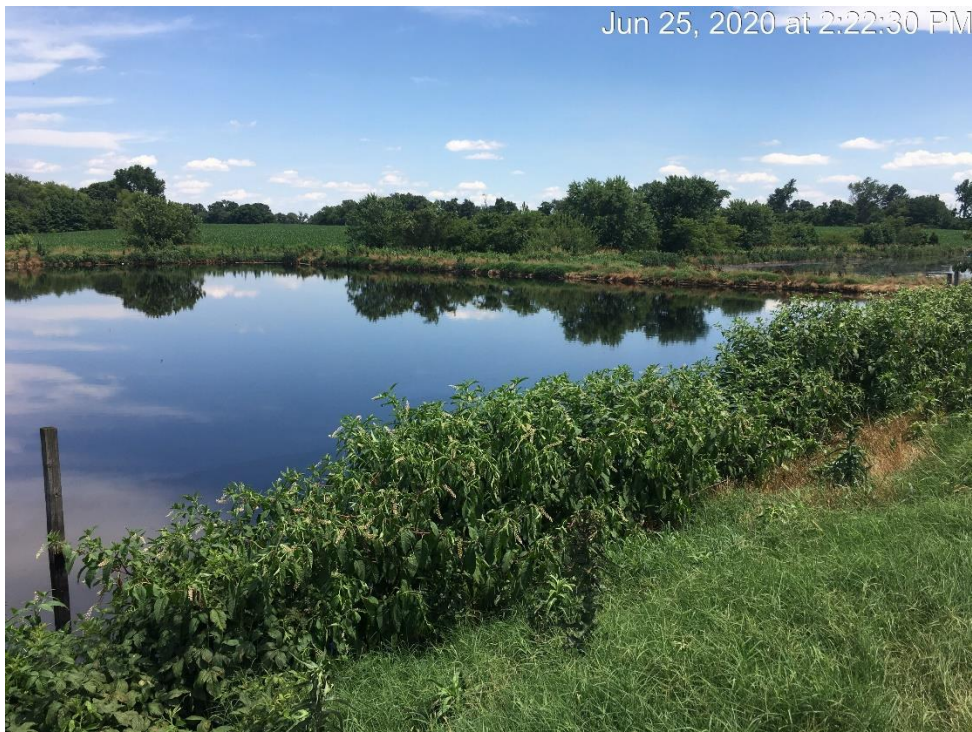
Picture 8

The lagoon levees have good vegetation on them. At the time of my visit they had not been recently mowed but it does appear that they are mowed at least once or twice a year. Facility should make sure the levees are mowed and maintained so they can conduct weekly waste storage system inspections looking for any erosion concerns or animal burrows that may occur in the banks of the levee.

Date of Photo: 6/25/20. Photo taken by: Kevin Smith. Location/Site Name: Cypress Creek Farms / TN0081779. TDWR personnel Present: Kevin Smith. Remarks: Picture is of primary lagoon. Picture was taken on northwest side of primary lagoon facing southeast. There appears to be good vegetation established around the levees. The vegetation was tall at the time of inspection. It appears the levees may have been mowed once this year.

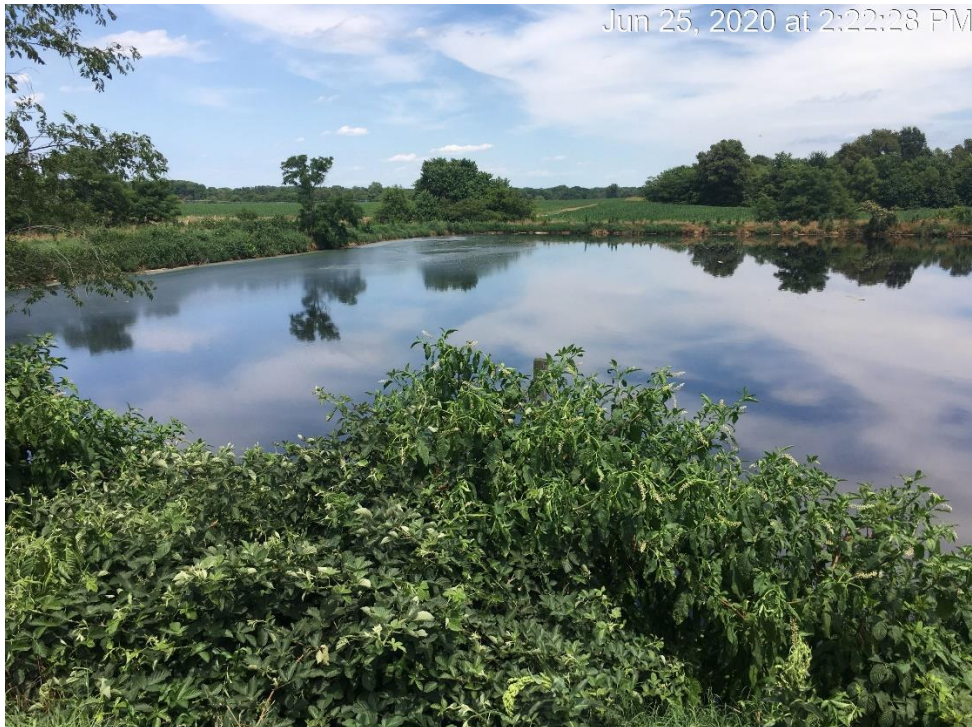
Picture 9

Date of Photo: 6/25/20. Photo taken by: Kevin Smith. Location/Site Name: Cypress Creek Farms / TN0081779. TDWR personnel Present: Kevin Smith. Remarks: Picture is of primary lagoon. Picture was taken on northwest side of primary lagoon facing east/northeast. There appears to be good vegetation established around the levees. The vegetation was tall at the time of inspection. It appears the levees may have been mowed once this year.

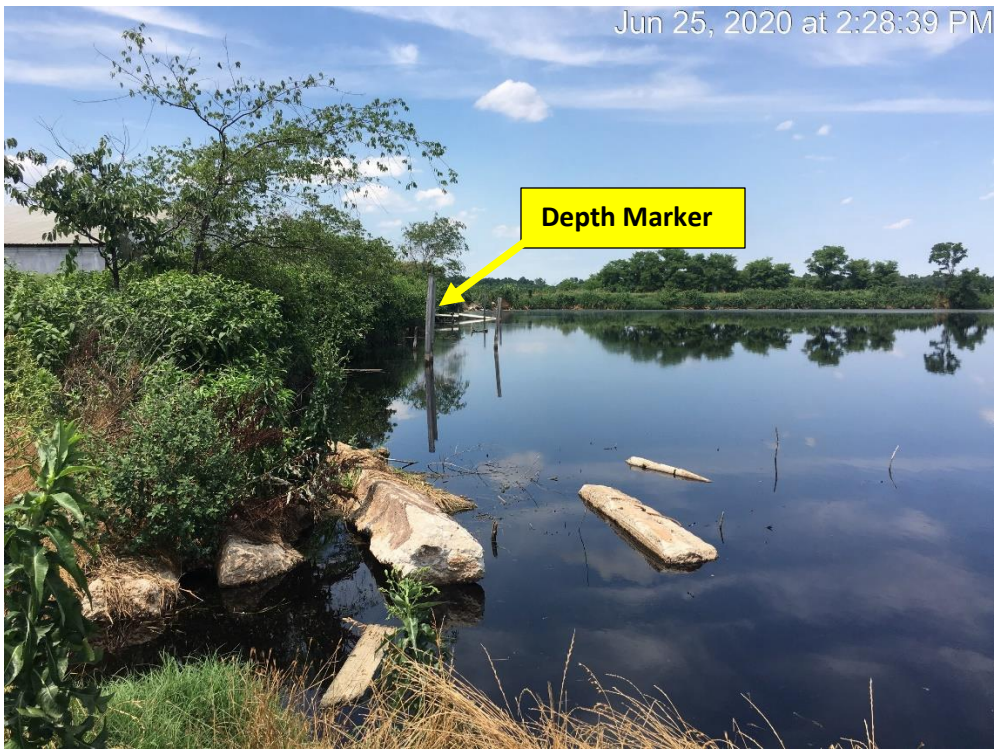
Picture 10

Freeboard	X		Appeared to be over 2 feet of freeboard on day of inspection.

The marks on the depth marker in the lagoon have faded and are hard to see. Mr. Thompson indicated he will re-mark the depth marker so that it is more easily visible.

Date of Photo: 6/25/20. Photo taken by: Kevin Smith. Location/Site Name: Cypress Creek Farms / TN0081779. TDWR personnel Present: Kevin Smith. Remarks: Picture is of location of the depth marker in the primary lagoon. There appeared to be at least 2 feet of freeboard on the day of inspection. The marks on the depth marker have faded. Facility is going to re-mark the depth marker where it is visible.

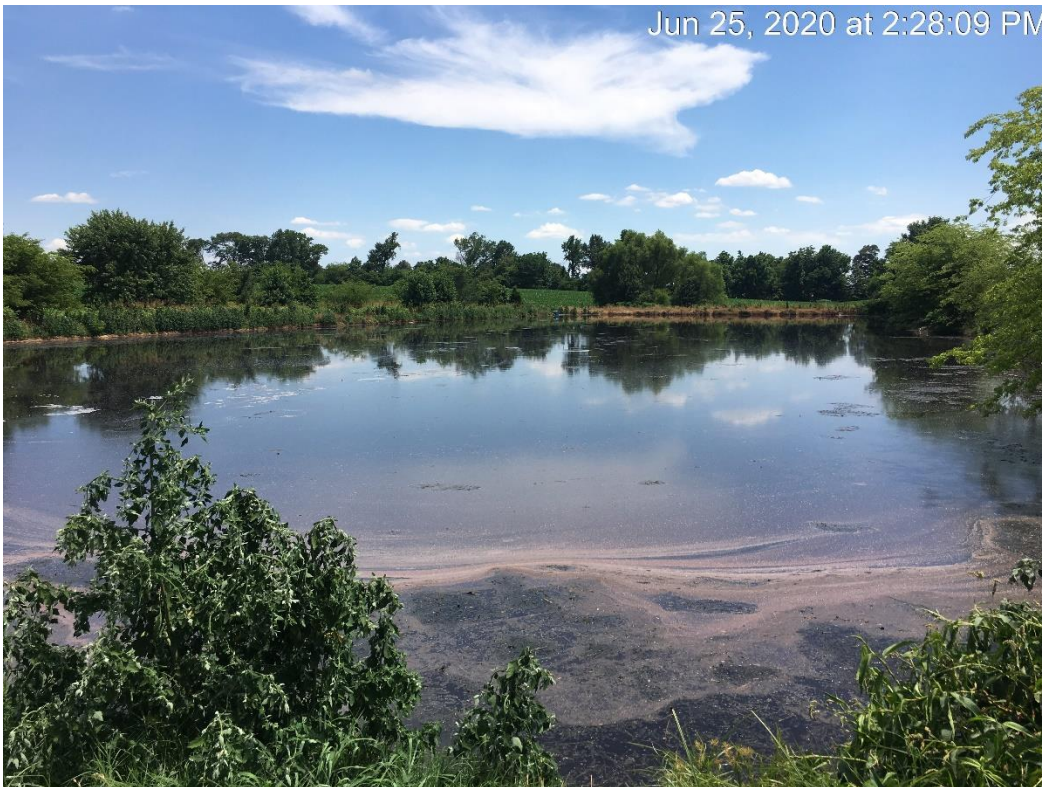
Picture 11

Date of Photo: 6/25/20. Photo taken by: Kevin Smith. Location/Site Name: Cypress Creek Farms / TN0081779. TDWR personnel Present: Kevin Smith. Remarks: Picture is of the southern (secondary lagoon).

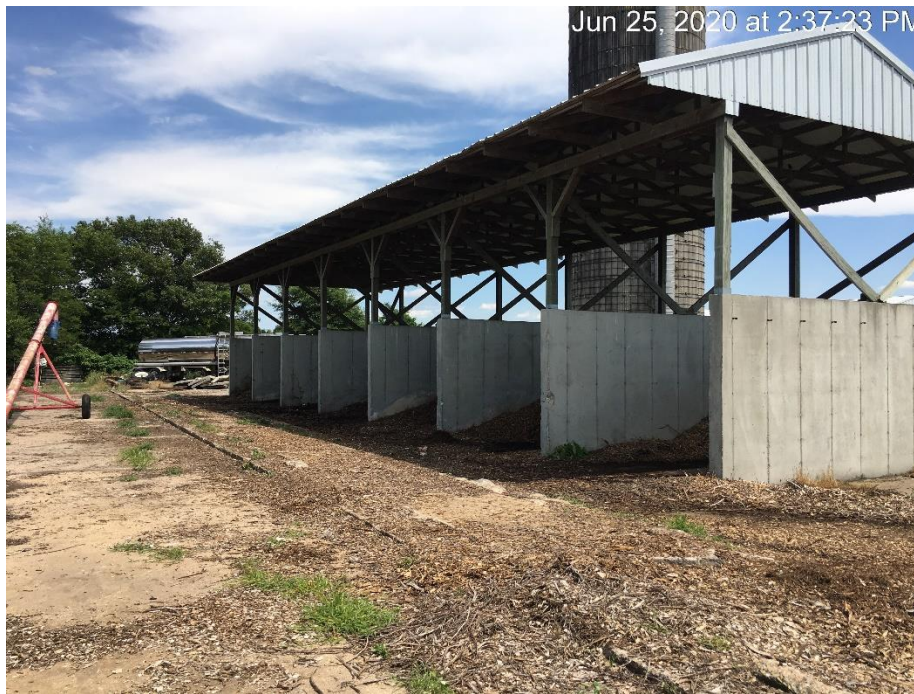
Picture 12

Mortalities are composted on-site in covered concrete compost sheds. The hog barns located off Red McCorkle Road have a covered 7-bay concrete compost shed. The hog barns off Capps Drive have a covered 5-bay concrete compost shed. The facility uses wood chips as the bulking agent. There were a few uncovered bones observed in the compost bays but there were no uncovered carcasses observed. Facility should try to keep adequate cover over all hog remains. There were quite a few wood chips on the ground just outside of the compost bays at both compost sheds. These may have been mostly clean wood chips that fell off from the loader while placing new chips in the compost bays. There is a concrete lip that runs the length of the 7-bay compost shed and prevents runoff and material from leaving the concrete pad of the compost shed. Facility indicated that the concrete lip causes them to lose some wood chips when the drive over it getting to the compost bays to add new wood chips to the compost bays. Facility should try to keep the wood chips from the compost piles in the compost bays under roof as much as possible. I did not observe any leachate leaving any of the compost bays at the time of my inspection.

Date of Photo: 6/25/20. Photo taken by: Kevin Smith. Location/Site Name: Cypress Creek Farms / TN0081779. TDWR personnel Present: Kevin Smith. Remarks: Picture is of the 7 bay compost shed located at the barns off Red McCorkle Road. There a few bones observed scattered. I did not observe any uncovered hog carcasses at time of inspection. I did not see any leachate running out from the compost bays at time of inspection. Facility uses wood chips for the bulking agent. There were wood chips outside of the compost bays. Most may have been clean wood chips. Facility indicated they lose some wood chips when driving over concrete curb in front of the bays. Facility should try to keep the wood chips from the compost piles pushed back in the compost bays.

- There were a few bones observed in the compost shed at the time of inspection. There were no uncovered carcasses observed. Be sure to keep adequate cover over all hog remains. There were quite a few wood chips observed just outside of the compost bays at the time of inspection. These may have been mostly clean wood chips that fell off from the loader while placing new chips in the compost bays. Try to keep the wood chips from the compost piles in the covered compost bays as much as possible. I did not observe any leachate leaving any of the compost bays at the time of my visit.

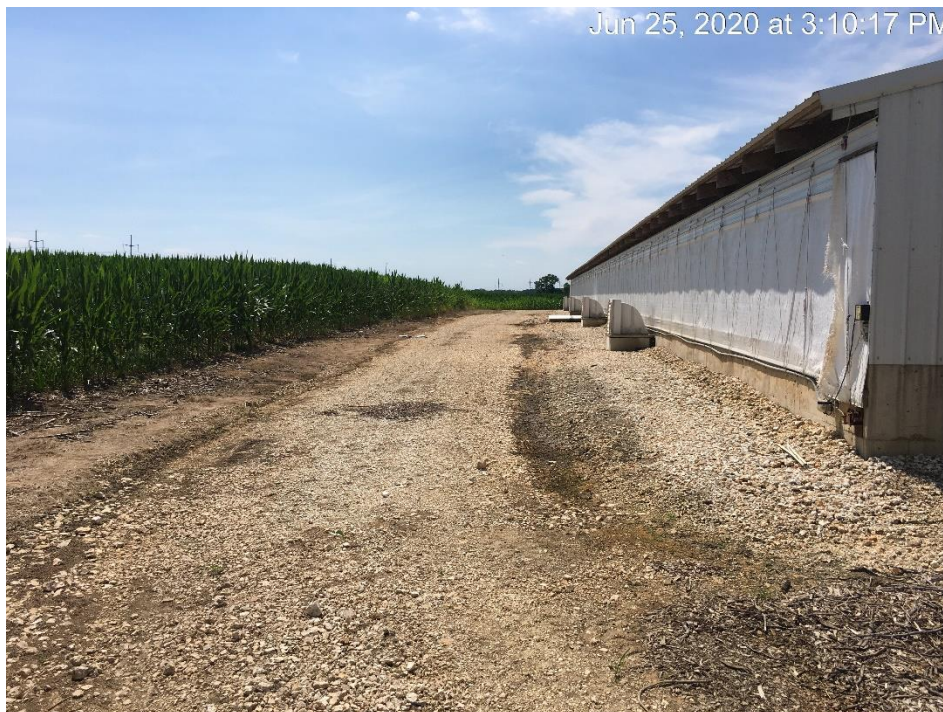
Picture 13

Date of Photo: 6/25/20. Photo taken by: Kevin Smith. Location/Site Name: Cypress Creek Farms / TN0081779. TDWR personnel Present: Kevin Smith. Remarks: Picture is of hog barns located off Capps Drive. Picture was taken standing on southeast side of hog barns facing west. Area around the hog barns is stable with vegetation or gravel.

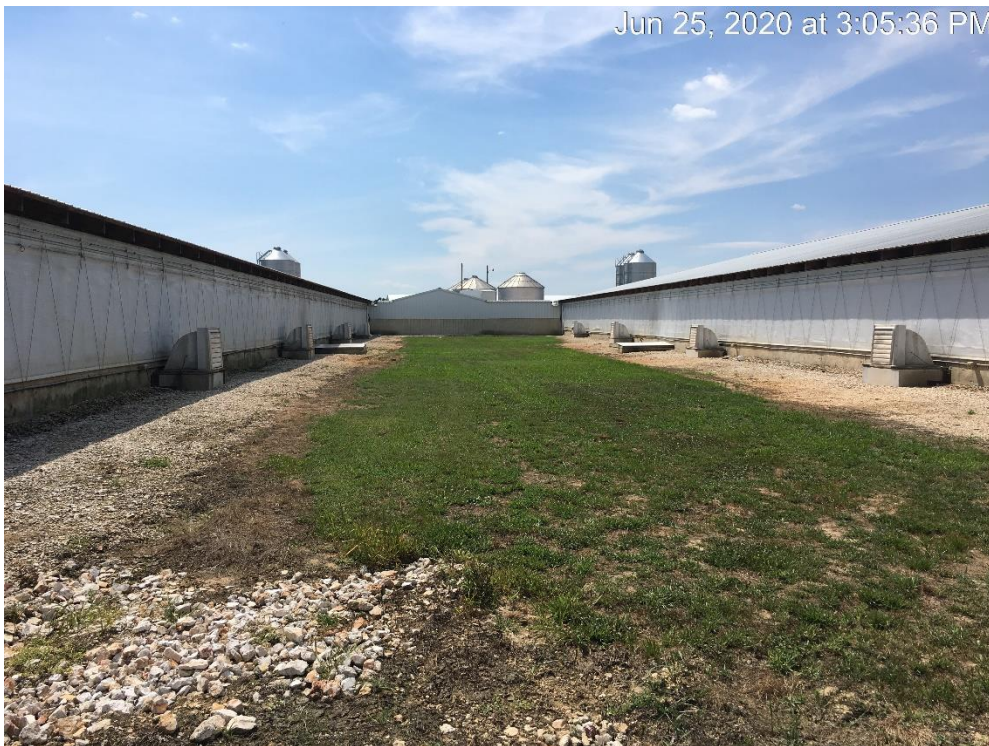
Picture 14

Date of Photo: 6/25/20. Photo taken by: Kevin Smith. Location/Site Name: Cypress Creek Farms / TN0081779. TDWR personnel Present: Kevin Smith. Remarks: Picture shows area between the two hog barns located off Capps Drive. Area around the hog barns is stable with vegetation or gravel. Picture was taken standing on the east side of the hog barns facing west.

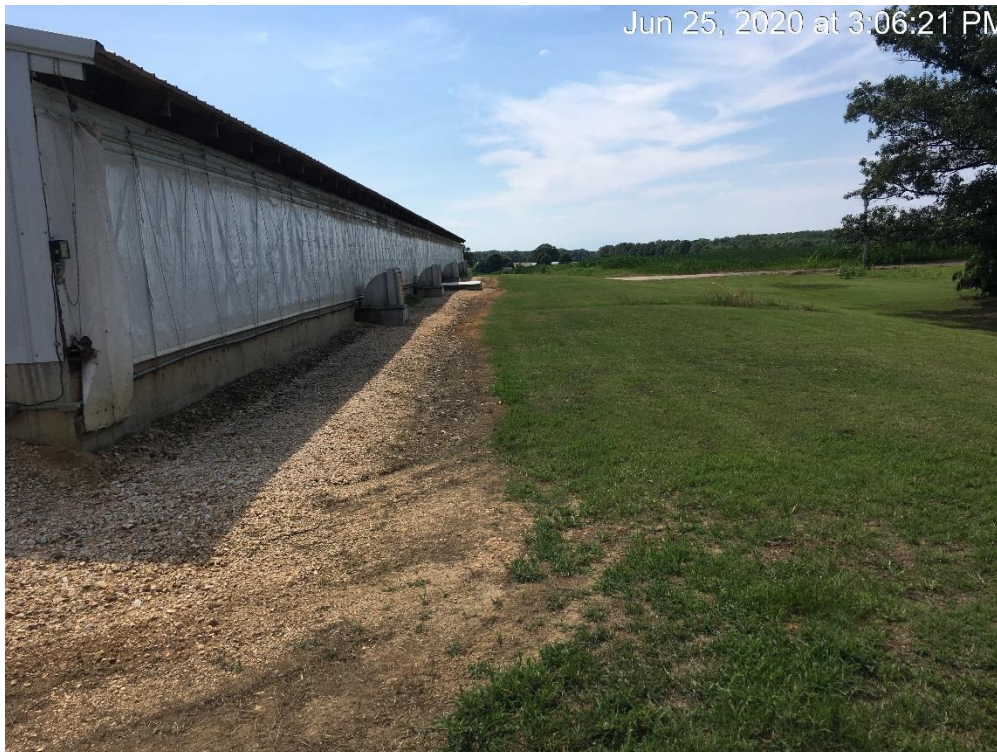
Picture 15

Date of Photo: 6/25/20. Photo taken by: Kevin Smith. Location/Site Name: Cypress Creek Farms / TN0081779. TDWR personnel Present: Kevin Smith. Remarks: Picture is of hog barns located off Capps Drive. Picture was taken standing on northeast side of hog barns facing west. Area around the hog barns is stable with vegetation or gravel.

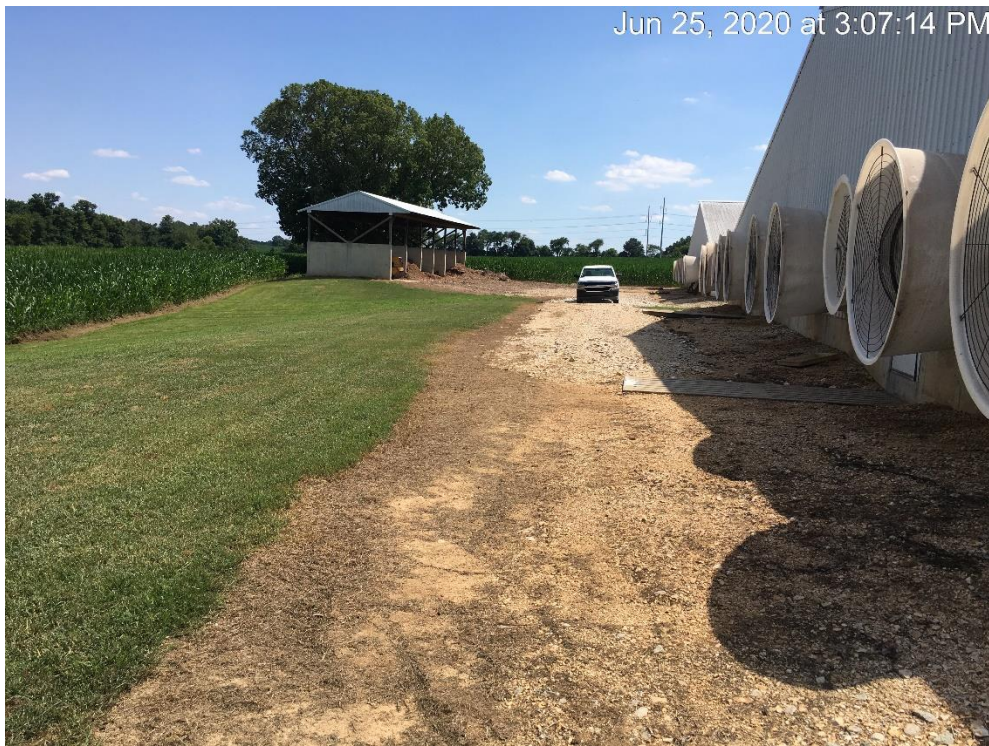
Picture 16

Date of Photo: 6/25/20. Photo taken by: Kevin Smith. Location/Site Name: Cypress Creek Farms / TN0081779. TDWR personnel Present: Kevin Smith. Remarks: Picture is of hog barns located off Capps Drive. Picture was taken standing on northeast side of hog barns facing south. Area around the hog barns is stable with vegetation or gravel.

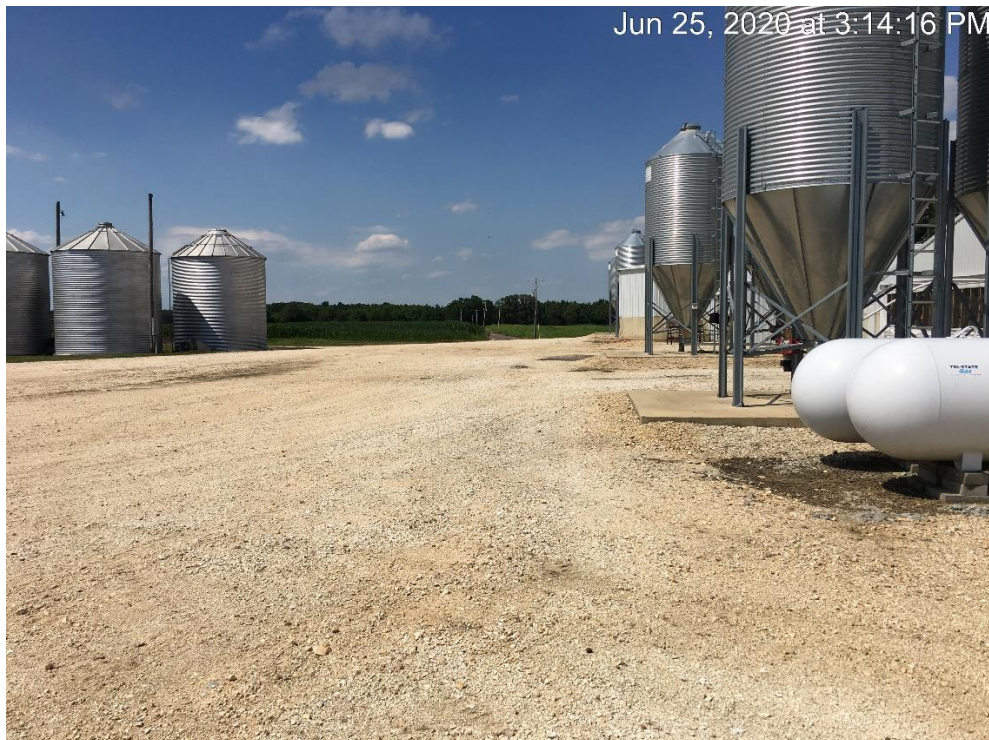
Picture 17

Date of Photo: 6/25/20. Photo taken by: Kevin Smith. Location/Site Name: Cypress Creek Farms / TN0081779. TDWR personnel Present: Kevin Smith. Remarks: Picture is of hog barns located off Capps Drive. Picture was taken standing on southwest side of hog barns facing north. Area around the hog barns is stable with vegetation or gravel.

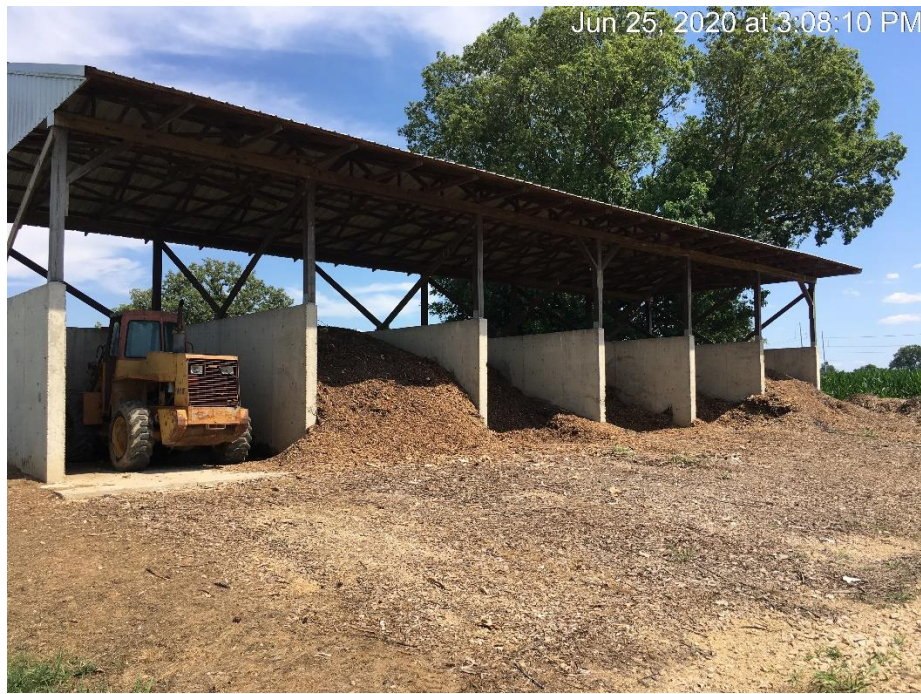
Picture 18

Date of Photo: 6/25/20. Photo taken by: Kevin Smith. Location/Site Name: Cypress Creek Farms / TN0081779. TDWR personnel Present: Kevin Smith. Remarks: Picture shows compost shed at the hog barns off Capps Drive. Wood chips are used as the bulking agent. There were several wood chips in the gravel in front of the compost bays. These may have been clean wood chips. Facility should try to keep the wood chips from the compost piles pushed back in the compost bays. I did see a few bones scattered around but I did not observe any uncovered hog remains at the time of inspection. I did not observe any leachate leaving the compost bays.

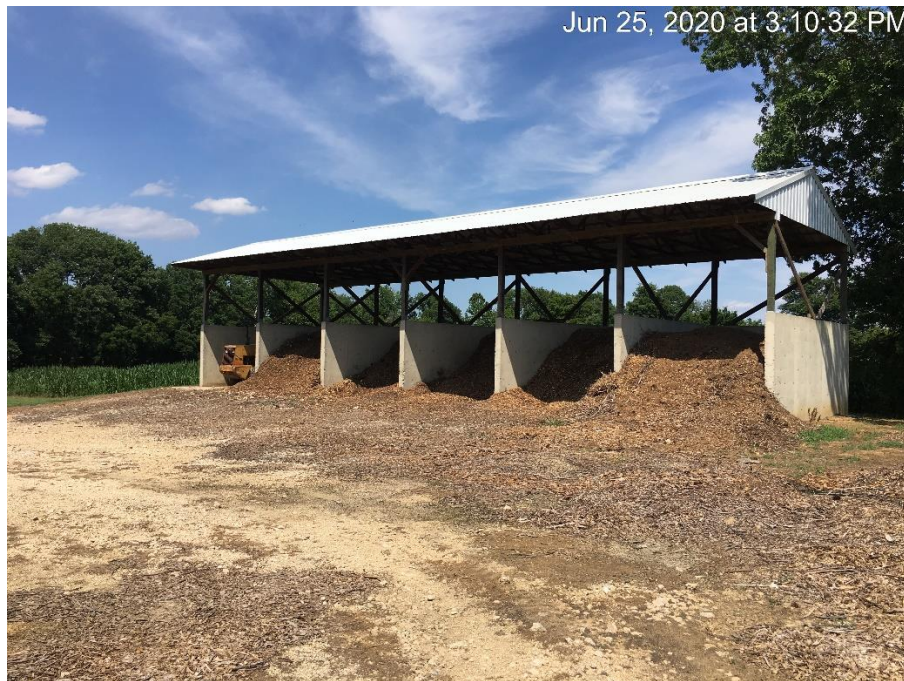
Picture 19

Date of Photo: 6/25/20. Photo taken by: Kevin Smith. Location/Site Name: Cypress Creek Farms / TN0081779. TDWR personnel Present: Kevin Smith. Remarks: Picture shows compost shed at the hog barns off Capps Drive. Wood chips are used as the bulking agent. There were several wood chips in the gravel in front of the compost bays. These may have been clean wood chips. Facility should try to keep the wood chips from the compost piles pushed back in the compost bays. I did see a few bones scattered around but I did not observe any uncovered hog remains at the time of inspection. I did not observe any leachate leaving the compost bays.
