Photographic Log

Client or Facility Name: Frey Branch Cottages		Site Location: Wilkinson Ln White House Robertson County	Site ID.: TNR245154
Photo No. 1	Date 11/21/2023

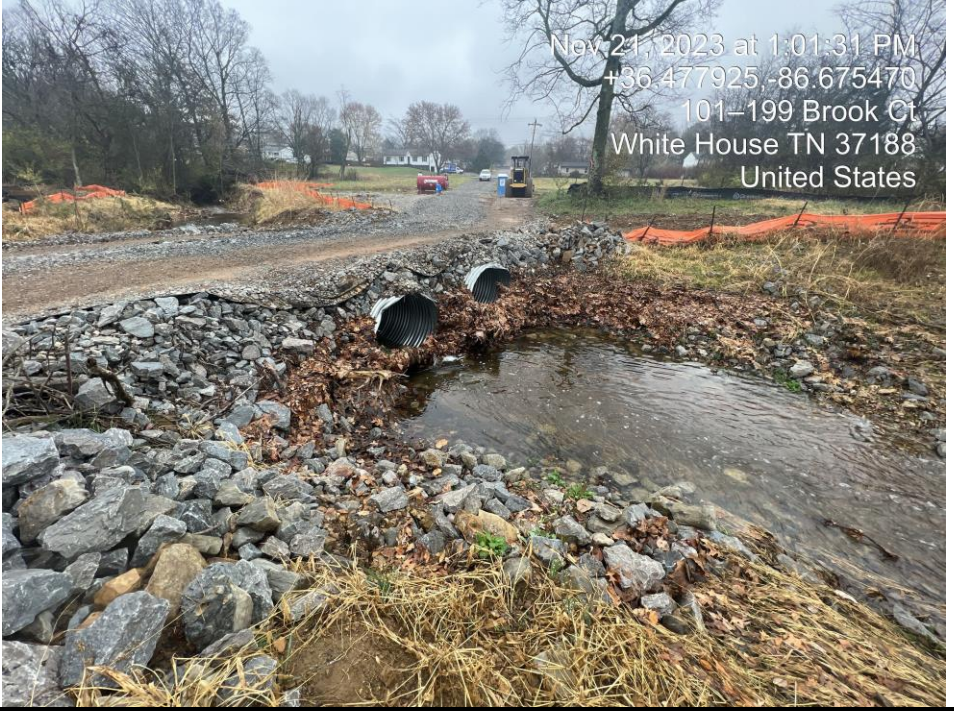
<p style="text-align: right; font-size: small; color: gray;">Nov 21, 2023 at 1:01:31 PM +36.477925, -86.675470 101-199 Brook Ct White House TN 37188 United States</p>	
Description View of upstream of culvert, with leaves and debris accumulating around the pipes indicating crossing acting as an obstruction,			
Photo No. 2	Date 11/21/2023

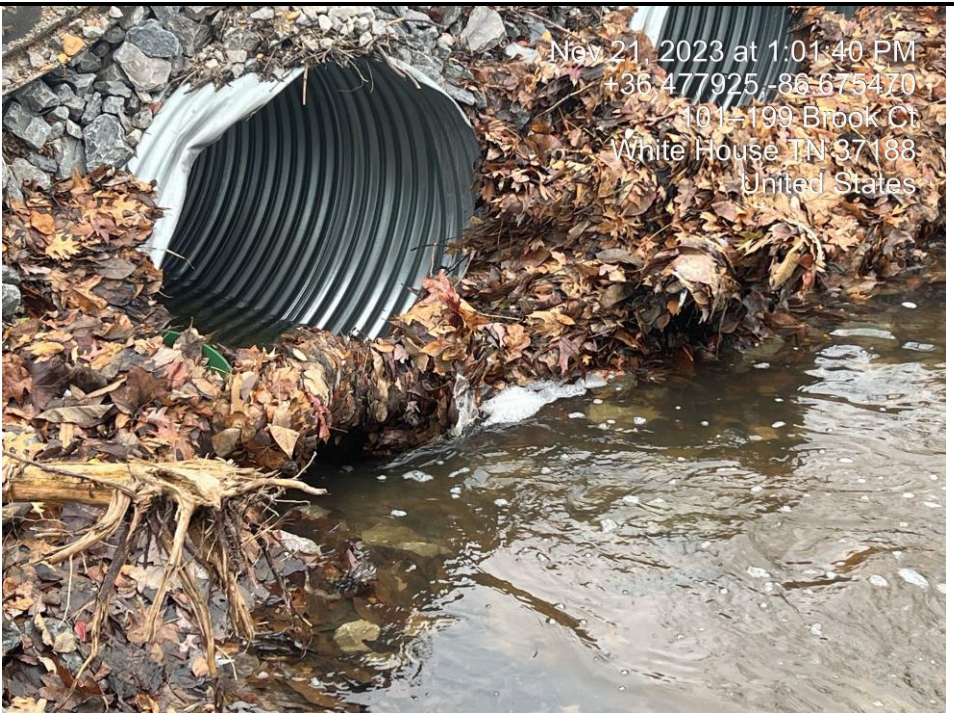
<p style="text-align: right; font-size: small; color: gray;">Nov 21, 2023 at 1:01:40 PM +36.477925, -86.675470 101-199 Brook Ct White House TN 37188 United States</p>	
Description Close-up view of upstream end of culvert, demonstrating large difference in elevation of bottom of the pipes and streambed. Stream is flowing under pipes.
