STATE OF TENNESSEE  
**DEPARTMENT OF ENVIRONMENT AND CONSERVATION**  
JACKSON ENVIRONMENTAL FIELD OFFICE  
1625 HOLLYWOOD DRIVE  
JACKSON, TENNESSEE 38305-4316  
PHONE (731) 512-1305 STATEWIDE 1-888-891-8332 FAX (731) 661-6283

### **Supplemental Inspection Information**

DATE OF INSPECTION: 12/6/2021  
COMPANY NAME: Camden Gravel Company  
FACILITY NAME: Camden Pit No. 5  
NPDES PERMIT NUMBER: TN0070076  
TDEC INSPECTORS PRESENT: Kevin Smith

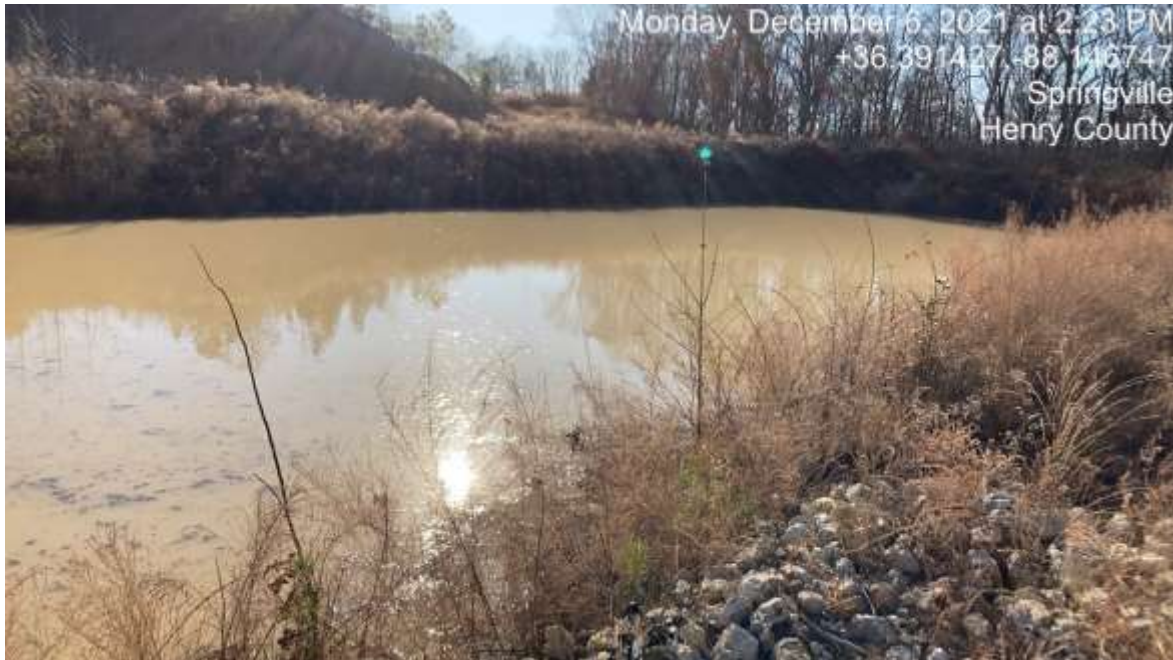
**Picture 1**

**Date of Photo: 12/06/2021. Photo taken by: Kevin Smith. Location/Site Name: Camden Gravel Company, Camden Pit No. 5 / TN0070076. TDWR personnel Present: Kevin Smith. Remarks: Picture is of Pond 1 where Outfall 001 is located. Picture was taken standing on northeast side of Pond 1 facing southwest.**

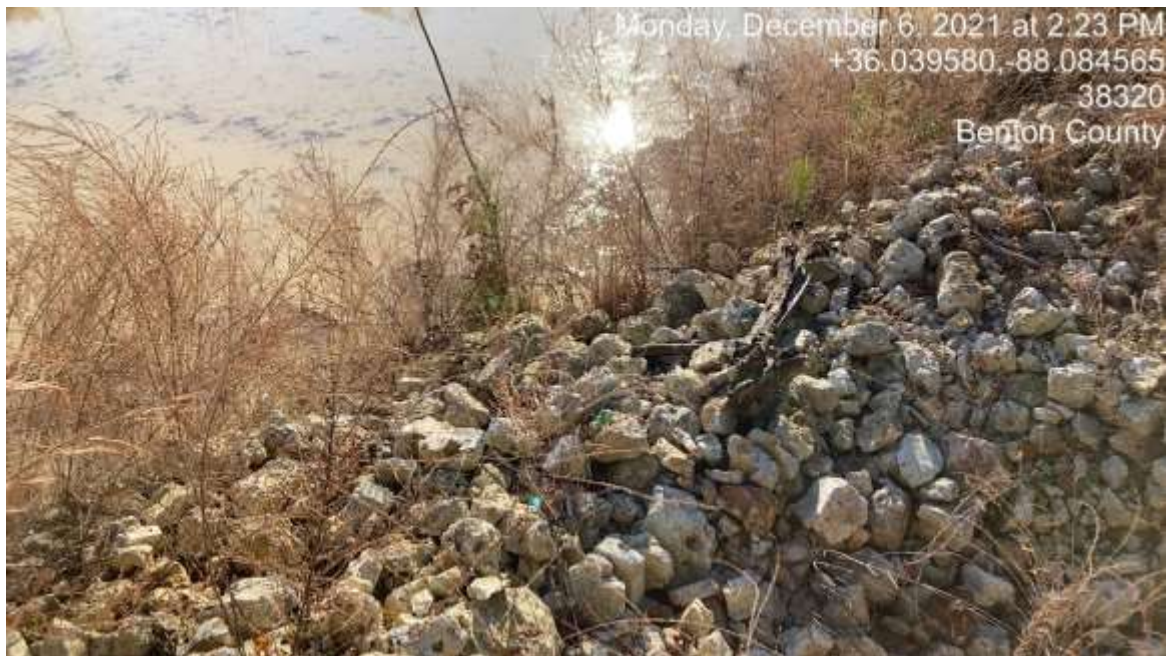
**Picture 2**

**Date of Photo: 12/06/2021. Photo taken by: Kevin Smith. Location/Site Name: Camden Gravel Company, Camden Pit No. 5 / TN0070076. TDWR personnel Present: Kevin Smith. Remarks: Picture shows spillway for Outfall 001. There was no discharge observed at Outfall 001 at time of inspection. Facility should monitor Outfall 001 for discharges and sample as required by the NPDES permit.**

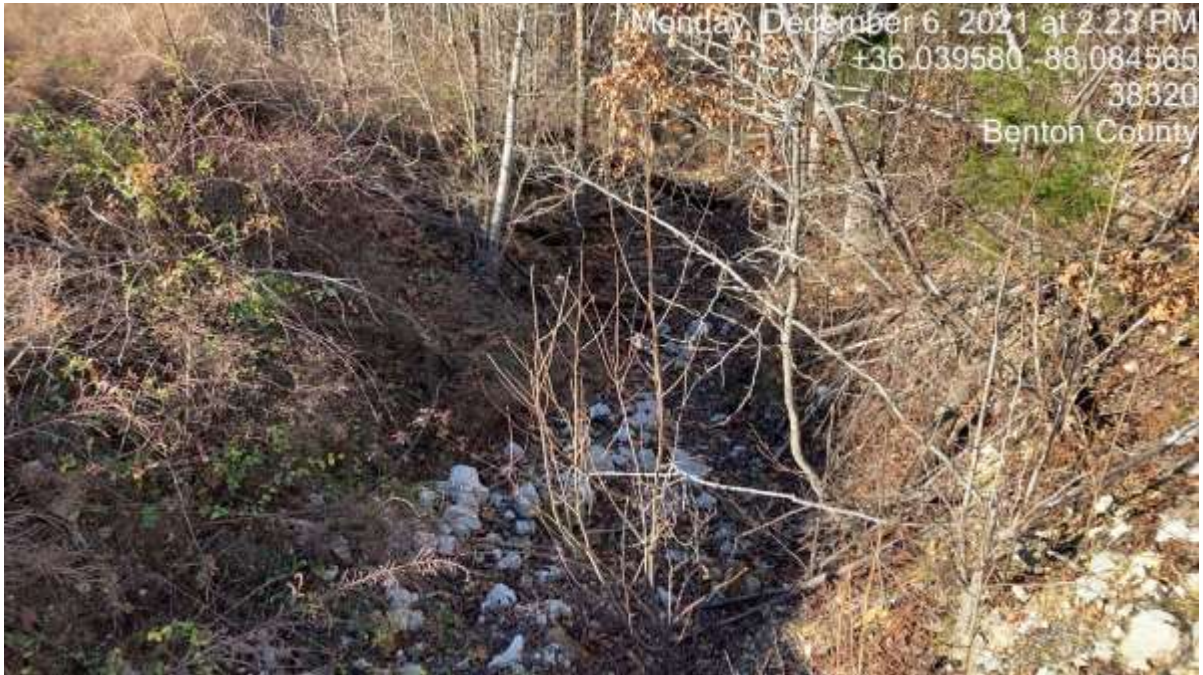
Picture 3

Date of Photo: 12/06/2021. Photo taken by: Kevin Smith. Location/Site Name: Camden Gravel Company, Camden Pit No. 5 / TN0070076. TDWR personnel Present: Kevin Smith. Remarks: Picture was taken standing at Outfall 001 looking down the spillway. There was no discharge observed at Outfall 001.

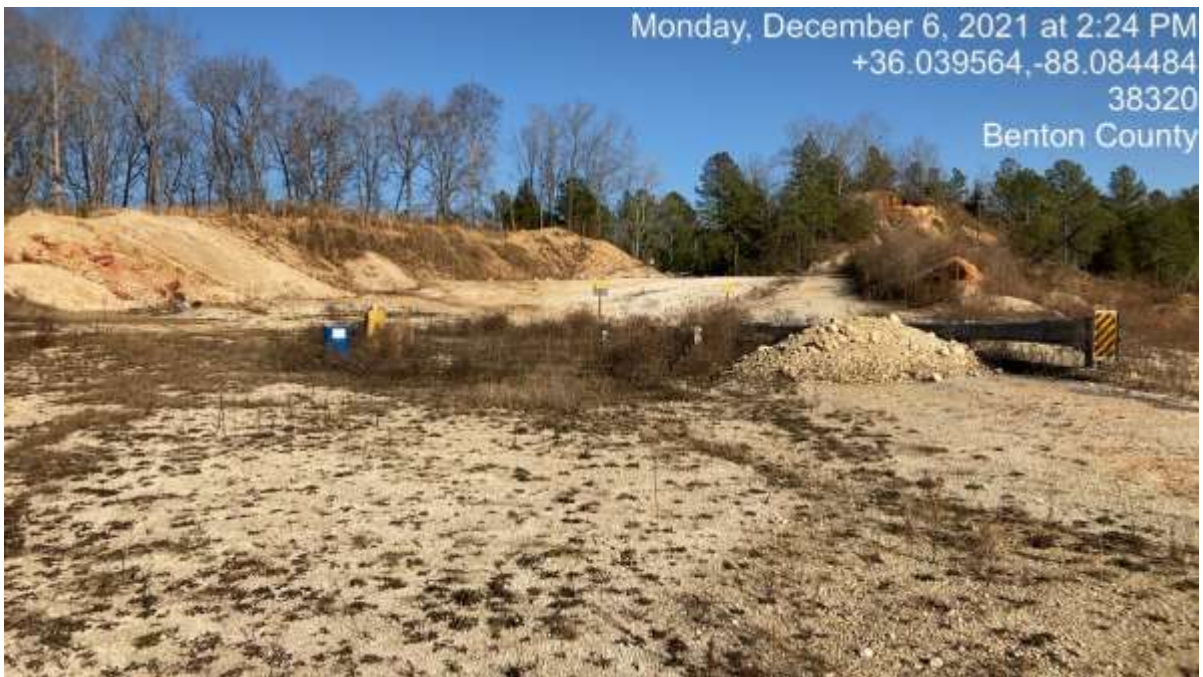
Picture 4

Date of Photo: 12/06/2021. Photo taken by: Kevin Smith. Location/Site Name: Camden Gravel Company, Camden Pit No. 5 / TN0070076. TDWR personnel Present: Kevin Smith. Remarks: Picture was taken standing on the east side of Pond 1 facing northeast. Drainage from mined areas comes back to Pond 1.

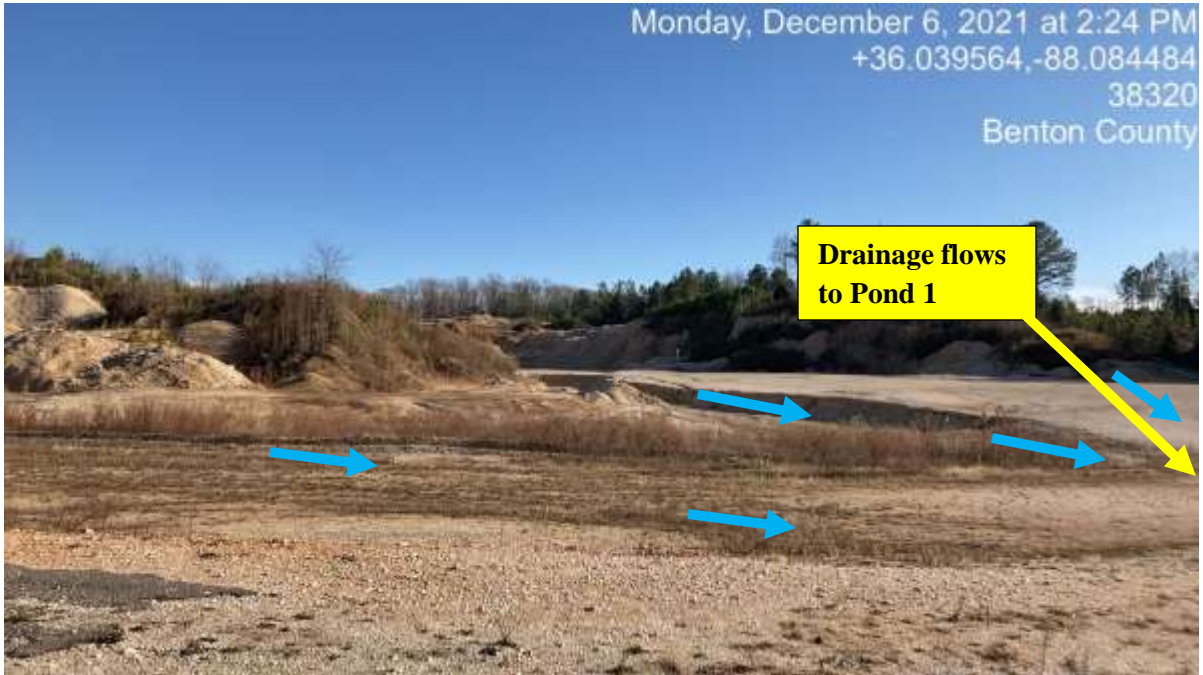
Picture 5

Date of Photo: 12/06/2021. Photo taken by: Kevin Smith. Location/Site Name: Camden Gravel Company, Camden Pit No. 5 / TN0070076. TDWR personnel Present: Kevin Smith. Remarks: Picture was taken standing in same location as Picture 4 only now I am facing southeast. Picture shows that drainage from mined areas goes to Pond 1.

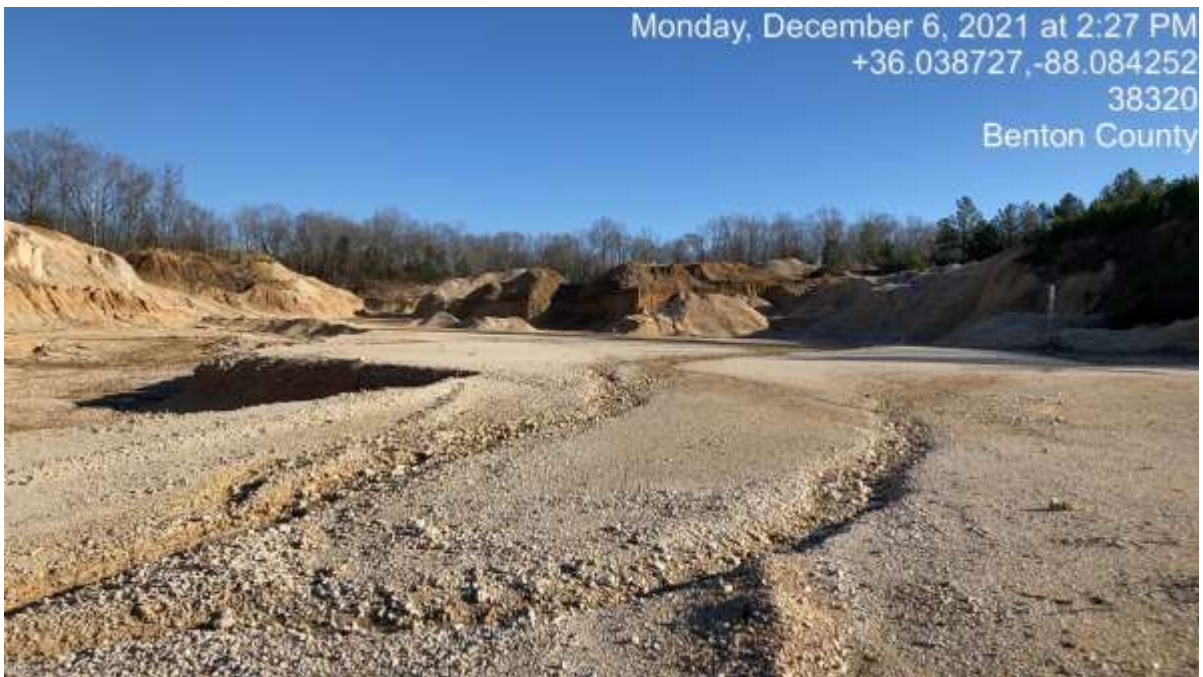
Picture 6

Date of Photo: 12/06/2021. Photo taken by: Kevin Smith. Location/Site Name: Camden Gravel Company, Camden Pit No. 5 / TN0070076. TDWR personnel Present: Kevin Smith. Remarks: Picture was taken standing on the east side of Pond 1 facing east. Drainage from the mined areas goes back to Pond 1.

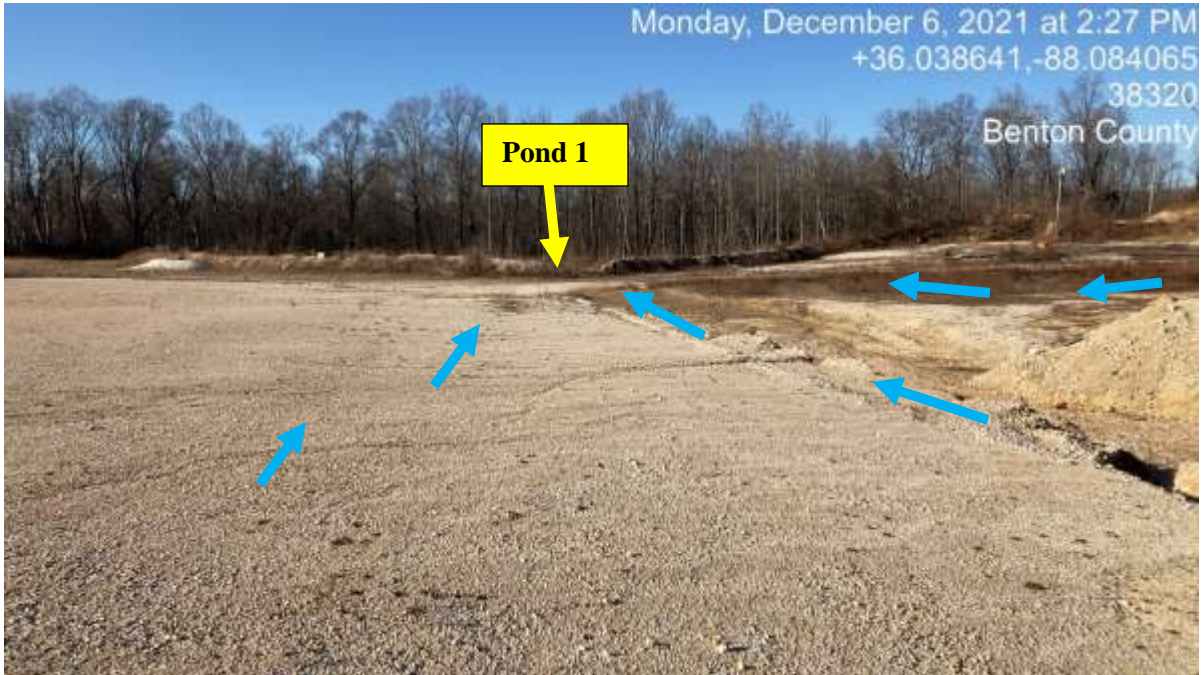
Picture 7

Date of Photo: 12/06/2021. Photo taken by: Kevin Smith. Location/Site Name: Camden Gravel Company, Camden Pit No. 5 / TN0070076. TDWR personnel Present: Kevin Smith. Remarks: Picture was taken standing in the same location as Picture 6 only now I am facing west/northwest towards Pond 1. Drainage from the mined areas is directed to Pond 1.

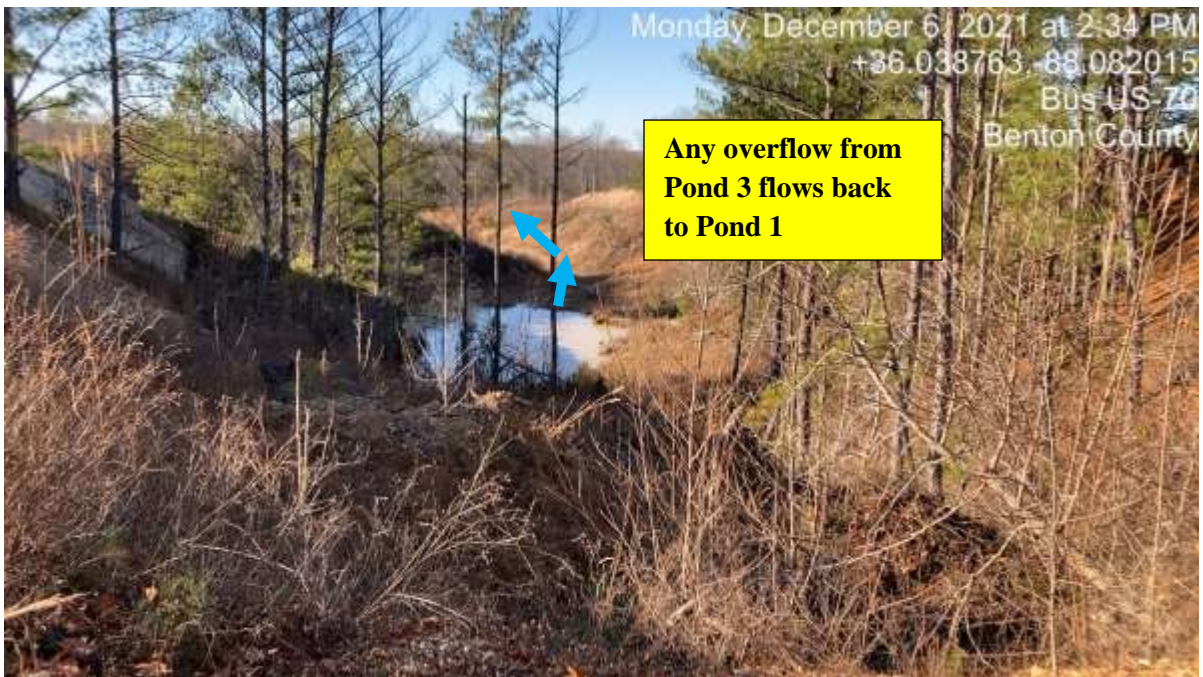
Picture 8

Date of Photo: 12/06/2021. Photo taken by: Kevin Smith. Location/Site Name: Camden Gravel Company, Camden Pit No. 5 / TN0070076. TDWR personnel Present: Kevin Smith. Remarks: Picture is of what I think is Pond 3. Overflow from Pond 3 goes to Pond 1. Picture was taken standing on the northeast side of Pond 3 facing southwest.

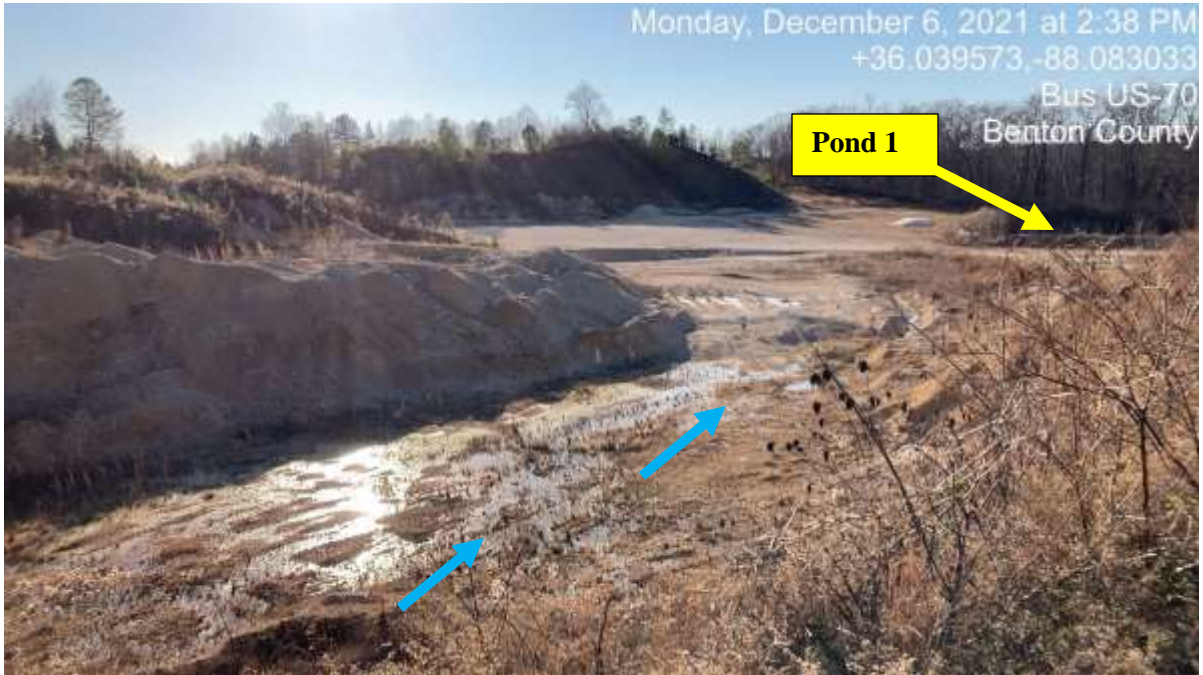
Picture 9

Date of Photo: 12/06/2021. Photo taken by: Kevin Smith. Location/Site Name: Camden Gravel Company, Camden Pit No. 5 / TN0070076. TDWR personnel Present: Kevin Smith. Remarks: Picture was taken standing on the west side of Pond 3. Picture shows that overflow from Pond 3 goes into Pond 1.

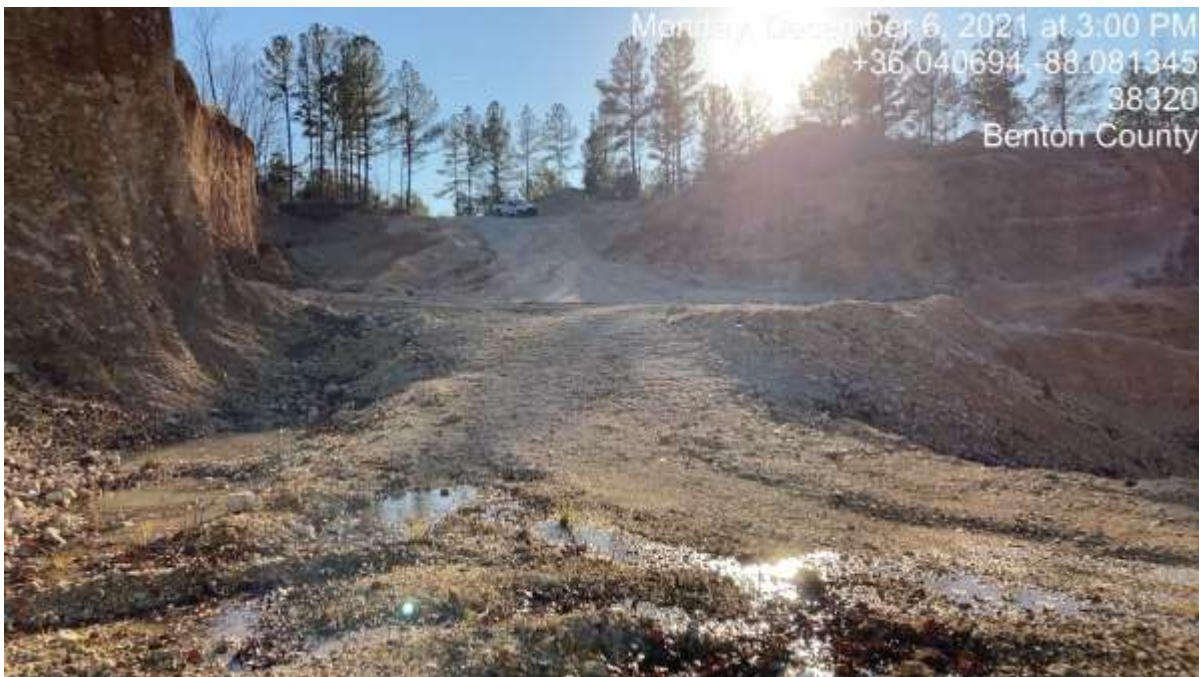
Picture 10

Date of Photo: 12/06/2021. Photo taken by: Kevin Smith. Location/Site Name: Camden Gravel Company, Camden Pit No. 5 / TN0070076. TDWR personnel Present: Kevin Smith. Remarks: Picture was taken standing in mined area on north side of U.S. 70 East facing south. Drainage on the north side of U.S. 70 East is contained in the mined-out areas and a former mine void in the southwest portion of it.

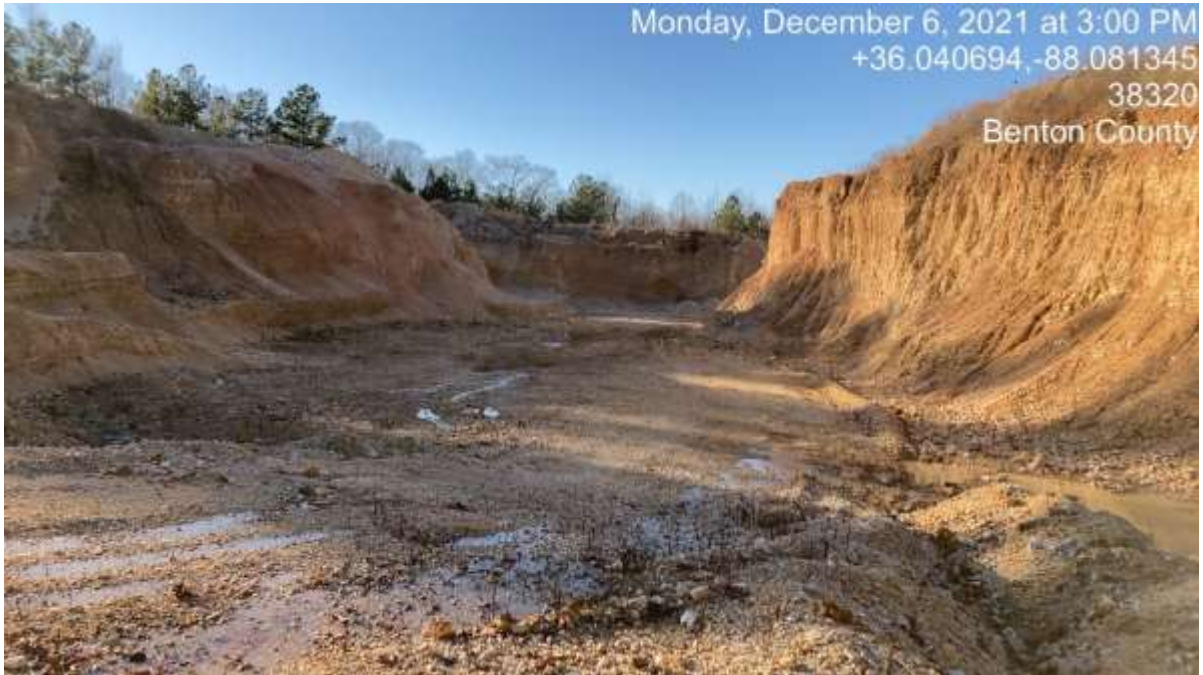
Picture 11

Date of Photo: 12/06/2021. Photo taken by: Kevin Smith. Location/Site Name: Camden Gravel Company, Camden Pit No. 5 / TN0070076. TDWR personnel Present: Kevin Smith. Remarks: Picture was taken standing in same location as Picture 10 only now I am facing west.

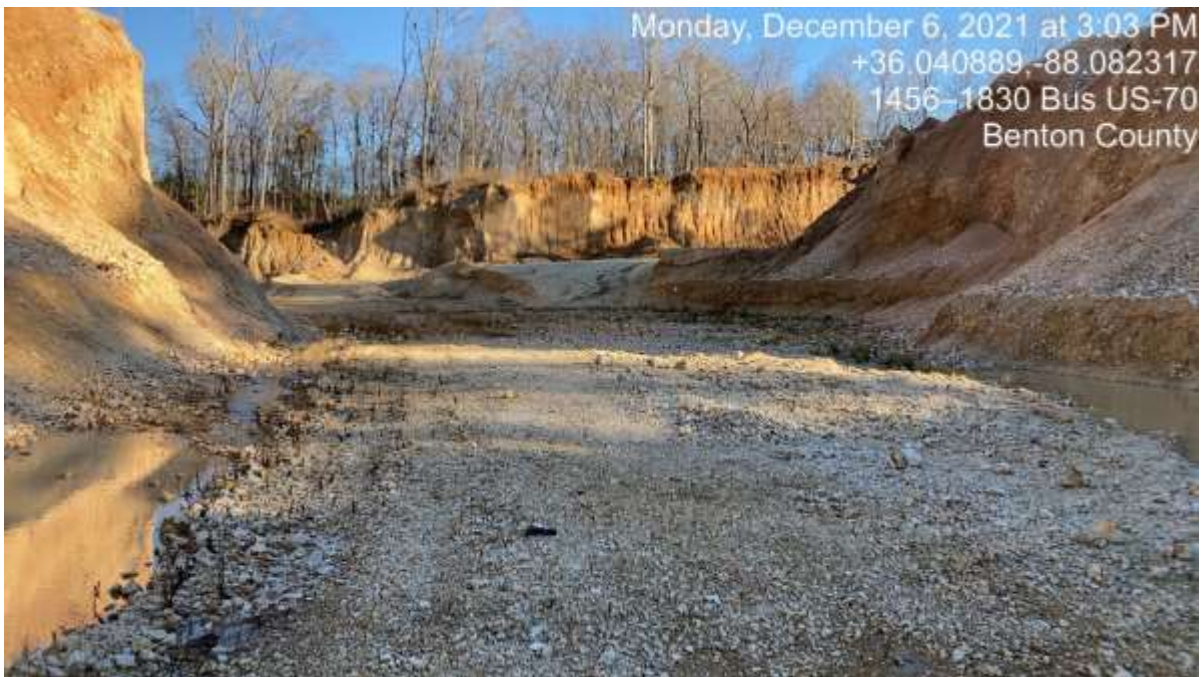
Picture 12

Date of Photo: 12/06/2021. Photo taken by: Kevin Smith. Location/Site Name: Camden Gravel Company, Camden Pit No. 5 / TN0070076. TDWR personnel Present: Kevin Smith. Remarks: Picture was taken standing further west in the mined area looking back east where I was standing in Pictures 10 and 11.

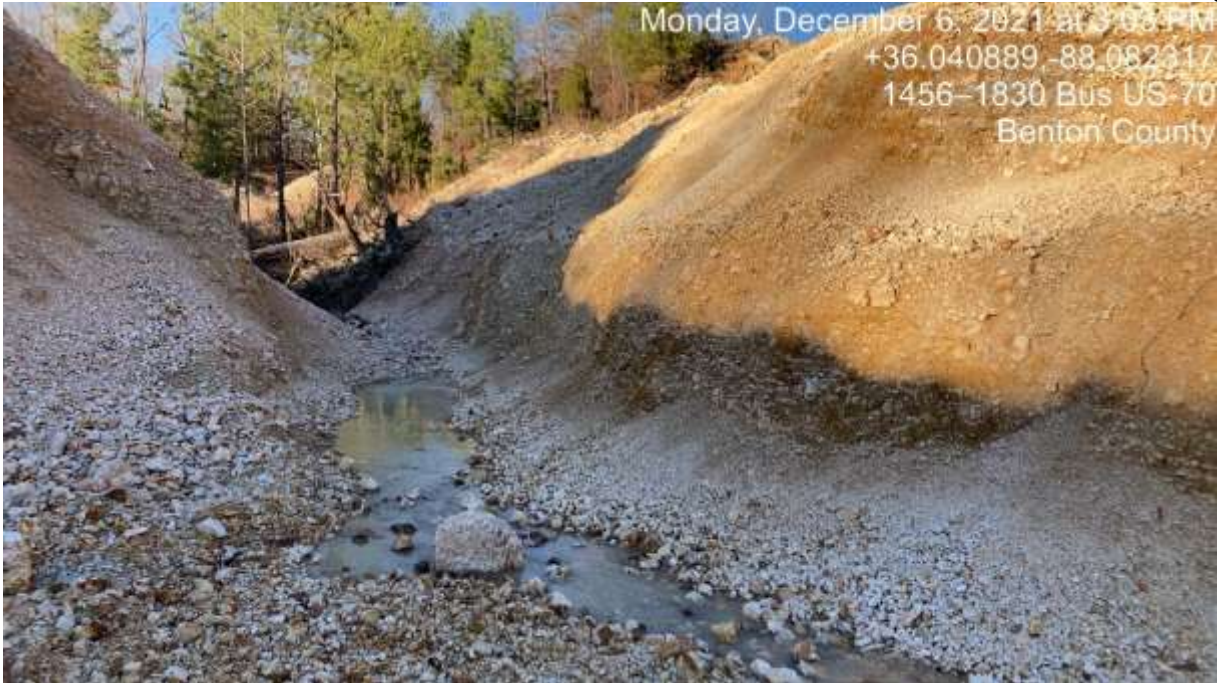
Date of Photo: 12/06/2021. Photo taken by: Kevin Smith. Location/Site Name: Camden Gravel Company, Camden Pit No. 5 / TN0070076. TDWR personnel Present: Kevin Smith. Remarks: Picture 13 shows how water leaves the mined areas shown in Pictures 11 and 12. This ditch goes to what appears to be a former mine void in the southwest portion of the site.

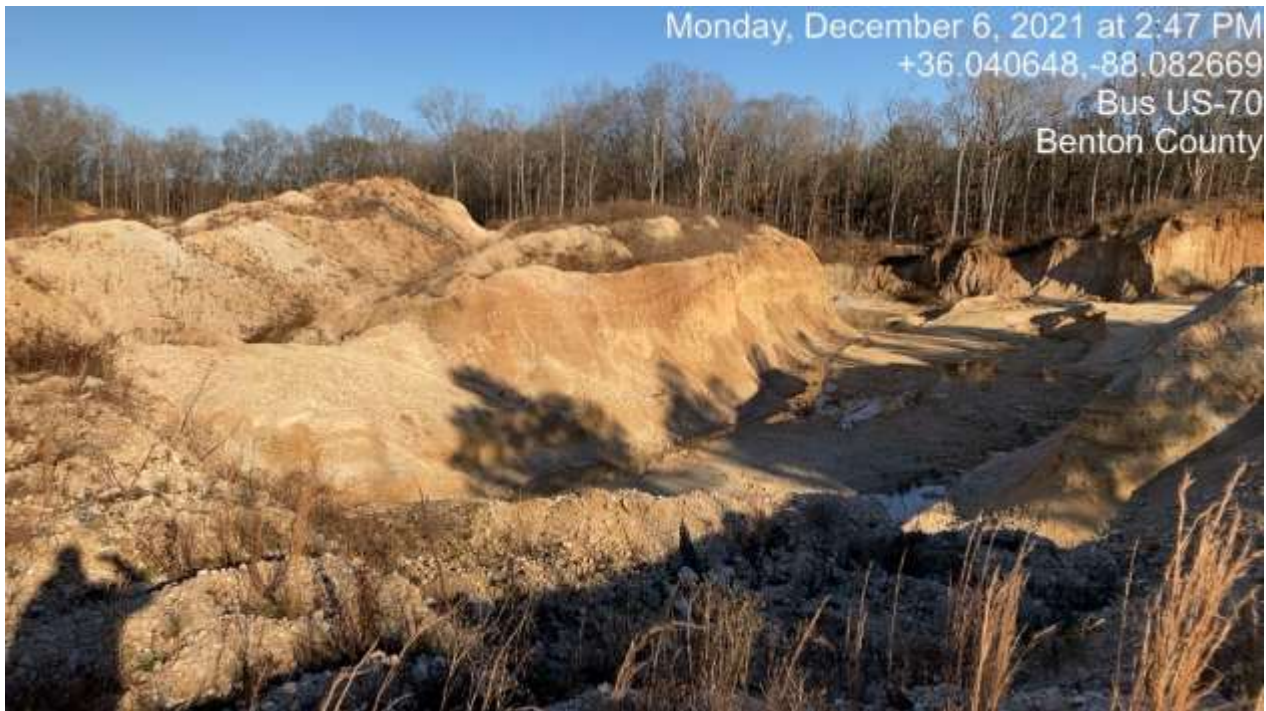
Picture 14

Date of Photo: 12/06/2021. Photo taken by: Kevin Smith. Location/Site Name: Camden Gravel Company, Camden Pit No. 5 / TN0070076. TDWR personnel Present: Kevin Smith. Remarks: Picture was taken standing on the west side of the mined area shown in Pictures 10-13 facing northeast. I am looking down into the mined area shown in Pictures 10-13.

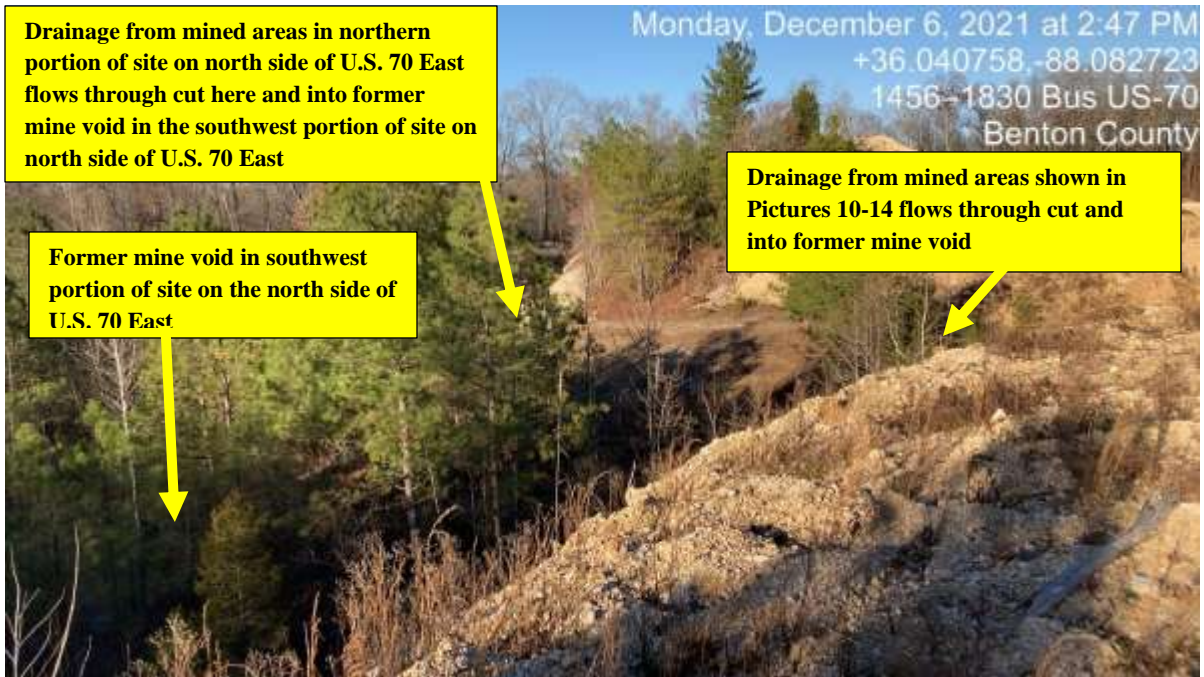
Picture 15

Date of Photo: 12/06/2021. Photo taken by: Kevin Smith. Location/Site Name: Camden Gravel Company, Camden Pit No. 5 / TN0070076. TDWR personnel Present: Kevin Smith. Remarks: Picture was taken standing in same location as Picture 14 only now I am facing north. Any overflow from the mined-out areas goes to a former mine void in the southwest portion of the site. I observed no discharge from this former mine void, and it was not close to discharging.

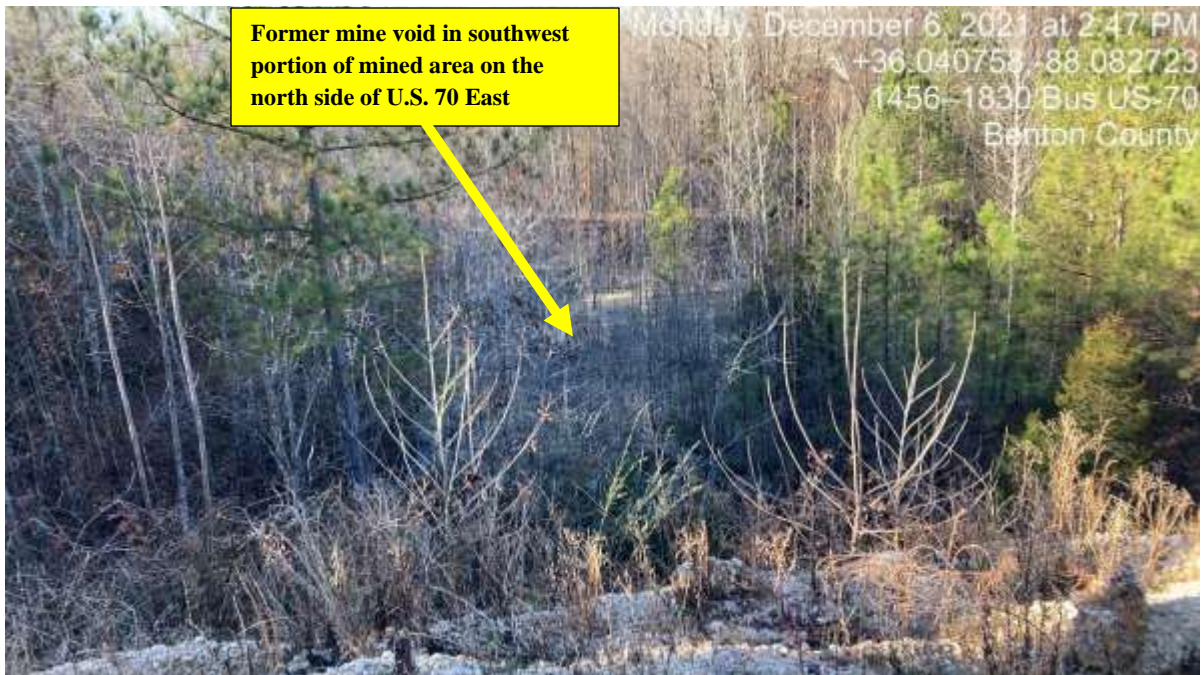
Picture 16

Date of Photo: 12/06/2021. Photo taken by: Kevin Smith. Location/Site Name: Camden Gravel Company, Camden Pit No. 5 / TN0070076. TDWR personnel Present: Kevin Smith. Remarks: Picture shows former mine void in southwest portion of the site where any overflow drainage from the mined areas flows. I walked around this former mine void and could find no obvious discharge outlet. The water level was low in it and was not close to discharging.

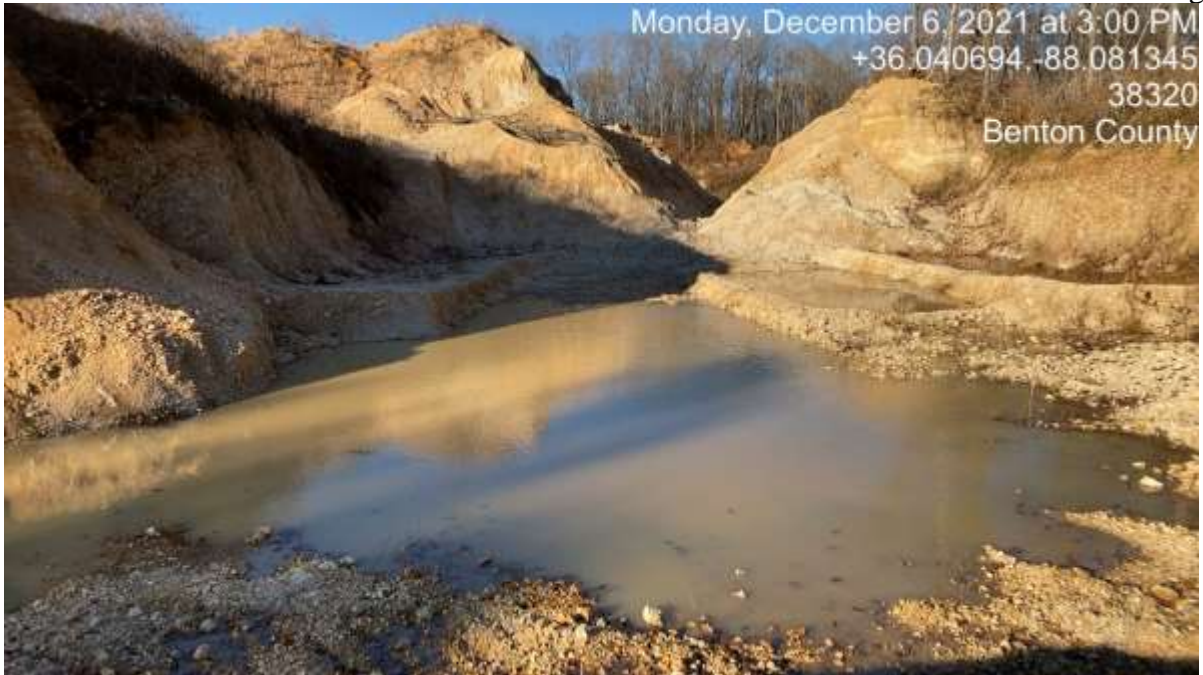
Picture 17

Date of Photo: 12/06/2021. Photo taken by: Kevin Smith. Location/Site Name: Camden Gravel Company, Camden Pit No. 5 / TN0070076. TDWR personnel Present: Kevin Smith. Remarks: Picture shows mined area in eastern portion of site. Picture was taken facing north. There are voids that hold water in the mined out areas on the north side of U.S. 70 East. Just on the other side of the cut is another mined out area in northern portion of the site.

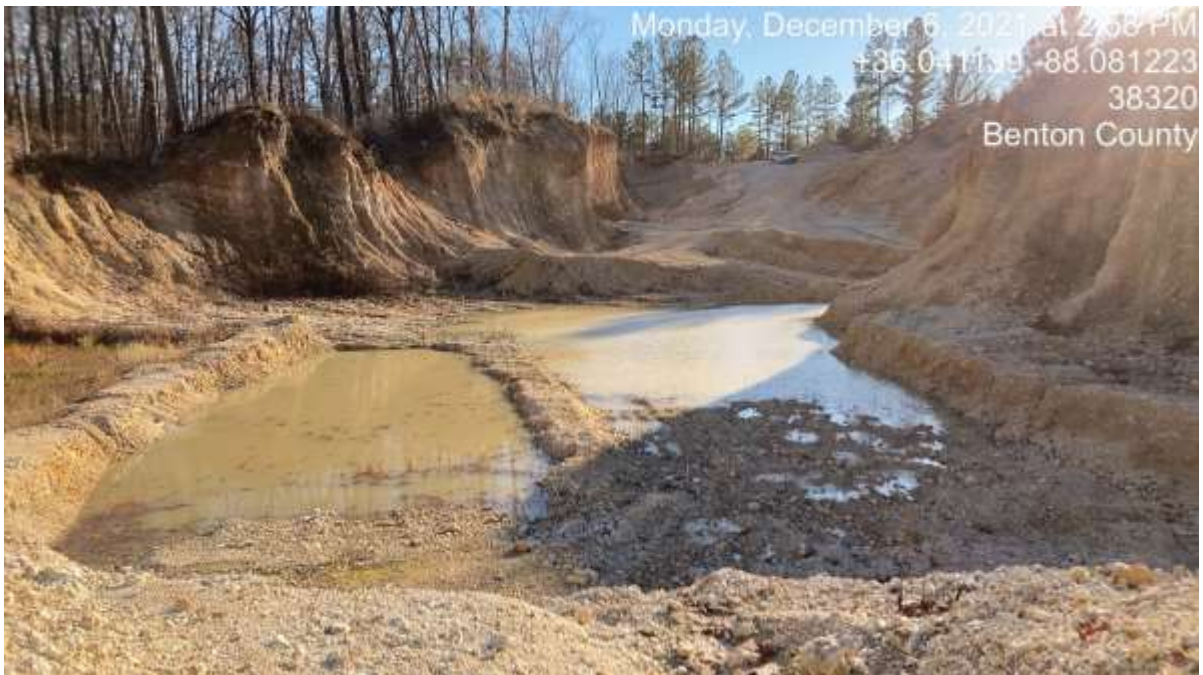
Picture 18

Date of Photo: 12/06/2021. Photo taken by: Kevin Smith. Location/Site Name: Camden Gravel Company, Camden Pit No. 5 / TN0070076. TDWR personnel Present: Kevin Smith. Remarks: Picture is of same void holding water in Picture 17. I am now standing on the north side of it facing south.

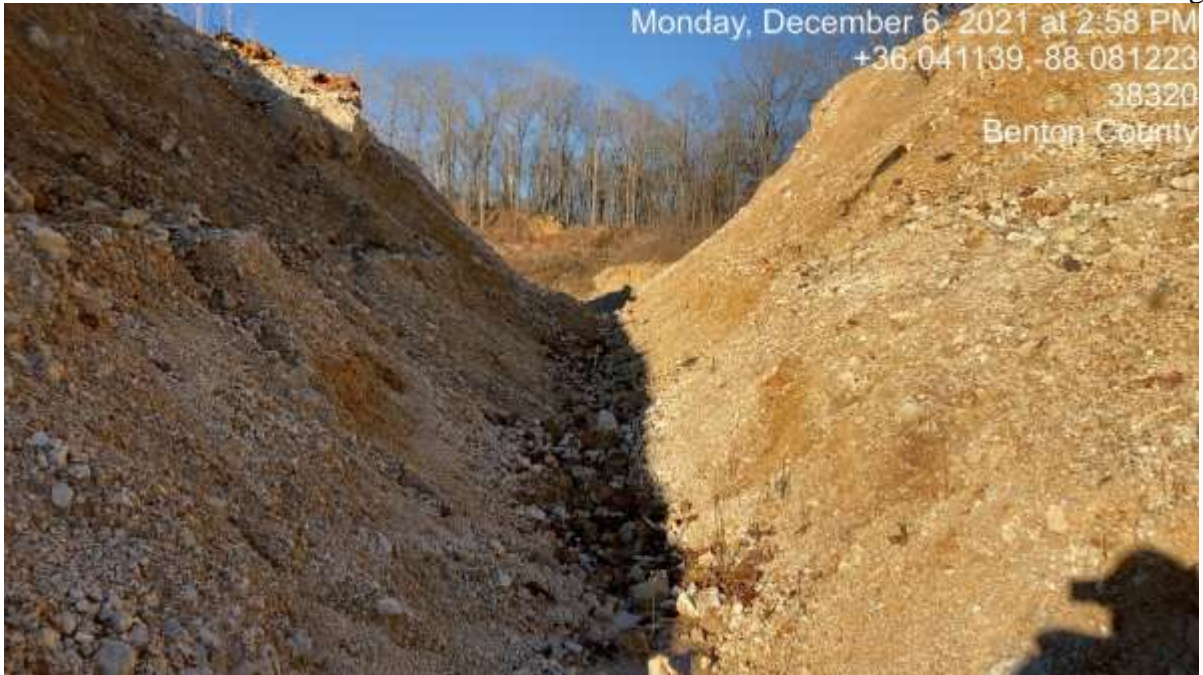
Picture 19

Date of Photo: 12/06/2021. Photo taken by: Kevin Smith. Location/Site Name: Camden Gravel Company, Camden Pit No. 5 / TN0070076. TDWR personnel Present: Kevin Smith. Remarks: Picture was taken standing in same location as Picture 18 only now I am facing north. There is another mined out area on the north side of this cut.

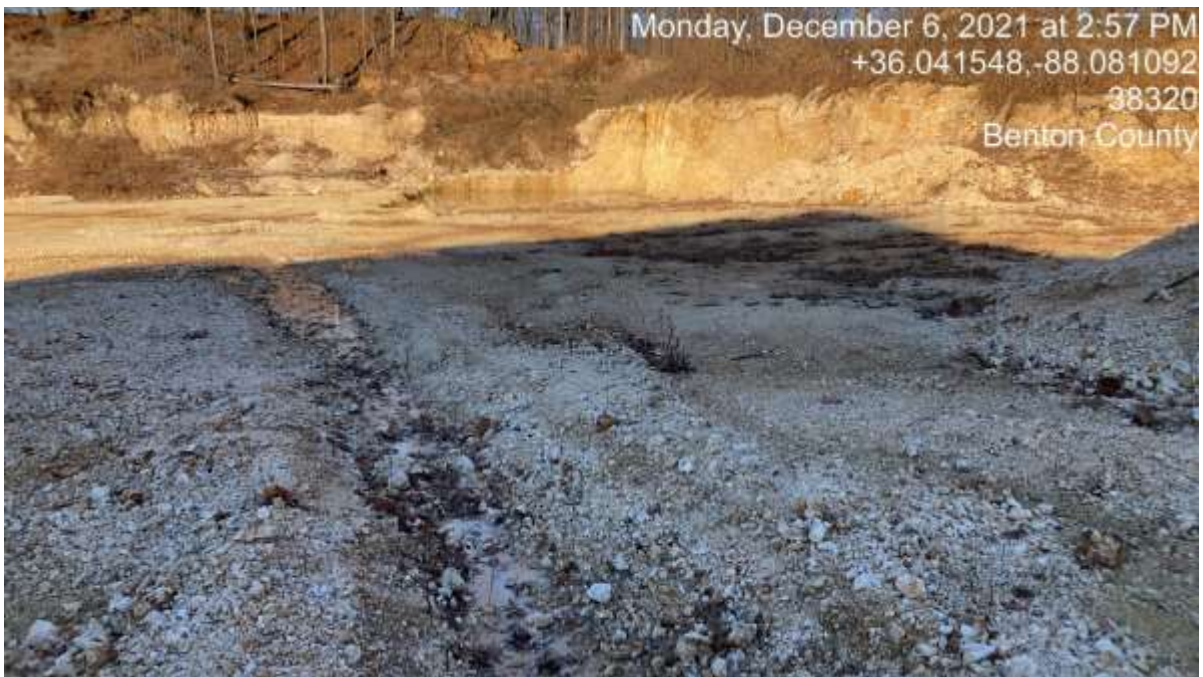
Picture 20

Date of Photo: 12/06/2021. Photo taken by: Kevin Smith. Location/Site Name: Camden Gravel Company, Camden Pit No. 5 / TN0070076. TDWR personnel Present: Kevin Smith. Remarks: Picture shows mined out area in the northeast portion of the site located on the north side of U.S. 70 East. Picture was taken facing north/northeast.

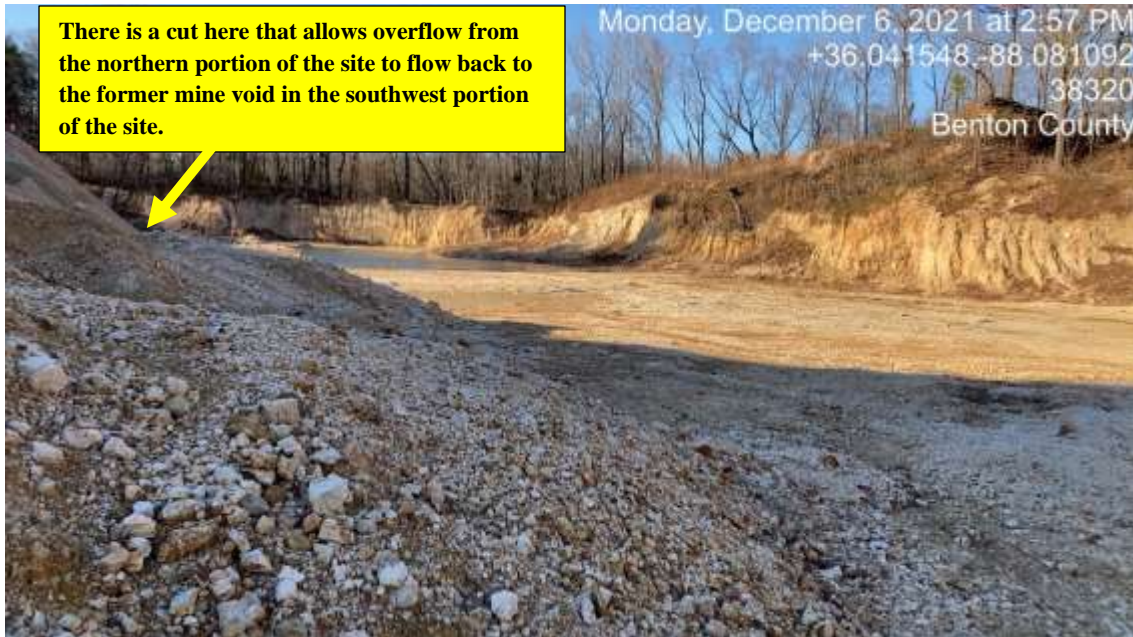
Picture 21

Date of Photo: 12/06/2021. Photo taken by: Kevin Smith. Location/Site Name: Camden Gravel Company, Camden Pit No. 5 / TN0070076. TDWR personnel Present: Kevin Smith. Remarks: Picture was taken standing in same location as Picture 20 only now I am facing northwest. Pond 2 was shown in northwest corner of the site. There is some water standing in this area. Any overflow would flow through a cut that directs drainage back to the former mine void in the southwest portion of the site as shown in Picture 15. There was no water flowing through this cut at the time of inspection.

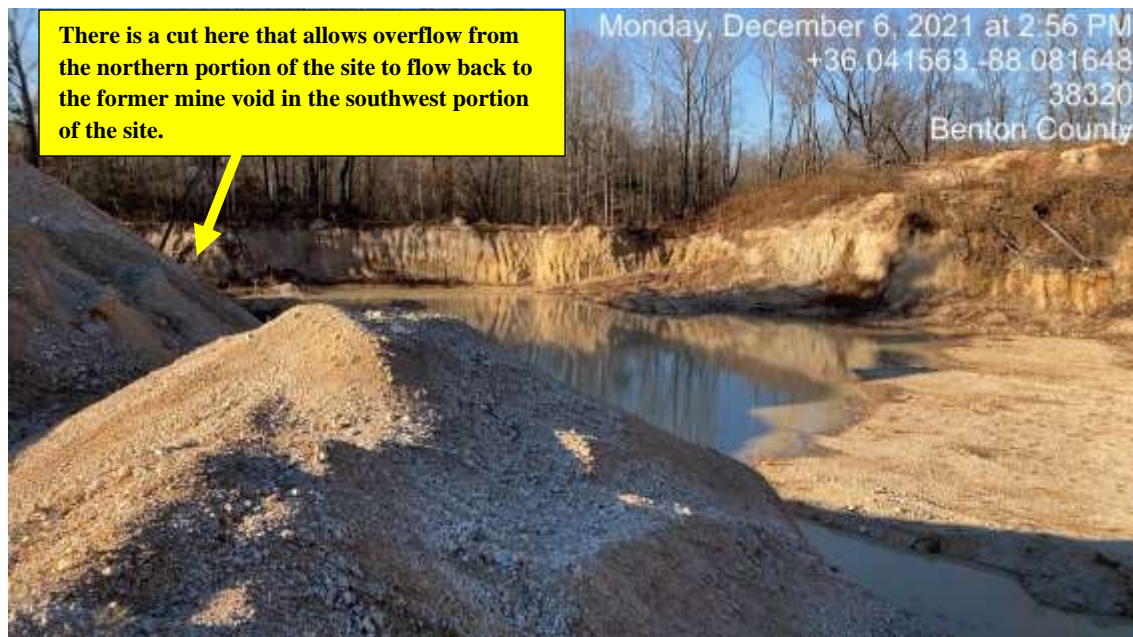
Picture 22

Date of Photo: 12/06/2021. Photo taken by: Kevin Smith. Location/Site Name: Camden Gravel Company, Camden Pit No. 5 / TN0070076. TDWR personnel Present: Kevin Smith. Remarks: Picture shows area in northwest portion of site on the north side of U.S. 70 East. On the site plans it shows Pond 2 would be located here along with Outfall 002. It does not appear Outfall 002 was ever constructed. Any overflow is directed through a cut back to a former mine void in the southwest portion of the site as shown in Picture 15. There was no water flowing through this cut at the time of inspection.
