**TENNESSEE DEPARTMENT OF ENVIRONMENT AND CONSERVATION
ENVIRONMENTAL FIELD OFFICE
1301 RIVERFRONT PKWY, SUITE 206
CHATTANOOGA, TENNESSEE 37402
PHONE (423) 634-5745 STATEWIDE 1-888-891-8332 FAX (423) 634-6389**

Re: **Notice of Violation (NOV)**
Bradley Concrete
NPDES Permit Tracking Number: TNG 110039
340 Durkee Road NE
Bradley County, Tennessee

On March 7, 2018, Jennifer Dulin and Mike Bascom of the Division of Water Resources (DWR) conducted a Compliance Evaluation Inspection (CEI) of the above referenced facility. They met with Jason Frey, who provided information during the inspection. The purpose of the inspection was to evaluate Bradley Concrete's compliance with the terms and conditions of your National Pollution Discharge Elimination System (NPDES) permit, NPDES Permit Tracking Number TNG110039.

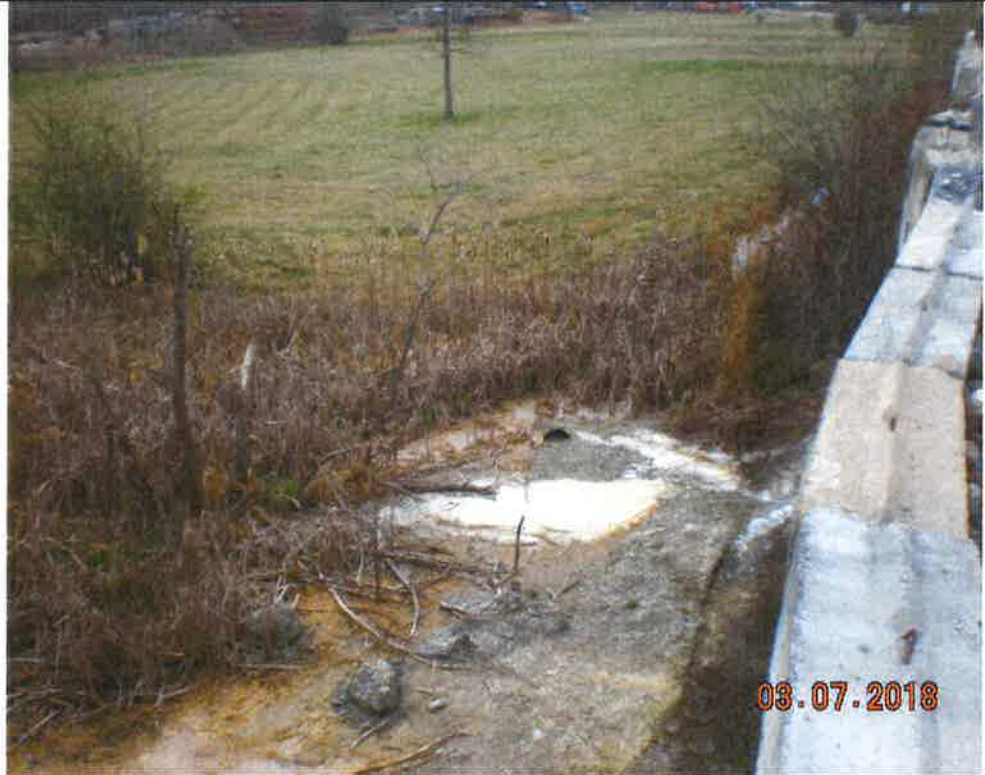
Figure 1.

Stock piles of aggregate are located at the south corner of the site. Process waste water settling basins and piles of leftover aggregate are located at the east corner of the property. A block wall ran the entire length of the southeast property line. Upon inspection of the other side of the block wall, Ms. Dulin and Mr. Bascom observed aggregate and waste concrete had been pushed over the top of the wall and were now located in the wetland east of the facility (Figure 1 and 2).

Aggregate and concrete waste allowed to migrate offsite into the wetland at the southeast block wall.

- Bradley Concrete must remove cement dust and aggregate that was discharged into the wetland. A corrective action plan for removal of this material must be submitted to this office within 30 days of receipt of this letter. It is your responsibility to coordinate and obtain permission with the property owner before removal.

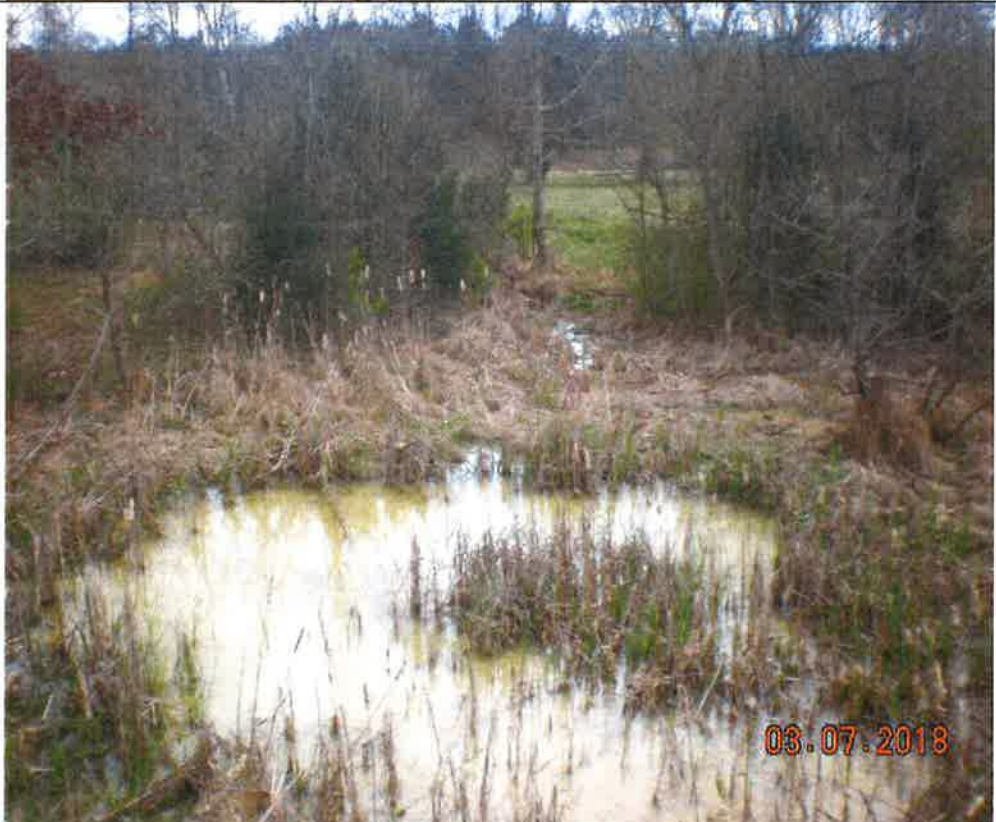
Figure 2.

Aggregate allowed to migrate offsite, into Waters of the State, at the Southeast corner of the property.

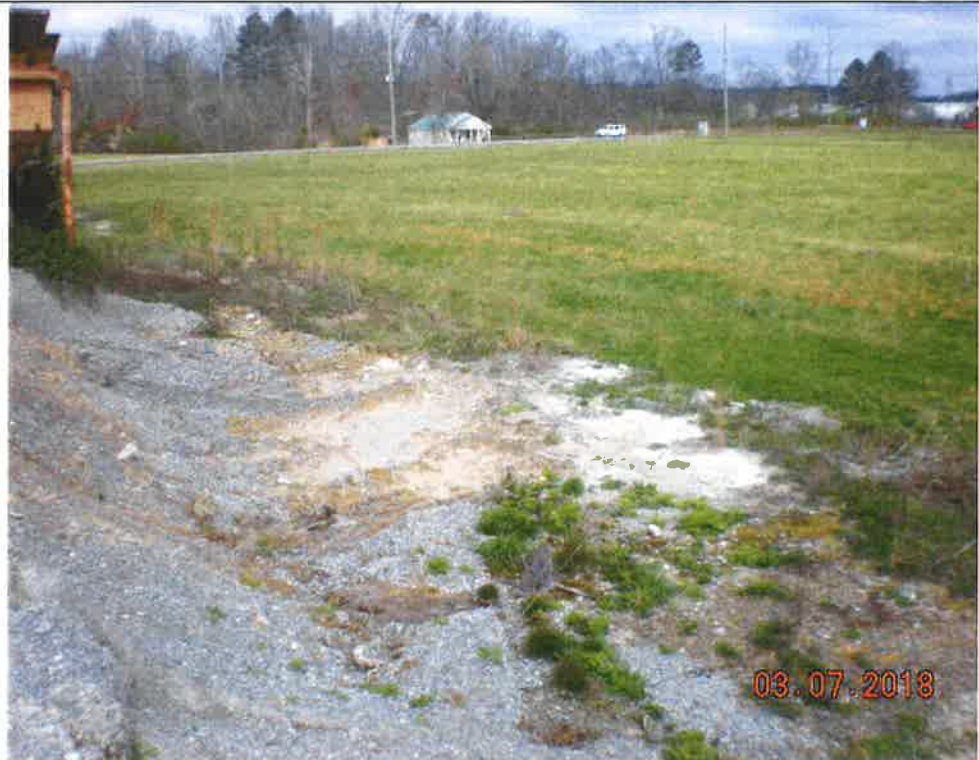
Figure 3.

Inspectors observed aggregate and waste concrete migrating down slope into a vegetated area along the north side of the property (Figure 3).

Aggregate allowed to migrate offsite at the east property line.

- Structural controls must be installed and maintained to ensure pollutants do not discharge to Waters of the State. Documentation of installation of structural controls must be submitted to DWR within 30 days of receipt of this letter.

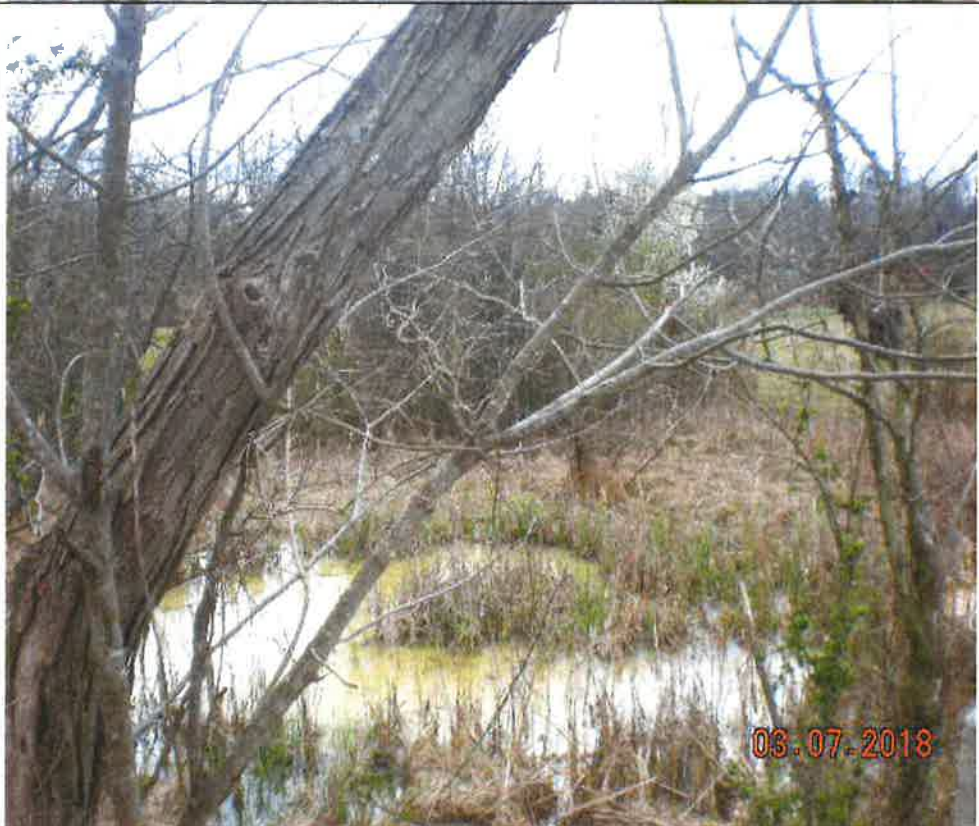
Figure 4.

The site has one stormwater outfall: Outfall SW1 is located at the east corner of the property. Outfall 001 would be the truck wash-out basin's outfall. No discharge was observed during the inspection. Ms. Dulin and Mr. Bascom observed a considerable amount of cement dust in the wetland located behind the truck wash-out basin (Figure 4).

Wetland filled with aggregate and concrete dust southeast of the facility.
