STATE OF TENNESSEE DEPARTMENT OF ENVIRONMENT AND CONSERVATION CHATTANOOGA ENVIRONMENTAL FIELD OFFICE

Subject: Notice of Violation

Compliance Evaluation Inspection A & B Eagle Line Equipment, Inc. NPDES Permit Number: TNR054361

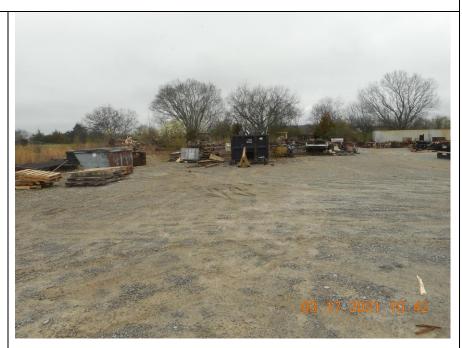
Photo 1.

Southwestern corner of site.

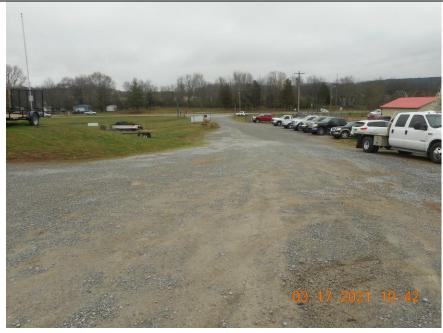
Photo 2.

Facing east across site; stormwater flows east and north to Sweetwater Creek.

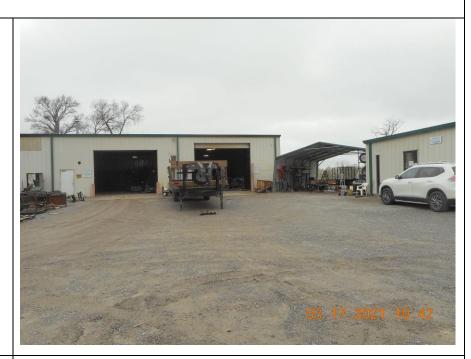
Photo 3.

Facing north towards plant, shed, and office.

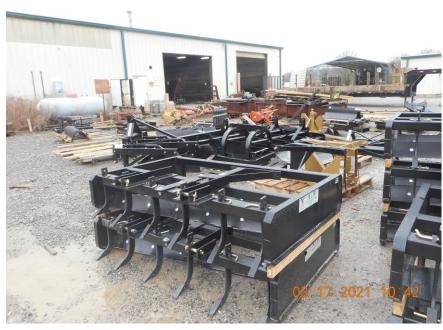
Photo 4.

A & B Eagle Line Equipment, Inc. is a facility that manufactures, repairs, and sells farm equipment, with approximately 10 employees. Vehicles are serviced under cover, in the facility plant, and there is no fueling station. There is a considerable amount of raw metal stored outside and several empty paint barrels, with lids, that are scheduled to be removed from site. There is a dumpster and scrap dumpster, both of which are tidy. Stormwater is discharged from the site after flowing across several hundred feet of grass to the northeast corner of the site before entering Sweetwater Creek. Discharge consists of sheet flow runoff from its building, gravel parking lot, and grassy swale behind plant.

Storage outside plant.

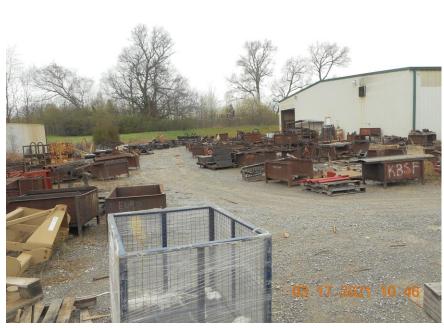
Photo 5.

Storage behind plant in western portion of site.

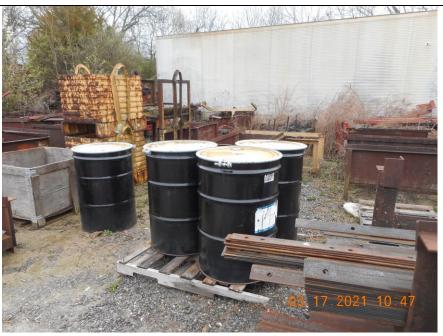
Photo 6.

Empty paint containers in rear of facility.

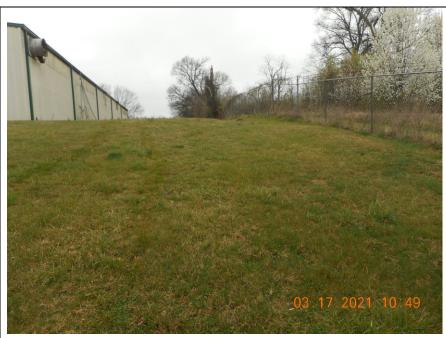
Photo 7.

Path of stormwater flow behind plant along northern boundary of site.

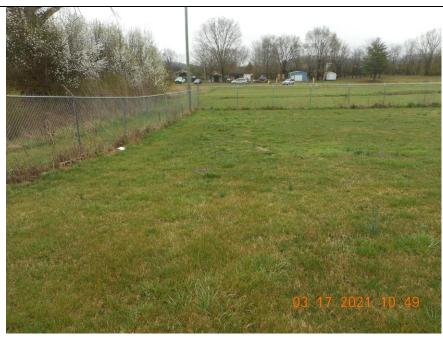
Photo 8.

The outfall was observed during the inspection and no evidence of pollution was noted. The receiving stream is east of the site beyond the facility's fence.

Housekeeping at the facility is good and appears to be well maintained. Good housekeeping practices reduce the potential for significant materials to come in contact with stormwater. No trash, debris, or indication of pollution was observed near the outfall.

Facing outfall point in northeast corner of site.

- 3. Quarterly Visual Examinations of the outfall area should begin immediately, and documentation should be kept on site for future inspections. Examinations should be conducted regularly as specified by section 5.3 of the permit.
- 4. Annual analytical monitoring results for each outfall should be submitted to the Division as specified by section 5.2 of the permit.
