Photographic Log

Client or Facility Name: 31 W Insulation Facility		Site Location: 36.414903 / -86.715389	Project No.: TNR242083
Photo No. 1	Date 06/01/2018	 	
Description Looking southeast from the southern boundary of the project site. 36.415170 / -86.716496

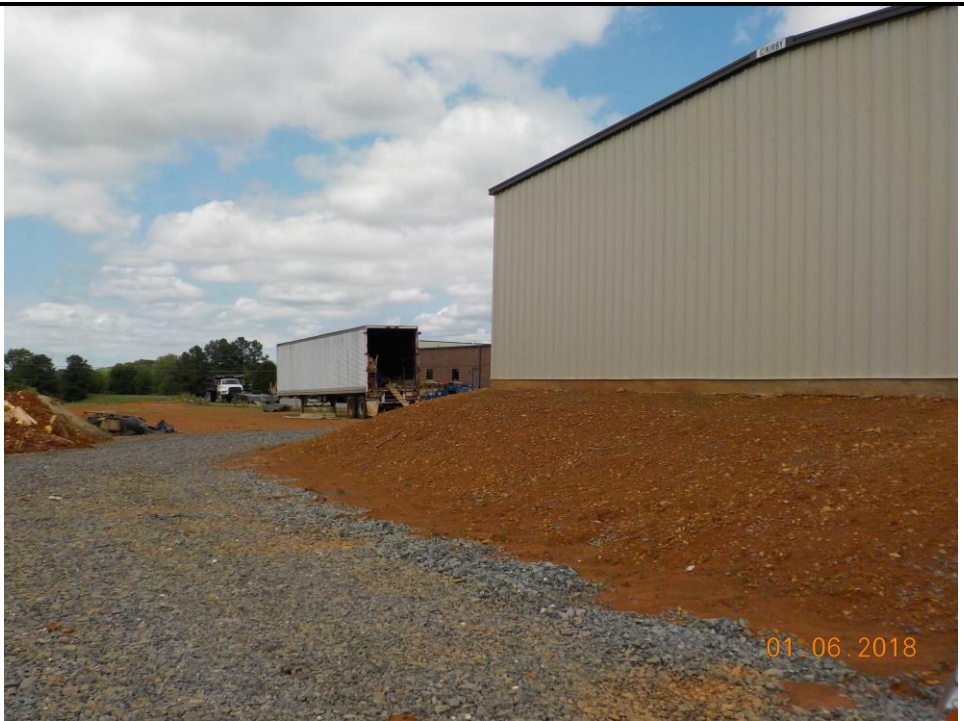
Photo No. 2	Date 06/01/2018

Description Looking northeast from the southwest portion of the project site. 36.415170 / -86.716496

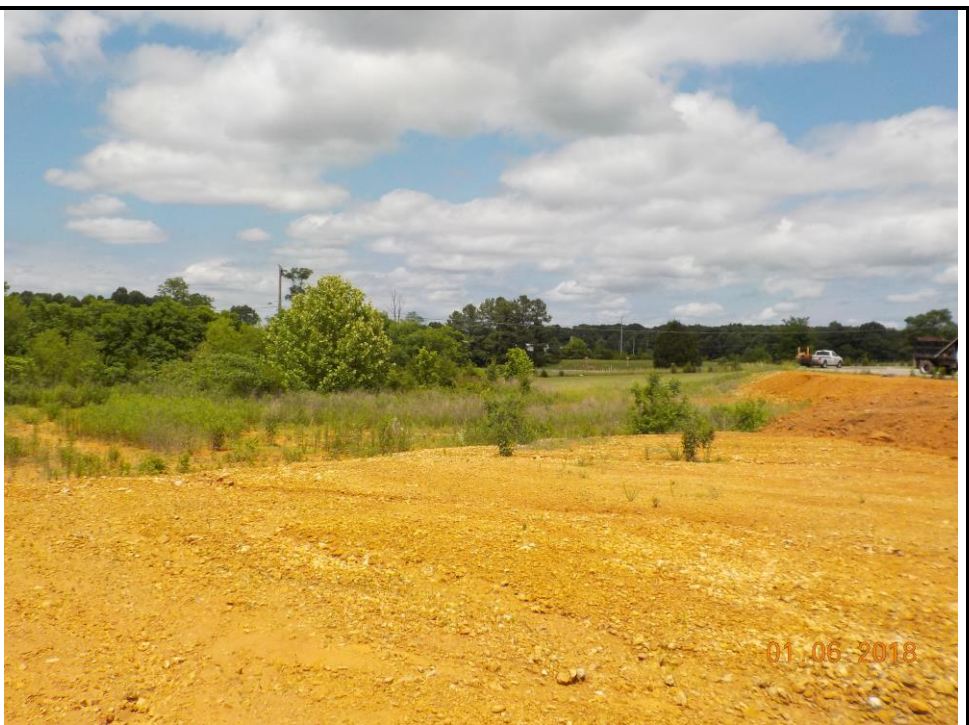
Photo No. 4	Date 06/01/2018

Description Looking north from the western portion of the project site. 36.415618 / -86.716385

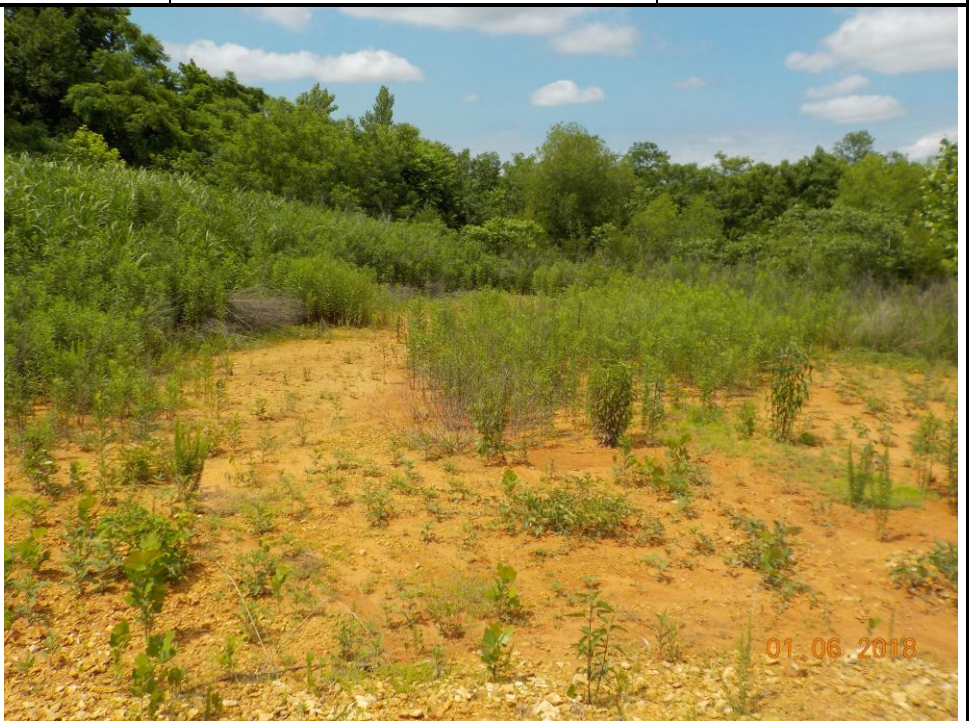
Photo No. 5	Date 06/01/2018

Description Looking north from the northwestern portion of the site. 36.415755 / -86.716288
