# Photographic Log

<b>Client or Facility Name:</b> Nancy LLC		<b>Site Location:</b> HWY 124, Greenfield	<b>Driller:</b> Gus Naranjo, #643
<b>Photo No.</b>	<b>Date</b> 2/14/2024

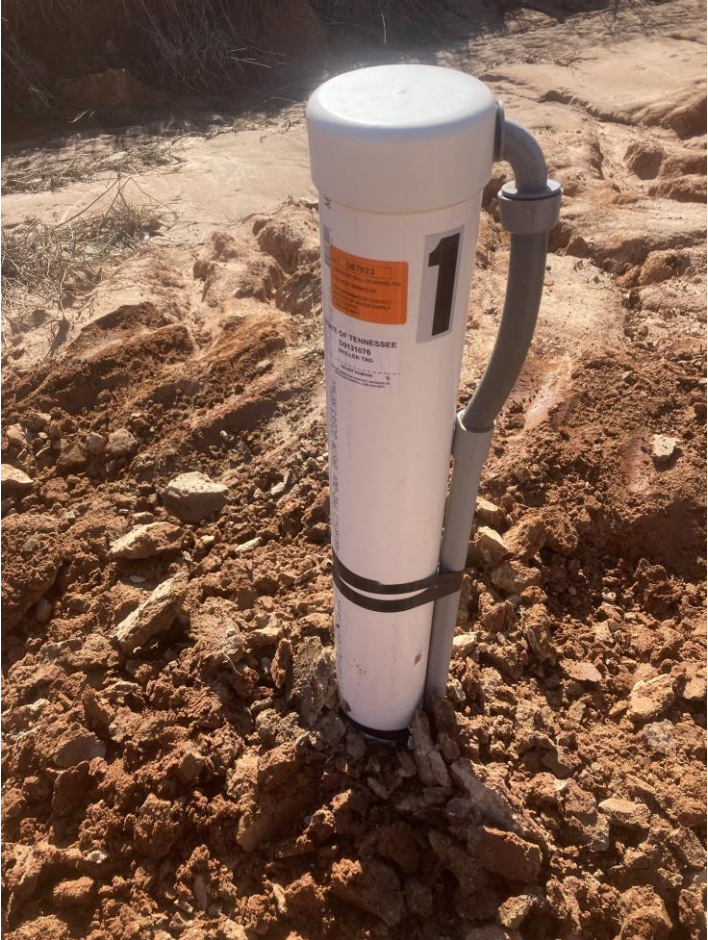
<b>Description</b> Photo of Corrected - Driller Tag

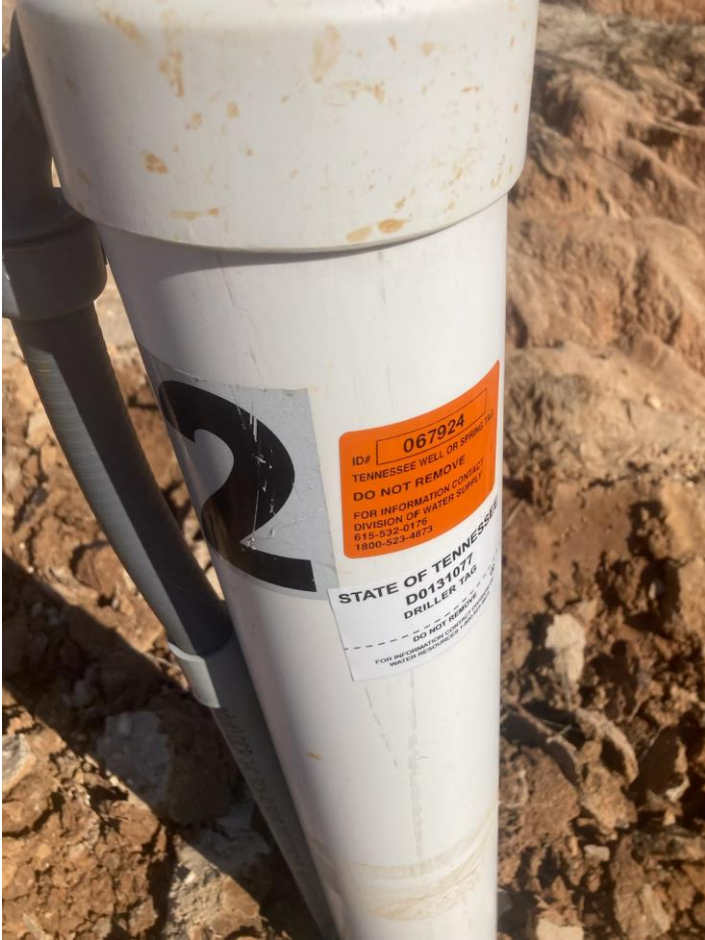
<b>Description</b> Photo of Corrected – Driller Tag

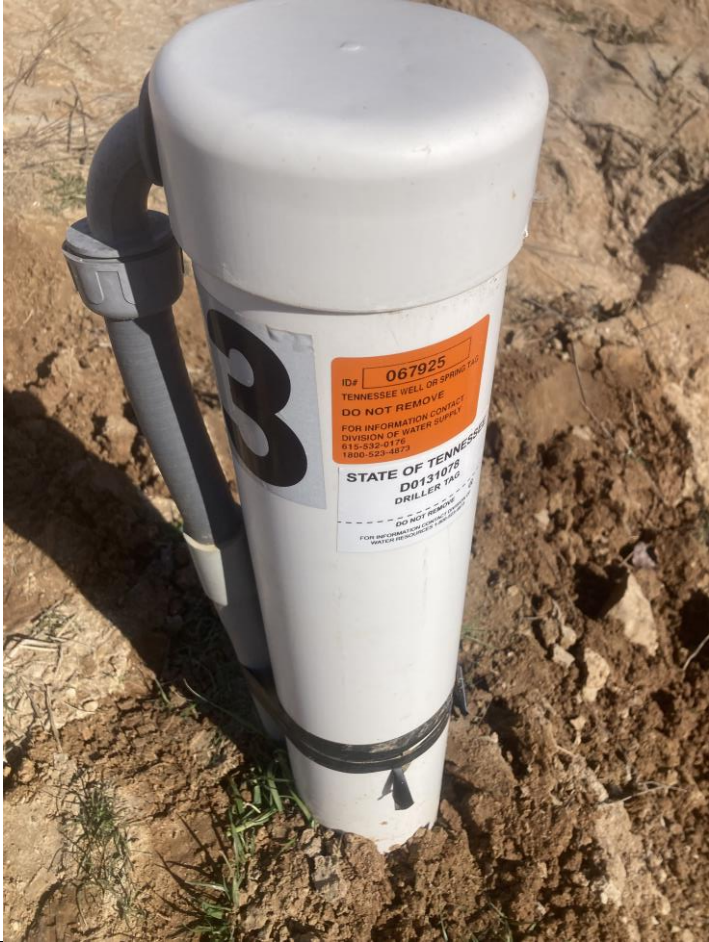
<b>Description</b> Photo of Corrected – Driller Tag

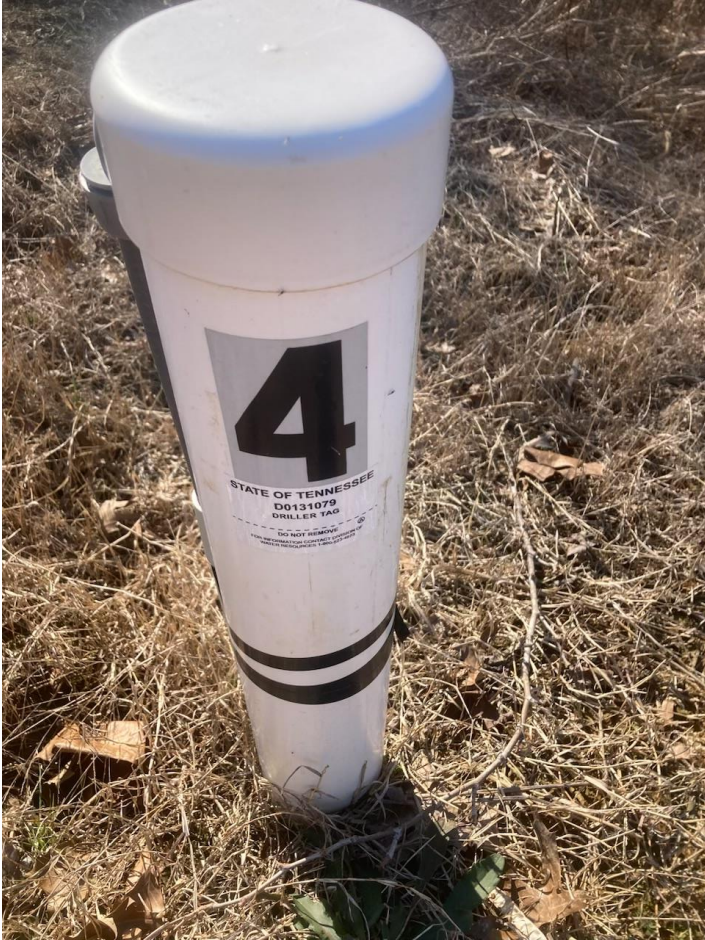
<b>Description</b> Photo of Corrected – Driller Tag

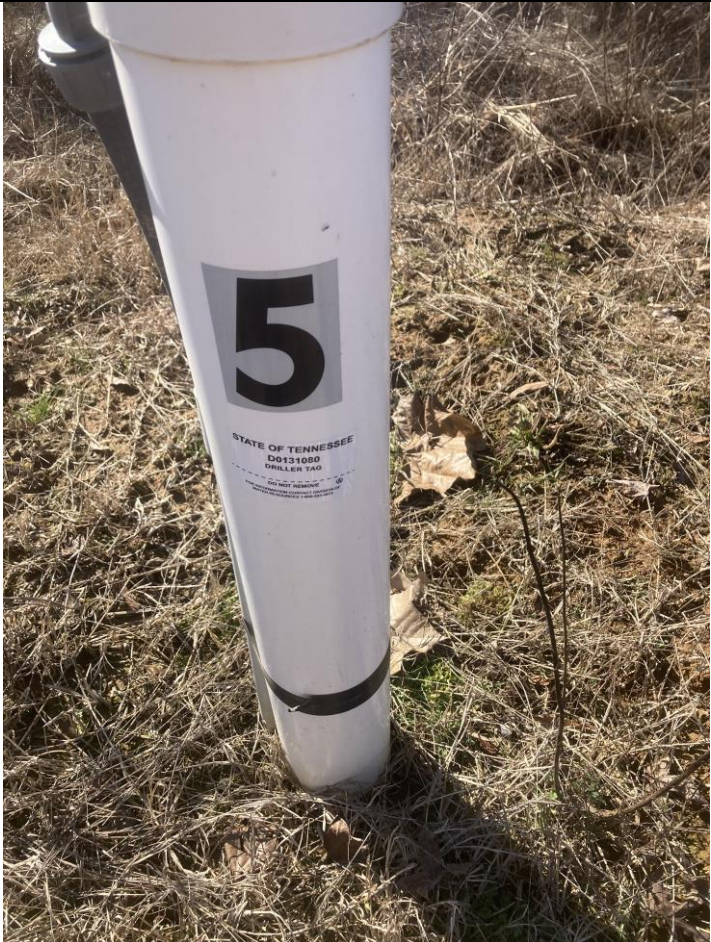
2/14/2024		
Description			
Photo of Corrected – Driller Tag
