RE: Compliance Review Meeting, (CRM), May 18, 2023, in Celina
Compliance Evaluation Inspection (CEI), Notice of Violation (NOV)
City of Celina Sewer Treatment System, NPDES # TN0063886

Enclosure: CEI Site Photographs by W. Oakley Hall

City of Celina Sewage Treatment Plant (TN0063886) Compliance Evaluation Inspection, Clay County.

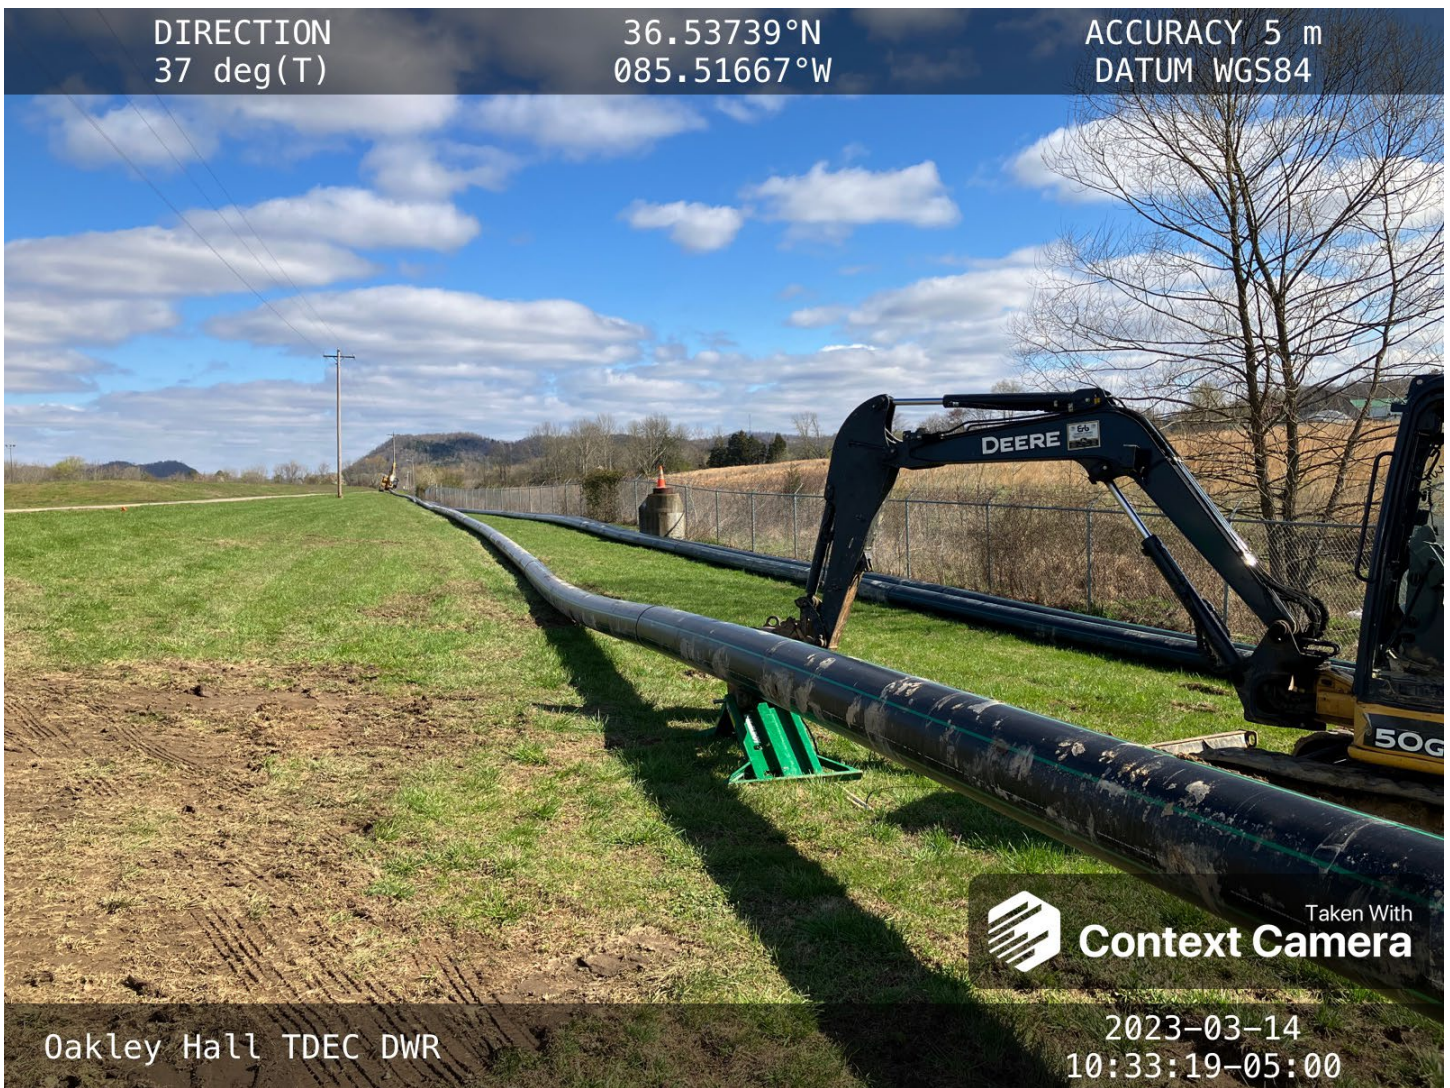
The new influent line is pictured. It will be installed after the existing line is pipe burst. The method of installation was discussed with the contractor. This line is coming in at the influent of the plant through the existing sewer pump station.

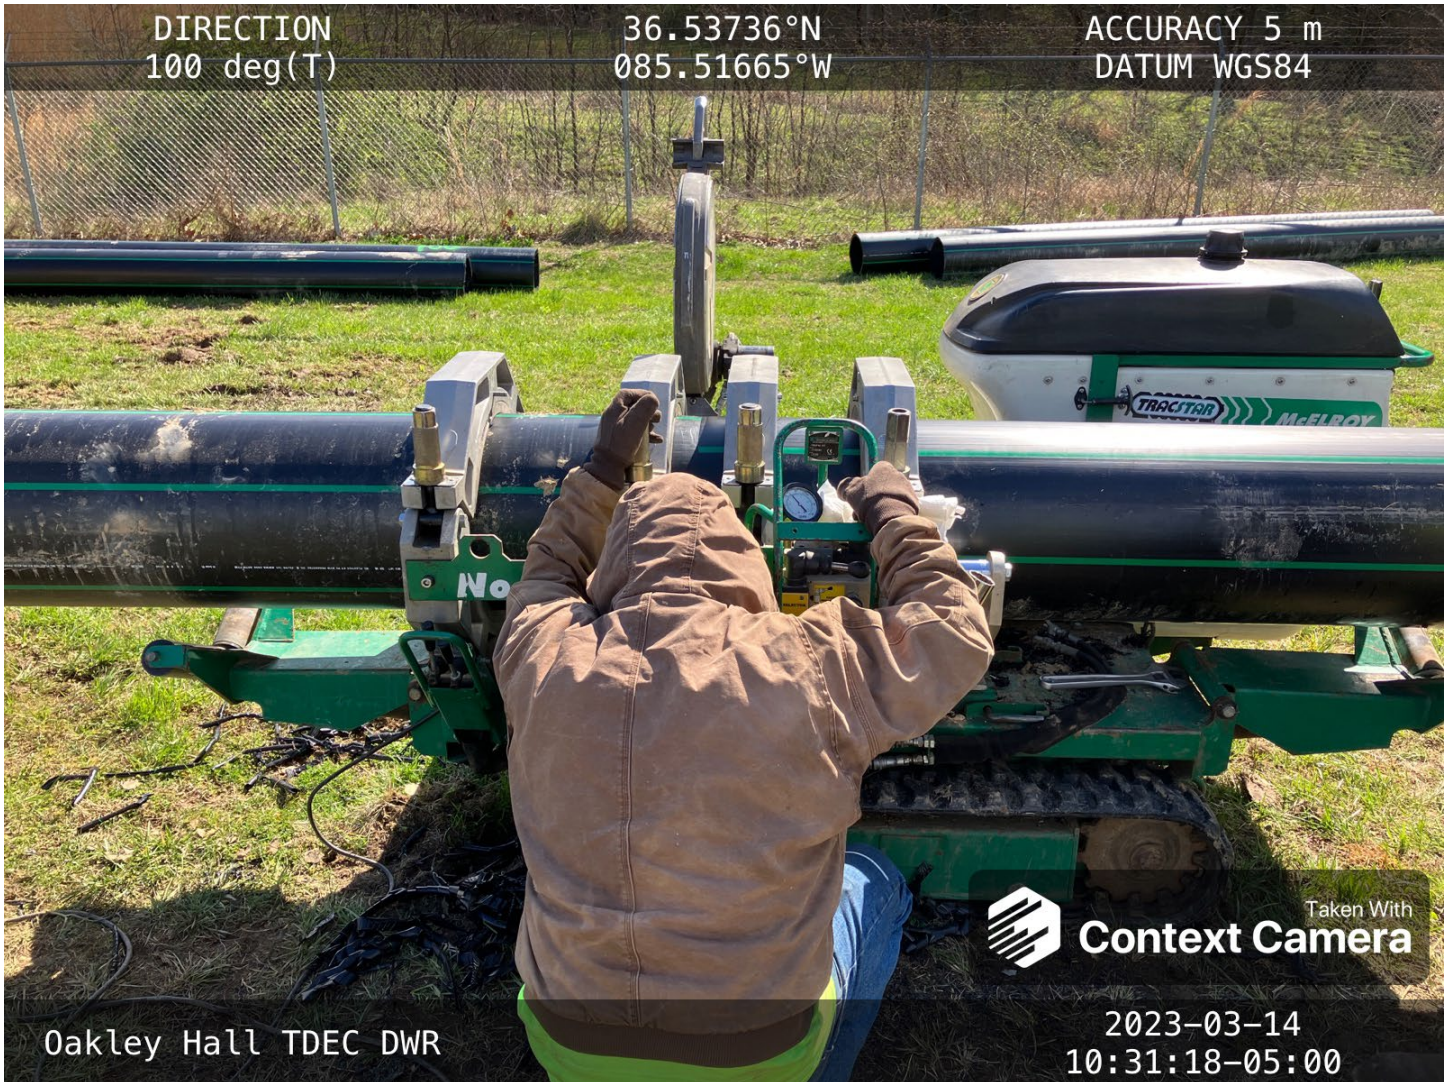
One of the flush heated pipe connections of the poly pipe was observed. The connection process and strength were discussed with the contractor.

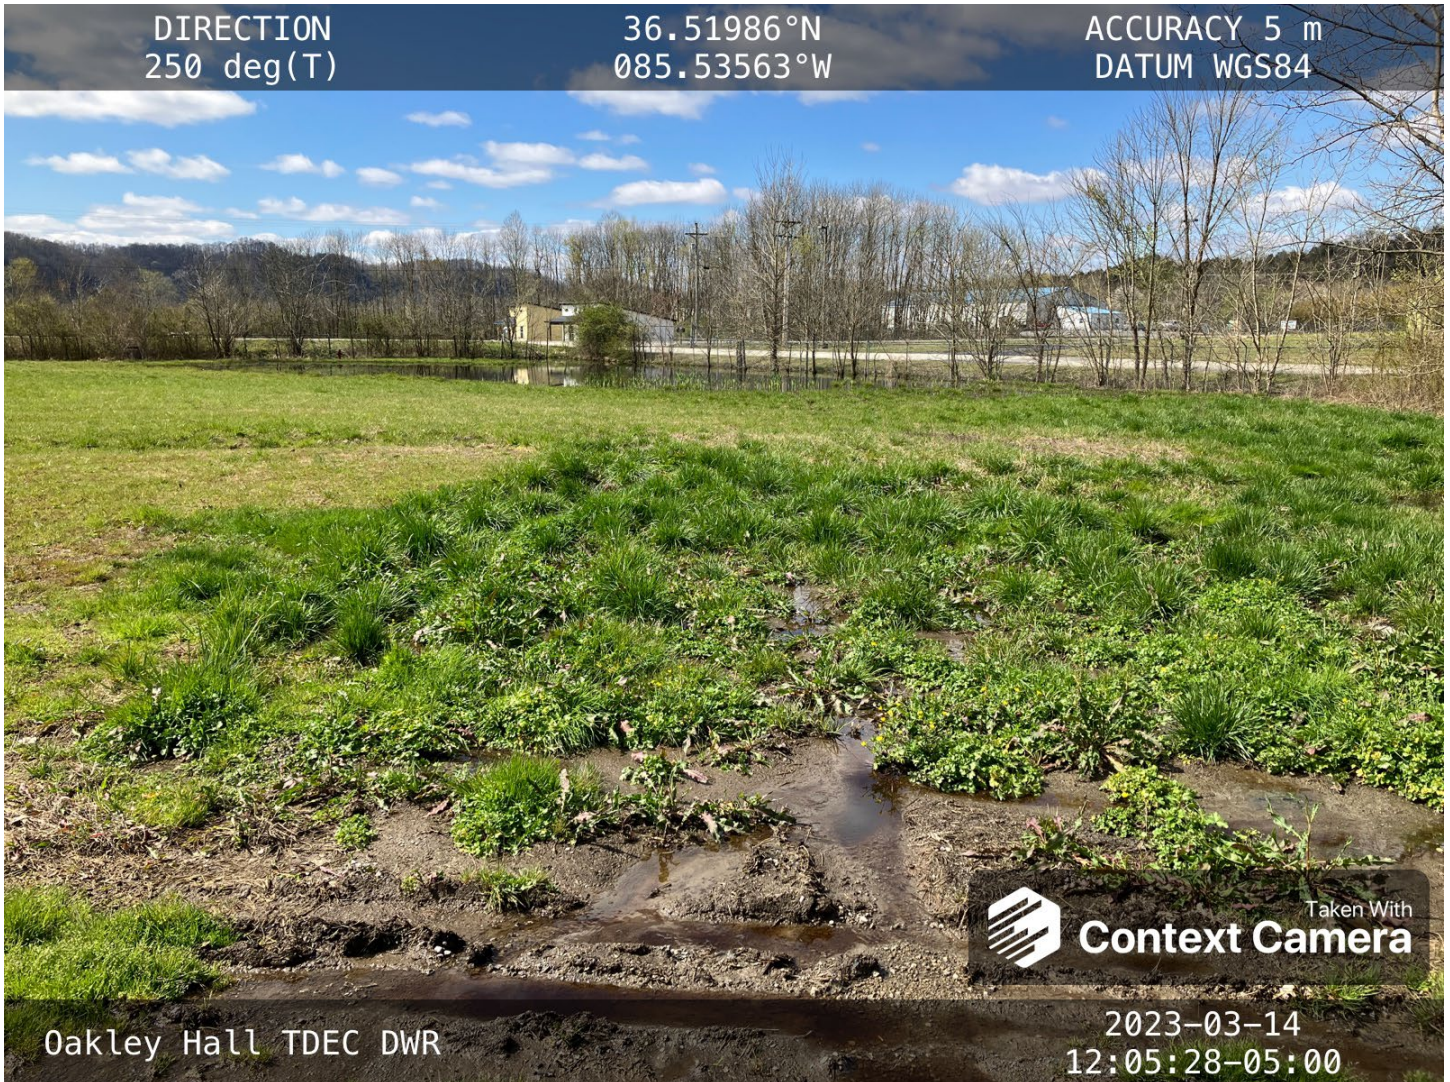
The wetland area around the industrial park is pictured. It appears that a heavy flow of surface water exists. This is in close proximity to the Cumberland River.

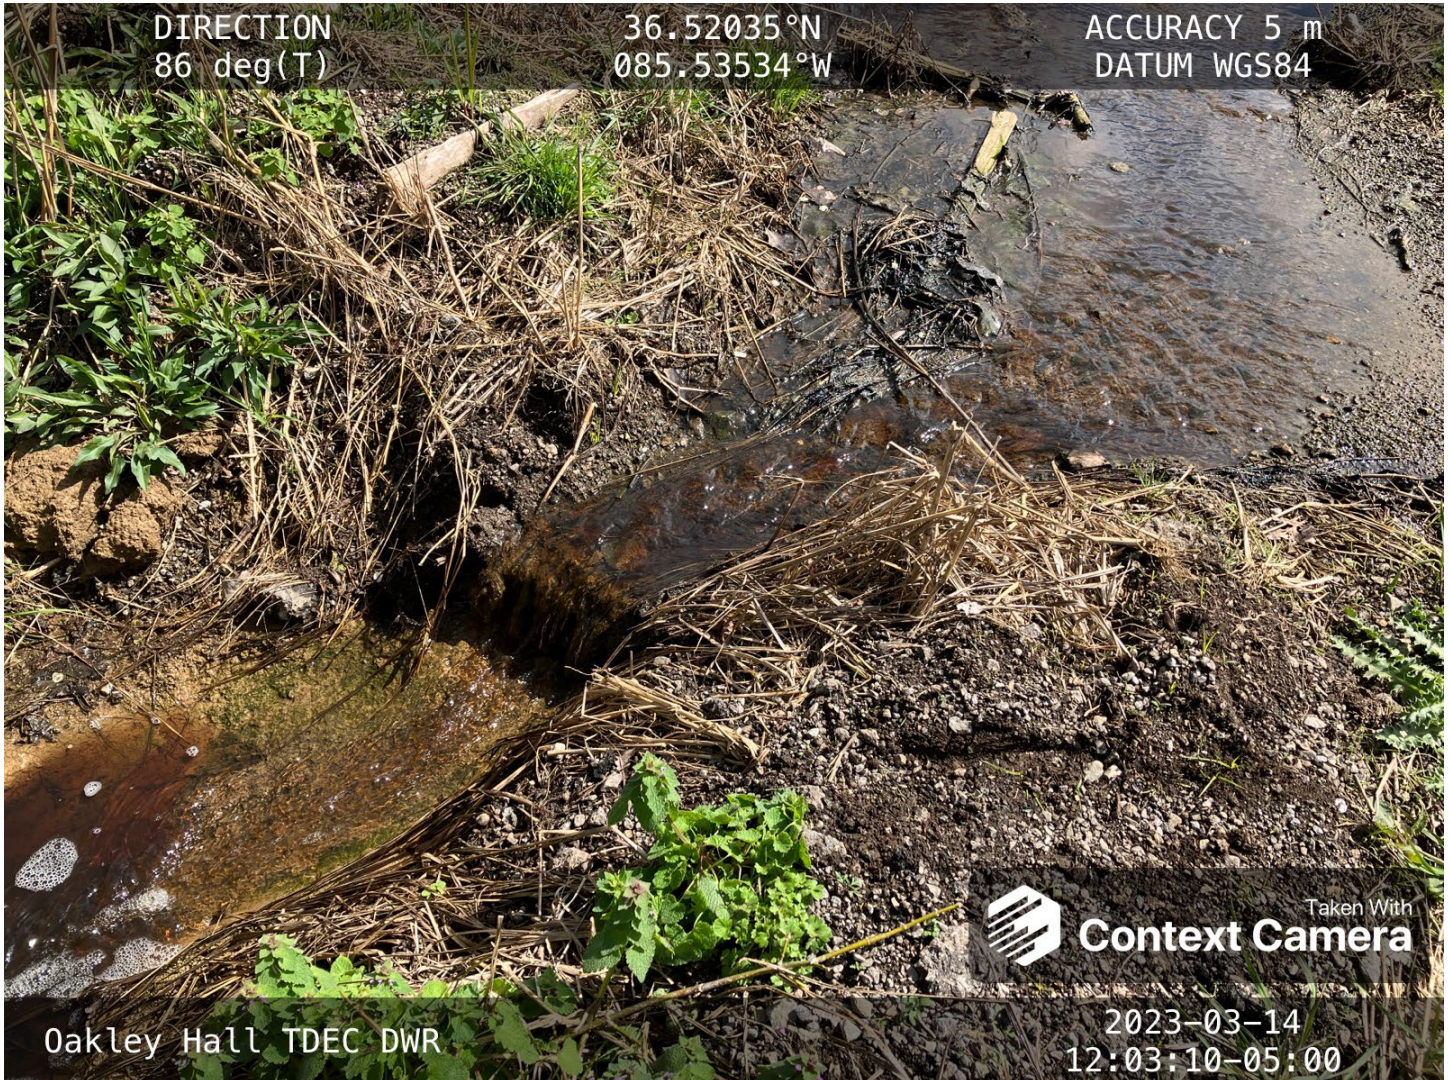
At the industrial park, the color of the surface water was dark, possibly some tannins. A considerable amount of surface water was flowing. The quantity of water moving through the area was considerable. Impacts from historical industrial activity may be present.

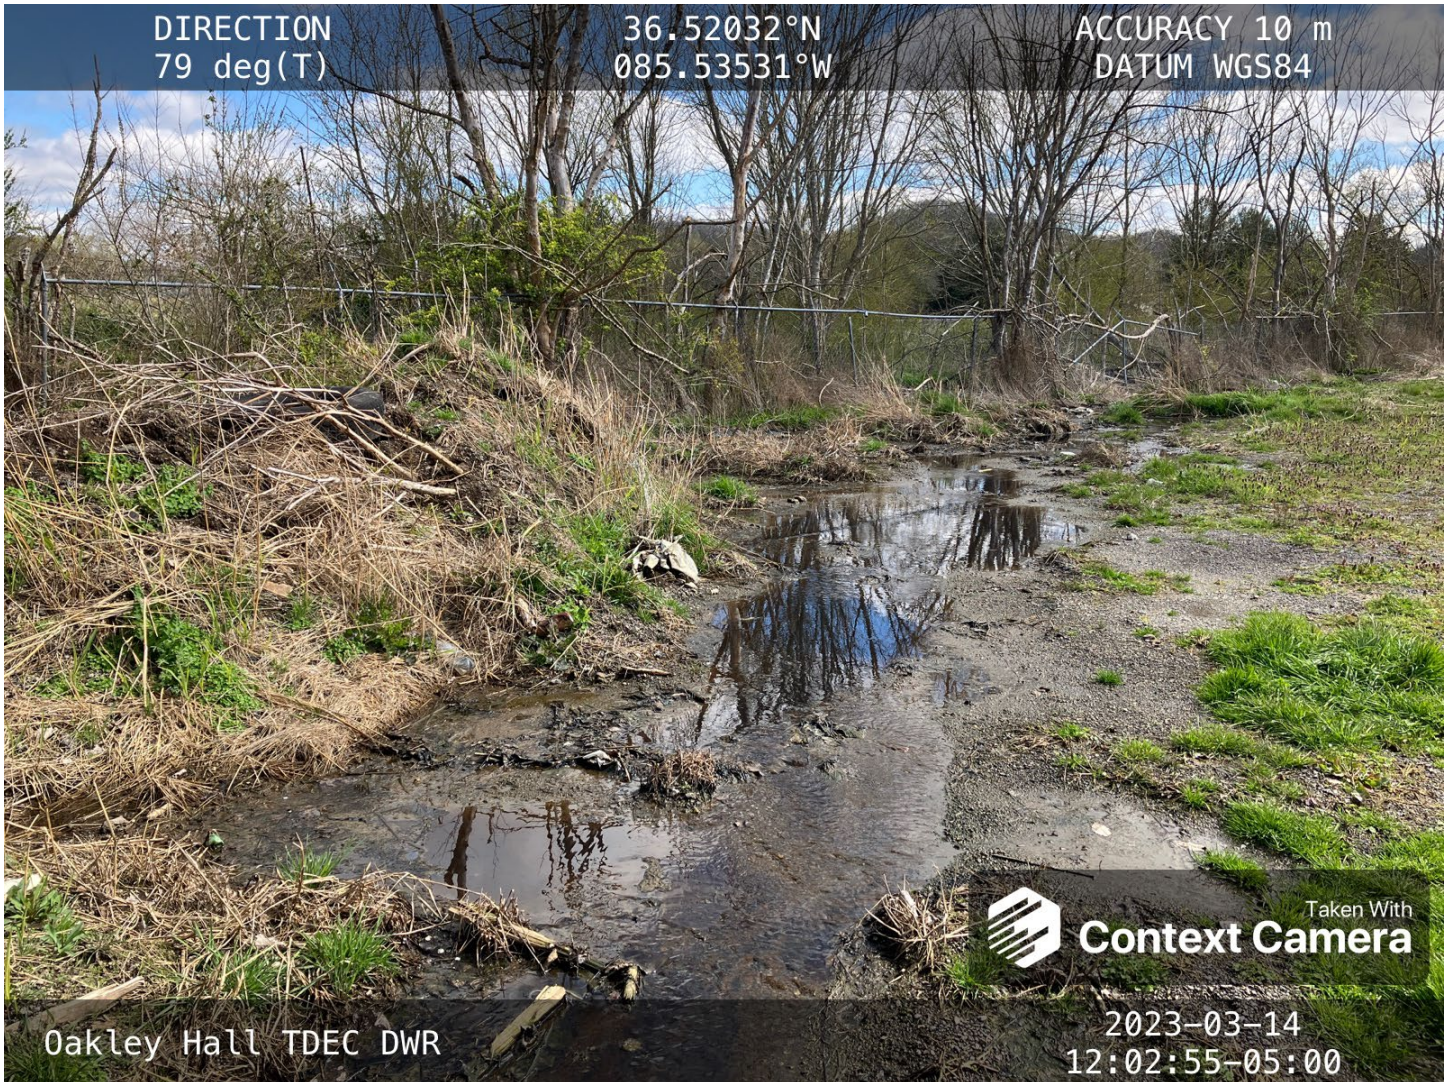
The water on the surface around the industrial park area, it was dark in color. Large oil tanks were once in the area. The tanks burned several years ago. The surface water does not appear to be related to possible overflows from the Industrial Park sewer pump station. An odor of sewage or leachate was not apparent.

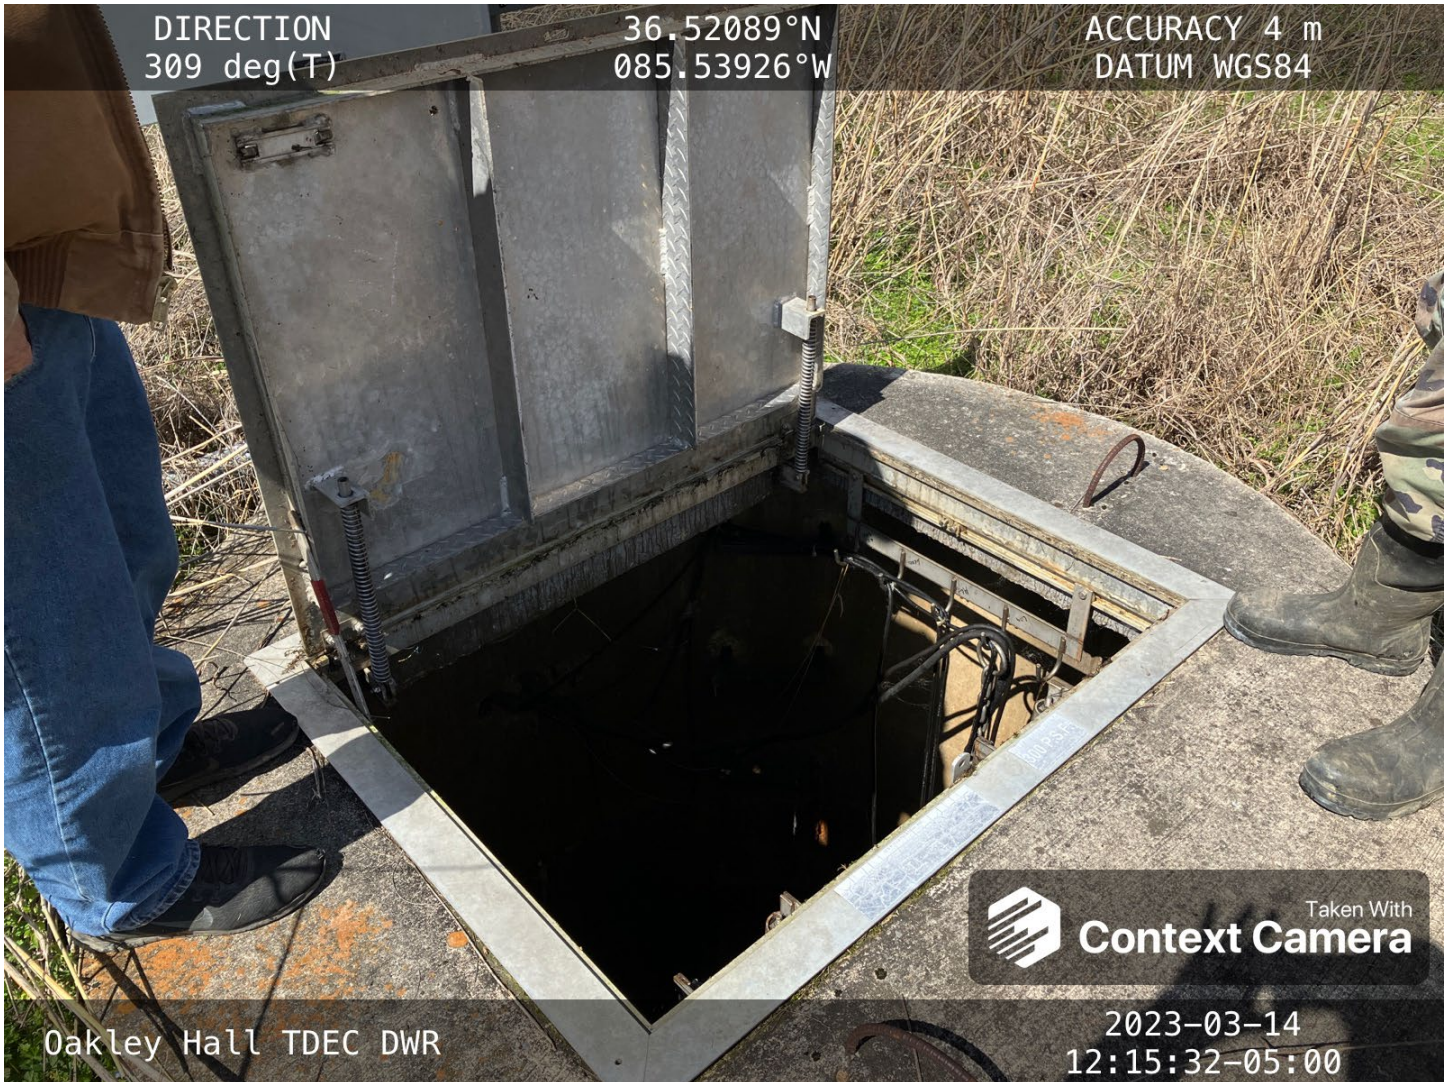
The collection system was discussed. The Industrial Park pump station was reviewed. It was noted that two pump stations (the Industrial Park and the In Plant pump station) were each running on a single pump. Improvements to the collection system are in process. The city is working to make repairs and to remove Inflow and Infiltration of stormwater from the sewer collection system.

This is the Industrial Park sewer pump station. At the time of the photo, only one (1) pump in this pump station was operational. This station receives leachate from a privately operated landfill. A manhole just above the pump station is used to accept the landfill leachate wastewater. This area was reviewed in relation to the industrial park wetland and concerns about exfiltration from the effluent pump line. Losses from the pump line were not observed. Area industrial activity (historical) may be the cause of discoloration concerns in surface water.

- ✓ Maintain operable dual sewage pumps in each sewer pump station. Review any electrical issues.

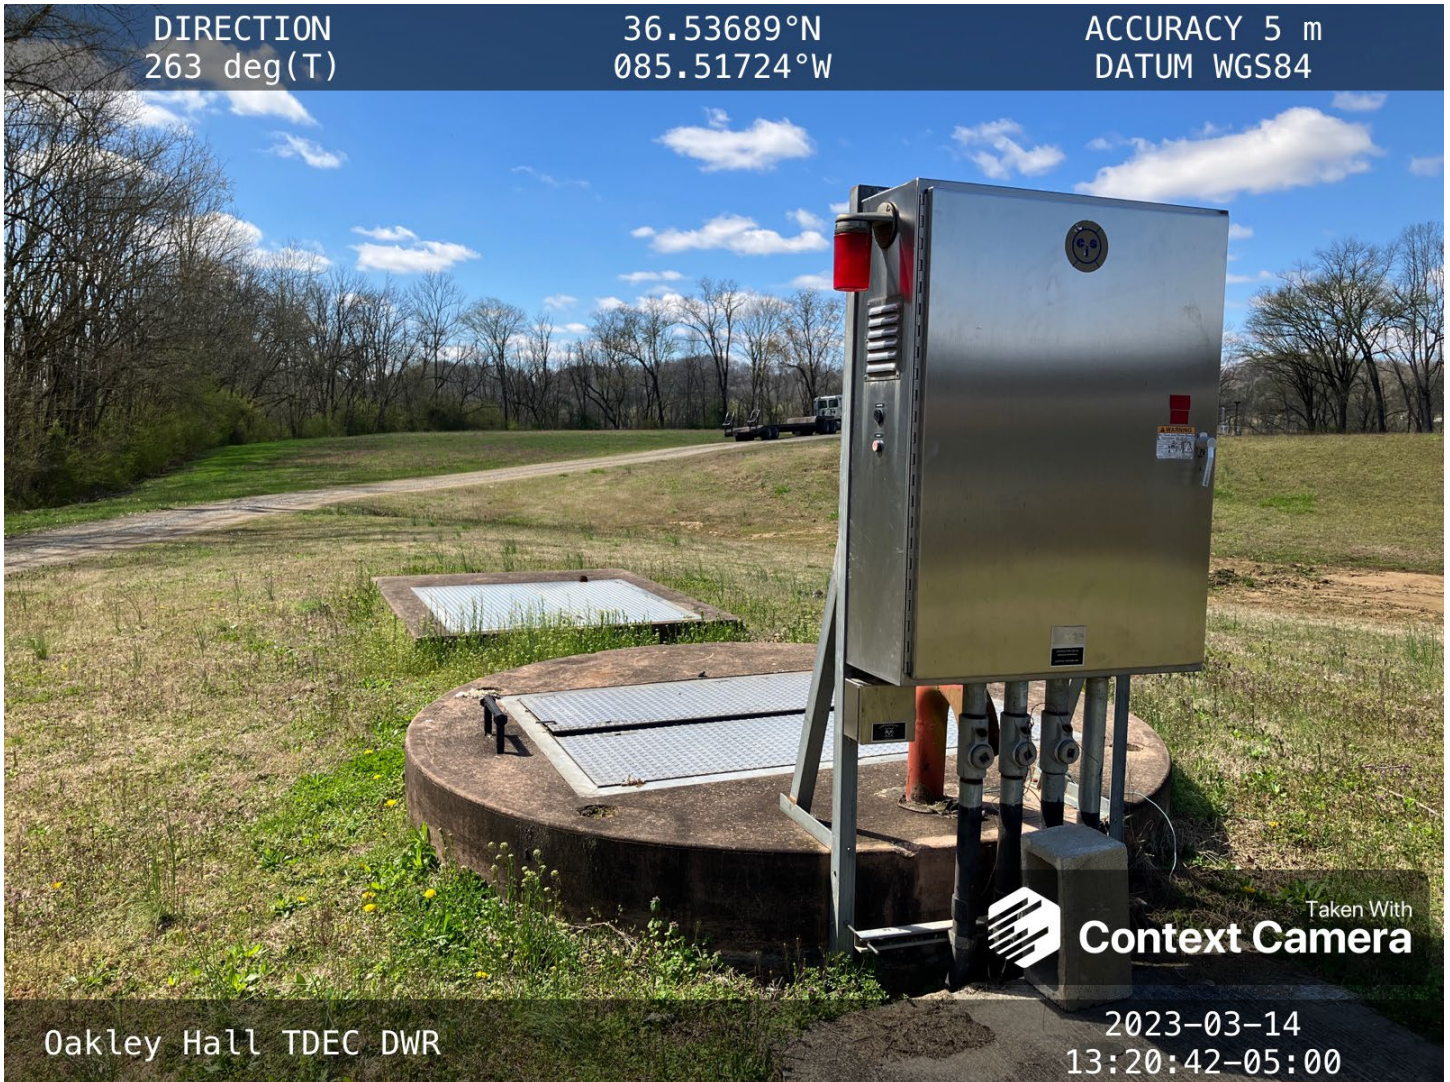
The last pump station for the city wastewater supply line is pictured. Both pumps were in place. Some electrical problems persist. It was discussed that TVA or the local electrical utility should be asked to visit the facility in order to see if electrical protections can be added to the system.

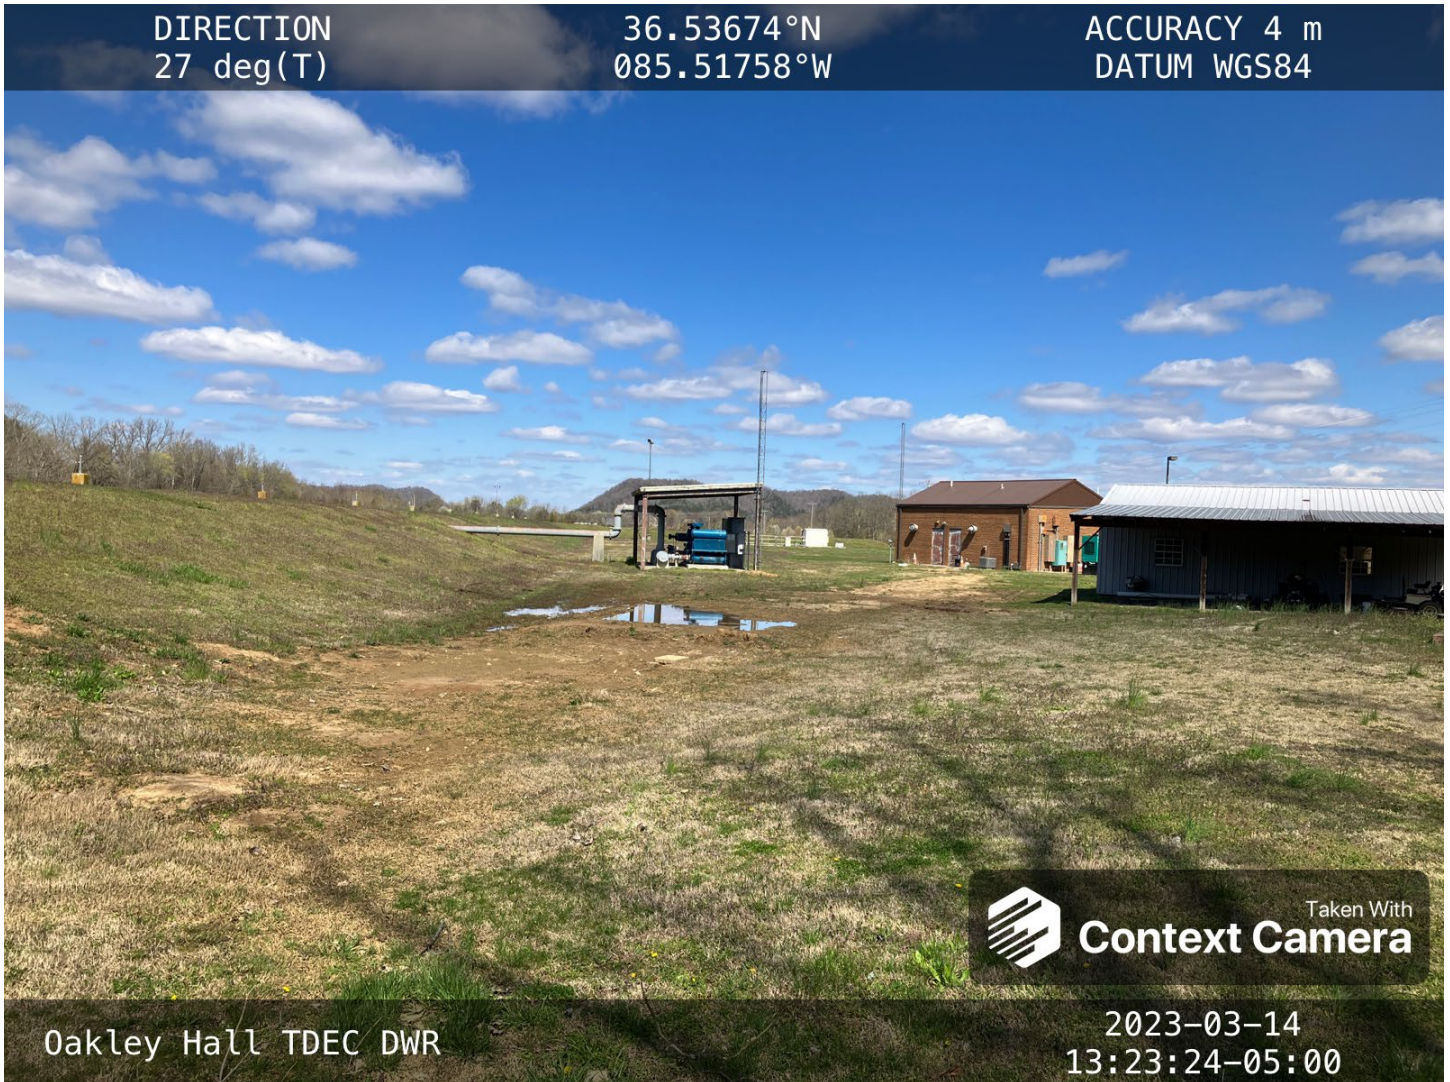
Electrical service lines are buried in this area. Some landscaping is needed. The blowers were operational. The blowers' filters were recently alternated with cleaned (used) filters. It is recommended that new filters be kept in stock and be replaced when needed. Using cleaned (used) filters could prove problematic. The manufacture's required replacement filters should be kept in stock. Blowers are expensive, the cost of air filters is a fraction of what a rebuild will cost.

- ✓ Repair the BOD incubator so that intermittent operation is eliminated.
- ✓ Replace blower air filters per the manufacturer’s recommendations with new filters.

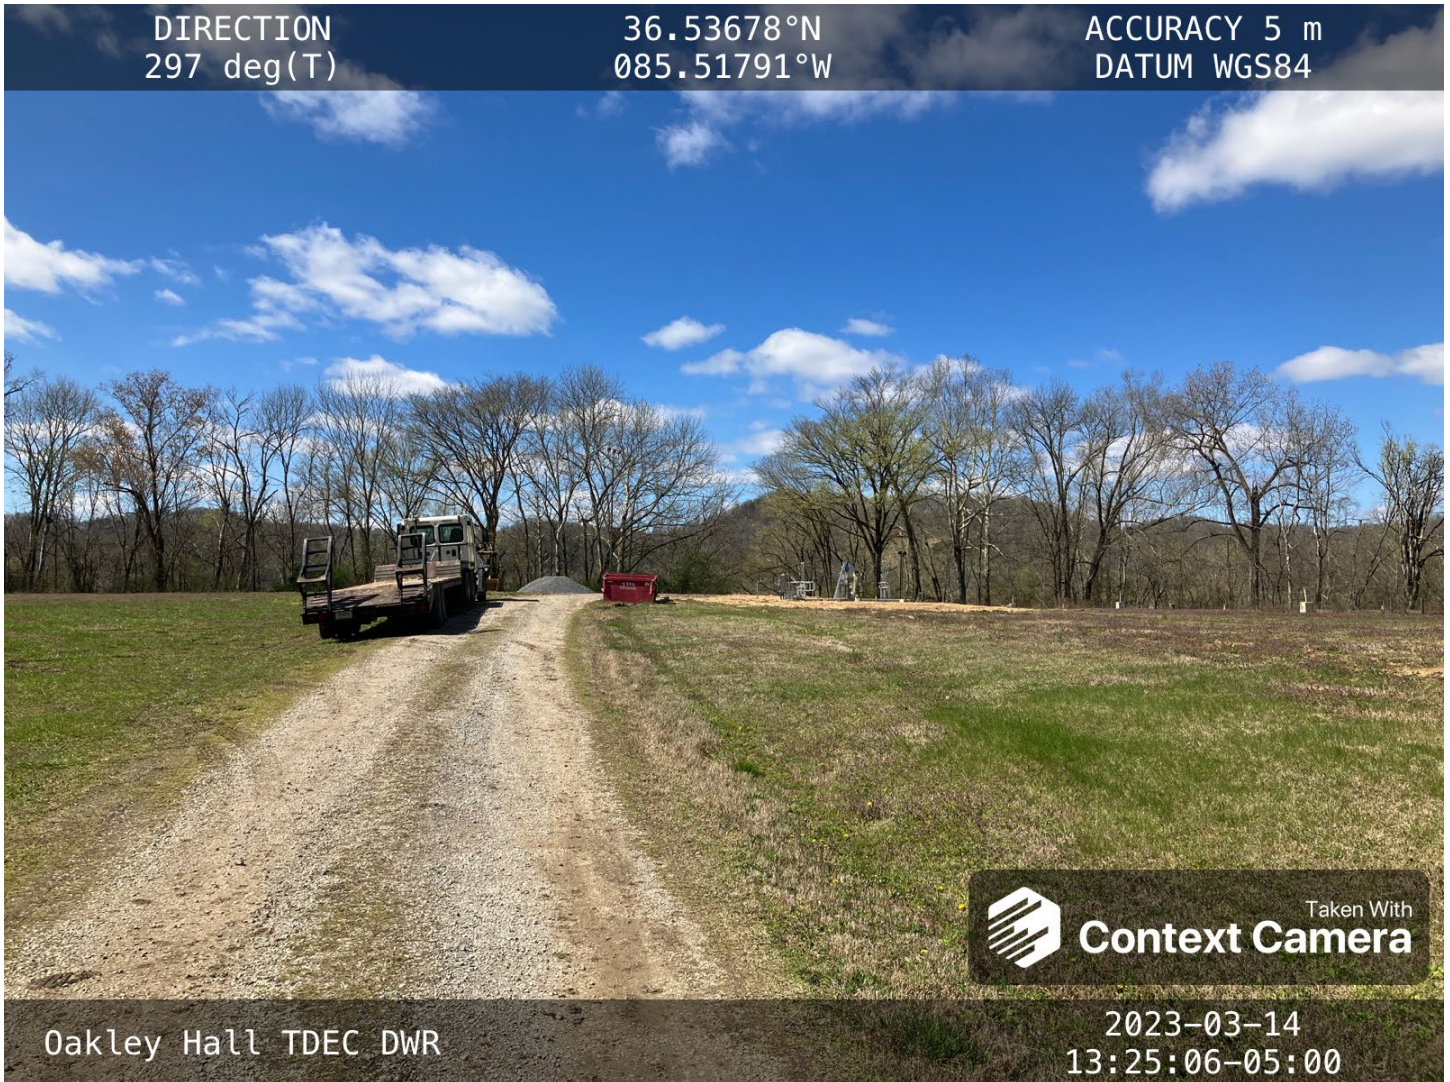
Construction of the mechanical and electrical equipment is mostly complete. The entrance road is in good condition.

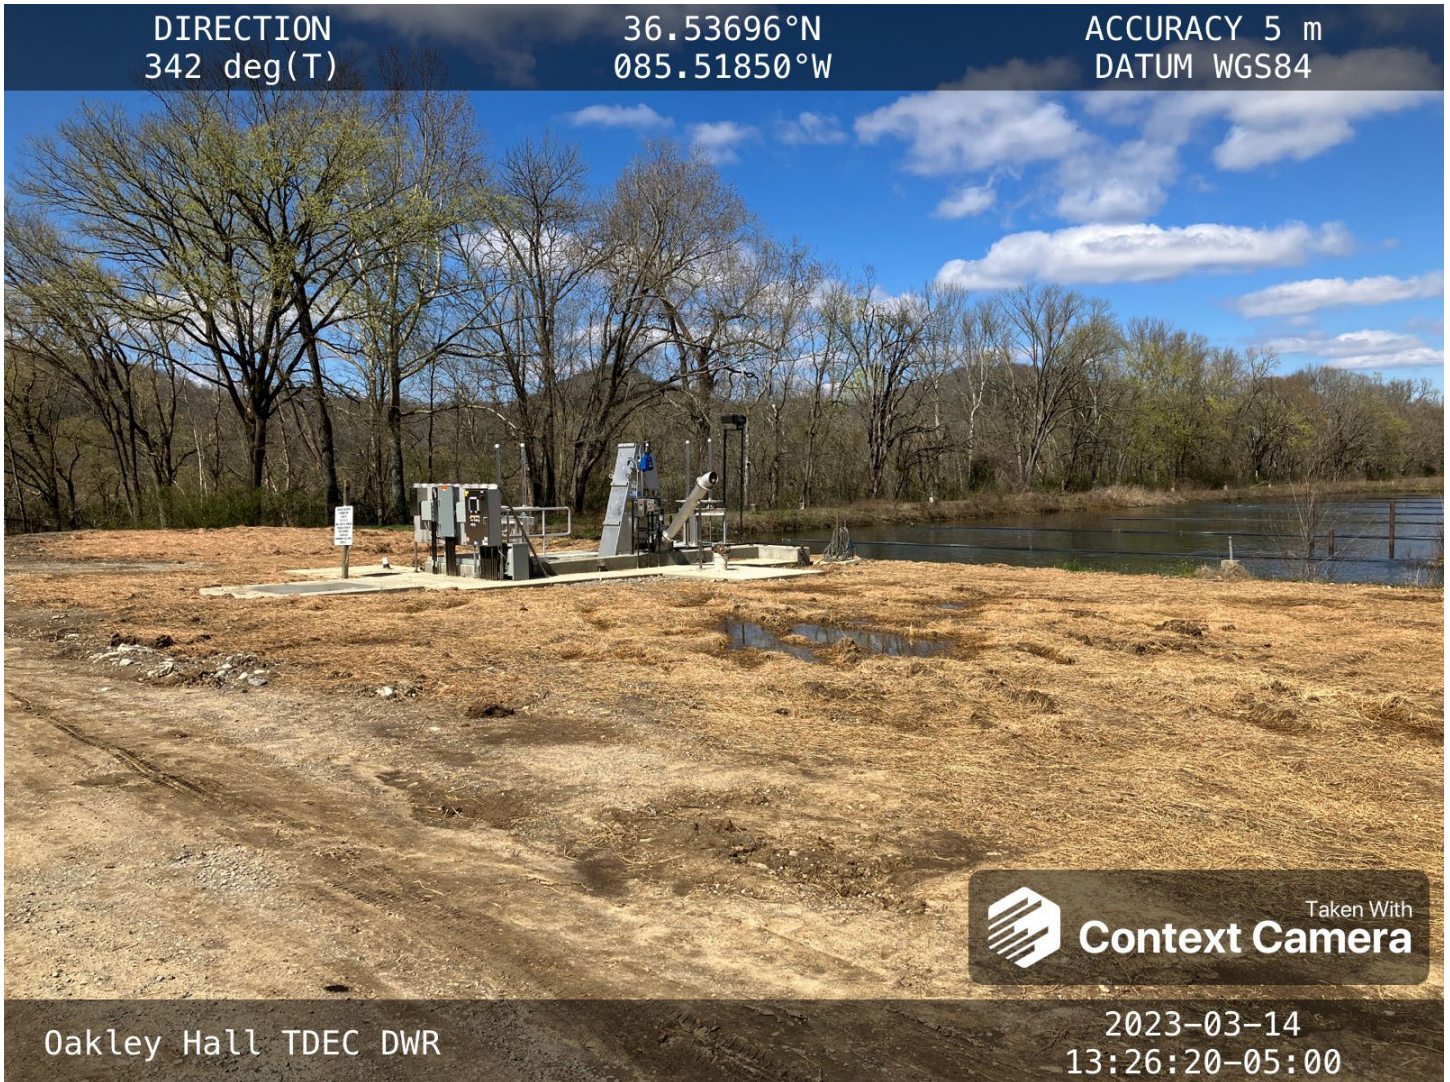
The soil around the new headworks is wet. Some final landscaping is needed. Cleaning solids out of the first lagoon is the next major maintenance item to be completed.

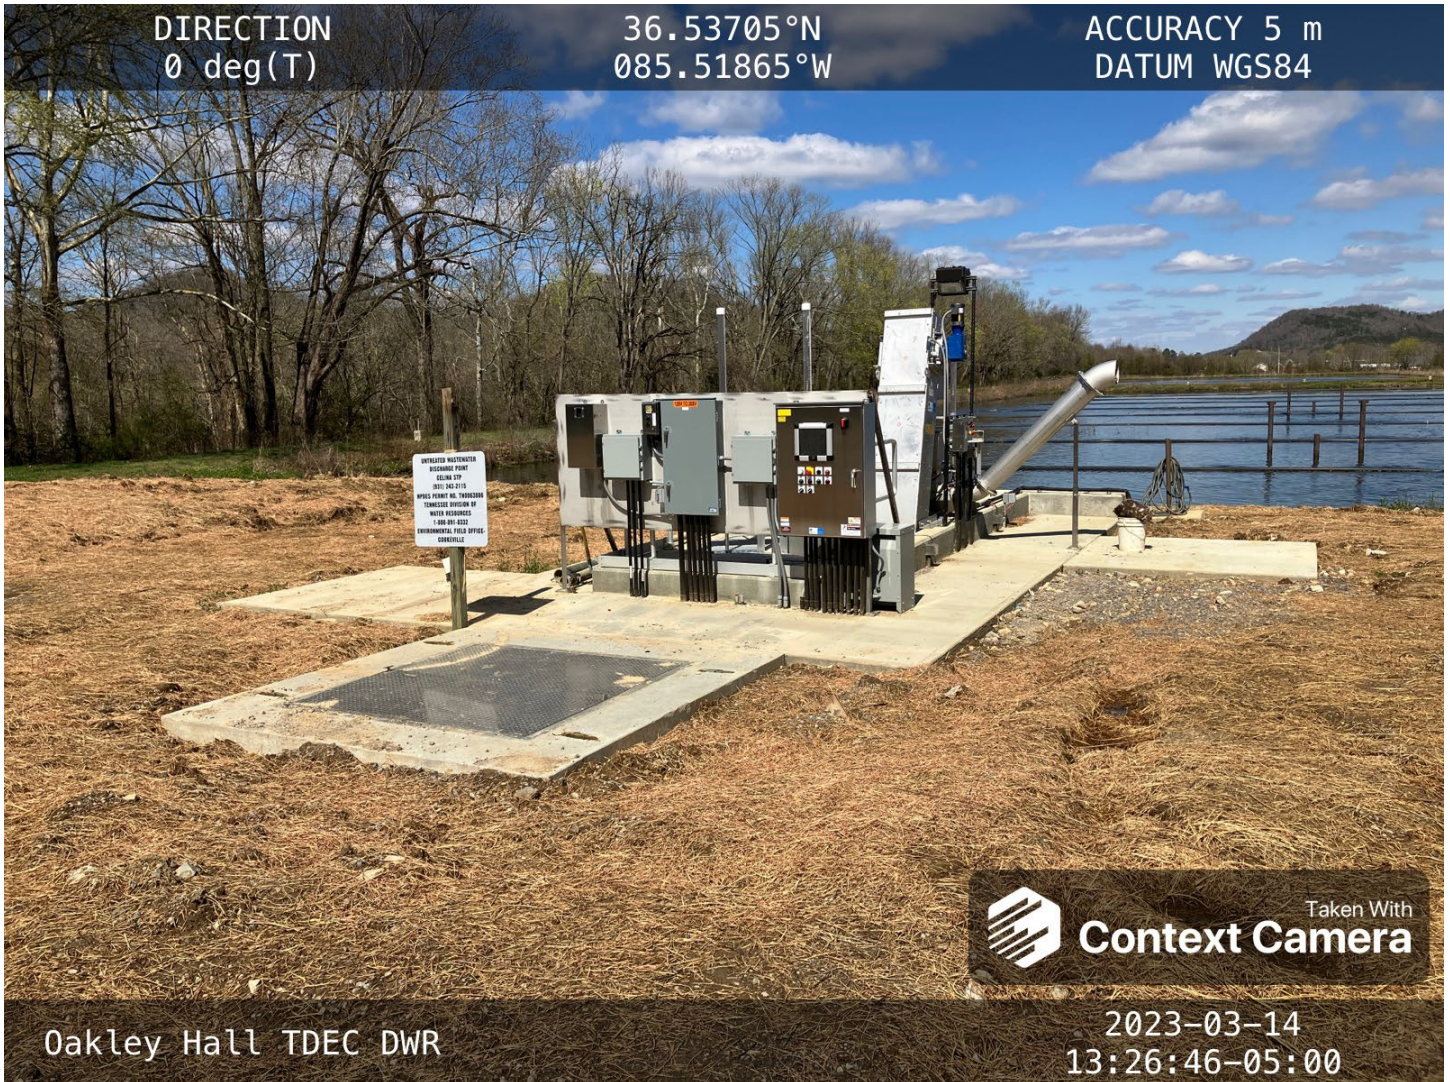
The headworks have been completed. The ground around the headworks is soft and a dumpster could not be brought in at this time. It was recommended that a larger wheeled trashcan be used to catch the removed solids until the dumpster can be placed in operation. At the time of this photograph, it would be difficult for a dump truck to maneuver a large dumpster.

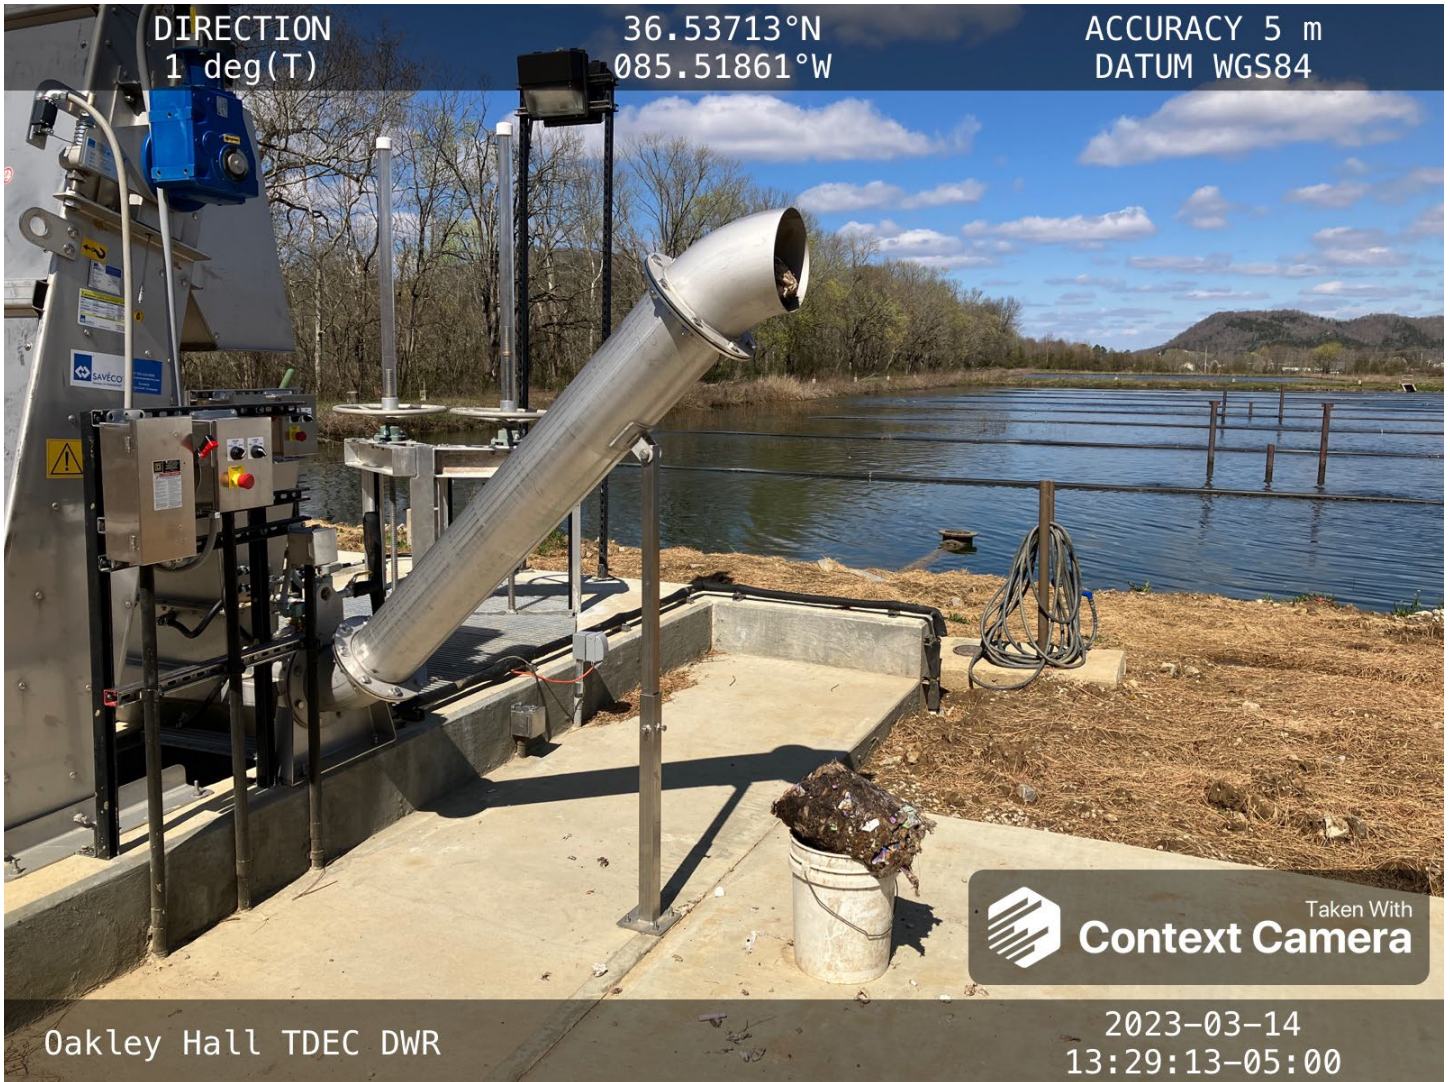
Solids are being removed by the new machinery and pushed out into an undersized 7-gallon bucket.

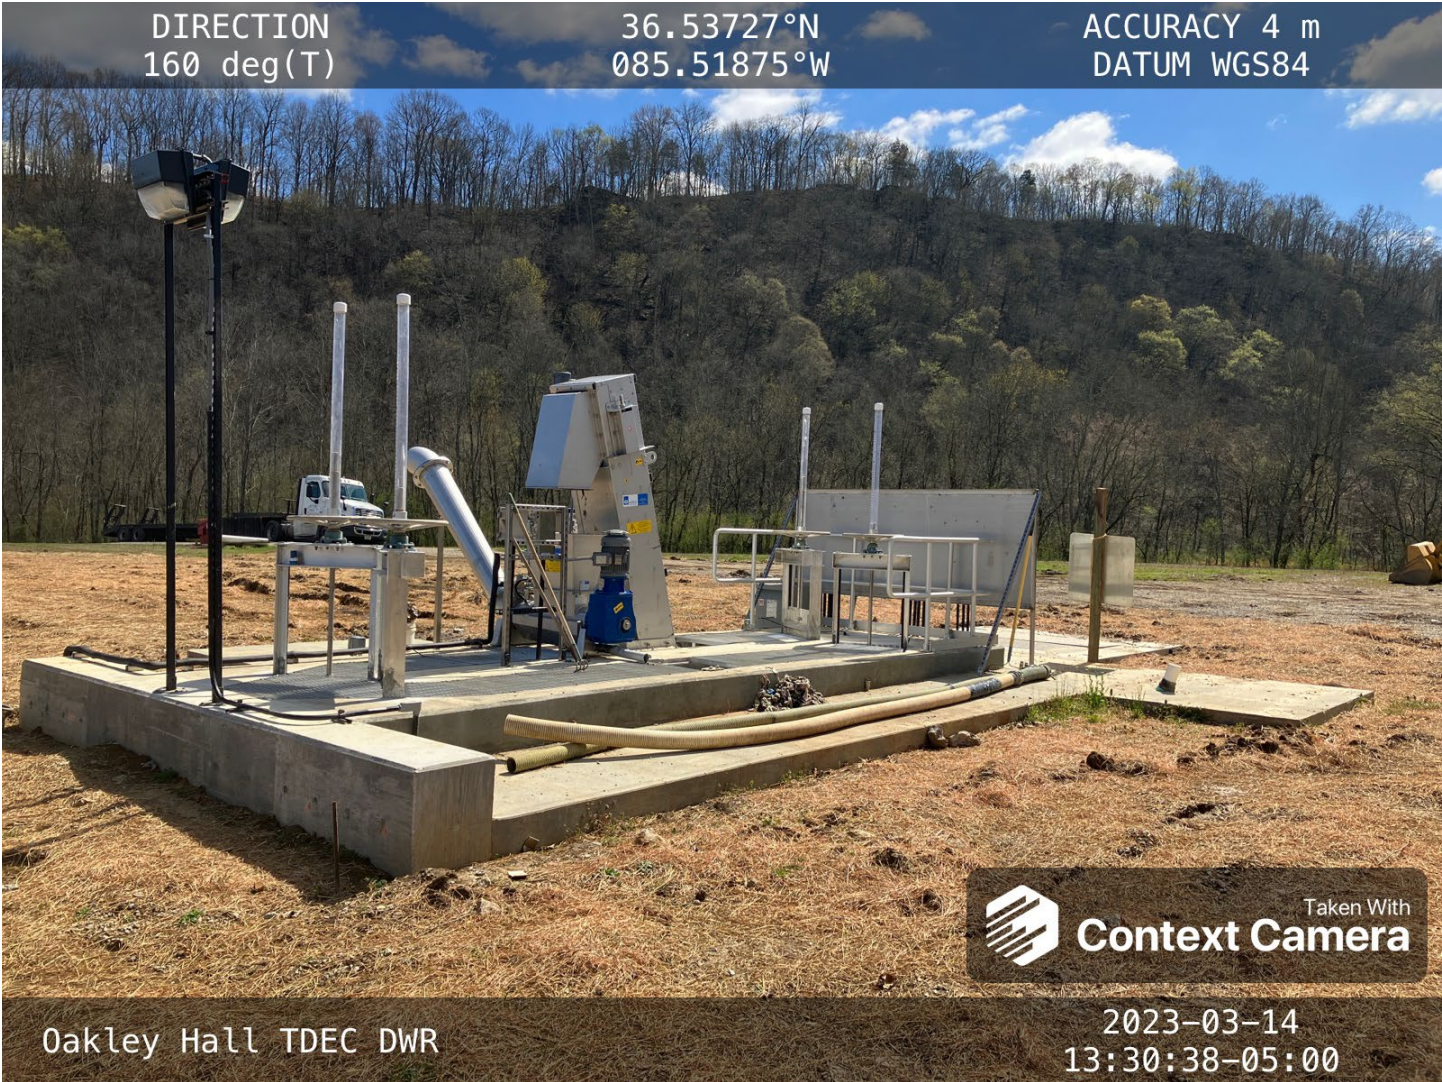
The new headworks is in place. Some landscaping work is still in process.

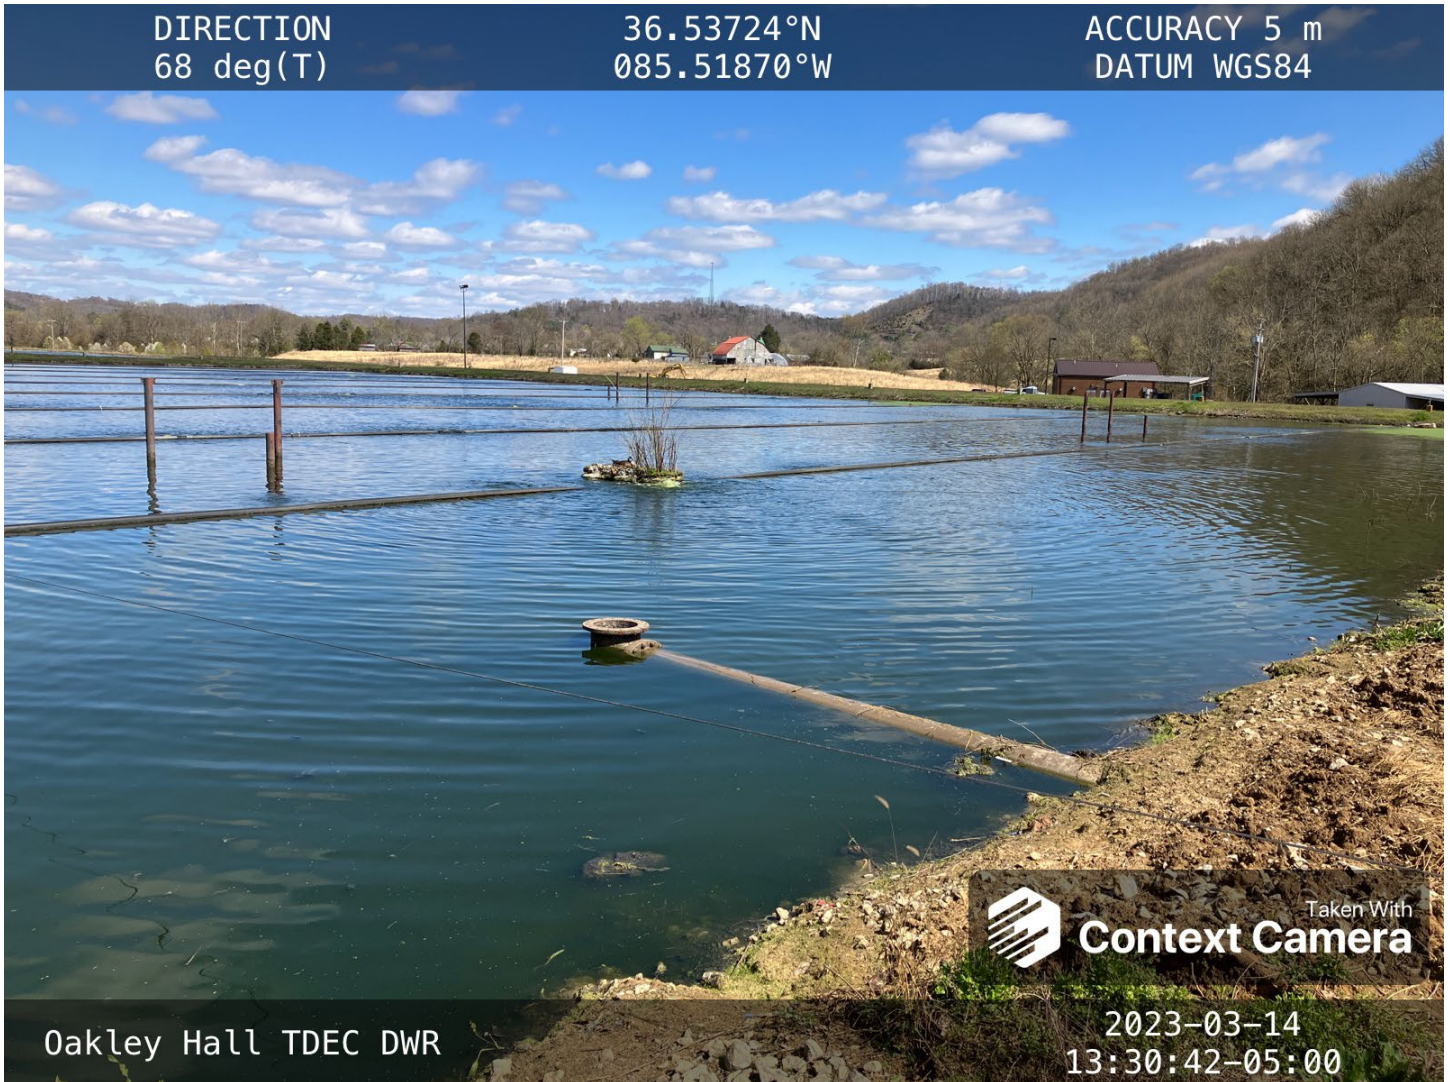
The discharge from the headworks to the first lagoon is pictured. It is entering the lagoon through the bottom of the pipe.
