RE: Compliance Review Meeting, (CRM), May 18, 2023, in Celina
Compliance Evaluation Inspection (CEI), Notice of Violation (NOV)
City of Celina Sewer Treatment System, NPDES # TN0063886

Enclosure: CEI Site Photographs by W. Oakley Hall

City of Celina Sewage Treatment Plant (TN0063886) Compliance Evaluation Inspection, Clay County.

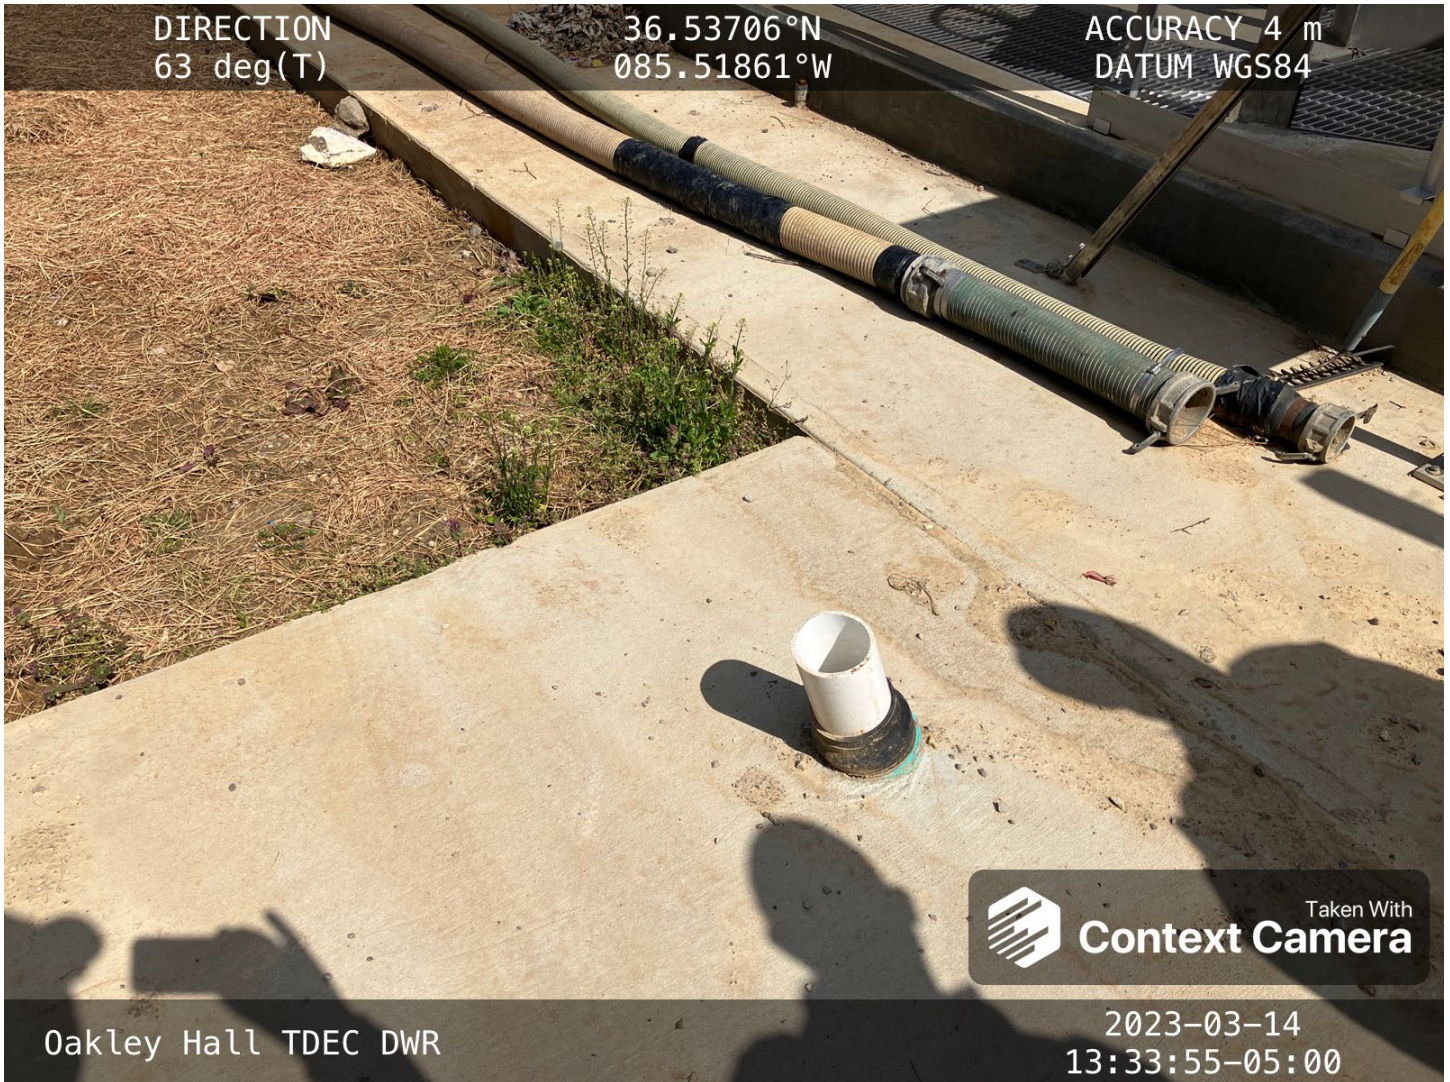
A pipe is configured to add wastewater into the system. This port is after flow measurement and cannot be used to except septage waste brought in from offsite, e.g., marina or septic tank waste. This port should be capped.

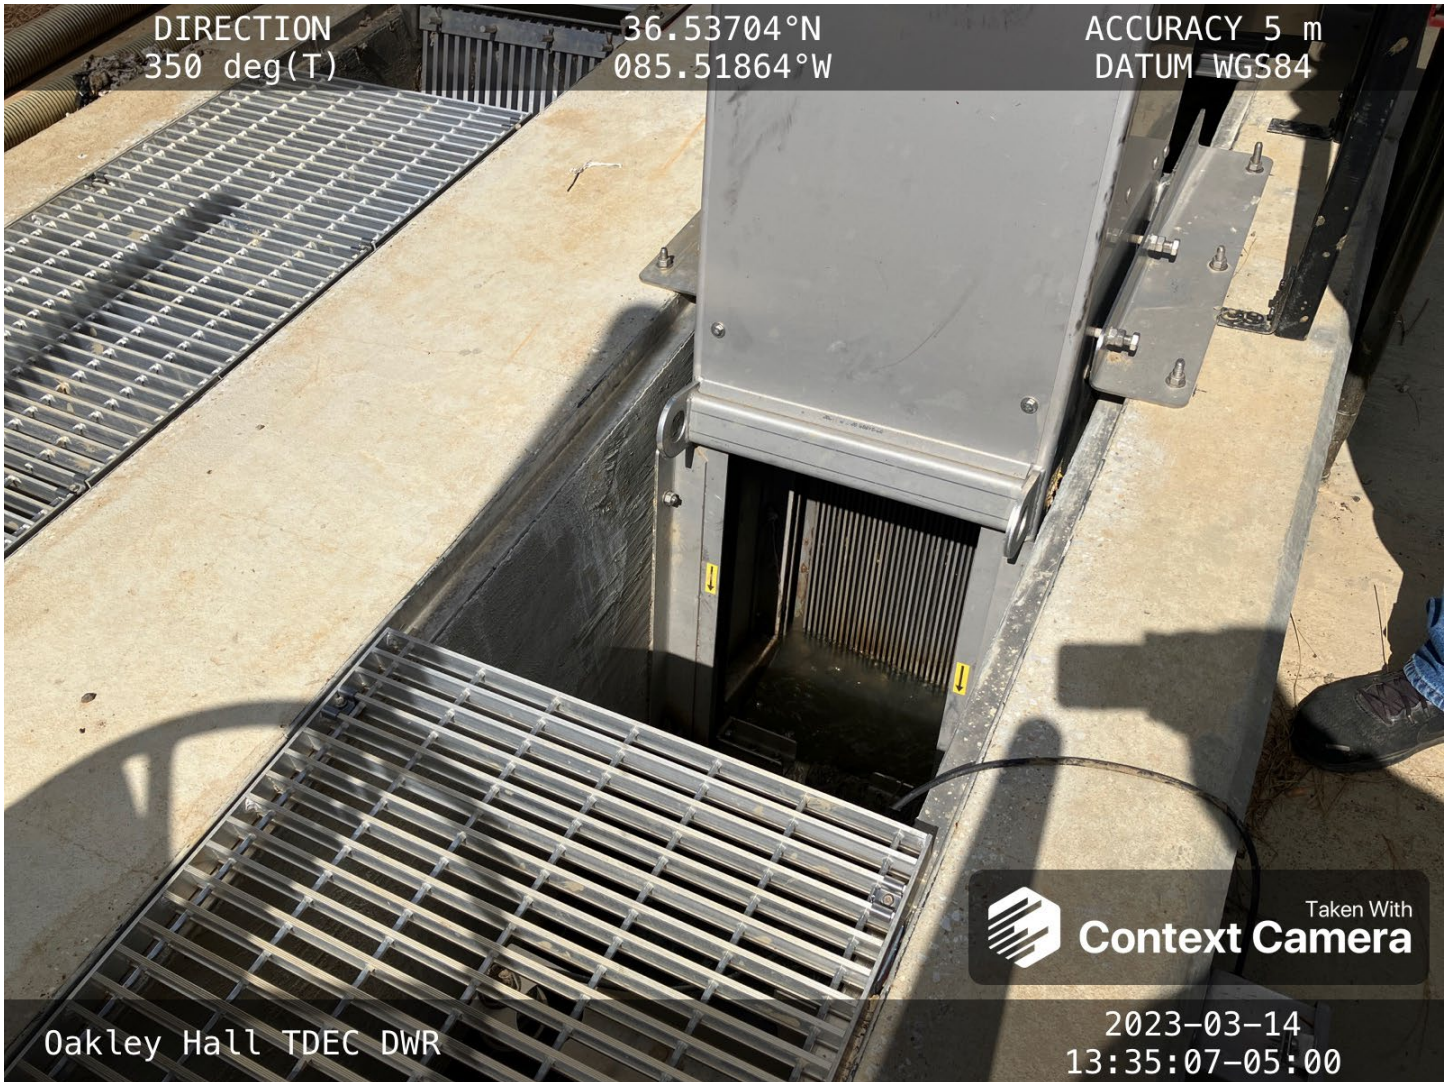
The screens were operable. This was an important improvement to the system.

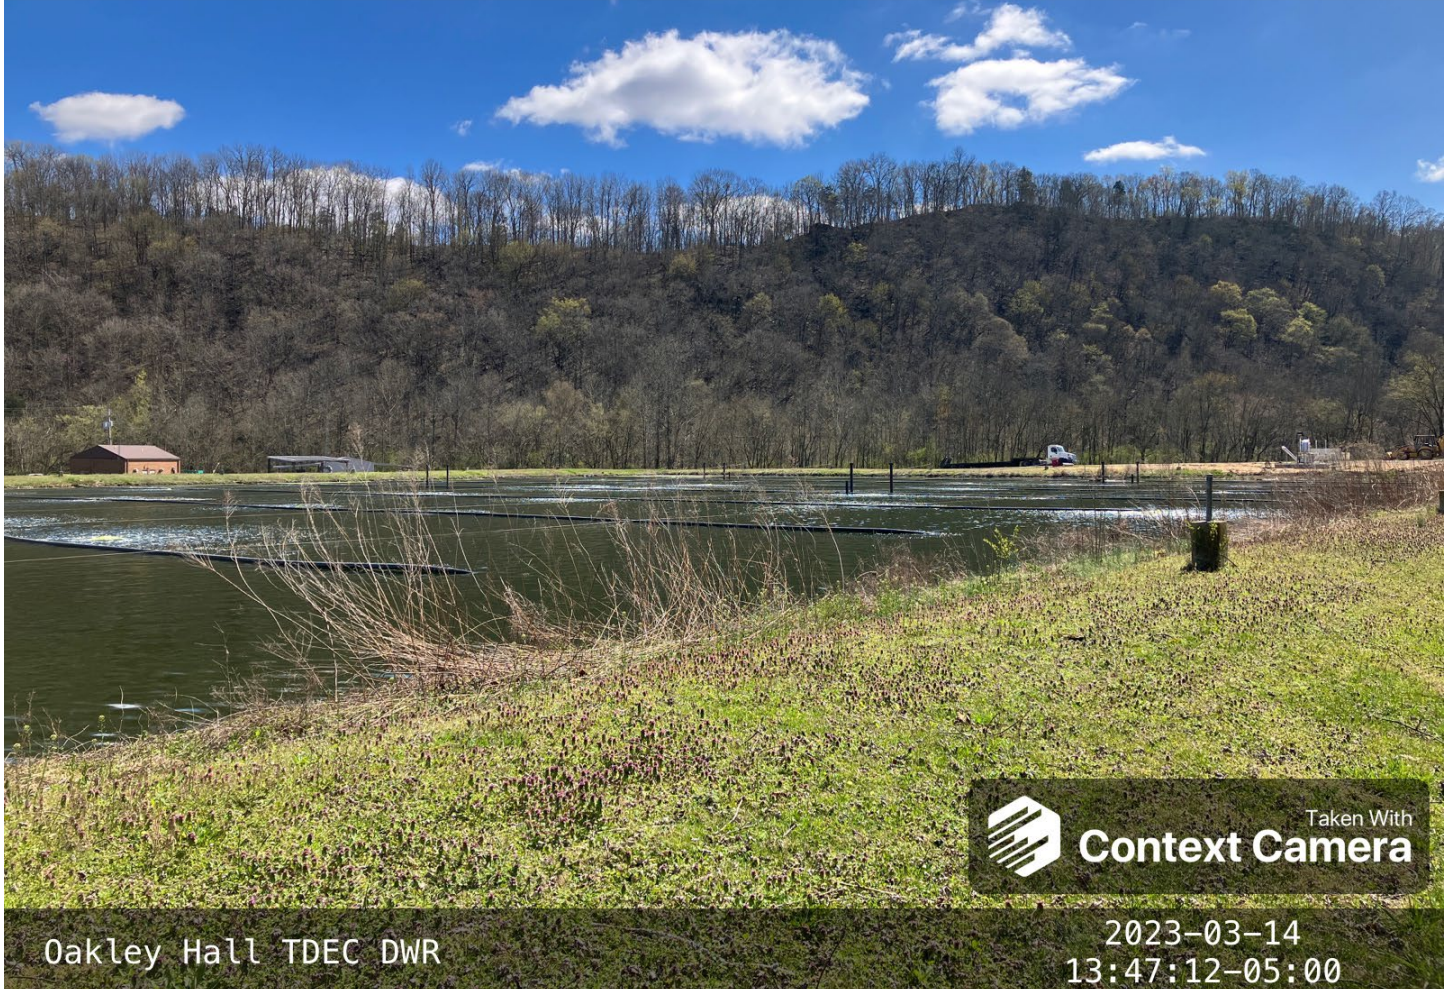
The first pond or lagoon is reported to be 7 feet deep while the final two ponds are reportedly 5 feet in depth. The removal of solids in the ponds will likely help to improve some pH issues that are seasonally occurring at the facility. Solids removal will be needed throughout the service life of this sewer treatment works. Solids removal has been discussed in previous inspections along with preparation for the associated cost. Plans for the removal of solids were discussed as an associated plan for a bypass valve of the first pond is being considered. The bleach system was

Aeration is pictured across the first lagoon. The aeration is to be inspected and improved when the sludge/solids are removed from this pond.

- ✓ Report sewer collection system overflows as required by the NPDES permit.
- ✓ Determine the sludge depth in all three ponds and develop a zone map illustrating the levels. Estimate the solids volume in each pond to be removed. Develop a plan for disposal of the solids. It is understood that this plan is currently under development with your consulting engineering firm.

- ✓ Starting with the first pond, provide an updated timely plan for the removal of the solids from the three ponds.
- ✓ Complete the block work in the chlorine contact chamber.

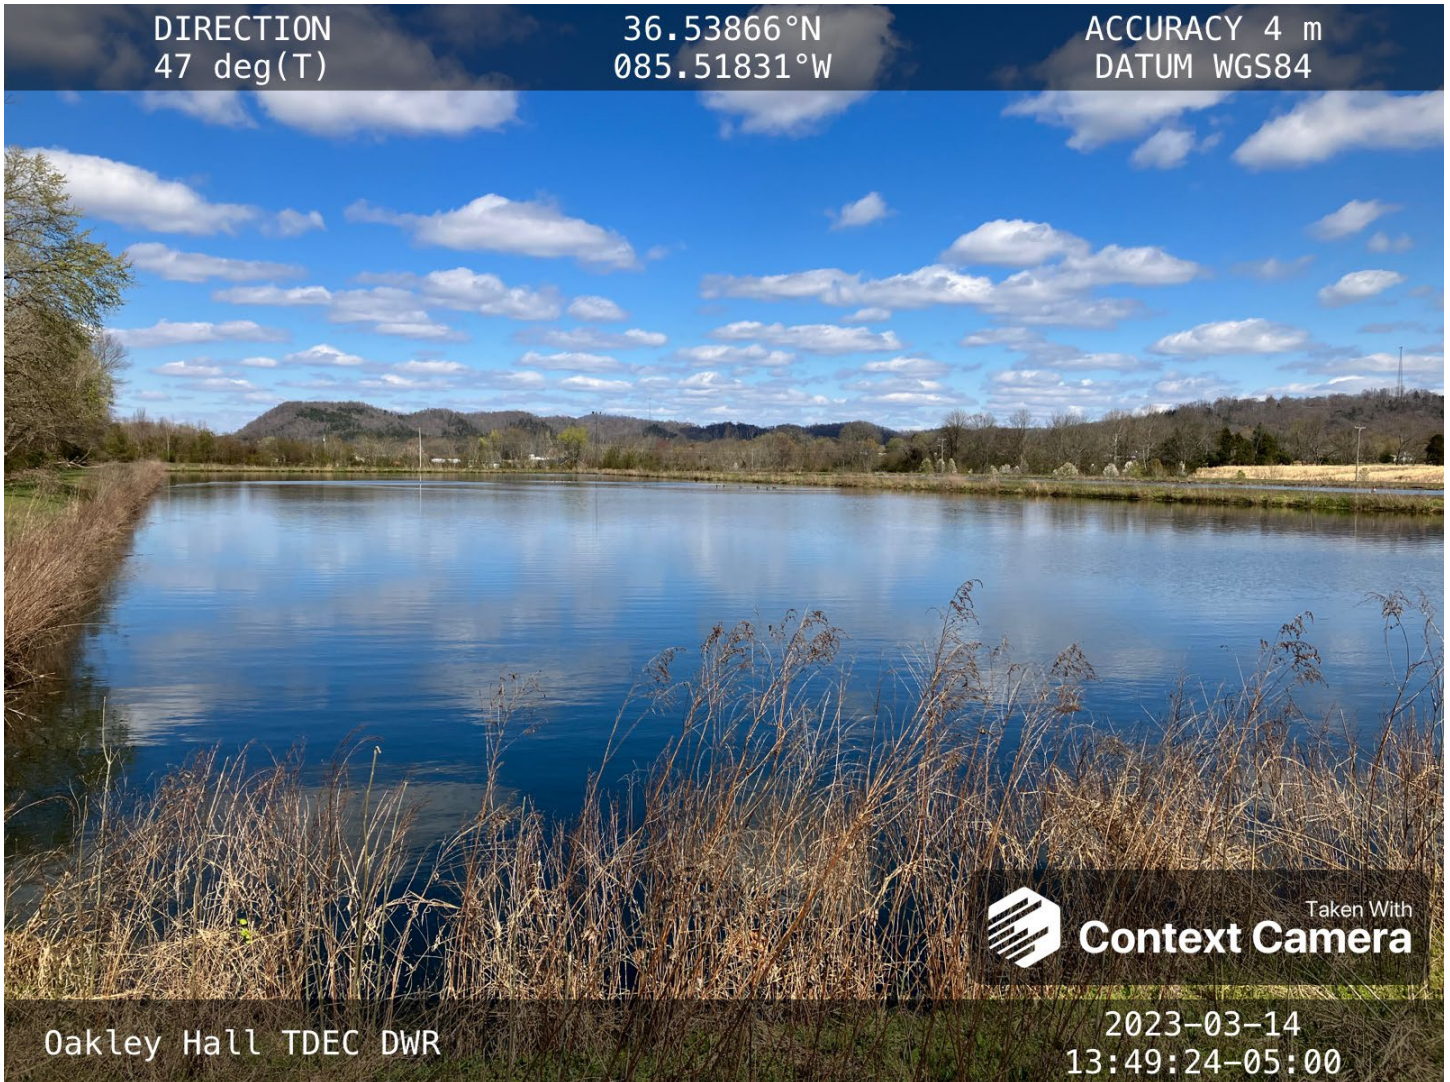
The second of the three ponds in a series is pictured. It is to be inspected for the solids level. Solids are to be removed to improve the effluent discharge of the system.

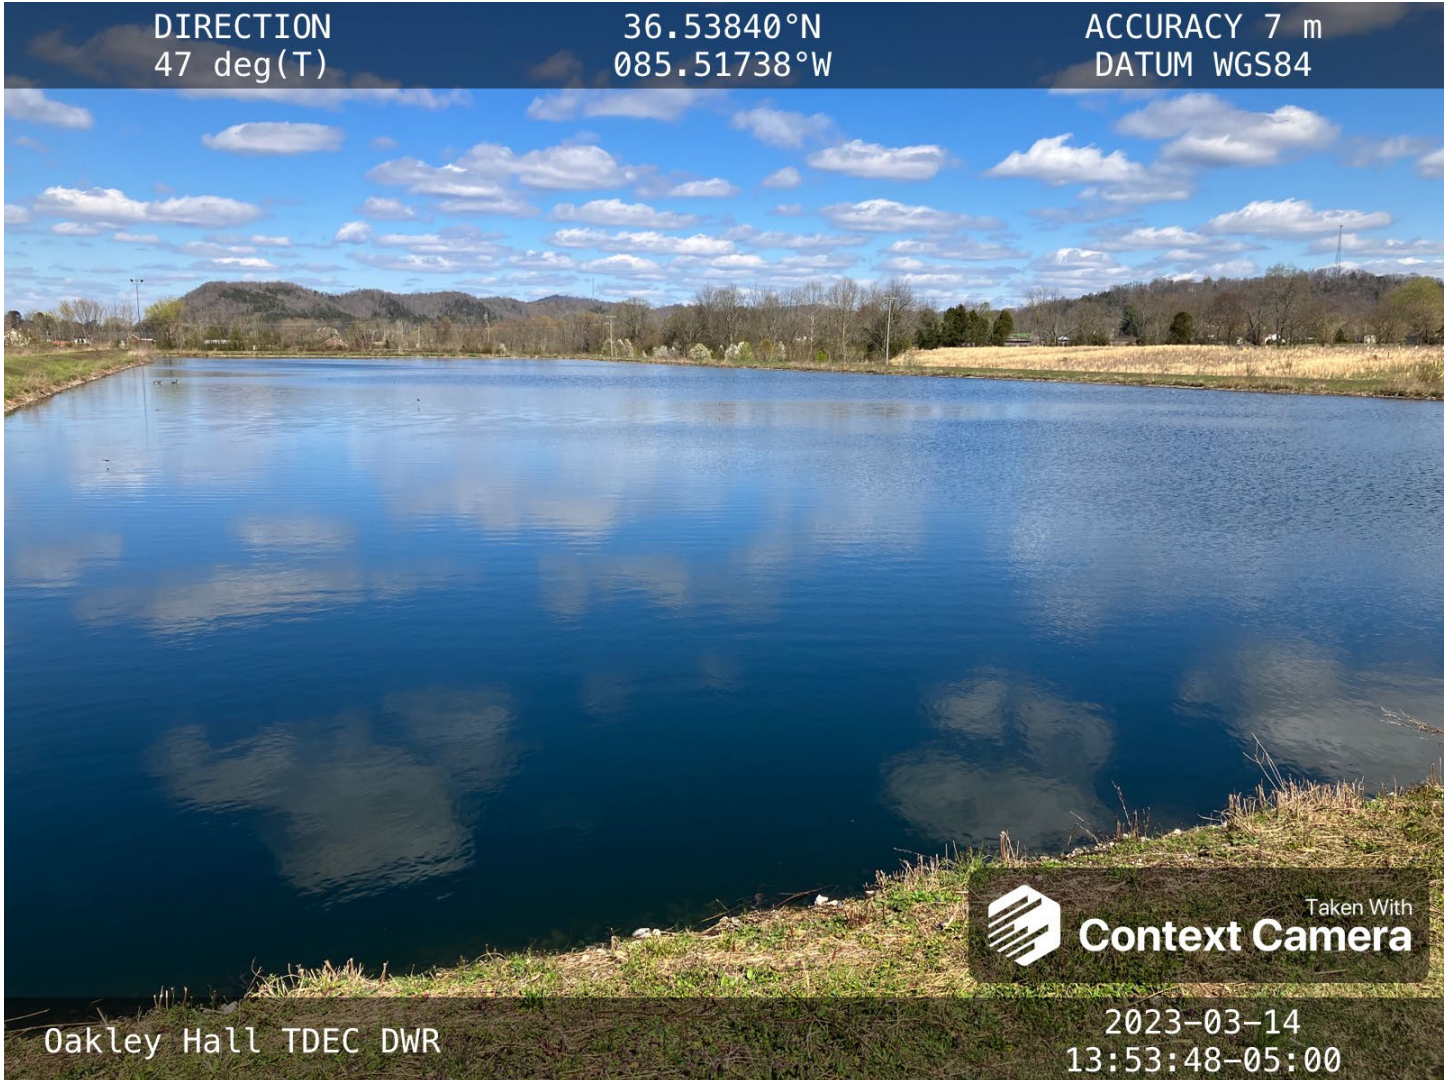
The third lagoon of the three in the series is pictured. Various wild birds were using the lagoon. Algae was present in the water column. This lagoon is to be inspected for sludge/solids depth.

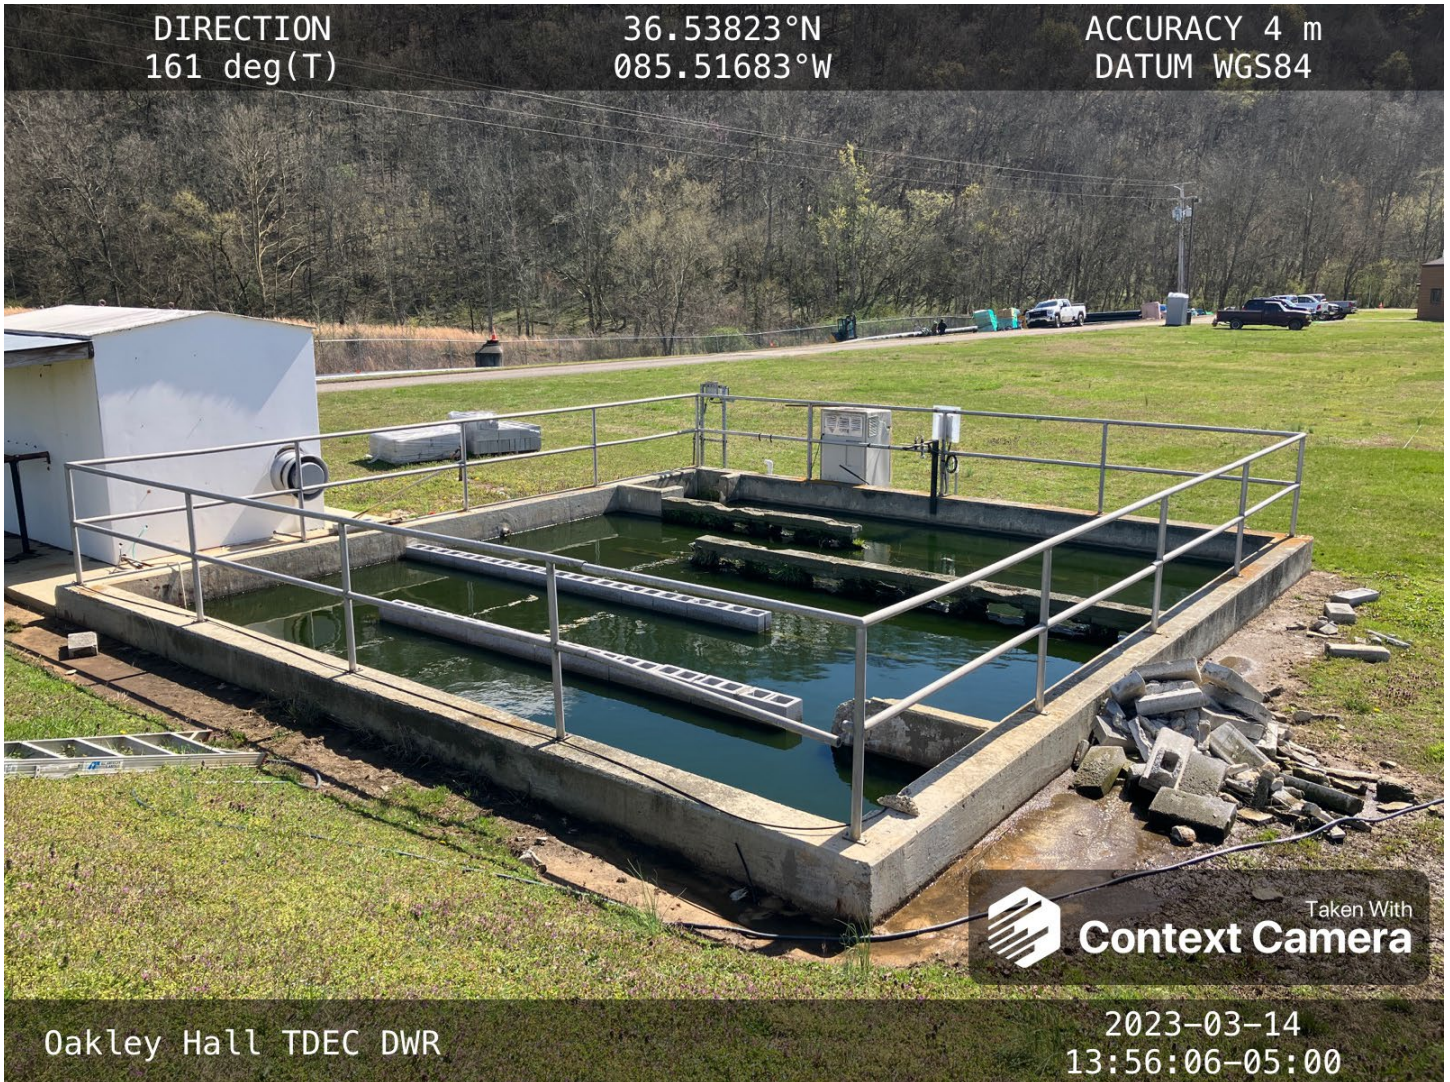
Operators have started the block work on the chlorine contact chamber. Mortar has only been tested on a few of the block.

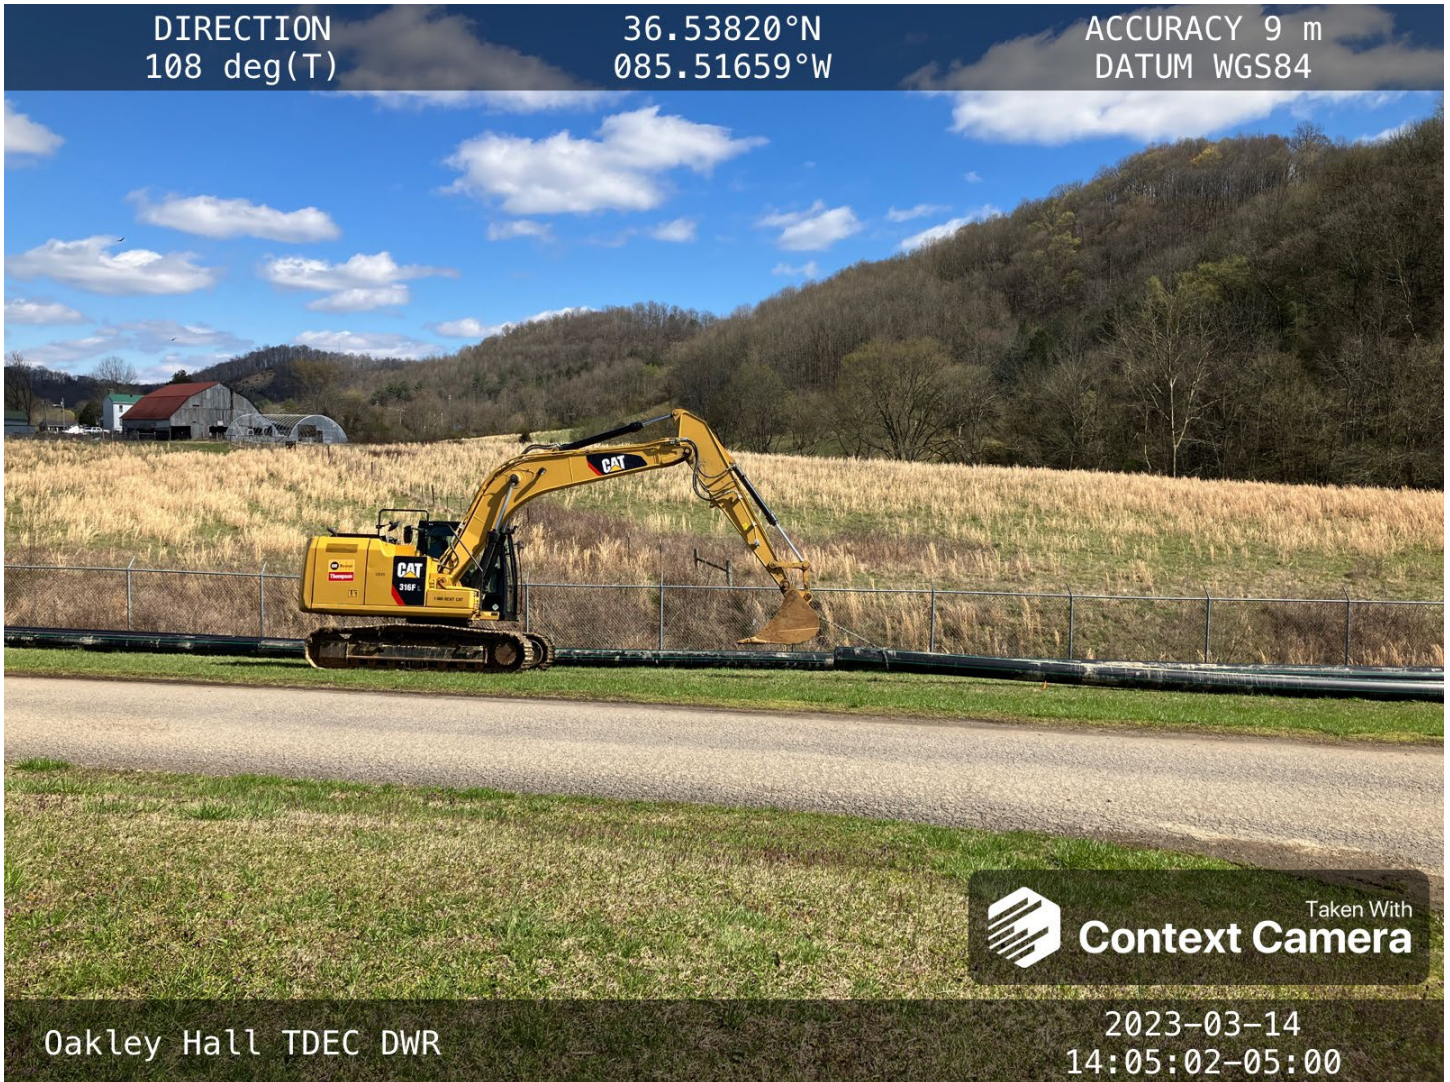
Pipe bursting is to begin on the influent line from the city. The joining of the plastic pipeline was reviewed. The line is in place, being staged for installation.

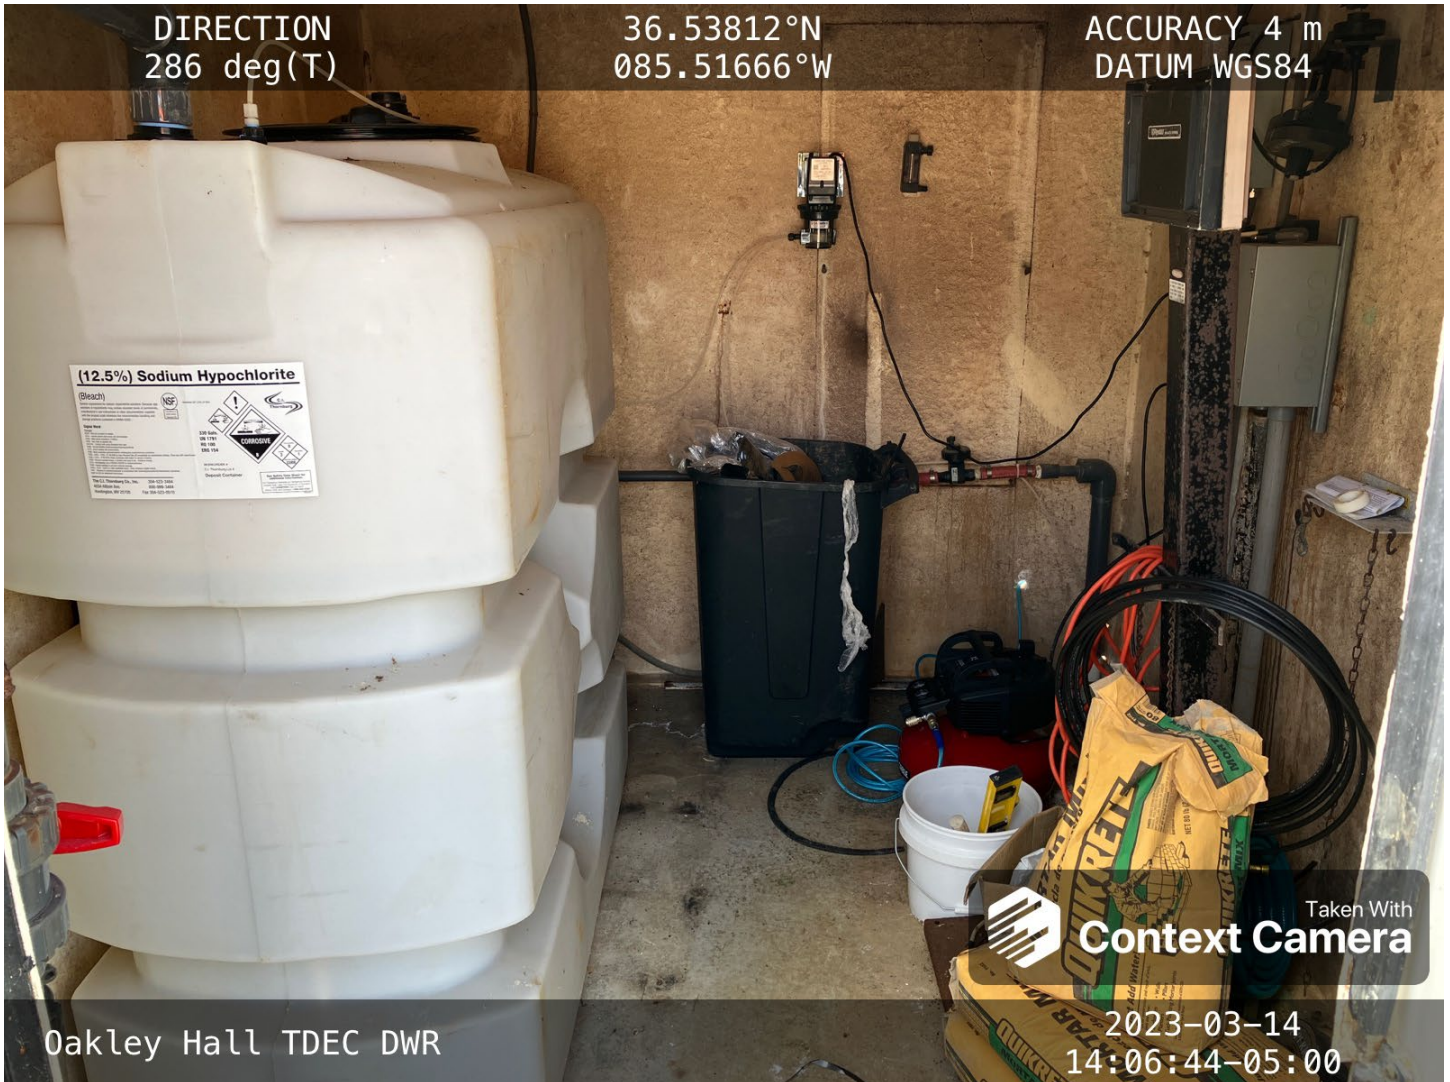
The bleach tanks and dosing pump were reviewed and found to be in operation.

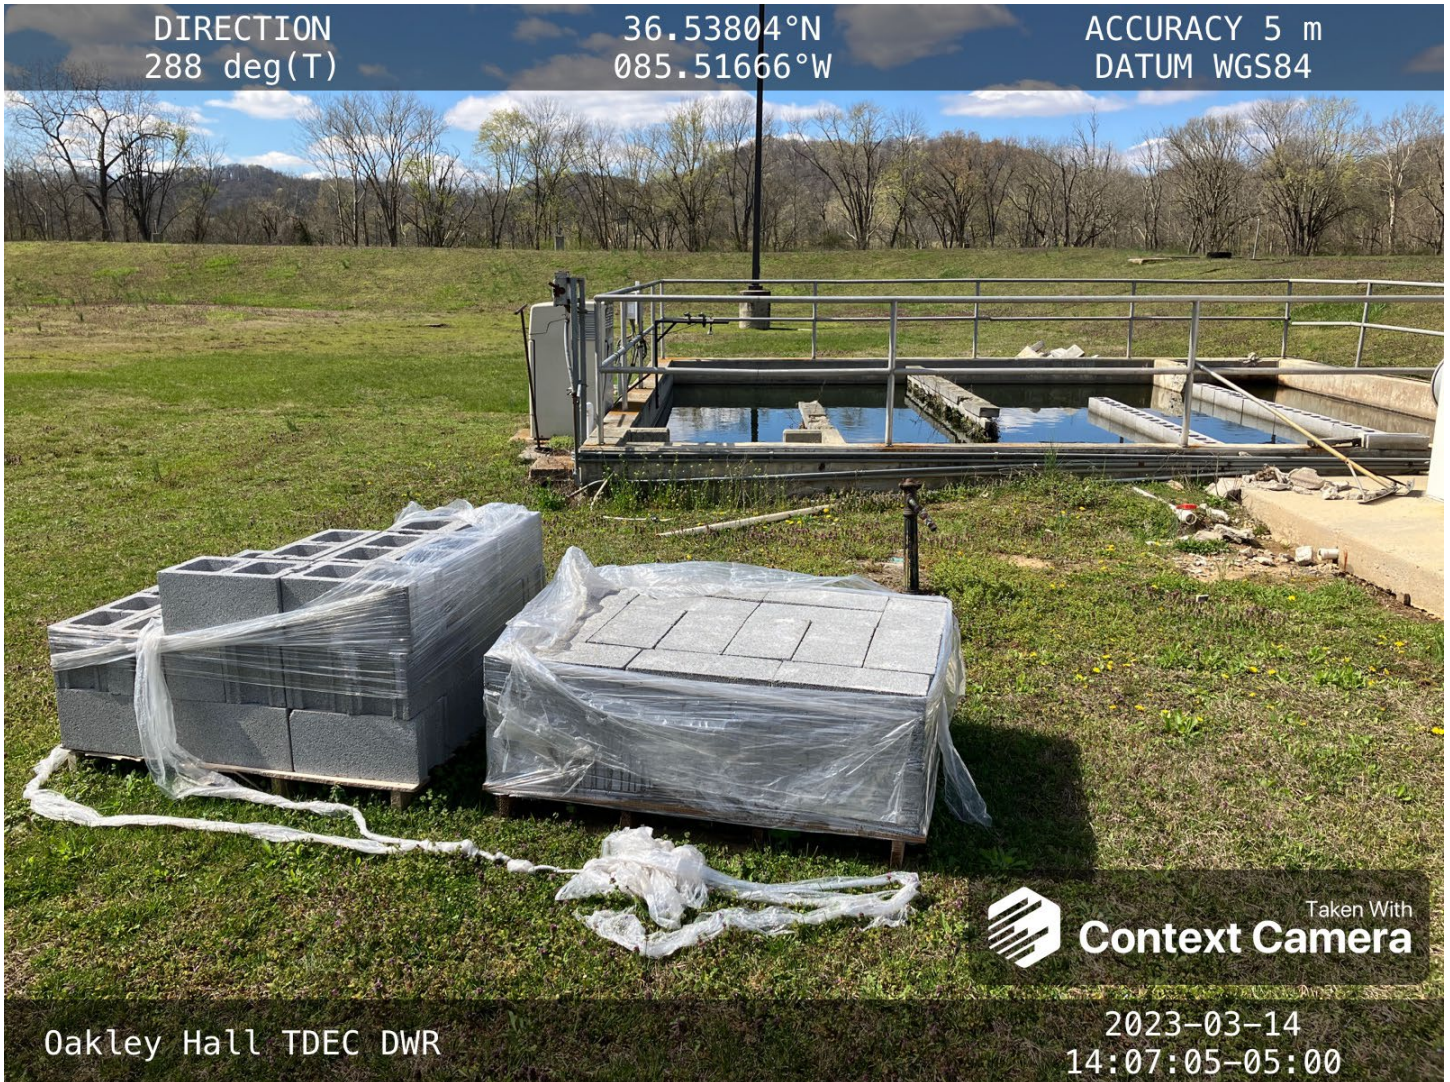
Block work is being prepared for the Chlorine Contact Chamber. Some block has been laid, most with no mortar This was explained by the operator so to see how the process is going to work out.

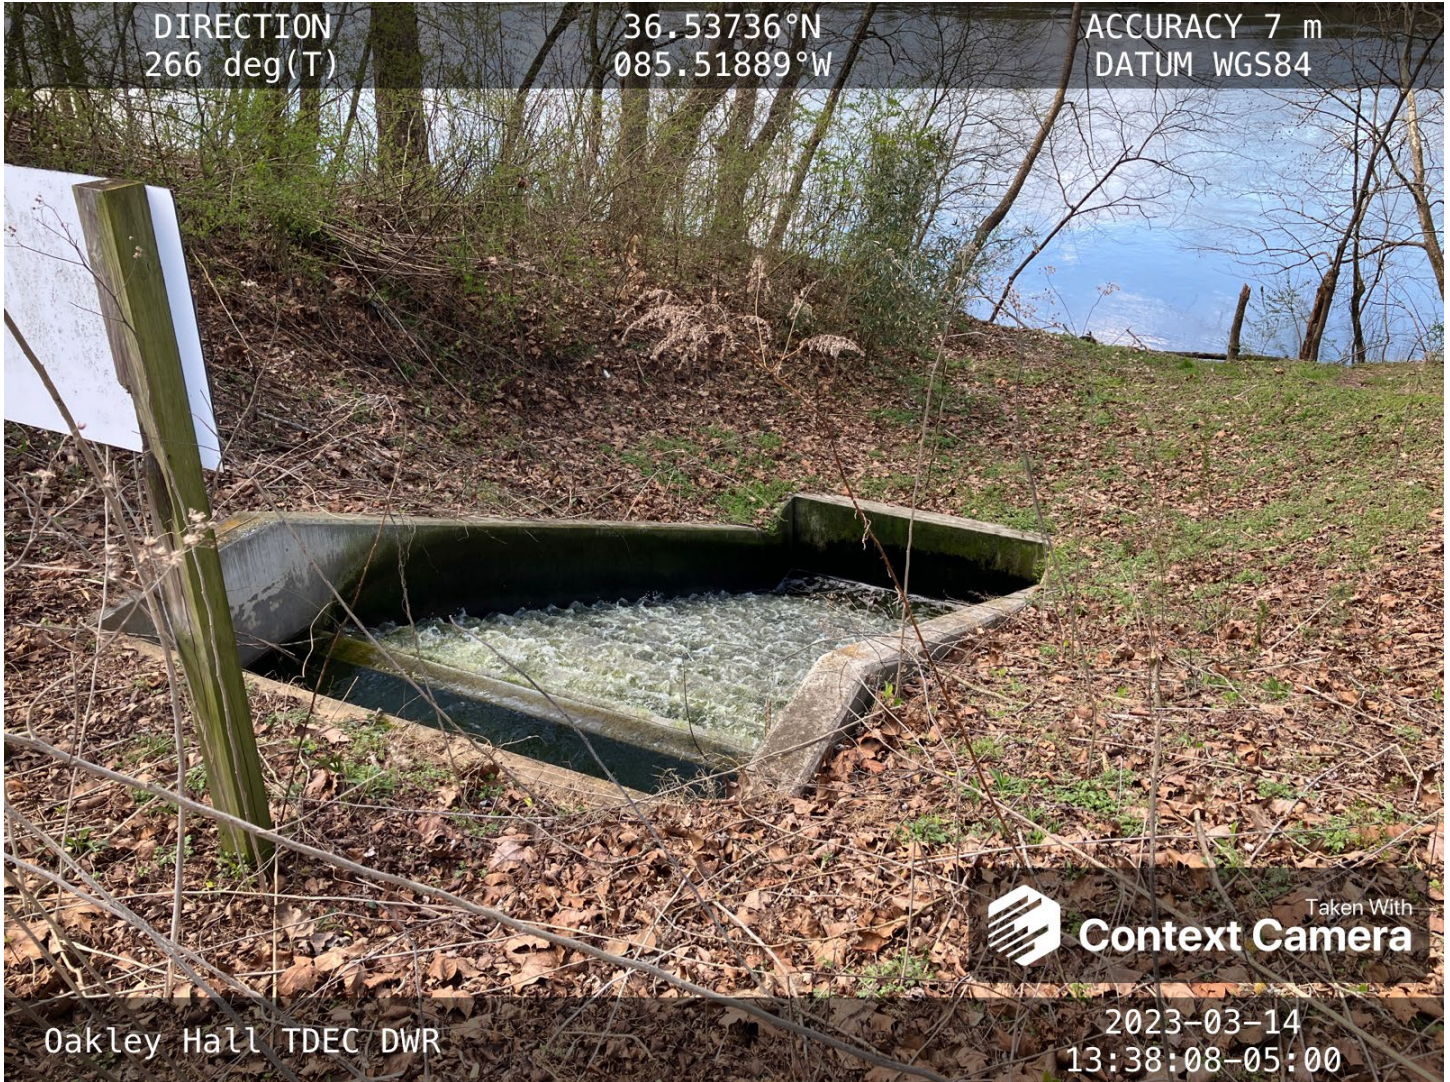
The effluent outfall to the Cumberland River is pictured.

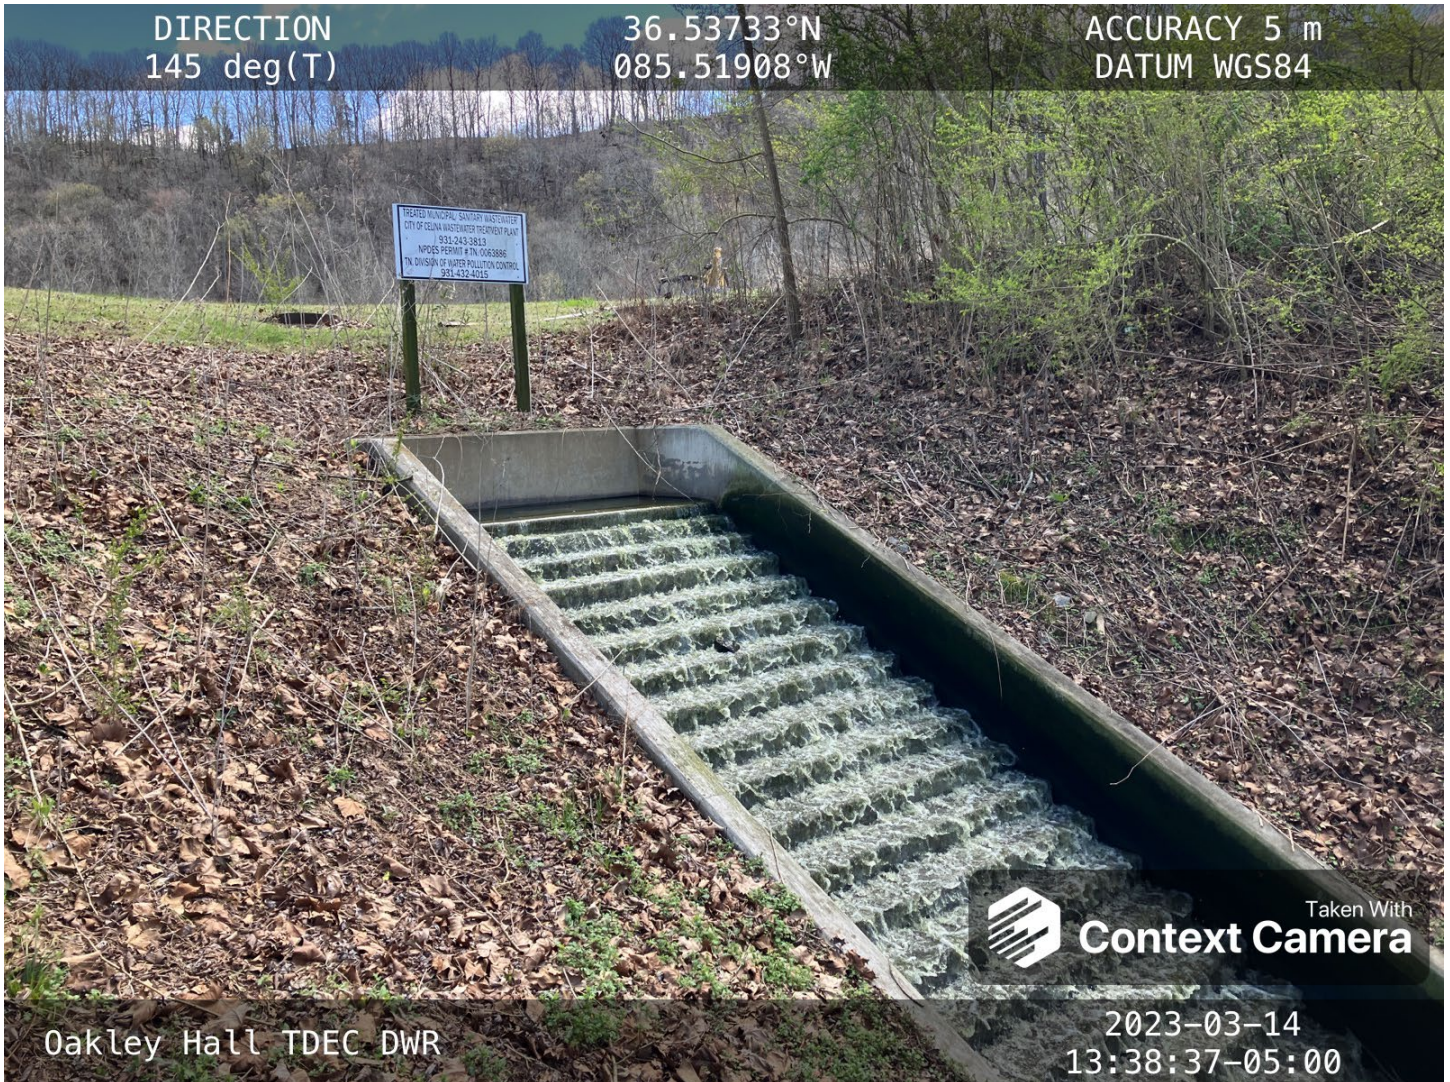
The effluent aeration steps are pictured (just above the outfall). A slight green color from algae was observed.

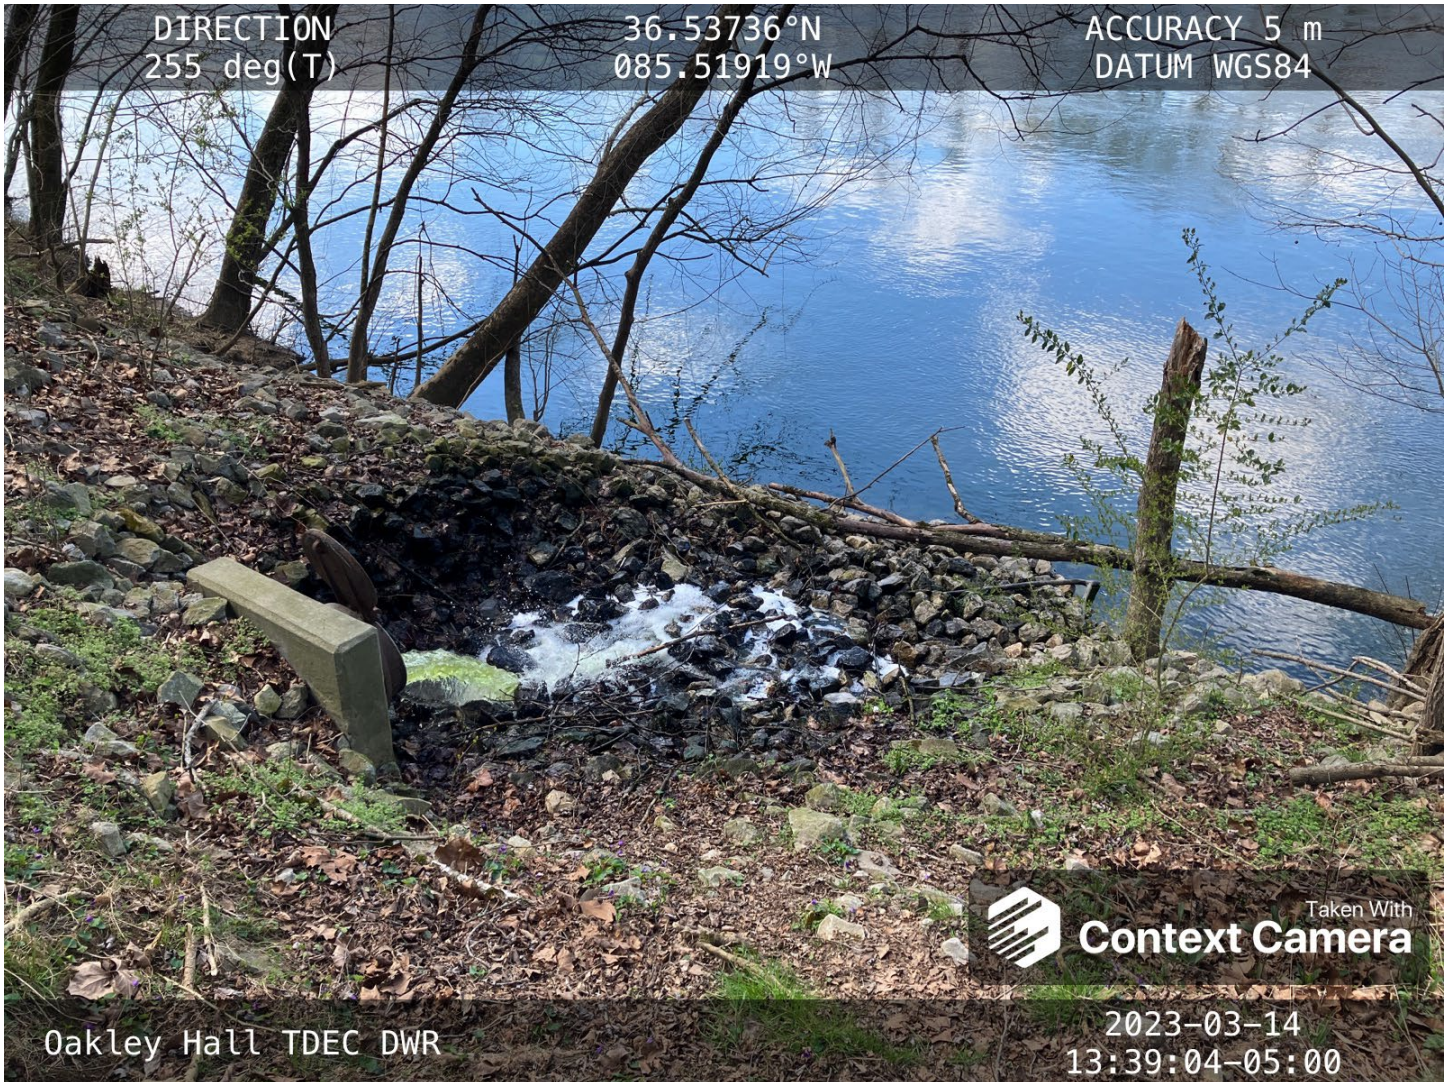
The effluent outfall is pictured. It is entering the Cumberland River. A color contrast was not observed in the river. Foam was not present in the outfall into the Cumberland River.
