Mining Facility Inspection Report

Inspection start date and time: March 27, 2023 10:30 AM

NPDES permit number: TN0070408

Landslide at TN0070408
Alden Resources, LLC - Area 6

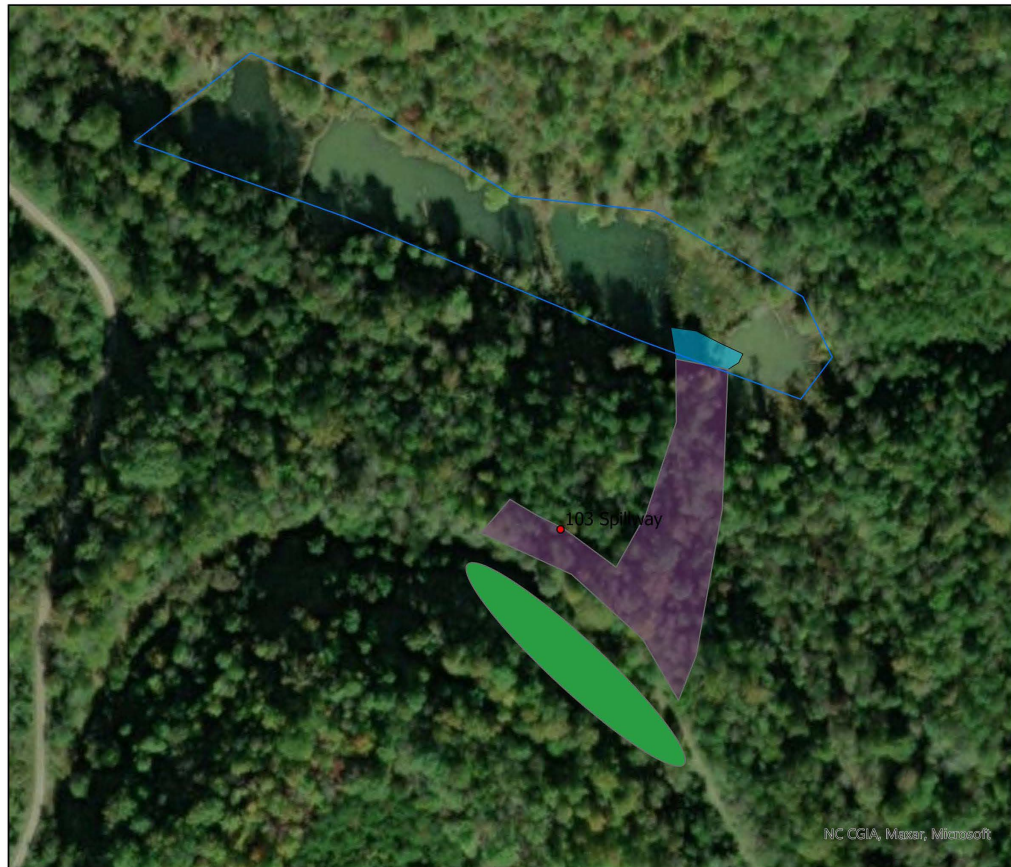
Item 1. Map of affected area. This map is an approximation of the slide area. The slide area is represented in purple, with the portion impacting the jurisdictional feature in blue.

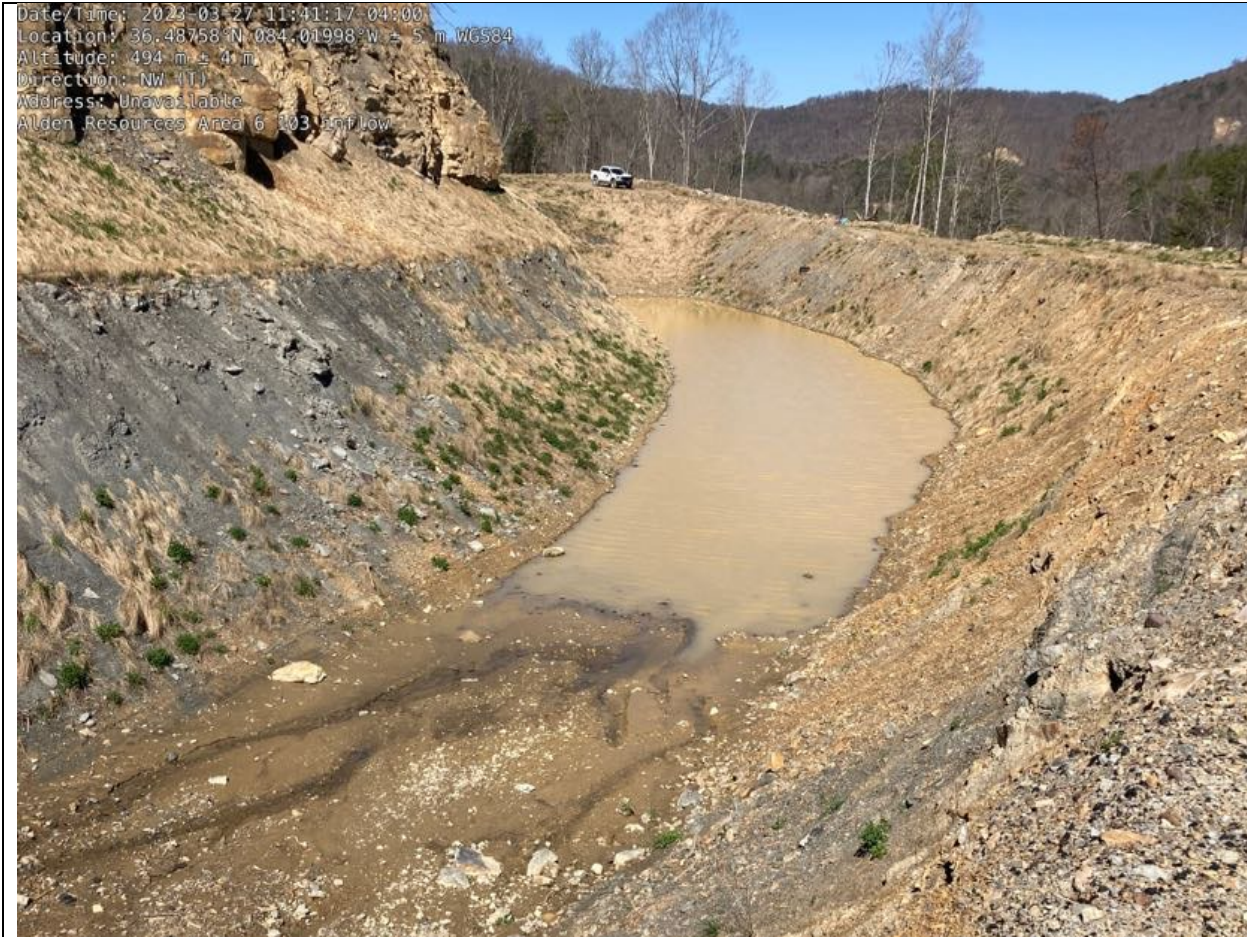
36.48758, -84.01998 2023/03/227

At the time of inspection pond 103 was receiving inflow but was not discharging. This condition was previously documented in an inspection on 8/22/22. Approximately 60 ft below the haulroad elevation and 30 ft below the pond floor water was seeping out of the pond outslope in the landslide area. These factors indicate that the pond floor was leaking, sending water laterally to the outslope and saturating the outslope, likely causing the landslide.

Item 2: Photo of pond 103. The pond was receiving storm water at the time of inspection but not discharging, indicating the pond is leaking. This was documented on the previous inspection conducted 8/22/2022.

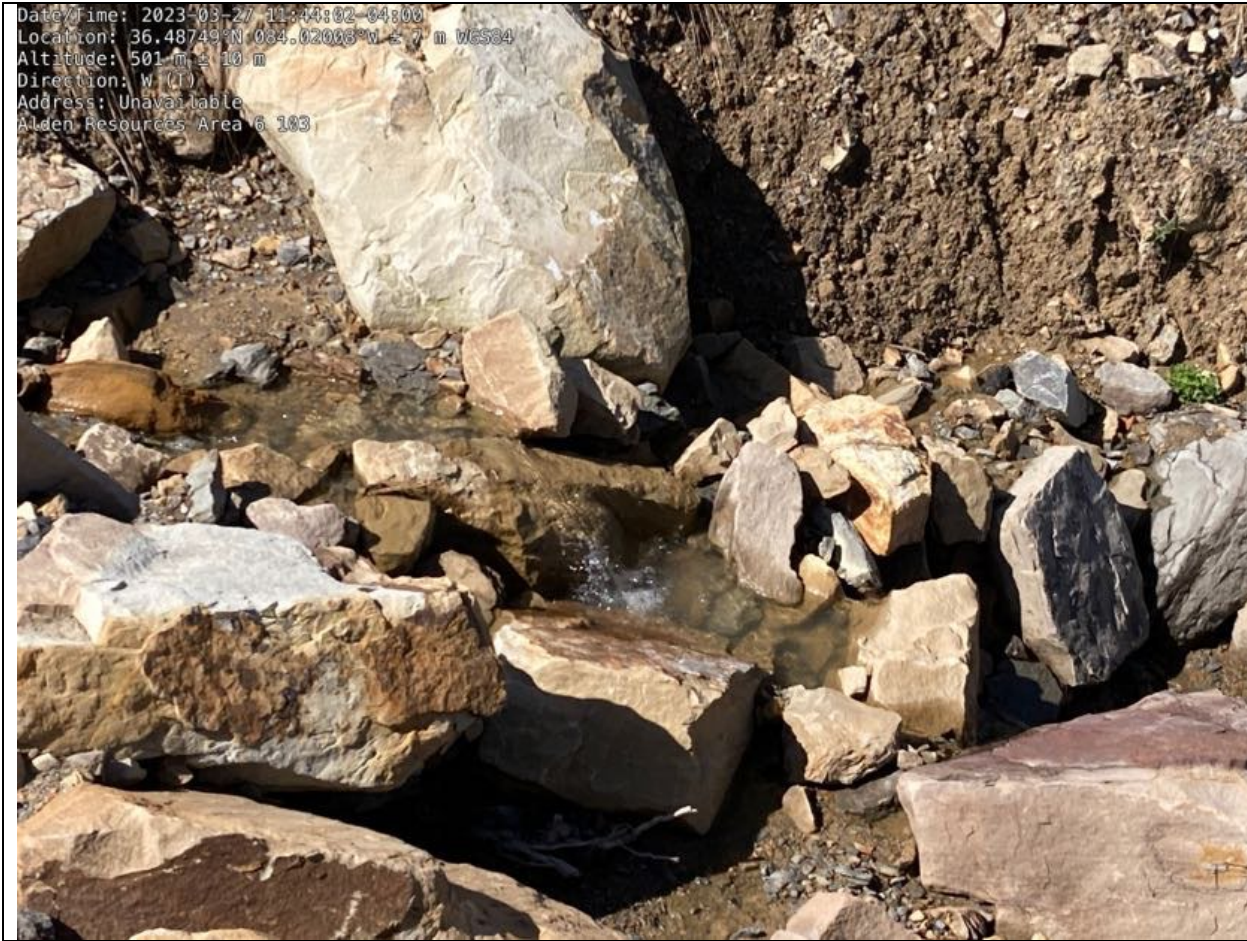
36.48749, -84.02008 2023/03/27

Item 3: Pond 103 receiving storm water inflow.

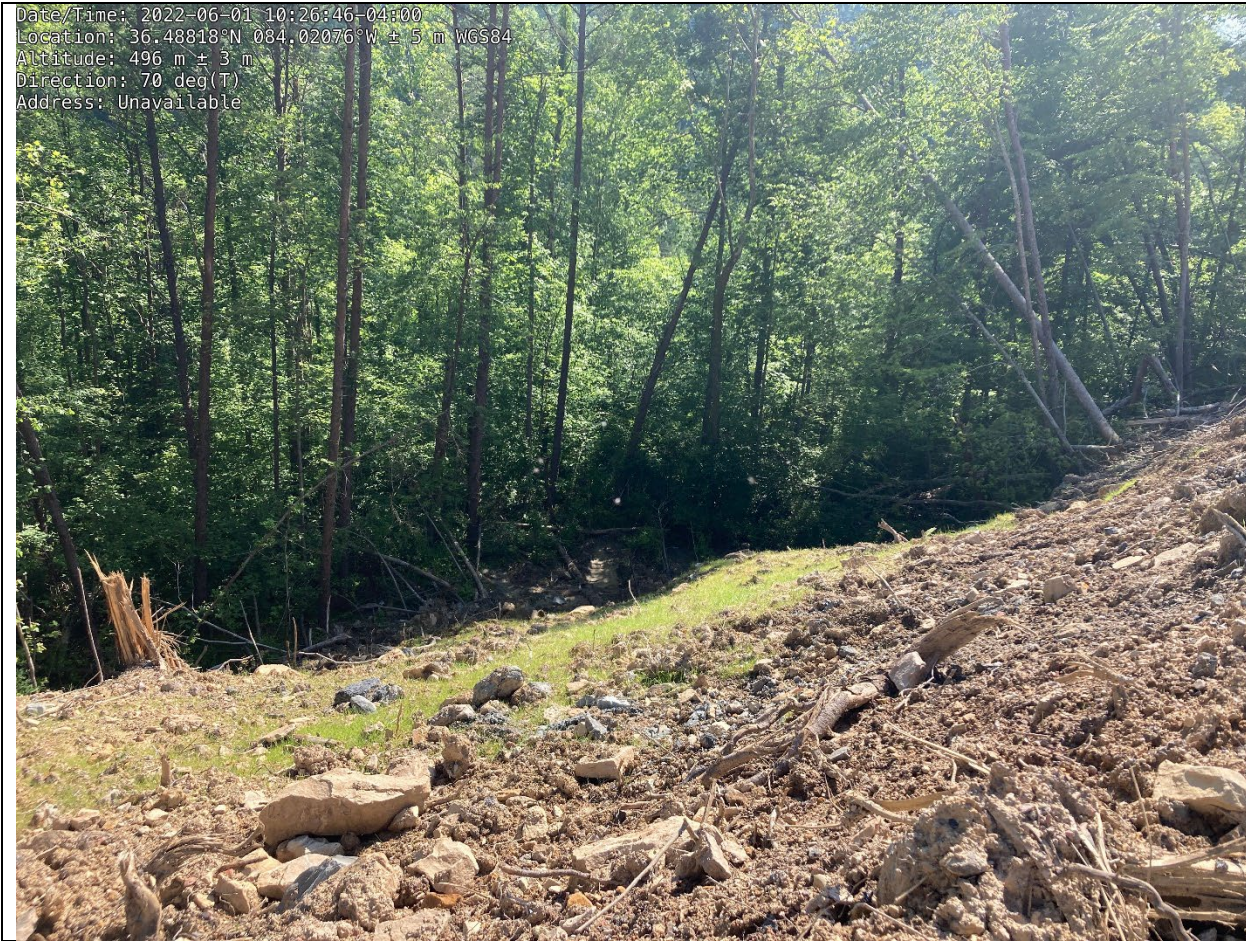
36.48818, -84.02076 2022/06/01

Item 4: Photo of the outslope depicted in item 3 before the landslide occurred. Photo taken on August 4, 2022.

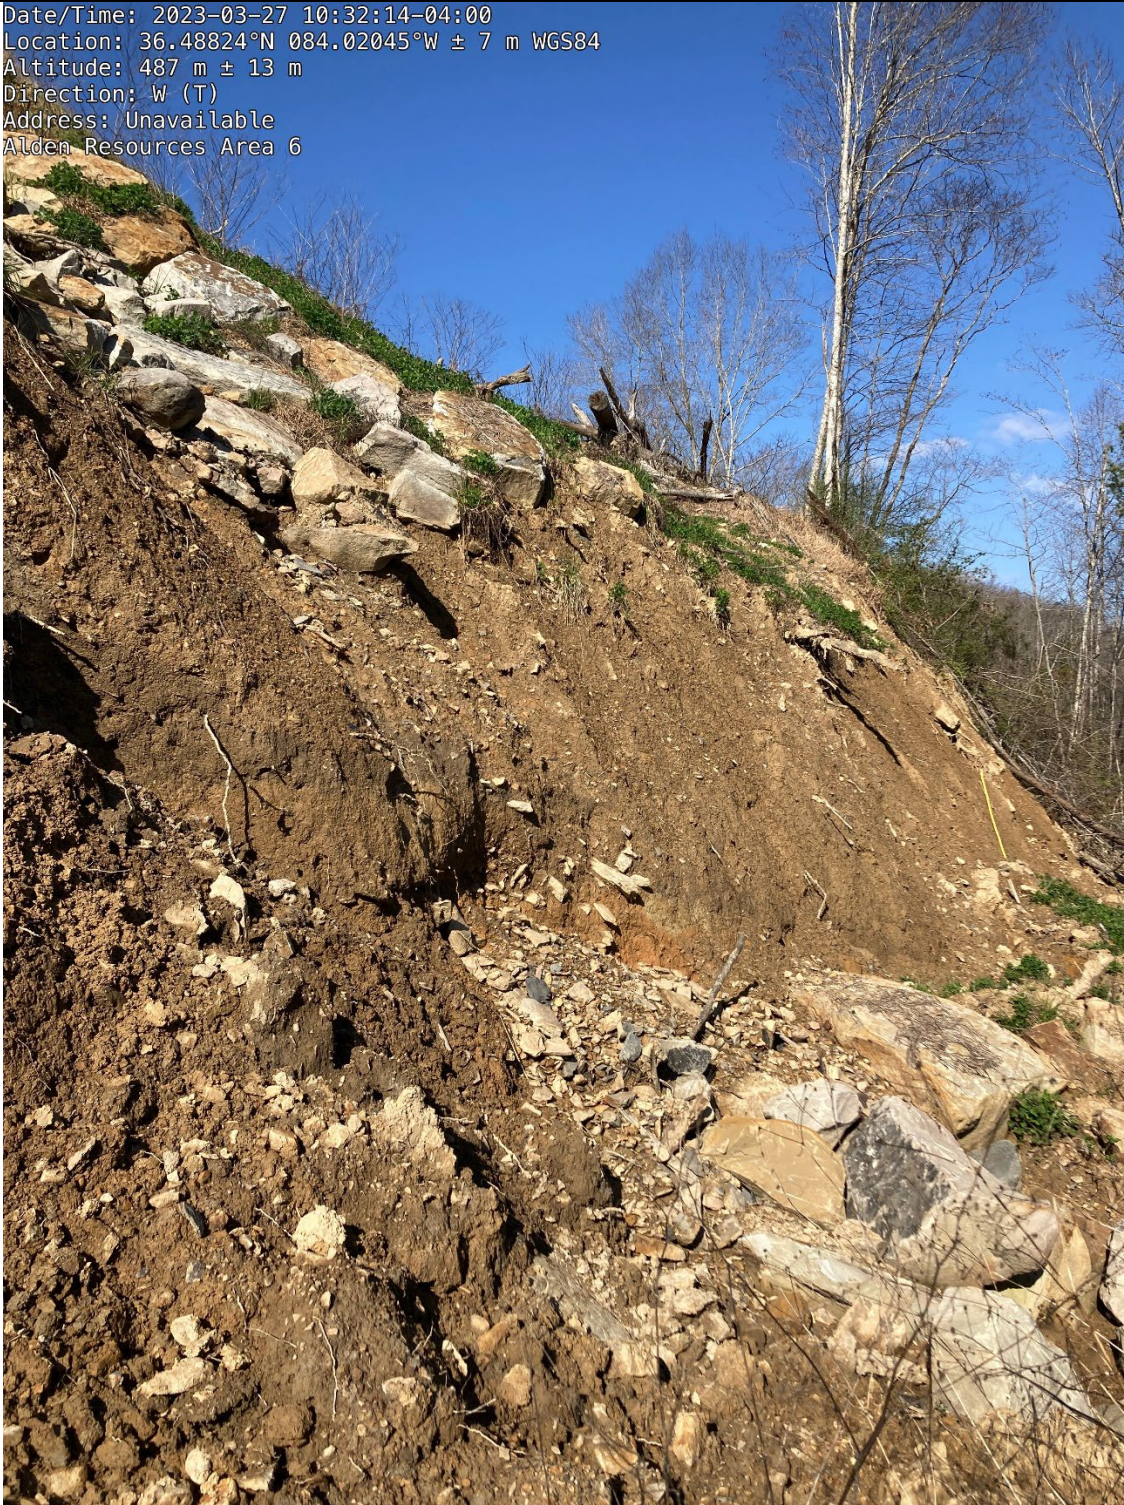
36.48824, -84.02045 2023/03/27

A slide investigation was conducted on March 27, 2023 in response to a notification received by OSMRE. The slide area begins on the outslope of the road and embankment of pond 103. At the pond a 315 ft wide segment of the road outslope slid 30 ft down the slope before settling on an old roadbed, leaving a 30 ft sheer face on the outslope. A 100 ft wide section of the right descending side of the landslide continued to move past the roadbed and down the slope until it reached a jurisdictional water feature that has been impounded into cells by beavers. The landslide created a delta 100 ft wide and extending thirty feet into the feature, with material accumulations reaching a depth of four ft along the bank of the feature and thinning as the material extended into the water. The slide's length from the road to the jurisdictional feature is 350 ft. Along with material accumulations being deposited into the feature, the sediment entering the feature was creating a color contrast of the feature. This feature drains into Hogcamp Branch, which is listed on the TDEC 2022 303(d) list of impaired waters as impaired for sedimentation/siltation due to impacts from abandoned mine lands.

Item 5: Photo of the landslide looking at the left descending side. Pond 103's rocklined spillway (fractured from the landslide) is pictured in the photo. The landslide has caused the outslope of the road to slide approximately 30 feet down the slope before settling.

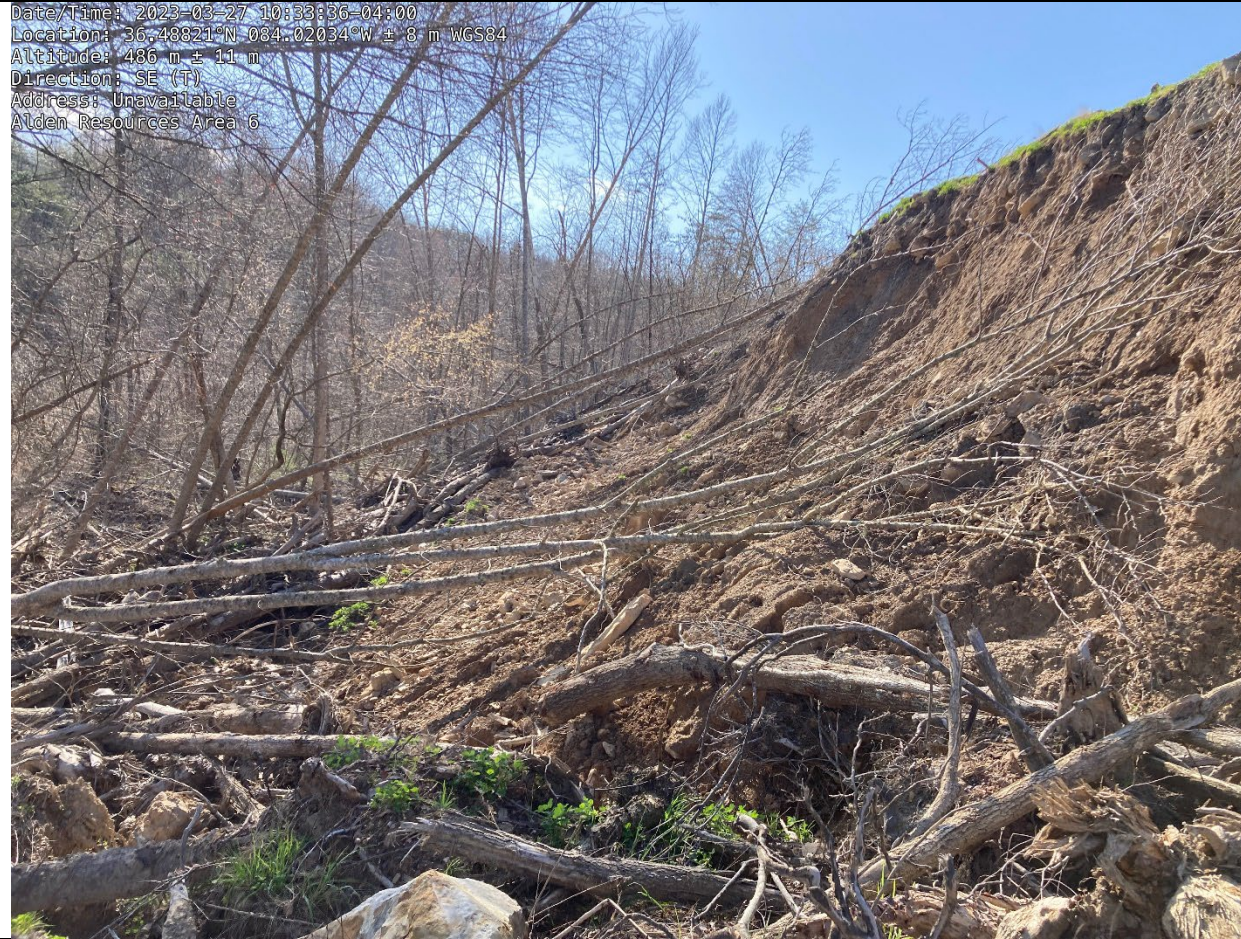
36.59921, -84.02034 2023/03/27

Item 6: Photo of the landslide of the right descending side. The landslide has caused the outer embankment of the road to migrate approximately 30 feet down the slope.

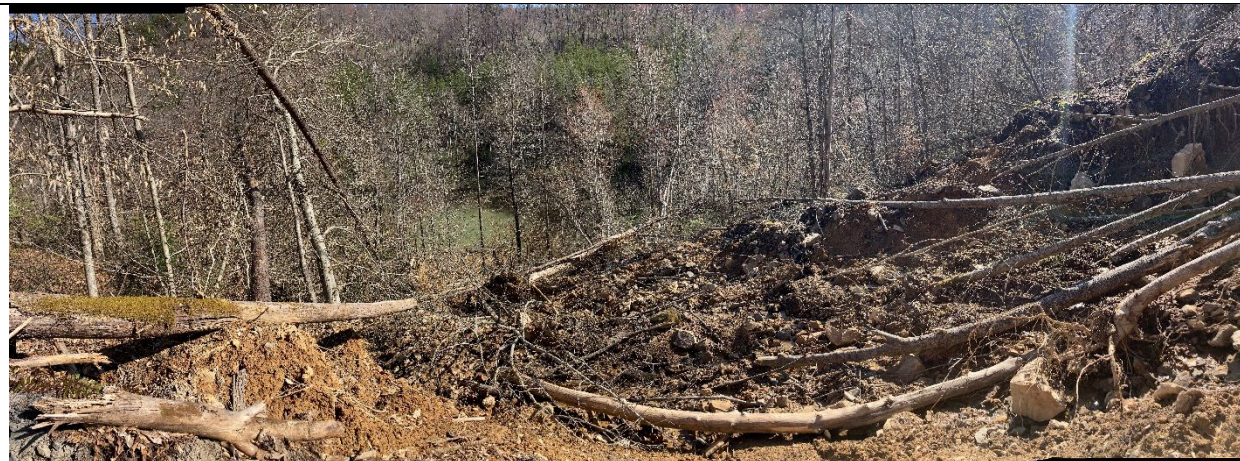
36.48848, -84.02000 2023/03/27

Item 7: Photo of the width of the landslide that extends down the slope and into the jurisdictional feature

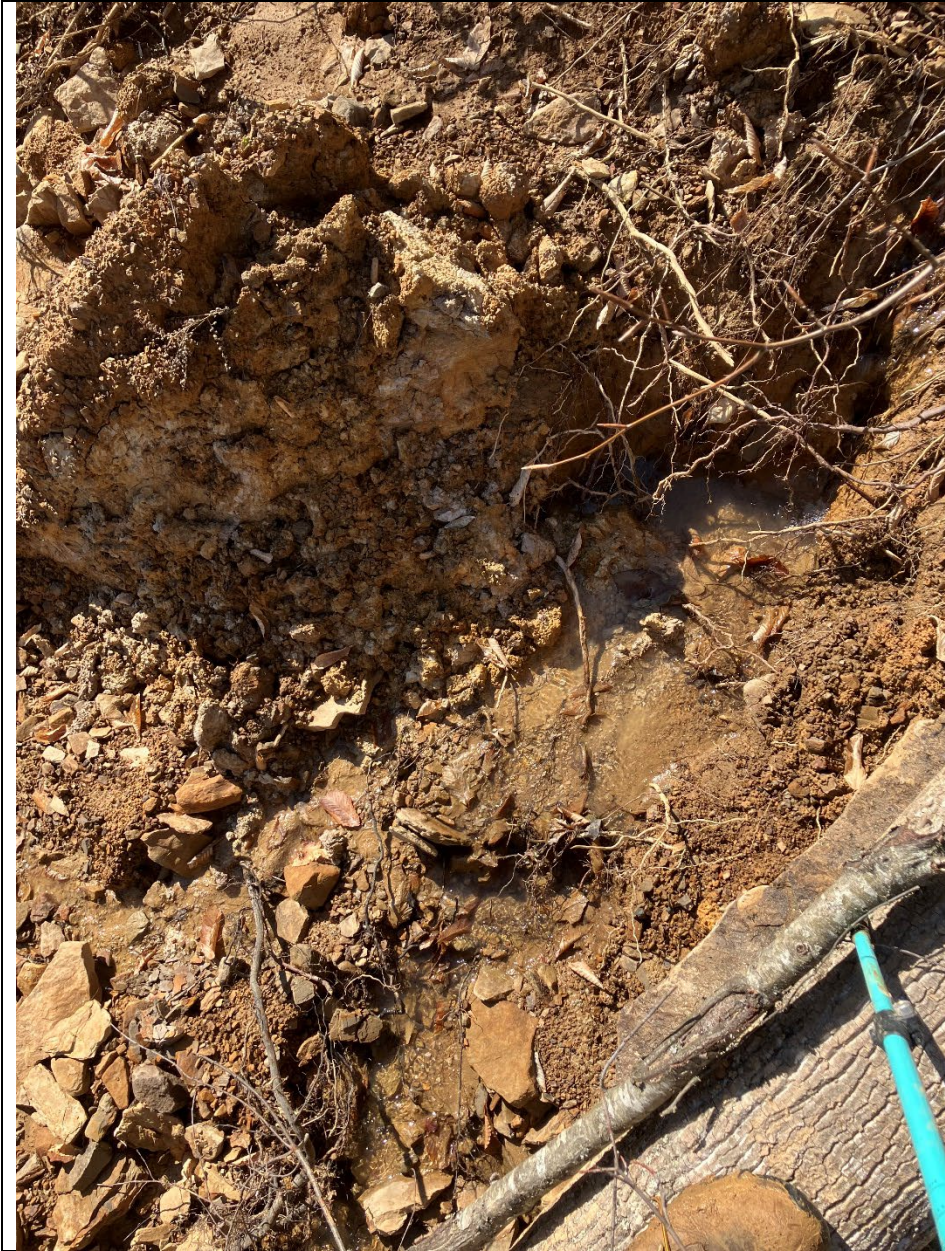
2023/03/27

Item 8: Photo of water seeping from the slide 60 feet below the elevation of the road and 30 feet below the bottom elevation of pond 103. The seep is directly below pond 103 and likely originates from the pond.

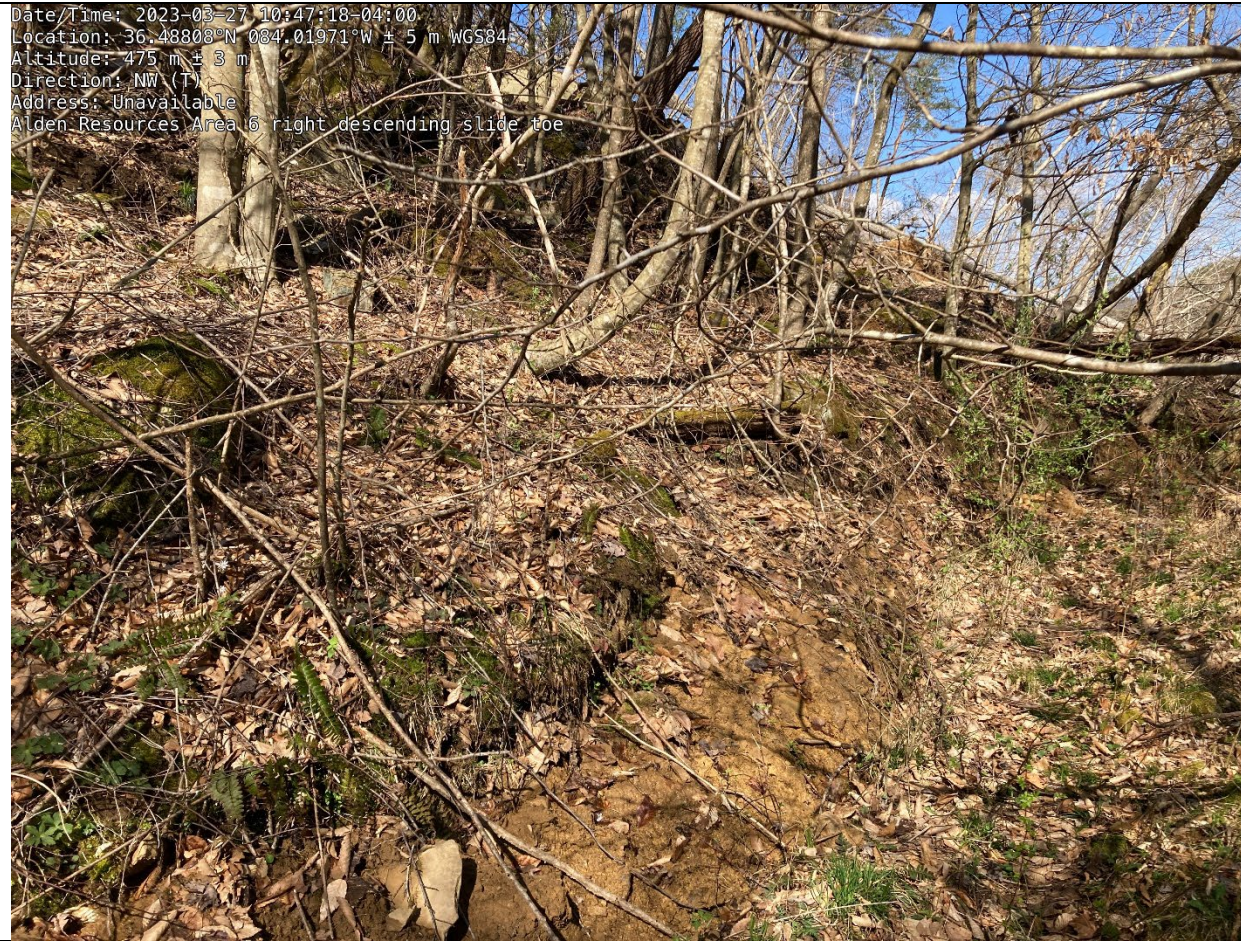
36.48808, -84.01971 2023/03/27

Item 9: Photo of an area directly west of the right descending side of the slide. In this area a two foot thick strip of fresh soil with water weeping out of indicates that this section of the outslope has started to slide and may continue to do so.

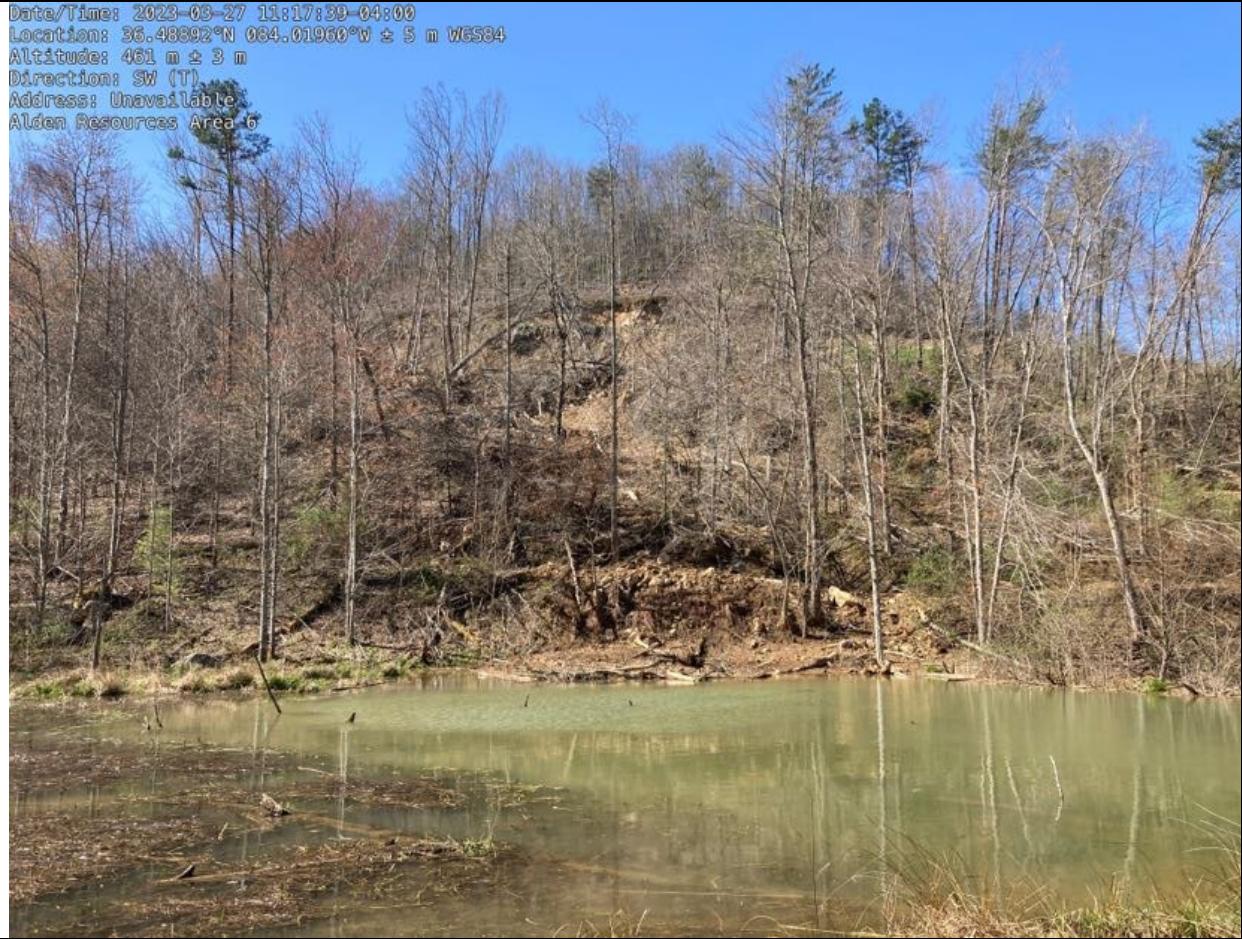
36.48892, -84.01960 2023/03/27

Item 10: Photo of the landslide extending from the road outslope at pond 103 down the slope and into the jurisdictional feature.

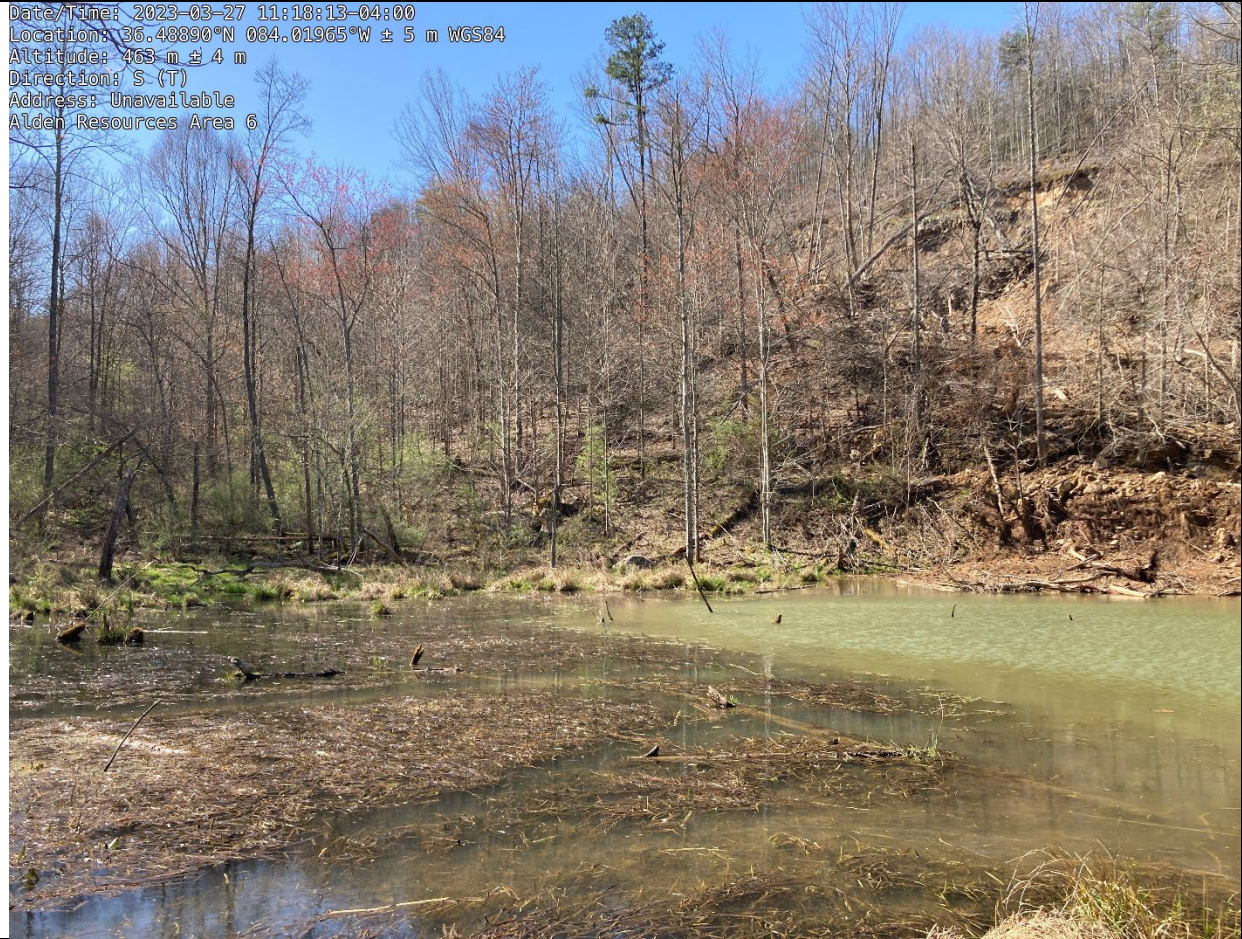
36.48890, -84.01965 2023/03/27

Item 11: Photo of the jurisdictional feature upstream of and at the landslide. The water is clear as the stream enters the first cell impounded by beavers, but becomes cloudy once it encounters the sediment from the landslide. The landslide is causing a color contrast to the receiving stream.

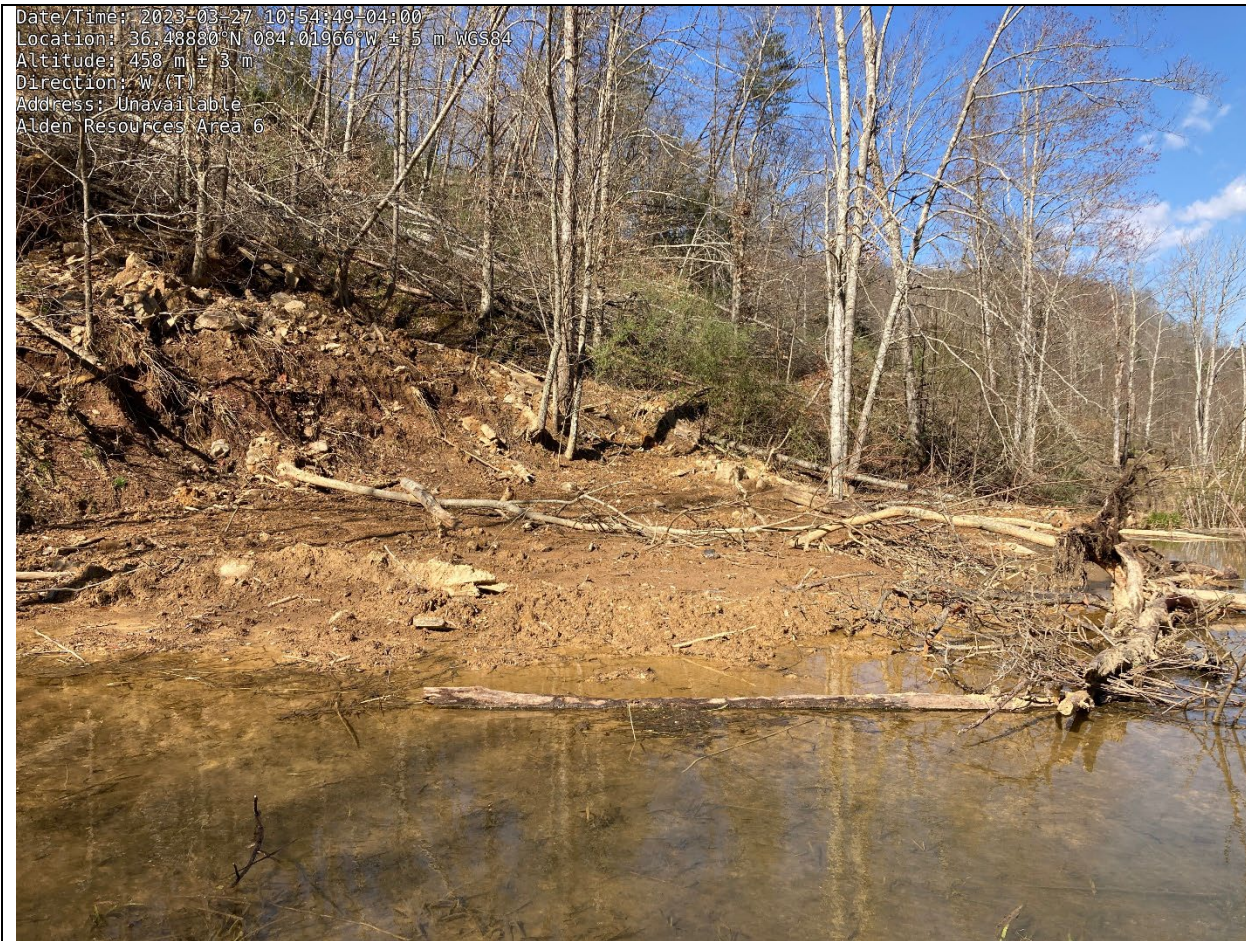
36.48880, -84.01966 2023/03/27

Item 12: Photo of the landslide entering the jurisdictional feature. Photo taken from the right descending bank.

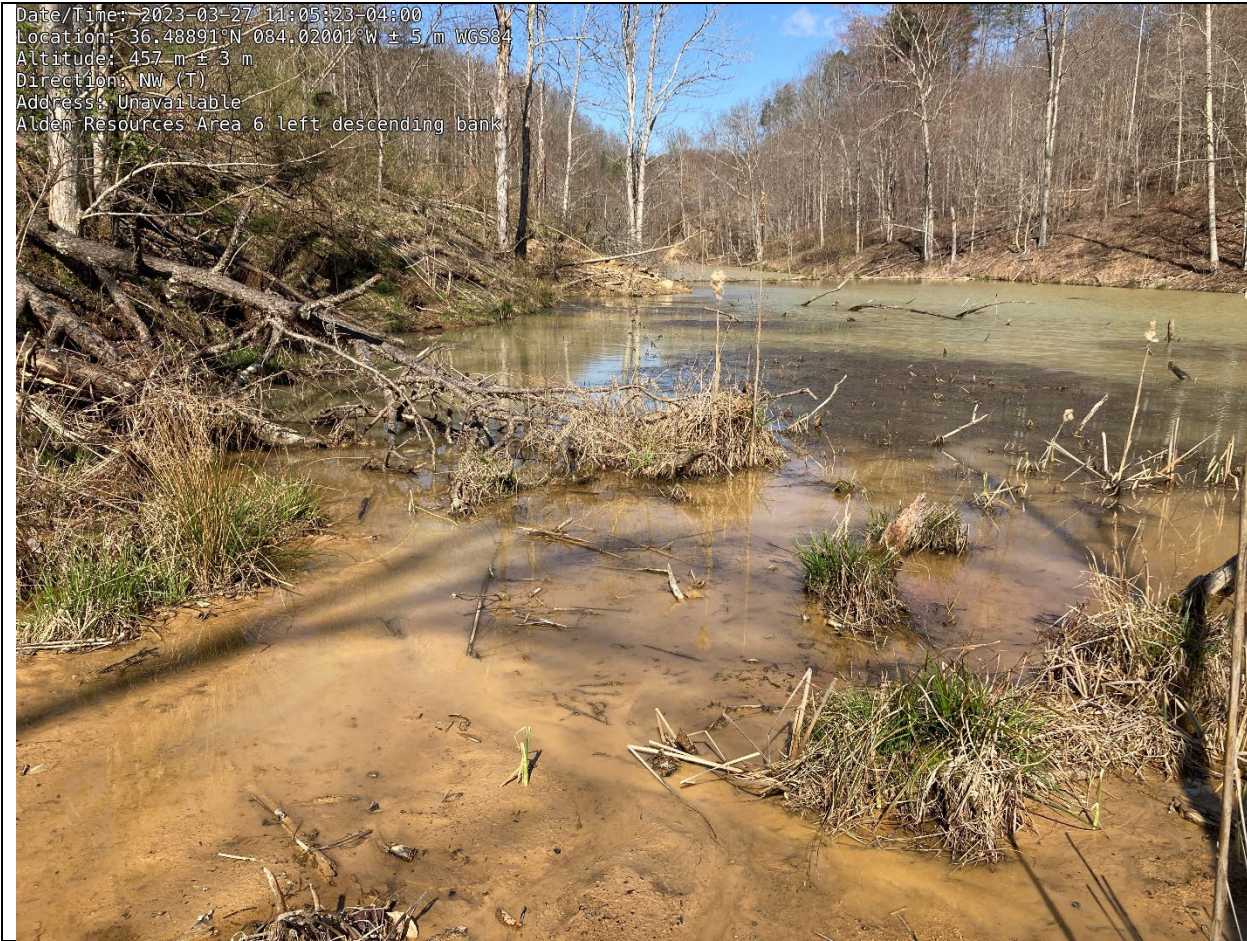
36.48891, -84.02001 2023/03/27

Item 13: Photo of material from the landslide extending out into the second beaver cell at the jurisdictional feature. Photo of the left descending side of the landslide.
