RE: Alexandria Sewer Treatment Plant (STP), Compliance Evaluation Inspection (CEI), Notice of Violation (NOV), Compliance Review Meeting (CRM) DeKalb County; NPDES # TN0021539 Permit Expiration: July 31, 2027

Town of Alexandria Sewage Treatment Plant (TN0021539) Compliance Evaluation Inspection, DeKalb County.

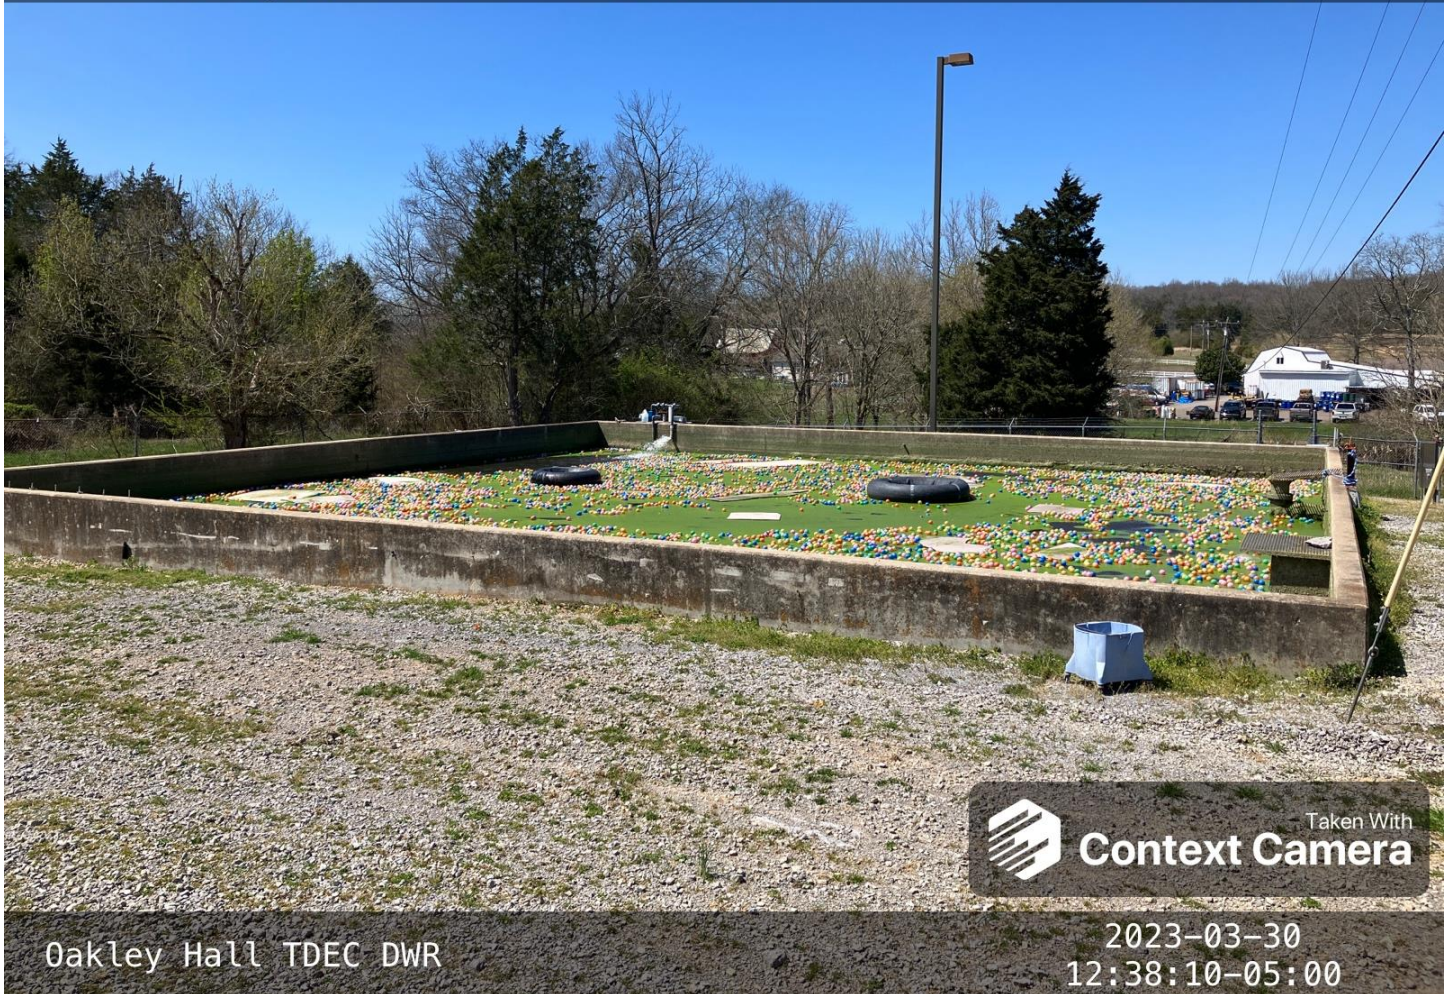
The final polishing basin is pictured. Floating plastic materials have been placed on the water surface to reduce the amount of Duck Weed on the surface. Historically, the Duck Weed has contributed to a higher total suspended solids (TSS) discharge. Prior to the inspection the operator turned on the aeration which is stirring the rectangular basin. This was done to increase Dissolved Oxygen levels. During the inspection, it was observed that solids were being stirred up and lost to the effluent discharge. This was observed in the U.V. disinfection channel.

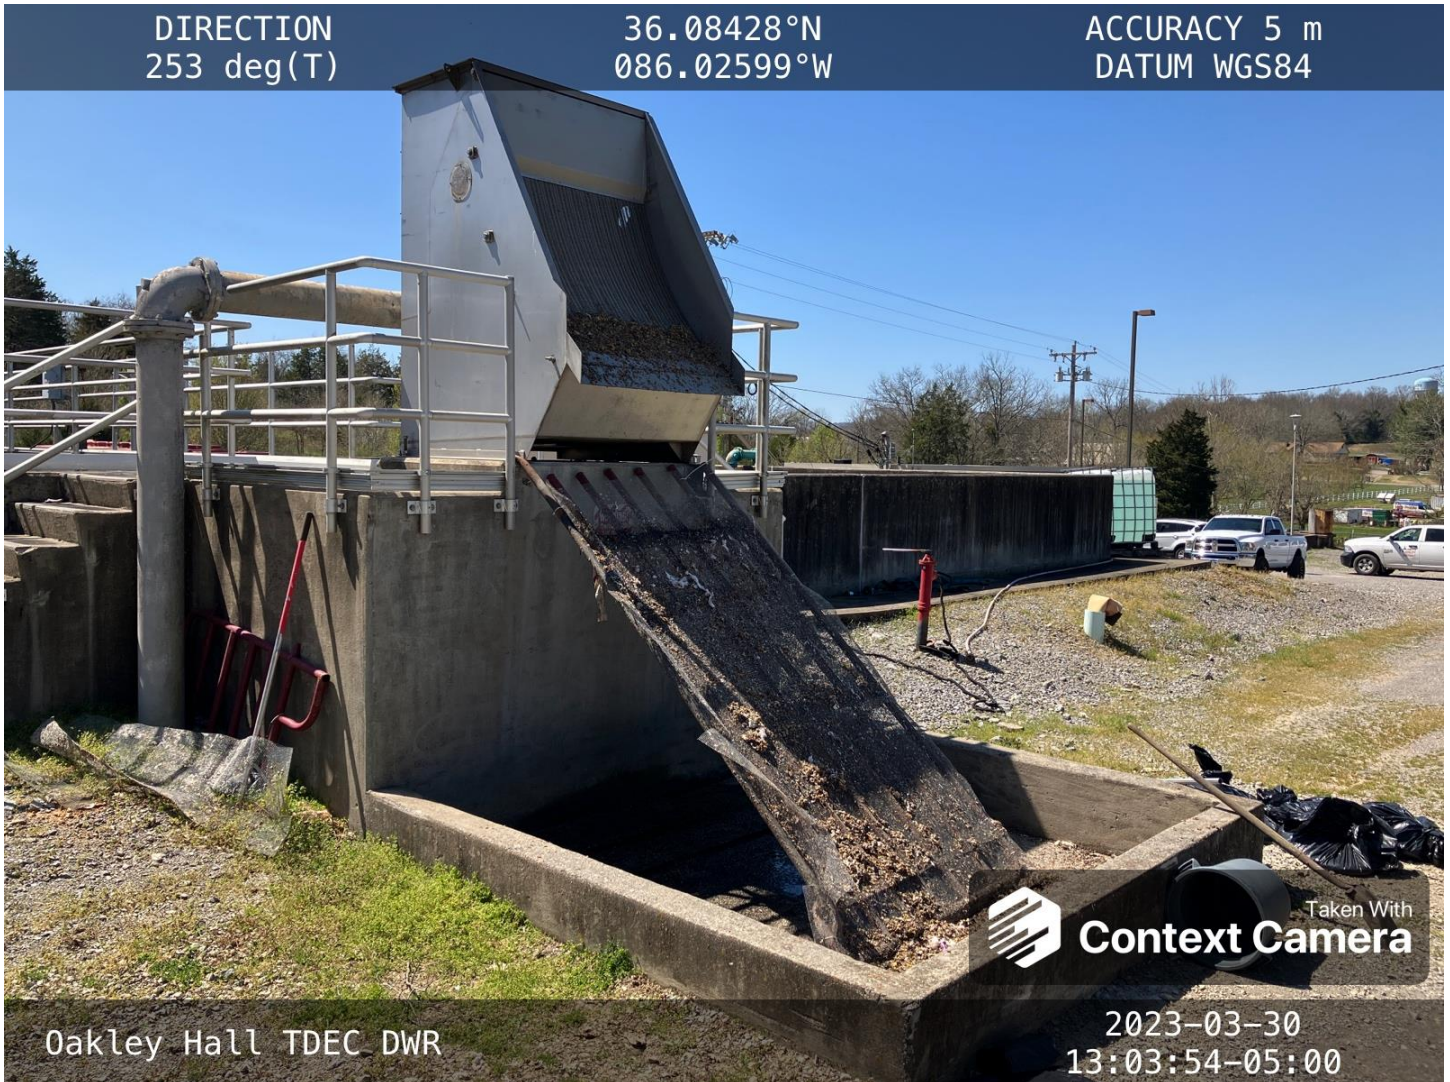
The influent screen is operational. Solids are raked and bagged. They are disposed of in the landfill.

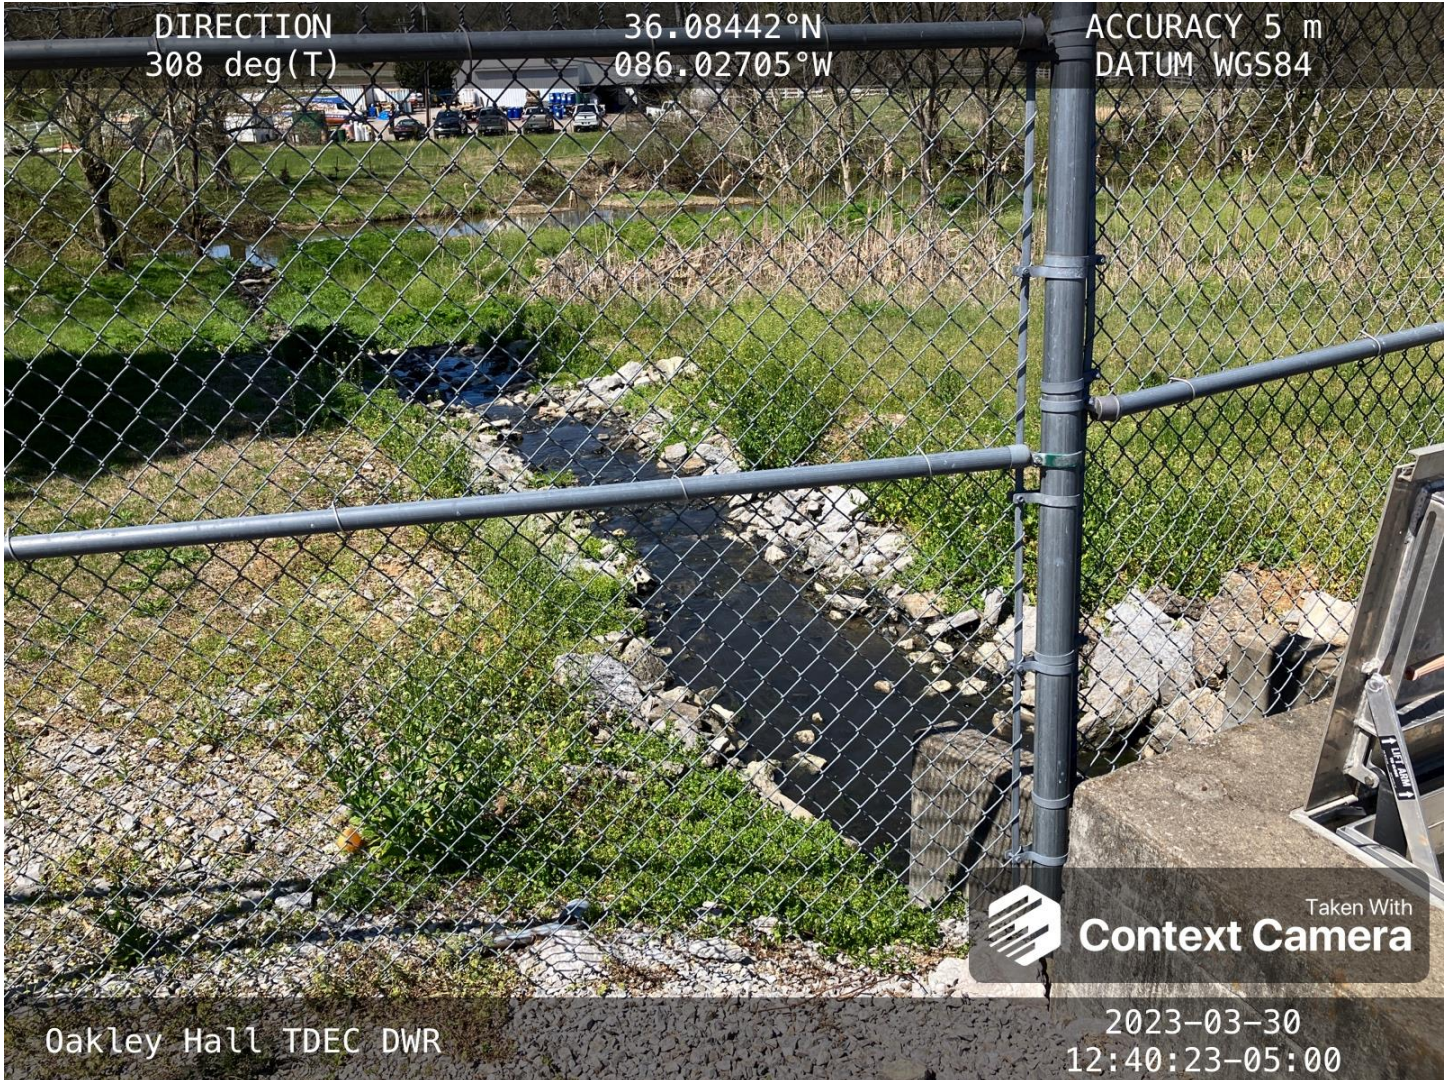
The effluent discharge to Hickman Creek was observed to be dark in color.

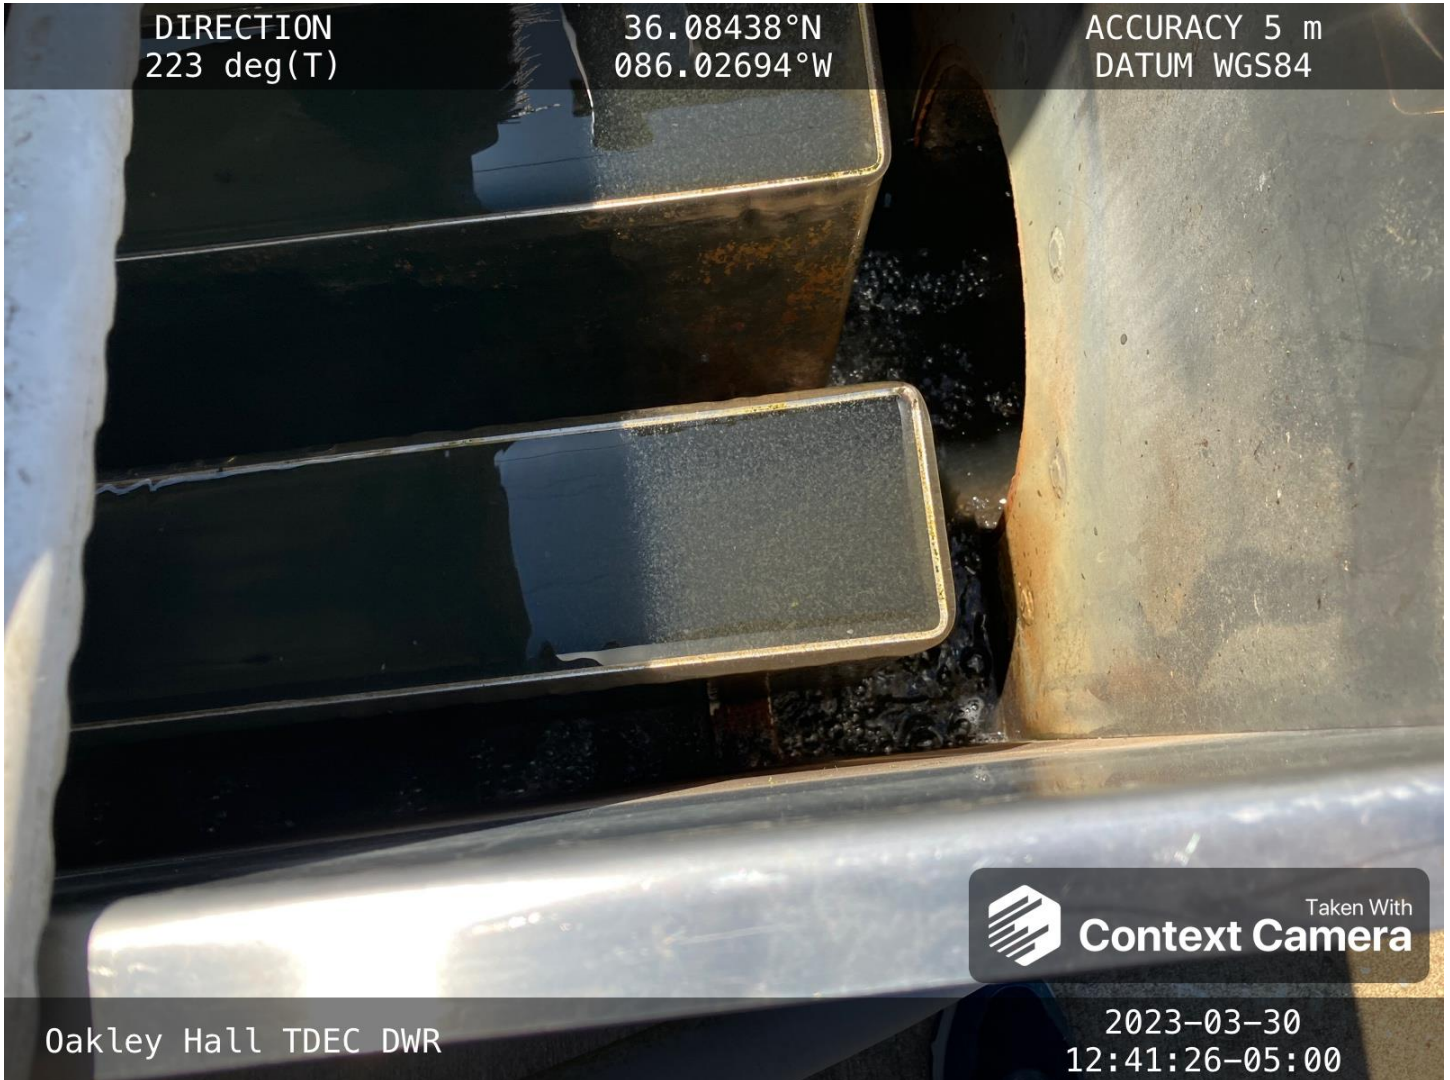
At the Ultra Violet (U.V.) system discharge, it was observed that suspended solids were present.

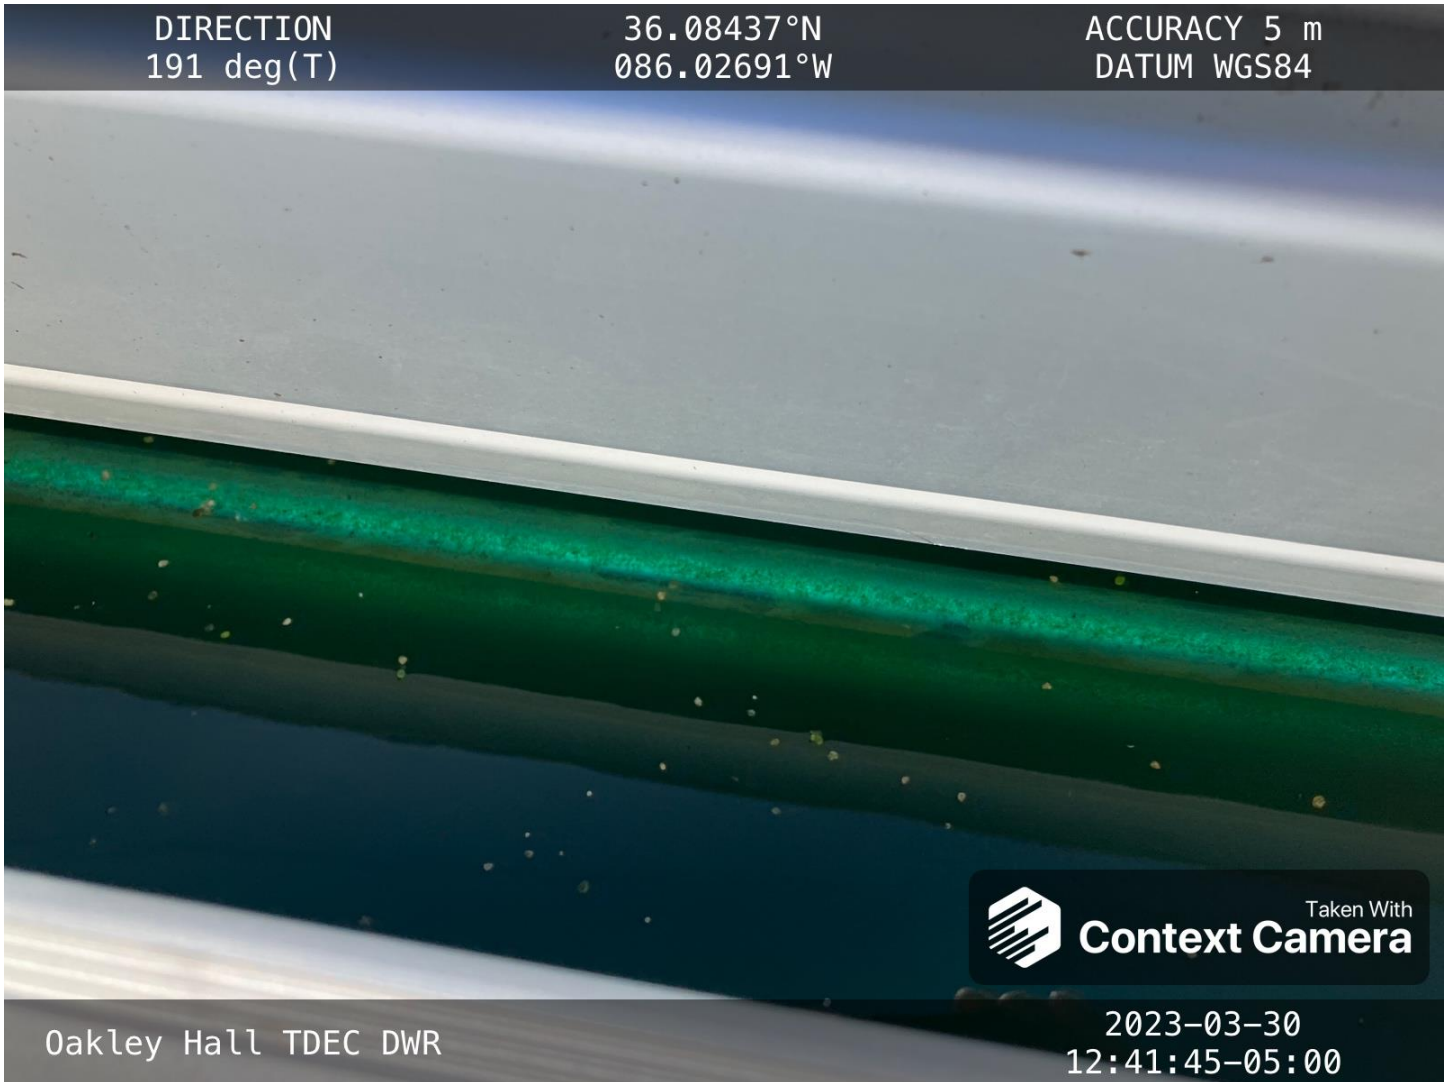
Particles from the rectangular basin are in the effluent water column and collecting on the U.V. bulbs. Operators reported that they have recently cleaned the U.V. bulbs.

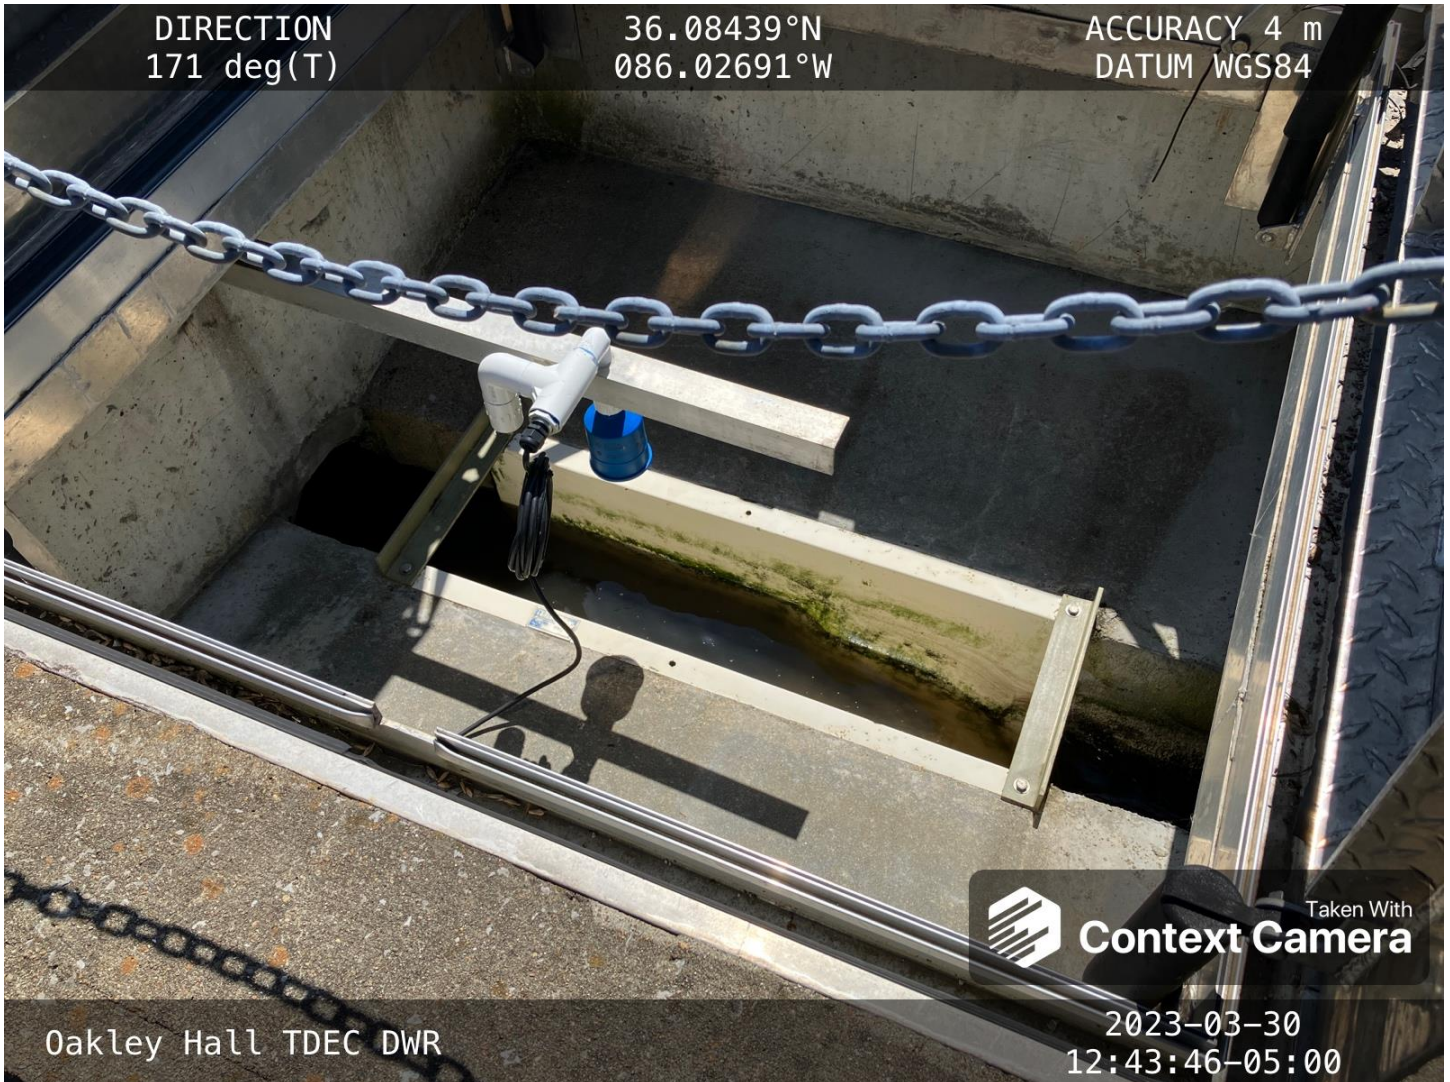
This effluent flume (Palmer-Bowlus) is pictured. The effluent discharge flowing through the flume was dark due to the suspended solids in the discharge.

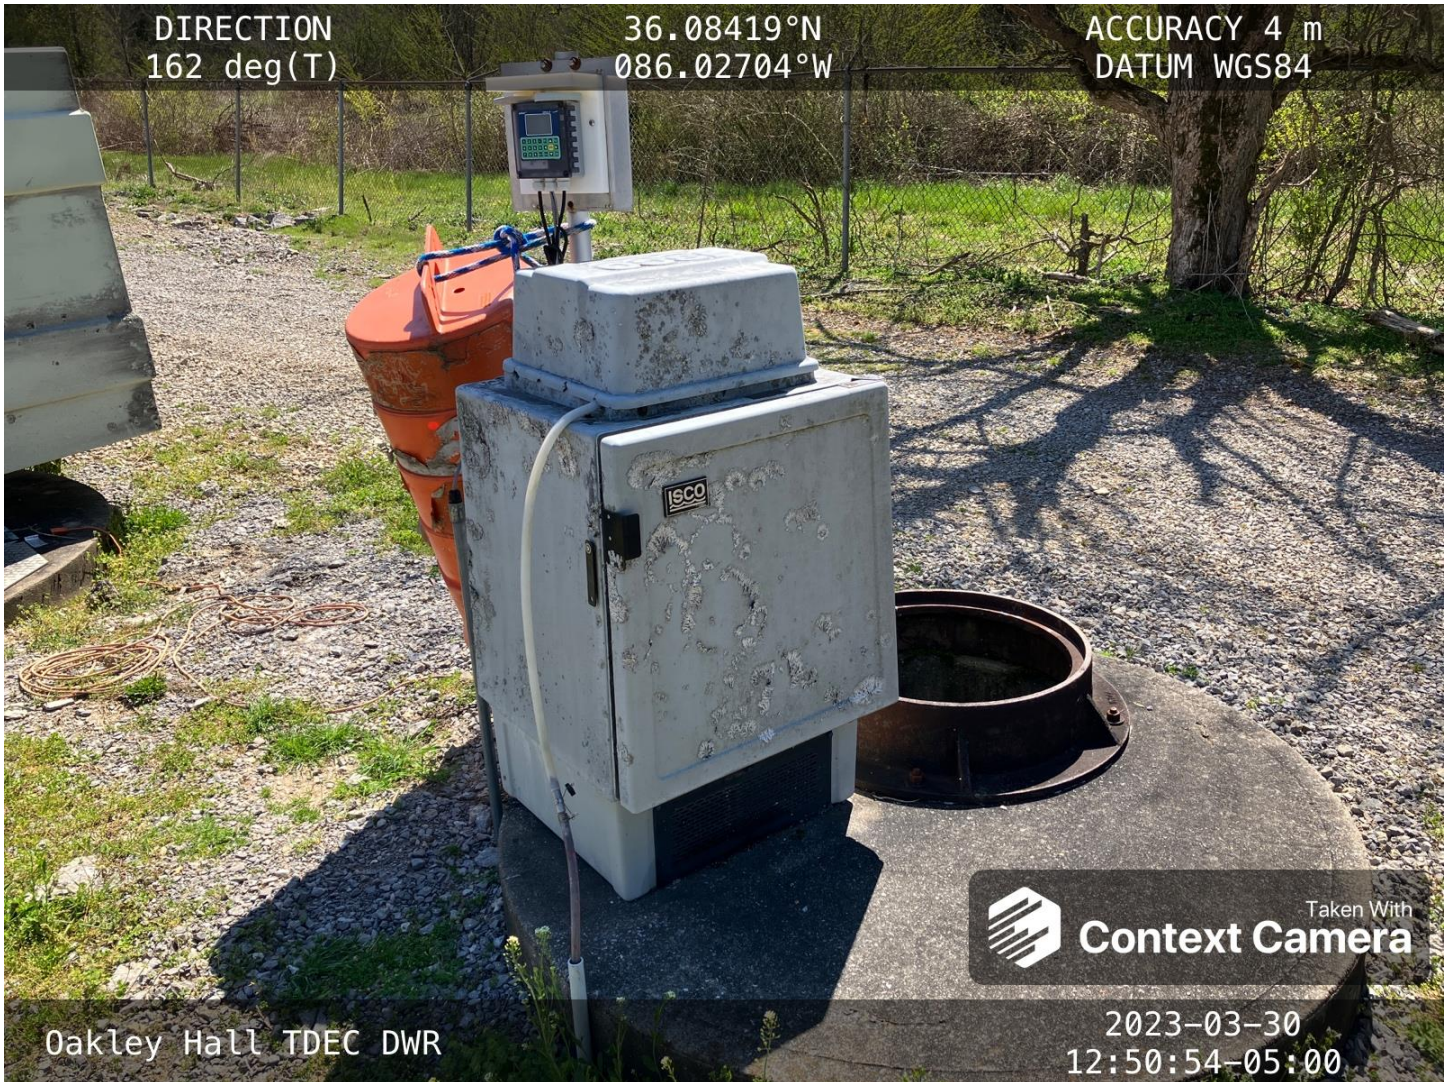
The influent sampler is pictured. It is not connected to the flow meter. The work to connect the flow meter to the sampler is in process. Currently, an automated flow proportional sample cannot be collected. The flow meter is operational. Historically the flow transducer in the manhole would be submerged during rain events. Operators report that recent work in the collection system has reduced inflow and infiltration, and this has reduced the submersion of the influent flow measuring devices in this relatively deep manhole. The refrigeration unit was operational. The hose into the manhole needs to be replaced.

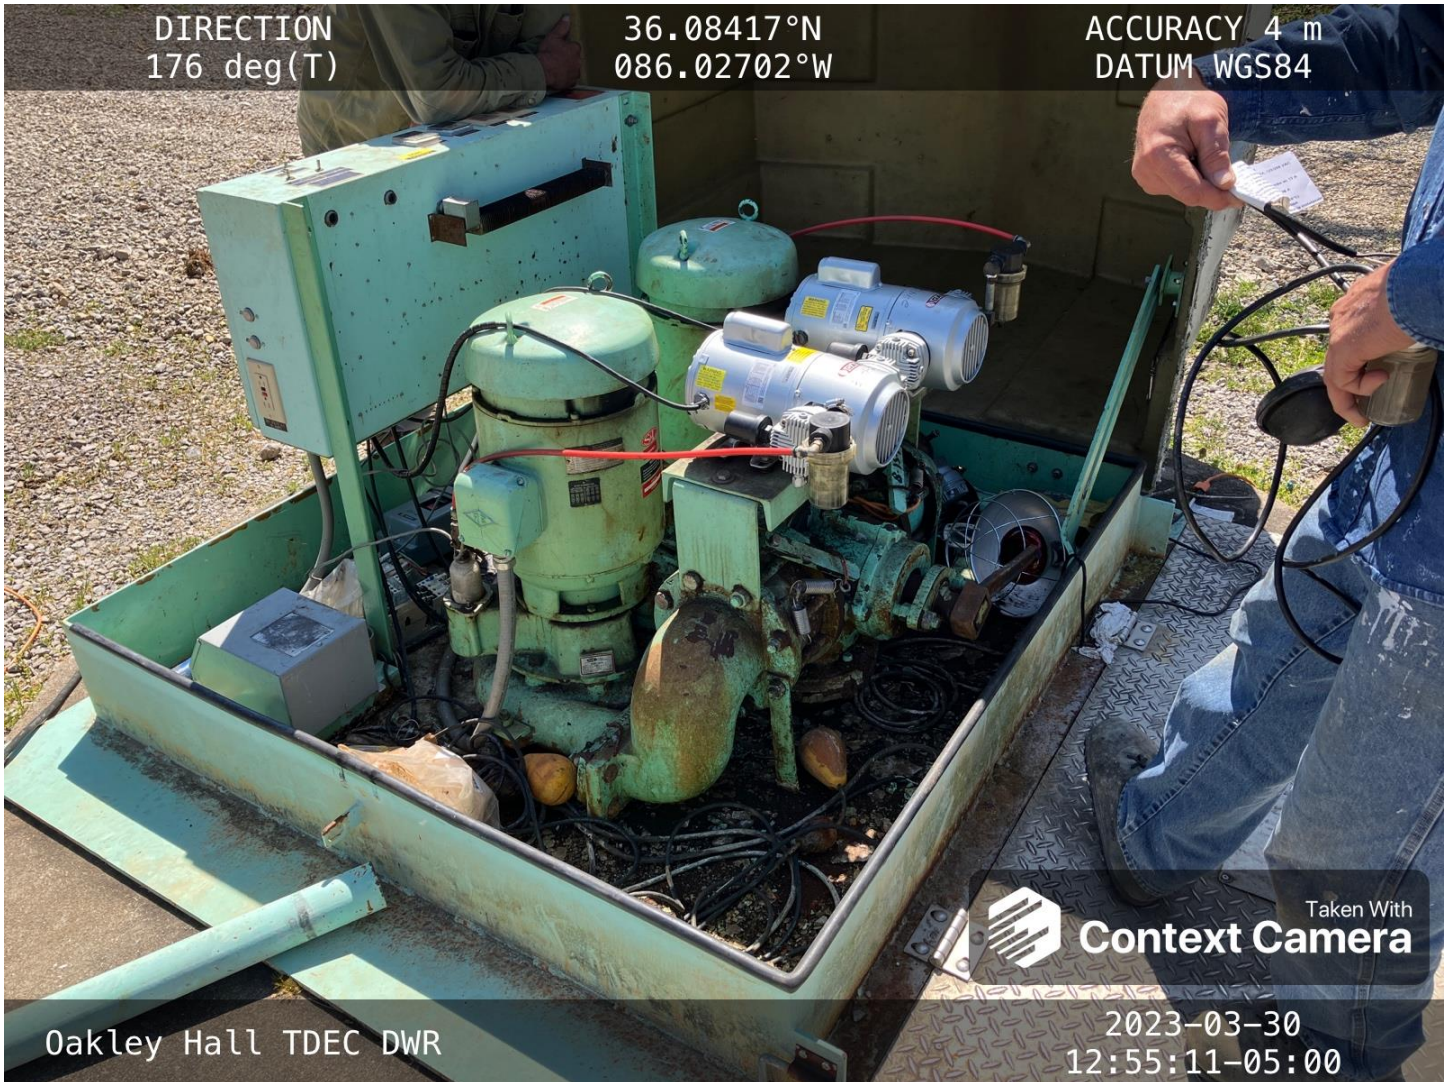
The in-plant pump station was in operation.

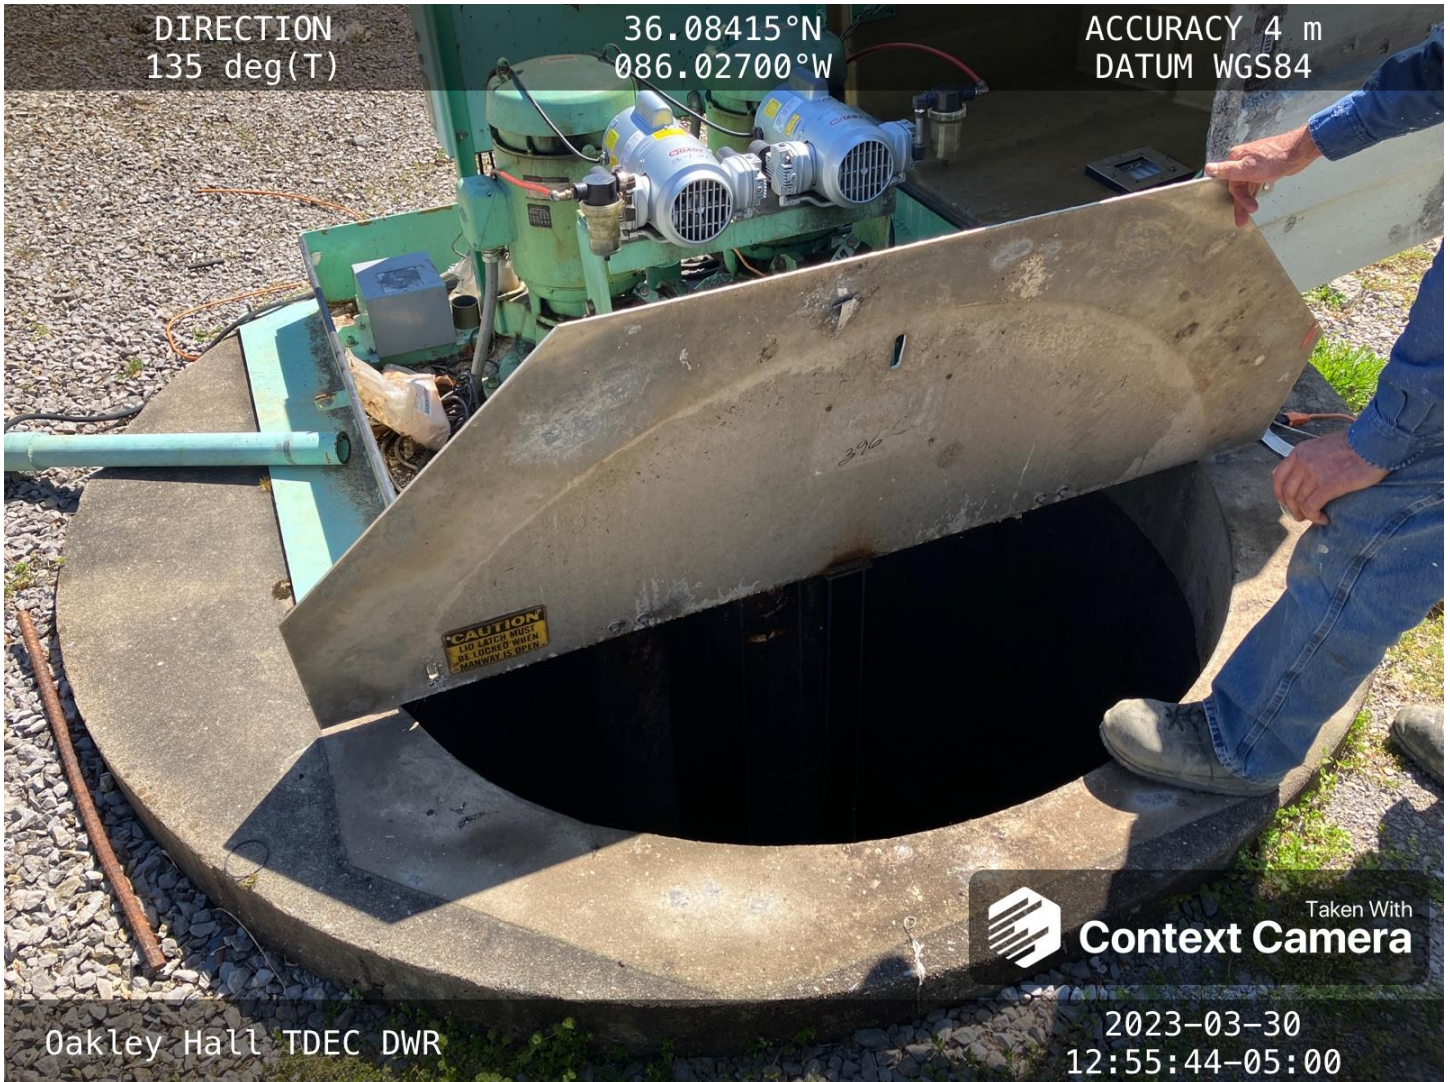
The wet well for the pumpstation was reviewed. Grease was not present in the wet well.

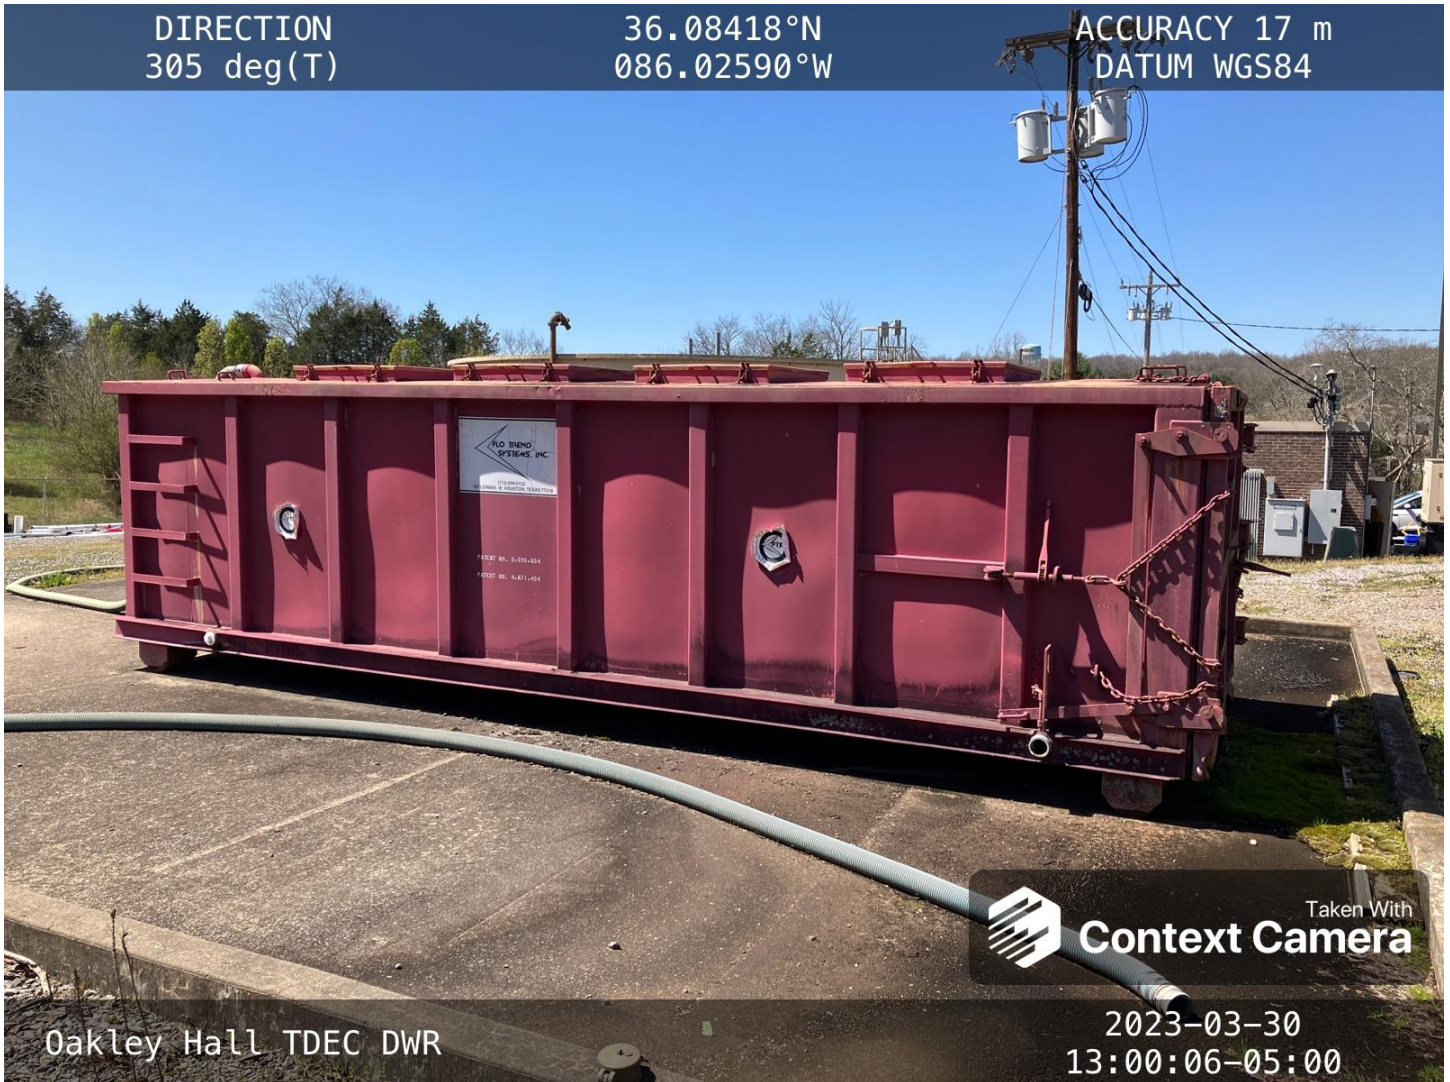
The Town of Alexandria is now permitted to haul biosolids to a local farm. The pictured Sludge Mate is currently not in use. It was used to thicken biosolids prior to their disposal at a landfill. The town has a large digester.

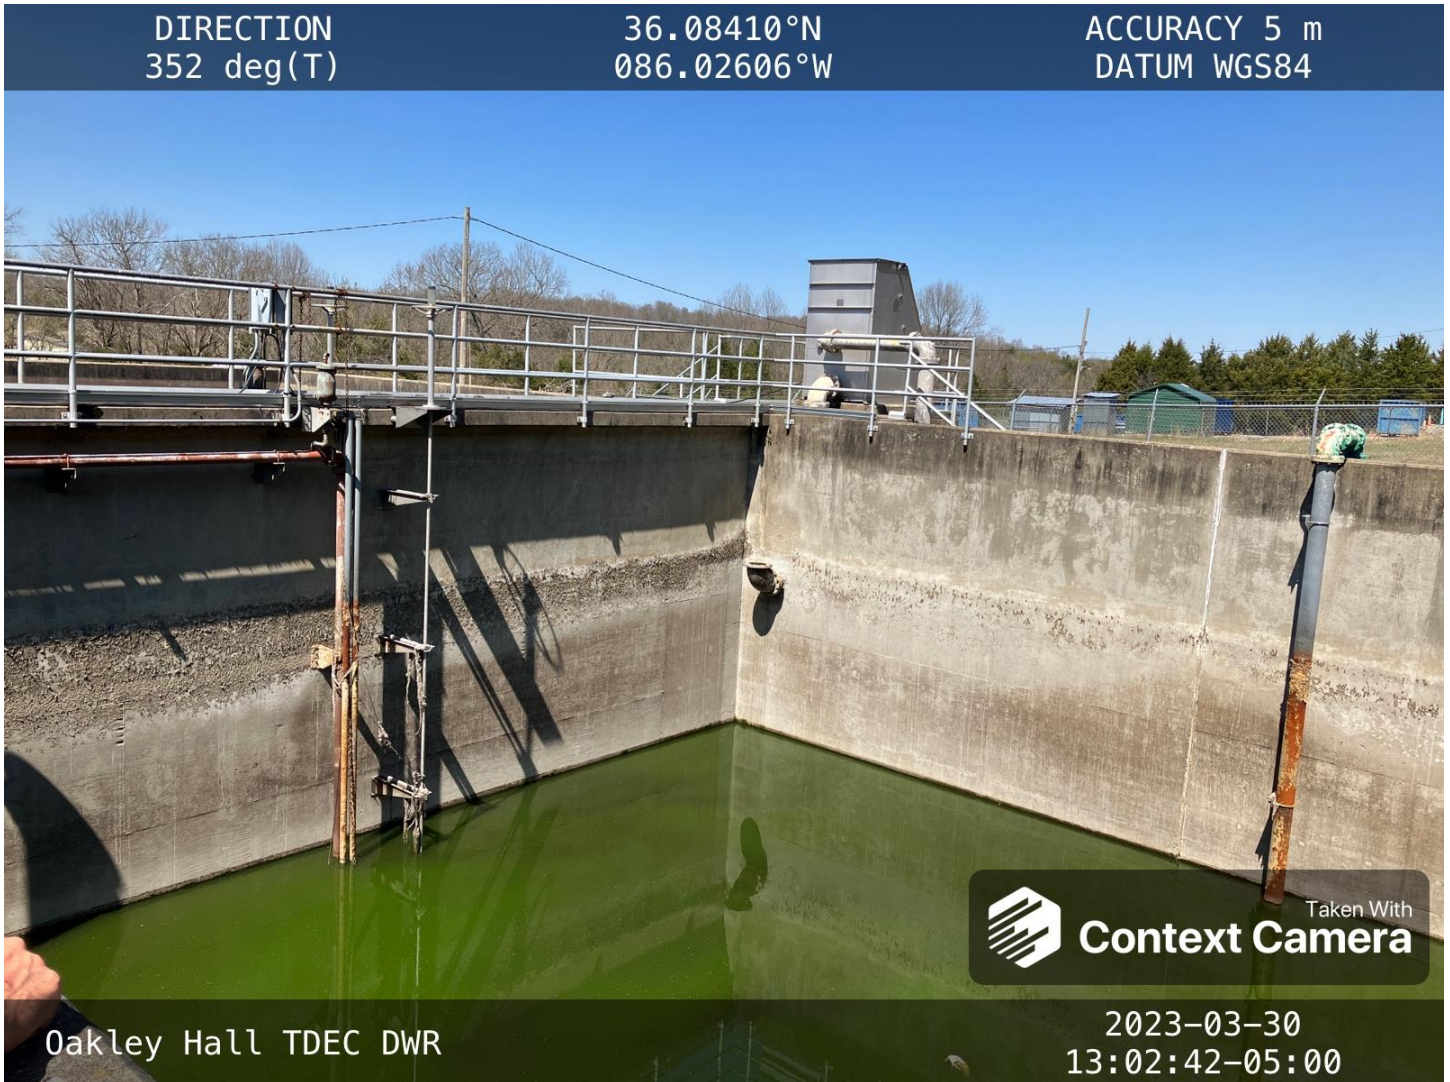
The Sequencing Batch Reactor (SBR) was not working as designed. One of the SBR units has been shut down for an extended period. This is a bypass of treatment. Solids were visible in the effluent discharge. The influent sampler was not capable of collecting a flow composite sample. The single dissolved oxygen meter was out for repair. Only two manual influent samples were reported as being collected daily. The two manual samples are not representative of 24 hour (daily) influent flow.

The sewer plant is a Sequencing Batch Reactor (SBR) system. One of the reactors was not operational and had not been for several months. It was shut off due to a clogged aeration line. The operator felt that it was causing a decrease in dissolved oxygen. The air lines in this basin need to be repaired and this reactor placed back on-line. The sewer treatment plant is not operating as designed.

- ✓ Present the Corrective Action Plan (CAP) at the upcoming Compliance Review Meeting.
- ✓ Include the repair/implementation information and available results for the SBR unit(s).
- ✓ Include the completion repair plan of the process controls for the collection of representative Influent flow composite samples.
- ✓ Include the development of additional quality control techniques in the laboratory, e.g., blanks and spiked samples. The Chief Operator is to document the capabilities of the personnel performing laboratory work. Complete the development of Alexandria's Laboratory Standard Operating Procedure (Lab SOP). Follow the SOP.

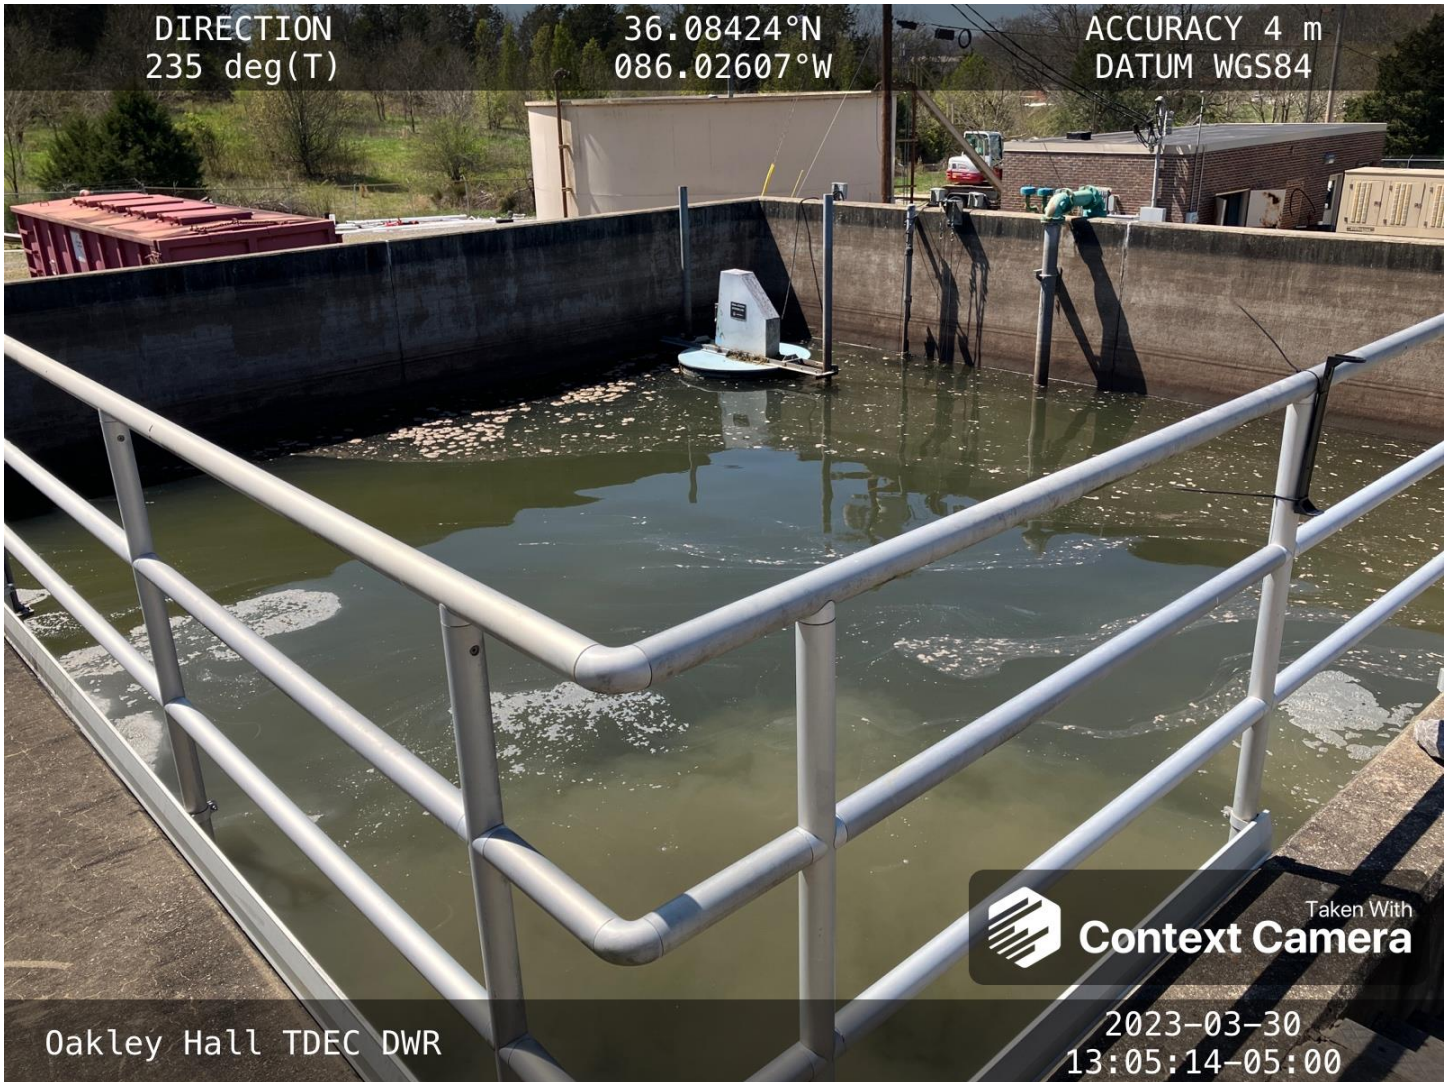
The other reactor was operational. It may be hydraulically overloaded, especially during the wetter seasons of the year. The wastewater SBR system is not being operated as designed because the sequencing of the reactors (allowing optimal treatment) cannot be maintained. This constitutes a bypass of treatment.

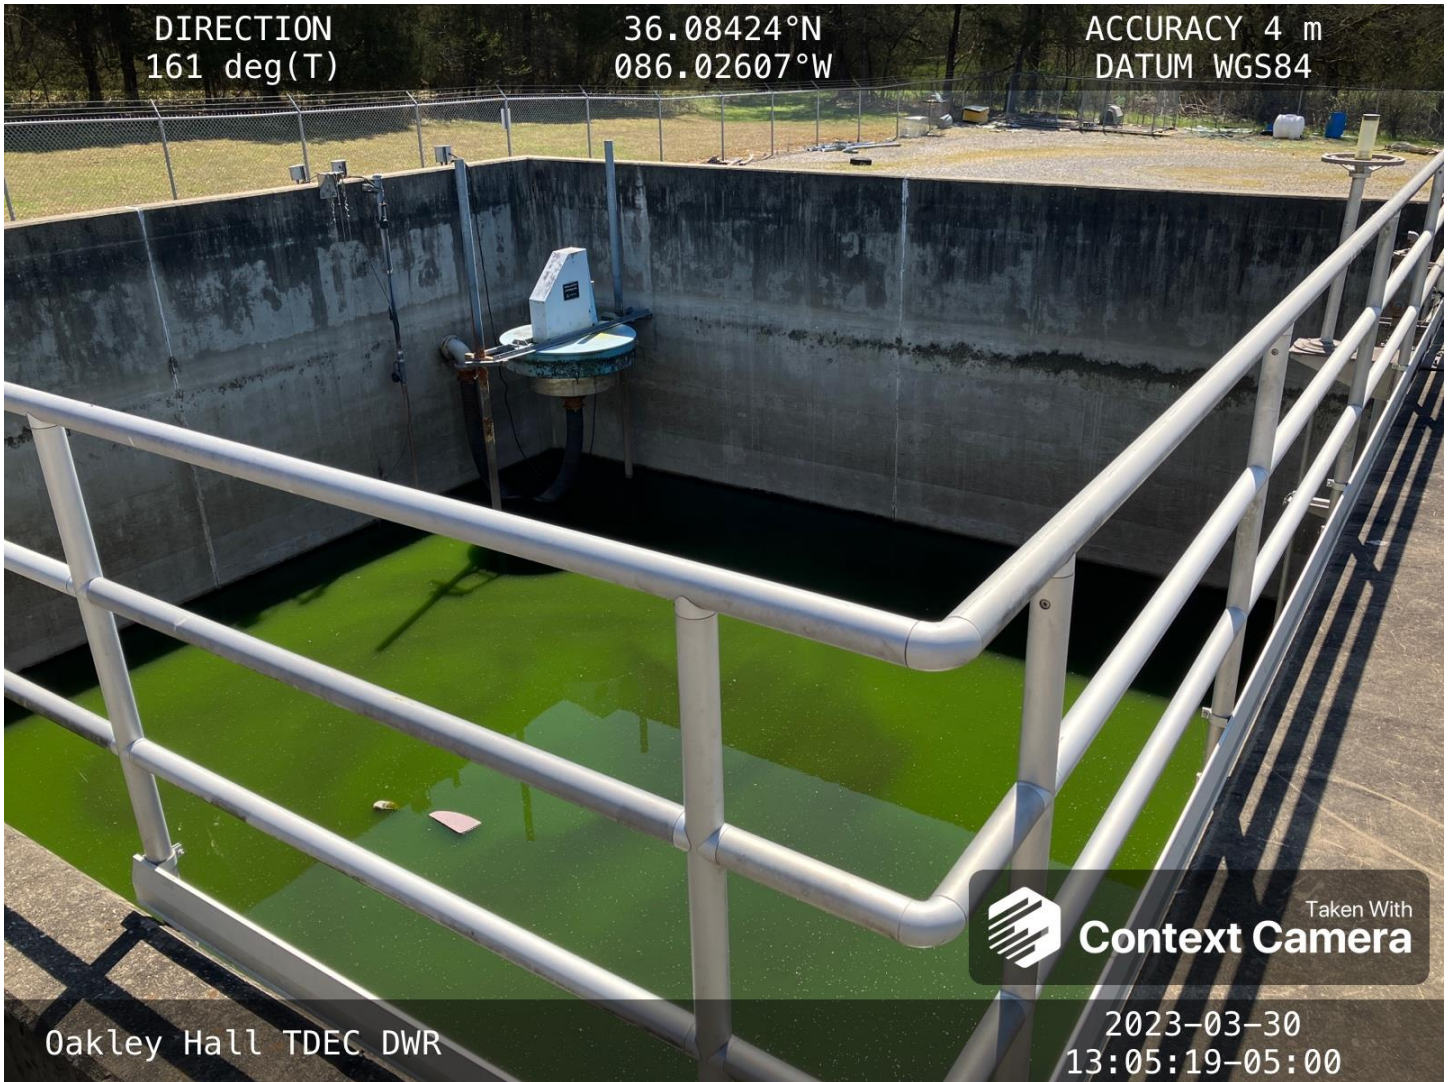
The inoperable reactor is dormant. Seals and other equipment may need further work.

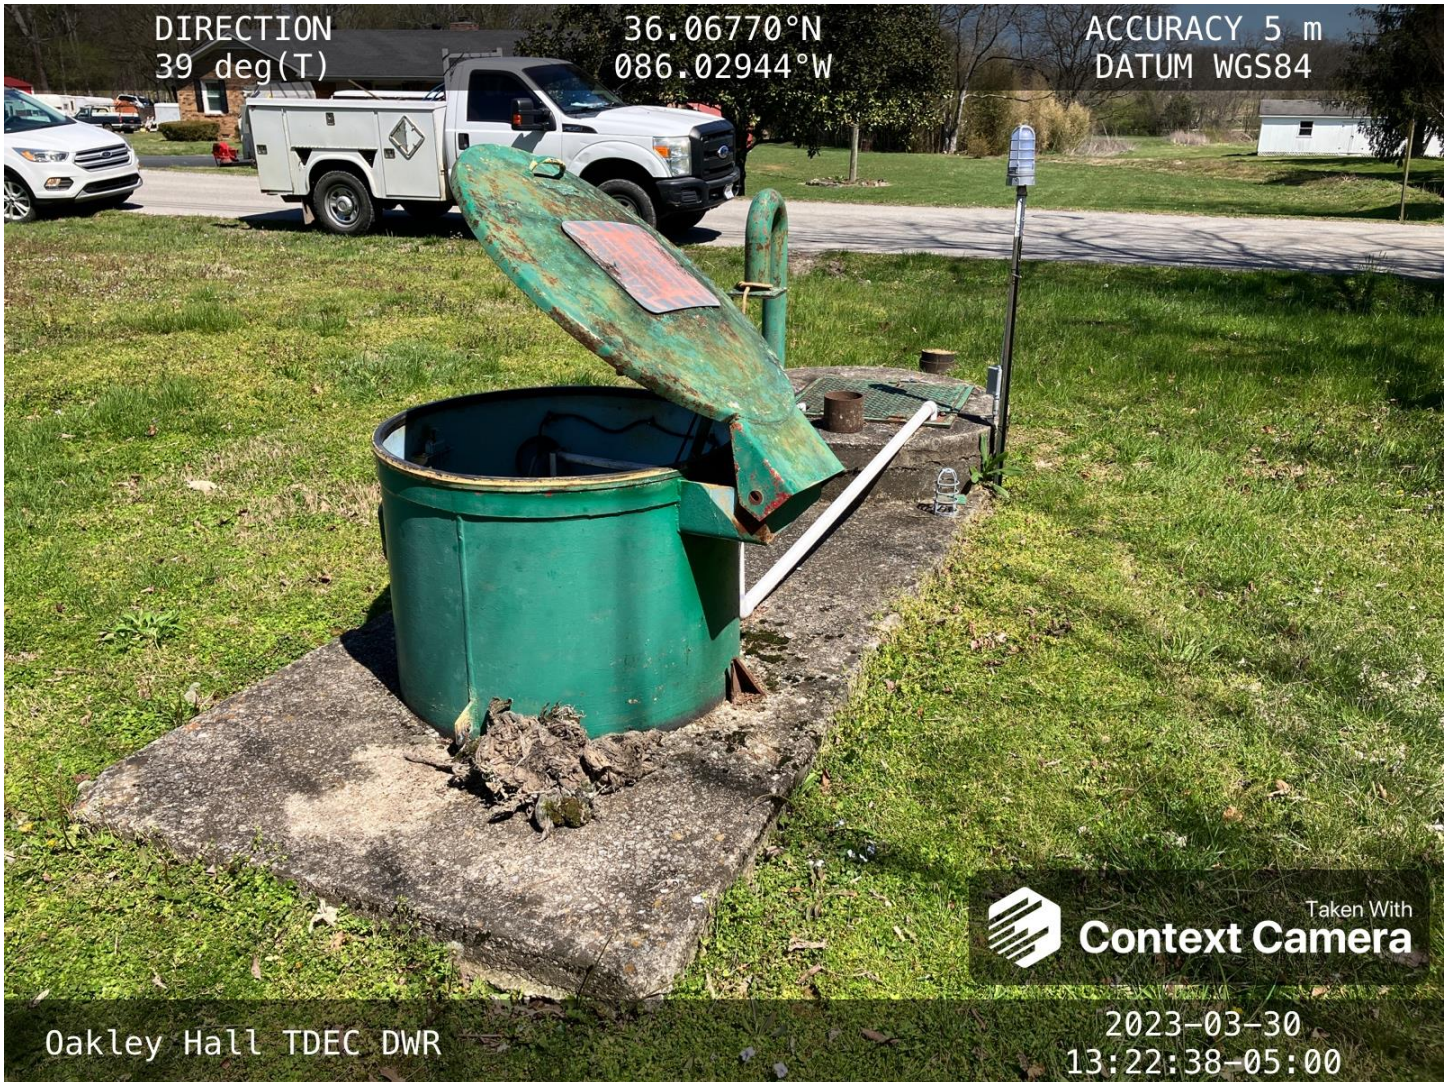
The single pump station in the collection system is pictured. The hinge on the manhole entry door is in need repair. The pump station has recently had a warning light installed in case of high-water levels. Flushable wipes within the pump station have been a problem. The pumps will often clog. The pumps in this station are reportedly becoming more difficult to repair. The pump station may need a major overhaul or upgrade.
