RE: Alexandria Sewer Treatment Plant (STP), Compliance Evaluation Inspection (CEI), Notice of Violation (NOV), Compliance Review Meeting (CRM) DeKalb County; NPDES # TN0021539 Permit Expiration: July 31, 2027

Town of Alexandria Sewage Treatment Plant (TN0021539) Compliance Evaluation Inspection, DeKalb County.

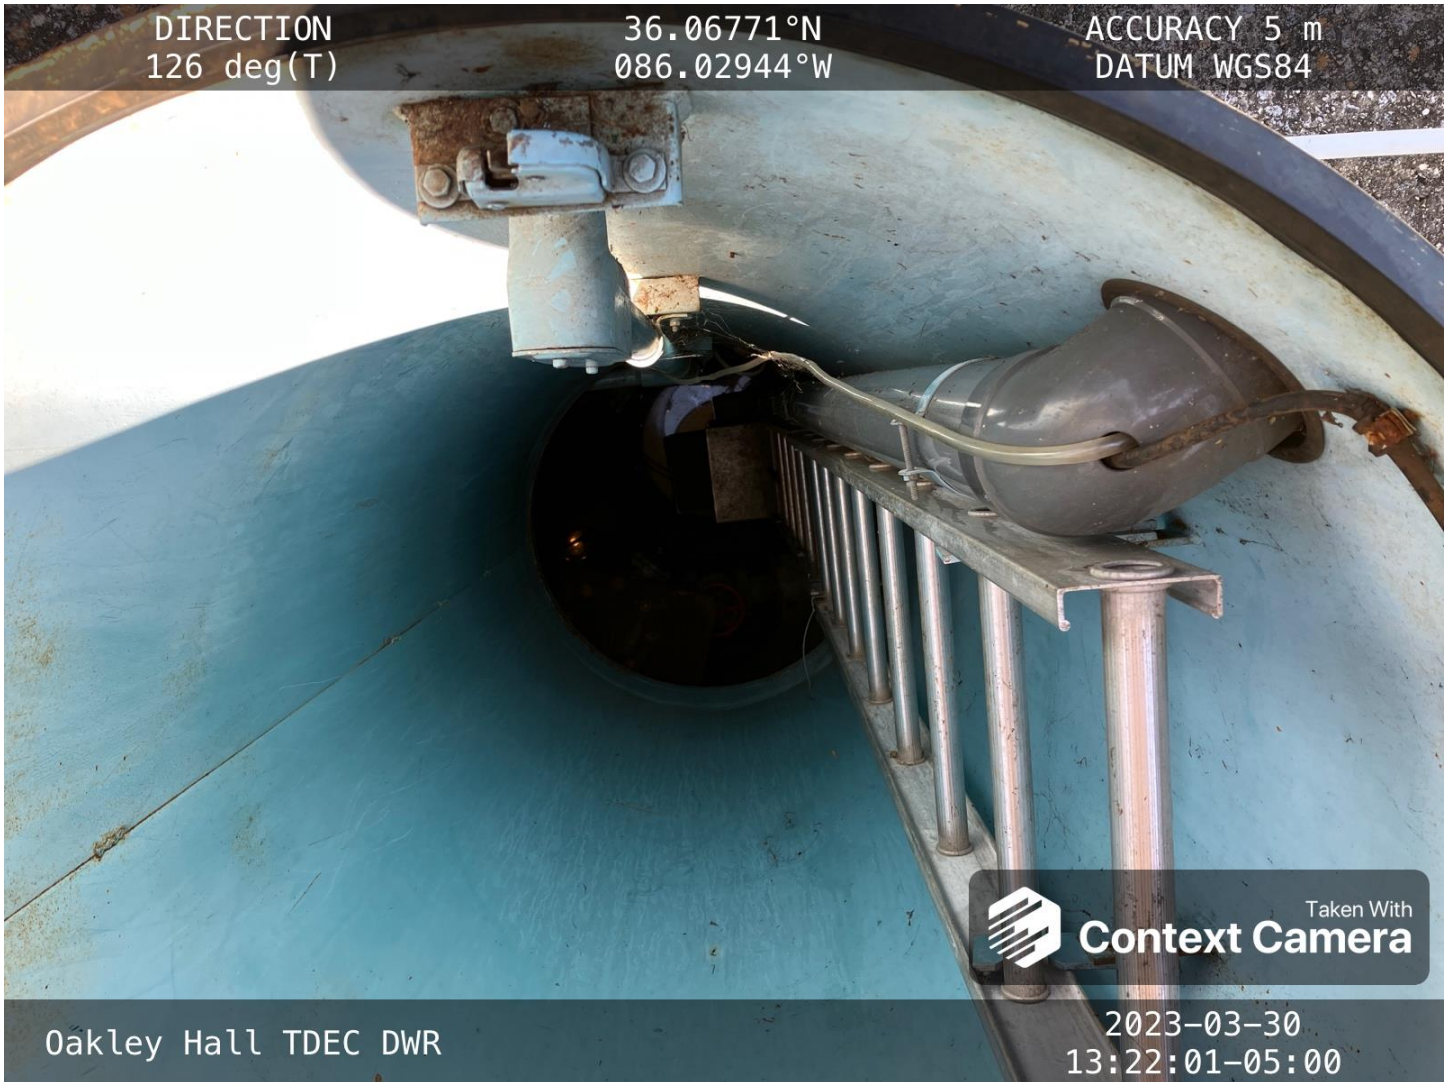
The sump in the pump station can no longer sit low enough to remove all the ground water in the floor of the pump station. Water was observed standing on the floor. The moisture may damage components in the pump station. It could be dangerous during repairs.

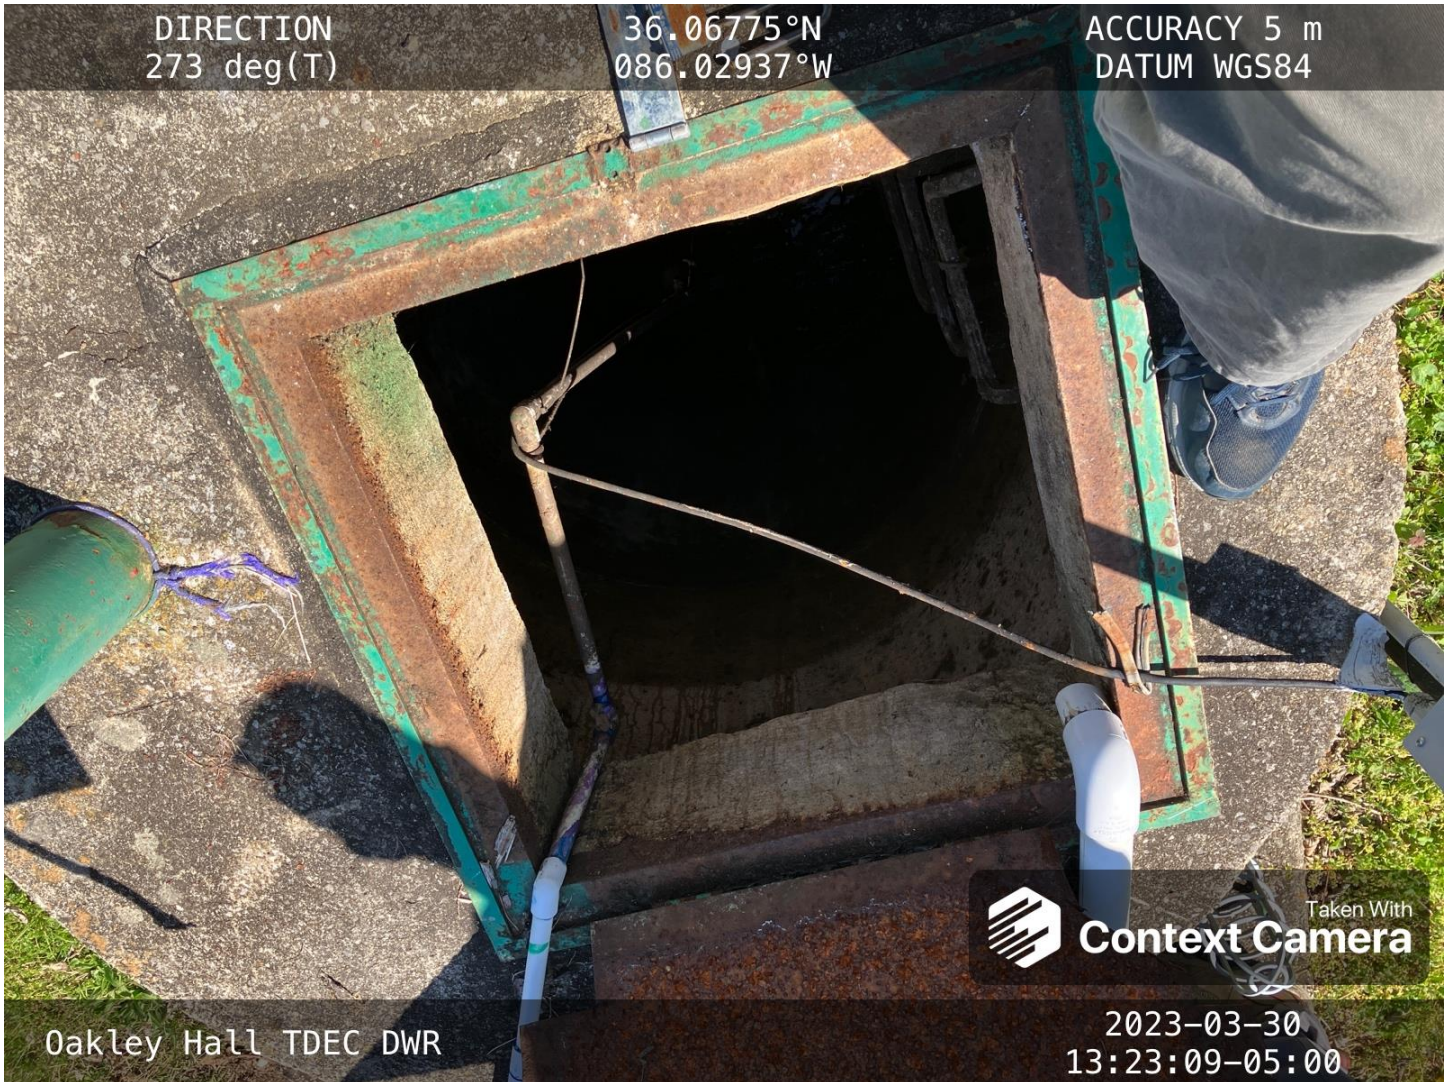
The pump station wet well was observed. The well was clean with a minimal amount of grease.

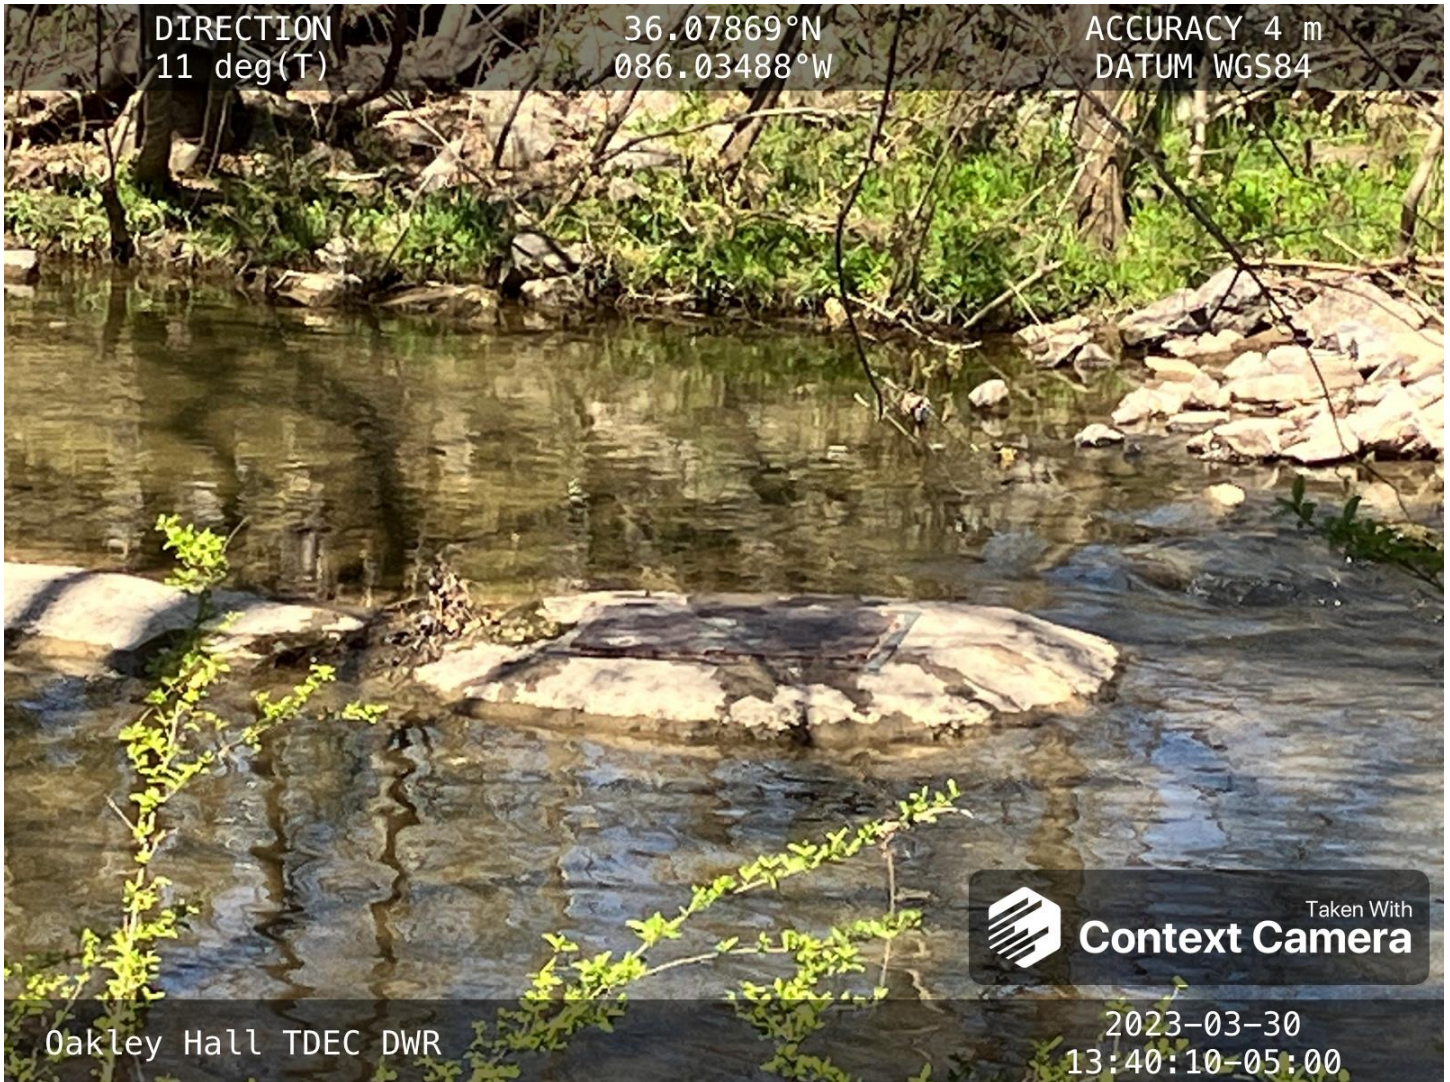
A series of manholes are located in-stream. Operators have recently sealed the manhole covers (complete welds) to reduce inflow and infiltration from the stream(s). The operators believe it has helped significantly.
