Bays Mountain Park Wastewater System
Preliminary Engineering Report
Revised Nov. 2016

Appendix A: Abandoned Waterline Observation Library

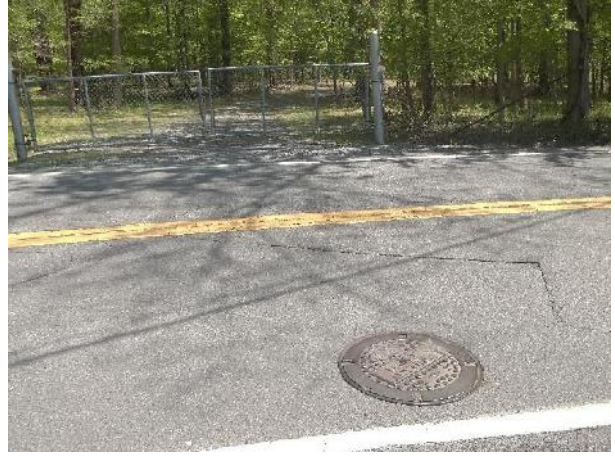
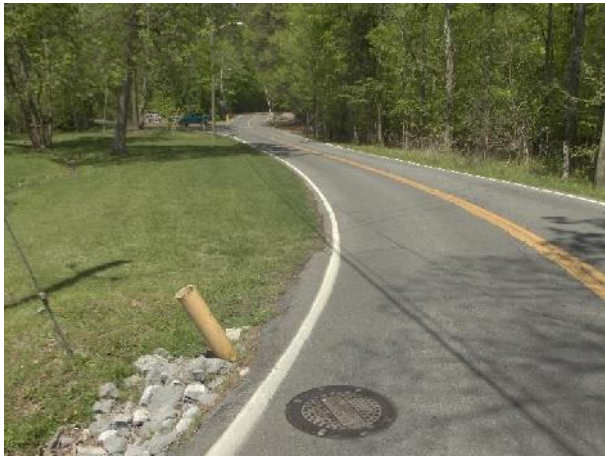
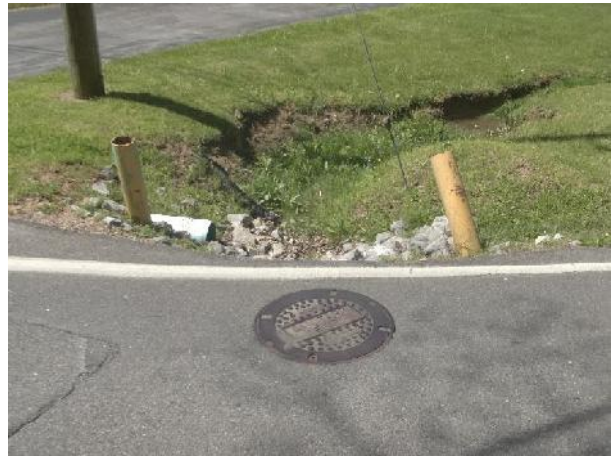
Location of first manhole at bottom of mountain

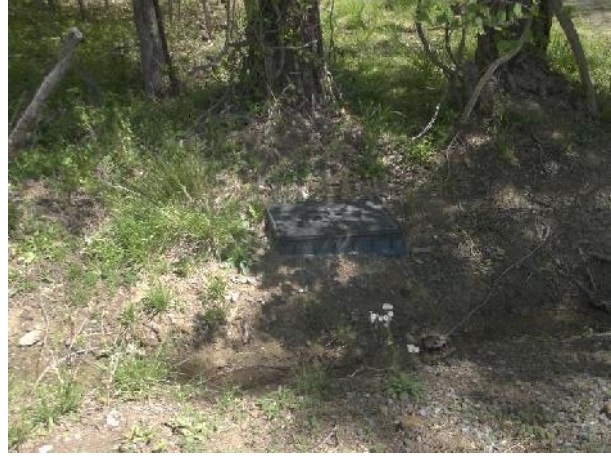
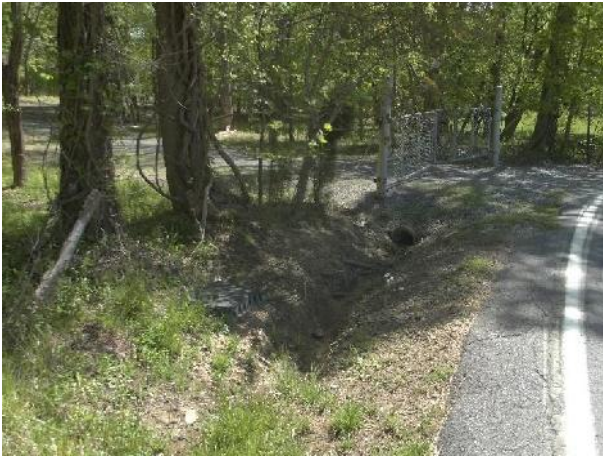
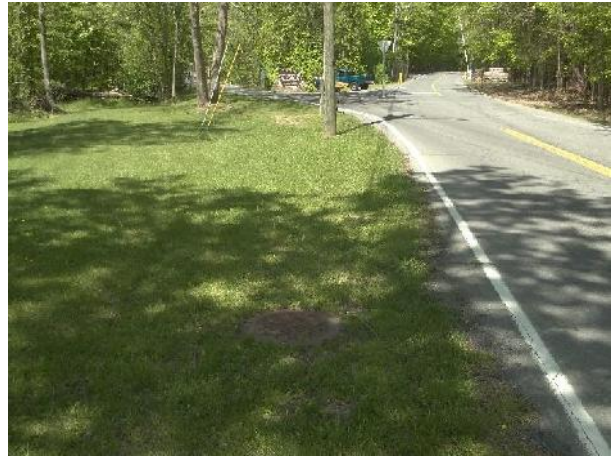
Location of second manhole and water meter at bottom of mountain

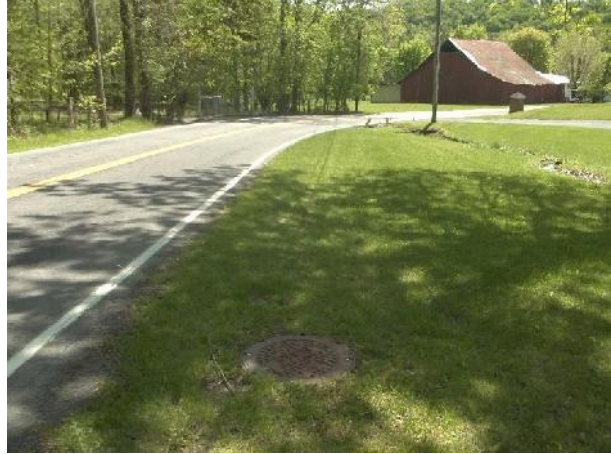
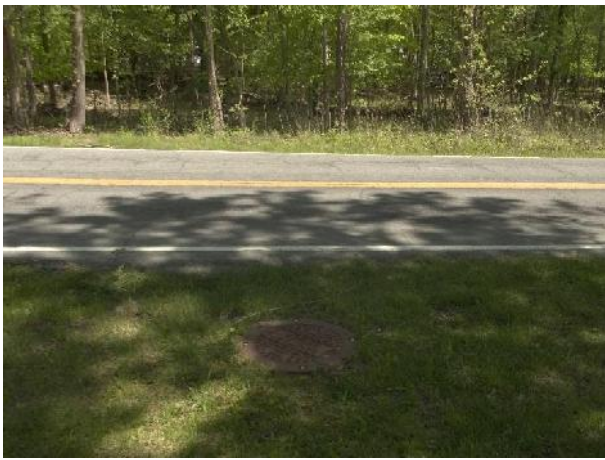
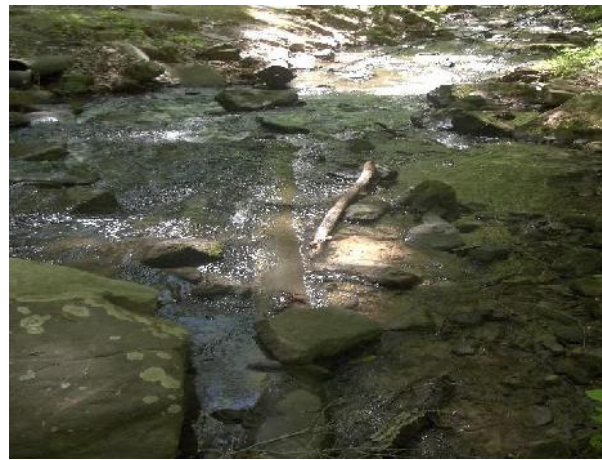
Location of second manhole at bottom of mountain and first stream crossing of abandoned water line

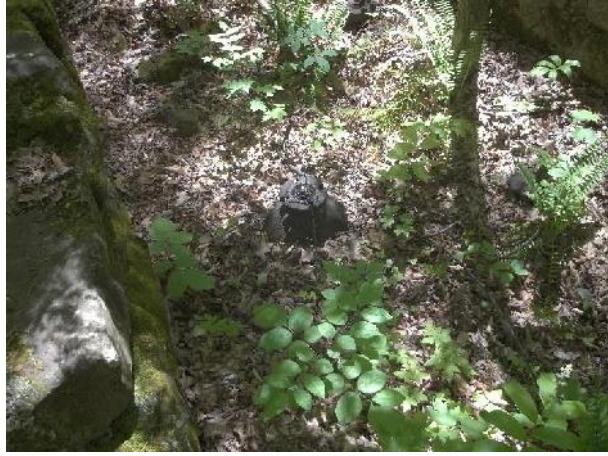
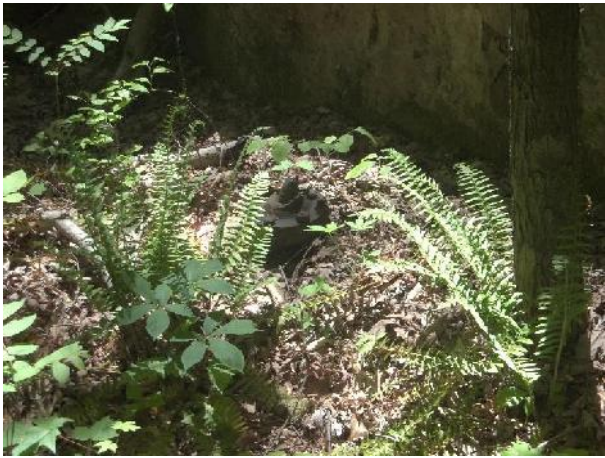
First crossing of abandoned water line across Dolan Branch in Eastman Chemical Company property as well as an abandoned gate valve

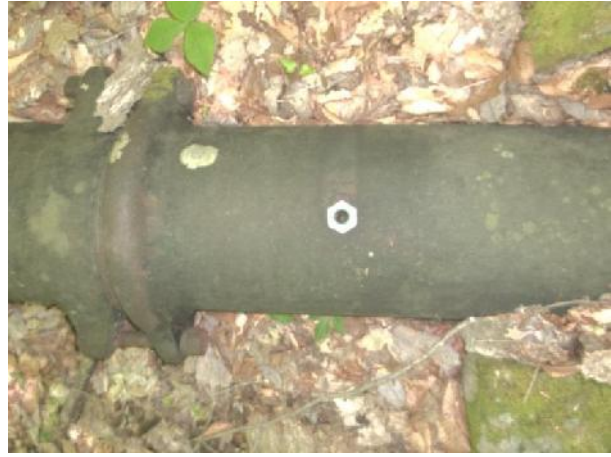
Depictions surface routing and taps in old water line

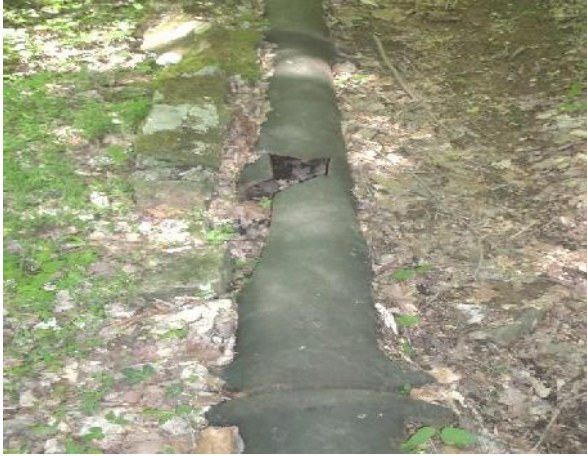
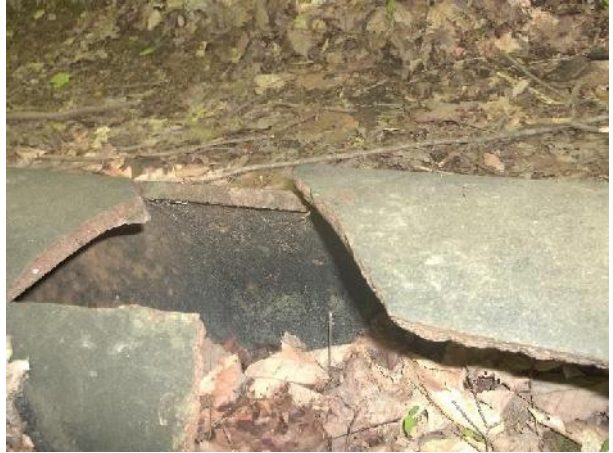
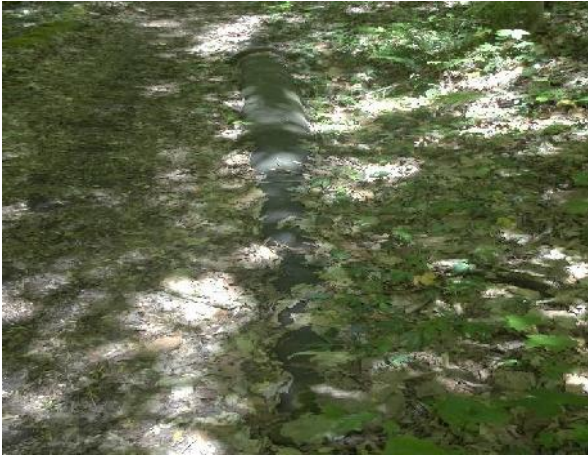
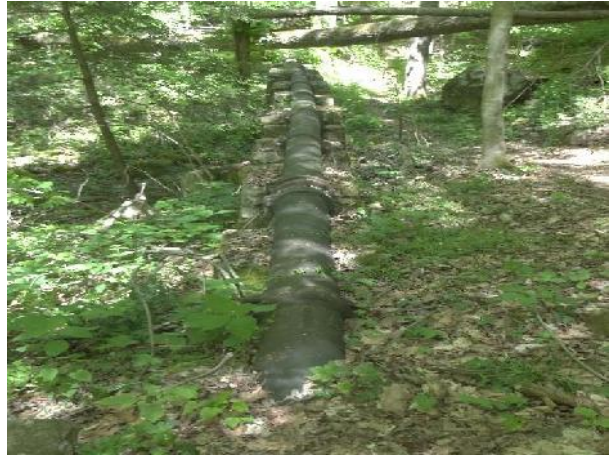
Photos showing fracture in pipe as well as rock pile pipe support and surface routing of abandoned line

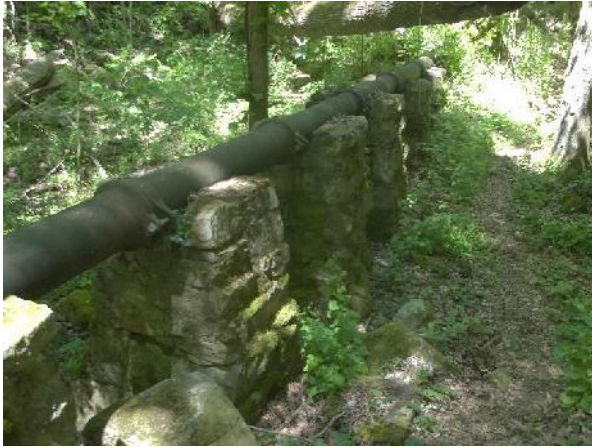
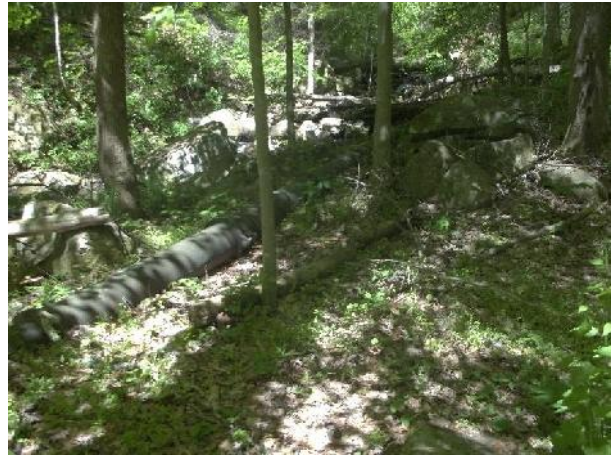
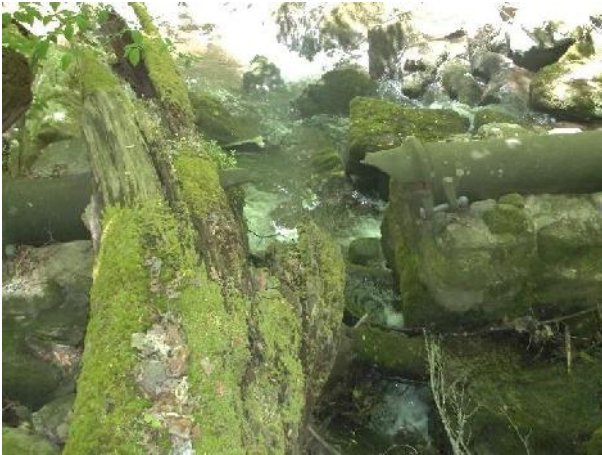
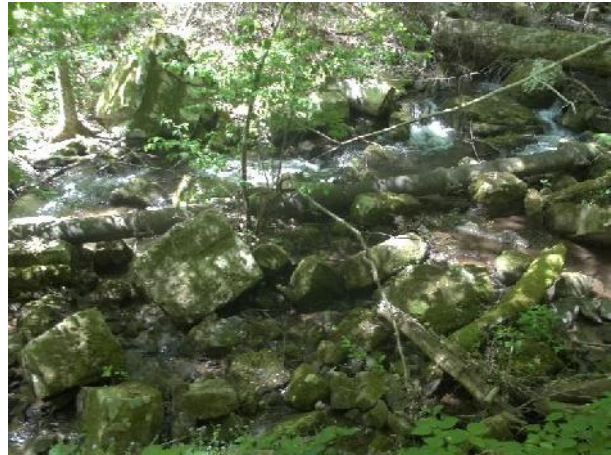
Rock pipe supports are approximately 4-5 feet tall. Also about 2 feet of pipe fractured, unsure of cause. There are lots of rock debris

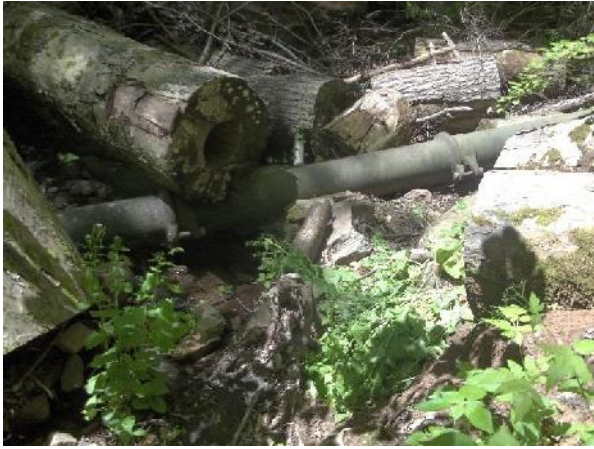
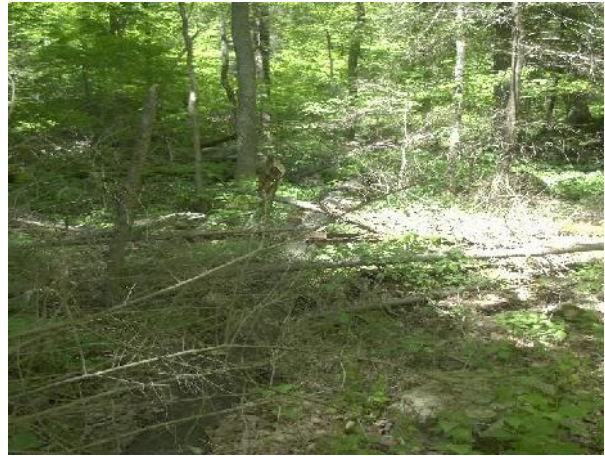
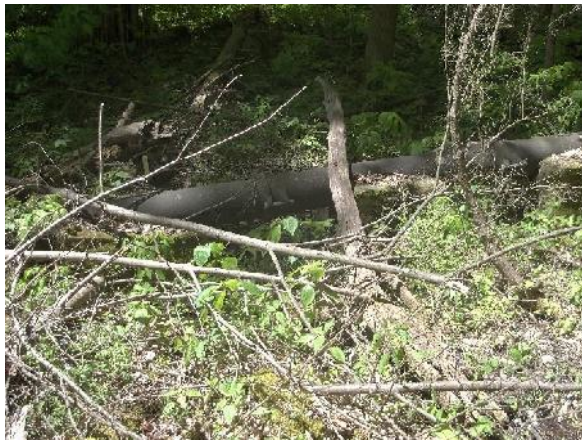
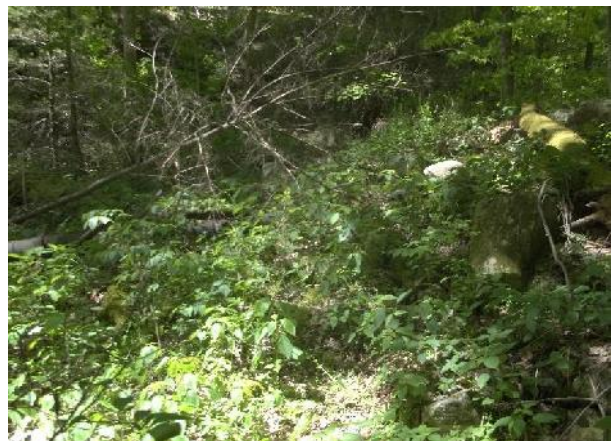
Pictures showing more debris and vegetation around old water line.

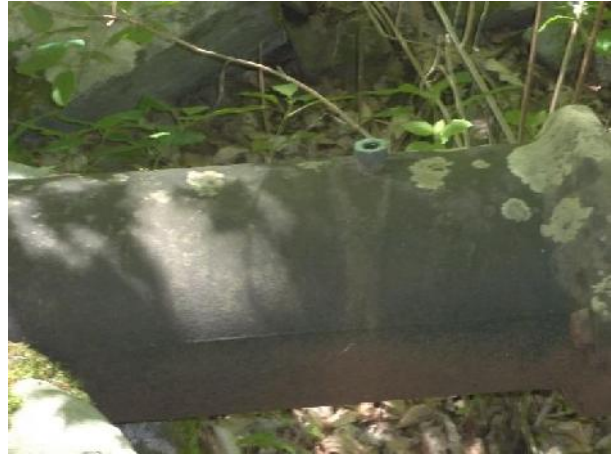
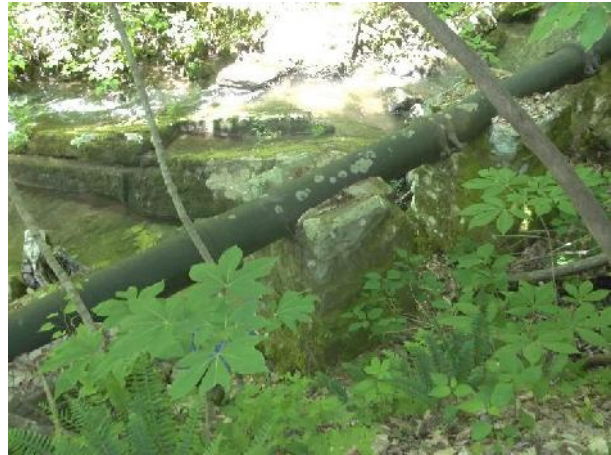
Photos showing debris around pipe, a tap, rock pipe supports, and complete separation of pipe.

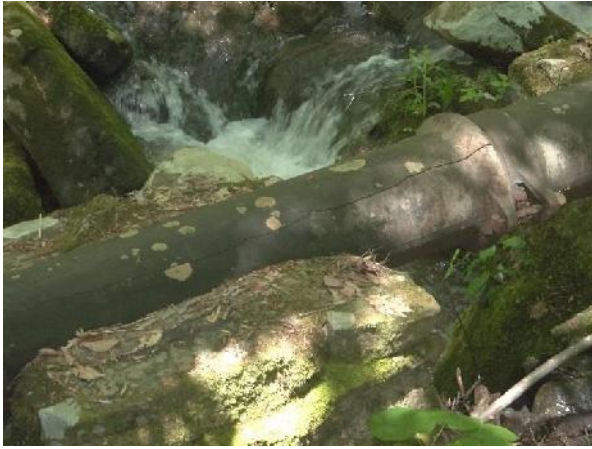
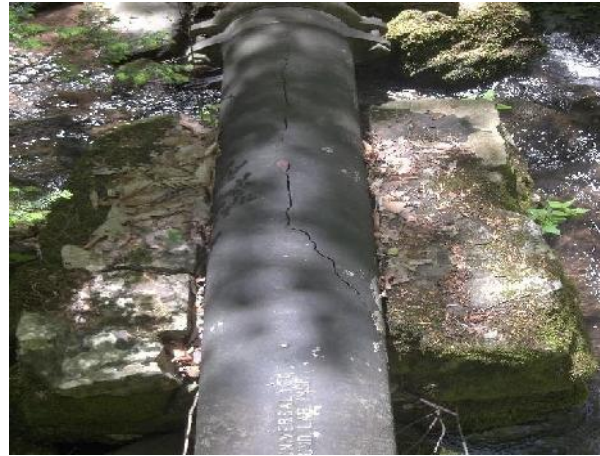
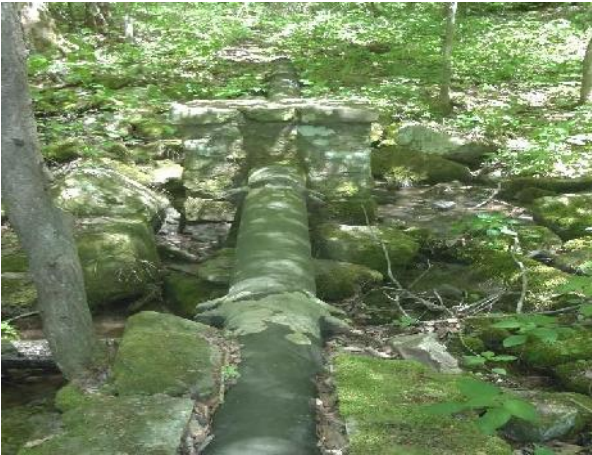
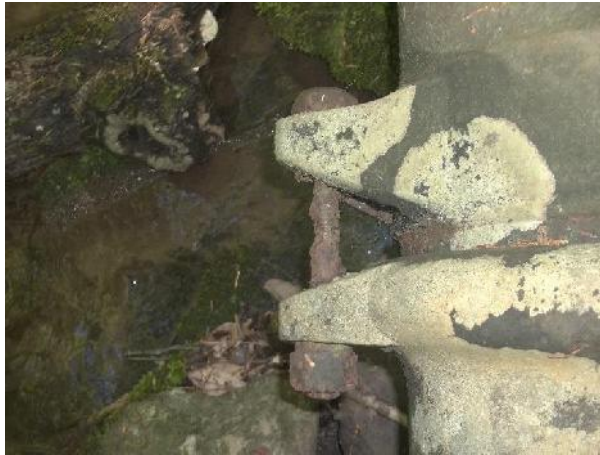
Photos of surface crack along pipe, stone enveloping pipe support, and severe corrosion of bolt.

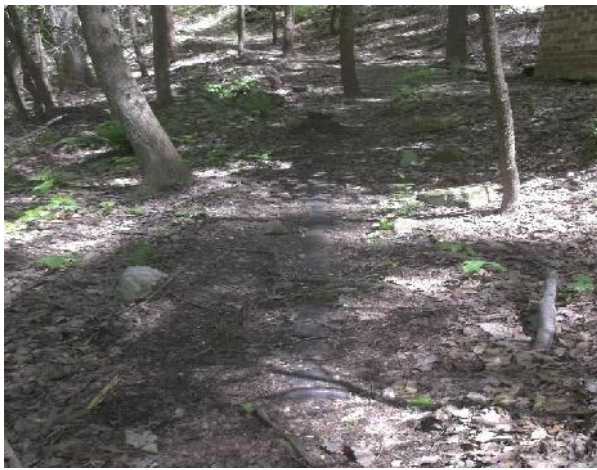
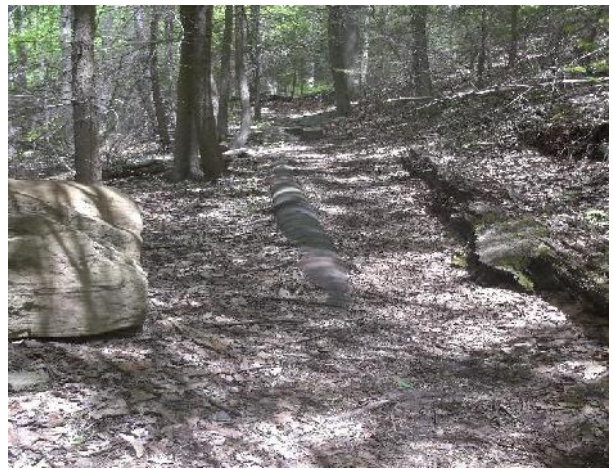
Photos of surface routing as well as a tap house.

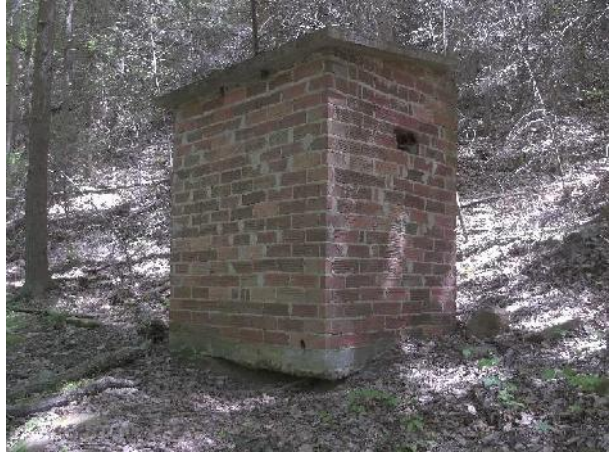
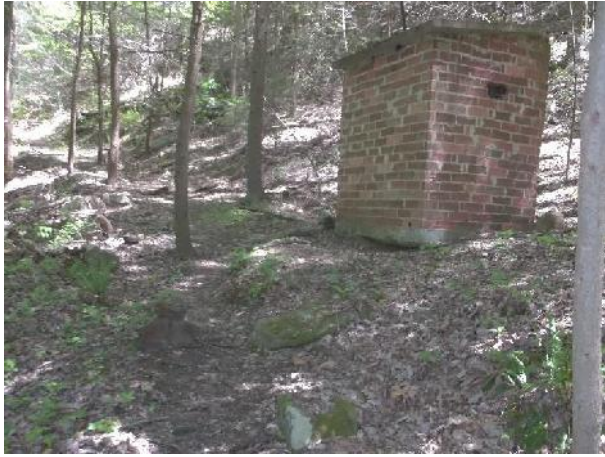
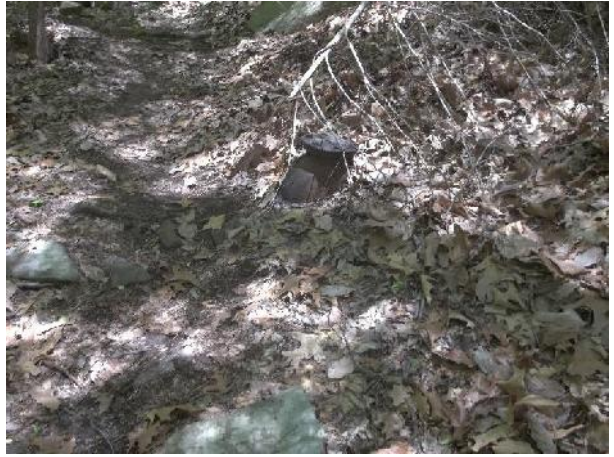
Abandoned gate valve and tap house possibly used for sampling

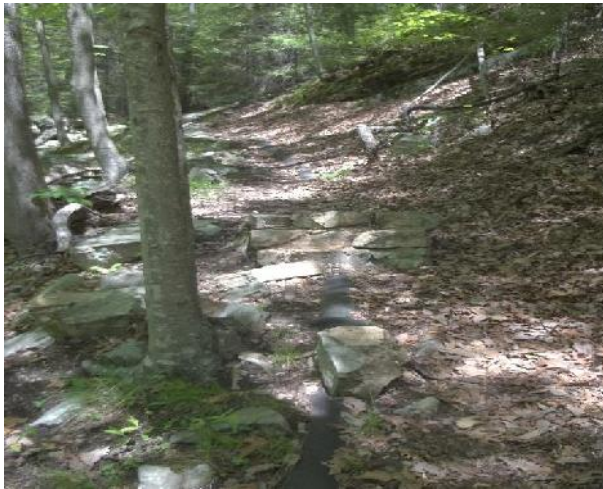
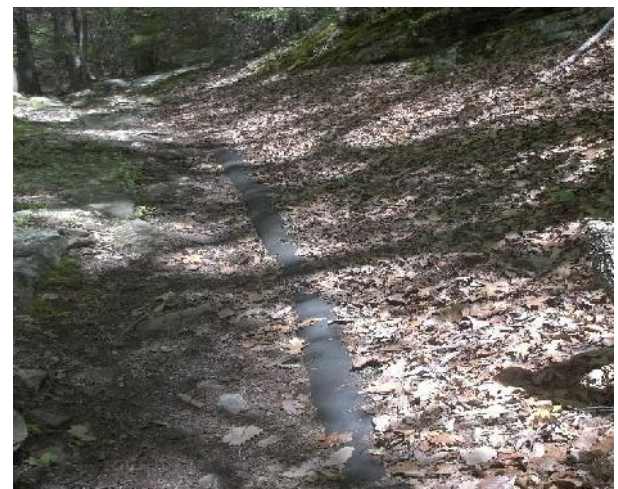
Cast iron tee used to water to concrete structure across stream. Also photos of concrete pipe supports where the discharge from the concrete structure came back across the stream to reconnect with the main water line.

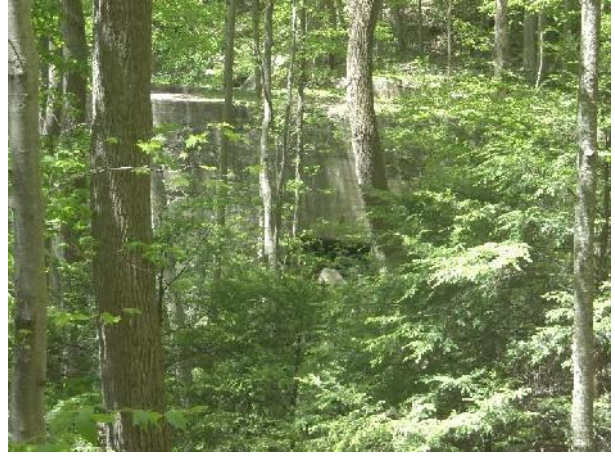
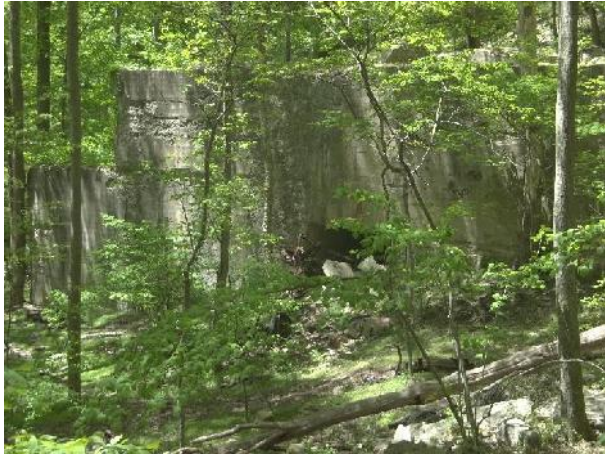
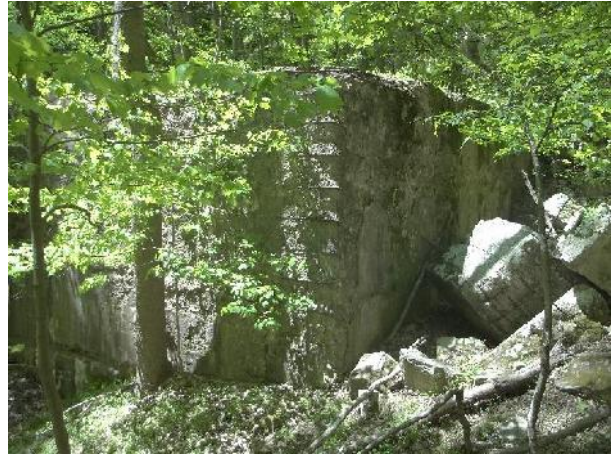
Photos of concrete structure across the stream from the water main

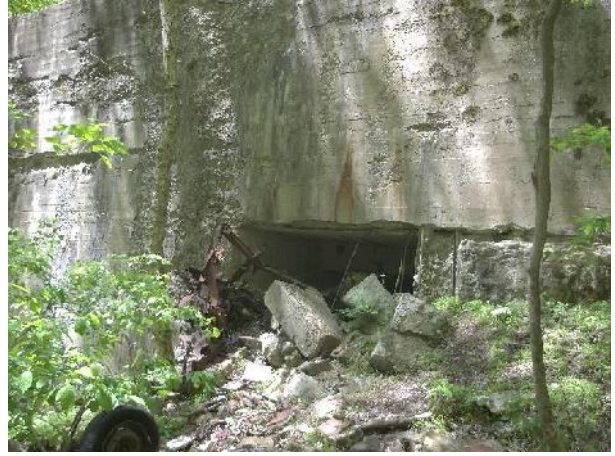
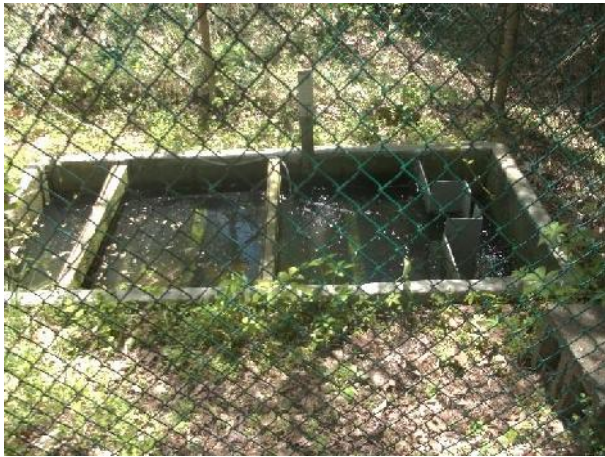
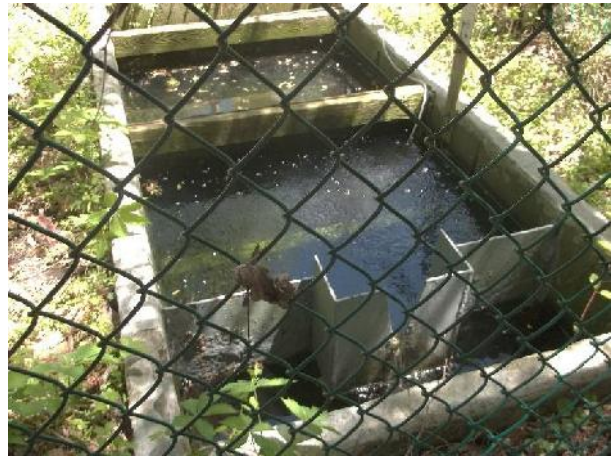
Photos of concrete structure across the stream from the water main as well as photos of the chlorine contact chamber with the newly installed aerator

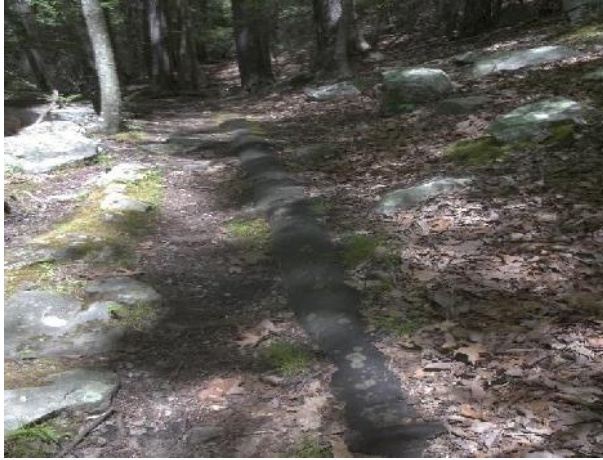
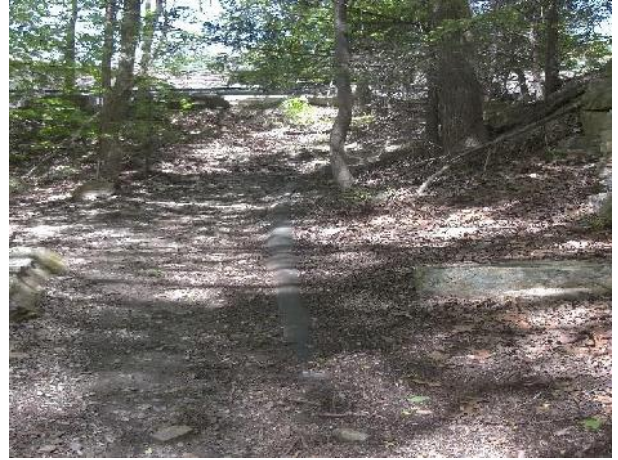
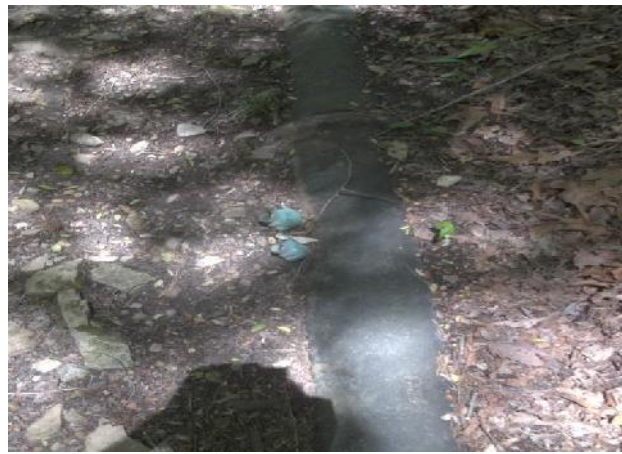
Photos of surface routing and taps towards to the top of the mountain. Bays Mountain Road can be seen at the top of one of the photos.

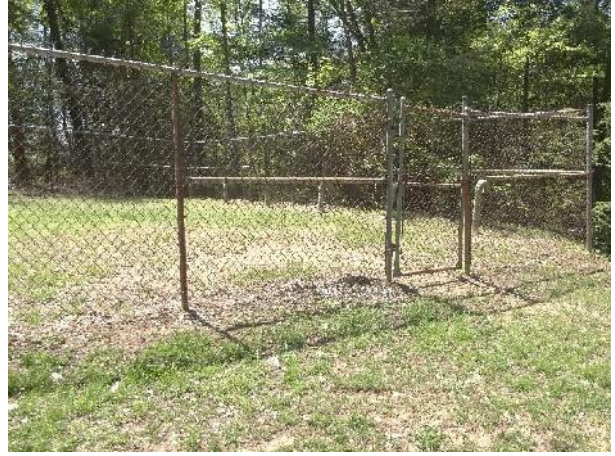
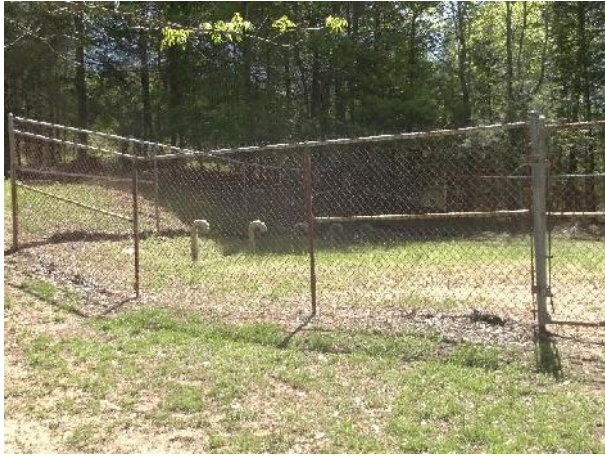
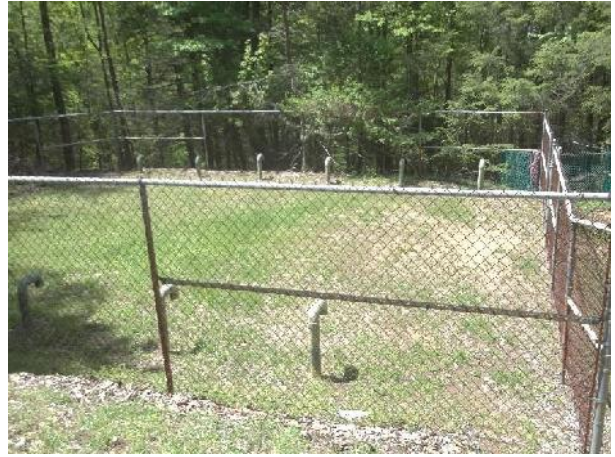
Photos of the current chlorine contact chamber and of the existing sand filtration bed.

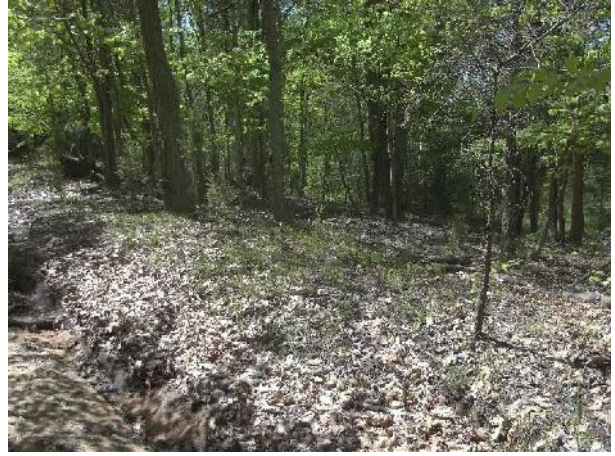
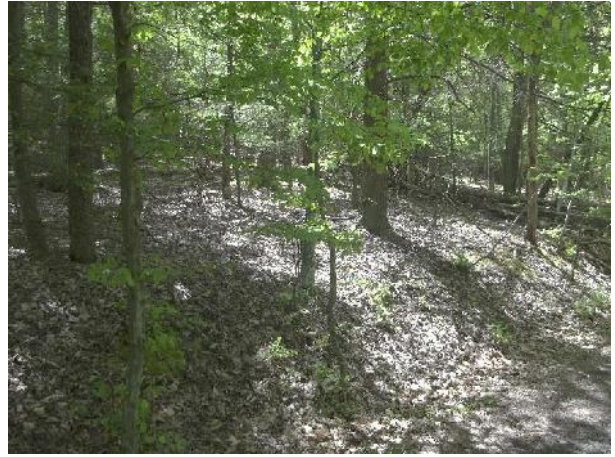
Photos of sand filtration bed as well as potential sites for land application across the dam.

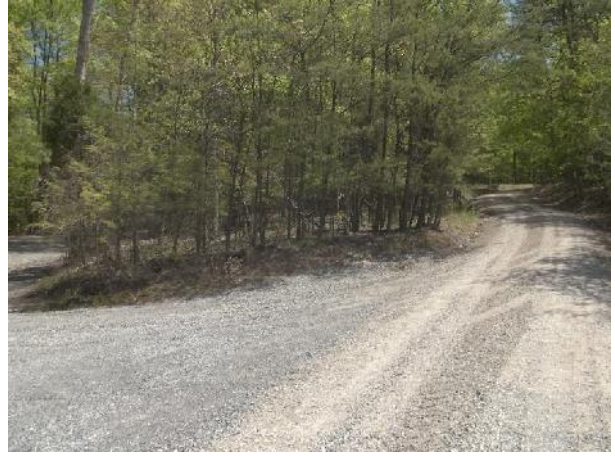
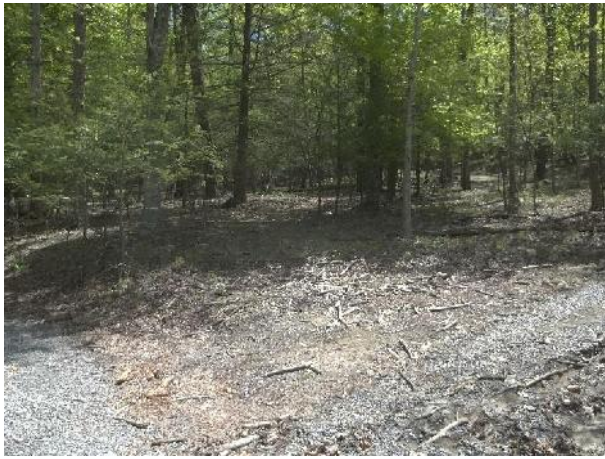
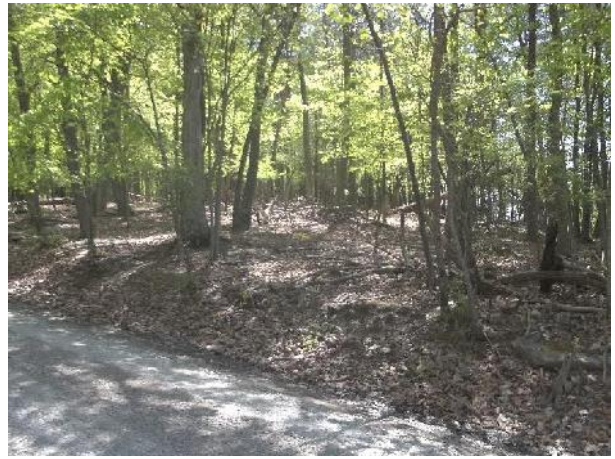
Photos of potential land application located up from the observatory.

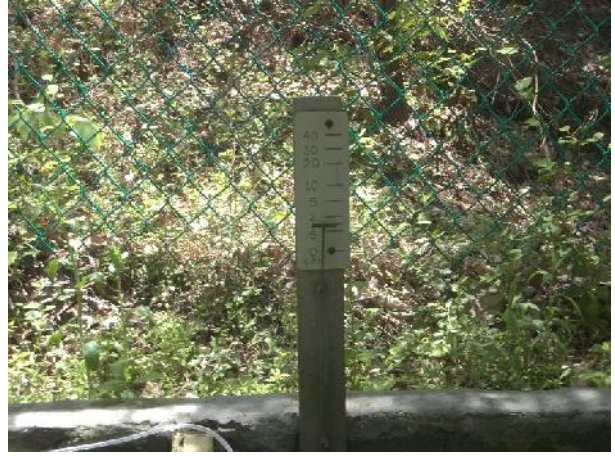
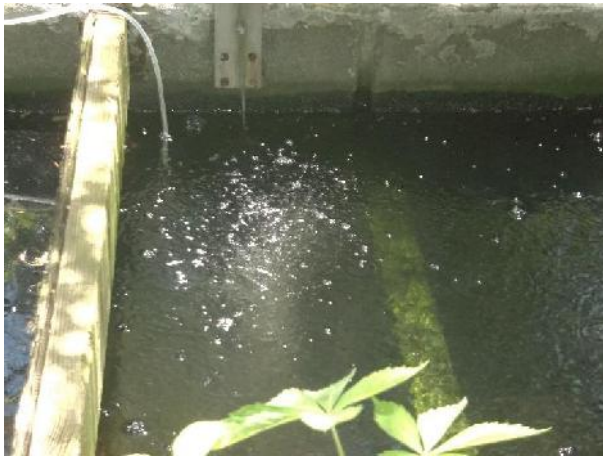
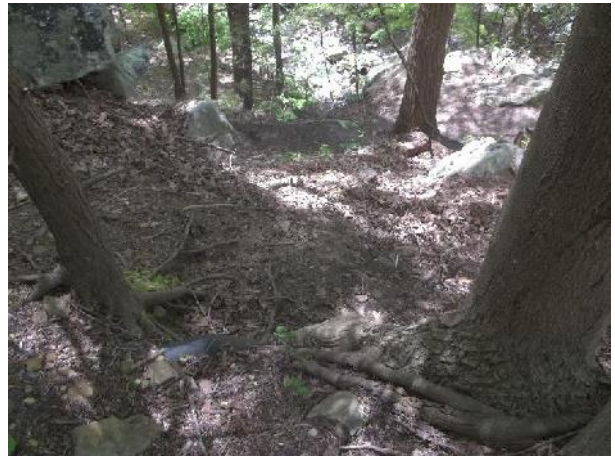
Photos of the grade between the sand filtration bed and the chlorine contact chamber, the flow monitoring method used at the chlorine contact chamber, the newly installed aeration system, and the routing of the pipe to the discharge point.

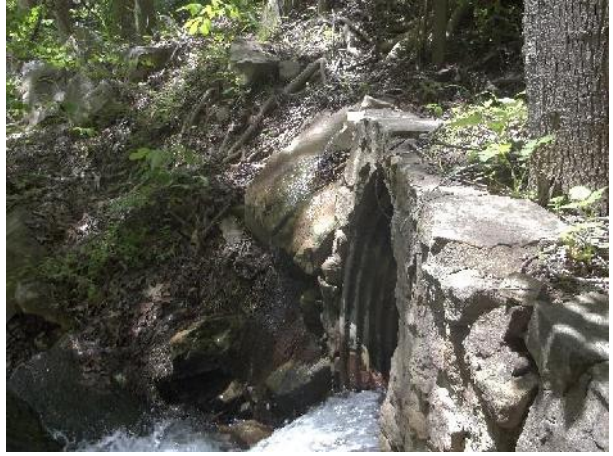
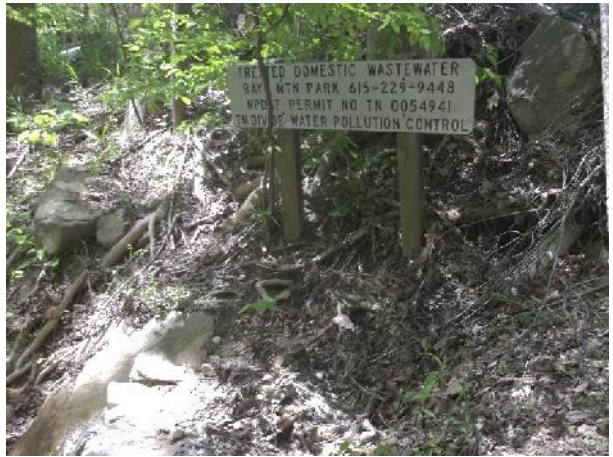
Photos depicting the finished effluent as it discharges into the Dolan Branch at stream mile 1.5
