General NPDES Permit for Stormwater Discharges from Construction Activities (CGP)

RE: Site Assessment Report Individual Construction Permit TN0081949 Jasper Highlands ADE Project No. 16161

JASPER HIGHLANDS Site Assessment Report Marion County, TN

RE: Site Assessment Report Individual Construction Permit TN0081949 Jasper Highlands

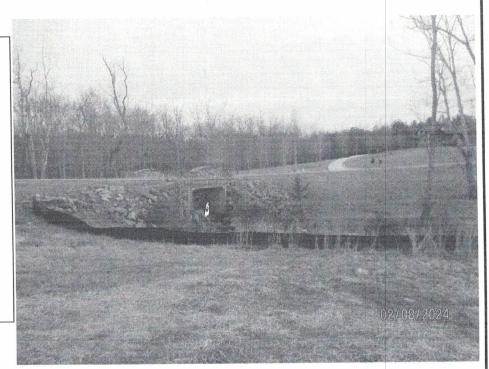
Photo 1:

- Currently the disturbed area within outfall S59 consists of two homes being constructed totaling approximately 1.0 acres of disturbance.
- The individual lot-level erosion controls were observed and appeared to be functioning properly (see photo 1).
- The outfall sampling location was observed, and no signs of sediment discharge were observed.

The individual lot level erosion controls have been installed and appear to be functioning properly.

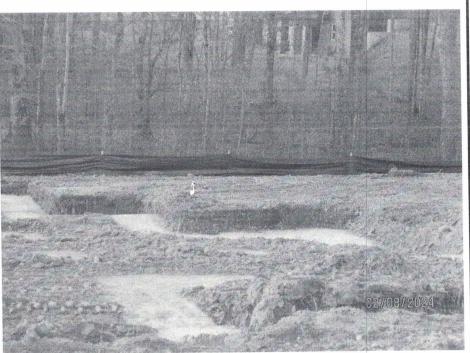
Photo 2:

- Currently the disturbed area within outfall S98 consists of two homes being constructed totaling approximately 0.60 acres of disturbance.
- The individual lot-level erosion controls were observed and appeared to be functioning properly (see photo 2).
- The outfall sampling location was observed, and no signs of sediment discharge were observed.

The individual lot level erosion controls have been installed and appear to be functioning properly.

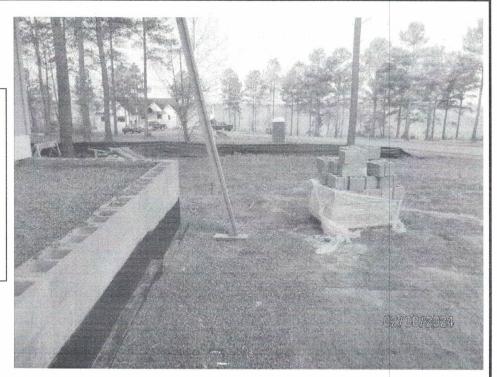
Photo 3:

- Currently the disturbed area within outfall S153 consists of three home construction sites. The disturbed area within the outfall S153 drainage basin is approximately 1.5 acres.
- The individual lot-level erosion controls were observed and appeared to be functioning properly (see photo 3).
- The stormwater basins have been installed and appear to be stabilized.

The individual lot level erosion controls have been installed and appear to be functioning properly.

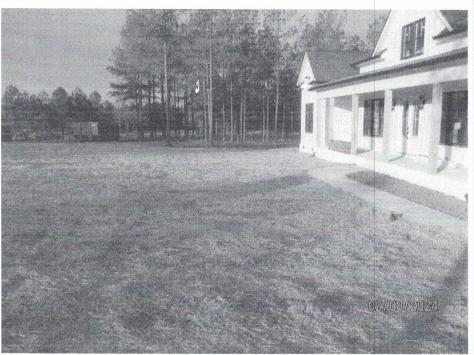
Photo 4:

- Currently the disturbed area within outfall S201 consists of three home construction sites. The disturbed area within the outfall S201 drainage basin is approximately 1.2 acres.
- The individual lot-level erosion controls were observed and appeared to be functioning properly (see photo 4).
- The stormwater basins have been installed and appear to be stabilized.

The individual lot level erosion controls have been installed and appear to be functioning properly.

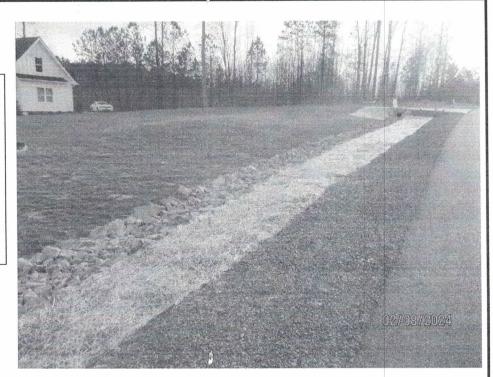
Photo 5:

- Currently the disturbed area within outfall S208 consists of the construction of 2 home construction sites and utility installation along the roadway. The disturbed area within the outfall S208 drainage basin is approximately 2.0 acres.
- The stormwater basins have been installed and appear to be stabilized.
- The individual lot-level erosion controls were observed and appeared to be functioning properly (see photo 5).

The individual lot level erosion controls have been installed and appear to be functioning properly.

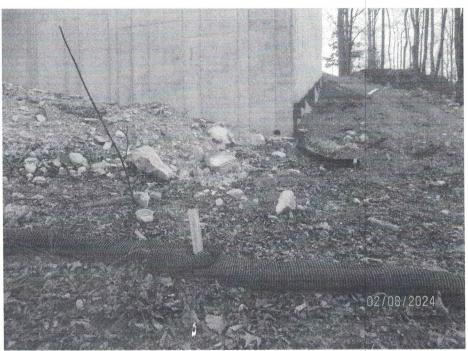
Photo 6:

- Currently the disturbed area within outfall S218 consists of 7 home construction sites, roadway construction, and utility installation along the roadway. The disturbed area within the outfall S218 drainage basin is approximately 2.5 acres.
- The individual lot-level erosion controls were observed and appeared to be functioning properly (see photo 6).

The individual lot level erosion controls have been installed and appear to be functioning properly.

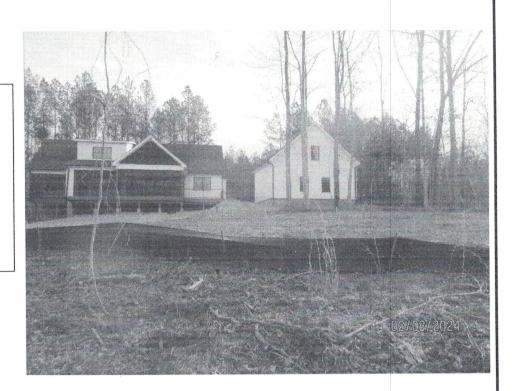
Photo 7:

- Currently the disturbed area within outfall S275 consists of roadway construction, utility installation along the roadway, and one home construction site. The disturbed area within the outfall S275 drainage basin is approximately 0.75 acres.
- The individual lot-level erosion controls were observed and appeared to be functioning properly (see photo 7).
- A sediment basin was observed and appeared to be functioning properly.

The individual lot level erosion controls have been installed and appear to be functioning properly.

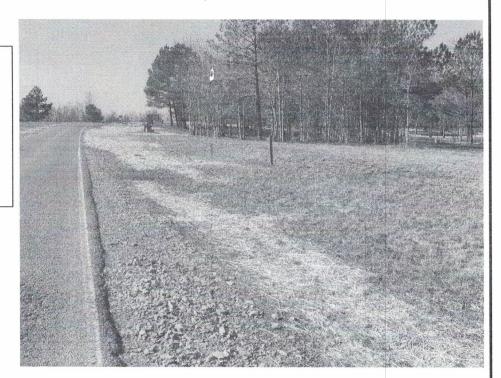
- Currently the disturbed area within outfall S59 consists of two homes being constructed totaling approximately 1.0 acres of disturbance.
- The outfall sampling location was observed. The runoff appeared to be free of sediment.
- Areas along the roadside have recently been stabilized with seed and straw (see photo 1).

Areas along the roadside have recently been stabilized with seed and straw.

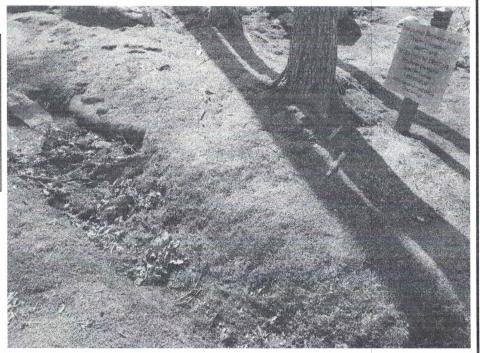
Photo 2:

- Currently the disturbed area within outfall S98 consists of two homes being constructed totaling approximately 0.6 acres of disturbance.
- The outfall sampling location was observed, and the runoff appeared to be free of sediment (see photo 2).

The outfall sampling location was observed. The runoff appeared to be free of sediment.

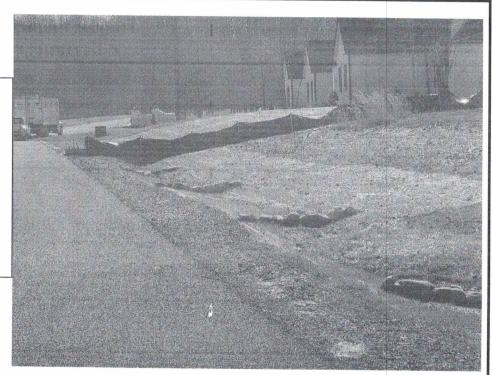
- Currently the disturbed area within outfall S153 consists of three home construction sites. The disturbed area within the outfall S153 drainage basin is approximately 1.5 acres.
- An individual home construction site was observed, and erosion control measures appeared to be in place and functioning properly (see photo 3).
- The outfall sampling location was observed, and no signs of sediment discharge were observed.

An individual home construction site was observed, and erosion control measures appeared to be in place and functioning properly.

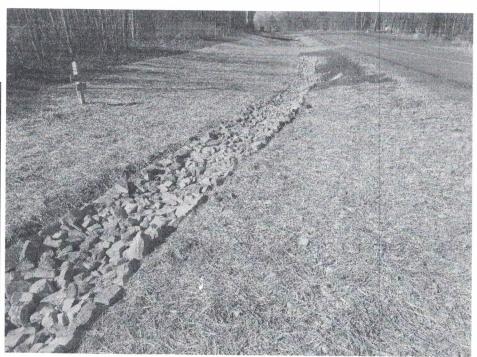
Photo 4:

- Currently the disturbed area within outfall S201 consists of three house construction sites. The disturbed area within the outfall S201 drainage basin is approximately 1.2 acres.
- A roadside swale was observed. The swale has recently been stabilized with rock, and the side slopes have recently been stabilized with seed and straw as well as matting in some areas (see photo 4).

A roadside swale was observed. The swale has recently been stabilized with rock, and the side slopes have recently been stabilized with seed and straw as well as matting in some areas.

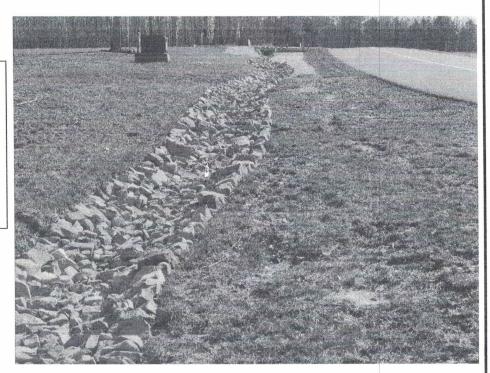
- Currently the disturbed area within outfall S208 consists of the construction of 2 home construction sites, roadway construction, and utility installation along the roadway. The disturbed area within the outfall S208 drainage basin is approximately 2.0 acres.
- A roadside swale was observed. The swale has recently been stabilized with rock (see photo 5).

A roadside swale was observed. The swale has recently been stabilized with rock.

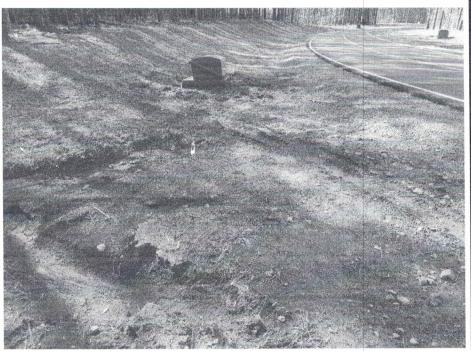
Photo 6:

- Currently the disturbed area within outfall S218 consists of 7 home construction sites, roadway construction, and utility installation along the roadway. The disturbed area within the outfall S218 drainage basin is approximately 2.5 acres.
- Recent roadside utility work was observed. Disturbed areas should be stabilized after the utility work is complete (see photo 6).

Recent roadside utility work was observed. Disturbed areas should be stabilized after the utility work is complete.

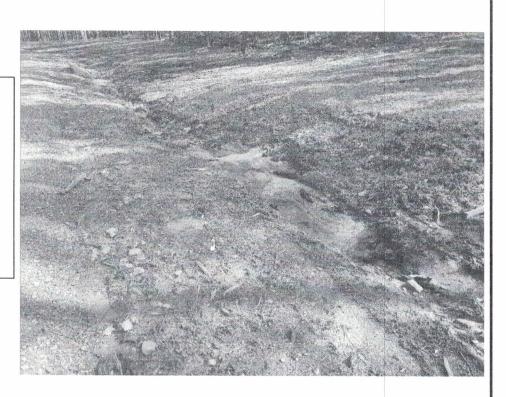
- Currently the disturbed area within outfall S275 consists of roadway construction, utility installation along the roadway, and one home construction site. The disturbed area within the outfall S275 drainage basin is approximately 0.75 acres.
- A roadside swale was observed. The checkdams appear to be capturing sediment, and should be cleaned out when capacity reaches 50% (see photo 7).

A roadside swale was observed. The checkdams appear to be capturing sediment, and should be cleaned out when capacity reaches 50%.
