STATE OF TENNESSEE
DEPARTMENT OF ENVIRONMENT AND CONSERVATION
KNOXVILLE ENVIRONMENTAL FIELD OFFICE
DIVISION OF MINERAL & GEOLOGIC RESOURCES – MINING SECTION
3711 MIDDLEBROOK PIKE
KNOXVILLE, TENNESSEE 37921-6538
PHONE (865) 594-6035 STATEWIDE 1-888-891-8332 FAX (865) 594-6105

Mining Facility Inspection Report

Inspection start date and time: May 8, 2023 9:30 AM

NPDES permit number: TN0070408

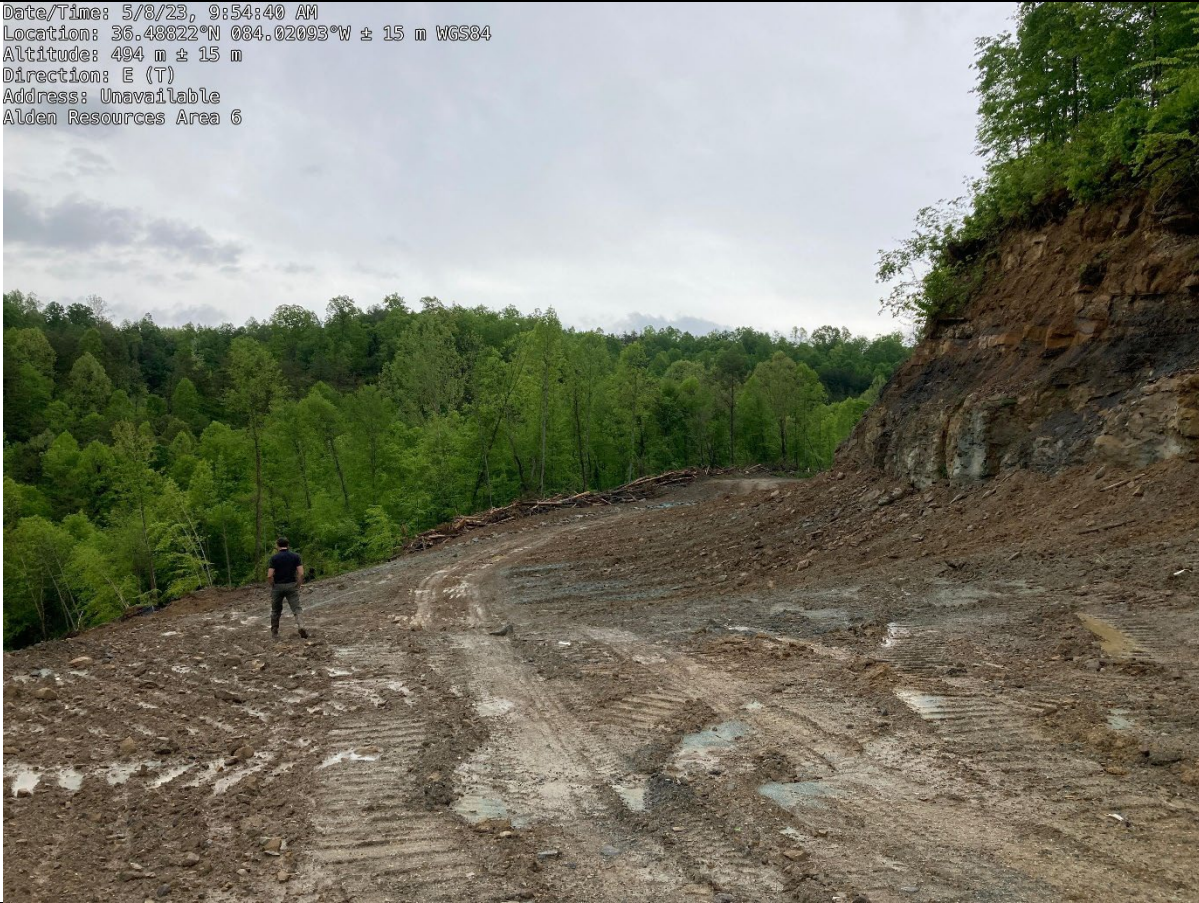
This site was inspected in response to notification that work had been completed to stabilize the landslide as per the CAP plan. Pond 103 has been removed and regraded. A rock-lined channel has been constructed down the landslide and tied into an existing wet weather conveyance. The channel and conveyance drain water off of the landslide. The areas were hydroseeded.

Item 1: Photo of the area where pond 103 was formerly located. The pond was filled in and area graded and hydroseeded to help stabilize the slide area, which begins below the former pond.

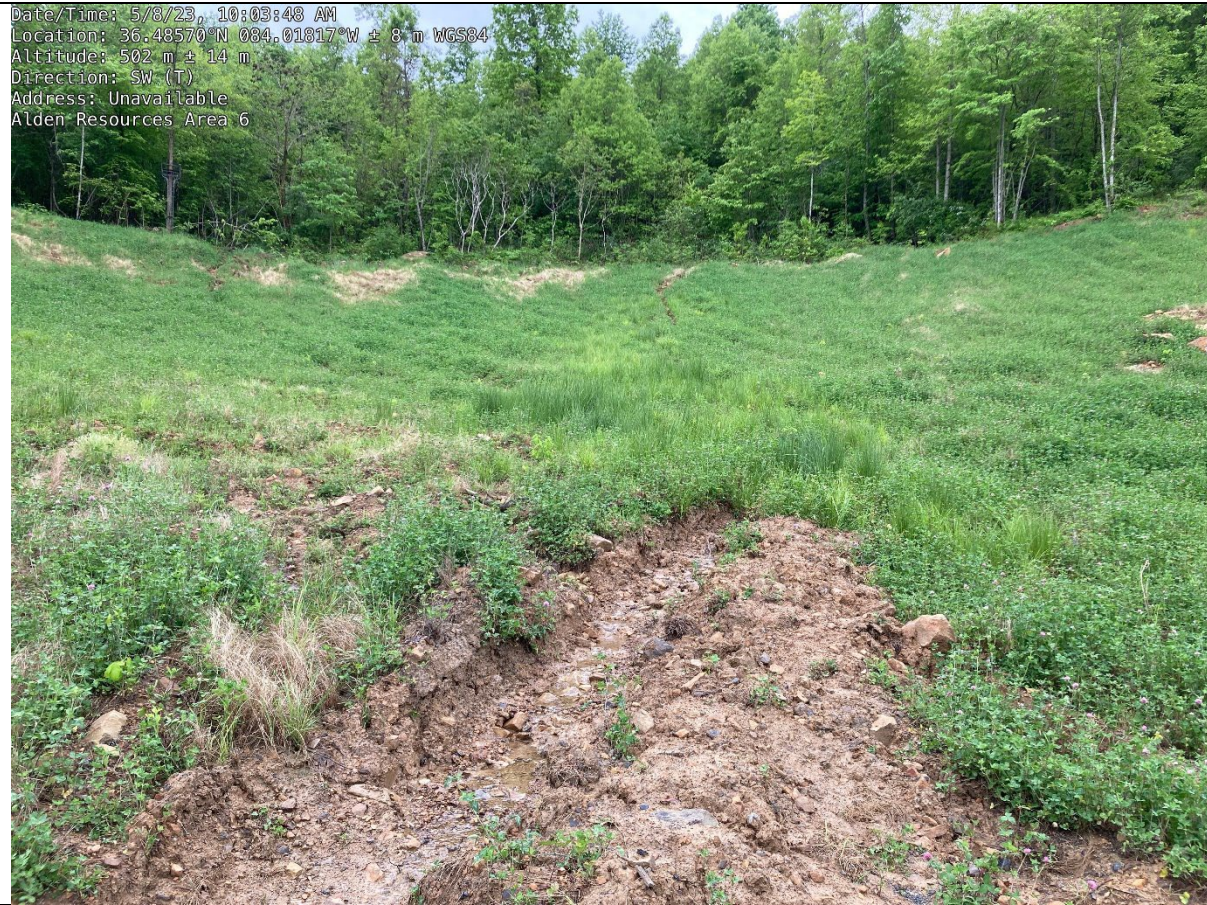
Item 2: Photo of the wet weather conveyance descending down the right side of the head of hollow. This is one of the features that was discussed as an area to improve during the 4/25/2023 inspection.

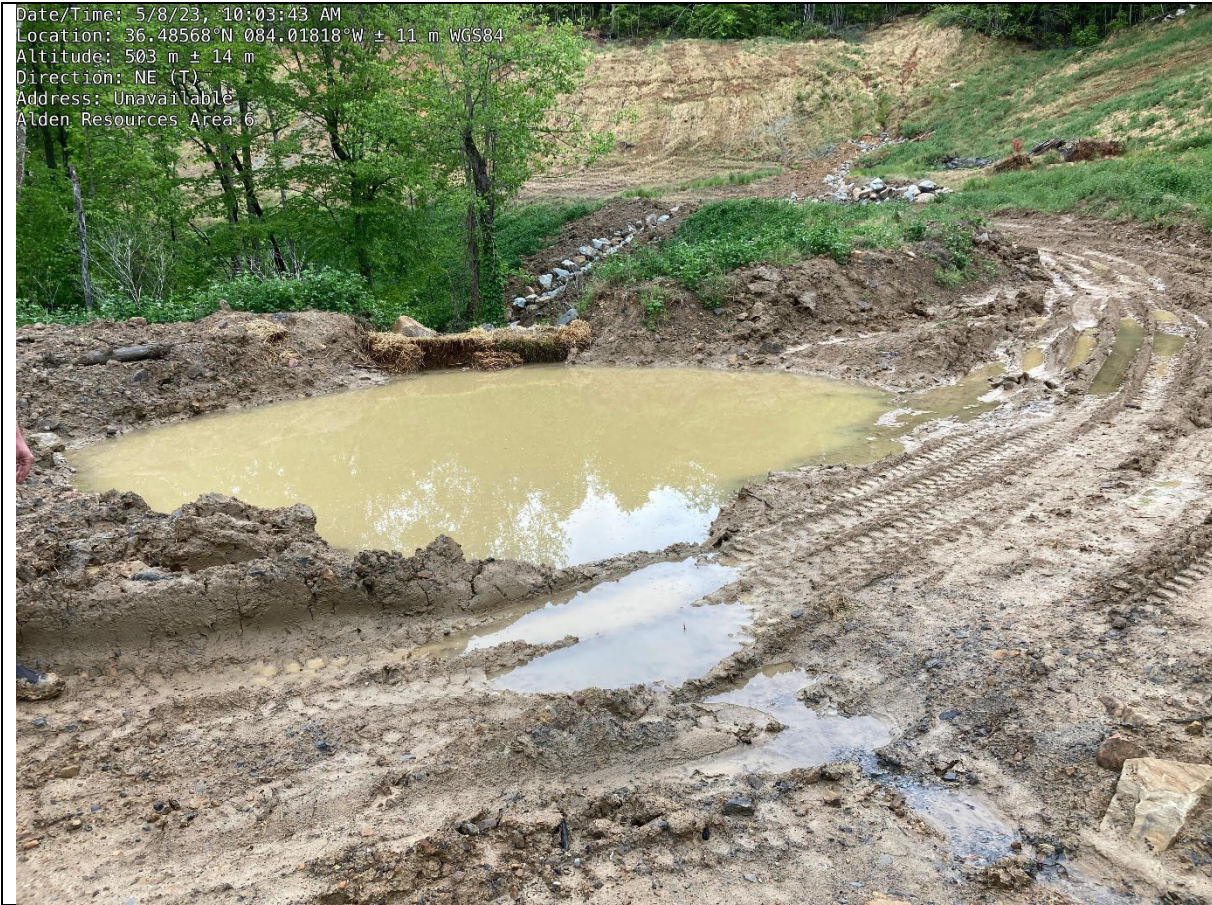
Item 3: Photo of the sump constructed at the head of the hollow to capture and treat stormwater before it is discharged into a rock lined channel to the receiving stream.

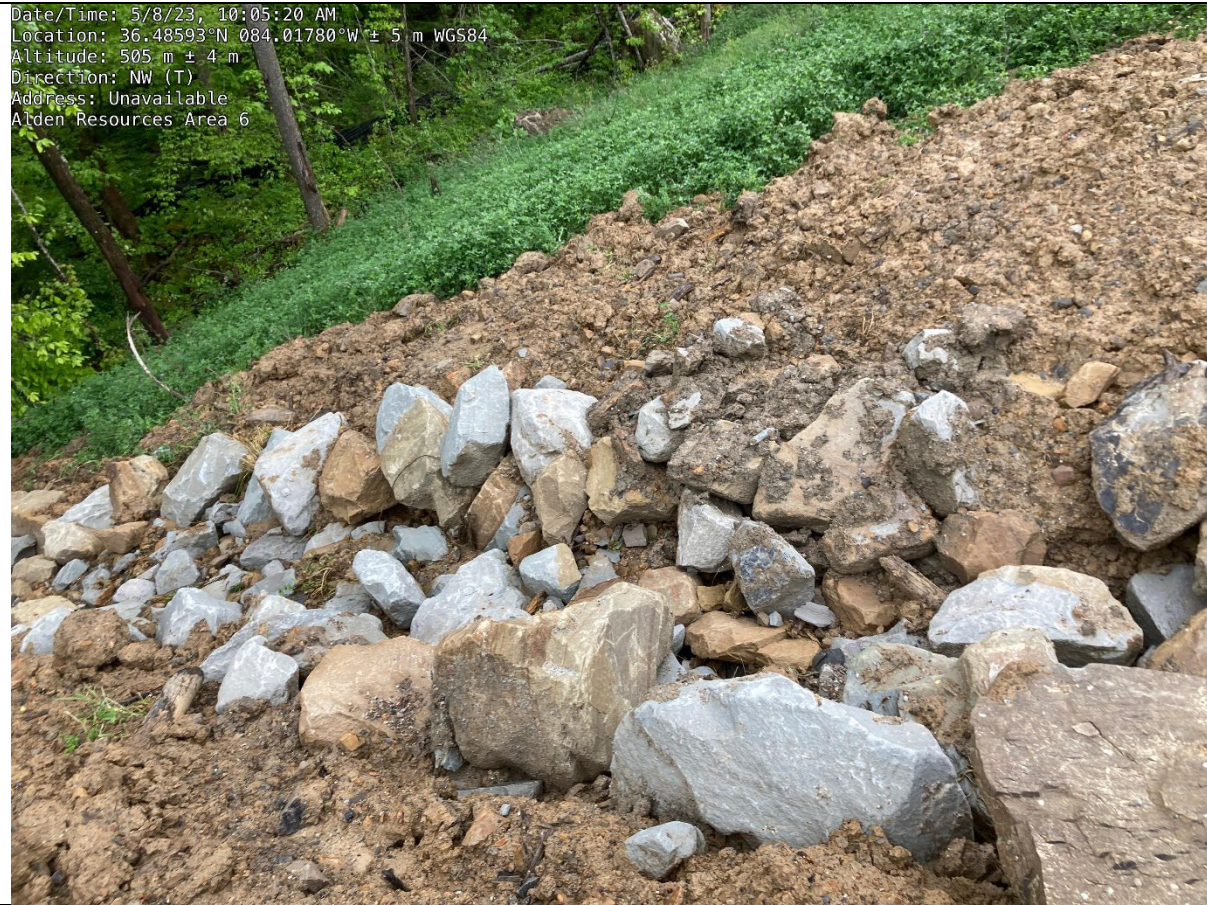
Item 4: Photo of a drainage channel constructed on the left side of the head of hollow to drain water from the hollow to the receiving stream.

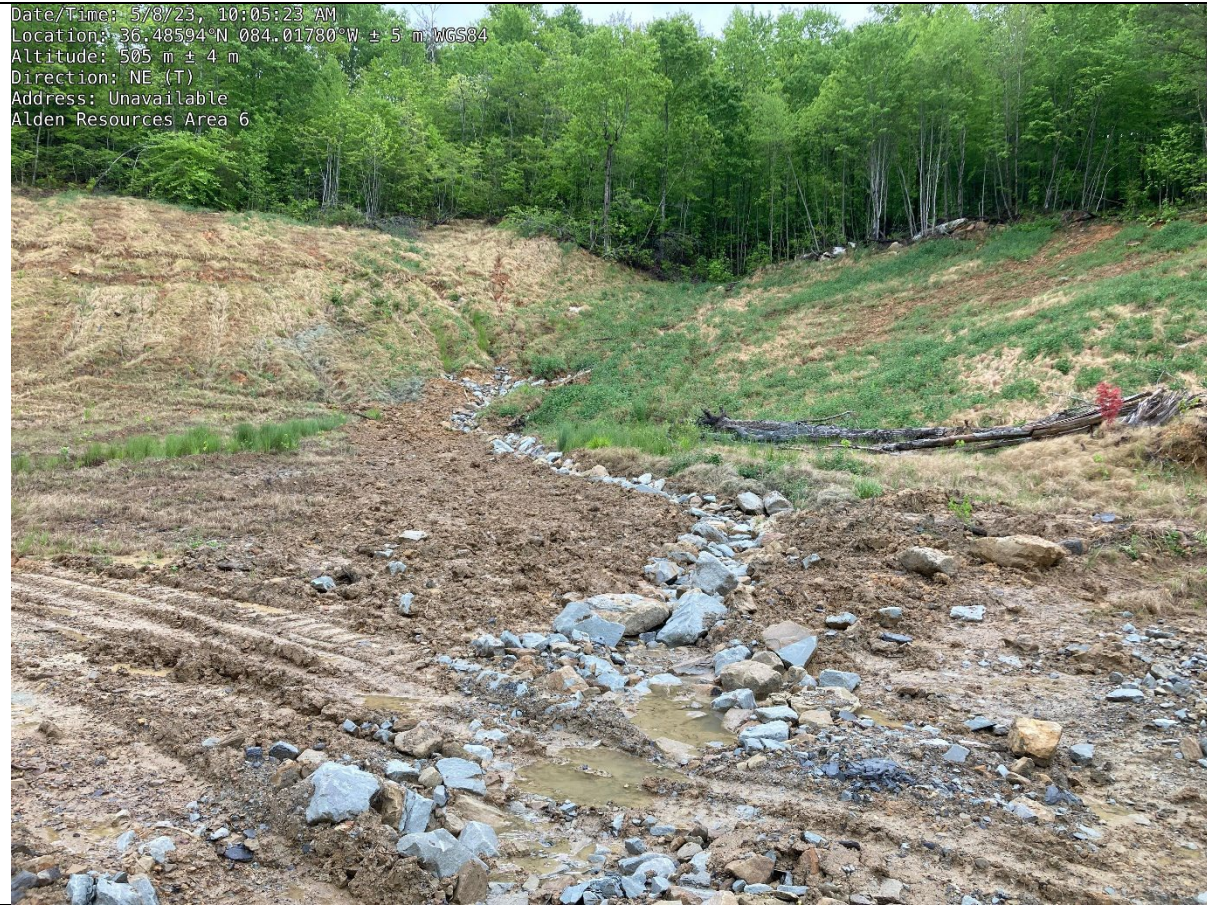
Item 5: Photo of the left side of the head of hollow where a rock lined channel was constructed to improve wet weather conveyance/stream flow.

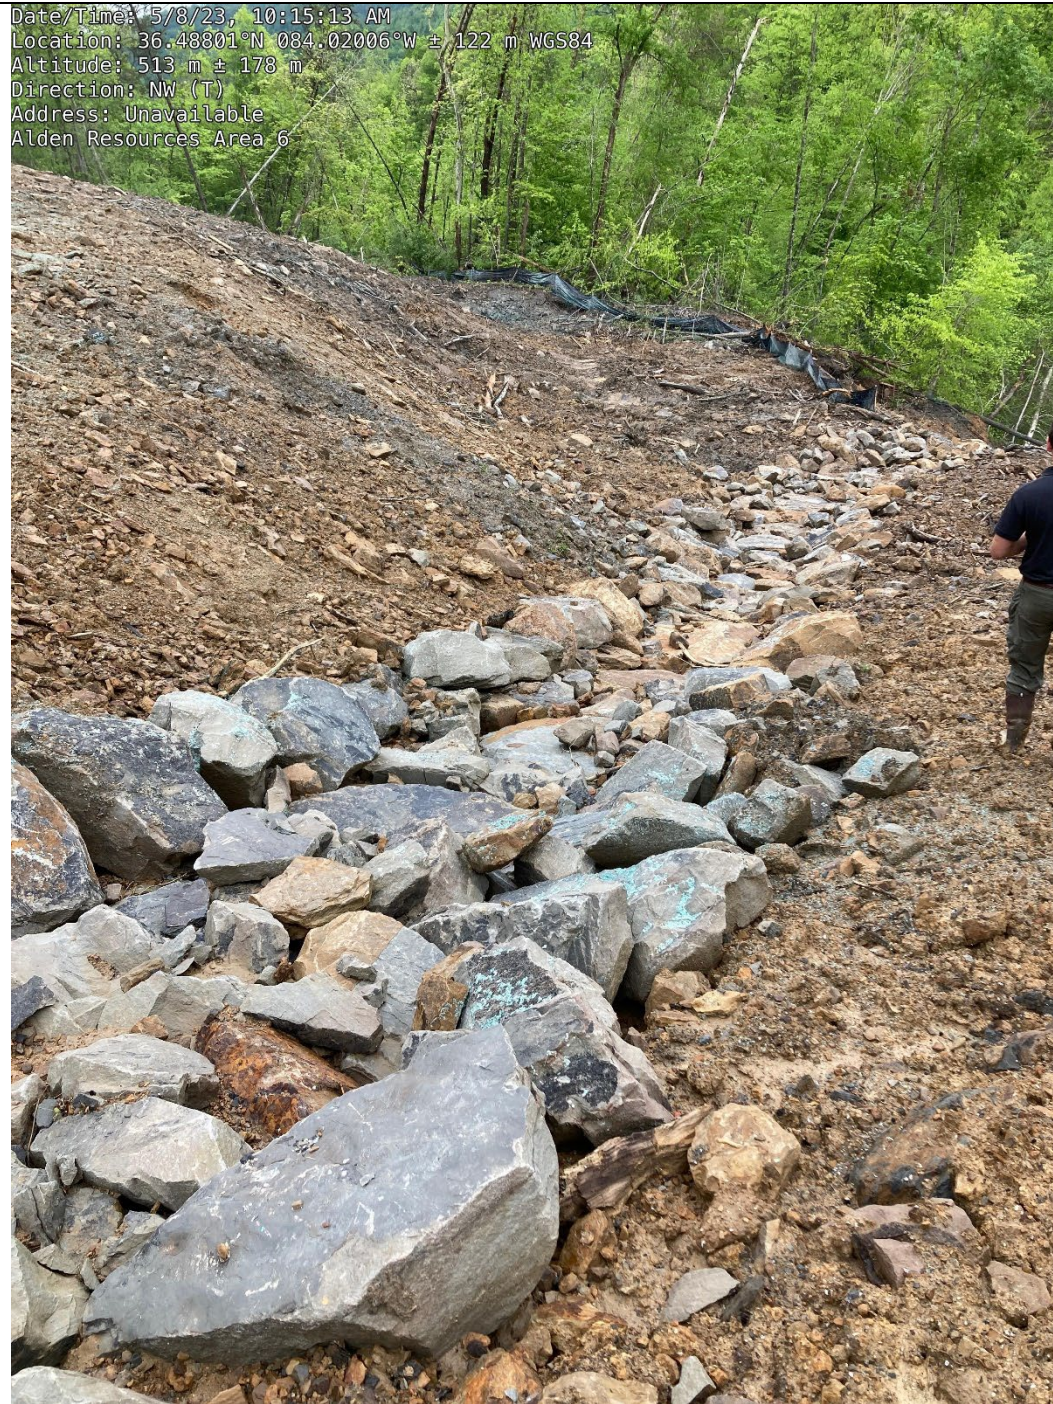
Item 6: Photo of the rock-lined channel constructed down the landslide at pond 103.

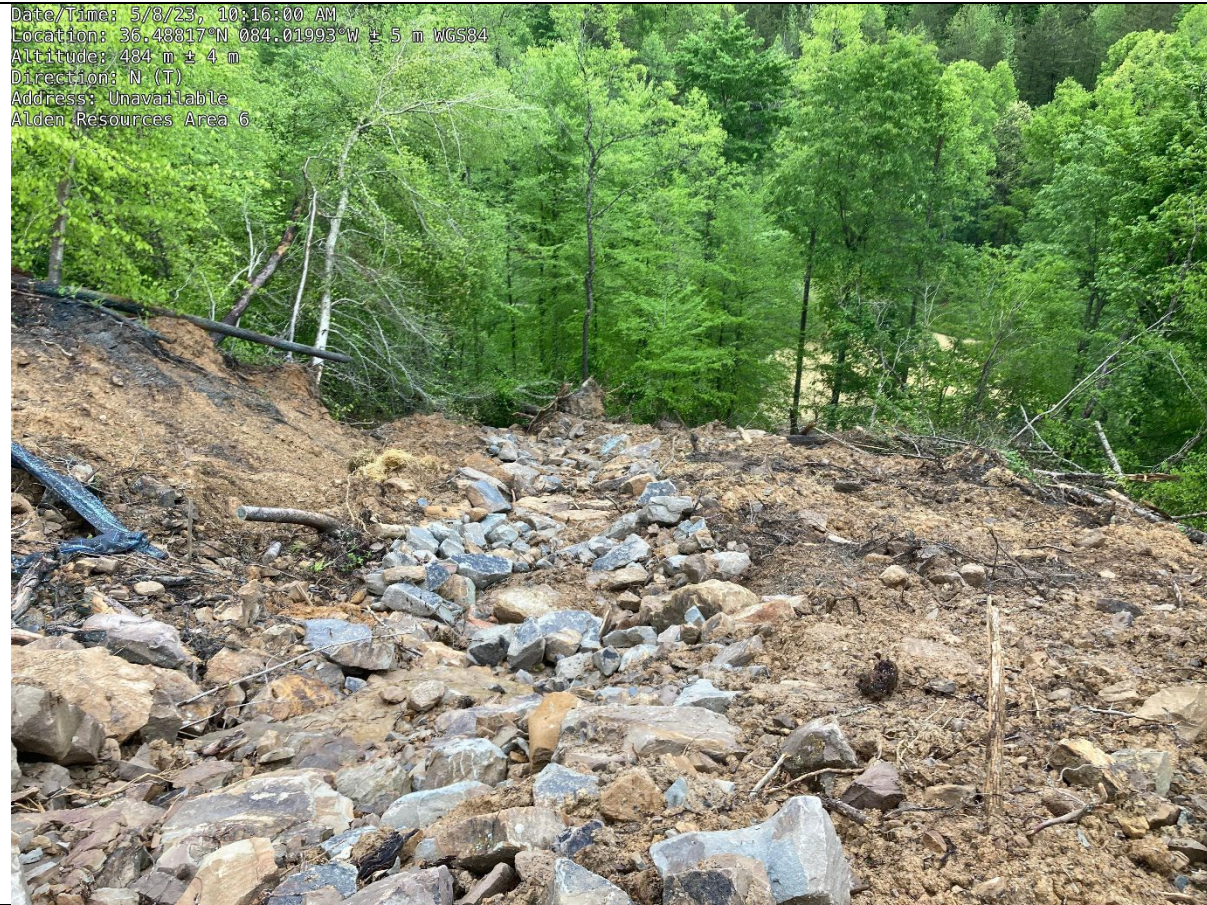
Item 7: Additional photo of the rock lined channel descending down the landslide at pond 103. The channel is tied into an existing wet weather conveyance.

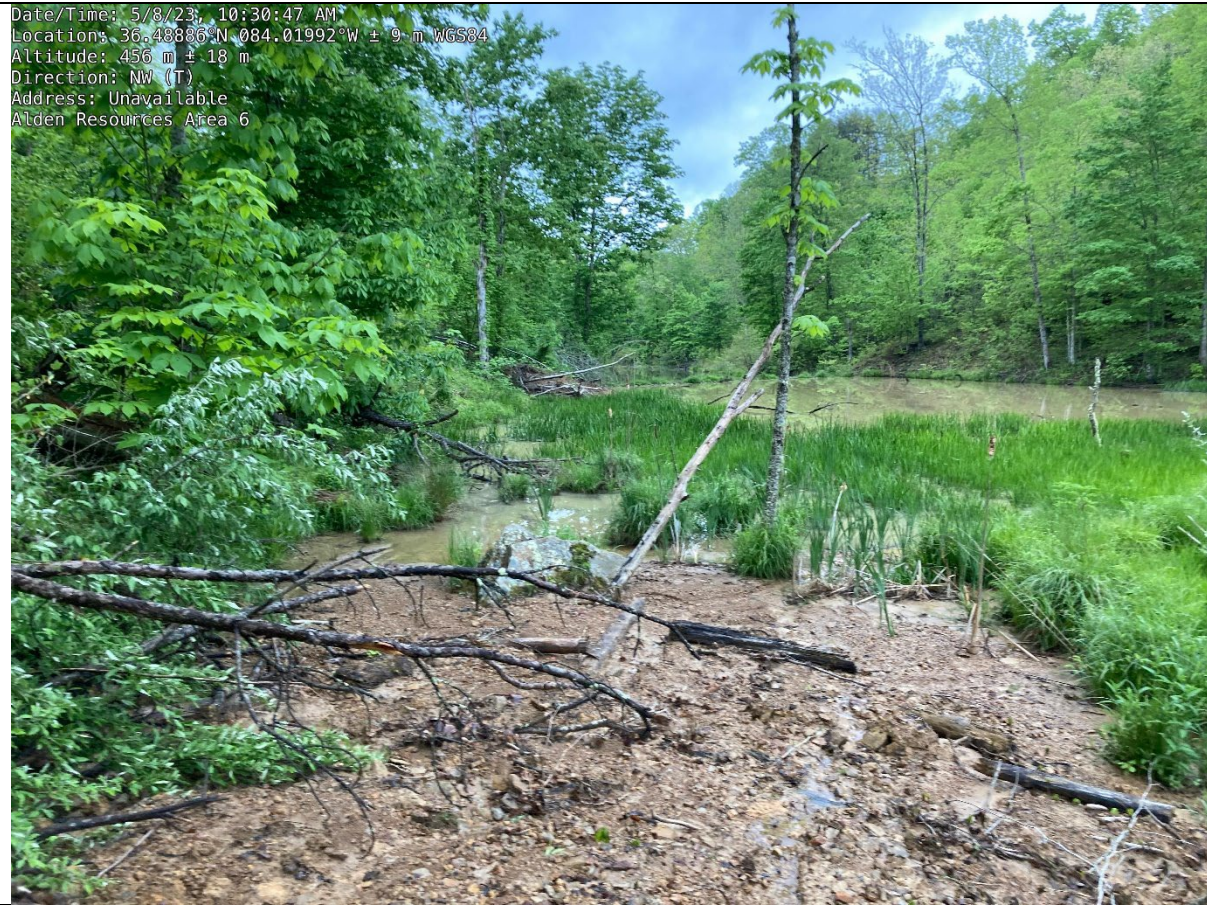
Item 8: Photo of sediment delta entering waters of the state. This delta needs to be seeded with a wetland seed mix for stabilization.

The hydroseeder did not reach the bottom of the landslide area. This area needs to be seeded by hand. Additionally, the sediment delta extending into Waters of the State needs to be seeded using a wetlands mix as agreed to on a previous pond removal inspection with Alden Resources on 4/12/2023. The small secondary slide west of the slide at pond 103 also needs to be seeded.

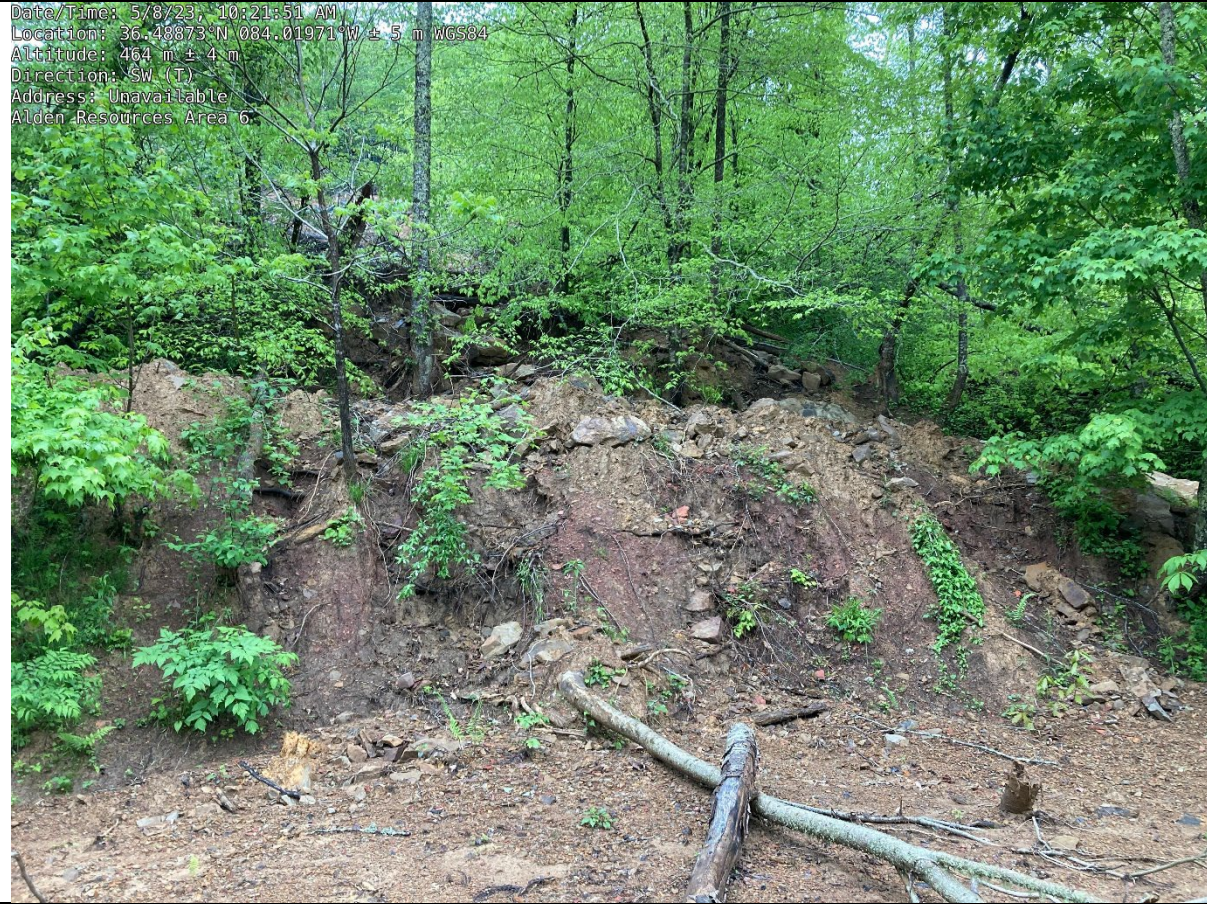
Item 9: Photo of landslide toe at the beaver pond area.

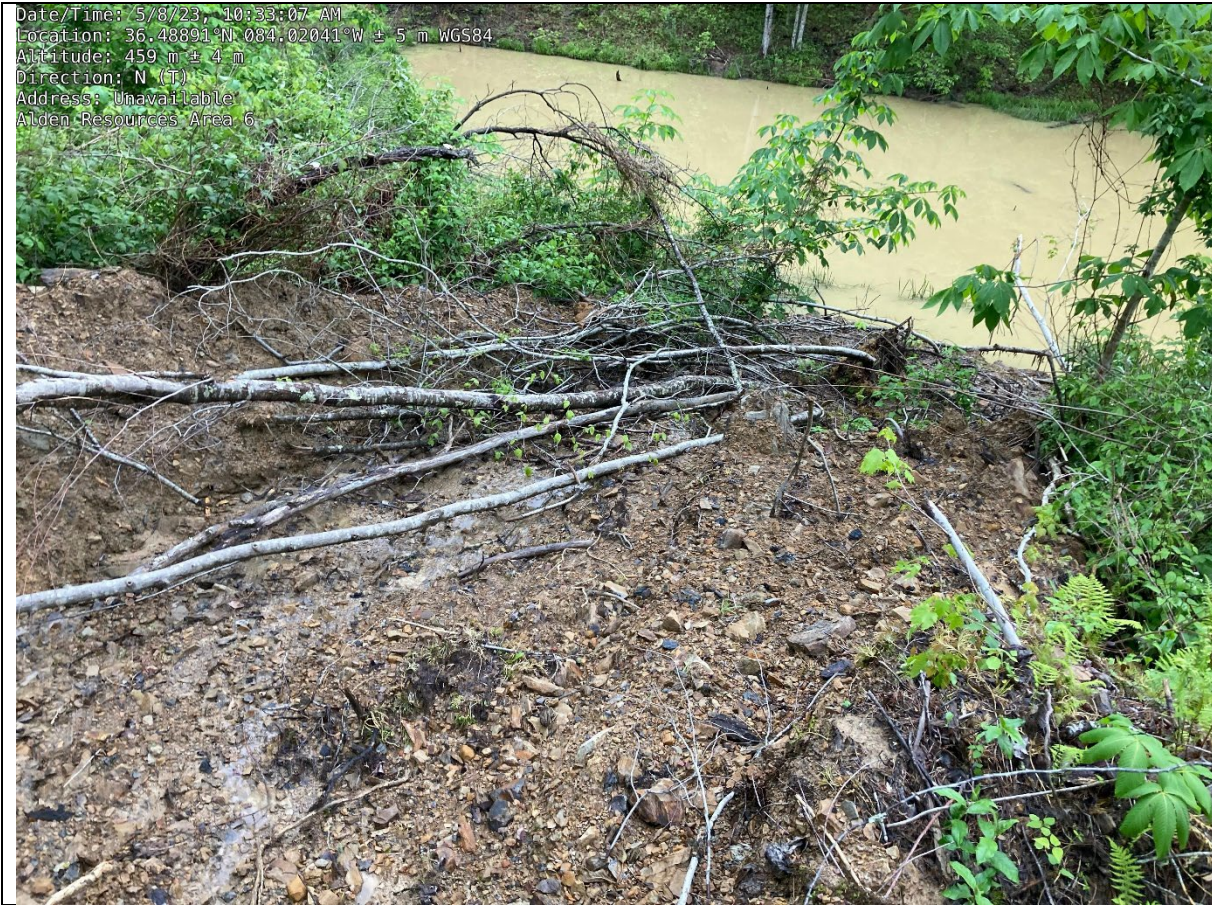
Item 10: Photo of small secondary slide located west of the large slide. This slide needs to be seeded.

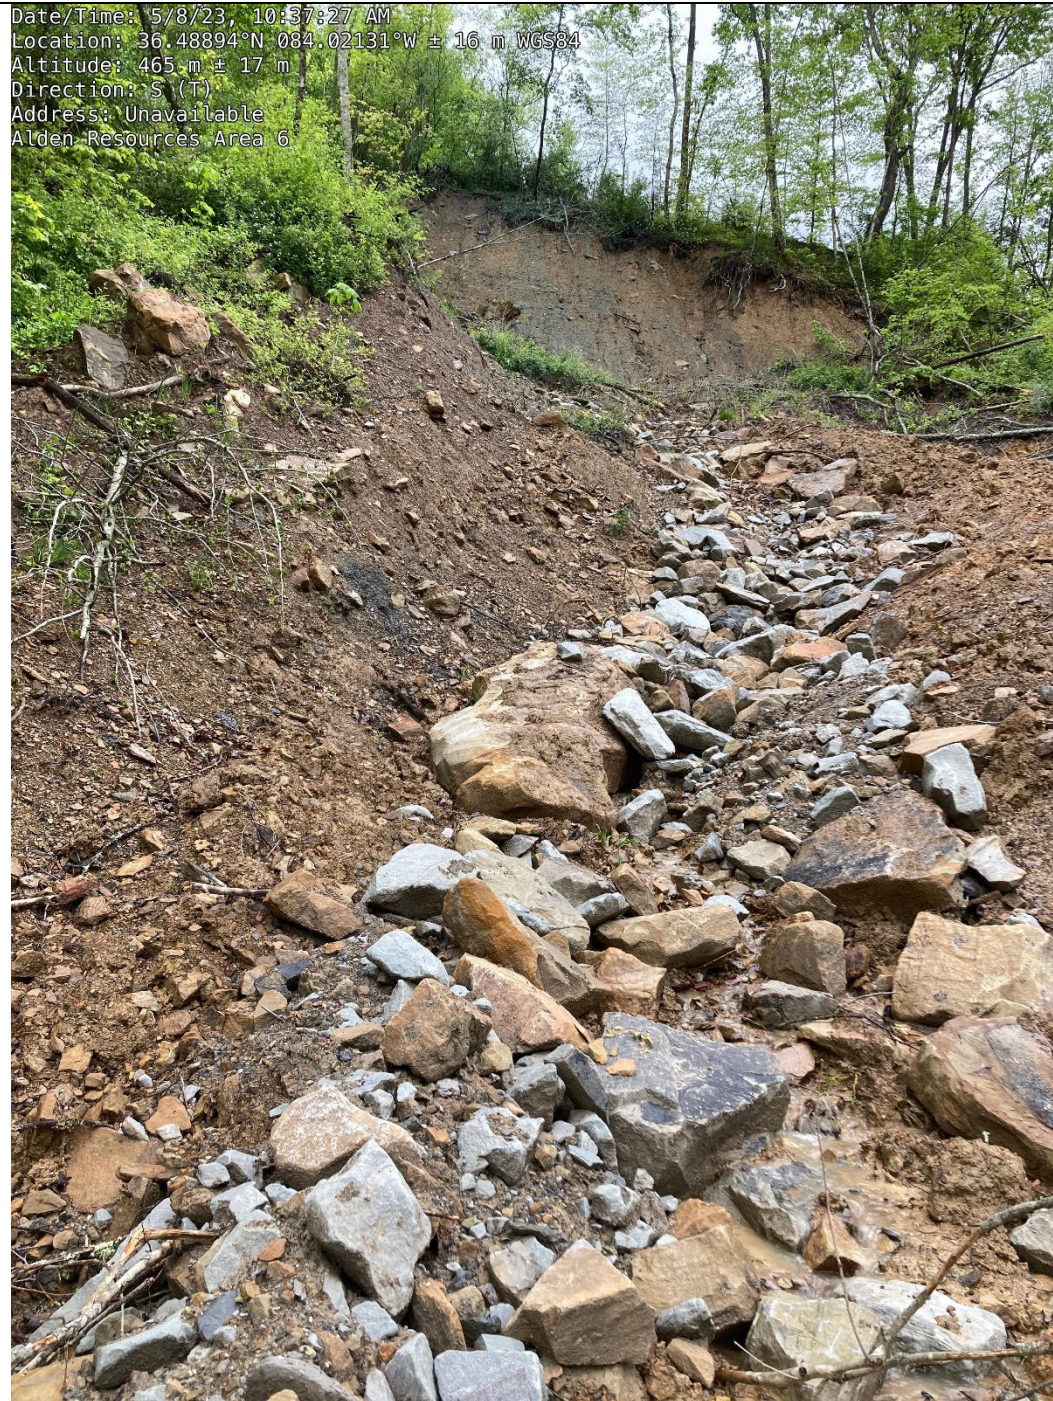
Item 11: Photo of the pre-mining slide the permittee did work to as a mitigation alternative for the slide at pond 103. The slide was rocked to convey water off of the slide to the beaver ponds.

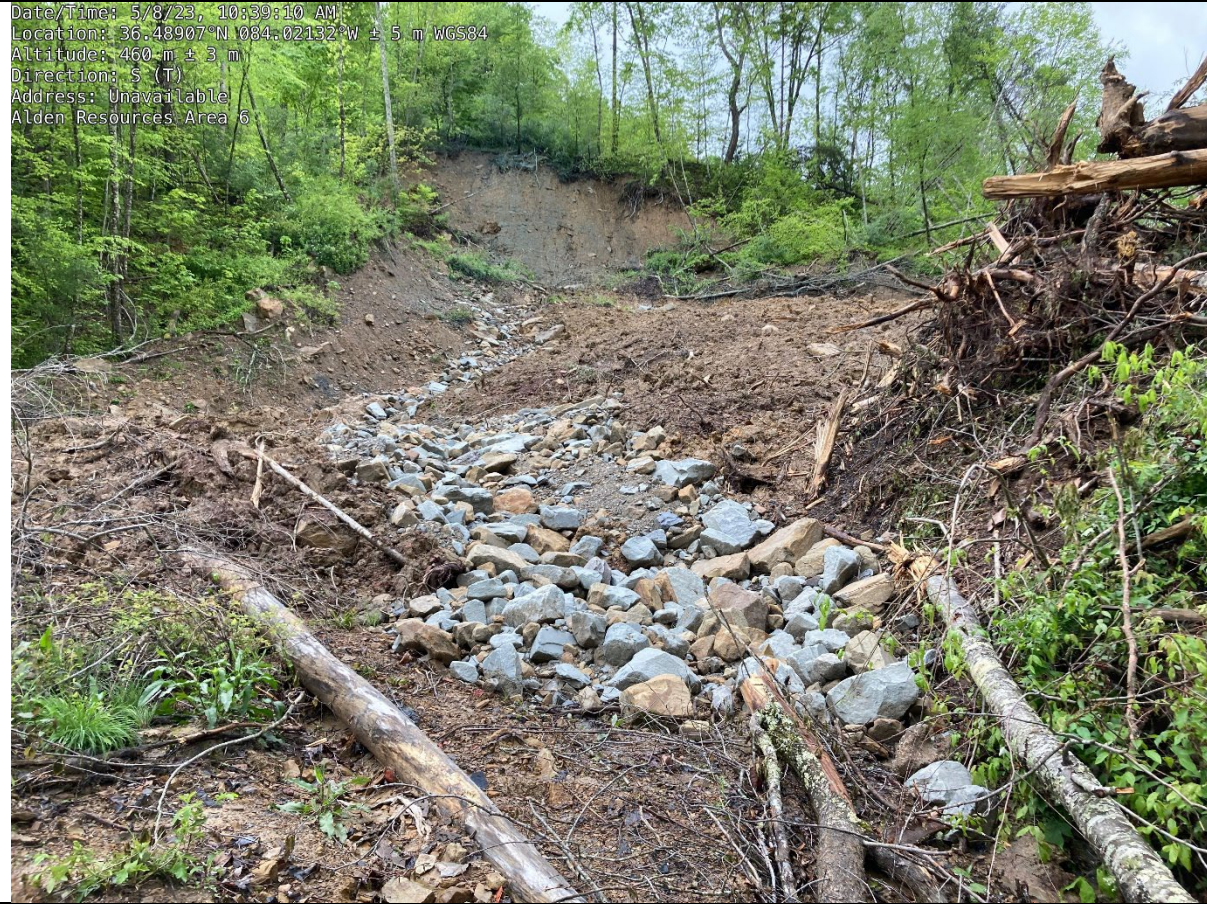
Item 12: Additional photo of the work done on the pre-mining slide.

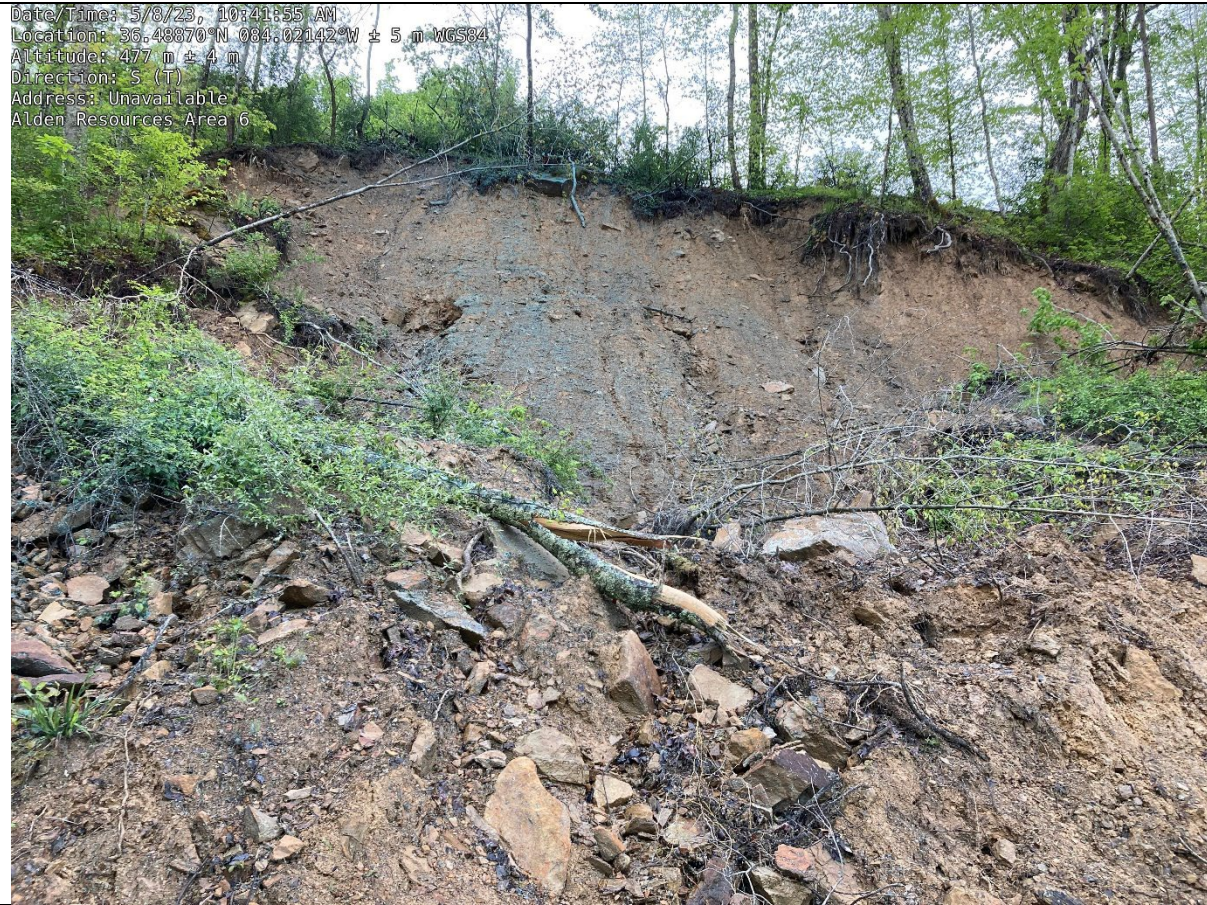
Item 13: Photo of the upper portion of the pre-mining slide.

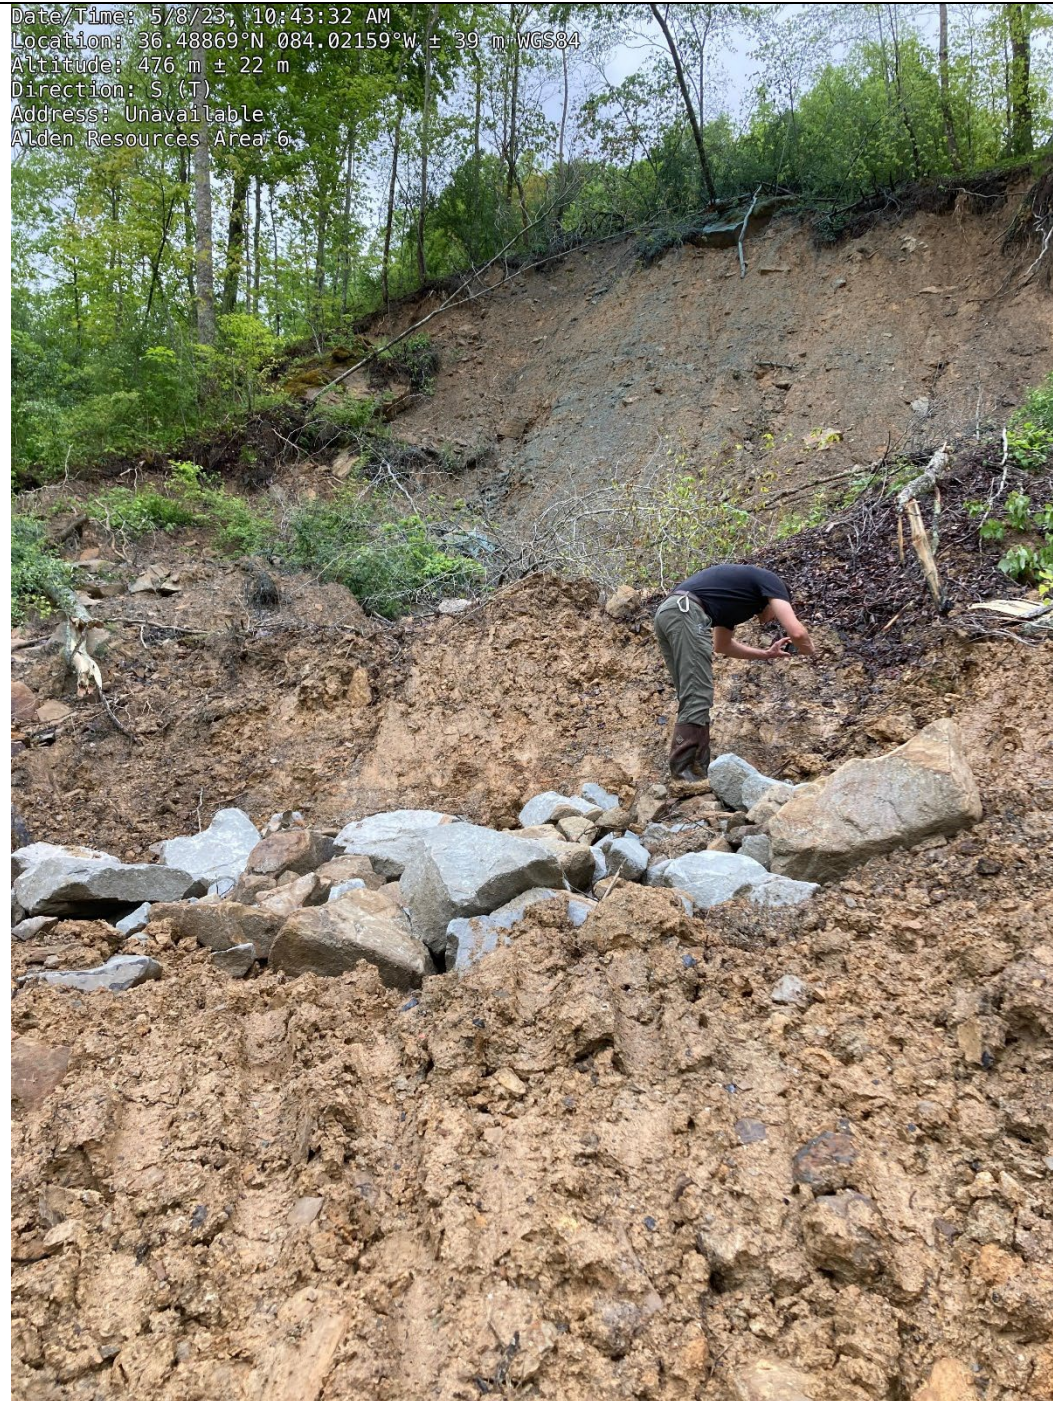
Item 14: Photo of the upper right section of the rock lined channel in the pre-mining slide. Some water is flowing over the fill material instead of into the channel at the spot where the individual in the photo is standing. The area where water is flowing should be tied into the rock lined channel to convey the water down the channel. This could be done with a shovel.

As alternative mitigation for the landslide at pond 103 the Division met with Mr. Erp on site to discuss possible opportunities on 4/25/2023. One opportunity was to stabilize the pre-mining landslide located west of the landslide at pond 103. The permittee chose to do the work on the slide and constructed a rock lined channel to convey water off the slide. The channel is performing as designed. **During this inspection, inspectors noticed that some water draining at the top west area of the rock lined channel was not draining into the channel, instead draining over the face of the regraded soil area (Item 14). The channel should be extended to capture this drainage. This could be accomplished without the use of equipment – by using a shovel to extend the channel a few feet.**
