TENNESSEE DEPARTMENT OF ENVIRONMENT AND CONSERVATION

Compliance Inspection for General NPDES Permit for Stormwater Discharges from Construction Activities (CGP)

Site/Project Name: Memphis Regional Megasite WWTP and Emergency Effluent Lagoon
NPDES Tracking Number: TNR122630
Date Coverage was Issued: 6-20-22
Street Address or Location: West of Fredonia Loop Road, south of Keeling Road
Start Date: 6-1-2022
Estimated End Date: 12-21-2023
Site Description: Construction of WWTP and emergency effluent lagoon
Latitude (dd.dddd): 35.4334385
Longitude (-dd.dddd): -89.4713148
County(ies): Haywood EFO: Jackson MS4 Jurisdiction:
Acres Disturbed: 39.01
Total Acres:

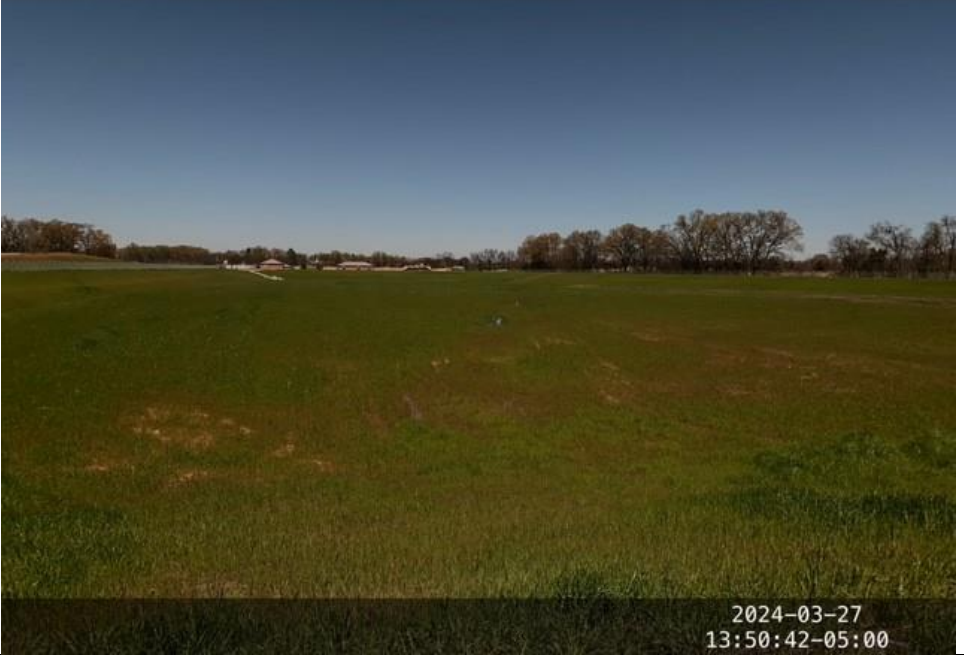
| Photo No. 1 | Date 3-27-24 | DIRECTION 356 deg (T) | 35.42838°N 089.47271°W | ACCURACY 9 m DATUM WGS84 |

Project area appeared mostly completed. Lagoon has been constructed and stabilized with vegetation (photo 1). Matting was installed along top of slope. Access road along top of crest covered with gravel. Minor bare areas noted, for example adjacent to spillway (photo 2). No rill or gully formation observed during inspection, but area should continue to be monitored to ensure sufficient stabilization remains to prevent sediment migration and rill/gully formation. Inspections in this area can be reduced to once/month until sufficient perennial vegetative cover is achieved and documented. Once area achieves permanent stabilization (perennial vegetative cover) inspections of the area can cease.

| Description View of the emergency effluent lagoon looking north from the southern side of the lagoon. Vegetative cover appeared to be established across much of the lagoon, including the slopes and crest. Portions of the lagoon had matting installed. The top of the crest was a gravel access road. | | | | |

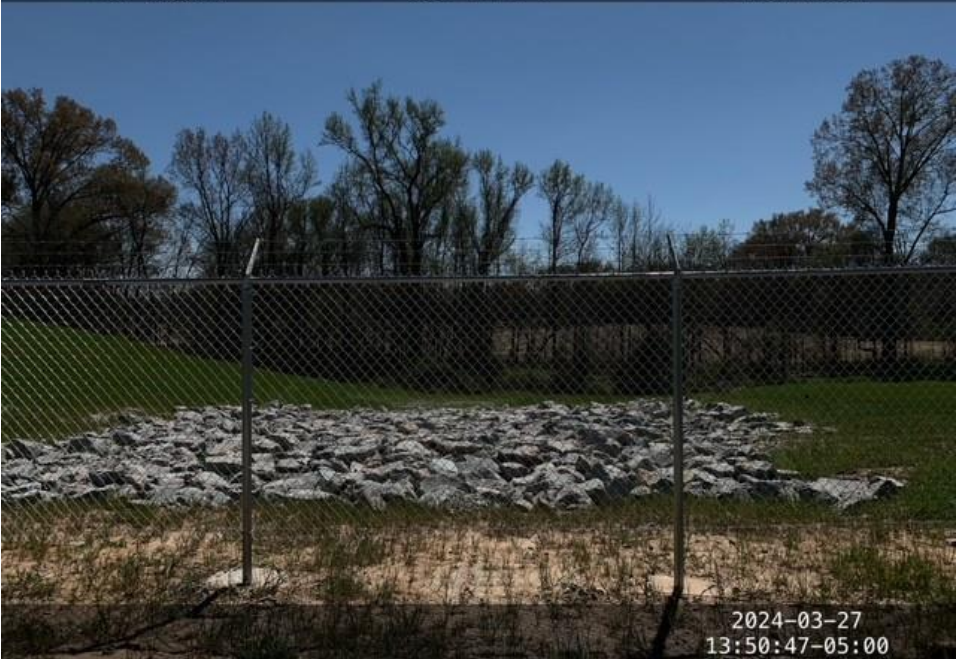
| Photo No. 2 | Date 3-27-24 | DIRECTION 204 deg (T) | 35.42834°N 089.47274°W | ACCURACY 7 m DATUM WGS84 |

| Description View of emergency effluent lagoon spillway. Bare soils observed at the top of the slope. | | | | |

- Stabilize portions of the site that are at grade and/or temporarily inactive with temporary or permanent stabilization measures.
- Ensure sediment control measures (i.e. silt fence, sediment basin) are installed and maintained until vegetative cover is fully established. Long term/permanent goal of vegetative cover is perennial vegetation.

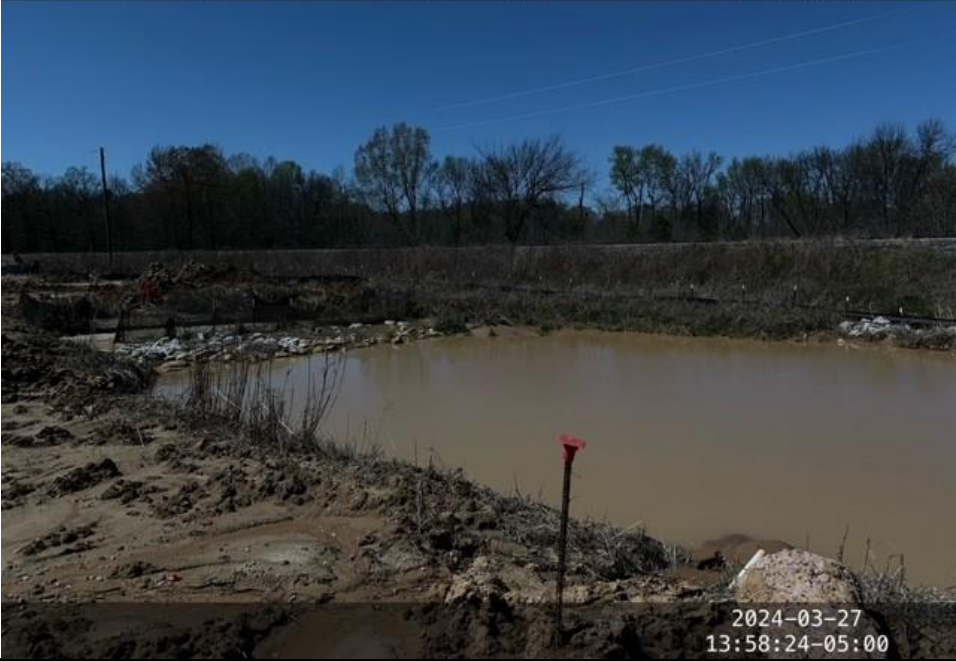
| Photo No. 3 | Date 3-27-24 | DIRECTION 291 deg (T) | 35.43442°N 089.47267°W | ACCURACY 7 m DATUM WGS84 | |

Most of project area is under construction. Sediment basin installed on northern edge of the site needs maintenance. Porous baffles are installed within the eastern and western forebays, but forebays appear to be beyond 50% capacity with sediment accumulation (photos 3-4). Area surrounding sediment basin including banks/berm are not stabilized, which allows for internal sediment migration. Minor amount of sediment accumulation and sediment-laden water observed at Outfall 1 (photo 5). Area to the east of the basin, including the stockpile of sediment is not sufficiently stabilized, allowing sediment migration towards the silt fence installed east of the basin. However, the silt fence is not accurately installed (not entrenched) and/or failing. Sediment is migrating beyond the silt fence and limits of disturbance (as shown on the EPSC plans), by passing the sediment basin. No issues noted regarding Outfalls 2 or 3.

| Description View of the western end of the sediment basin located north of the WWTP. The banks of the basin were not stabilized, which allows internal migration of sediment into the basin. The forebays at the western and eastern ends of the basin were beyond 50% capacity (see close-up view in photo 4). Sediment-laden water noted within basin. | | | | | |

- Submit written response by **April 22, 2024**, describing the corrective actions taken in regard to the sediment basin and failing silt fence along the northern portion of the site.

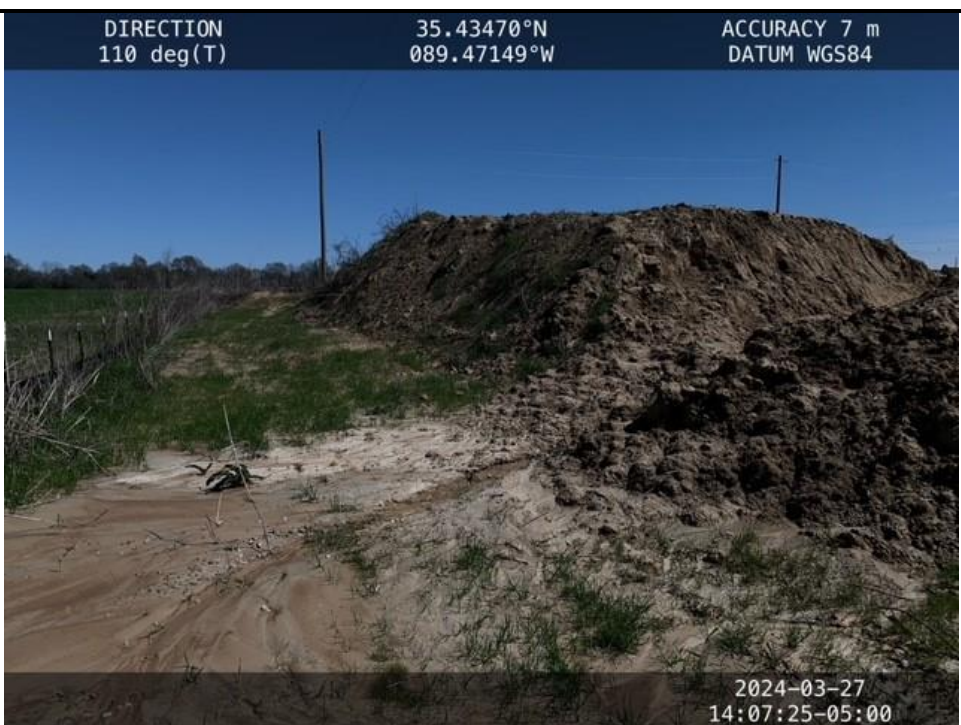
| Photo No. 6 | Date 3-27-24 | DIRECTION 35.43470°N 110 deg (T) 089.47149°W ACCURACY 7 m DATUM WGS84 |

| View of stockpile on the northern side of the site, east of the sediment basin. Stockpile was not stabilized. Sediment migration from this area was observed discharging beyond the silt fence and limits of disturbance downgradient (see photo 7). | | |
