SUBJECT: Notice of Corrective Actions

Foley Products Company, LLC – Franklin Plant

NPDES Permit No. TNG110406

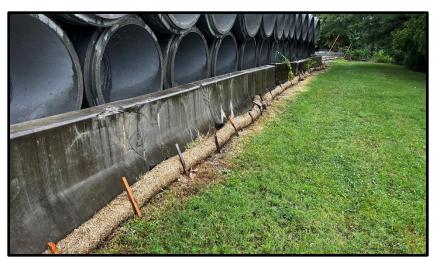
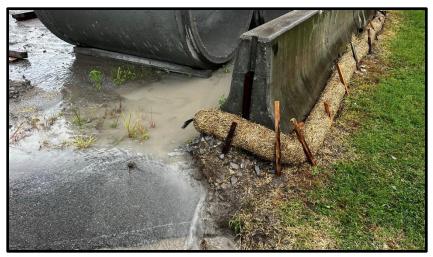
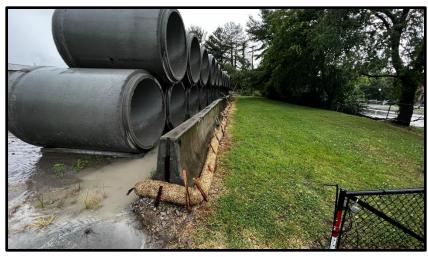
Straw waddle installation near outfall 002

Straw waddles were placed along the northern side of concrete barriers, south of outfall SW-002. Straw waddles were placed upgradient relative to the inlet, before stormwater moves down the slope along the northern perimeter of the site.

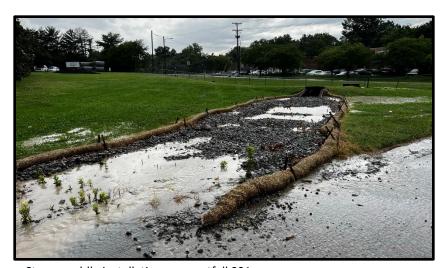
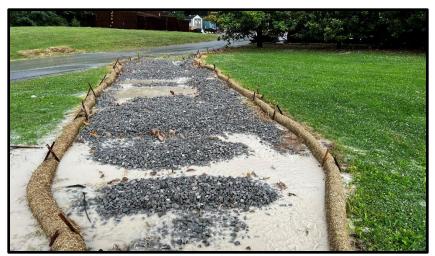
Straw waddle installation near outfall 001

Straw waddles were placed on contours around stormwater drainage paths to guide runoff waters towards SW-001. Failing and nonfunctioning straw waddles were removed and replaced in and around the area.

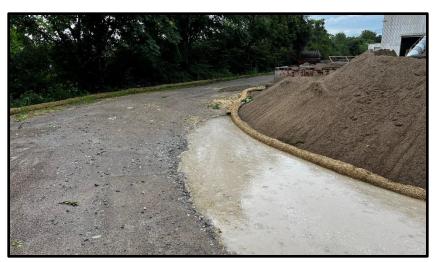
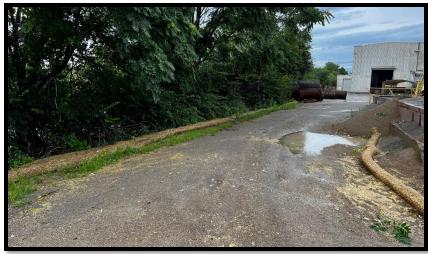
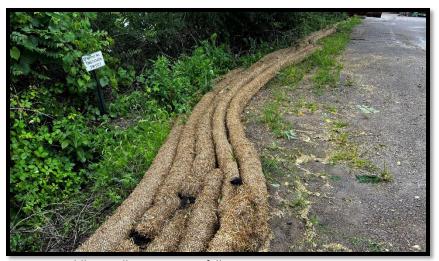
Straw waddle installation near outfall 003

Outfall SW-003 is located on the western side of the site, near aggregate piles. Four to five layers of straw waddles were placed in between aggregate piles and SW-003 for a length of approximately 150 feet, north to south. Failing and nonfunctioning BMPs were removed and replaced while still functioning BMPs were left in place and reinforced with new material.
