**Compliance Inspection for General NPDES Permit for Stormwater Discharges from Construction Activities (CGP)**

<b>Site/Project Name:</b>	Memphis Regional Megasite (WTP, Site Water, N. Water Tower Project)	<b>NPDES Tracking Number:</b>	TNR122613	
<b>Street Address or Location:</b>	2672 Keeling Road	<b>Date Coverage was Issued:</b>	July 1, 2022	
		<b>Start Date:</b>	June 2022	
<b>Site Description:</b>	construction of water treatment plant, North Water Tower, well development and internal piping of water lines	<b>Estimated End Date:</b>	August 2023	
		<b>Latitude (dd.ddd):</b>	35.4396	
<b>County(ies):</b> Haywood	<b>EFO:</b> Jackson	<b>MS4 Jurisdiction:</b>	<b>Longitude (-dd.ddd):</b>	-89.4299
			<b>Acres Disturbed:</b>	37.69
			<b>Total Acres:</b>

**Comments:**

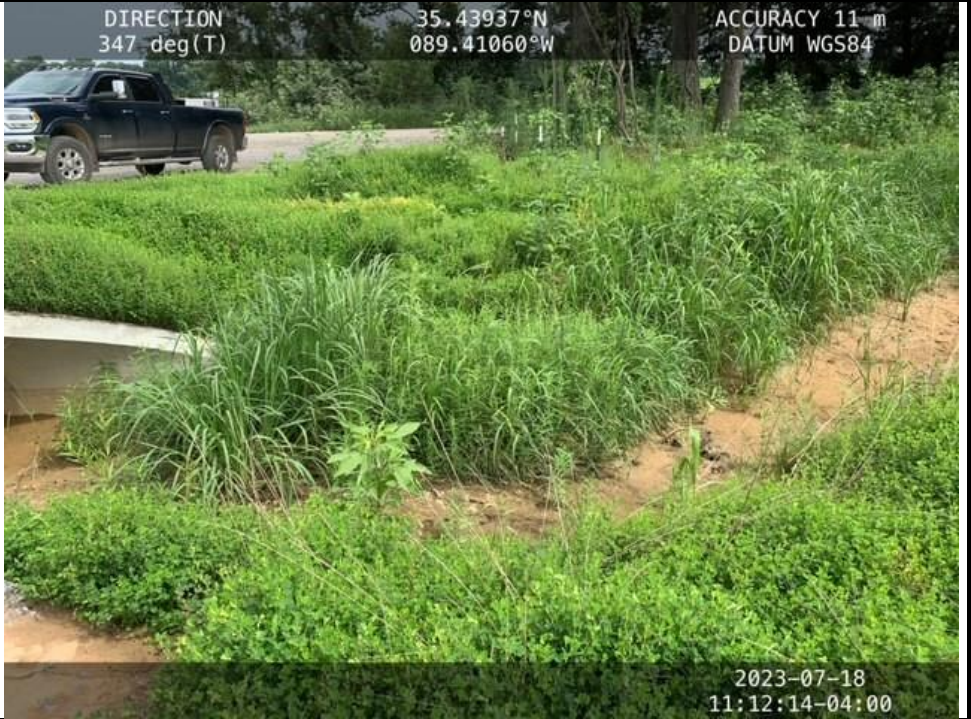
<b>Project:</b>		<b>Site Location:</b>	<b>Permit No.:</b>
Memphis Regional Megasite (WTP, Site Water, N. Water Tower Project)		2672 Keeling Road	TNR122613
<b>Photo No.</b>	<b>Date</b>	DIRECTION      35.43937°N 347 deg(T)      089.41060°W      ACCURACY 11-m DATUM WGS84	
1	7/18/23

- Construction exit installed along with stormwater culvert under exit (photos 1 and 2) as shown on Interim EPSC Plan 800-CE-600.
- Sediment accumulation was observed in ditch/swale downgradient (photo 1) from the culvert, indicating sediment migration from the active construction zone and has potential for discharge off-site.
- Filter ring installed in ditch/swale upgradient (photo 2) from culvert. Ring might need maintenance and re-establishment of rock. Sediment accumulation observed in ditch/swale up and downgradient from filter ring.
- Slope around the North Water Tower was covered with matting and what appeared to be annual grass. Gullies/rills on the slope were observed in a few locations and should be monitored. If slope is at grade, perennial vegetation should be established.

<b>Description</b> North Water Tower: Stormwater culvert downgradient/east of the access road/construction exit at the North Water Tower location. Sediment accumulation was observed in ditch/swale downgradient from the culvert, indicating sediment migration from the active construction zone and potential discharge off-site. Sheet 800-CE-600			
		2023-07-18 11:12:14-04:00

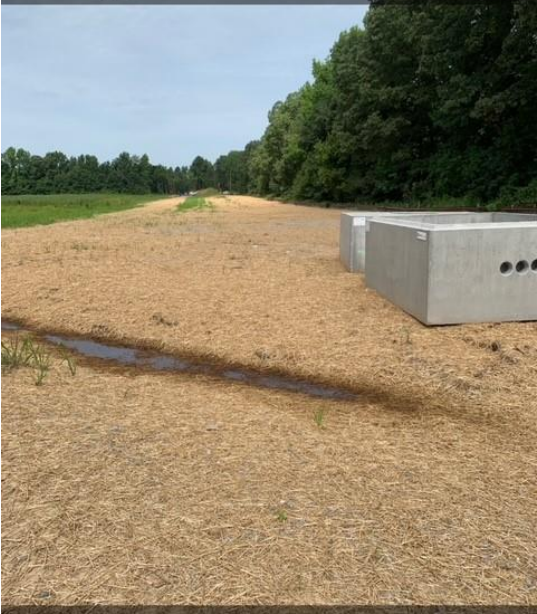
- Water line installation in between Well #7 and Well #6 (photo 3). Area had been seeded and covered with blown hay. EPSC plans denote “Stream Crossing” but doesn’t appear to be a “stream” but rather a wet weather conveyance. Permanent entrance will be placed to the east of the existing access location. EPSC Plan Sheet 600-CE-614. EPSC plans should be updated to reflect this change.
- Area around Well #6 had been seeded and covered with blown hay.
- Well #1 appeared to have EPSC installed per plans.
- Other wells not observed during inspection.

<div style="text-align: right; font-size: x-small; margin-top: 5px;"> 2023-07-18  11:22:48-04:00 </div>
<b>Description</b> Water line installation in between Well #7 and Well #6. Area had been seeded and covered with blown hay. EPSC plans denote "Stream Crossing", but doesn't appear to be a "stream" but rather a wet weather conveyance 9 (WWC 9) per NRS22.127 application. Sheet 600-CE-614

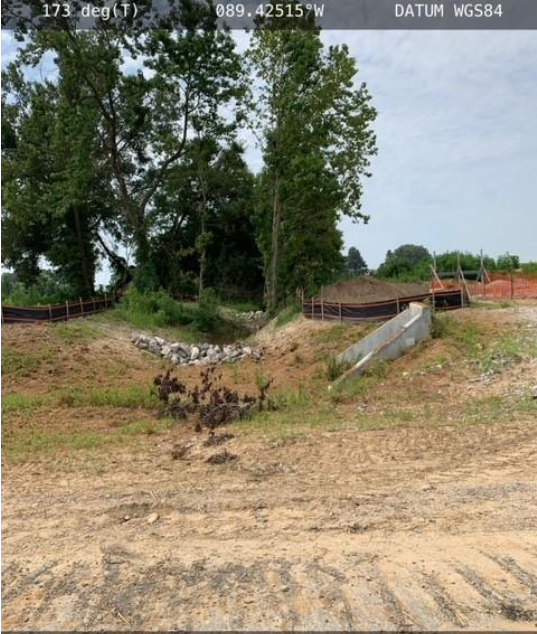
<b>Photo No.</b> 4	<b>Date</b> 7/18/23		<div style="background-color: #cccccc; padding: 2px; font-size: small;"> DIRECTION 35.43980°N ACCURACY 10 m  173 deg(T) 089.42515°W DATUM WGS84 </div>

- Water lines from end of Fredonia Road to South Water Tower completed. Area is actively under construction by Ford activities.
- Water line installation from South Water Tower to Wastewater Treatment Plant (WWTP) has not started yet. Will start at WWTP.
- Water line installation adjacent to Well #3 (photo 4). Check dams installed in wet weather conveyance.

<div style="text-align: right; font-size: x-small; margin-top: 5px;"> 2023-07-18  11:37:28-04:00 </div>
<b>Description</b> Well #3 area. Wet weather conveyance (WWC) immediately east of well. Check dams installed in the WWC. Sheet 600-CE-610

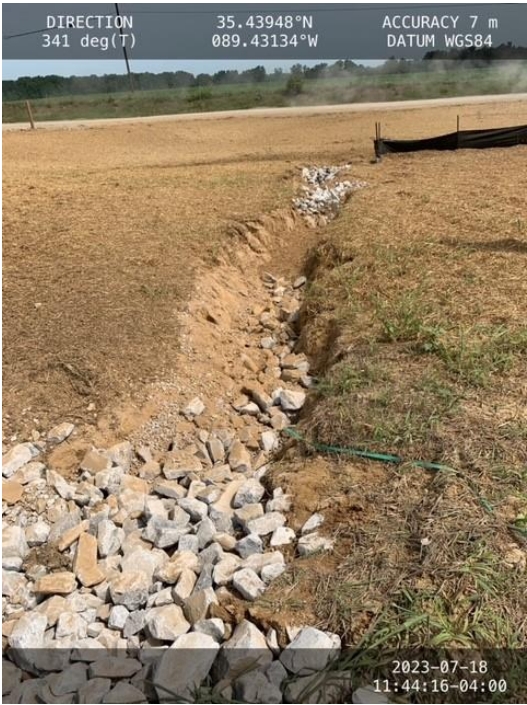
<b>Project:</b> Memphis Regional Megasite (WTP, Site Water, N. Water Tower Project)		<b>Site Location:</b> 2672 Keeling Road	<b>Permit No.:</b> TNR122613
<b>Photo No.</b> 5	<b>Date</b> 7/18/23

- Erosion gully observed on north side of site, south of sediment trap #1, east of western entrance (photo 5). Area was covered with seed and blown hay. EPSC Plan Sheet 700-CE-600

<b>Description</b> Water Treatment Plant: Erosion gully observed on north side of site, south of sediment trap #1, east of western entrance. Area was covered with seed and blown hay. Sheet 700-CE-600

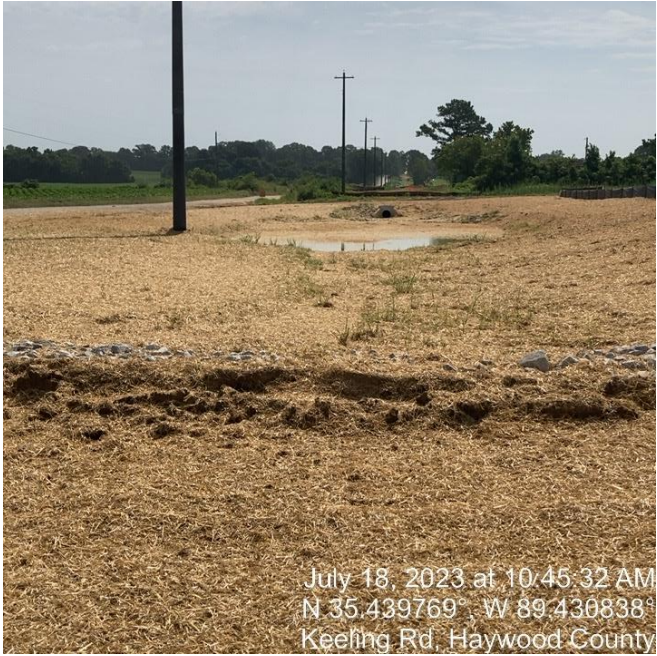
<b>Photo No.</b> 6	<b>Date</b> 7/18/23

- Sediment Trap #1-check dam installed and area was covered with seed and blown hay (photo 6). EPSC Plan Sheet 700-CE-600
- Discharge point of Sediment Trap #1 and Sediment Trap #2 at northeast corner of site (photo 7). Check dams installed and area covered with seed and blown hay.

<b>Description</b> Water Treatment Plant: Sediment Trap #1-check dam installed and area was covered with seed and blown hay. Sheet 700-CE-600

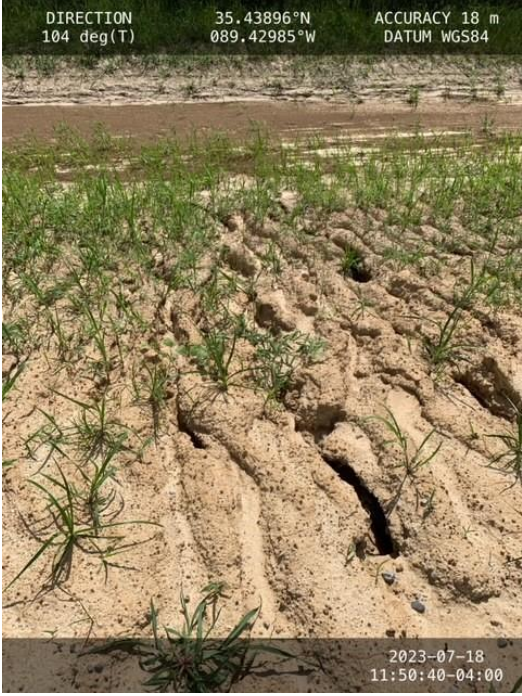
- Erosion gullies/rills were observed along the drainage ditch on the eastern edge of the site. Vegetative cover was sparse. Check dam at southeast corner observed installed. EPSC Plan Sheet 700-CE-600

<b>Photo No.</b> 8	<b>Date</b> 7/18/23	DIRECTION 104 deg(T)	35.43896°N 089.42985°W ACCURACY 18 m DATUM WGS84
<b>Description</b> Water Treatment Plant: Erosion gullies/rills were observed along the drainage ditch on the eastern edge of the site. Vegetative cover was sparse. Sheet 700-CE-600

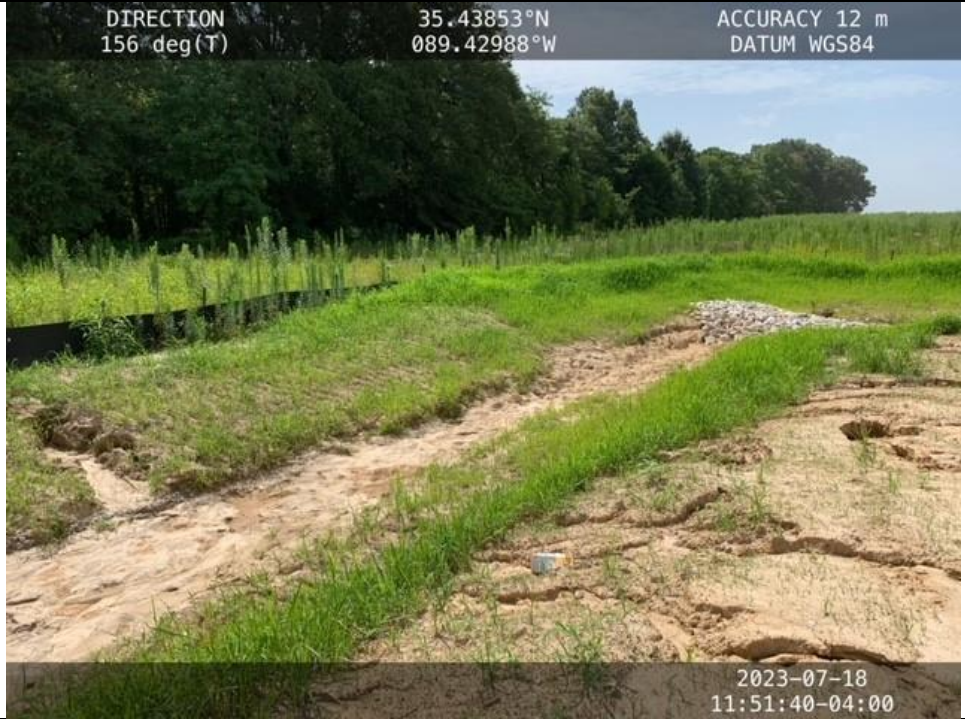
<b>Project:</b> Memphis Regional Megasite (WTP, Site Water, N. Water Tower Project)		<b>Site Location:</b> 2672 Keeling Road	<b>Permit No.:</b> TNR122613
<b>Photo No.</b> 9	<b>Date</b> 7/18/23	<b>DIRECTION</b> 156 deg (T)	<b>35.43853°N</b> <b>089.42988°W</b>
<b>Description</b> Water Treatment Plant: Erosion gullies/rills were observed along the drainage ditch on the eastern edge of the site. Vegetative cover was sparse. Check dam at southeast corner observed as shown on plans. Sheet 700-CE-600		<b>ACCURACY 12 m</b> <b>DATUM WGS84</b>	
		2023-07-18 11:51:40-04:00

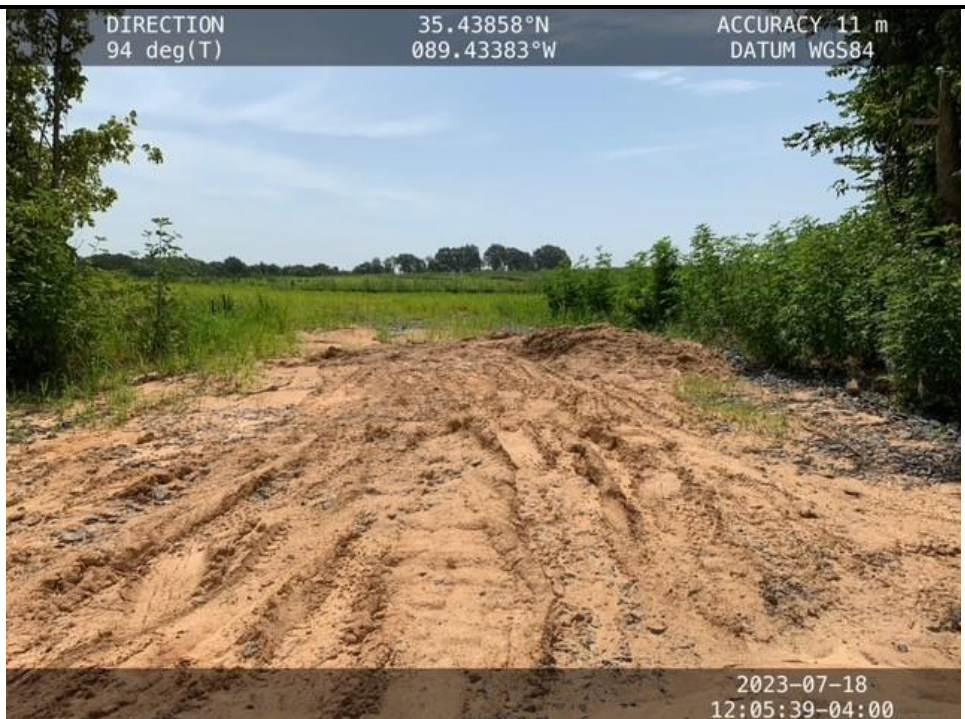
- Stockpiles located nearest to plant and stockpile south of Well #1 appeared to be sufficiently vegetated.
- East side of Fredonia Road, southwest of WTP-area was not sufficiently stabilized (photo 10). Sediment accumulation was observed in roadside ditch downgradient (photo 11).

<b>Project:</b> Memphis Regional Megasite (WTP, Site Water, N. Water Tower Project)		<b>Site Location:</b> 2672 Keeling Road	<b>Permit No.:</b> TNR122613
<b>Photo No.</b> 10	<b>Date</b> 7/18/23	<b>DIRECTION</b> 94 deg (T)	<b>35.43858°N</b> <b>089.43383°W</b>
<b>Description</b> East side of Fredonia Road, southwest of WTP. Area was not sufficiently stabilized. Sediment accumulation was observed in roadside ditch downgradient (photo 11).		<b>ACCURACY 11 m</b> <b>DATUM WGS84</b>	
		2023-07-18 12:05:39-04:00

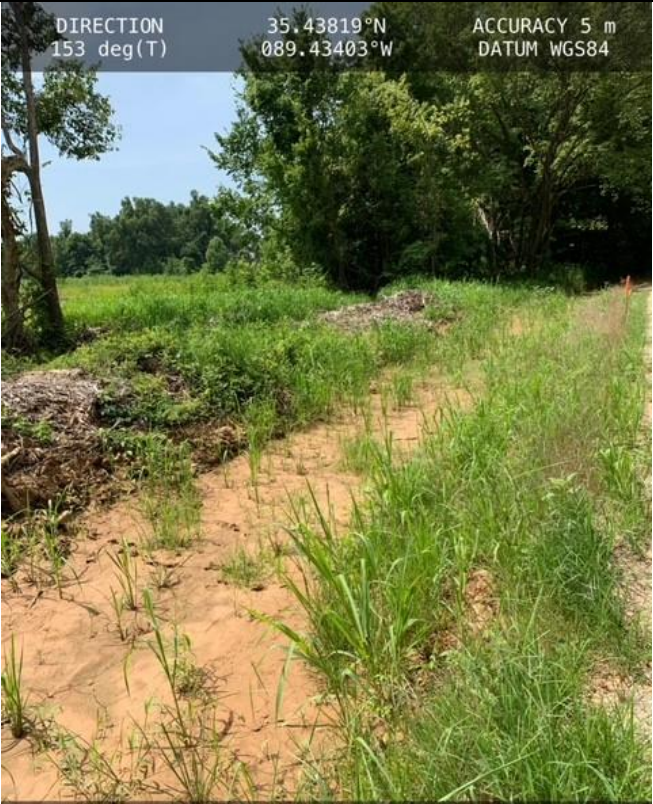
<div style="background-color: #cccccc; padding: 2px; font-size: x-small; text-align: right;">           2023-07-18            12:06:24-04:00         </div>	
<b>Description</b> Sediment accumulation in roadside ditch downgradient from east side of Fredonia Road, southwest of WTP. Area was not sufficiently stabilized.
