Application for Aquatic Resource Alteration Permit (ARAP) & State §401 Water Quality Permit

Site or Project Name: Wolf River Lateral J; from confluence to Shelton Road Crossing      Nearest City, Town or Major Landmark: Collierville, TN

**WOLF RIVER LATERAL "J"  
COLLIERVILLE, TN  
FIELD INVENTORY  
APRIL 22, 2016 PHOTO LOG**

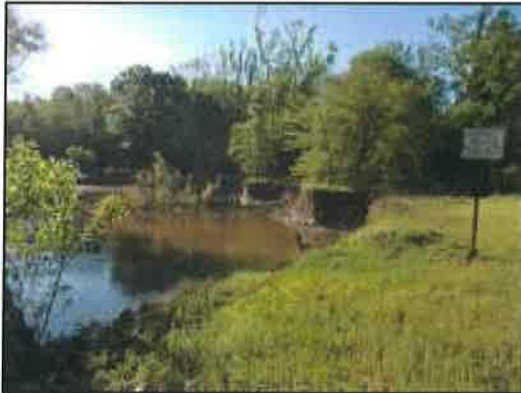
**Figure 1:** Standing over SS Outfall at the confluence of the Lateral with the Wolf

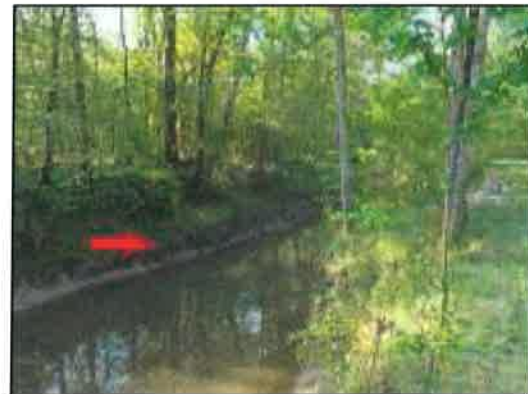
**Figure 4:** Looking up stream from same vantage point as Figure 3

The outfall line for the Shelton Road Waste Water Treatment Plant (WWTP) is located adjacent and parallel to the west bank of Lateral "J". The lateral intercepts the Wolf River at approximately the mid-point of a "hairpin" bend in the Wolf River. There is active erosion of the river bank on the outside of the bend as evidenced by the shear vertical bank (see Figure 1). The top bank of the bend has migrated south and is threatening the sewer outfall. The banks of the lateral immediately upstream are sloughing. A short distance upstream there is evidence of recent degradation of the bottom as evidenced by the vertical lower bank and the sloping upper bank. The change in slope is denoted by the red arrow in figure 4.

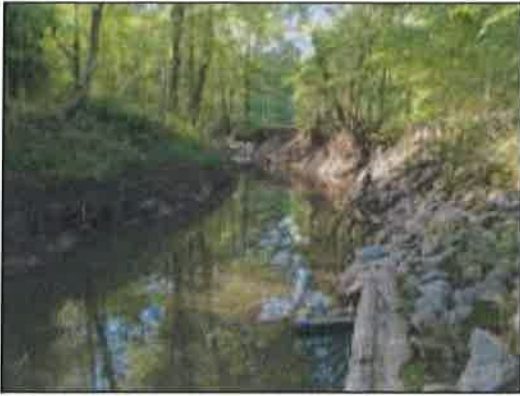
**Figure 5:** Stabilization of past bank failure; note the undermined and leaning trees just upstream of the bank repair

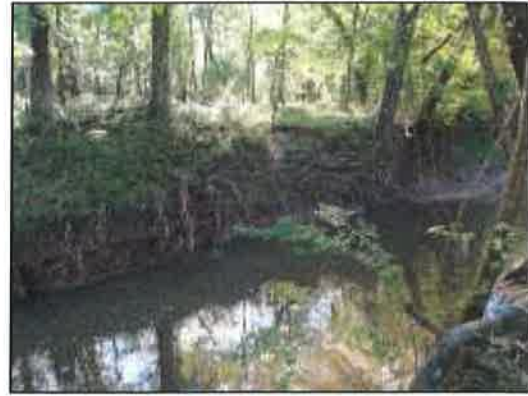
**Figure 6:** East bank just upstream of bank repair; note that root system of several trees are undermined

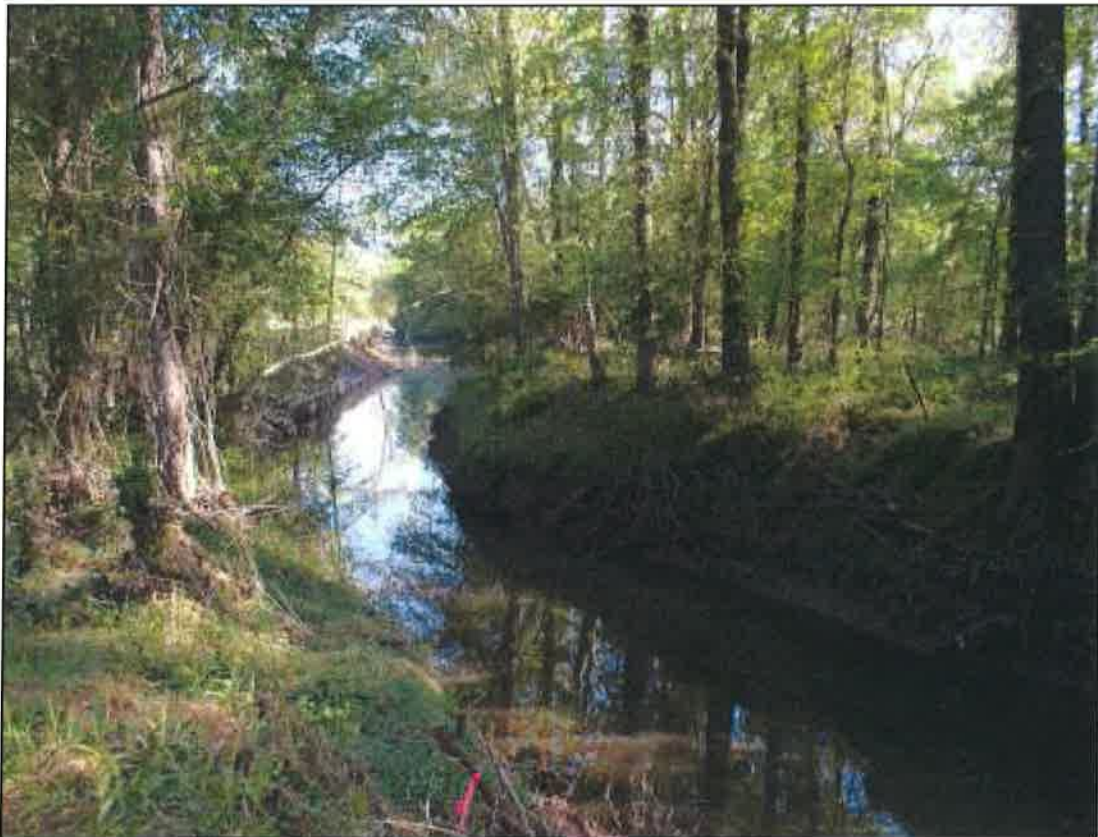
**Figure 7:** Upstream end of first bend looking downstream at the bank repair; note that the slope of the sloughed bank downstream of the repair is approximately the same as the slope of the repaired bank.

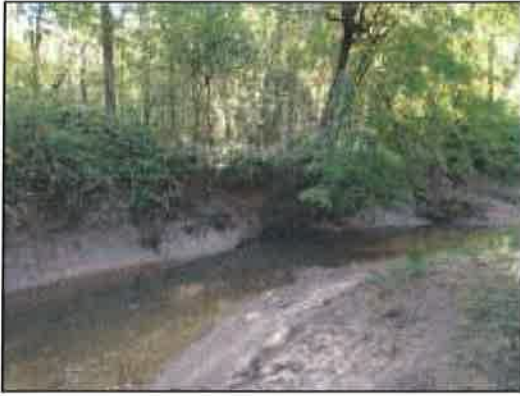
**Figure 8:** Lower end of next bend; note the deposition on the inside (west side) and the undermining of the east bank

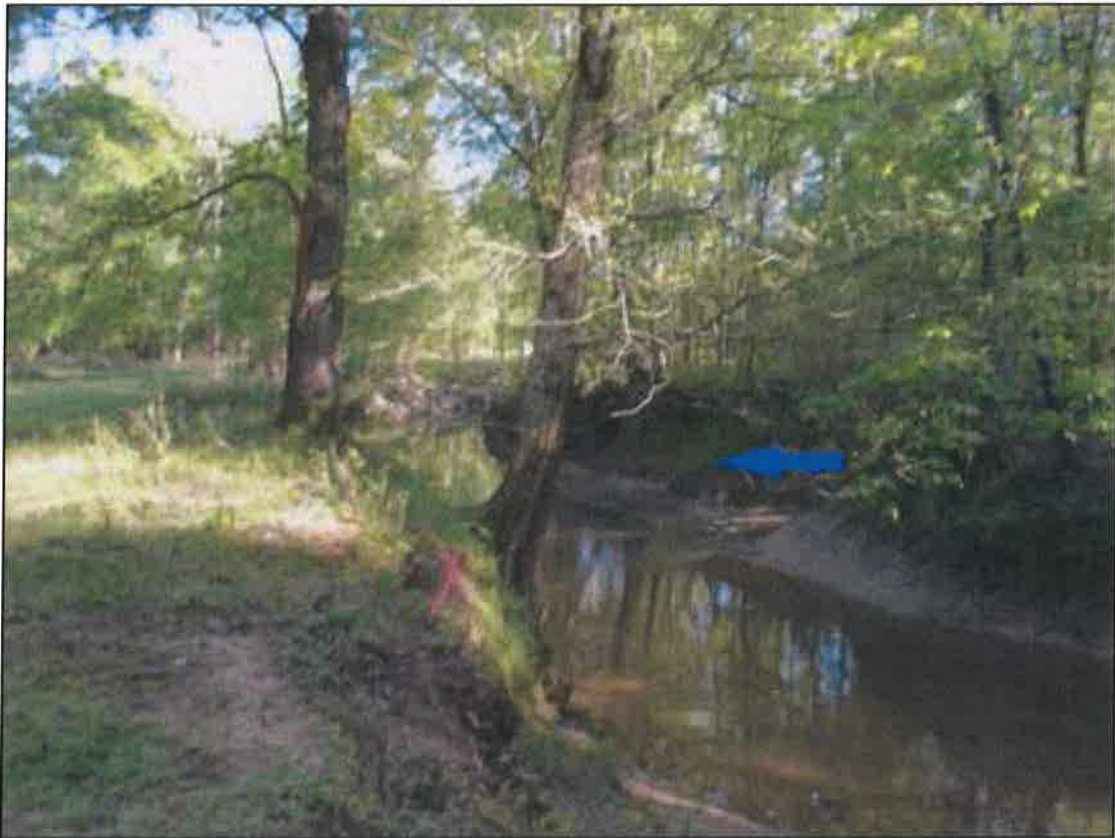
**Figure 10:** Just upstream of the bend looking downstream; the channel has undermined the upper bank on both sides; the blue arrow denotes the point where a wet weather conveyance discharges into the Lateral from the east

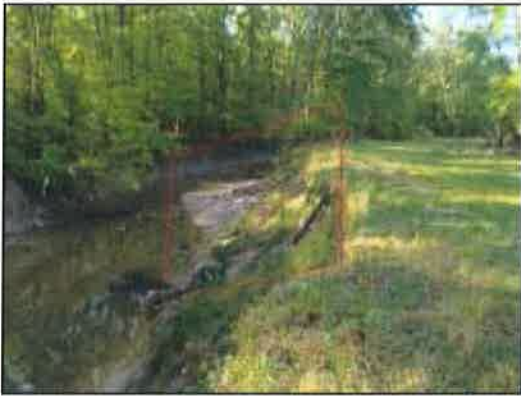
**Figure 11:** Looking upstream along a straight section of highly eroded bank; note the slope failure at the downstream end of the bend

Both banks of the section of the stream represented in photos 11, 12, and 14 are eroded and standing at a near vertical slope. There has been a recent slope failure occur near the downstream of the bend shown in these photos. At the failure the soils from the slope have “slid” out into the channel (see the area in figure 11 boxed in red).

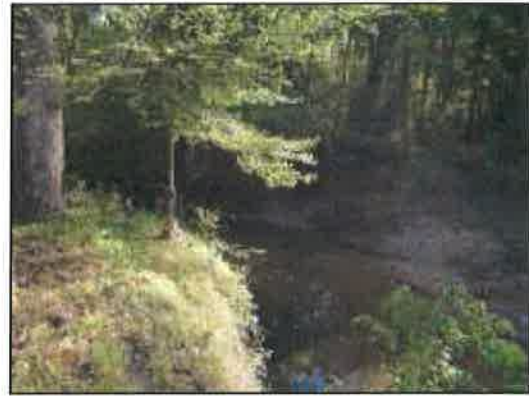
**Figure 12:** Looking downstream just beyond the end of the bend

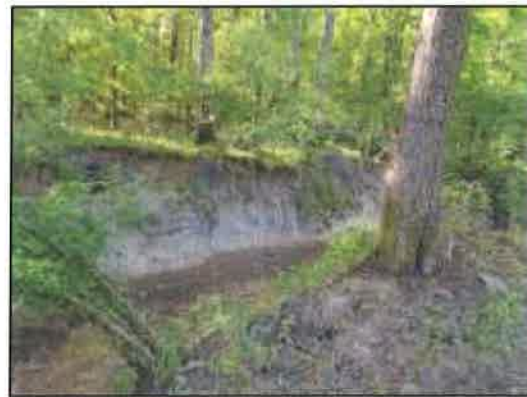
**Figure 14:** Looking upstream from the same vantage point as in figure 13

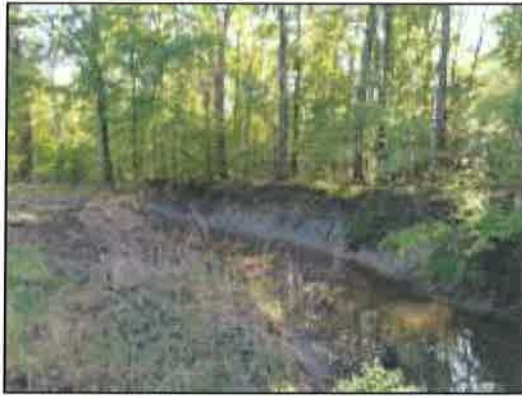
**Figure 15:** Looking downstream at the disturbed slope

The 500± lineal feet of the west bank shown in figures 15, 16, 18, 19 and 21 is unstable and has recently failed and/or there are indications of imminent failure.

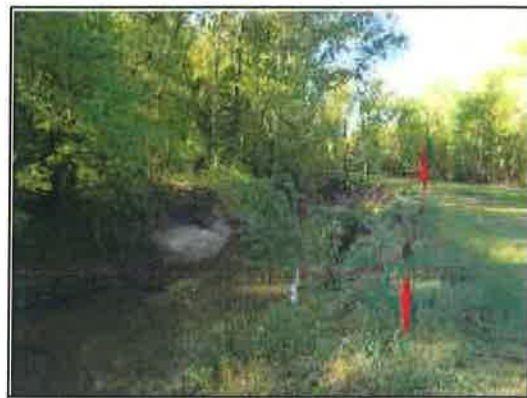
**Figure 18:** Red arrows indicate the ends of a vertical shear crack formed along the top bank

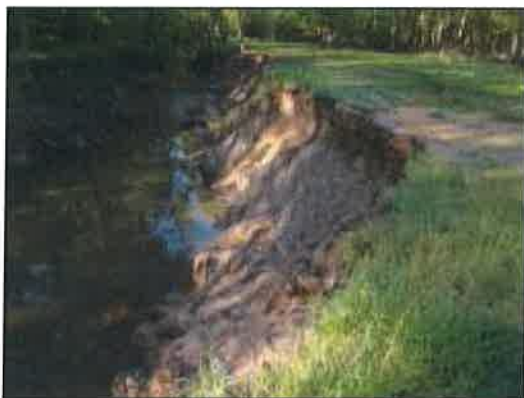
**Figure 19:** Face of recent bank failure just upstream of the shear crack

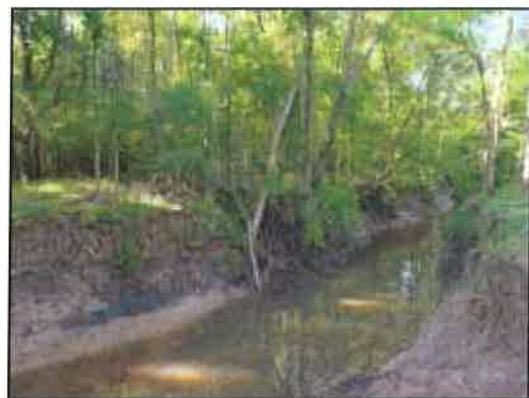
**Figure 20:** Looking upstream from the end of the failing section of the west bank

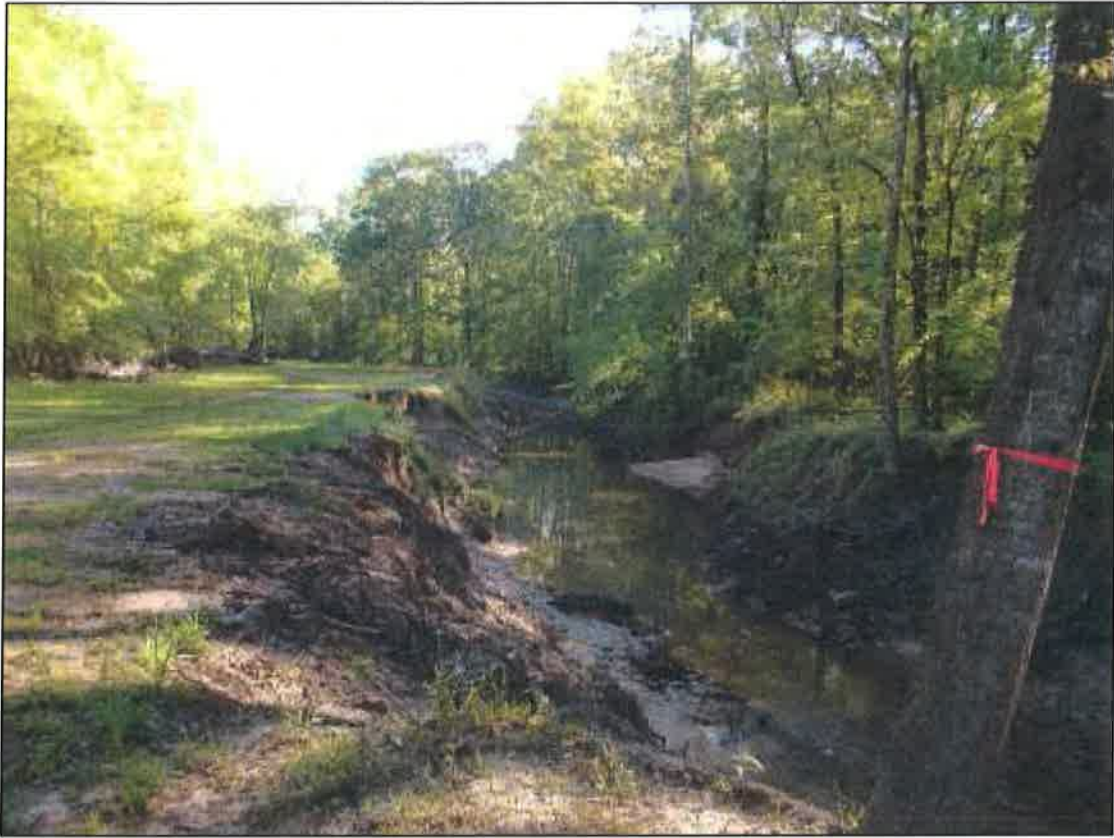
**Figure 21:** Looking downstream along the unstable bank shown in figures 15, 16, 18, and 19

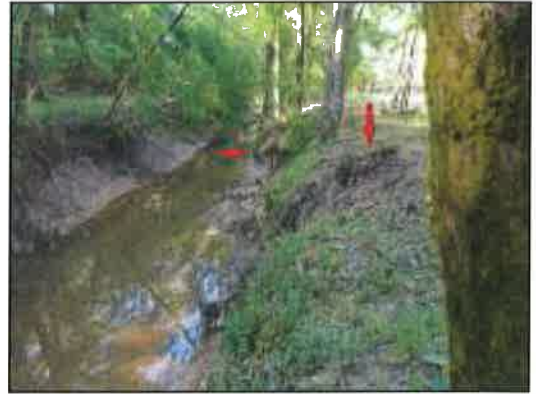
**Figure 29:** Looking upstream from the same vantage point as figure 28; note that east bank slope is beginning to lay back while the west bank is near vertical; the red arrows indicate where the root ball of trees have been undermined and failure is imminent

The bank conditions along the slightly meandering stream section depicted in figures 28 through 35 demonstrate the effects that trees can have upon the slope stability. The majority of the bank slopes on the west side of the stream are vertical and near vertical. The root systems of the trees along the top of the west bank are serving to temporarily stabilize the vertical slopes. Much of the slopes along the east bank have a curved alignment that becomes steeper near the top of bank. There are areas along the east bank where trees are growing near the toe of slope. There is evidence of a past slope failure downstream of some of the trees near the toe of slope as evidenced by the sandy deposits in the area where you would expect an eddy to occur (see figure 35).

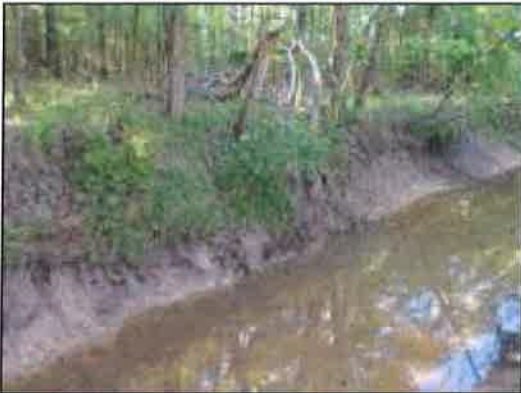
**Figure 30:** Undermined tree roots on the west bank

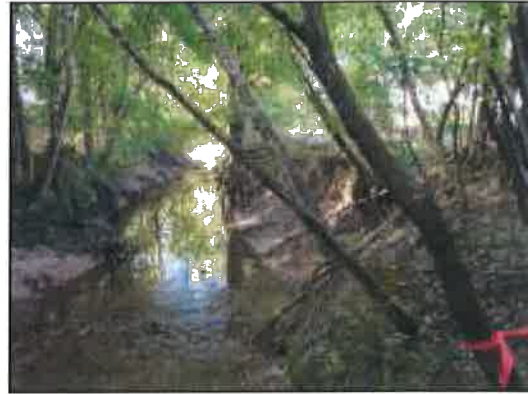
**Figure 33:** Looking upstream; note the sudden widening of the west bank where a bank failure has occurred and the more narrow section just upstream

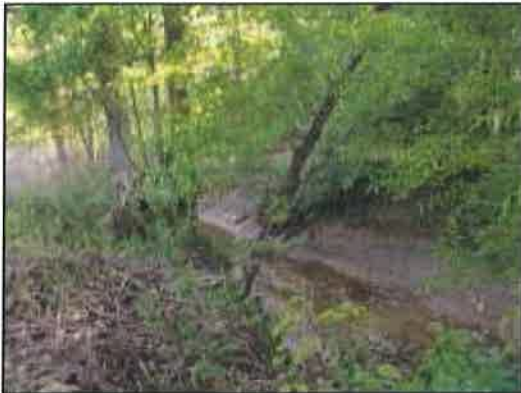
**Figure 34:** View from edge of the washout noted in figure 33; note the root ball beginning to slide down the slope

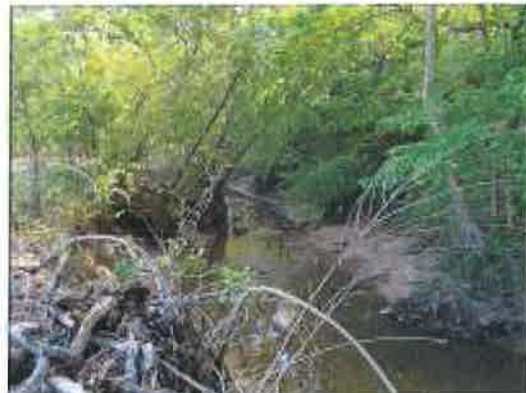
**Figure 35:** Standing at the edge of bank just upstream of the washout looking downstream

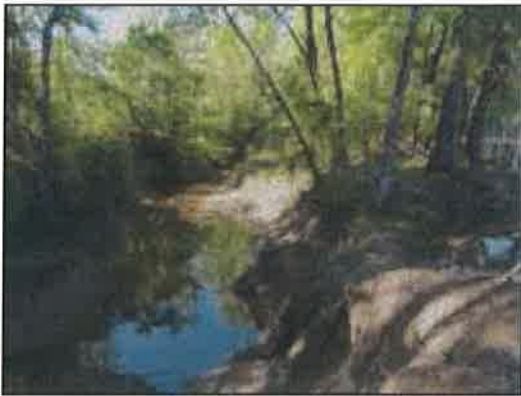
**Figure 36:** Culvert discharge over vertical slope

There is the potential for a washout to occur downstream of several culvert discharge points along the stream bank. The culvert shown in figures 36 and 37 is the first encountered during the inventory.

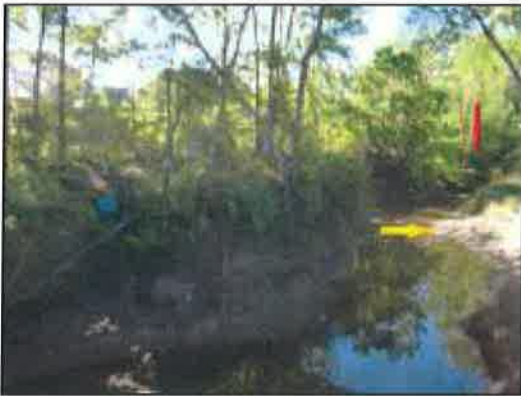
**Figure 38:** Looking upstream; the yellow arrow indicates the toe of a slope failure of the west bank; note the large leaning tree indicated by the red arrow.

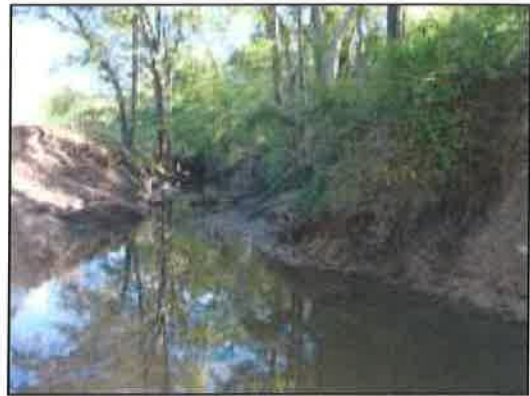
**Figure 39:** Standing at the toe of the slope failure of west bank looking downstream

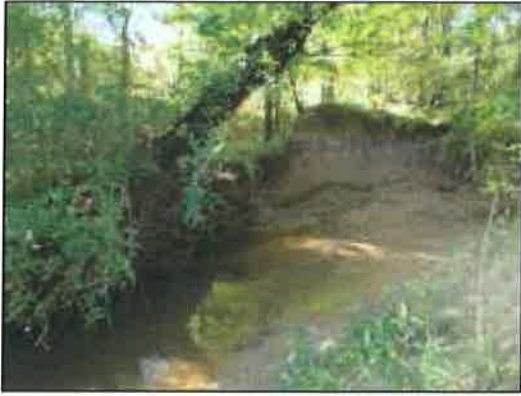
**Figure 40:** Leaning tree noted in figure 38

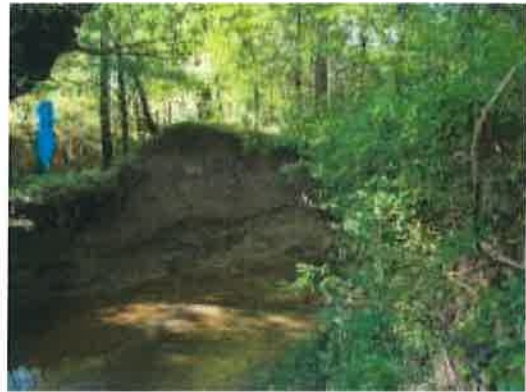
**Figure 41:** Bank erosion upstream of Leaning tree; the blue arrow is pointing to the flowline of the ditch beyond that serves as the outlet for the discharge from the pond in the adjacent subdivision

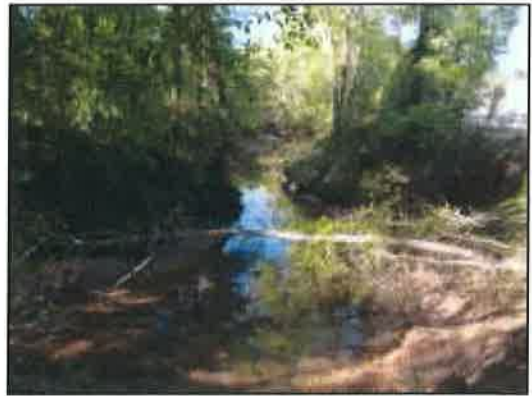
**Figure 45:** Looking upstream from same vantage point as figure 44; note the short meander pattern and the slope failure of the west bank on the outside bend

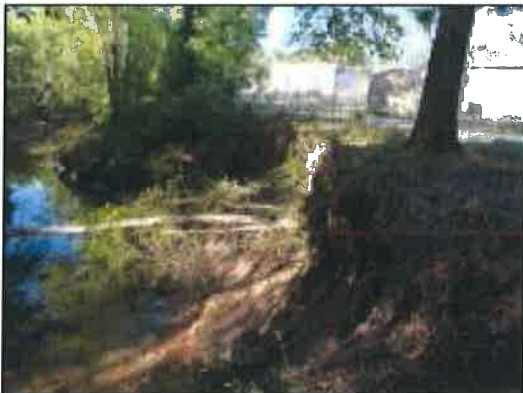
**Figure 46:** Closer view of slope failure shown in figure 45

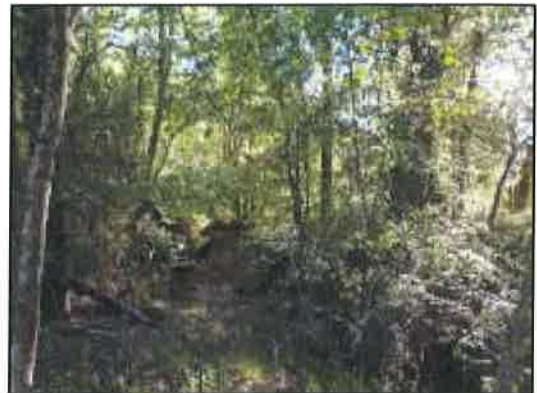
**Figure 47:** Upper end of the meandering pattern shown in figure 45 looking downstream; note the outside bend erosion in the background

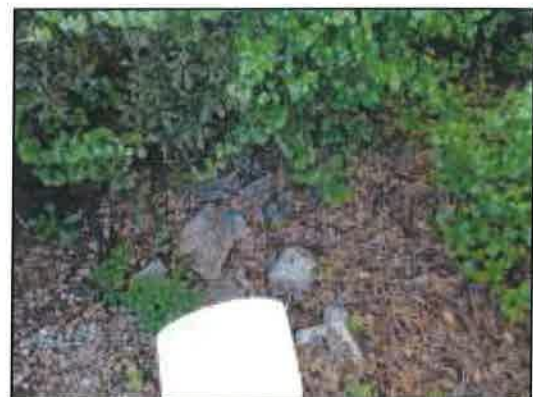
**Figure 49:** Close up of end of culvert

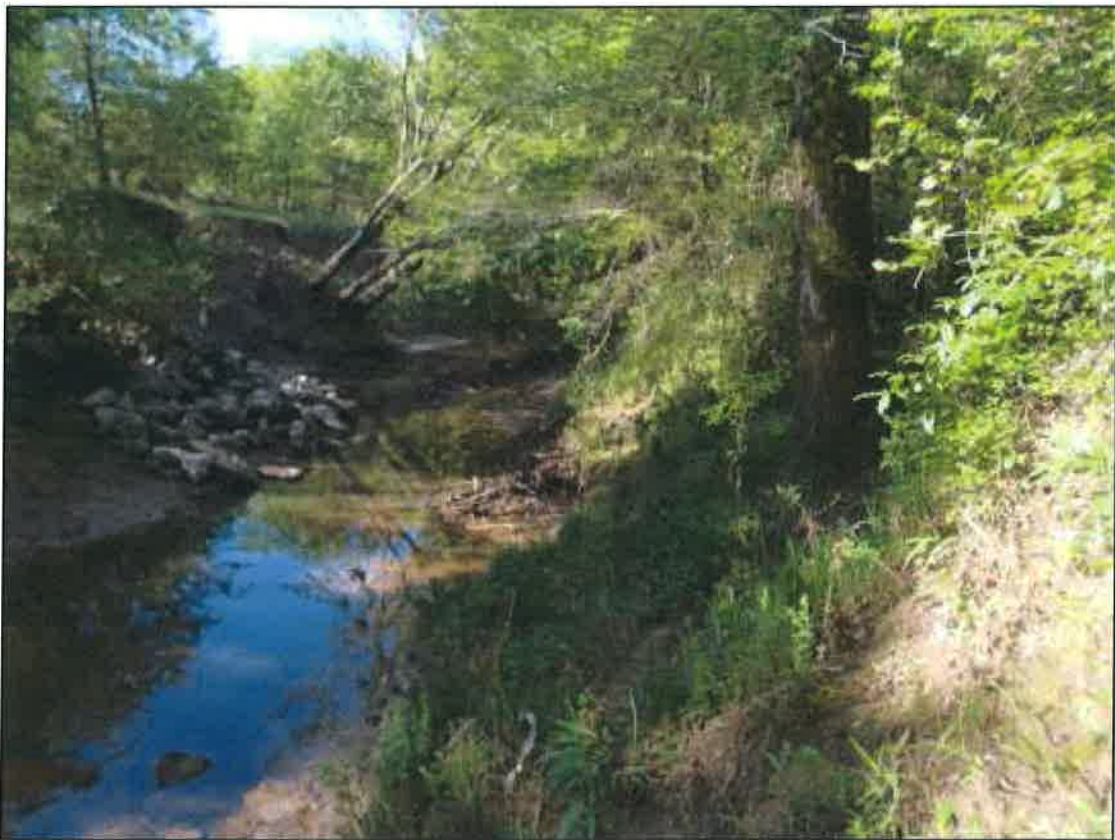
**Figure 52:** Looking upstream from same vantage point as figure 50; note the failure of the rip-rap at the end of the storm sewer outlet ditch, and the three trees that have slide into the stream channel

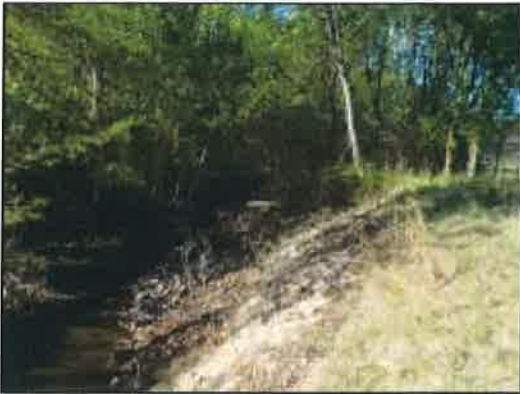
**Figure 53:** Slope repair using grouted Rip-rap; note the cantilevered pipe in the background

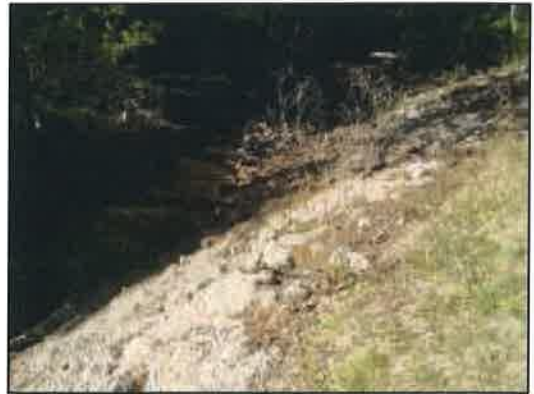
**Figure 54:** Close up of grouted rip-rap

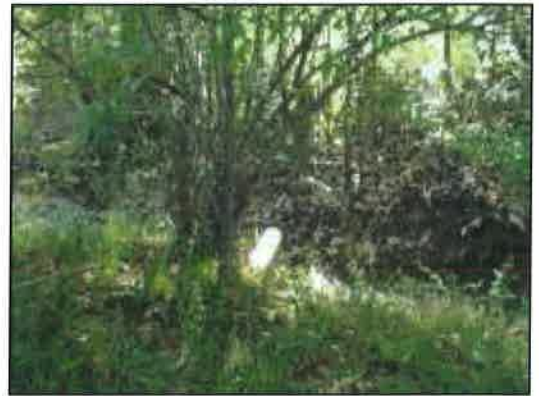
**Figure 56:** Pipe cantilevered from bank

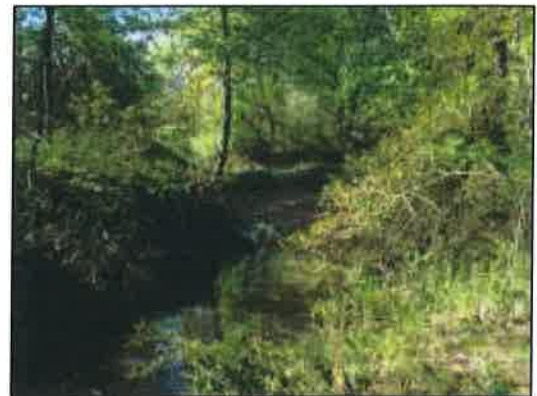
**Figure 58:** Just upstream of figure 57 looking upstream at bend erosion along a low bank on the east side

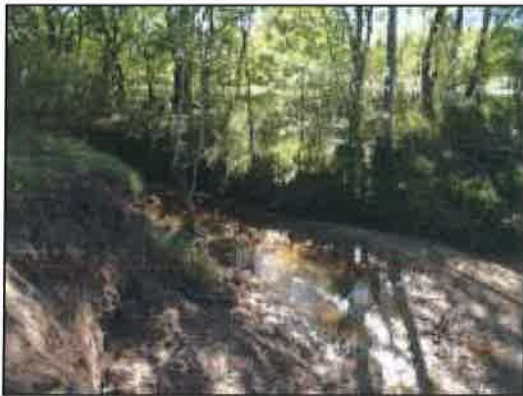
**Figure 67:** Slope failure of the west bank on the inside of a bend

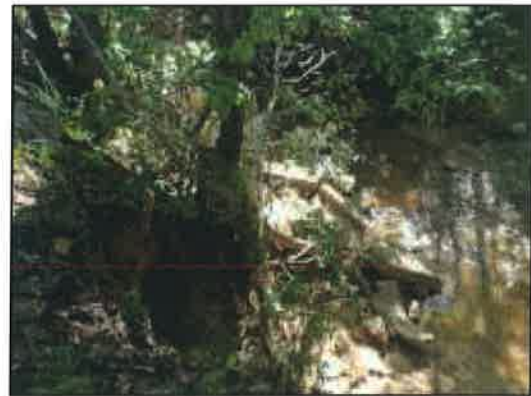
**Figure 68:** Broken concrete used as rip-rap at the upstream end of the failure shown in figure 67

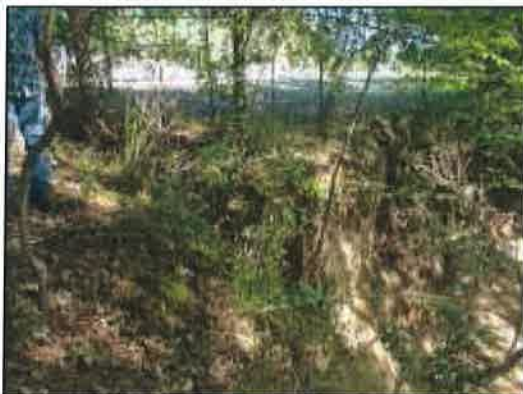
**Figure 69:** Gully erosion down the west Bank just upstream of the slope failure shown in figure 65

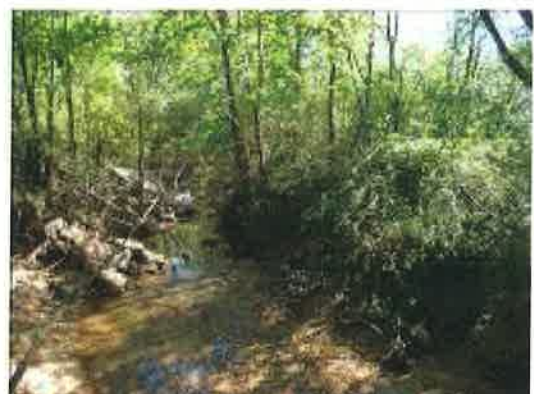
**Figure 70:** Upstream of the meander shown in figure 65; note the concrete rubble rip-rap (same as in figure 68)

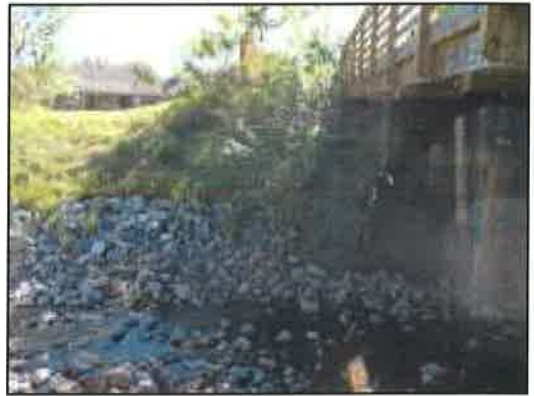
The conditions at the bridge crossing of Shelton Road are a dramatic example of the recent and potential future negative impacts due to head cutting.

**Figure 73:** 2016 water line undermined and removed.

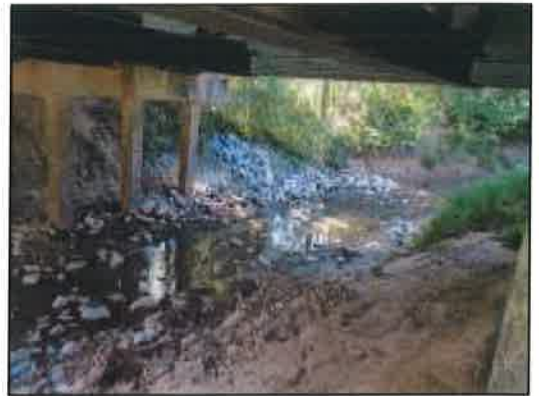
**Figure 75:** Approximately 1+ of additional pile length exposed in 2016
