Attached are photos in taken of the unnamed tributary to Carr Creek that is the receiving stream for the Greenbrier STP. These are the upstream photos. Note there appear to be normal stream conditions except some thin sediment deposits on the substrate.

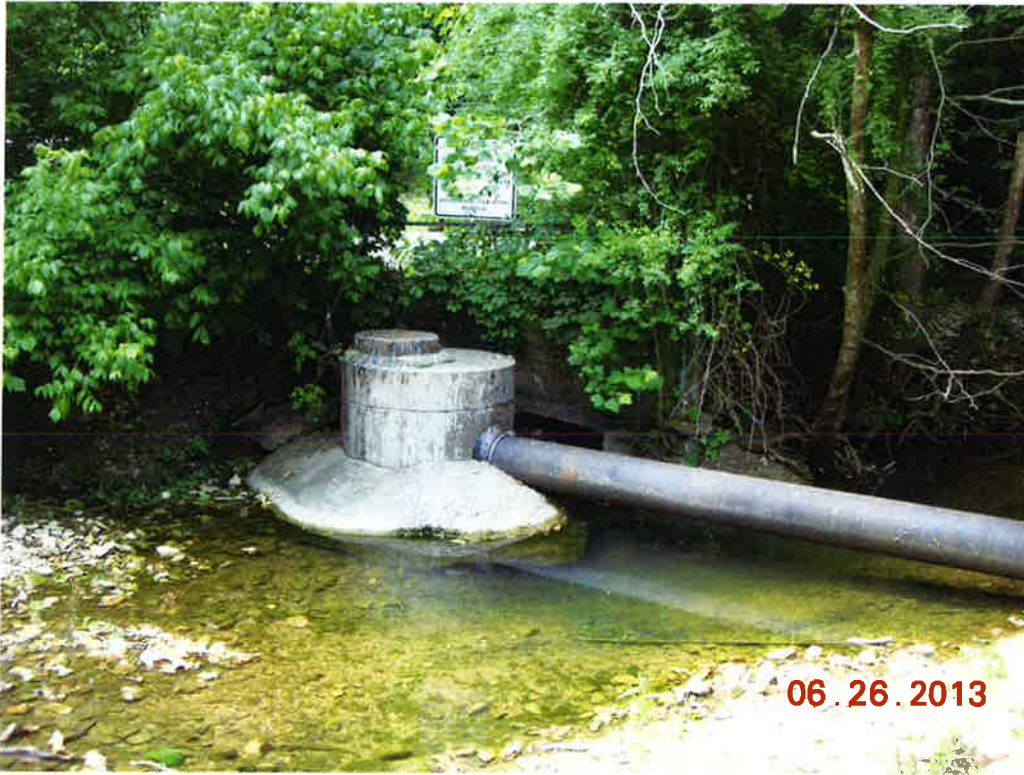
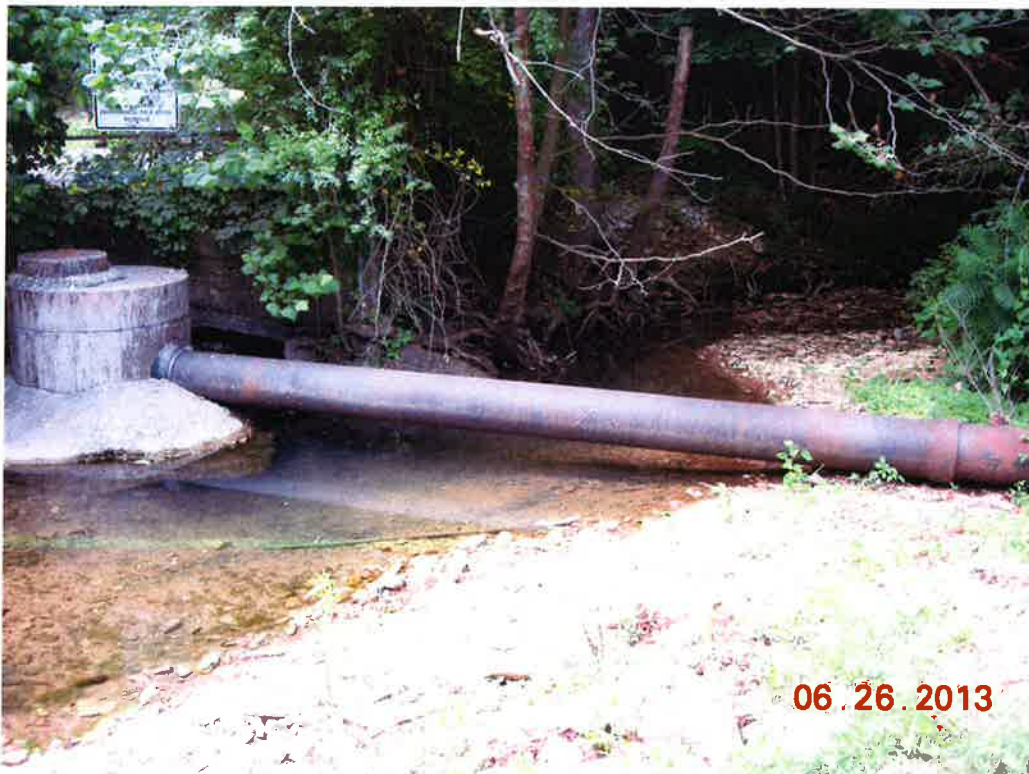
Overflow point at last manhole in collection system before the sewer main enters the treatment plant (combined flow from the whole system). Note the condition of the manhole, sewage debris visible from previous overflows, and sign posted on the plant fence to identify the untreated discharge point.

This is the location where most of the collection system overflows occur. It is just upstream of the plant outfall point.

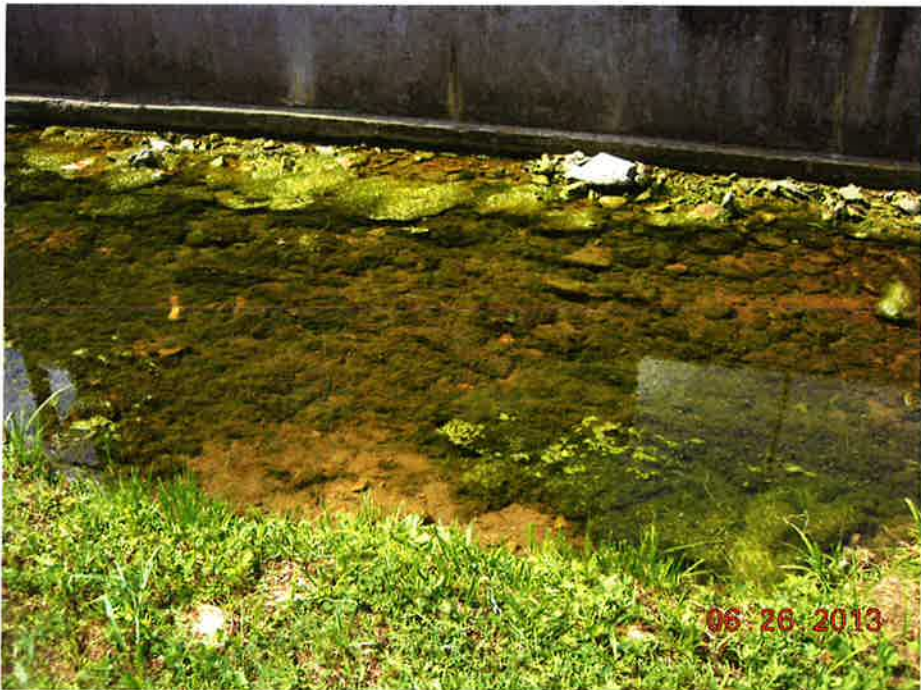
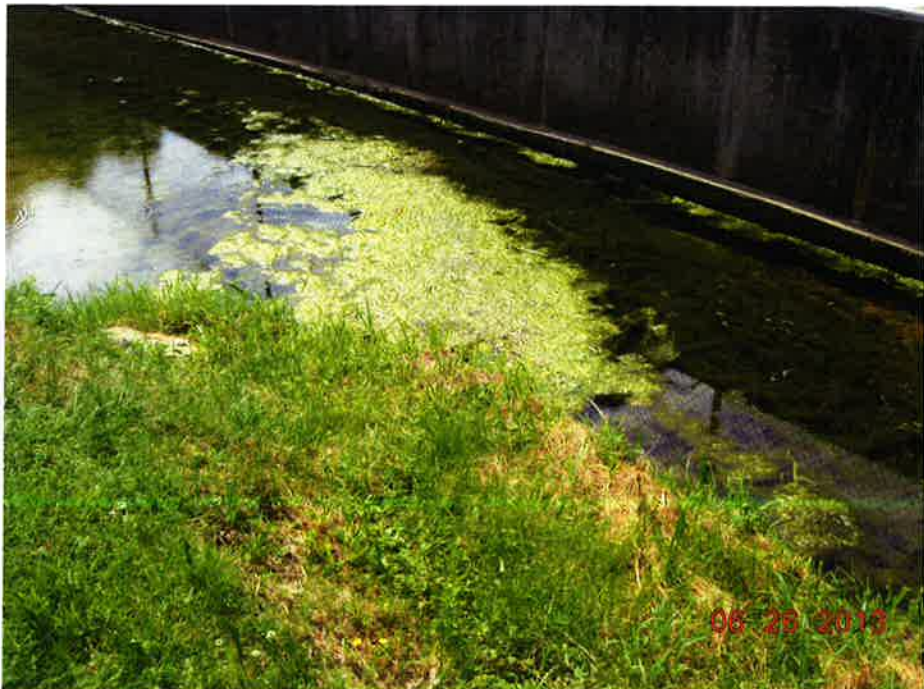
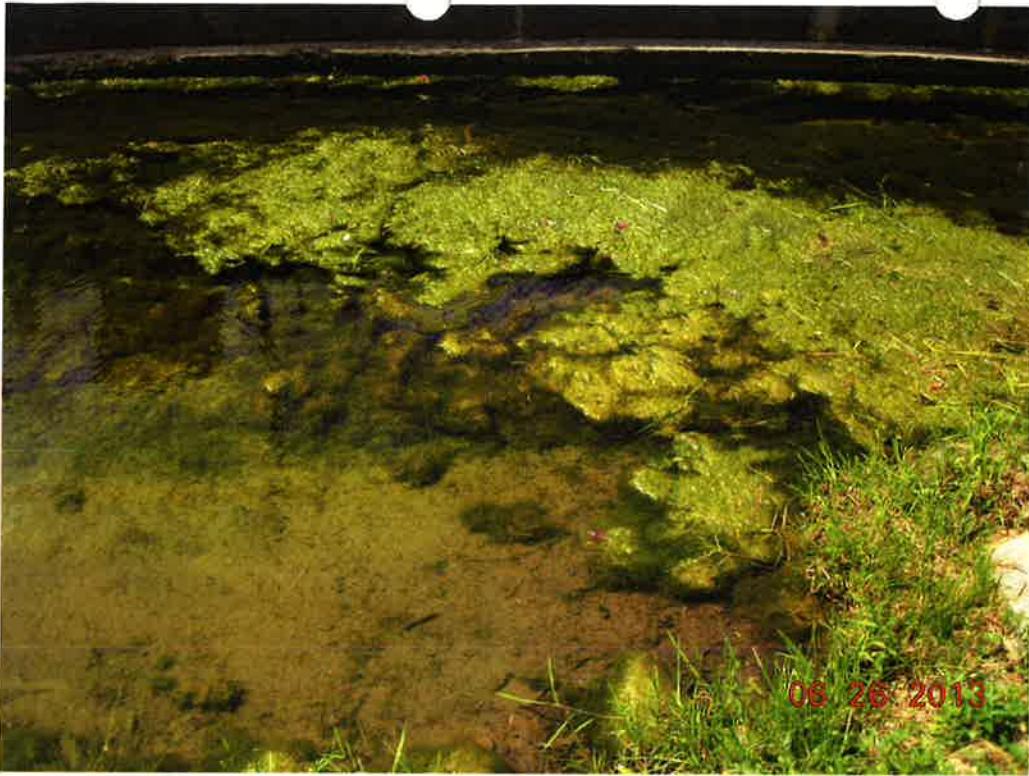
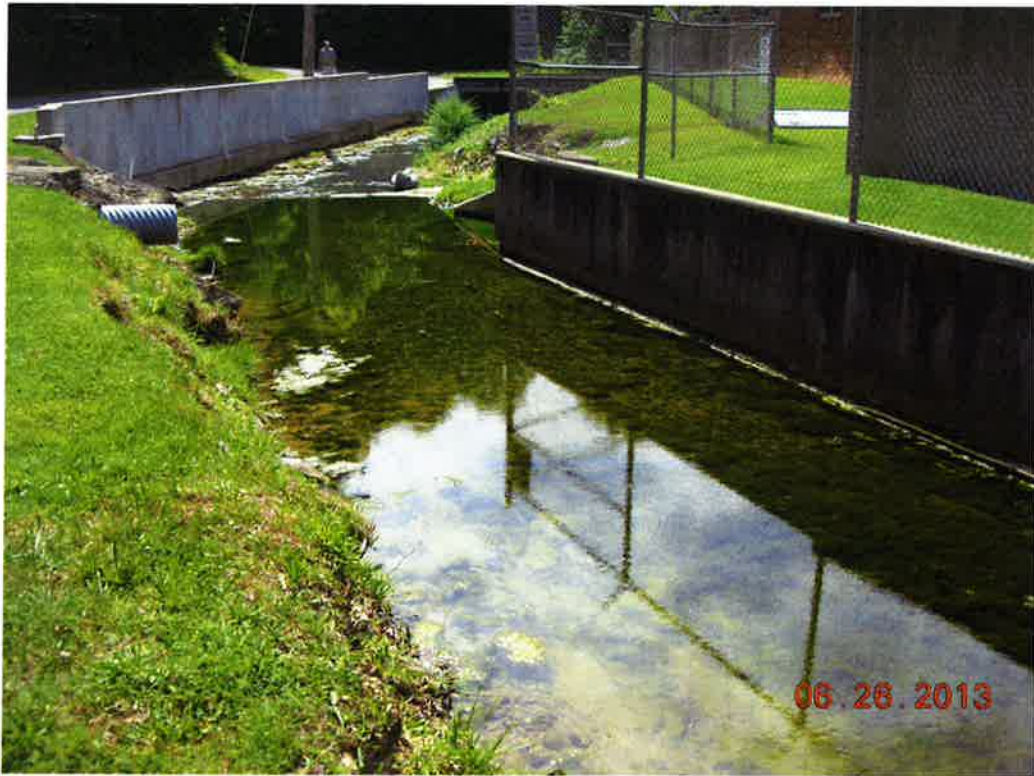
These are photos showing the outfall and just downstream. The heavy algae growth continues here due to both the permitted discharge and the manhole overflow. The system is an sequencing batch reactor (SBR), so the discharge is not continuous. The periodic discharges are released and flush downstream in a slug, then the stream flow returns to the normal low levels.
