Photographic Log for Memphis Regional Intermodal Facility

Permittee Name:		Site Location:	Tracking No.:
Norfolk Southern Railway Company		Rossville, Fayette County	TN0081108
Photo No.	Date

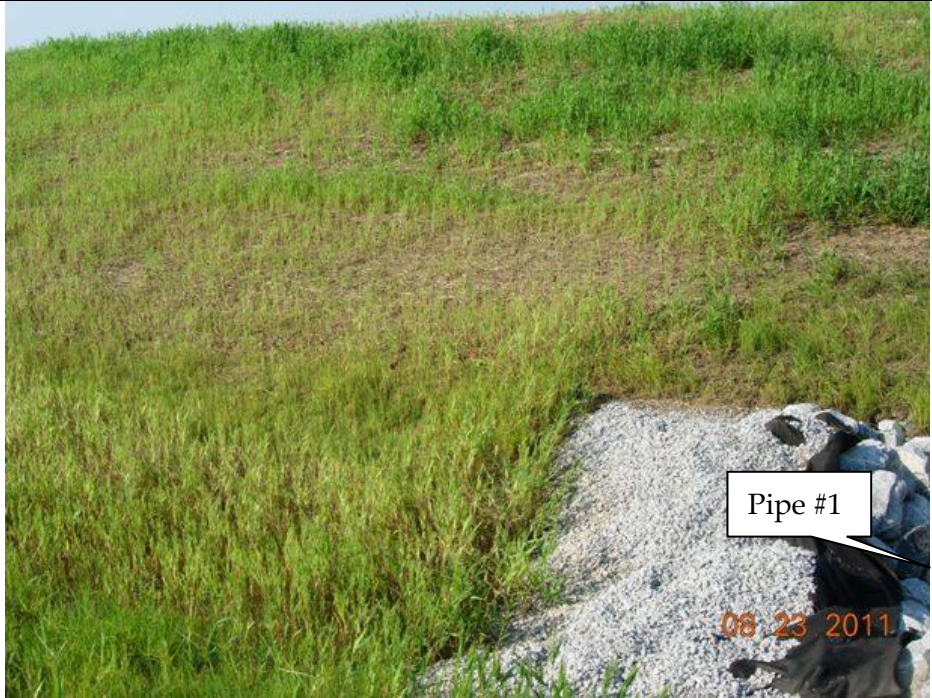
1	8-23-11		
Description <ul style="list-style-type: none"> • Phase 2 EC-21. • The slope adjacent to the inlet of Pipe #1 along the south side of the western wye track was sparsely vegetated. • The predominant grass was brown top millet. • Pipe #1 discharges toward SW 21. 			
Photo No.	Date

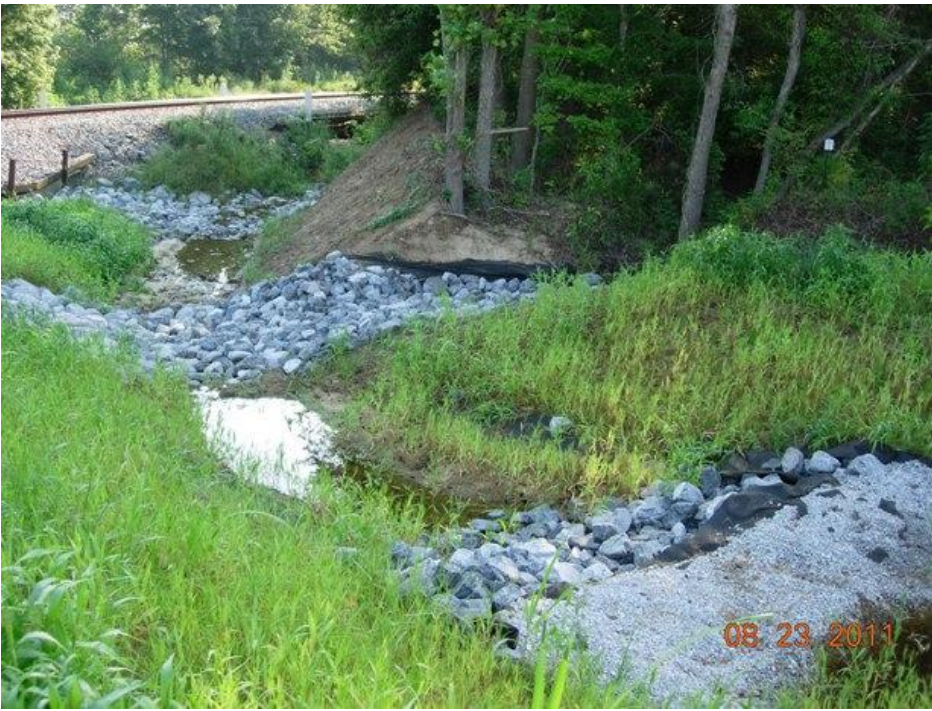
2	8-23-11		
Description <ul style="list-style-type: none"> • Phase 2 EC-21. • This photo is of SW 21. • The banks of the swale were sparsely vegetated with brown top millet and not sufficiently stabilized with permanent vegetative cover. • Bare areas and sparse vegetation were observed on the top bank along the swale. This area was also not sufficiently stabilized with a permanent vegetative cover. • The water within the swale was mostly clear with a slightly brown (tannic) hue.

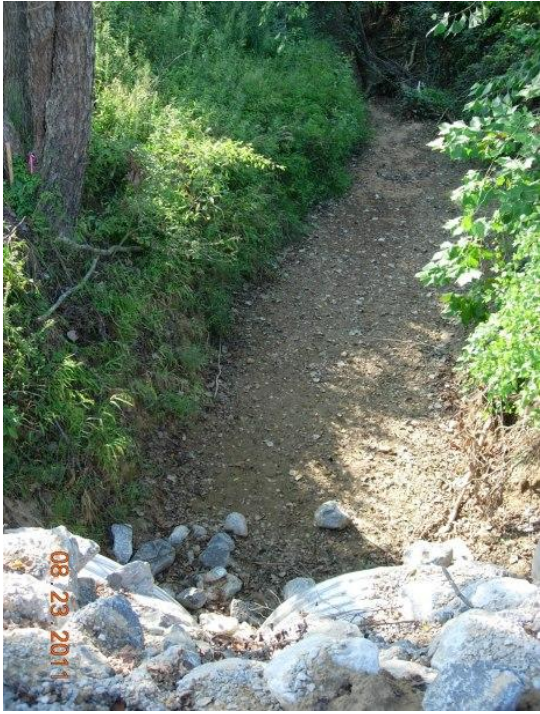
Permittee Name:		Site Location:	Tracking No.:
Norfolk Southern Railway Company		Rossville, Fayette County	TN0081108
Photo No.	Date		
5	8-23-11		
Description <ul style="list-style-type: none"> Phase 1A EC-11. This photo is of Stream 5, on the upstream side of the temporary road crossing.

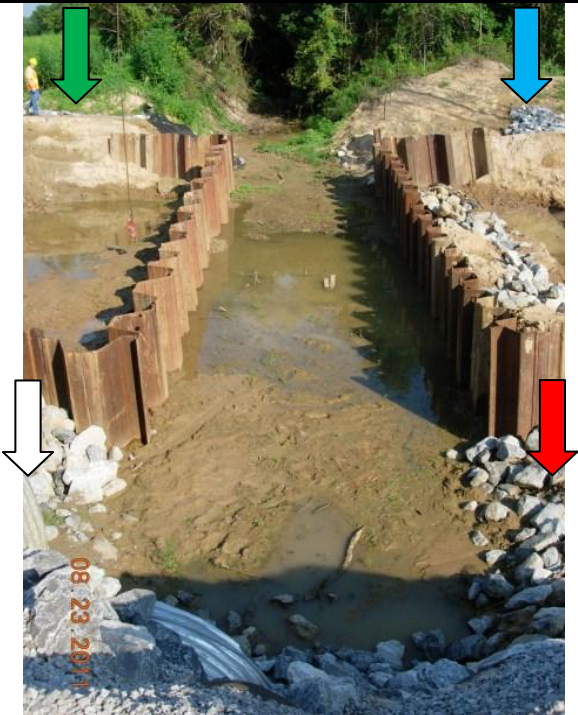
Photo No.	Date		
6	8-23-11		
Description <ul style="list-style-type: none"> Phase 1A EC-11. This photo is of Stream 5, downstream of the temporary road crossing. This photo also shows the bridge sheet-pilings installed for the permanent bridge. Sediment was observed covering the bottom of Stream 5. SW 24 (white arrow). SW 23 (red arrow). SW 22 (blue arrow). SW 25 (green arrow).

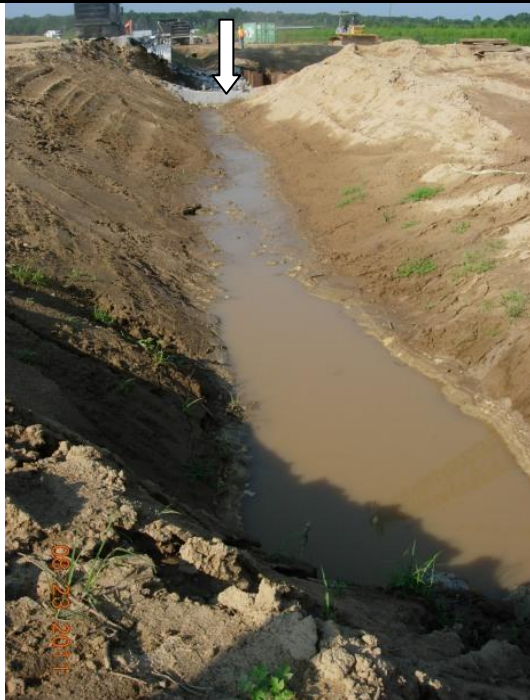
7	8-23-11		
Description			
<ul style="list-style-type: none">• Phase 1A EC-11.• SW 23 (arrow).• Other than the ERCD located at SW 23, the swale leading to SW 23 had no other EPSC measures installed.• Stream 5 is located just beyond SW 23.• The banks of the swale were not stable.• The water in the swale was sediment-laden.

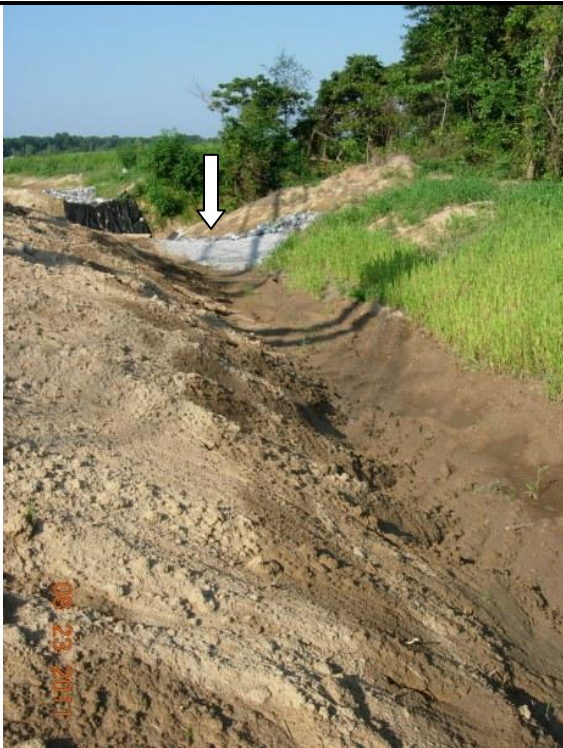
8	8-23-11		
Description <ul style="list-style-type: none">• Phase 1A EC-11.• The arrow indicates SW 22.• Other than the ERCD located at SW 22 and some vegetation on the upper portion of the western side of the swale, the swale leading to SW 22 had no other sediment control measures installed.• A portion of the western side of the swale was sparsely covered with brown top millet and not sufficiently stabilized.• The eastern side of the swale was not stabilized.• Stream 5 is located just beyond SW 22.

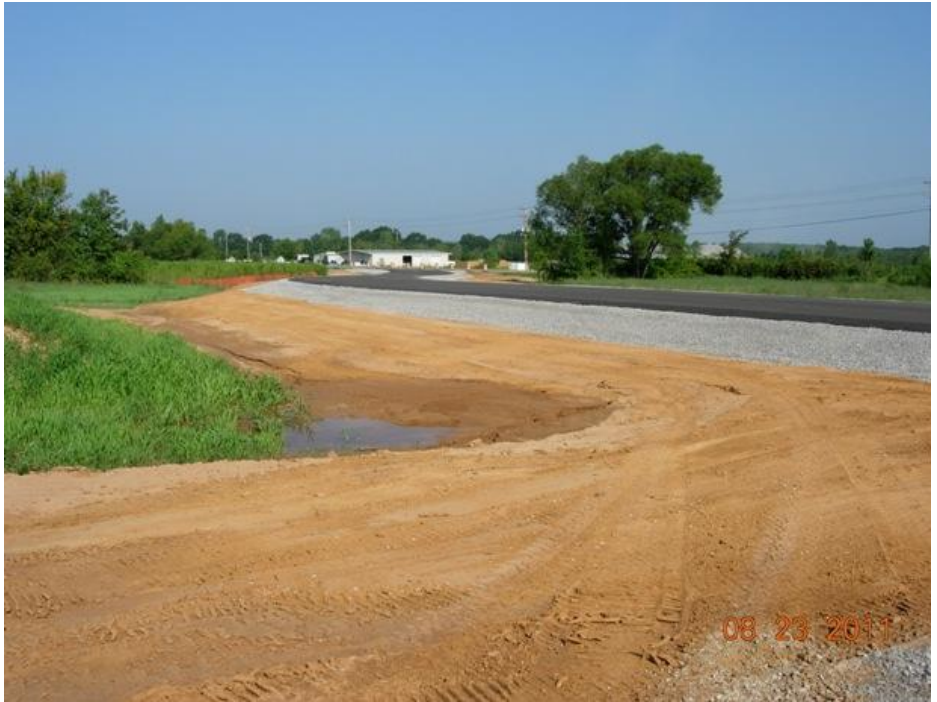
Permittee Name:		Site Location:	Tracking No.:
Norfolk Southern Railway Company		Rossville, Fayette County	TN0081108
Photo No.	Date		
11	8-23-11		
Description <ul style="list-style-type: none"> • Phase 2 EC-21 and EC-22. • The western end of the run-around road, south of Highway 57, is shown in this photo. • The area adjacent to the gravel base was not stabilized. • The western end of the road was connected to Highway 57, not to Neville Road as shown on the ECP.

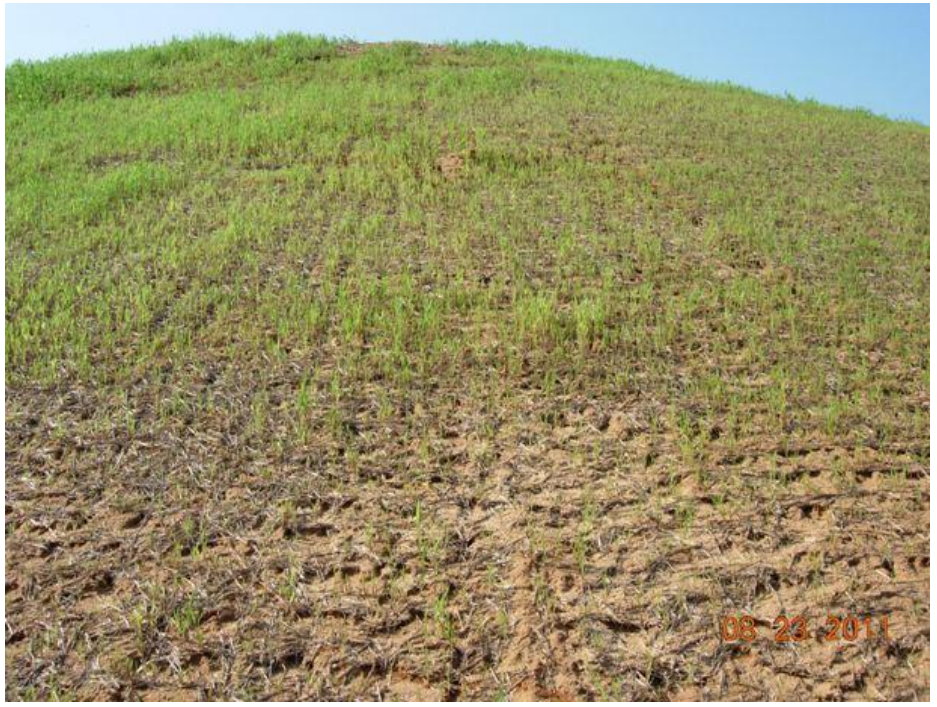
Photo No.	Date		
12	8-23-11		
Description <ul style="list-style-type: none"> • Phase 2. • This photo is of the northern end of the noise berm along the western side of the lead track, just south of the western end of the run-around road. • Sparse coverage of brown top millet was observed in this location as well as on a majority of the berm. • The berm was not sufficiently stabilized with permanent vegetation.

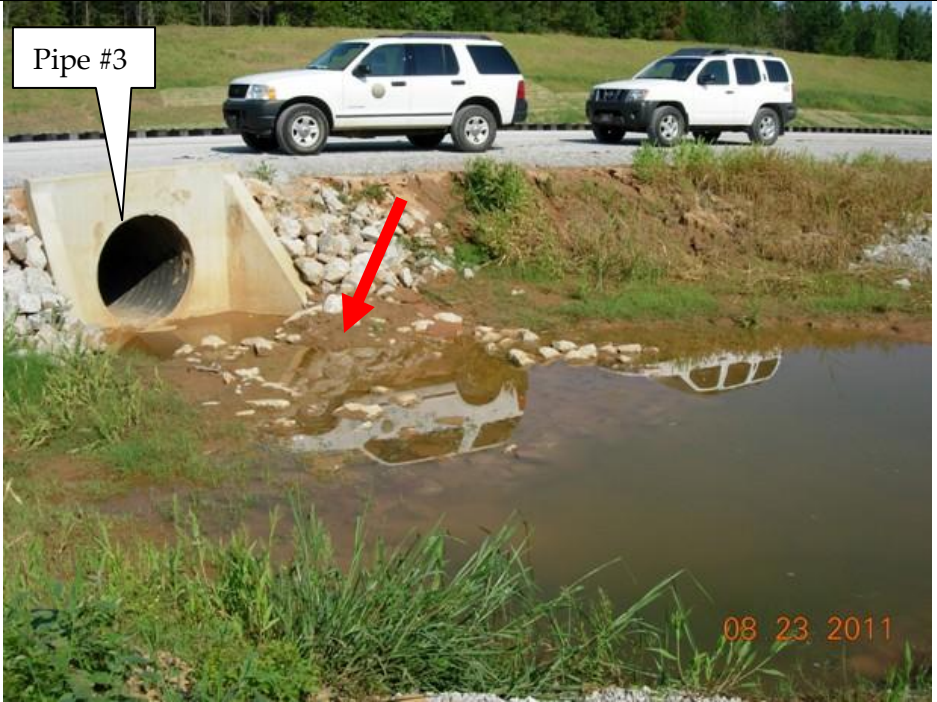
Permittee Name:		Site Location:	Tracking No.:
Norfolk Southern Railway Company		Rossville, Fayette County	TN0081108
Photo No.	Date		
13	8-23-11		
Description <ul style="list-style-type: none"> Phase 2 EC-23. Pipe #3 as depicted on EC-23 and associated with SW 3 is shown in this photo. Sediment deposition (arrow) was observed covering the rip rap down gradient from Pipe #3. The pooled water was clear. The slope banks adjacent to the outlet end of Pipe #3 were not sufficiently stabilized in some locations.

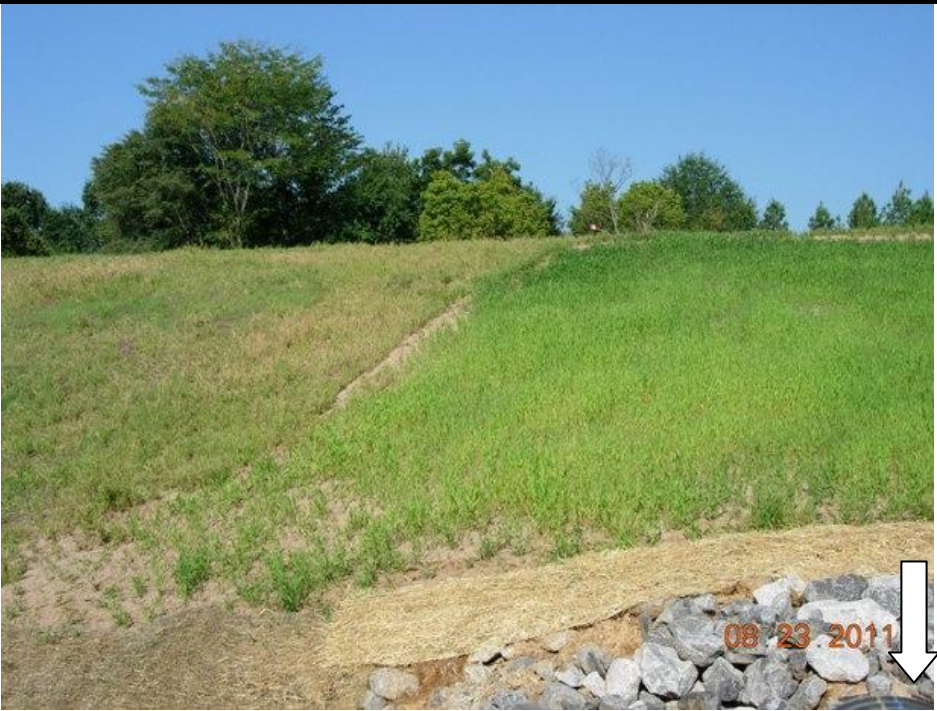
<p>A photograph showing the outlet of a concrete pipe (Pipe #3) into a body of water. A red arrow points to a pile of brown sediment deposited on the rip rap at the pipe's exit. Two white SUVs are parked on a gravel area in the background. The date '08 23 2011' is printed in orange in the bottom right corner.</p>	
Photo No.	Date		
14	8-23-11		
Description <ul style="list-style-type: none"> Phase 2 EC-23. The noise berm slope up-gradient (west) of Pipes #5 and #6 cross drain associated with SW 4 (arrow) was covered with brown top millet, but was sparse in areas. Ms. Hagerty indicated that Flexterra (greener grass) was used on the slope between the cross drains of SW 3 and SW 4. Patches of bermuda intermixed with the brown top millet were observed on the slope south of SW 4 cross drain.

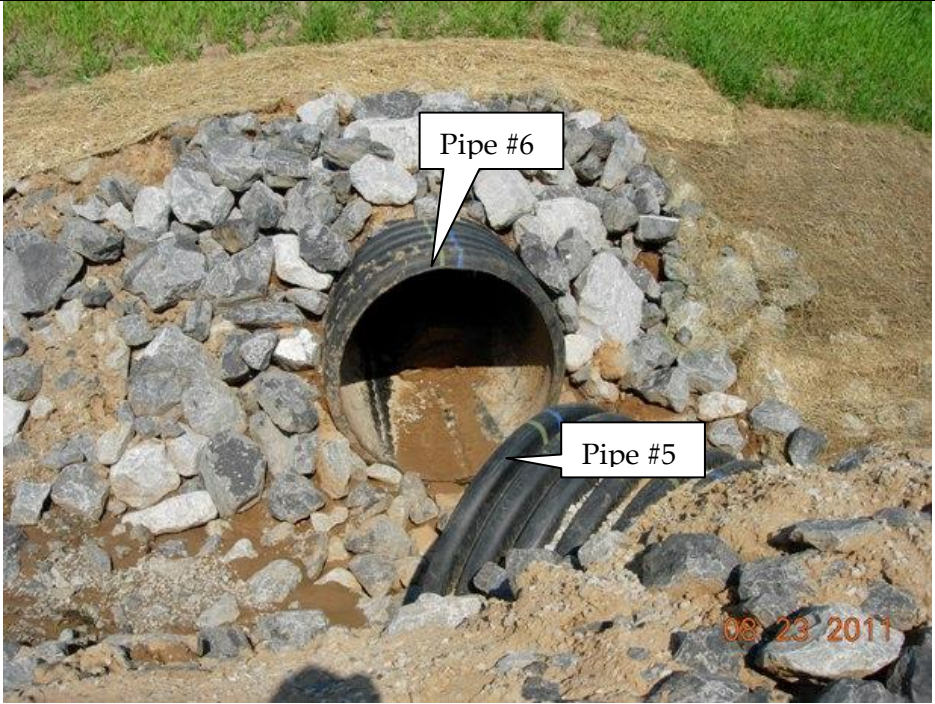
Permittee Name:		Site Location:	Tracking No.:
Norfolk Southern Railway Company		Rossville, Fayette County	TN0081108
Photo No.	Date		
15	8-23-11		
Description <ul style="list-style-type: none"> • Phase 2 EC-23. • The cross drain associated with SW 4 is shown in this photo. • The up-gradient pipe (Pipe #6) contained up to 8-10 inches of accumulated sediment. • The down-gradient pipe (Pipe #5) also contained accumulated sediment. • It appeared that matting had recently been installed adjacent to the pipes.

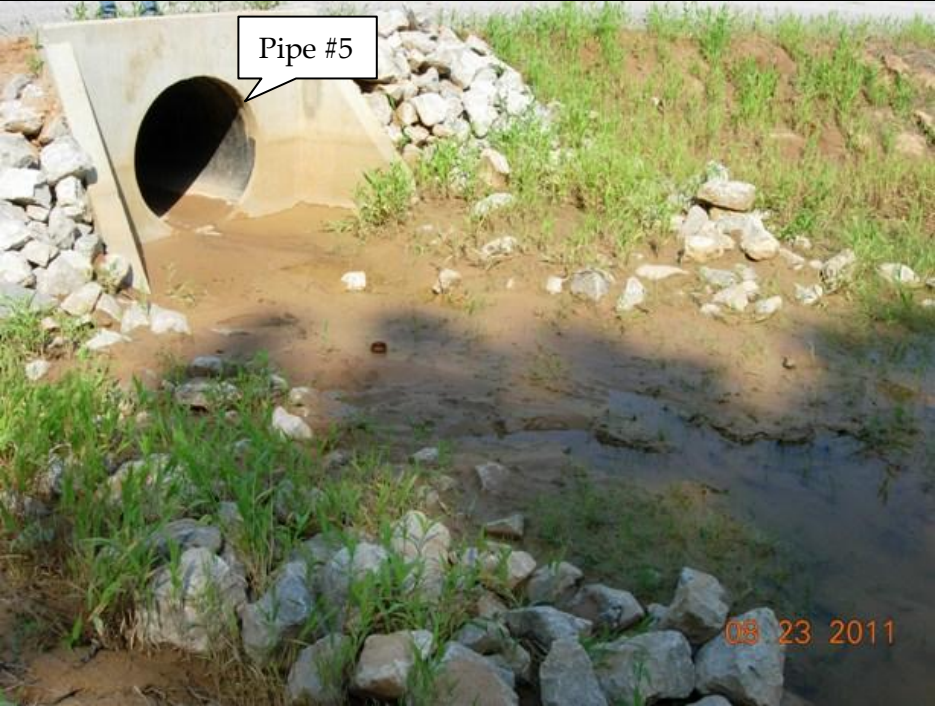
Photo No.	Date		
16	8-23-11		
Description <ul style="list-style-type: none"> • Phase 2 EC-23. • The outlet end of Pipe #5 up-gradient from SW 4 is shown in this photo. • Sediment accumulation was covering the rip rap down-gradient from the headwall. • The slopes adjacent to the outlet end of Pipe #5 were not sufficiently stabilized. • The pooled water down-gradient from Pipe #5 was clear.

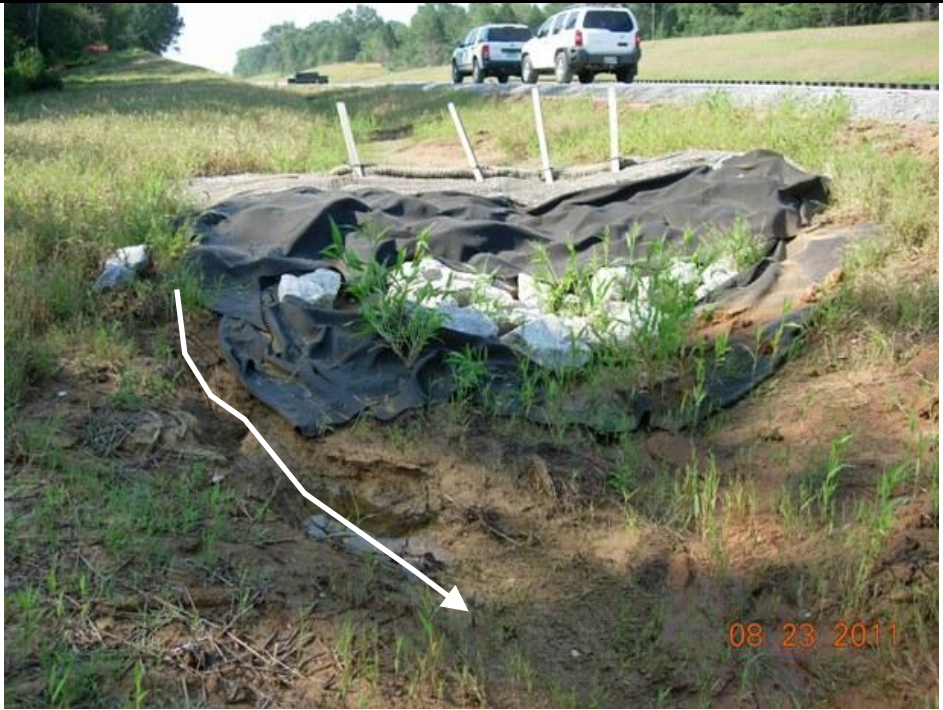
Permittee Name:		Site Location:	Tracking No.:
Norfolk Southern Railway Company		Rossville, Fayette County	TN0081108
Photo No.	Date		
17	8-23-11		
Description <ul style="list-style-type: none"> • Phase 2 EC-23. • An erosion gully (arrow) was observed on the east side of the ERCD that is installed up-gradient (south) of Pipe #7 and SW 5 indicating that flow has bypassed the ERCD. • The swale leading to the ERCD and down-gradient of the ERCD was not sufficiently vegetated.

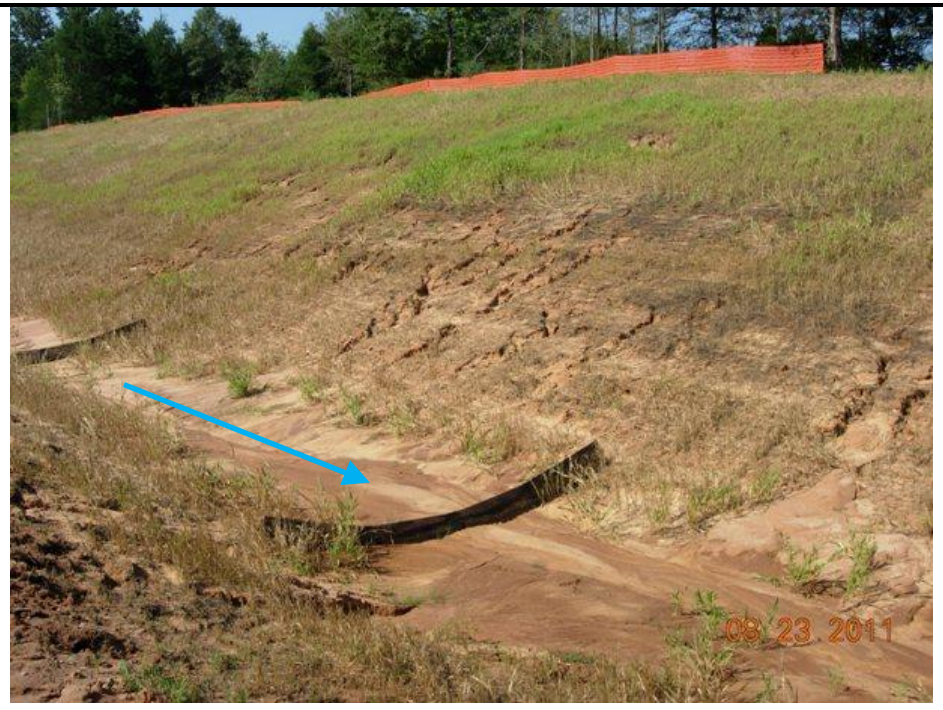
Photo No.	Date		
18	8-23-11		
Description <ul style="list-style-type: none"> • Phase 2 EC-23. • The slope and swale up-gradient from the inlet end of Pipe #7 associated with SW 5 (near Stations 59+00 and 60+00) were not sufficiently vegetated. • Sparse patches of brown top millet were observed. • Rills and gullies were observed. • The direction of flow toward the inlet end of Pipe #7 is shown with the blue arrow.

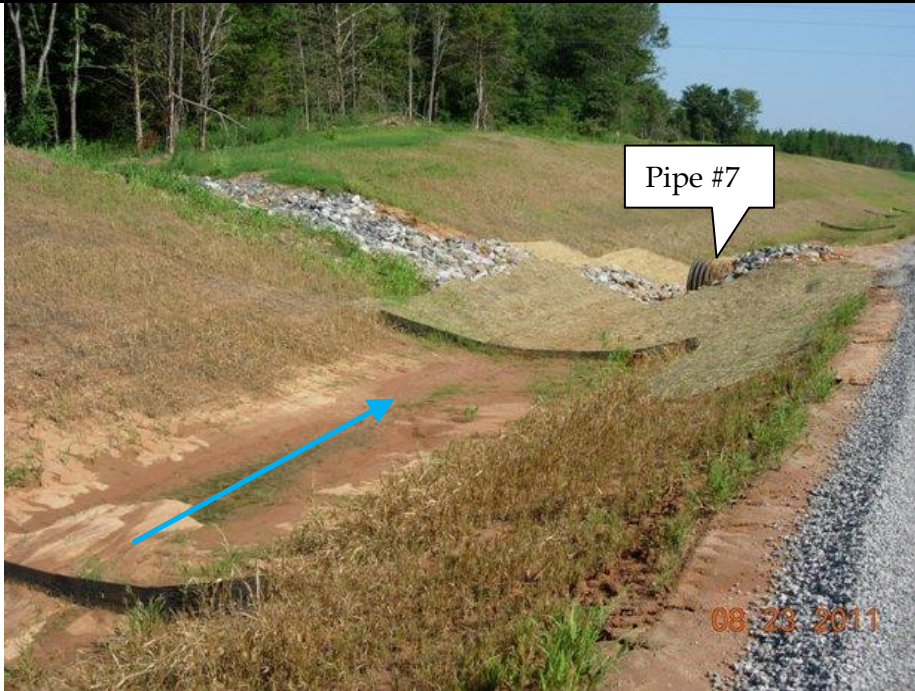
Permittee Name:		Site Location:	Tracking No.:
Norfolk Southern Railway Company		Rossville, Fayette County	TN0081108
Photo No.	Date		
19	8-23-11		
Description <ul style="list-style-type: none"> • Phase 2 EC-23. • Another view of the slope and swale up-gradient from the inlet end of Pipe #7 associated with SW 5. • The slope and swale were not sufficiently vegetated. • Sparse patches of brown top millet were observed. • Rills and gullies were observed. • The direction of flow toward the inlet end of Pipe #7 is shown with the blue arrow.

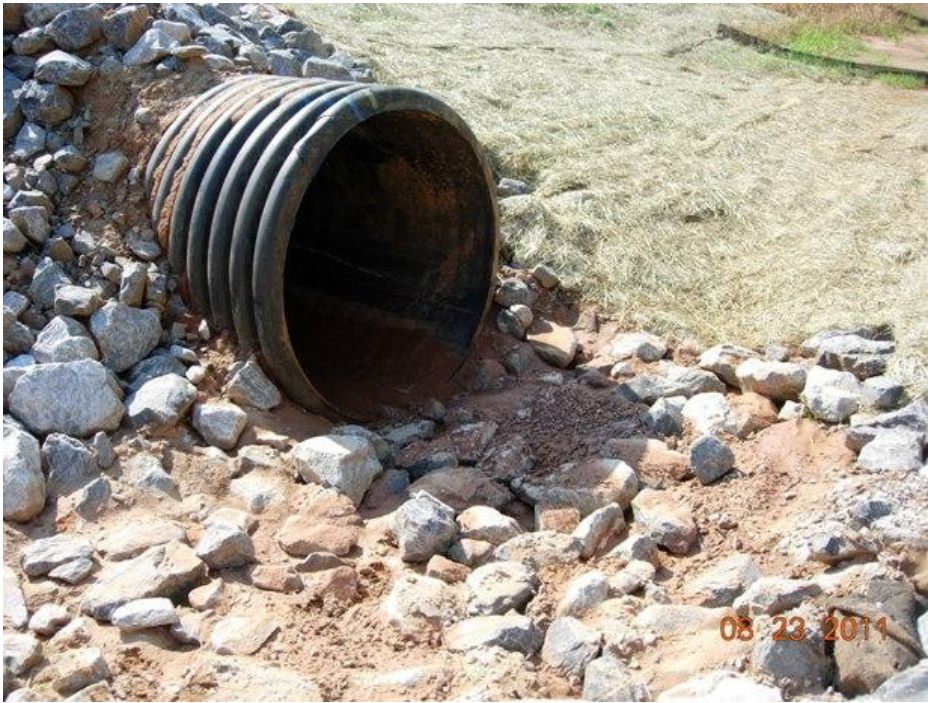
Photo No.	Date		
20	8-23-11		
Description <ul style="list-style-type: none"> • Phase 2 EC-23. • The inlet end of Pipe #7 associated with SW 5 is shown in this photo. • Sediment accumulation was observed within the pipe and covering the rip rap.

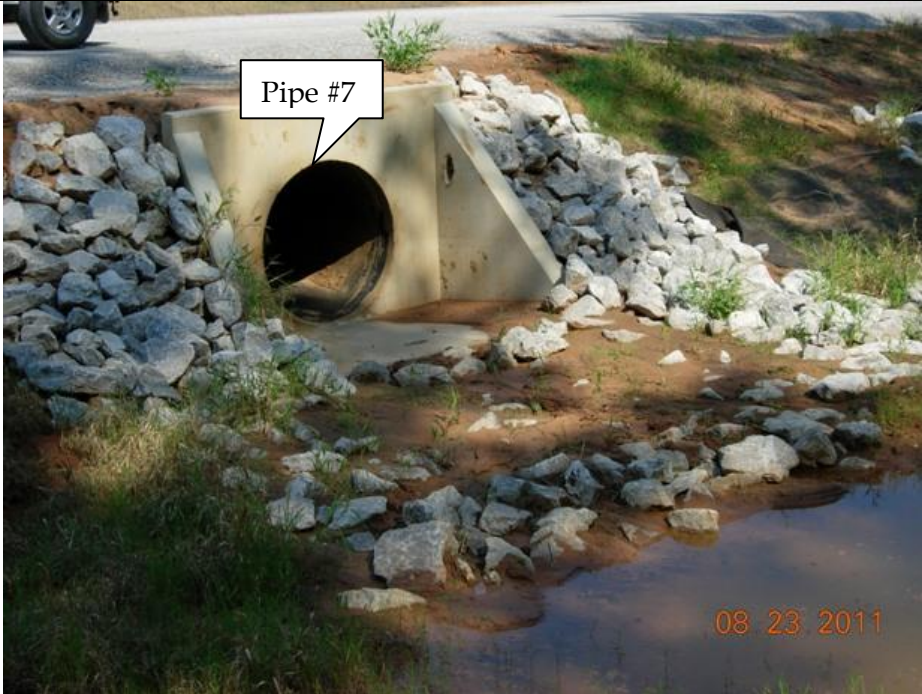
21	8-23-11		
Description <ul style="list-style-type: none"> • Phase 2 EC-23. • The outlet end of Pipe #7 associated with SW 5 is shown in this photo. • Sediment accumulation covered the rip rap down-gradient from the headwall. • The slopes adjacent to the outlet end of Pipe #7 were not sufficiently stabilized. • The pooled water down-gradient from Pipe #7 was clear • SW 5 discharges into WWC Y. Sediment accumulation was noted in WWC Y - see photo 22.

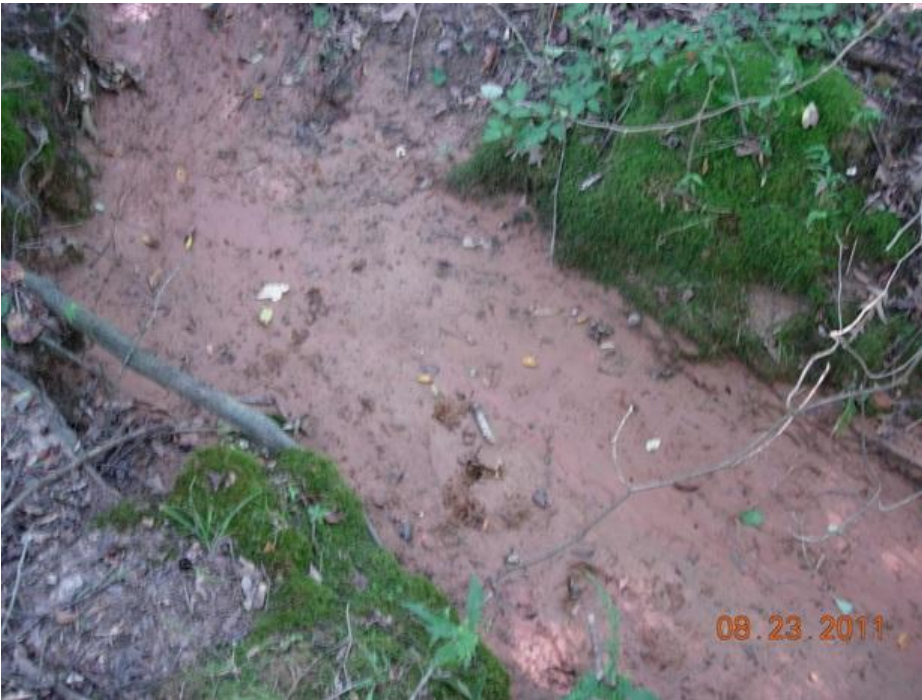
22	8-23-11		
Description <ul style="list-style-type: none"> • WWC Y is shown in this photo, downstream of the low water crossing. • 1-2 inches of sediment were observed covering the bottom of the conveyance. • WWC Y discharges less than 300 feet from Stream 5 at this location. • This photo was taken just outside the limits of clearing and the railroad right-of-way. • The accumulated sediment had a more reddish hue than the natural bottom of the conveyance.

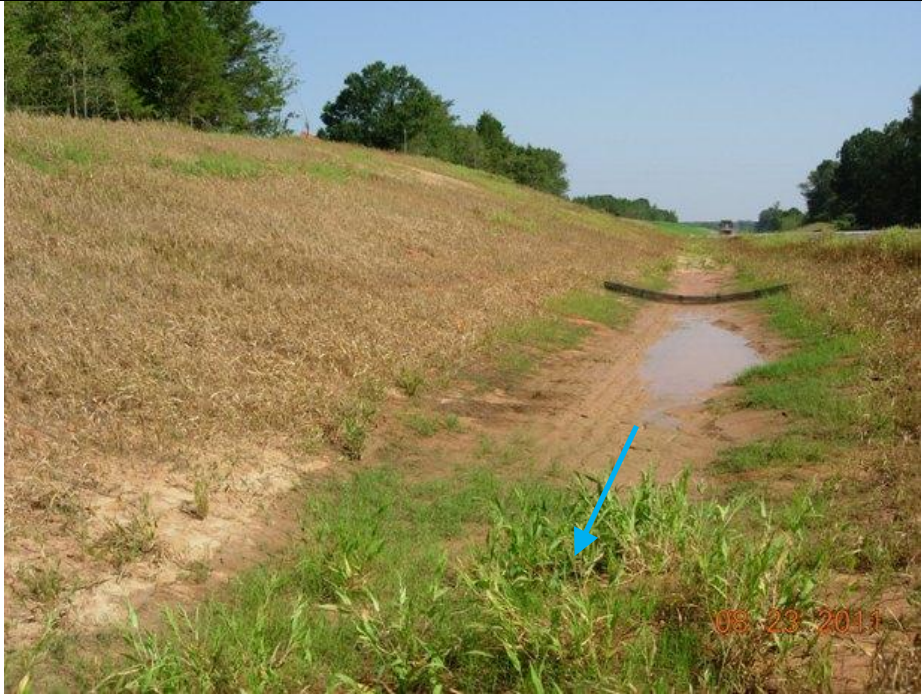
Permittee Name:		Site Location:	Tracking No.:
Norfolk Southern Railway Company		Rossville, Fayette County	TN0081108
Photo No.	Date		
23	8-23-11		
Description <ul style="list-style-type: none"> • Phase 2 EC-24. • Looking north at the slope and swale which leads to Pipe #8 associated with SW 6. • The direction of flow toward Pipe #8 is indicated by the blue arrow. • The area was not sufficiently vegetated. • The brown top millet appeared to be dead. • Small patches of Bermuda were observed.

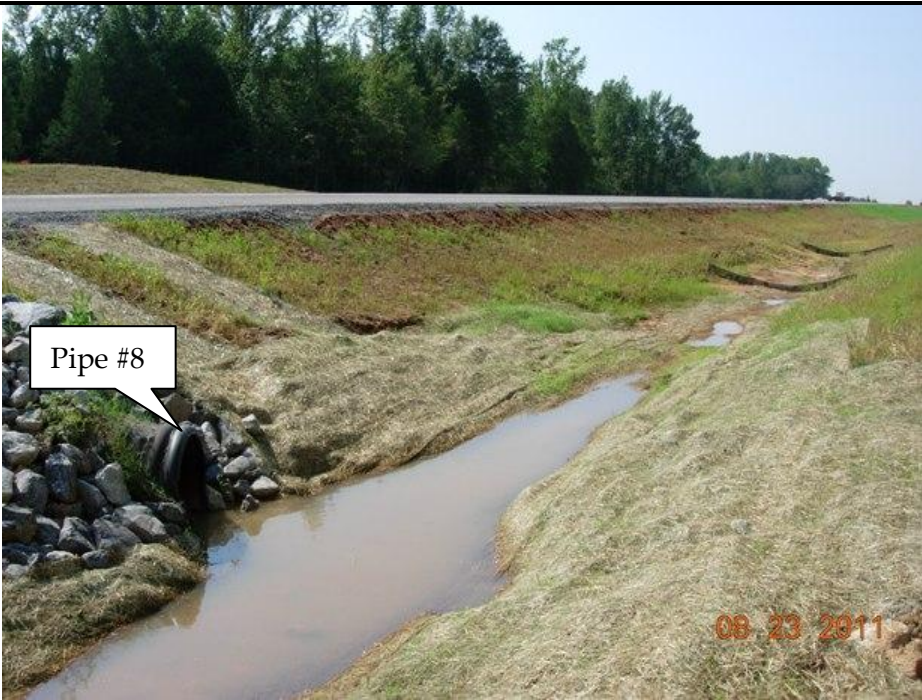
Photo No.	Date		
24	8-23-11		
Description <ul style="list-style-type: none"> • Phase 2 EC-24. • Looking south at Pipe #8 and the slope and swale south of Pipe #8. • It appeared that matting had recently been installed; however, very little grass growth was observed. • The slope and swale were not sufficiently vegetated. • Sparse patches of brown top millet were observed.

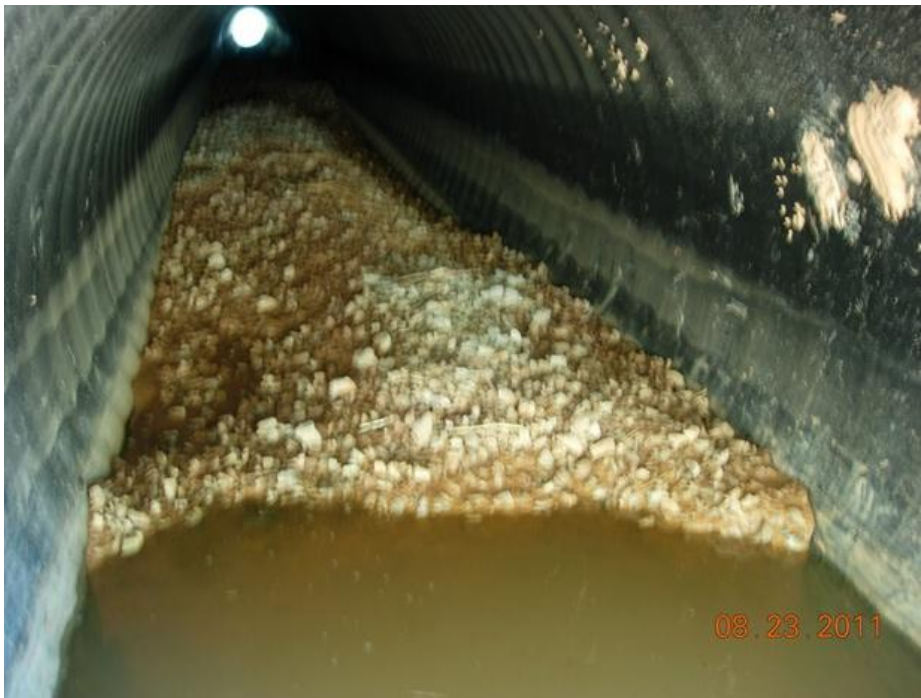
Permittee Name: Norfolk Southern Railway Company		Site Location: Rossville, Fayette County	Tracking No.: TN0081108
Photo No. 25	Date 8-23-11

Description <ul style="list-style-type: none"> • Phase 2 EC-24. • This photo is of the inside of Pipe #8 near the inlet end of the pipe. • Several inches of gravel and sediment had accumulated inside the pipe. 			
Photo No. 26	Date 8-23-11

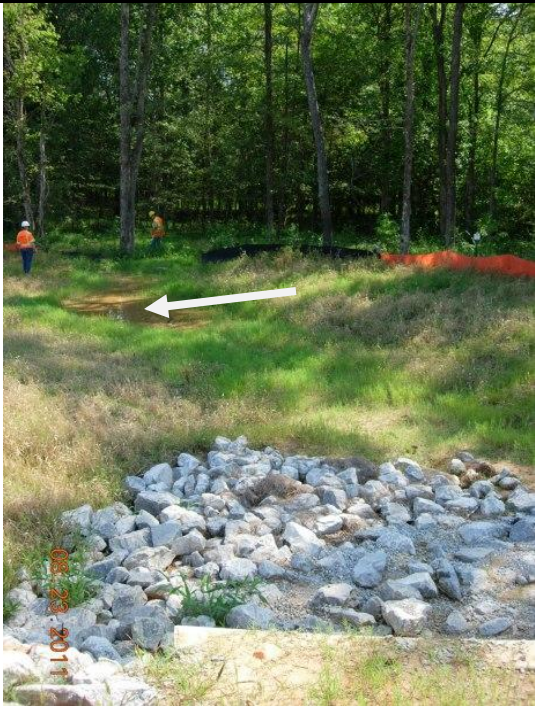
Description <ul style="list-style-type: none"> • Phase 2 EC-24. • The outlet end of Pipe #8 discharges across the rip rap and toward SW 6. • Accumulated sediment was observed west of the silt fence (arrow); however, only a thin layer of sediment accumulation was observed east of the silt fence.

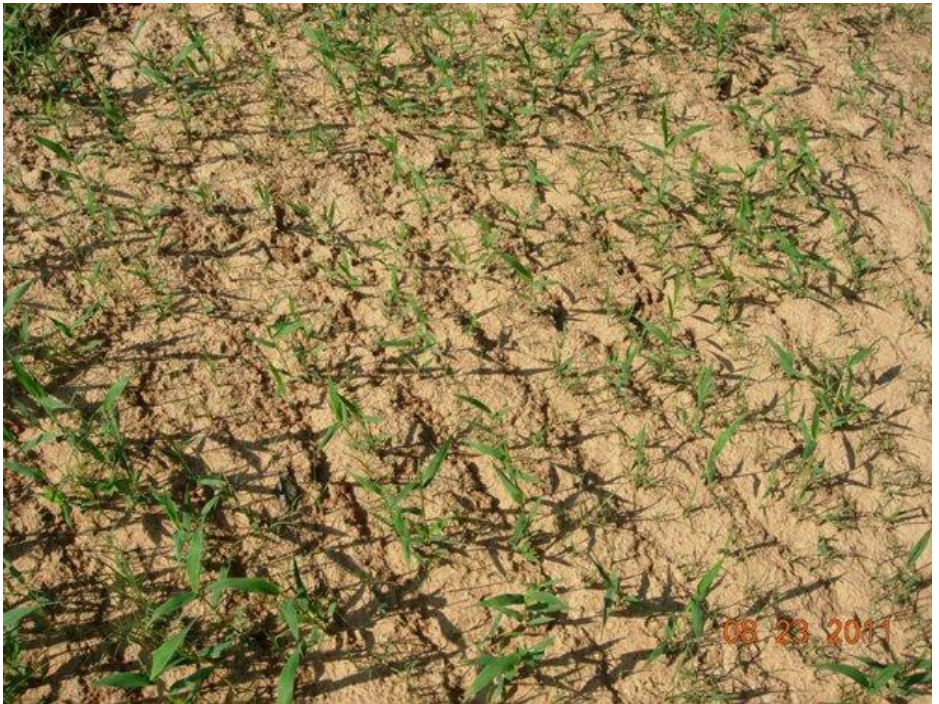
Permittee Name:		Site Location:	Tracking No.:
Norfolk Southern Railway Company		Rossville, Fayette County	TN0081108
Photo No.	Date		
27	8-23-11		
Description <ul style="list-style-type: none"> • Phase 2 EC-24. • This photo shows an example of the slope up gradient from SW 27 and SW 28. • The slope was not sufficiently stabilized.

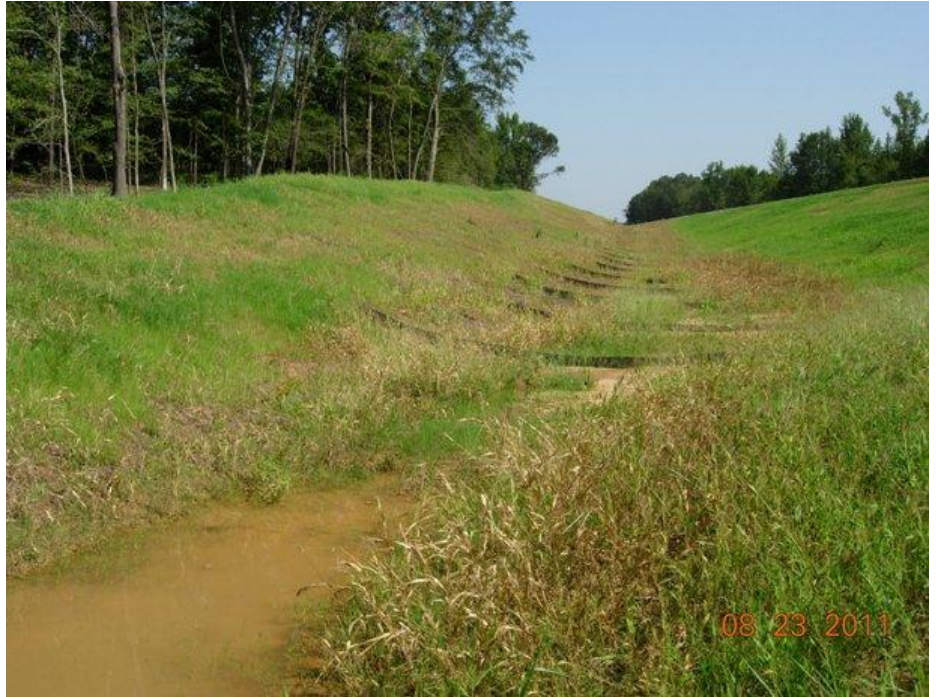
Photo No.	Date		
28	8-23-11		
Description <ul style="list-style-type: none"> • Phase 2 EC-24. • The slope and swale up gradient from SW 27 appeared to be mostly well vegetated; however, much of the vegetation was brown top millet, which is not a perennial grass. • Sediment accumulation was observed covering the bottom of the swale. • HDPE check dams were installed across the bottom of the swale, but are not adequate sediment control measures. • The water pooled in the swale near SW 27 was sediment-laden.

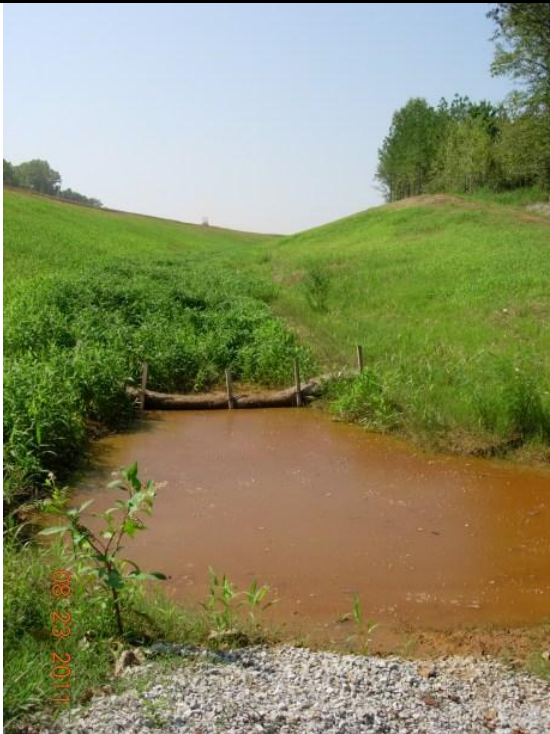
29	8-23-11		
Description <ul style="list-style-type: none">• Phase 2 EC-24.• The slope and swale up-gradient from SW 28 appeared to be mostly well vegetated with some sparse areas; however, much of the vegetation appeared to be brown top millet.• The water pooled in the swale near SW 28 was sediment-laden and covered with a film of what appeared to be brown colored iron oxidizing bacteria.

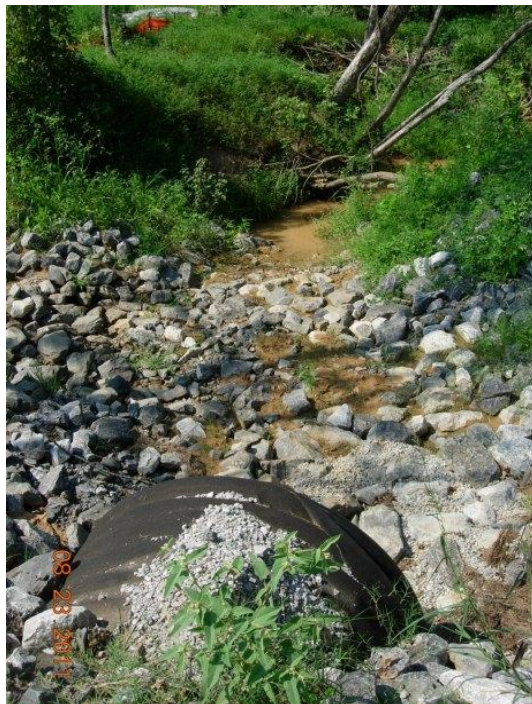
30	8-23-11		
Description <ul style="list-style-type: none">• Phase 2 EC-24.• Stream 3 enters the construction site upstream of SW 27 and SW 28.• The inlet end of Pipe #9 is shown in the lower portion of the photo.• The water in Stream 3 was sediment-laden.• Sediment accumulation was observed covering some of the rip rap.

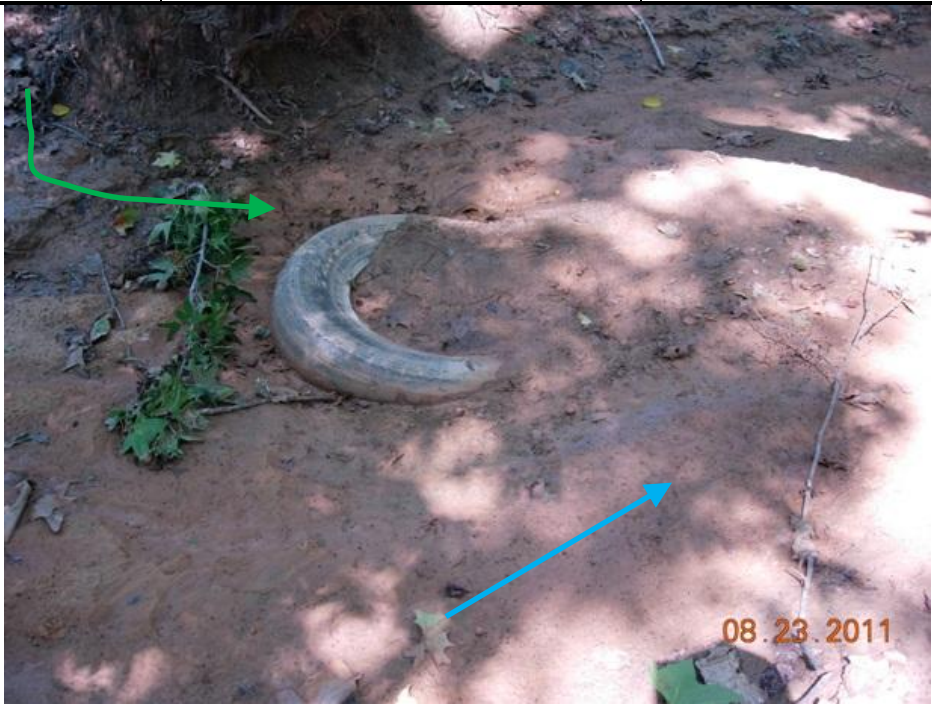
Photo No. 33	Date 8-23-11	<div style="display: flex;"> <div style="flex: 1; padding-right: 10px;"> Description <ul style="list-style-type: none"> This photo shows where Stream 3 (green arrow) enters Stream 5 (blue arrow) The low flow area of Stream 5 contained silt and a reddish colored sand, which appeared to have originated from the site. </div> <div style="flex: 2;">

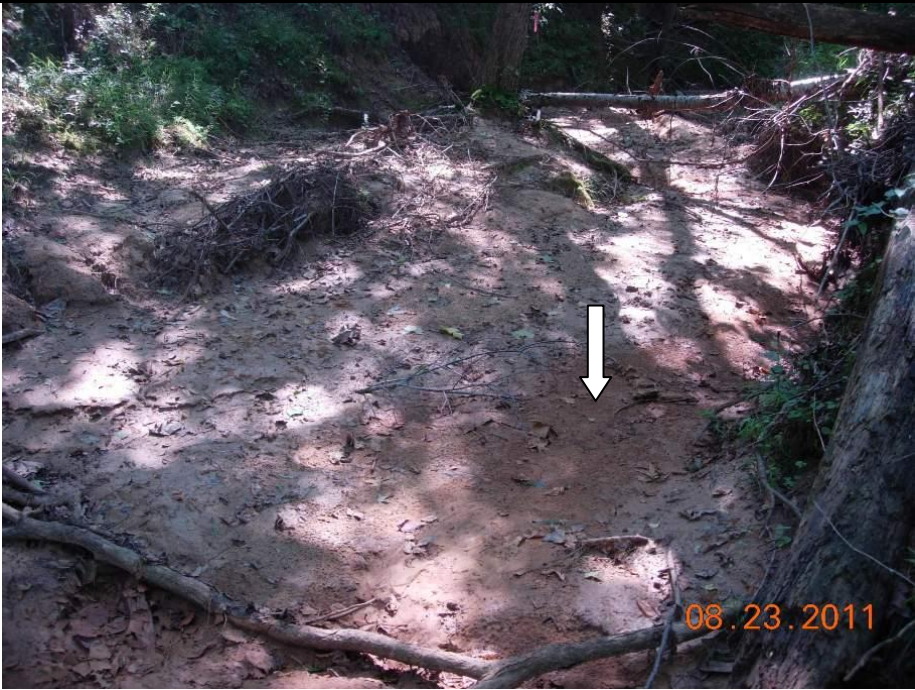
Photo No. 34	Date 8-23-11	<div style="display: flex;"> <div style="flex: 1; padding-right: 10px;"> Description <ul style="list-style-type: none"> Stream 5 upstream of the confluence of Stream 3 is shown in this photo. The low flow area was covered with a layer of silt and reddish colored sand (arrow). </div> <div style="flex: 2;">

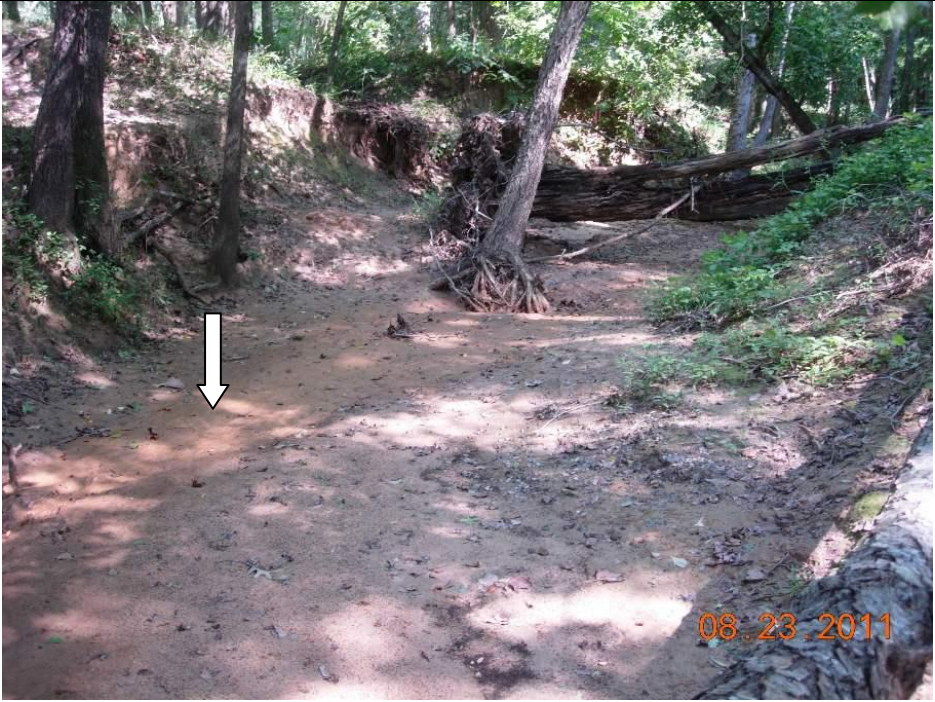
Permittee Name:		Site Location:	Tracking No.:
Norfolk Southern Railway Company		Rossville, Fayette County	TN0081108
Photo No.	Date		
35	8-23-11		
Description <ul style="list-style-type: none"> Stream 5 downstream of the confluence of Stream 3 is shown in this photo. The low flow area was covered with a layer of silt and reddish colored sand (arrow).

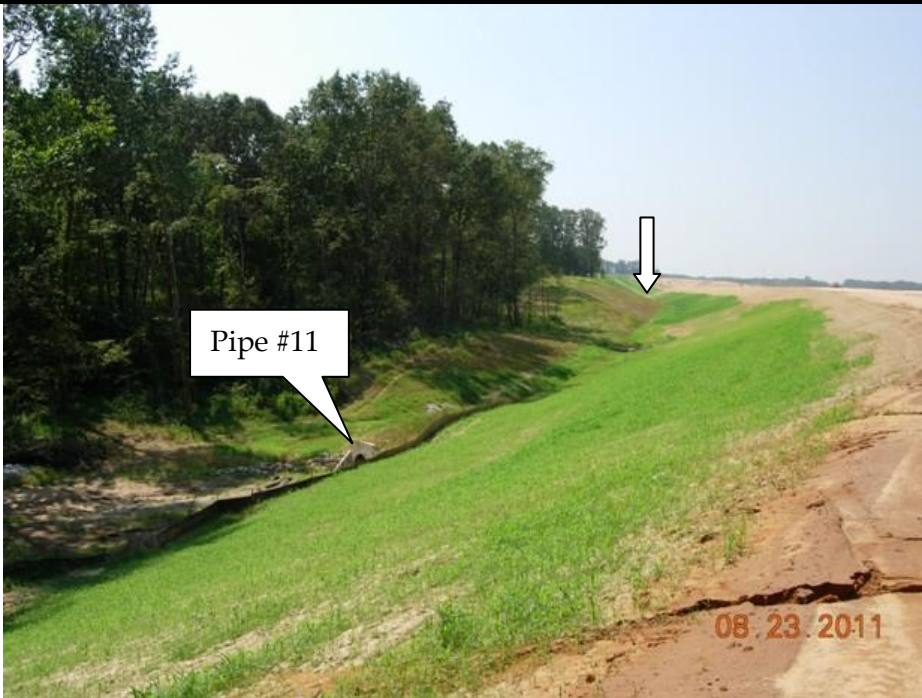
Photo No.	Date		
36	8-23-11		
Description <ul style="list-style-type: none"> Phase 1A EC-14. The slope up-gradient of SW 9, the eastern drainage ditch (white arrow) and the outlet end of Pipe #11 are shown in this photo. Vegetation was establishing on the slope, but was sparse. EC-14 indicates the use of Erosion Control Blanket, but it did not appear that a blanket had been used. A hydroseed type product was used instead. Several gullies (example on right side of photo) were observed along the top of the slope.

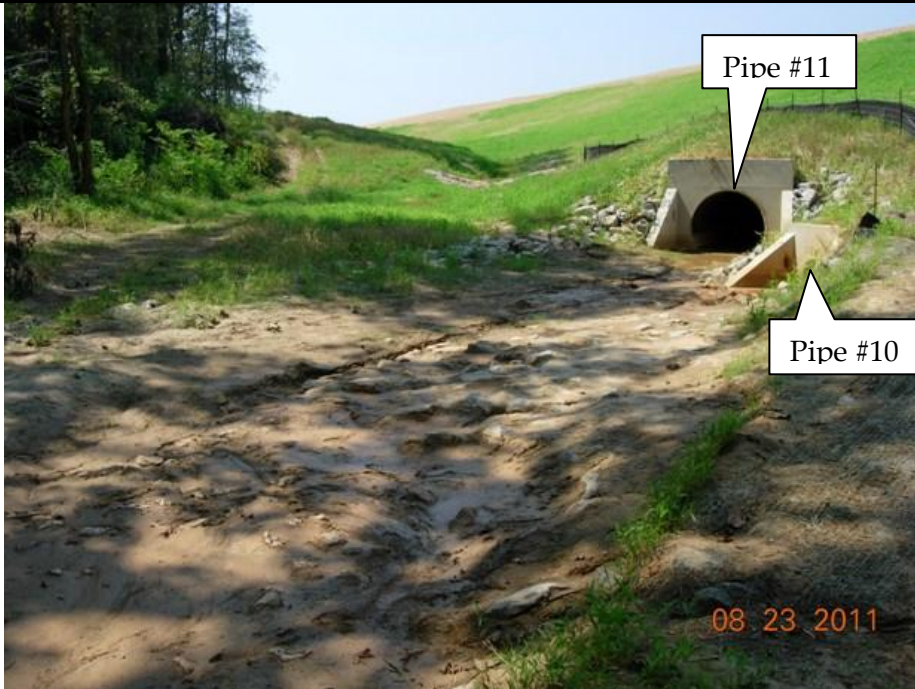
Permittee Name: Norfolk Southern Railway Company		Site Location: Rossville, Fayette County	Tracking No.: TN0081108
Photo No. 37	Date 8-23-11

Description <ul style="list-style-type: none">• Phase 1A EC-14.• The outlet end of Pipe #11 and Pipe #10 (18 inch pipe - green arrow) are shown in this photo.• Pipe #11 receives drainage from sediment basin #6 - see photo 46.• The rip rap pad down-gradient from Pipe #11 and #10 was covered with sediment.• Areas surrounding the rip rap pad were sparsely vegetated.• The area shown in this photo discharges into Stream 5 in less than 50 feet via SW 9.

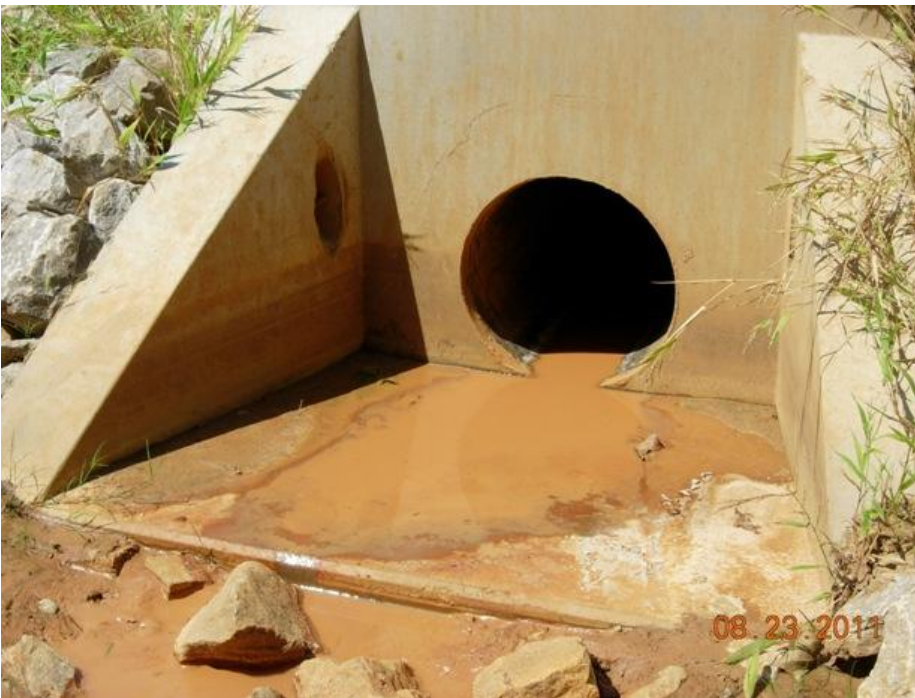
Photo No. 38	Date 8-23-11

Description <ul style="list-style-type: none">• Phase 1A EC-14.• The outlet end of Pipe #10 (18 inch pipe) is shown in this photo.• Sediment-laden water was pooled within the pipe, apron of the headwall, and down gradient from the headwall.• This pipe is connected to the low area shown in photo 45.
