Photographic Log for Memphis Regional Intermodal Facility

Permittee Name:		Site Location:	Tracking No.:
Norfolk Southern Railway Company		Rossville, Fayette County	TN0081108
Photo No.	Date

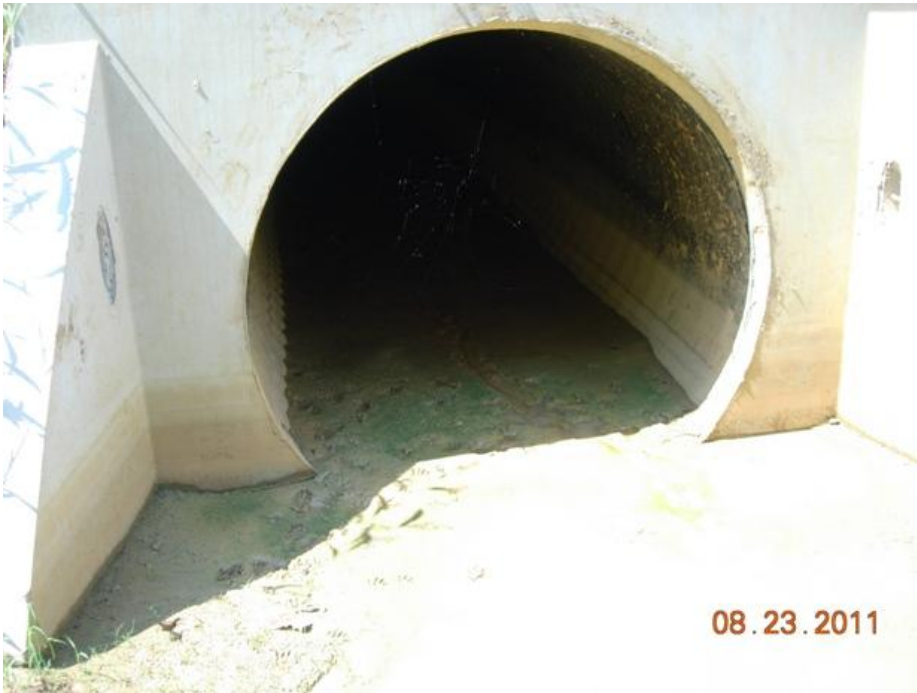
39	8-23-11		
Description			
<ul style="list-style-type: none">• Phase 1A EC-14.• The outlet end of Pipe #11 is shown in this photo, which is connected to sediment basin #6.• 2-3 inches of sediment covered the bottom of the pipe, apron of the headwall, and the area down gradient from the headwall.

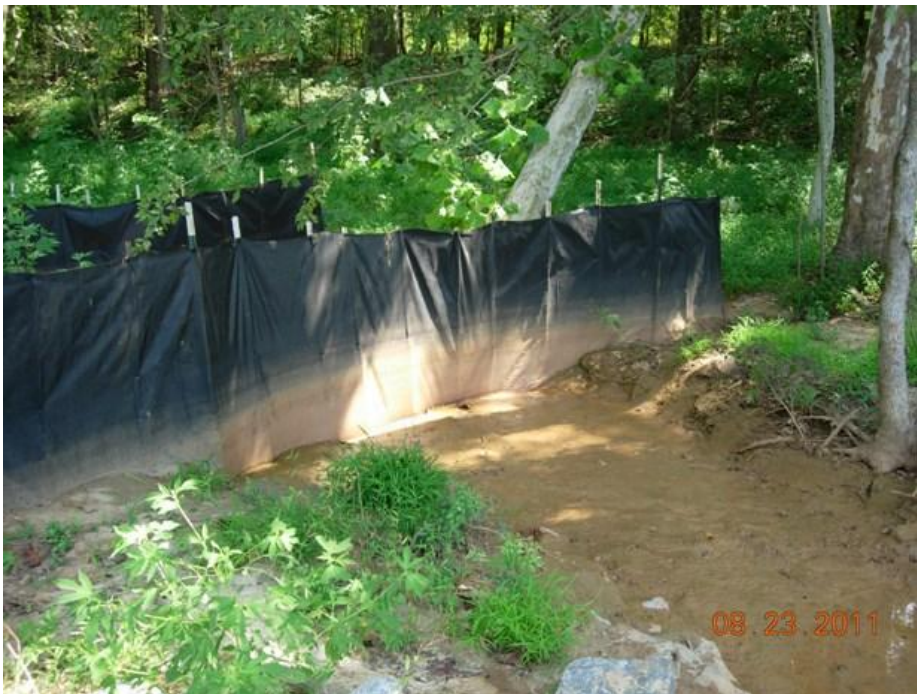
40	8-23-11	
Description		
<ul style="list-style-type: none">• Phase 1A EC-14.• Two rows of enhanced silt fence checks have been installed at SW 9.• The ERCD appears to have been removed.• It appeared that higher flows have bypassed the two rows of enhanced silt fence checks - see photo 41.• While the enhanced silt fence checks did appear to be retaining some sediment, 3 inches of sediment covered the bottom of Stream 5 - see photos 42-44.

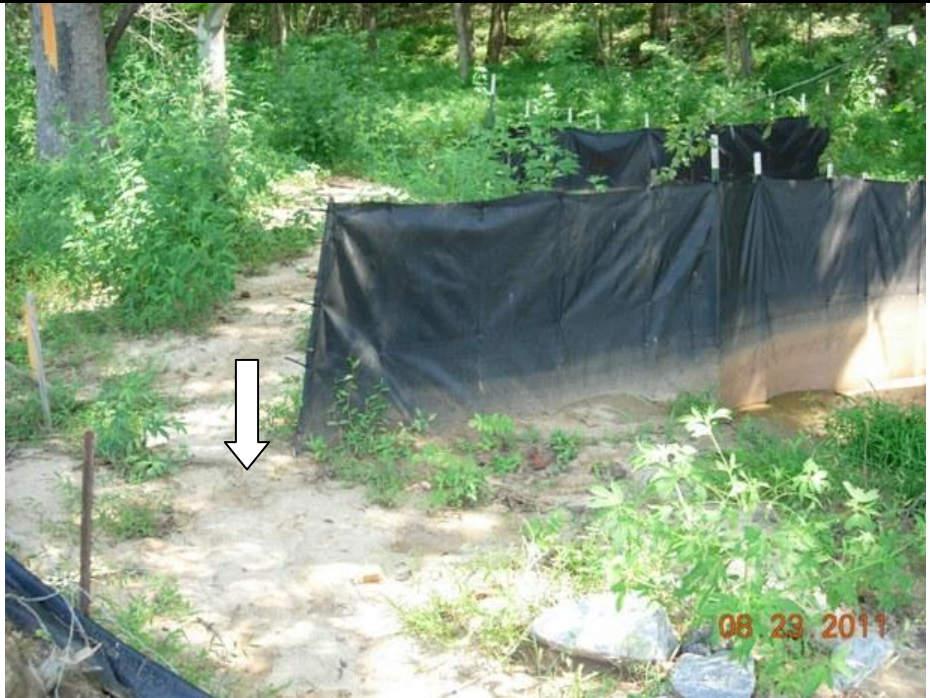
Permittee Name:		Site Location:	Tracking No.:
Norfolk Southern Railway Company		Rossville, Fayette County	TN0081108
Photo No.	Date		
41	8-23-11		
Description <ul style="list-style-type: none"> • Phase 1A EC-14. • Based on sediment accumulation west of the enhanced silt fence checks (arrow), it appears that higher flows have bypassed the two rows of enhanced silt fence check shown here.

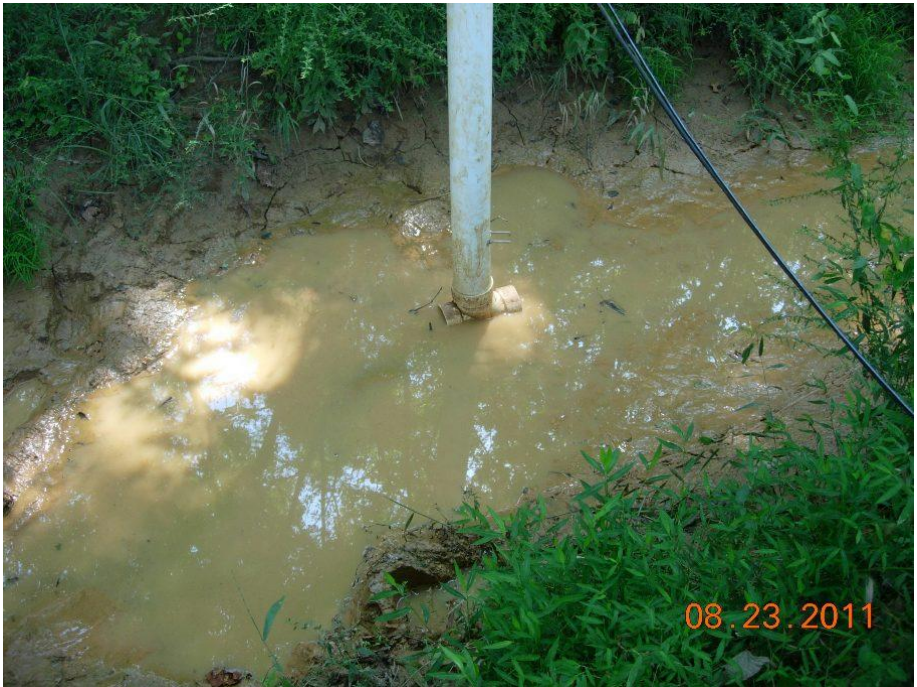
<p>A photograph showing a black silt fence in a wooded area. A white arrow points to a sandy area of sediment accumulation on the ground to the left of the fence. The date '08.23.2011' is printed in orange in the bottom right corner.</p>	
Photo No.	Date		
42	8-23-11		
Description <ul style="list-style-type: none"> • Ms. Hagerty explained that the continuous monitor for outfall SW 9 had been installed within Stream 5 (down gradient from the 2 rows of enhanced silt fence check shown in photos 40 and 41) so that the monitor would pick up flow from the eastern drainage ditch, sediment basin #6 (Pipe #11), and the 18 inch pipe (Pipe #10). • Several inches of sediment and sediment-laden water covered the bottom of Stream 5 at this location.

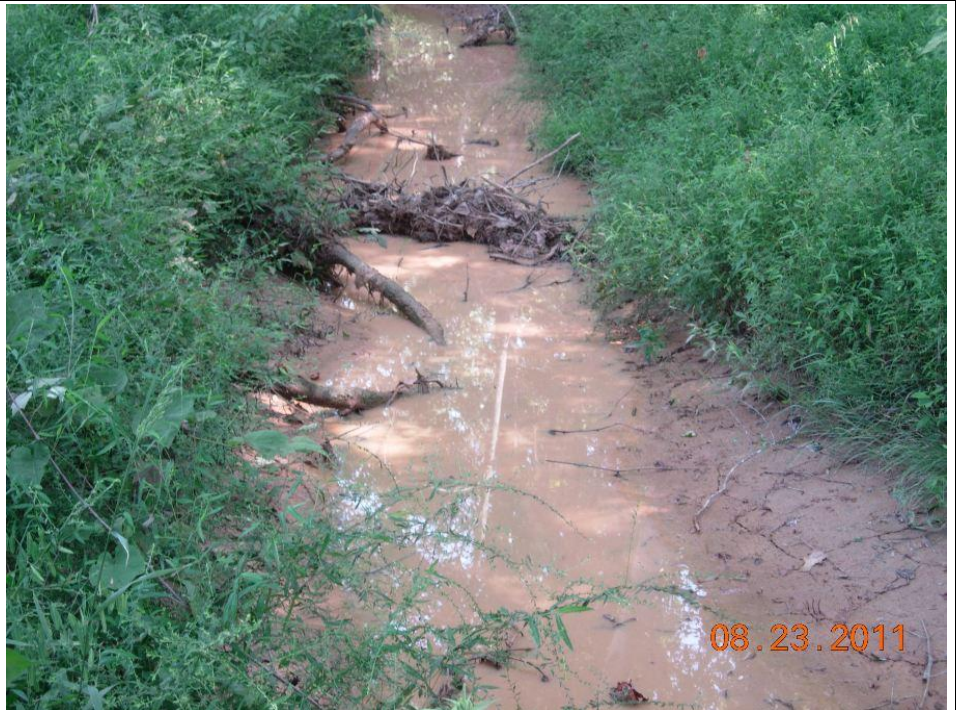
Permittee Name: Norfolk Southern Railway Company		Site Location: Rossville, Fayette County	Tracking No.: TN0081108
Photo No. 43	Date 8-23-11

Description <ul style="list-style-type: none">• Stream 5 downstream of the continuous monitor for SW 9 is shown in this photo.• Several inches of sediment and sediment-laden water covered a width of 4 feet of the bottom of Stream 5 - see also photo 44.• Sediment accumulation was visually observed for approximately 40-50 feet downstream from the location shown in the photo.			
Photo No. 44	Date 8-23-11

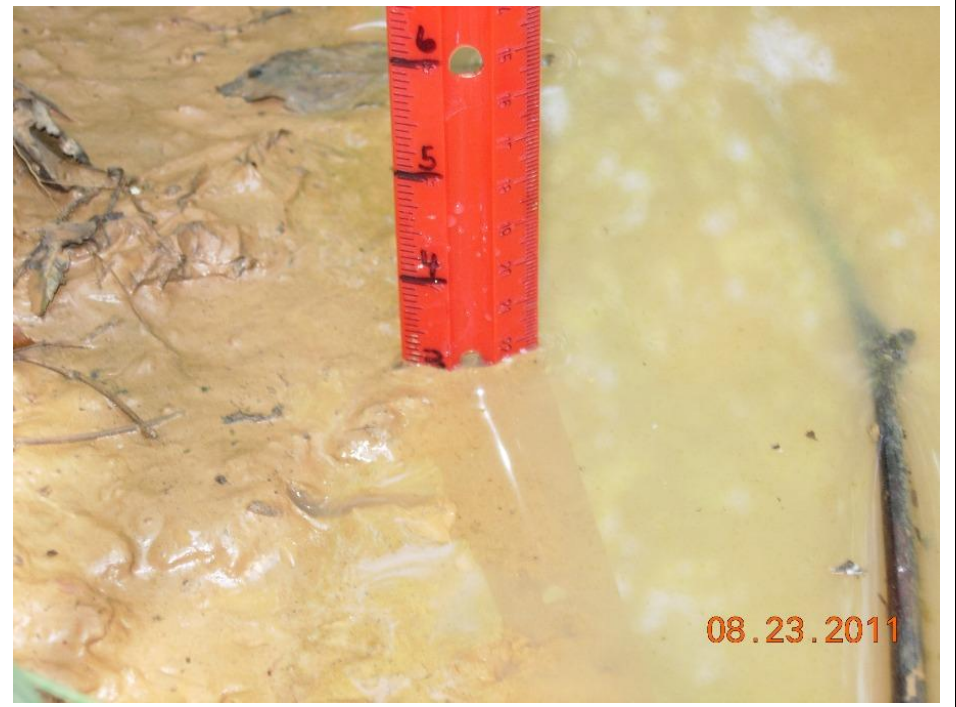
Description <ul style="list-style-type: none">• This photo is a close-up view of the sediment accumulation covering the bottom of Stream 5 downstream of the continuous monitor for SW 9.• 3 inches of sediment accumulation were measured at this location, covering a width of 4 feet on the bottom of the stream.

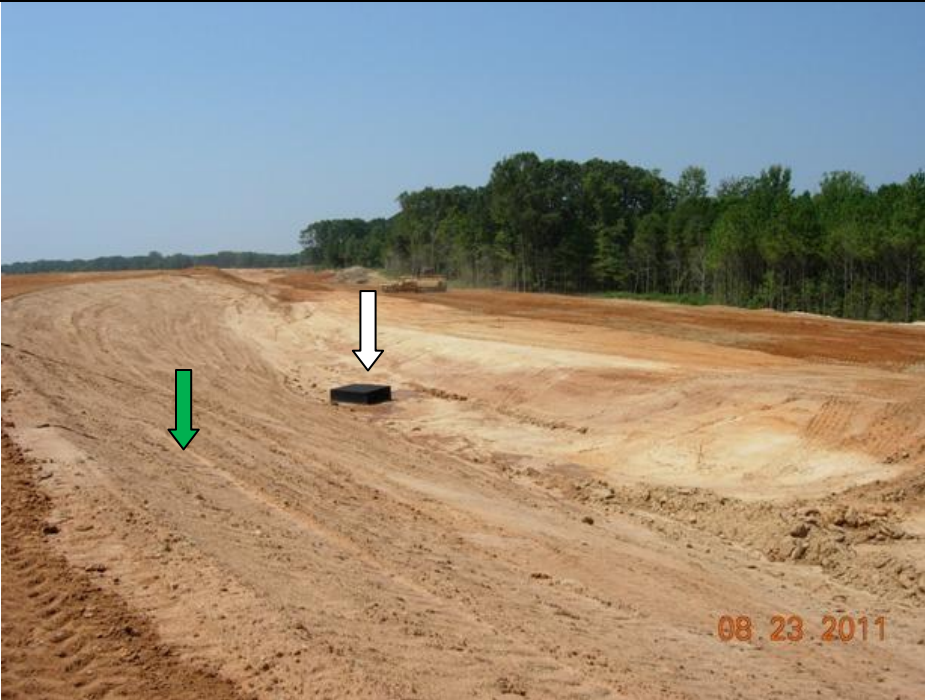
Permittee Name: Norfolk Southern Railway Company		Site Location: Rossville, Fayette County	Tracking No.: TN0081108
Photo No. 45	Date 8-23-11

Description <ul style="list-style-type: none">• Phase 1A EC-14.• The inlet end of the 18 inch pipe (Pipe #10) shown in photos 37 and 38 is indicated by the white arrow.• The area surrounding the inlet was actively being graded.• Besides the inlet cap protection, no EPSCs were observed in this drainage basin.• Mr. Caruso indicated that the slope east of the inlet (green arrow) was almost at grade and would likely be seeded within 2 weeks.

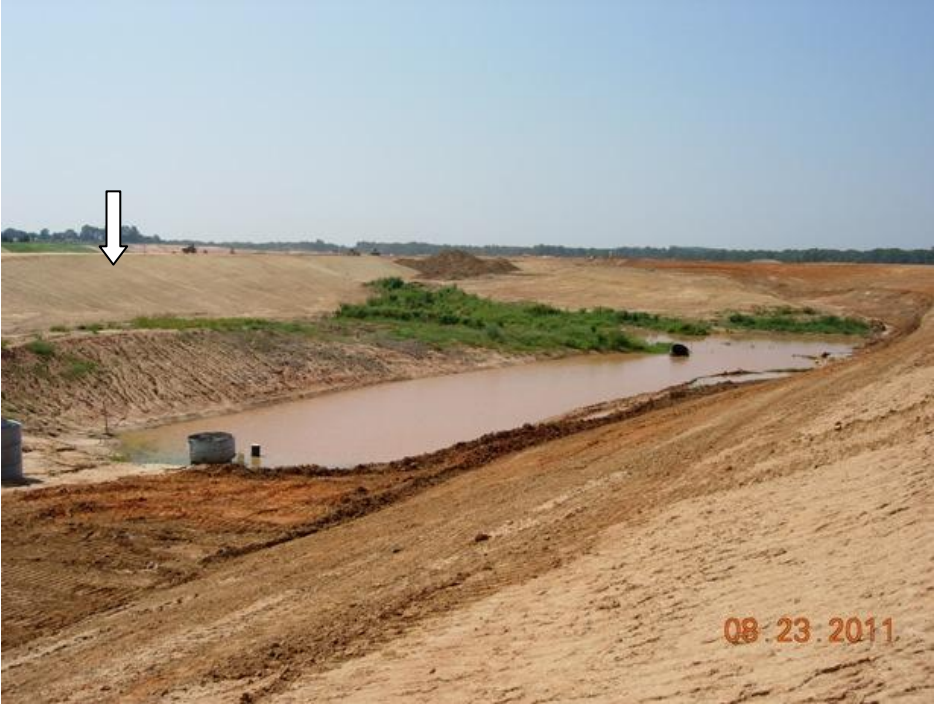
46	8-23-11		
Description <ul style="list-style-type: none"> • Phase 1A EC-14. • Ms. Hagerty indicated that the sediment basin associated with SW 9 is still designated as #6 although the erosion control plan identifies this basin as #1 in Phase 1A. • The banks of the basin were not sufficiently stabilized and were eroding. • Water in the basin was sediment-laden. • Rills and gullies were observed on the slope to the east of the basin (arrow). It was reported that the slope had been recently sprayed with Flexterra; however, no grass growth had established yet.

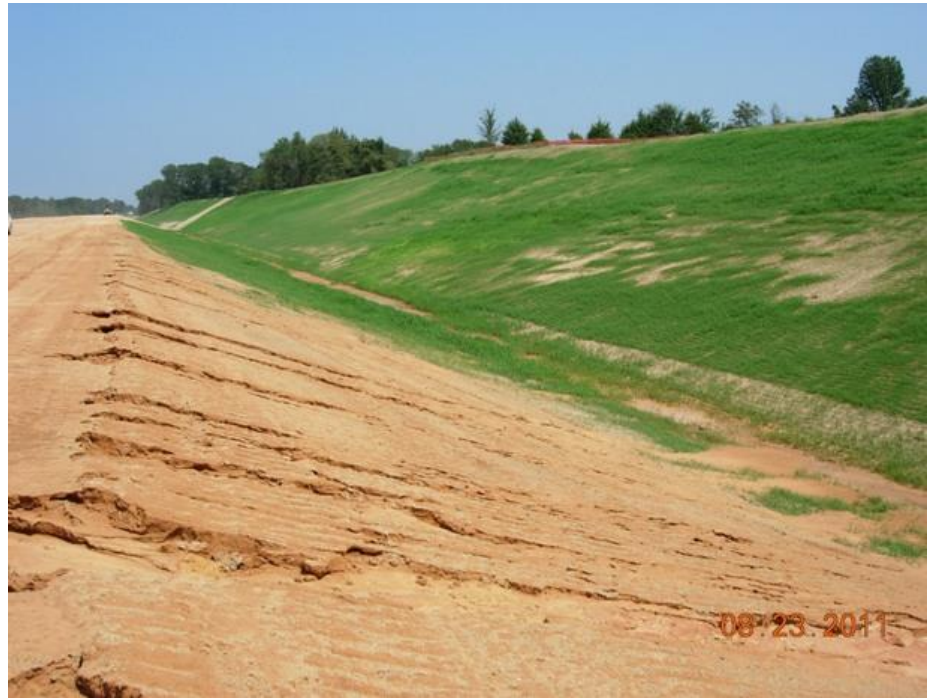
Photo No.	Date		
48	8-23-11		
Description <ul style="list-style-type: none"> • Phase 1A EC-15. • View looking north of the eastern drainage ditch down-gradient from photo 47. • Portions of the east and west slopes had been sprayed with either Flexterra or hydroseed. However, EC-15 indicates the use of Erosion Control Blanket to cover the slope. • Vegetative cover was sparse in areas. • Rills and gullies were observed on the western slope. • Drainage from this area ultimately discharges to SW 9.

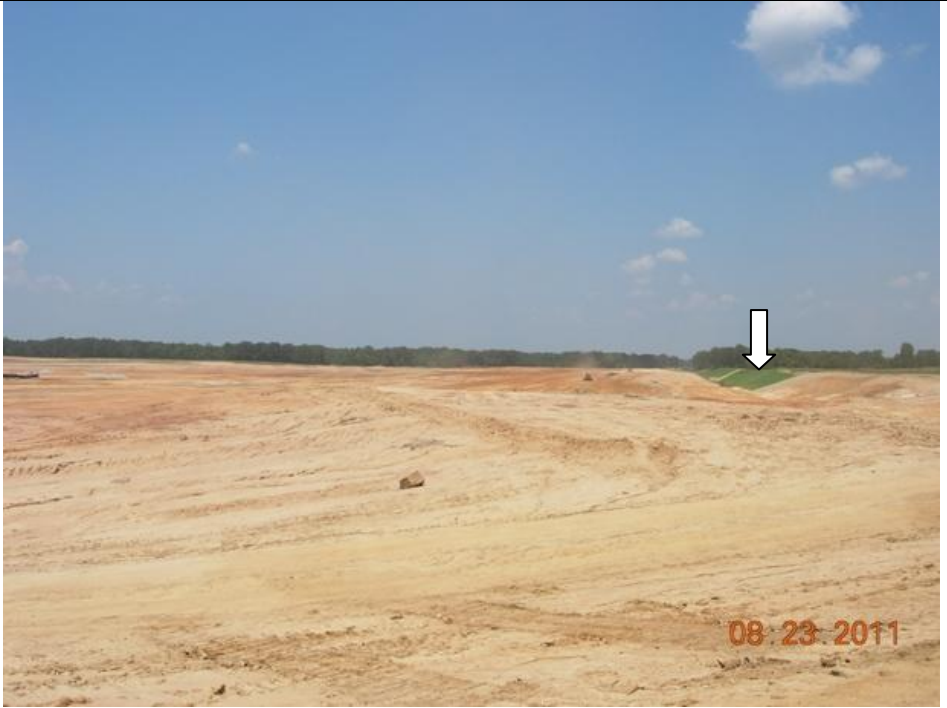
49	8-23-11		
Description <ul style="list-style-type: none"> • Phase 1A EC-15 and EC-16. • This photo is a view of the site looking north from the Knox Road construction exit at approximately Station 129+00 (Running Track R-1). • The eastern drainage ditch shown in photos 47 and 48 is indicated by the arrow. • The area shown in this photo was actively under construction. 			
Photo No.	Date

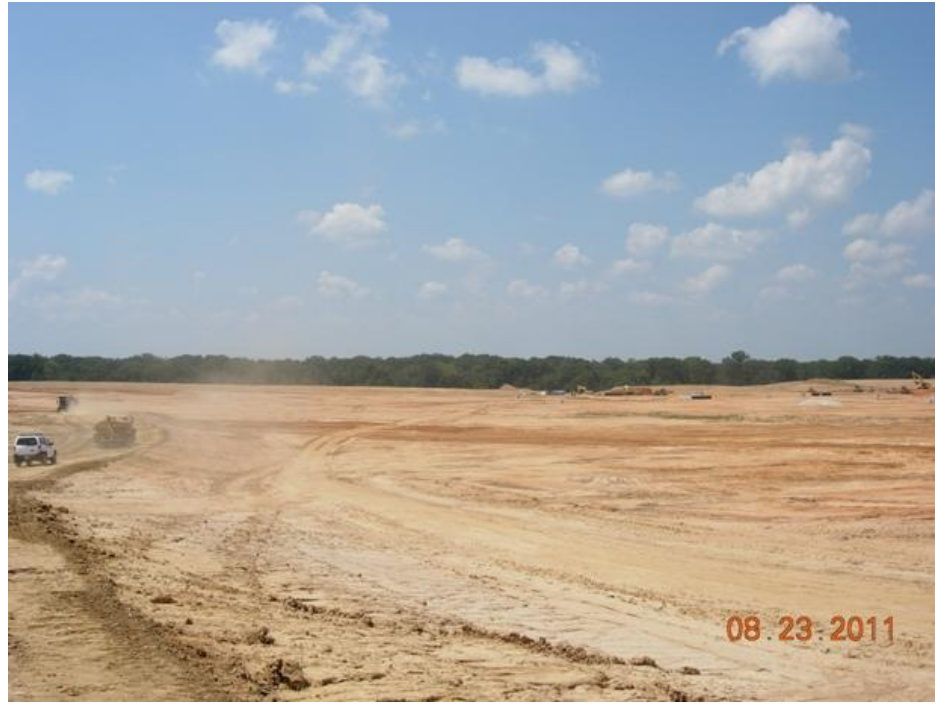
50	8-23-11		
Description <ul style="list-style-type: none"> • Phase 1A EC-16. • This photo is a view of the site looking west from the Knox Road construction exit at approximately Station 129+00 (Running Track R-1). • The area shown in this photo was actively under construction.

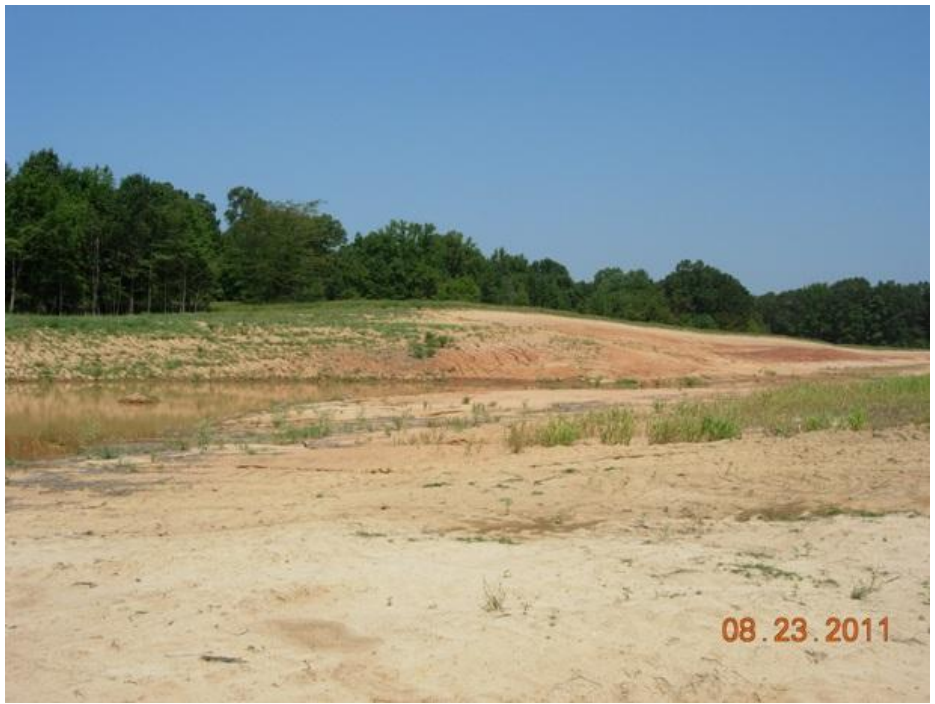
Permittee Name:		Site Location:	Tracking No.:
Norfolk Southern Railway Company		Rossville, Fayette County	TN0081108
Photo No.	Date		
51	8-23-11		
Description <ul style="list-style-type: none"> • Phase 1A EC-18. • The northwest corner of the site (northeast of SW 40) is shown in this photo. • Based on the weedy vegetation and rill formation it appears that this area was not actively under construction and therefore should have been temporarily stabilized.

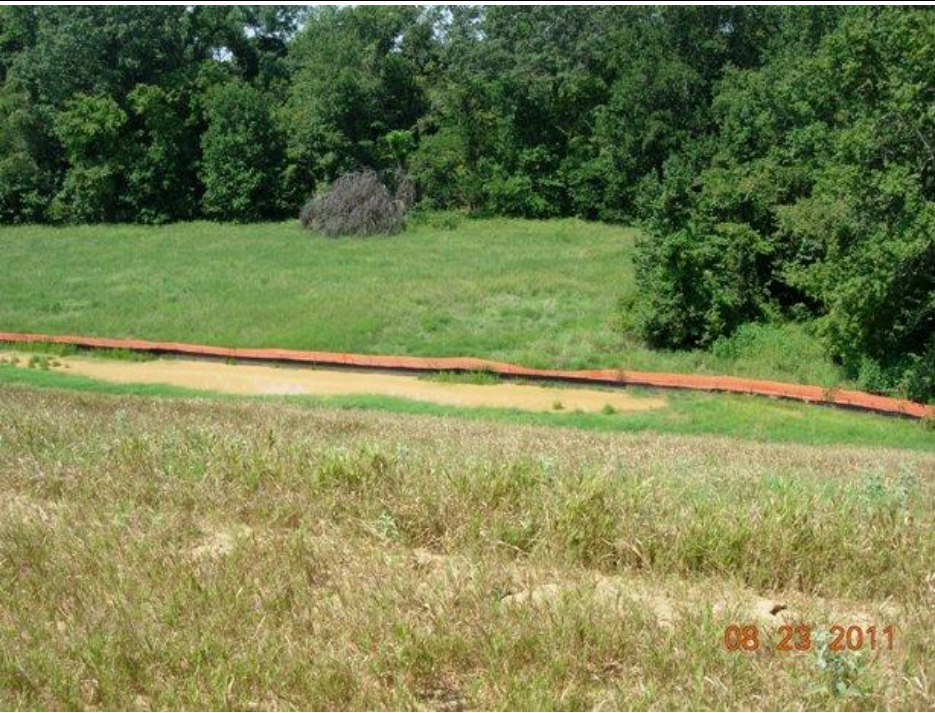
Description <ul style="list-style-type: none"> • Phase 1A EC-18. • Although SW 40 is not an active outfall during Phase 1A of construction, this photo is of the previous location of SW 40. • Sediment-laden water was pooled at the silt fence indicating sediment loss/erosion from the slope. • The upper 10-12 feet of the slope was sparsely vegetated with brown top millet.

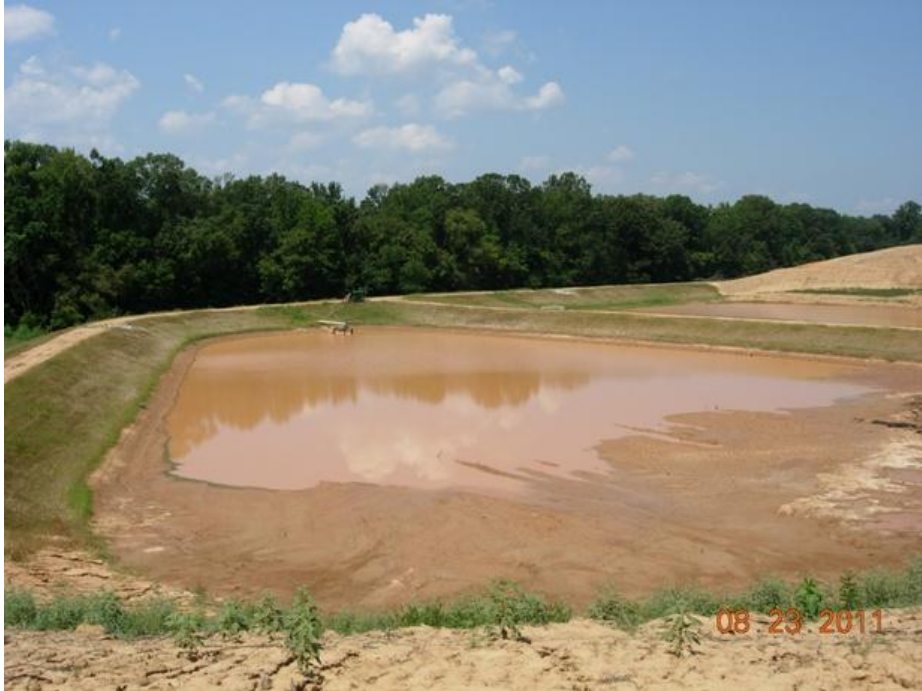
Permittee Name: Norfolk Southern Railway Company		Site Location: Rossville, Fayette County	Tracking No.: TN0081108
Photo No. 53	Date 8-23-11

Description <ul style="list-style-type: none">• Sediment basin #3.• From the map provided by Ms. Hagerty, it appears that the western portion of sediment basin #3 is in Phase 2 EC-29 and the eastern portion of basin #3 is in Phase 1A EC-19.• A concrete flume was being installed on the eastern bank (arrow).• The water in the basin was sediment-laden.• The southern, northern and western banks of the basin were covered with brown top millet and bermuda, but coverage was sparse.

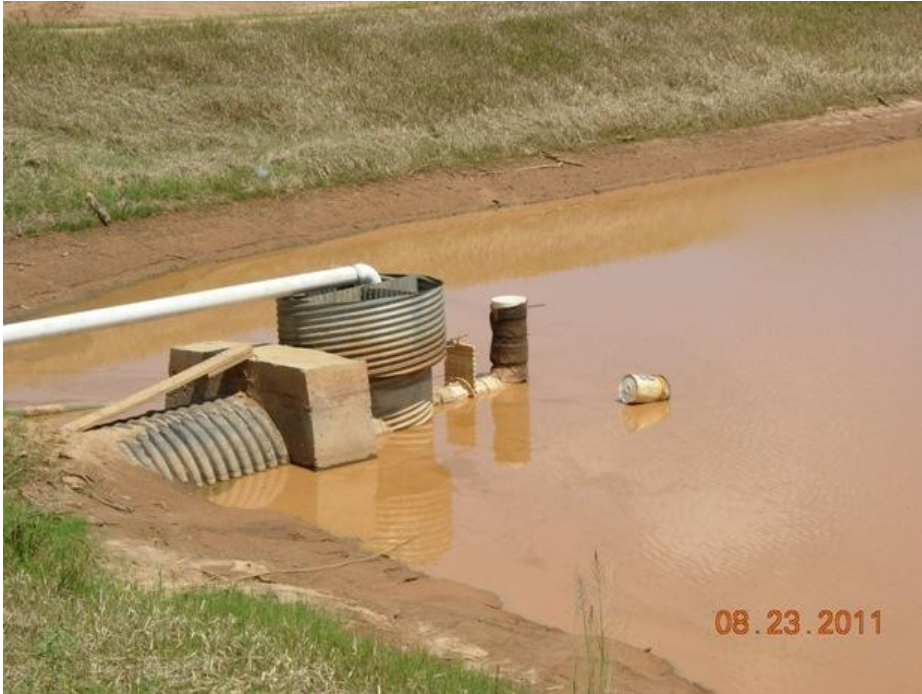
Permittee Name: Norfolk Southern Railway Company		Site Location: Rossville, Fayette County	Tracking No.: TN0081108
Photo No. 54	Date 8-23-11

Description <ul style="list-style-type: none">• Phase 2 EC-29.• The outlet structure of sediment basin #3 is shown in this photo.• The water in the basin was sediment-laden, but was not discharging at the time of the inspection.• Ms. Hagerty indicated that the bucket floating next to the riser pipe was being used to float the end of the hose attached to the pump. She also indicated that water removed via the pump is pumped back into the principal spillway via the white PVC pipe so that the discharge will be captured by the continuous monitor.• Mr. Hagerty also indicated that the basin had been treated with PAM the previous week.

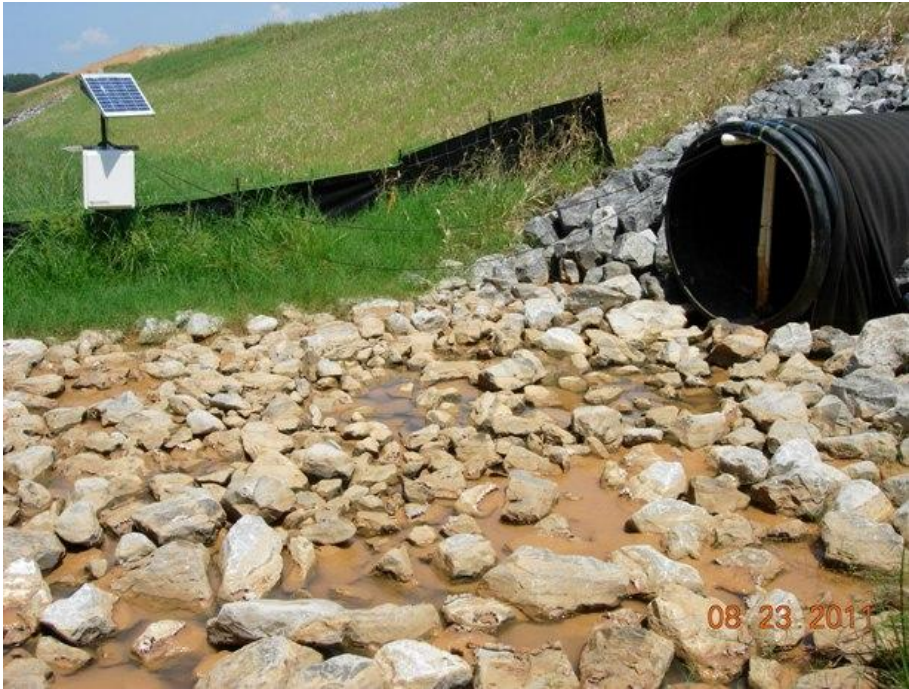
Permittee Name: Norfolk Southern Railway Company		Site Location: Rossville, Fayette County	Tracking No.: TN0081108
Photo No. 55	Date 8-23-11

Description <ul style="list-style-type: none">• Phase 2 EC-29.• SW 31, the discharge point of sediment basin #3.• The slope adjacent to SW 31 was sparsely covered with brown top millet.• Sediment accumulation was observed on the rip rap pad down gradient from SW 31.			
Photo No. 56	Date 8-23-11

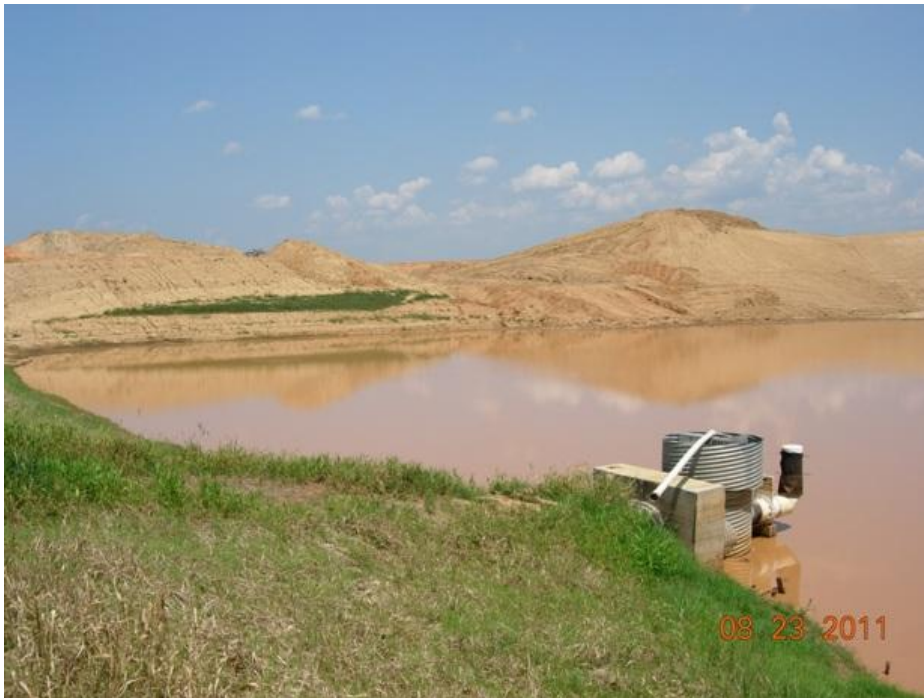
Description <ul style="list-style-type: none">• Sediment basin #2.• From the map provided by Ms. Hagerty, it appears that the western portion of sediment basin #2 is in Phase 2 EC-29 and the eastern portion of basin #2 is in Phase 1A EC-19.• The water in the basin was sediment-laden.• The northern and western banks of the basin were covered with brown top millet and bermuda, which was sparse in areas.

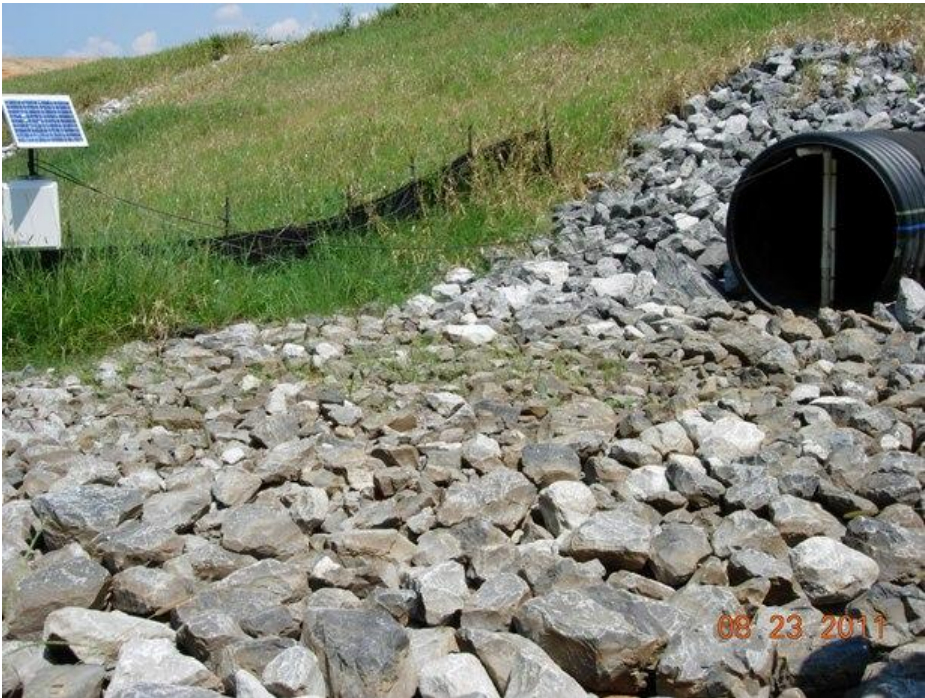
A photograph showing a steep, rocky slope covered in grey and white stones. In the upper left, a solar panel is mounted on a small structure. A large black pipe is visible on the right side of the slope. The date '08/23/2011' is printed in orange in the bottom right corner of the photo.	
Description <ul style="list-style-type: none">• Phase 2 EC-29.• SW 30, the discharge point of sediment basin #2.• The slope adjacent to SW 30 was covered with brown top millet, which was sparse in areas.

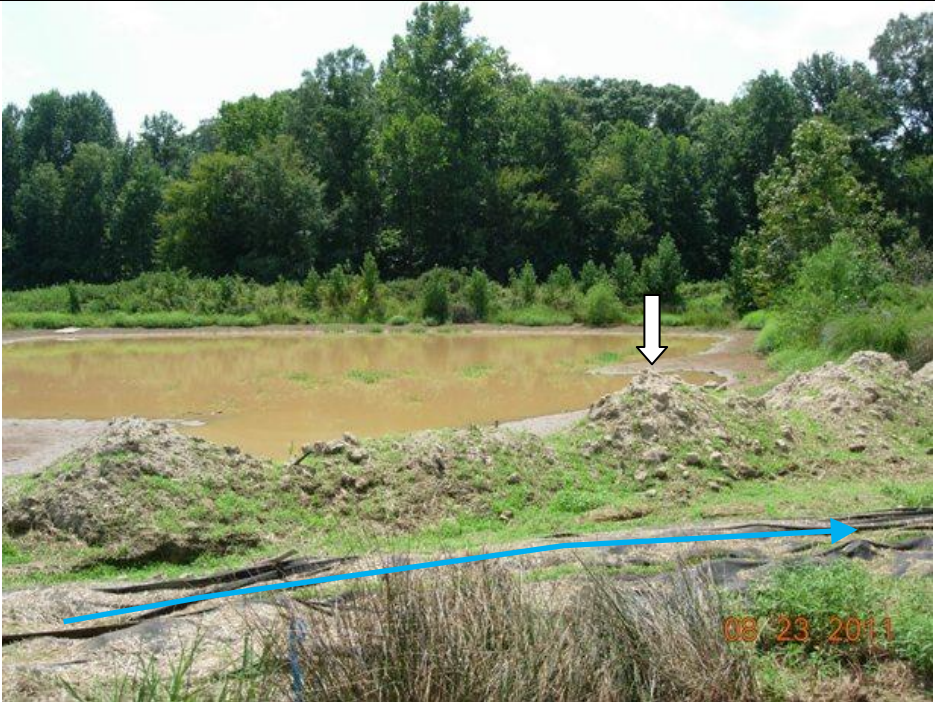
58	8-23-11		
Description <ul style="list-style-type: none"> • Phase 1A EC-16 (or EC-06). • Pond #3. • Ms. Hagerty indicated that Pond #3 is being used as a sediment basin. She stated that they apply PAM before the water is pumped out. She also explained that piles of sediment (arrow) had been placed along the edge of the pond to prevent drainage from Stream 4 from entering the pond. However, no outlet structure has been installed nor has the division been provided plans/information for this pond to be considered as a sediment basin. • Stream 4 is indicated by the blue arrow. • Stream 4 was filled with rip rap and covered with filter fabric and hay. • Flow was observed within Stream 4 downstream of Pond #3.

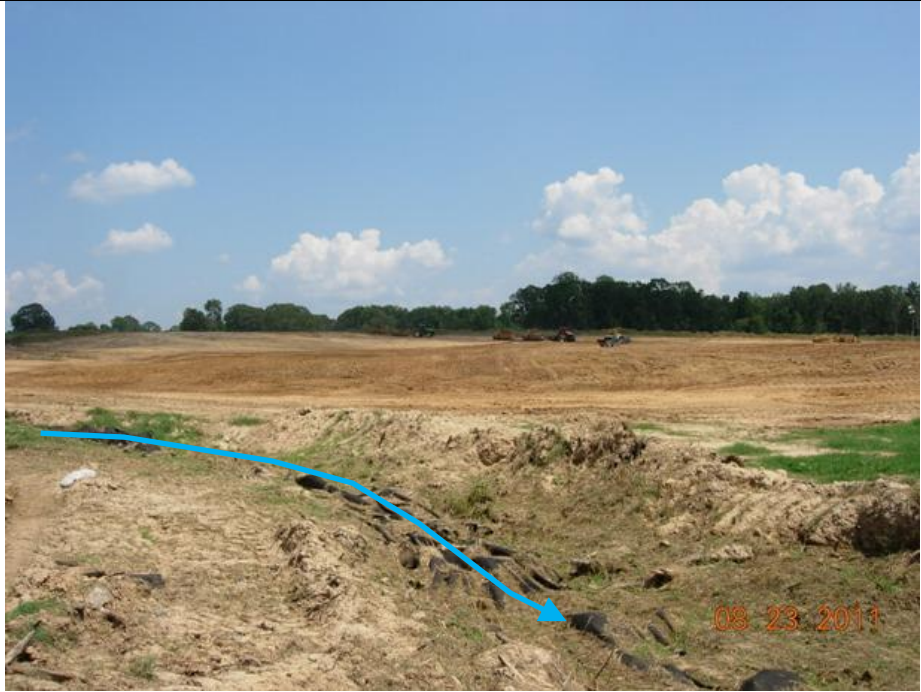
59	8-23-11		
Description <ul style="list-style-type: none"> • Phase 1A EC-16. • Looking east from Pond #3 - a portion of the area draining to Stream 4 is shown in this photo. • Stream 4 is indicated by the blue arrow. • Stream 4 was filled with rip rap and covered with filter fabric and hay. • No EPSCs were observed along Stream 4. 			
Photo No.	Date

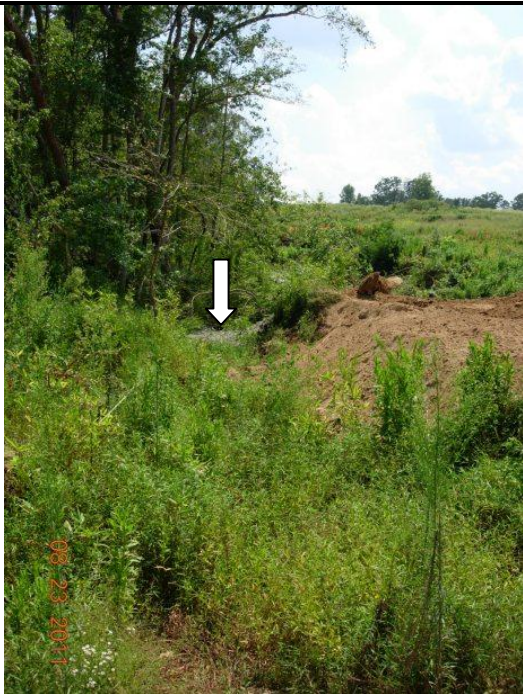
60	8-23-11		
Description <ul style="list-style-type: none"> • Phase 1A EC-17. • SW 12. • The ERCD installed at SW 12 is indicated by the arrow. • The slope adjacent to SW 12 was not stable.

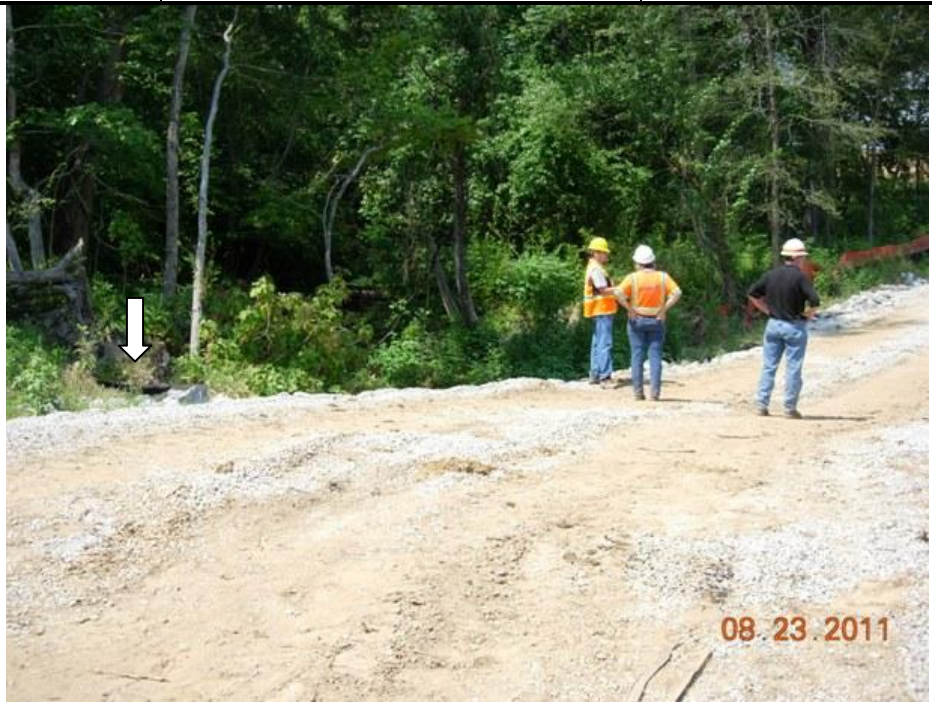
Permittee Name:		Site Location:	Tracking No.:
Norfolk Southern Railway Company		Rossville, Fayette County	TN0081108
Photo No.	Date		
61	8-23-11		
Description <ul style="list-style-type: none"> Phase 1 EC-07. The temporary road crossing over Stream 6 and SW 16 (arrow) is shown in this photo. The erosion control plan indicates that SW 16 is east of the road crossing, but according to the outfall sign in the field, SW 16 is located west of the road crossing. As of receipt of the updated ECP in June 2011 the ECP had not been updated to reflect this change.

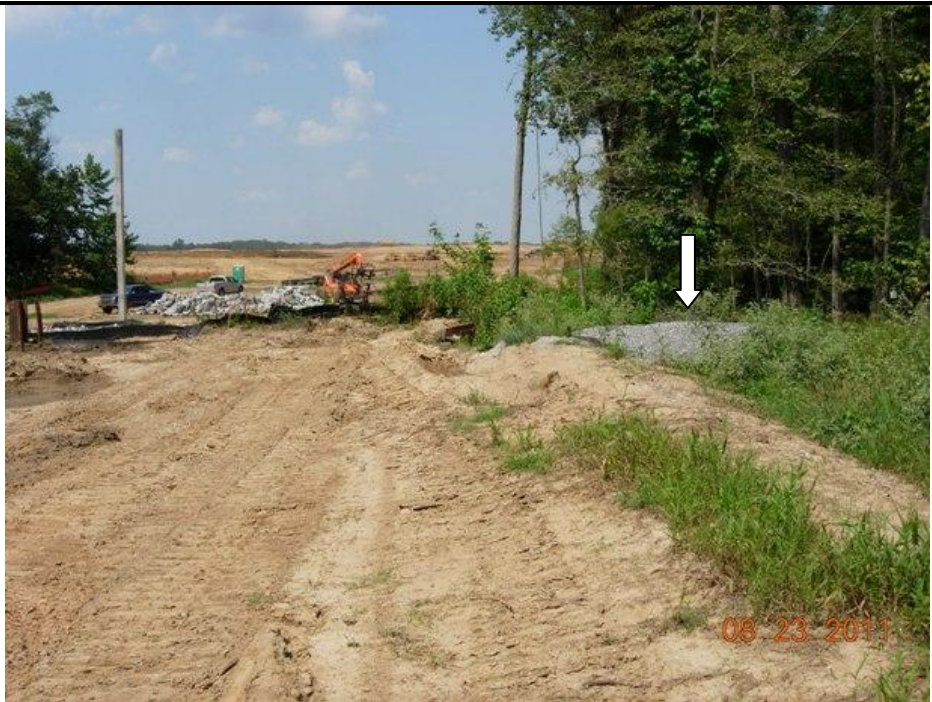
Photo No.	Date		
62	8-23-11		
Description <ul style="list-style-type: none"> Phase 1 EC-07. SW 15 is indicated by the arrow. Ms. Hagerty stated that the ditch which would direct drainage to SW 15 had not been constructed yet. Rip rap and 1 row of silt fence with backing had been installed along the top bank of Stream 6.

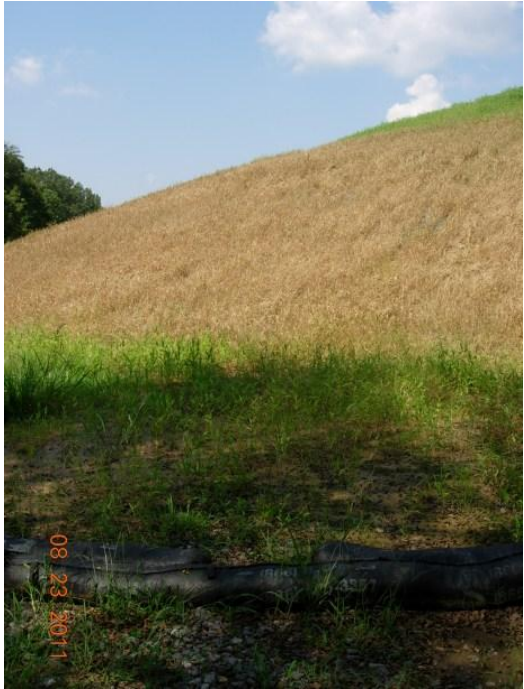
Permittee Name:		Site Location:	Tracking No.:
Norfolk Southern Railway Company		Rossville, Fayette County	TN0081108
Photo No.	Date		
63	8-23-11		
Description <ul style="list-style-type: none"> Phase 2 EC-29. This photo was taken looking north while standing on the old road bridge over Stream 6 just upstream of the Stream's confluence with Stream 7. The berm/slope was at final grade. The brown top millet covering the slope appeared to be dead and was sparse in places.
