# Limited Asbestos Survey

**Tennova Healthcare - Cleveland  
Hybrid Operating Room Renovation  
2305 Chambliss Avenue  
Cleveland, Bradley County, Tennessee**

**June 26, 2018**

Terracon Project No.: E2187071

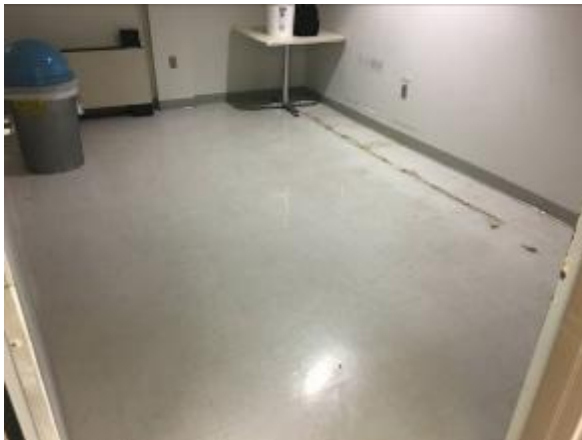
**Photo #1** View of the interior of the proposed hybrid operating room.

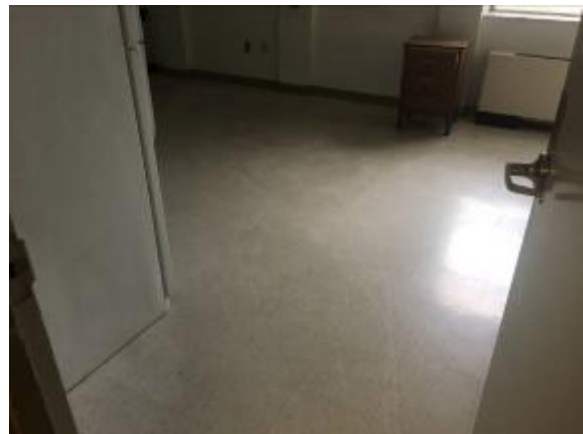
**Photo #2** View of the interior of the proposed hybrid operating room.

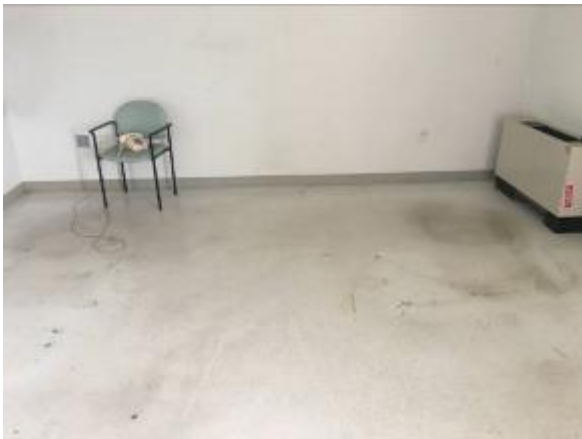
**Photo #3** View of the flooring and wall board of the proposed hybrid operating room.

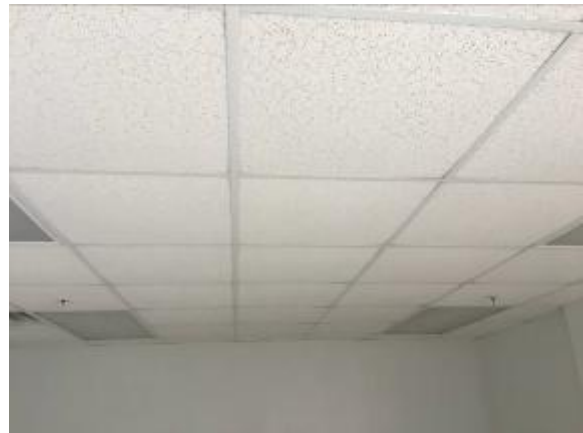
**Photo #4** View of the wall board and the drop ceiling tile of the proposed hybrid operating room.

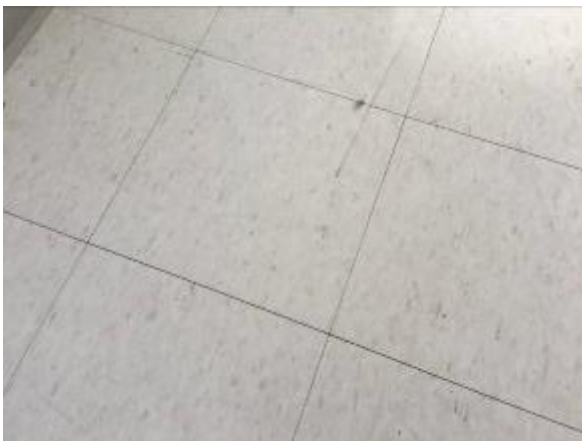
**Photo #5** View of the floor tile in the proposed hybrid operating room.

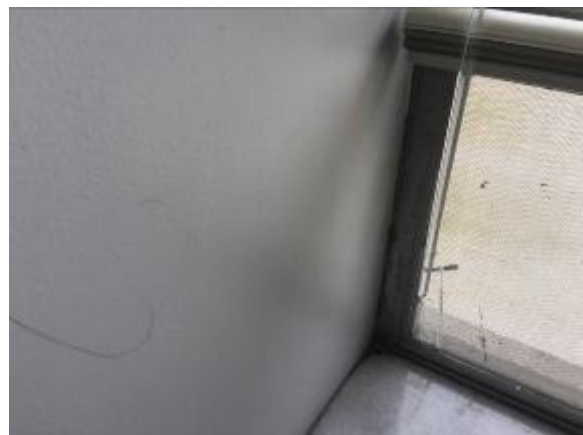
**Photo #6** View of the wall board and window caulking in the hybrid operating room.

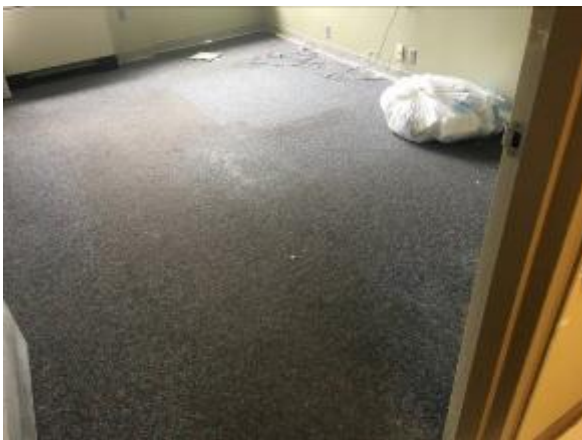
**Photo #7** View of the carpet in the proposed hybrid operating room.

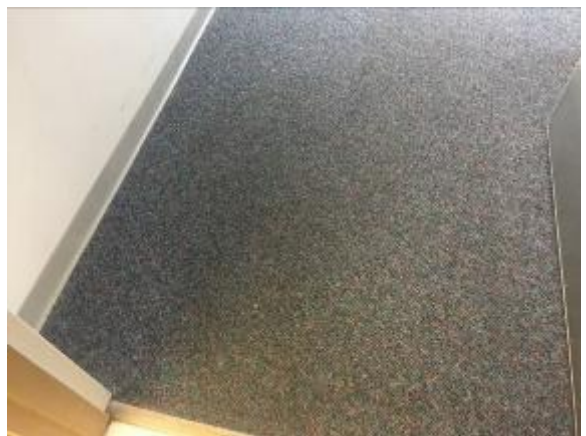
**Photo #8** View of the carpet and wall board in the proposed hybrid operating room.

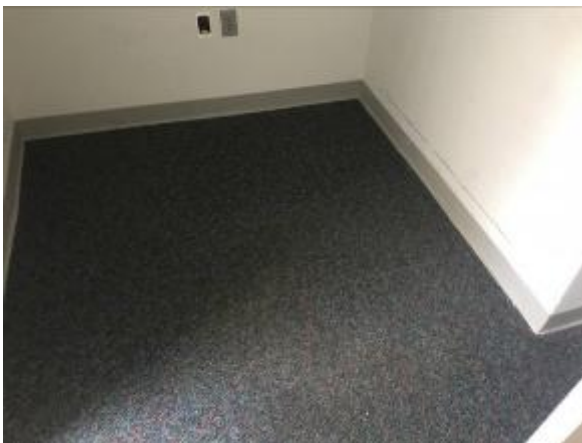
**Photo #9** View of the carpet and wall board in the proposed hybrid operating room

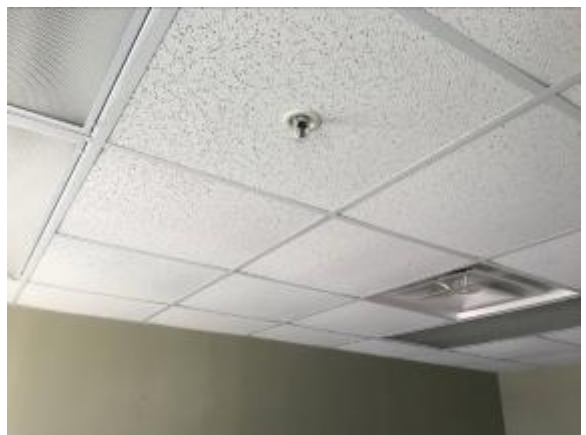
**Photo #10** View of ceiling tile in the proposed hybrid operating room.

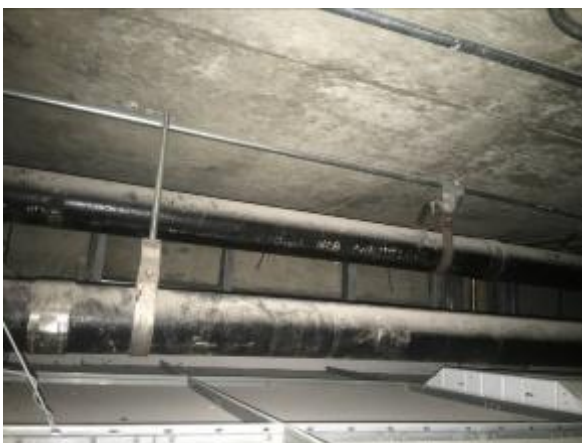
**Photo #11** View of the ceiling plenum.

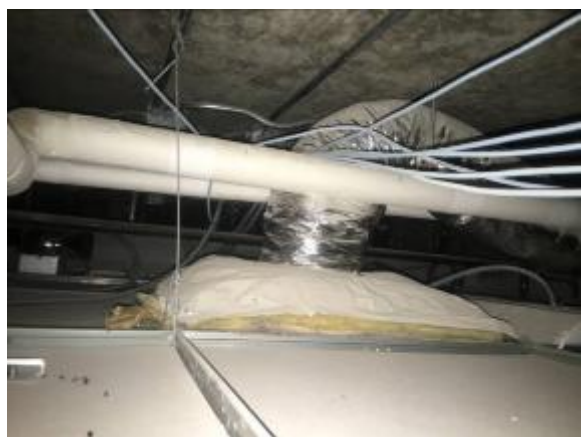
**Photo #12** View of the ceiling plenum
