**TENNESSEE DEPARTMENT OF ENVIRONMENT AND CONSERVATION  
MEMPHIS ENVIRONMENTAL FIELD OFFICE**

**RE: FOLLOW UP COMPLIANCE EVALUATION INSPECTION  
THIRD NOTICE OF VIOLATION  
HARDEMAN COUNTY LANDFILL  
SNL350000223**

## **SOLID WASTE INSPECTION REPORT**

Bolivar-Hardeman County Landfill  
SNL350000223  
75 Landfill Lane  
Bolivar, TN  
731-658-2884

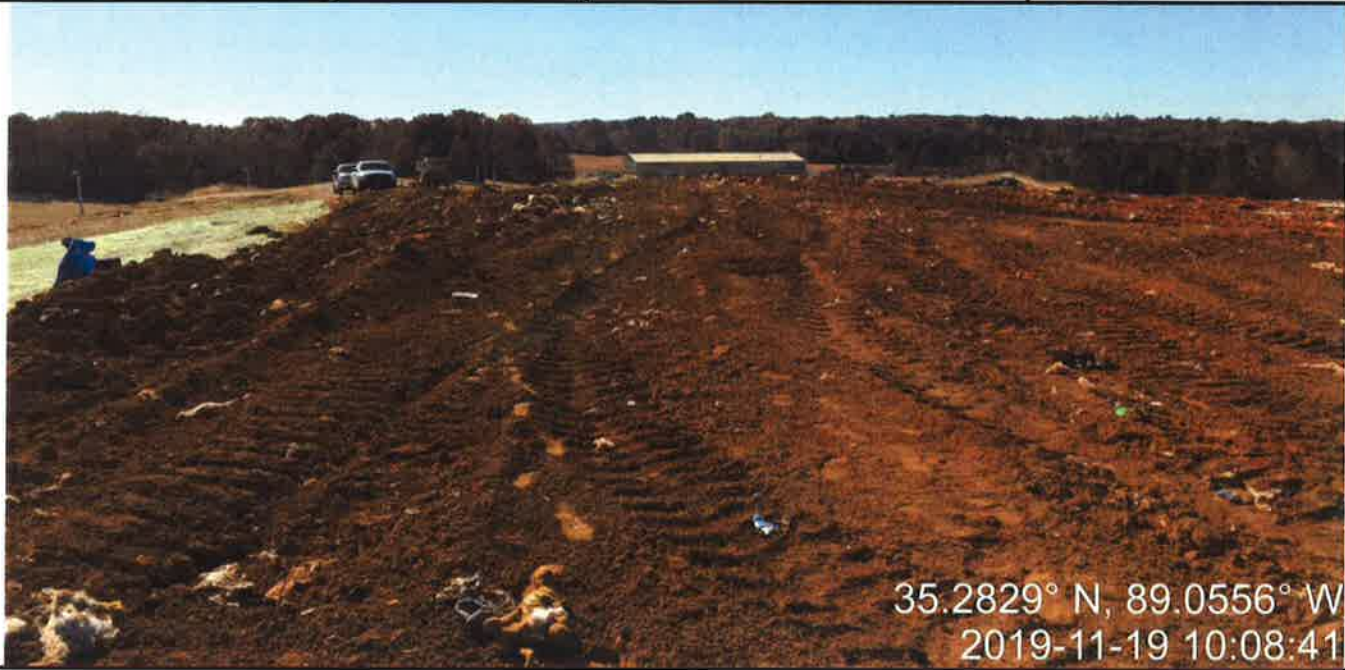
<p>35.2829° N, 89.0556° W 2019-11-19 10:08:41</p> <p><b>Photo 1.</b> View south over the last filled area. Note that the soil type is different from the previous sandy soil. Picture has been cropped to remove excess sky.</p>

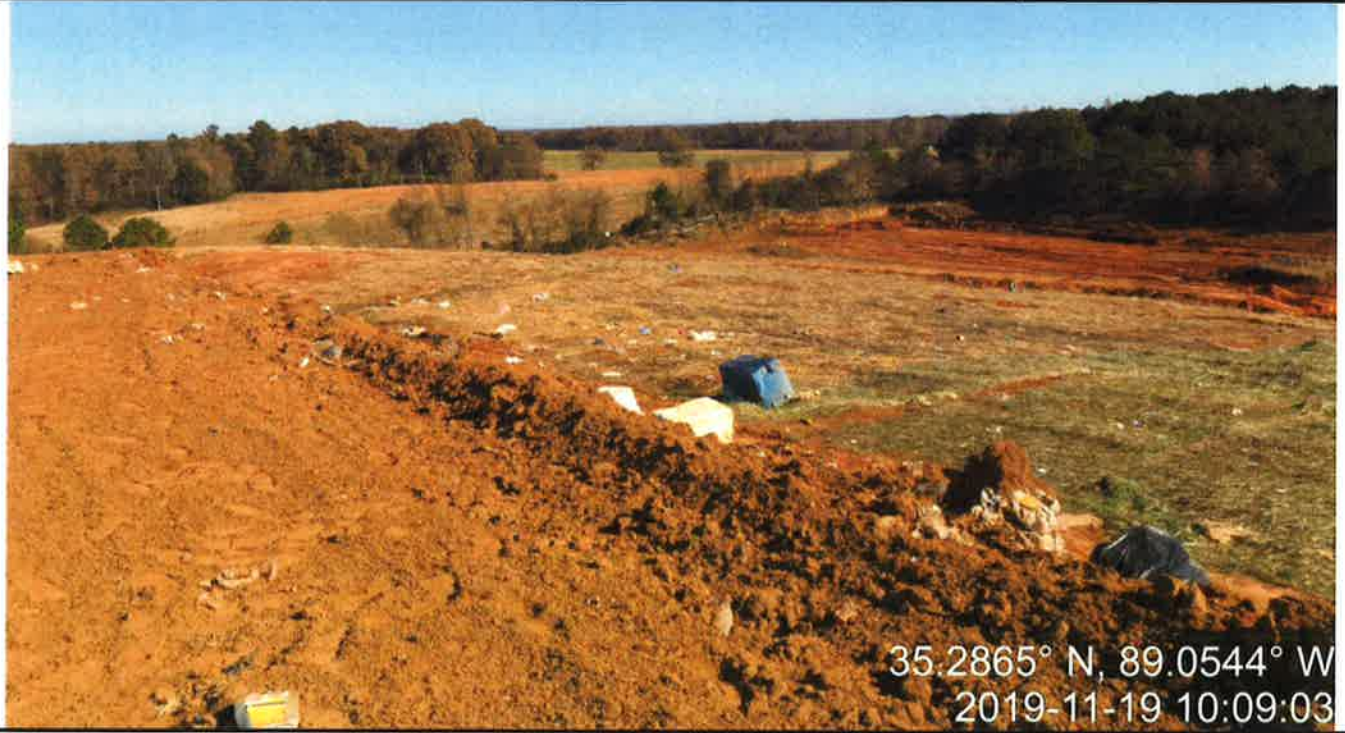
<p>35.2865° N, 89.0544° W 2019-11-19 10:09:03</p> <p><b>Photo 2.</b> View northeast over the east face. Note how the matting and straw are holding the soil in place. Picture has been cropped to remove excess sky.</p>

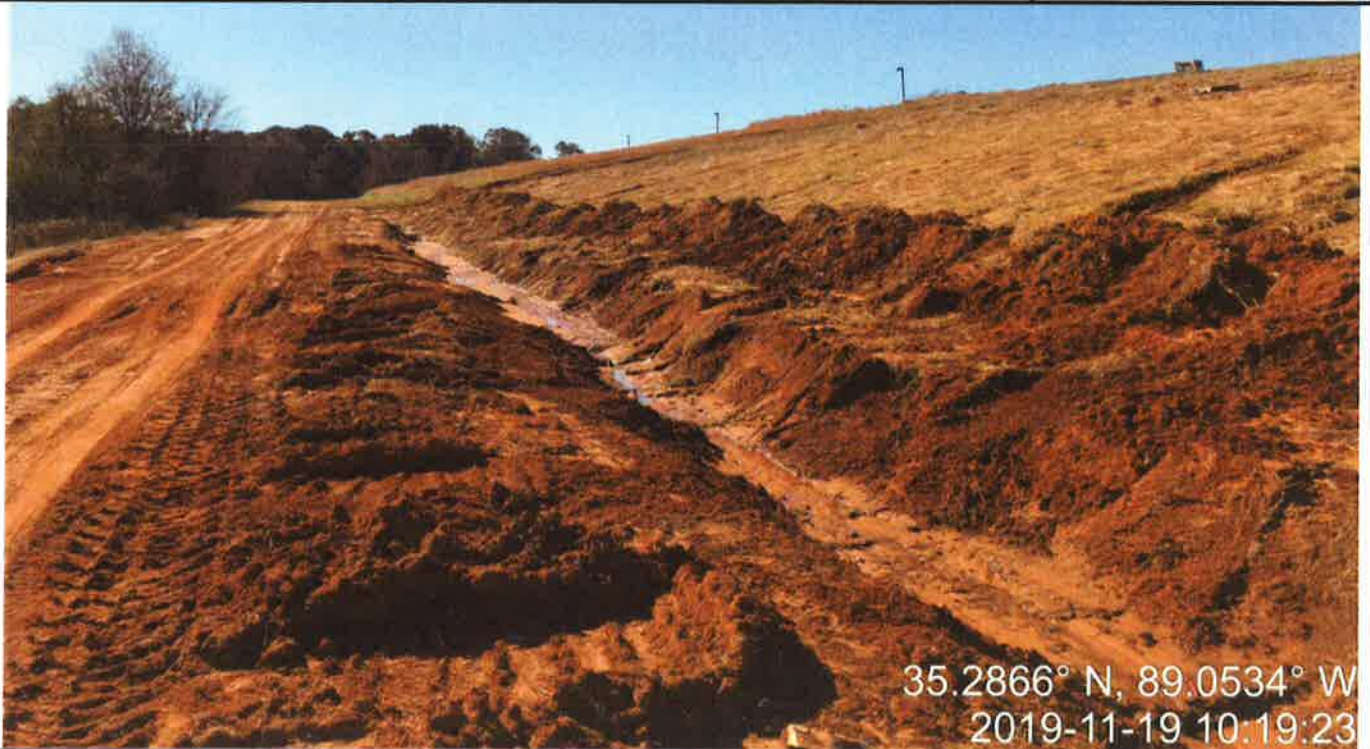
**Photo 3.** View south along the east face. Note the existence of a ditch. Also note that the erosion on the cover is near the toe of the slope. Picture has been cropped to remove excess sky.

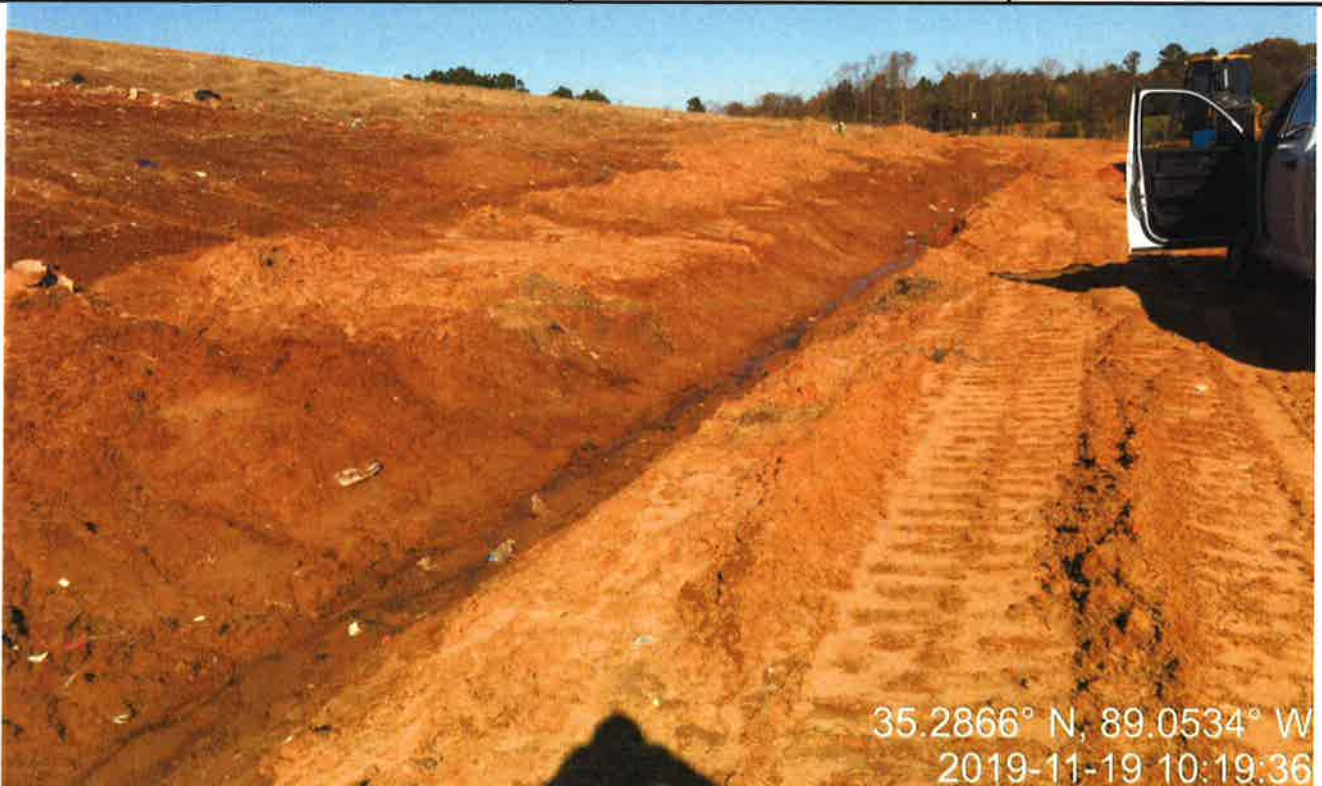
**Photo 4.** View north of the east face. The flow in this portion of the ditch appears to be from recent rains. Picture has been cropped to remove excess sky.

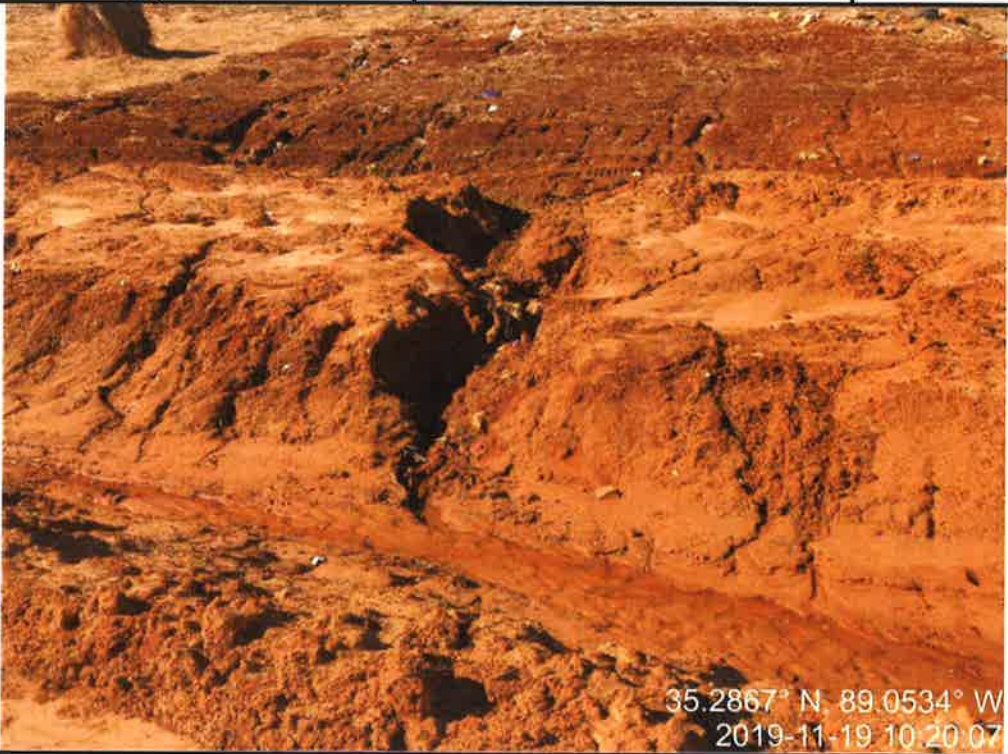
Solid Waste Exposed – The erosion of phases II and III cover had exposed waste during the inspection (photographs 5 and 7). This exposed waste is on the lower slope of the east and north slopes where the erosion of the intermediate cover is greatest.

<b>Photo 5.</b> Erosion gully at the bottom of the east face. Note the exposed/washed waste. Also note the rill erosion on the side slope.

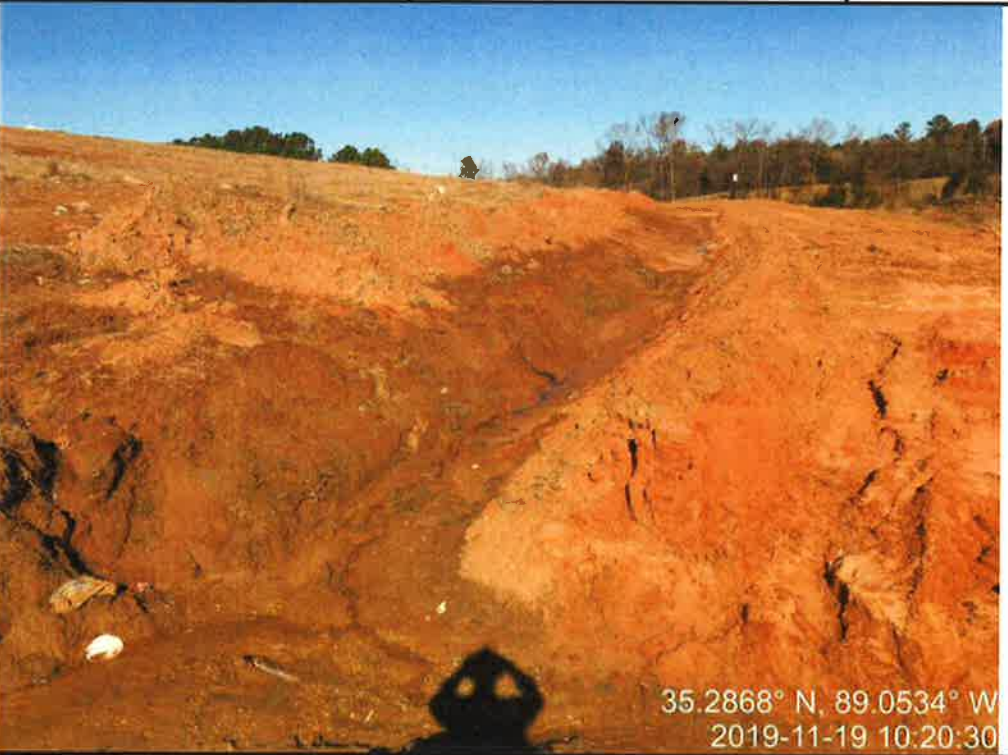
<b>Photo 6.</b> View north along the east face. Note the leachate breakout entering the run off system.

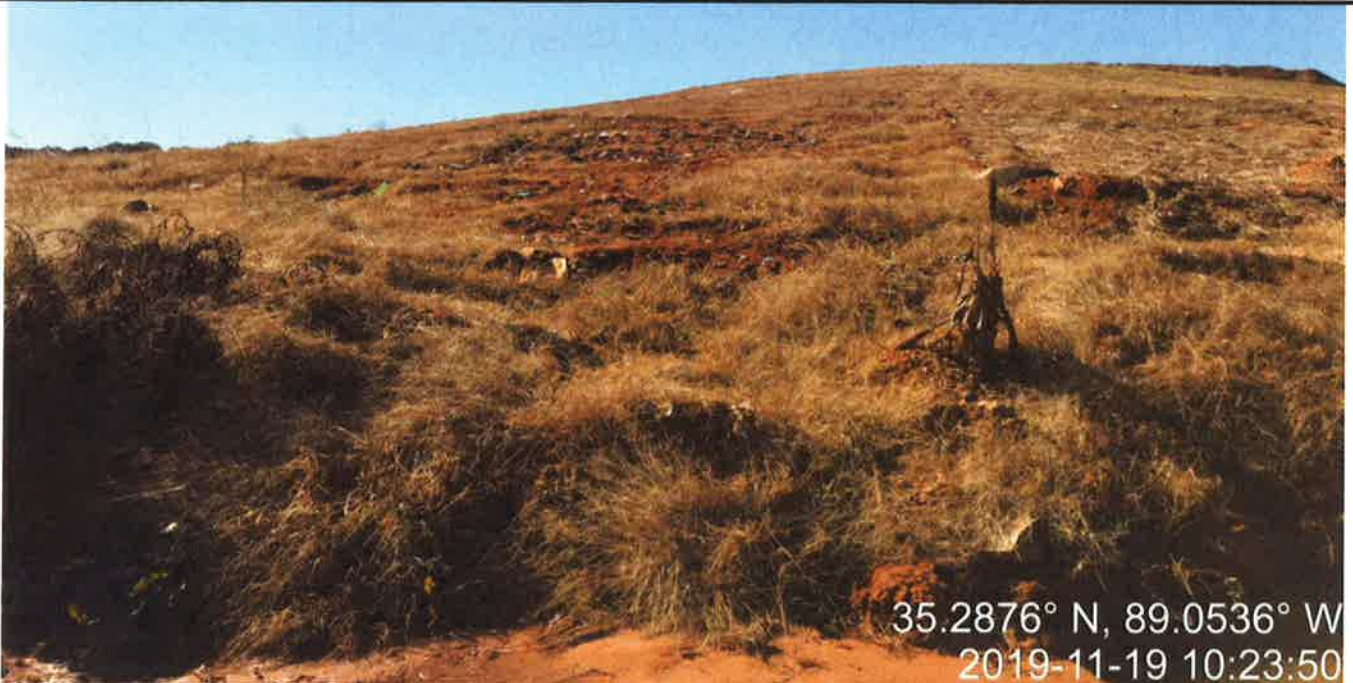
**Photo 7.** View south of the northeast corner of the fill. Note that the eroded cover and exposed waste is at the bottom of the slope. This is intermediate cover. Picture has been cropped to remove excess sky.

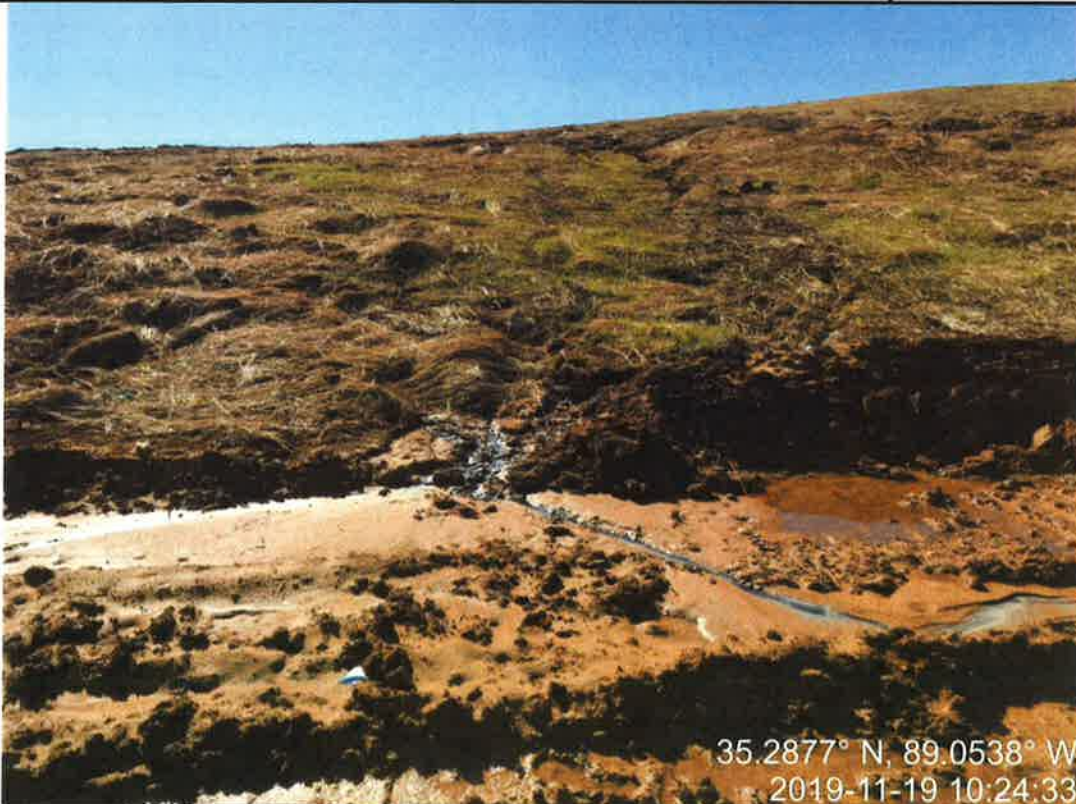
**Photo 8.** View of a leachate breakout on the north slope. Note that the erosion is on the lower slope of the fill.

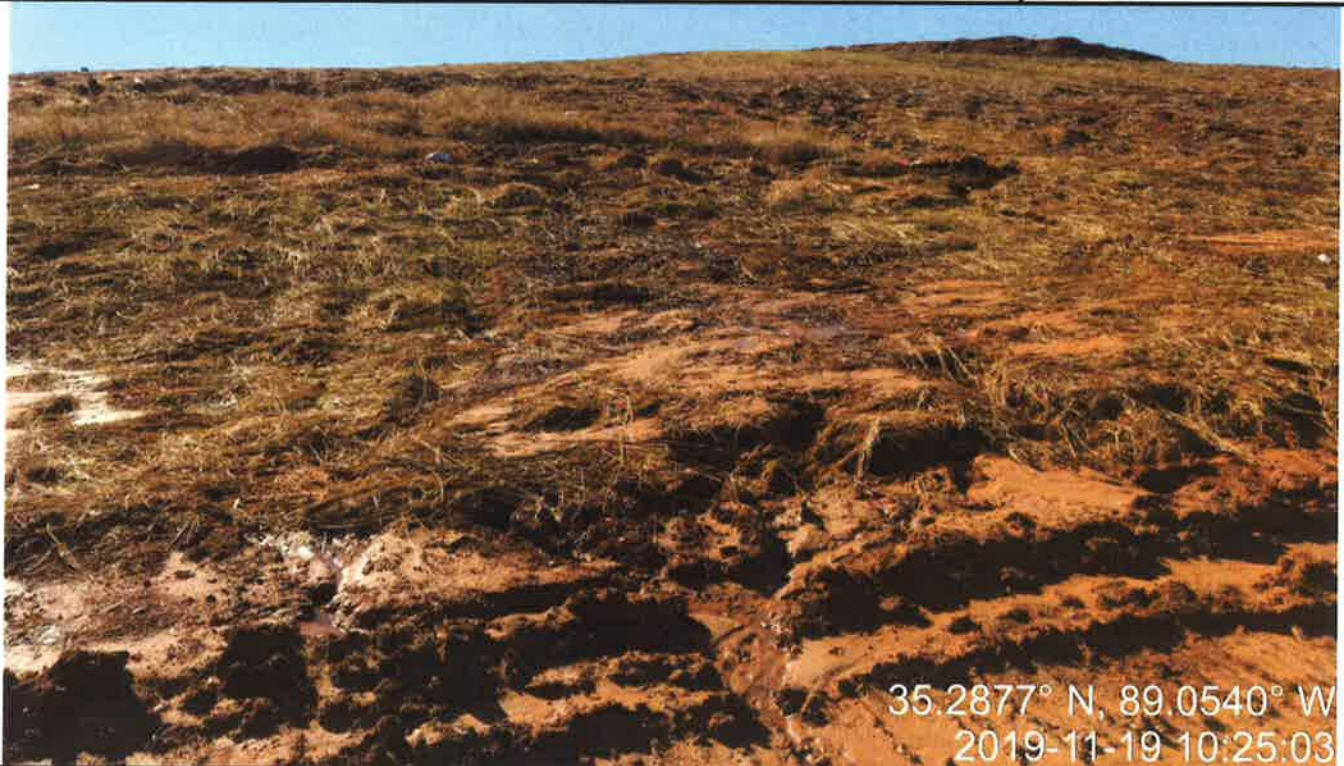
**Photo 9.** View of erosion on the north face. Note the water coming from the cover. Picture has been cropped to remove excess sky.

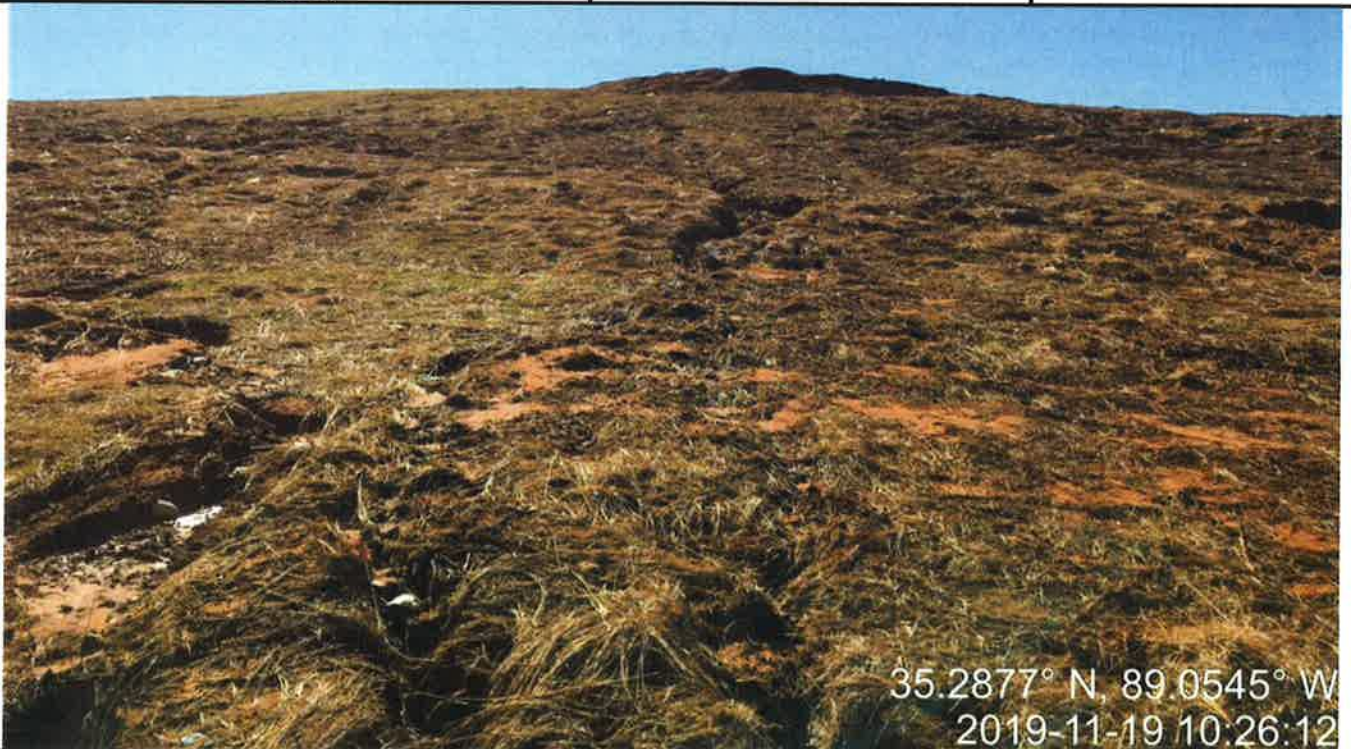
**Photo 10.** View of erosion on the north face. Note that the erosion is in the bottom of the covered area. Picture has been cropped to remove excess sky.
