**TENNESSEE DEPARTMENT OF ENVIRONMENT AND CONSERVATION  
MEMPHIS ENVIRONMENTAL FIELD OFFICE**

**RE: COMPLIANCE EVALUATION INSPECTION  
NOTICE OF VIOLATION  
HARDEMAN COUNTY LANDFILL  
SNL350000223**

## **SOLID WASTE INSPECTION REPORT**

Bolivar-Hardeman County Landfill  
SNL350000223  
75 Landfill Lane  
Bolivar, TN  
731-658-2884

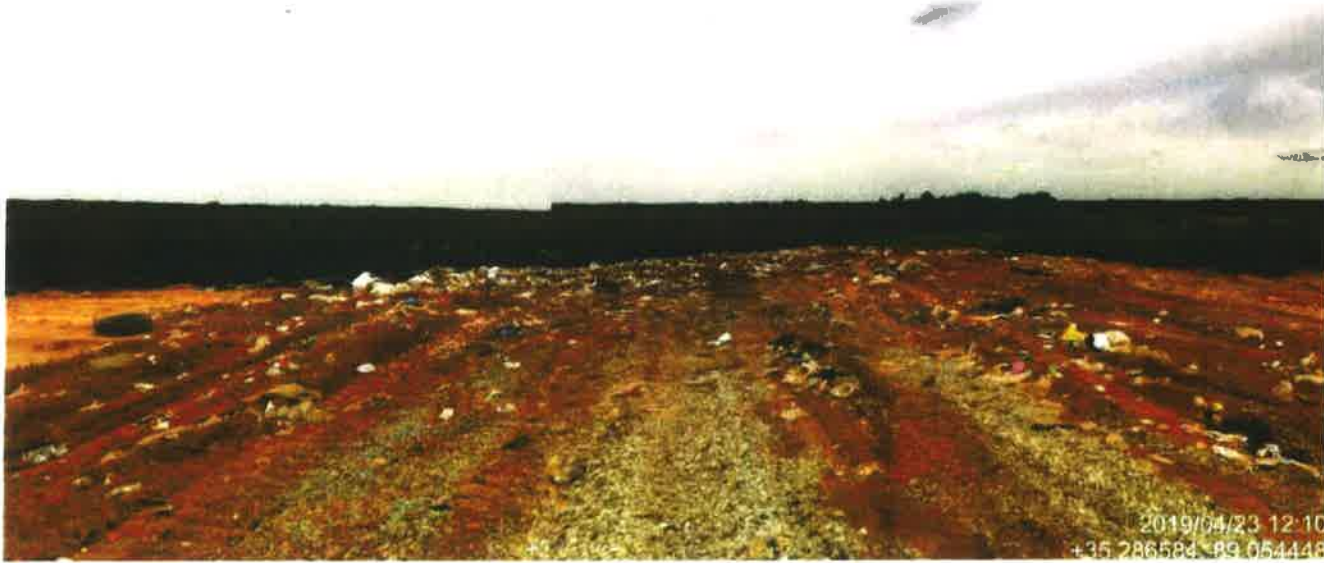
<p>2019/04/23 12:10 +35.286584,-89.054448</p>		
<b>Photo 2.</b> View over the working face.

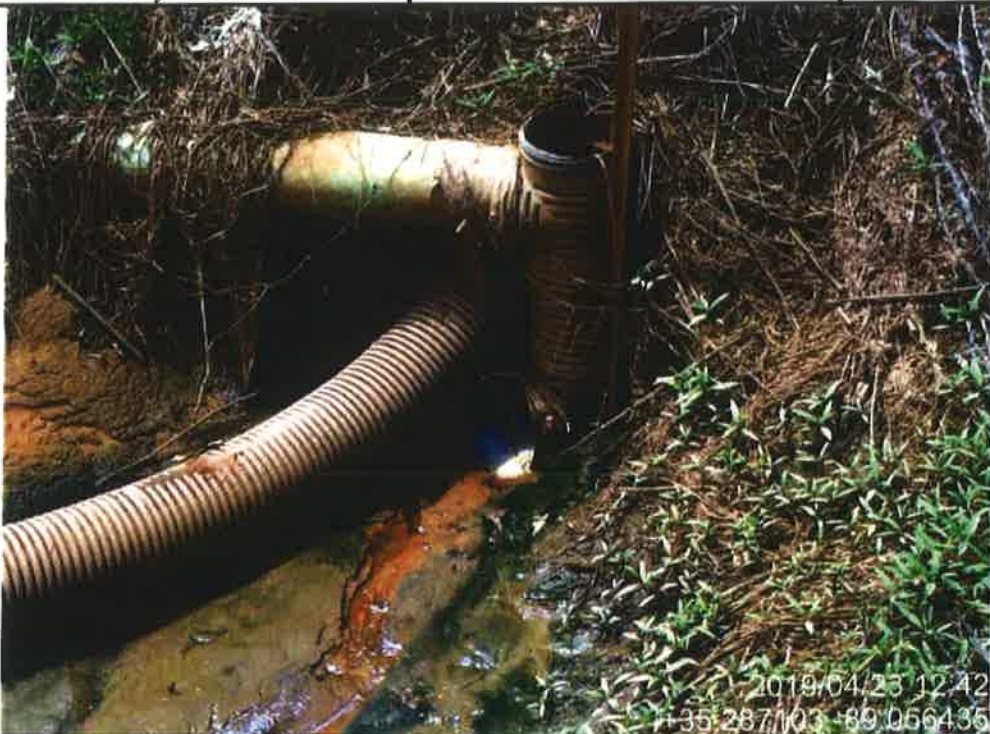
<b>Photo 3.</b> The leachate line riser below Phase IV. Note that the line from Phases I to III is disconnected.

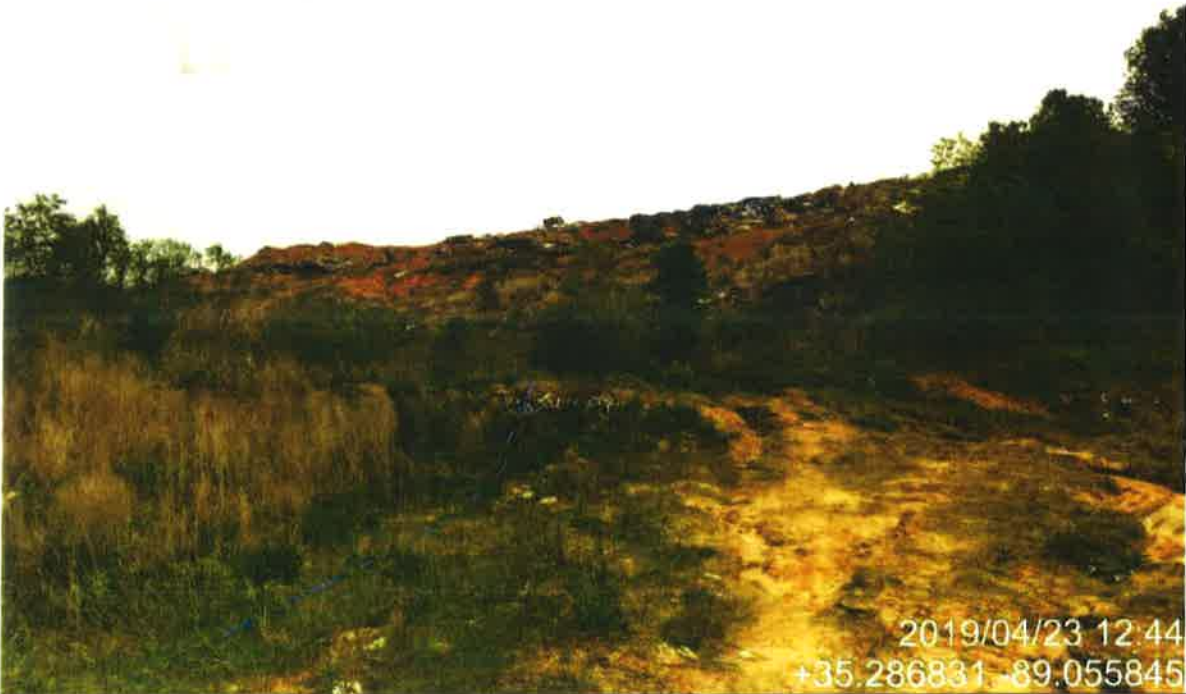
<b>Photo 4.</b> View from Phase IV of the West face of Phase II/III. Note the uncovered waste and the unapproved tarp. This picture has been cropped to remove excess sky.

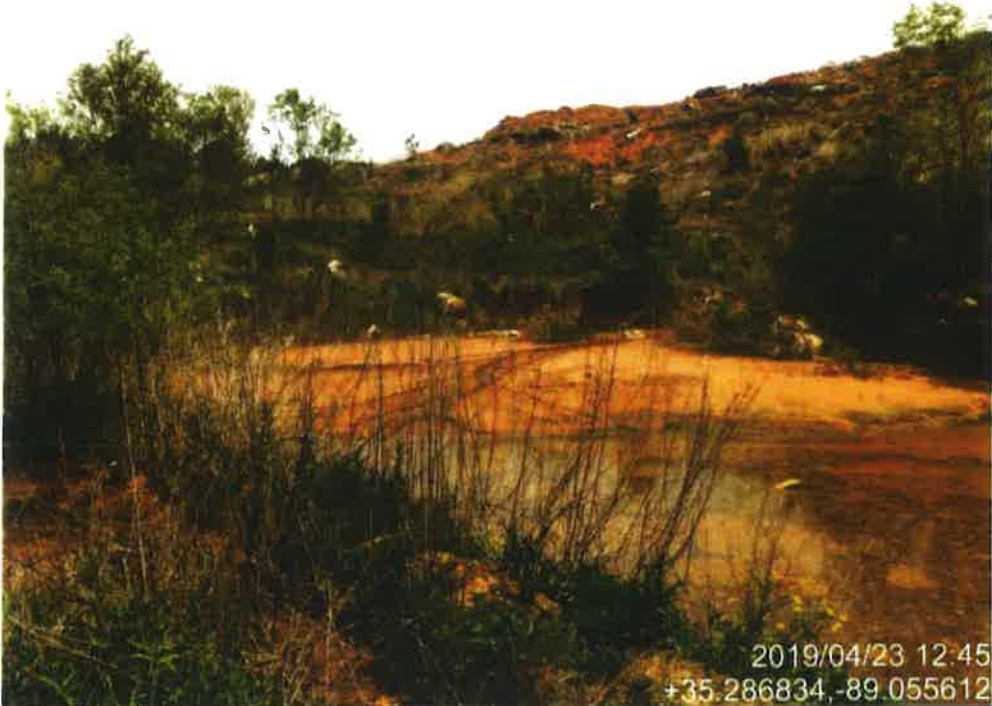
<p data-bbox="998 829 1328 898">2019/04/23 12:45 +35.286834,-89.055612</p>		
<b>Photo 5.</b> Sediment fan in the temporary leachate pit.

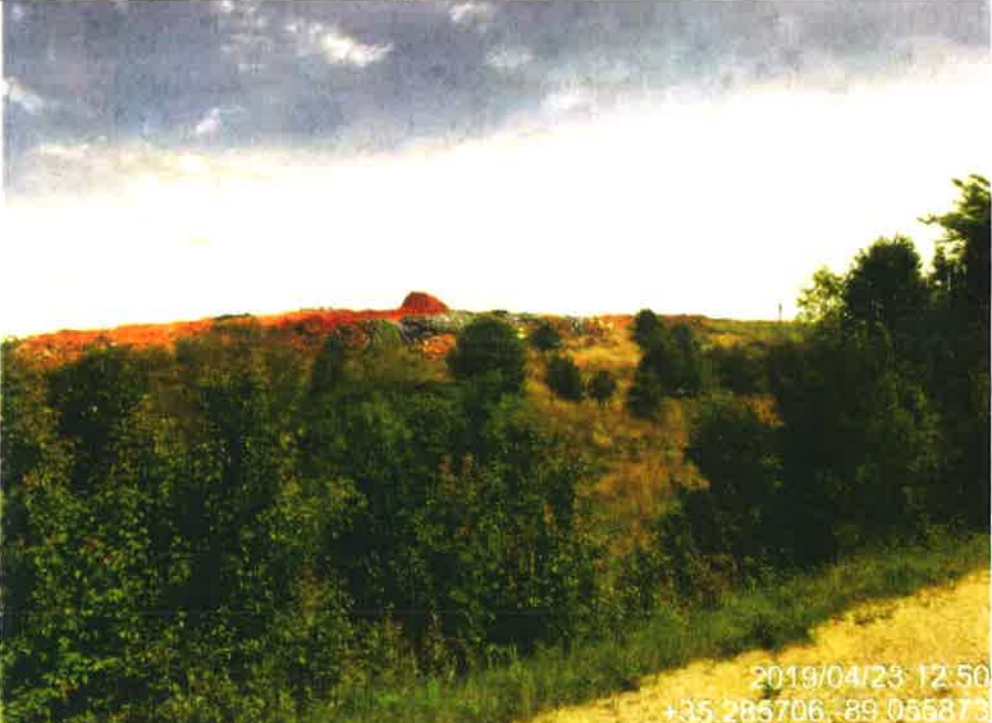
<p data-bbox="998 1732 1328 1795">2019/04/23 12:50 +35.285706,-89.055873</p>		
<b>Photo 6.</b> View from the Southwest of the active area of the landfill. Note the uncovered waste and the unapproved tarps.

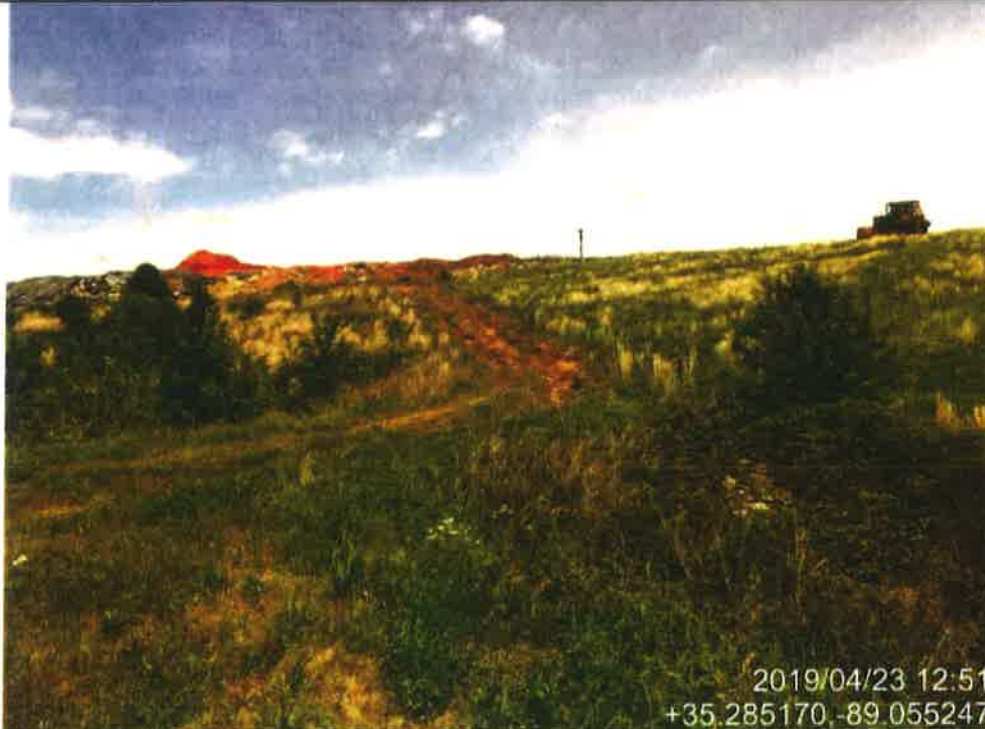
**Photo 7.** Erosion on Final cover of Phase I in Northwest corner of phase. Note that erosion from Phase II appears to have partially filled the erosion on Phase I.

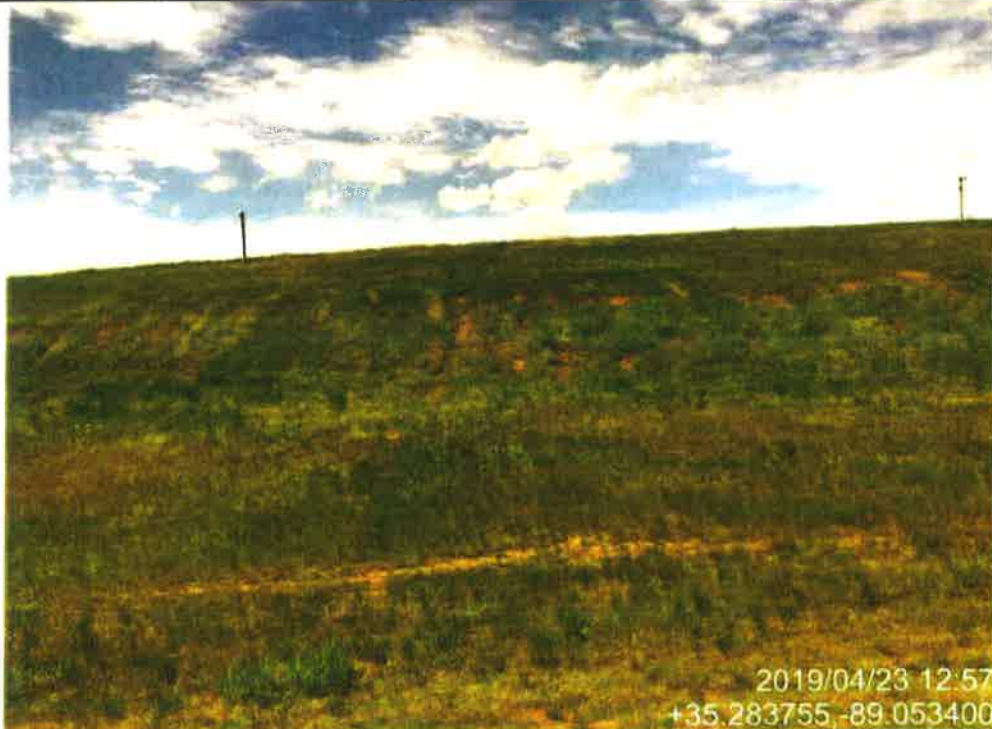
**Photo 8.** View of the East side of Phase I. Note the starter erosion rills on the final cover.

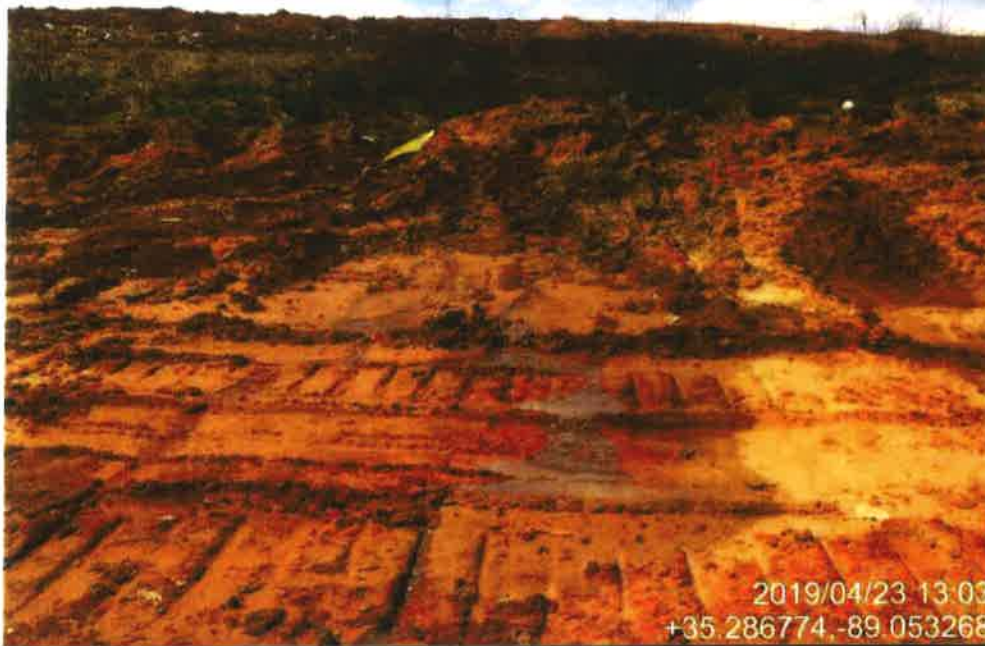
**Photo 9.** Leachate on the East face.

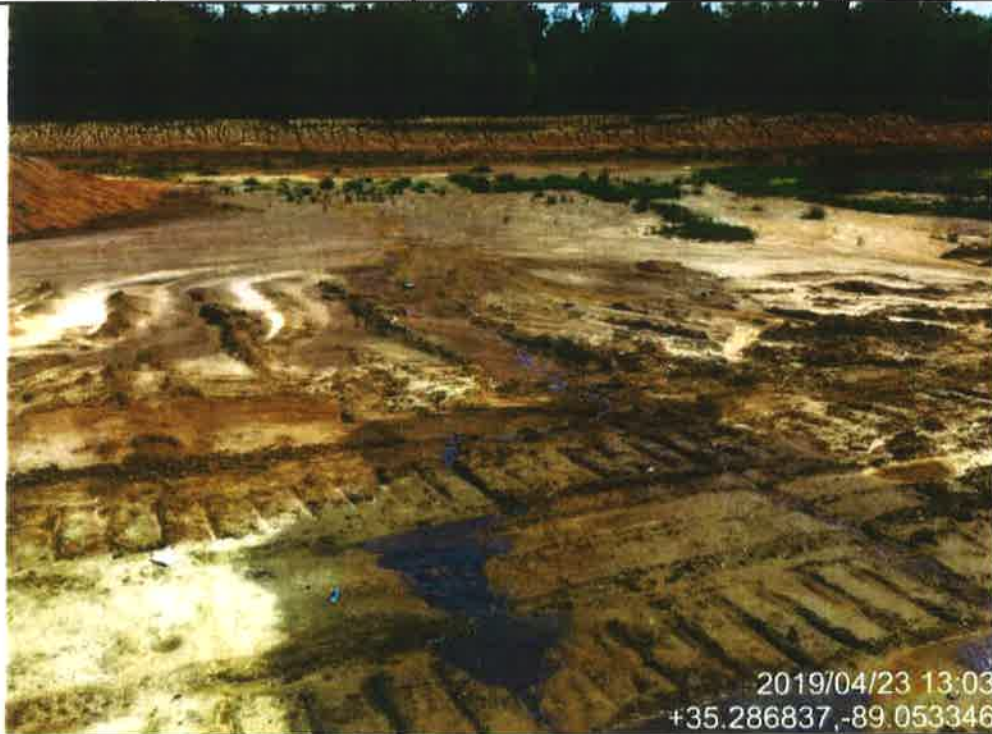
Leachate Observed Entering Run-Off – Leachate was observed entering the landfill run-off system at the time of the inspection. Photographs 10, 12, and 15 show the leachate flowing into the run-off system.

**Photo 10.** Leachate from Photo 09 entering the run-off system.

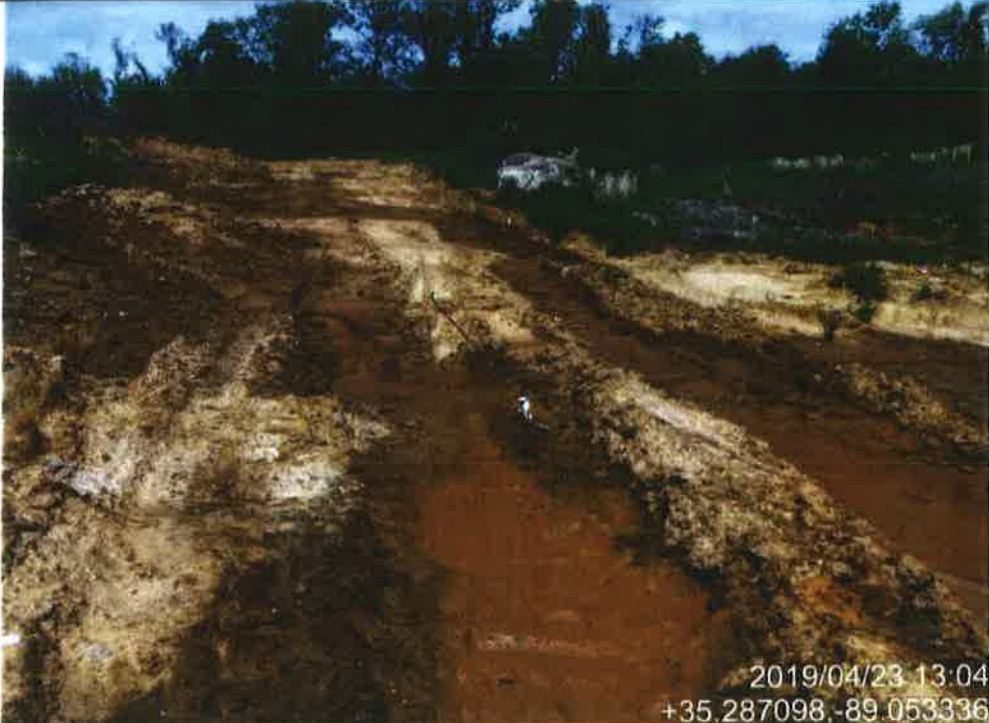
<b>Photo 11.</b> A group of leachate breakouts on the East face of Phase III.

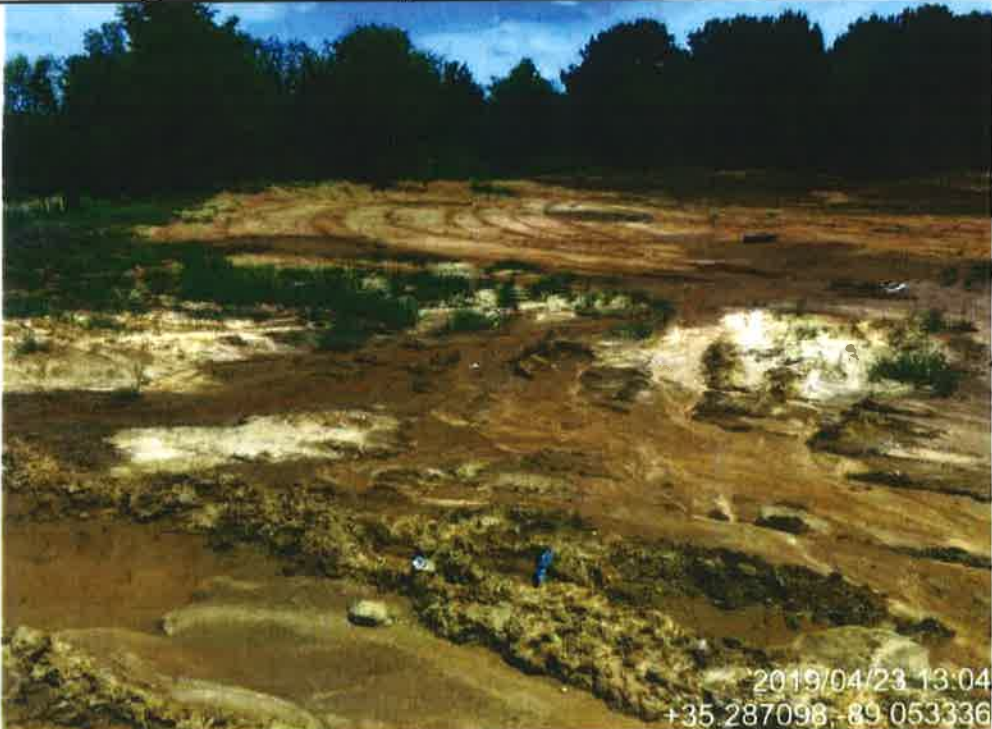
<b>Photo 12.</b> Leachate from Photo 11 entering the run-off.

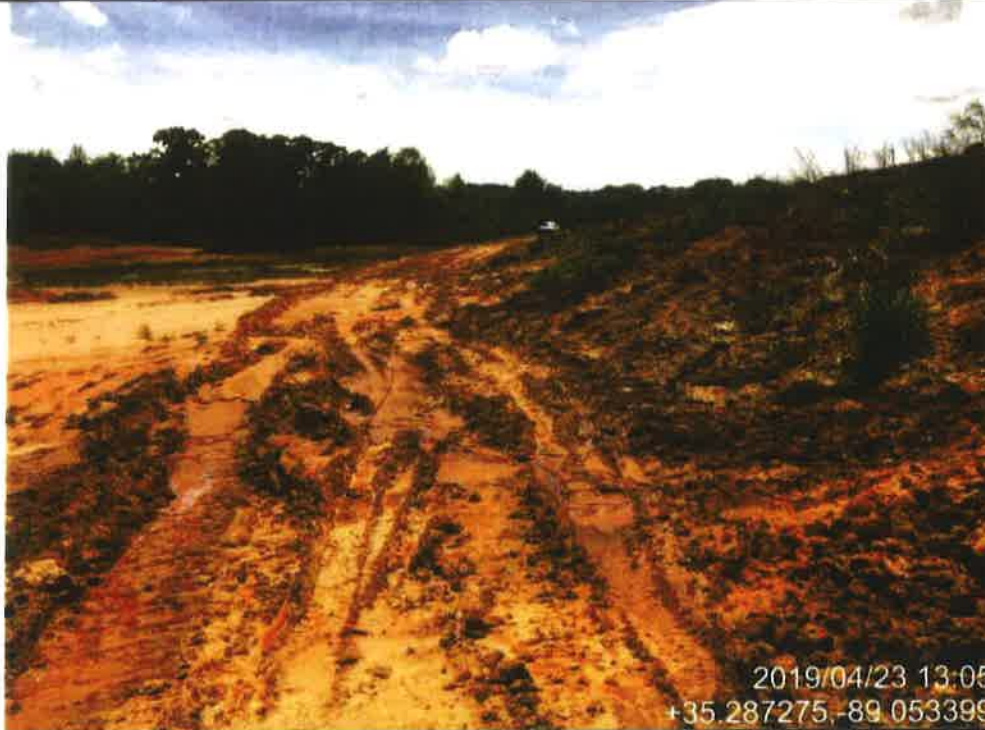
**Photo 13.** View south along the East face. Photo 11 leachate is in the foreground and photo 09 leachate is in the middle ground.

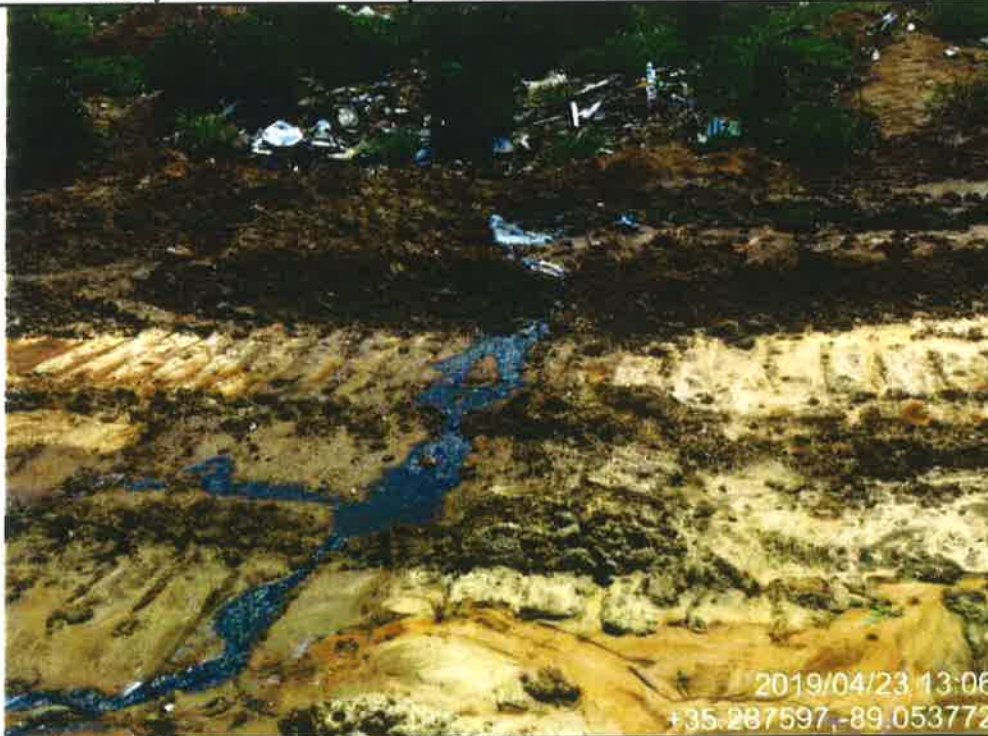
**Photo 14.** Leachate on the North face of Phase III. Note the exposed waste.

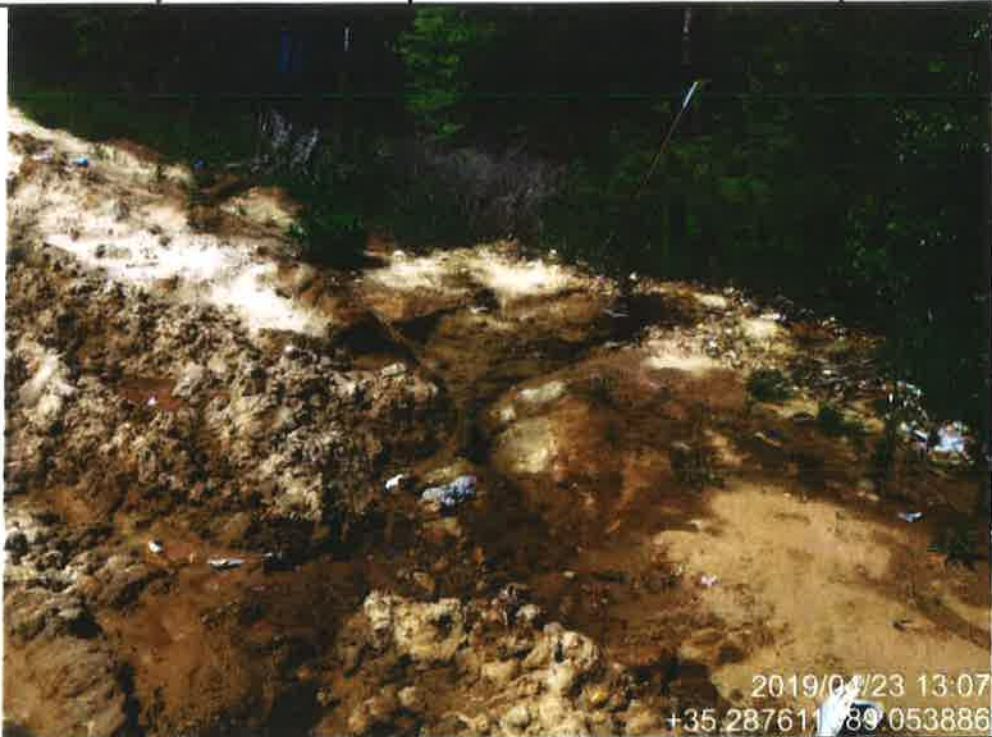
<b>Photo 15.</b> Leachate from Photo 14 enter the run-off.

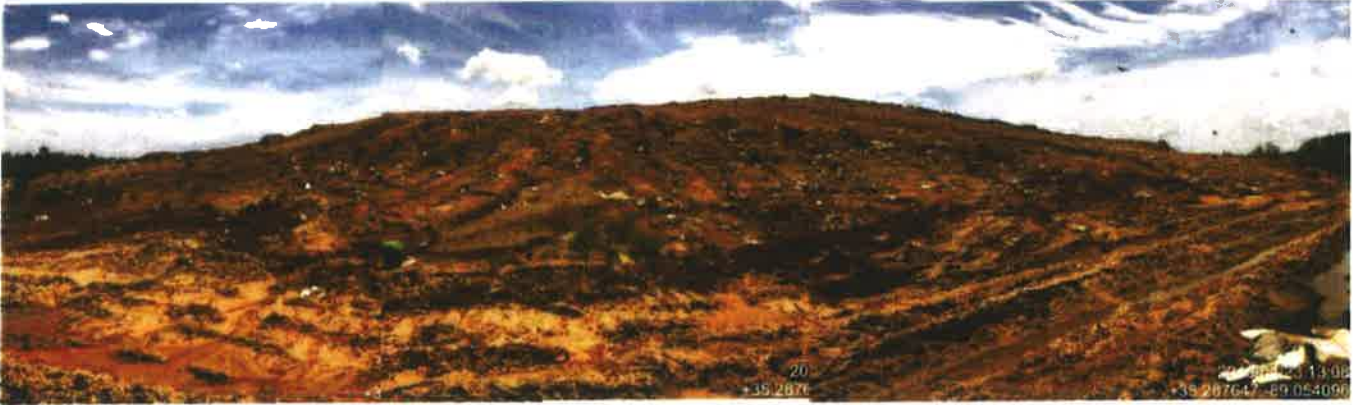
<p><b>Photo 17.</b> View of the North face of Phase III. Note the erosion down to waste and the waste washed out. This view is a panorama of three different pictures.</p>

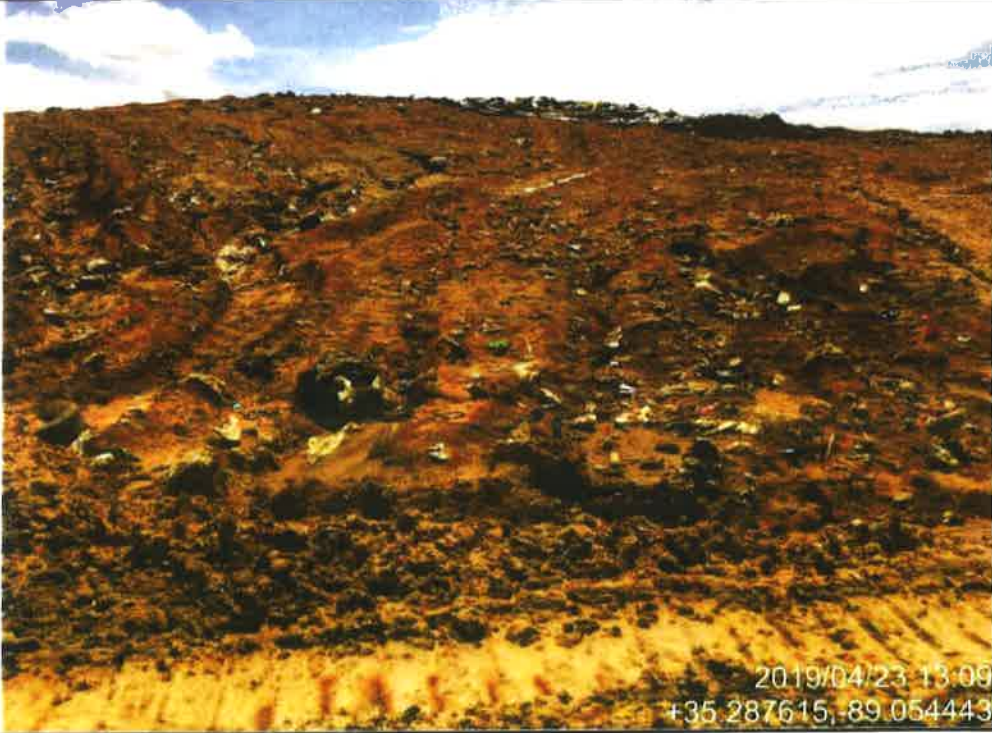
<p><b>Photo 18.</b> Center of the North face. The current working area is at the top of the picture. Note the washed out waste.</p>

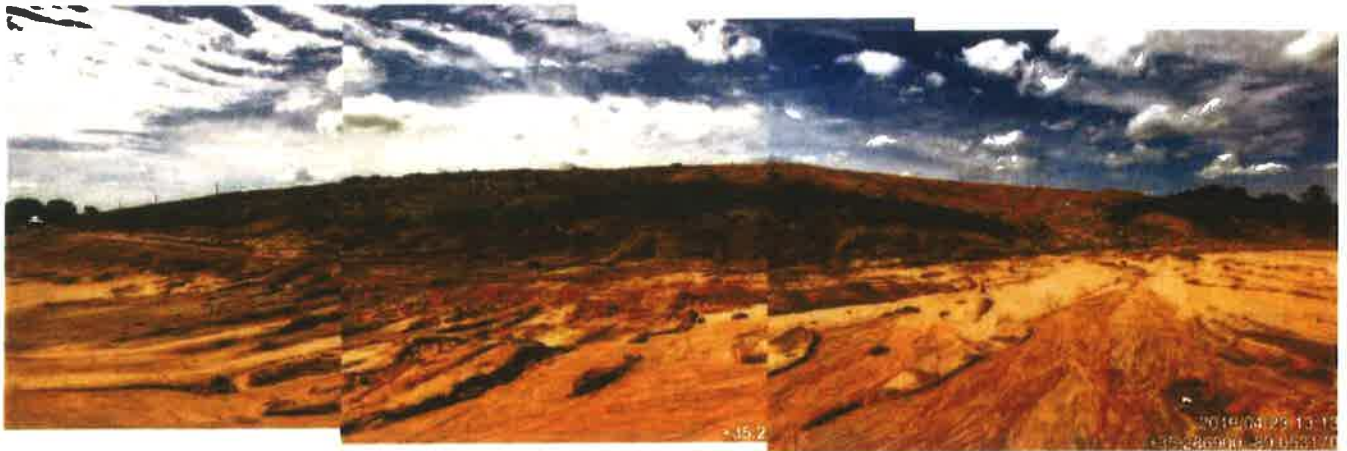
**Photo 19.** Panorama of the East face. Phase I is the covered area to the left. Note that areas where grass has been established are stable and areas where it is not have alluvial fans below them.

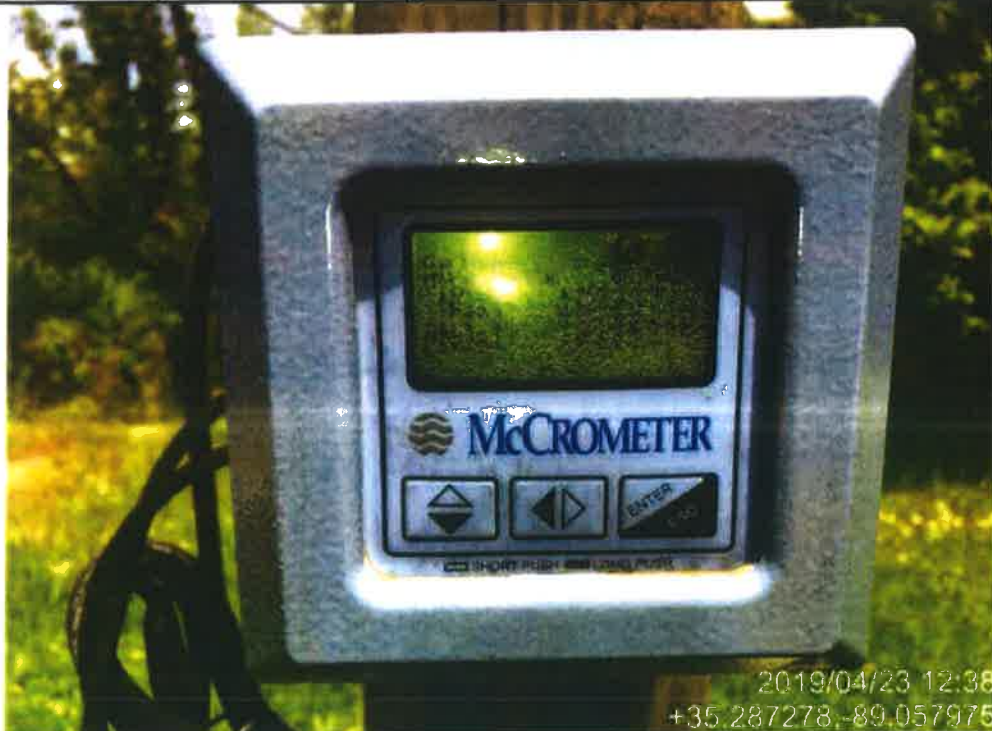
**Photo 20.** The damaged screen on the leachate flow meter.
