Re: Tennessee Department of Transportation Facility Monitoring Results Loudon County Garage

Attachments: Attachment A — Photographic Log Attachment A Photographic Log

Loudon County Garage

Region 1 Outfall 53-C-01

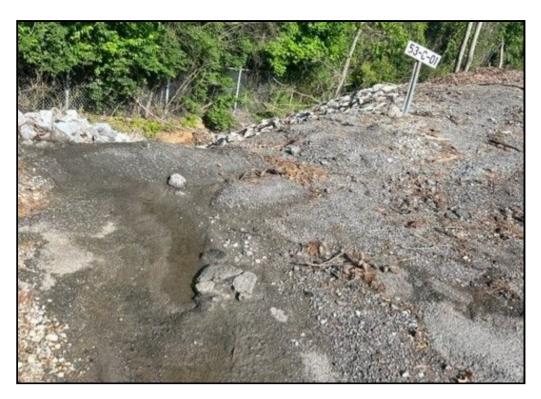
Photograph 1

Note: View of the area immediately upslope of Outfall 53-C-01. The stormwater sample collected at the outfall tested high for chemical oxygen demand (COD) and total suspended solids (TSS). The majority of the lot is paved with no signs of erosion or sediment deposits. The slightly elevated TSS levels likely came from area pictured. Additional stabilization may be required.

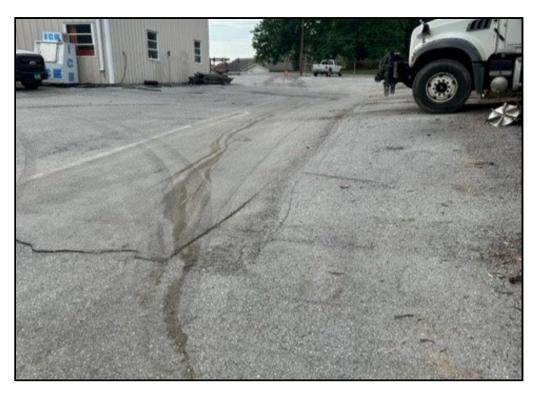
Photograph 3

Note: Another view of the lot upslope of Outfall 53-C-01. In general, it was in good condition with a few minor oil leaks observed that need to be properly addressed.

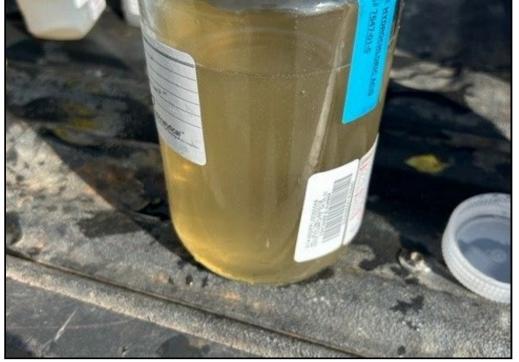
Photograph 4

Note: View of the stormwater sample collected from Outfall 53-C-01. The sample measured 168 mg/L for TSS which exceeds the action level of 150 mg/L.
