**Re: Tennessee Department of Transportation Facility Monitoring Results  
Anderson County Garage**

Photographic Log

**Anderson County  
Garage**

**Region 1  
Outfall 01-C-04**

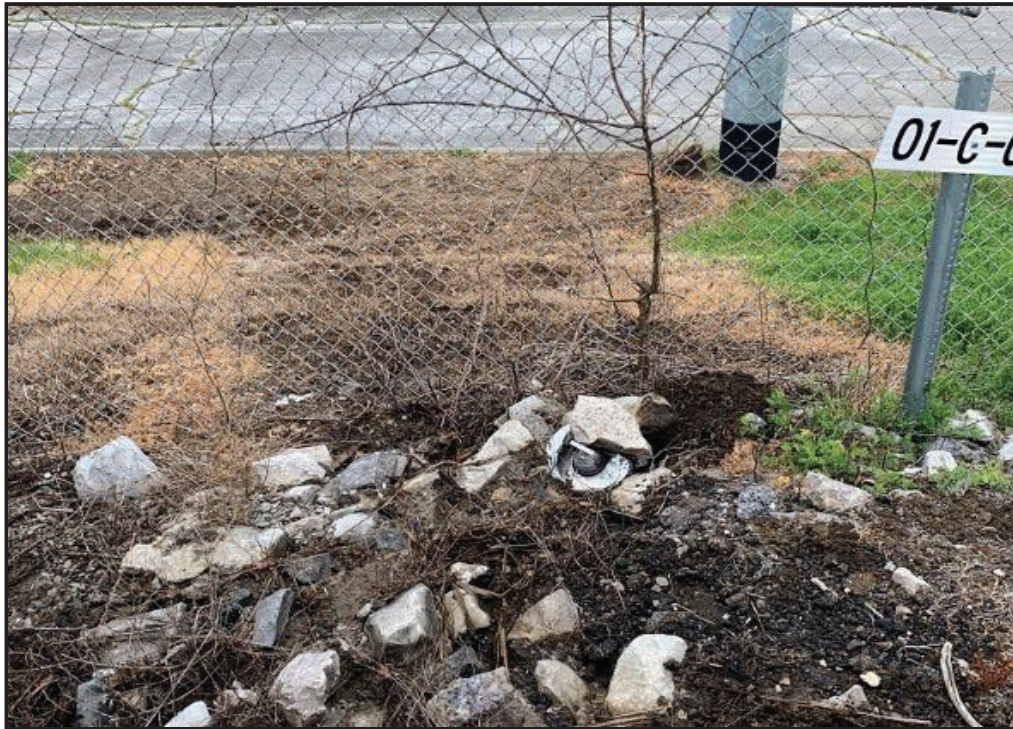
**Photograph 1**

On May 23, 2022, EnSafe Inc., consultants to the TDOT Environmental Compliance Office (ECO), conducted analytical monitoring of the storm water discharge from the Anderson County Garage in Clinton, Tennessee, according to the methods and requirements of the SFMP. The final laboratory analytical report from this sampling event was received on June 21, 2022. Samples were acquired from the principal outfall, Outfall 01-C-04, and lab results included a value for COD of 165 milligrams per liter (mg/L), which exceeds the action level concentration of 120 mg/L for COD specified in the SFMP. The sample also yielded a measured total suspended solids concentration of 283 mg/L, which exceeds the action level concentration of 150 mg/L. The chloride level was 1,000 mg/L, which approached the action level of 1,200 mg/L. Dead vegetation was observed beyond the fence line but there was no salt staining on the ground or other clear indications of a chloride source. The COD levels may have been raised by decomposing

**Note:** View looking southeast at Outfall 01-C-04. The collected storm water sample exceeded the action levels for total suspended solids (TSS) and chemical oxygen demand (COD), likely due to the exposed soil and dead vegetation. The area needs to be stabilized with vegetation or other means if vegetation cannot be established.

vegetation and TSS levels raised by the exposed soil. There were no observed spills or other obvious sources of the high COD levels. The ECO recommends efforts be taken to stabilize the area around the outfall and either reestablish vegetation or place additional riprap. Site personnel should continue to address spills and de-icing operations per the TDOT standard operating procedures. Please see the attached photo log.

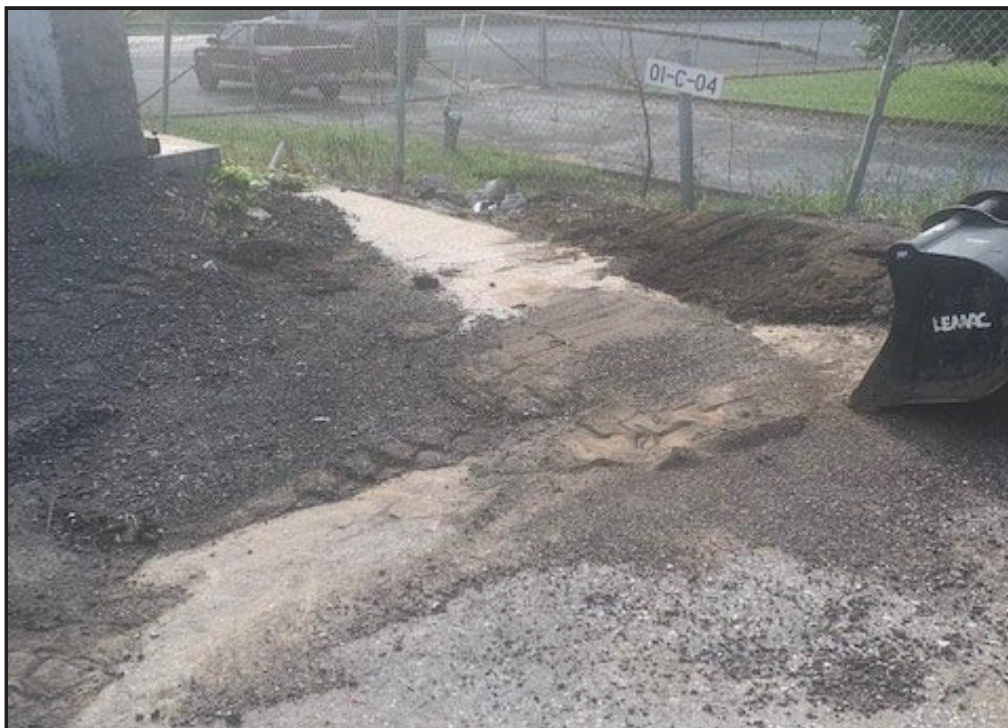
**Photograph 2**

**Note:** Stabilize exposed areas by reestablishing vegetation or placing riprap. Chloride levels were elevated but did not exceed the action level. It is suspected that a brine release may have occurred and it may take an extended amount of time for the residual chloride levels in the soil to be reduced.

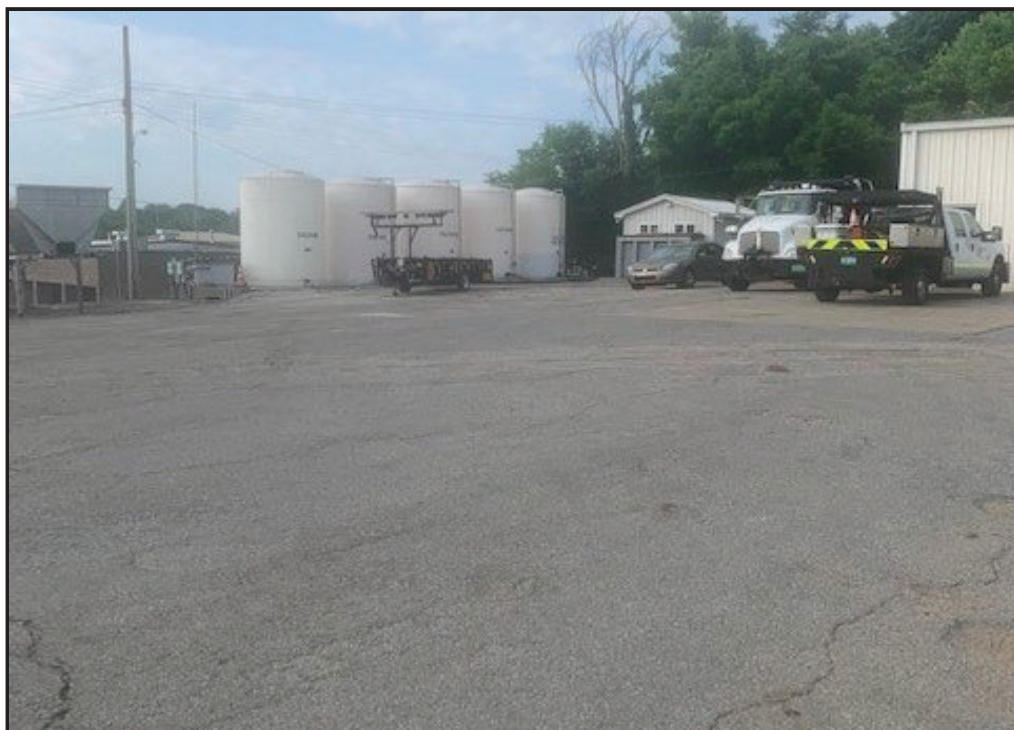
**Photograph 3**

**Note:** View of the typical condition of the paved lot. No other sources of total suspended solids or COD were observed.

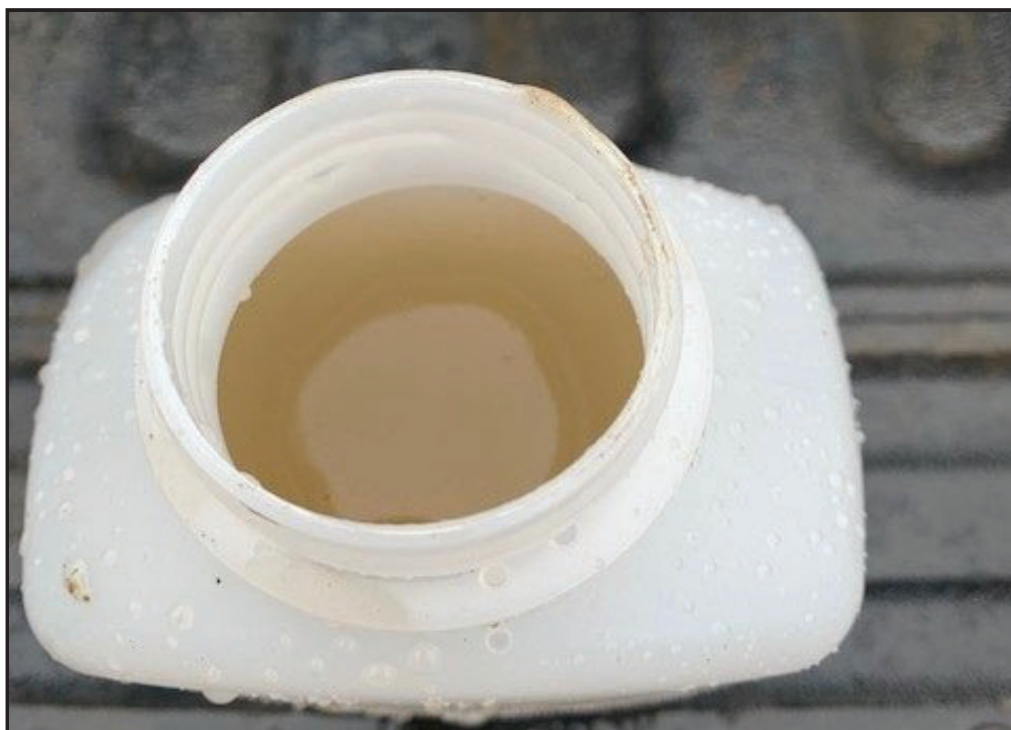
**Photograph 4**

**Note:** View of the storm water sample from Outfall 41-C-01. Sources of high COD and TSS were likely caused by decaying vegetation and exposed soil near the outfall.
