**Re: Tennessee Department of Transportation Facility Monitoring Results  
Arlington District Garage**

## Arlington District Garage

**Region 4  
Outfall 79-D-03**

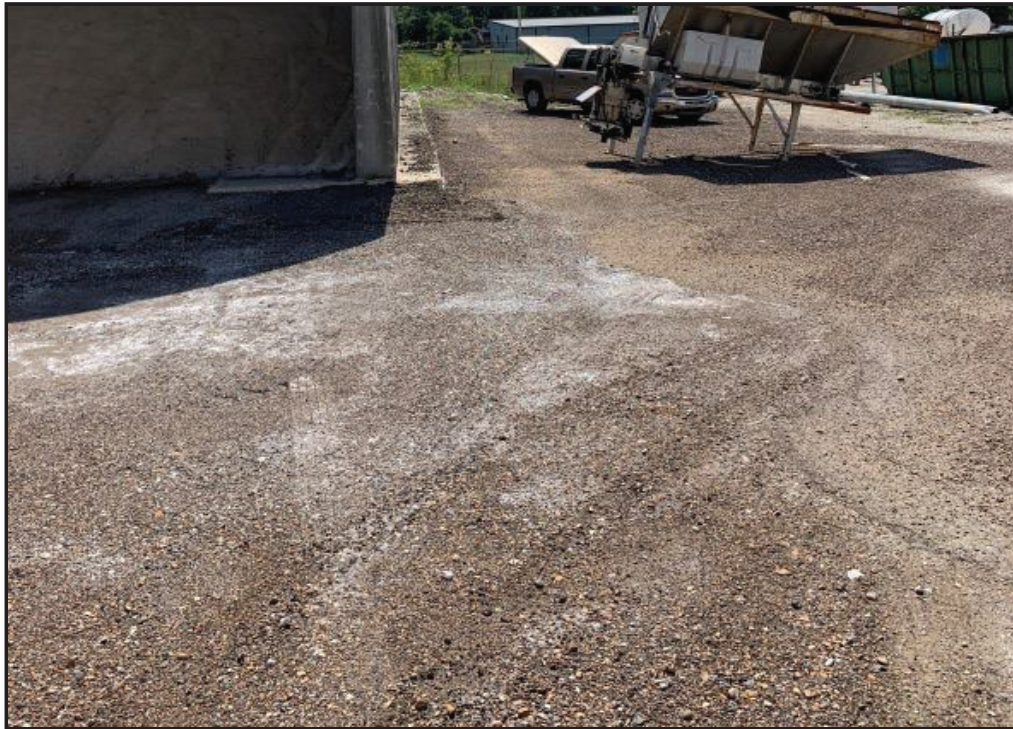
### Photograph 1

**Note:** View from the entrance of the salt shed looking west toward Outfall 79-D-03. Salt is under cover but there was some chloride staining visible. The collected storm water sample exceeded the action levels for chloride, total suspended solids, and chemical oxygen demand.

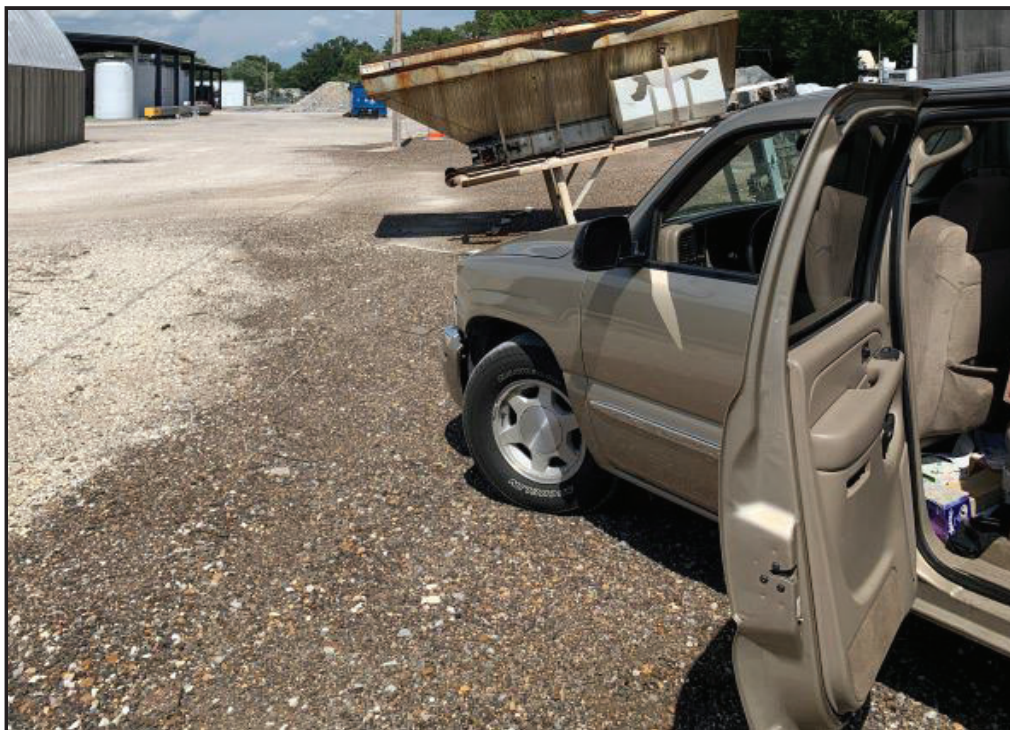
### Photograph 2

**Note:** View from Outfall 79-D-03 looking east. Much of the facility's surface is covered with gravel which is likely holding salt that can't be swept up and a potential source of suspended solids. It is recommended that the areas in front of the salt sheds and other salt-handling areas be paved so that salt can be swept up more completely.

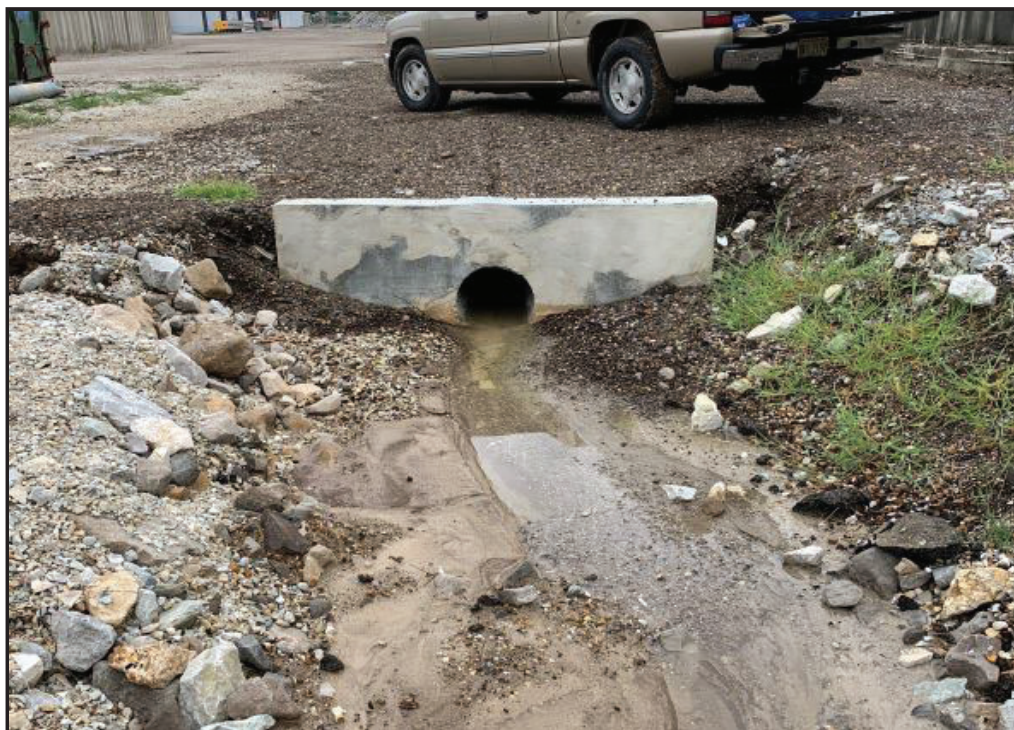
**Photograph 3**

**Note:** View from Outfall 79-D-03. Deposited sediment should be removed to reduce the amount of suspended solids and salt that may have been trapped by the sediment.

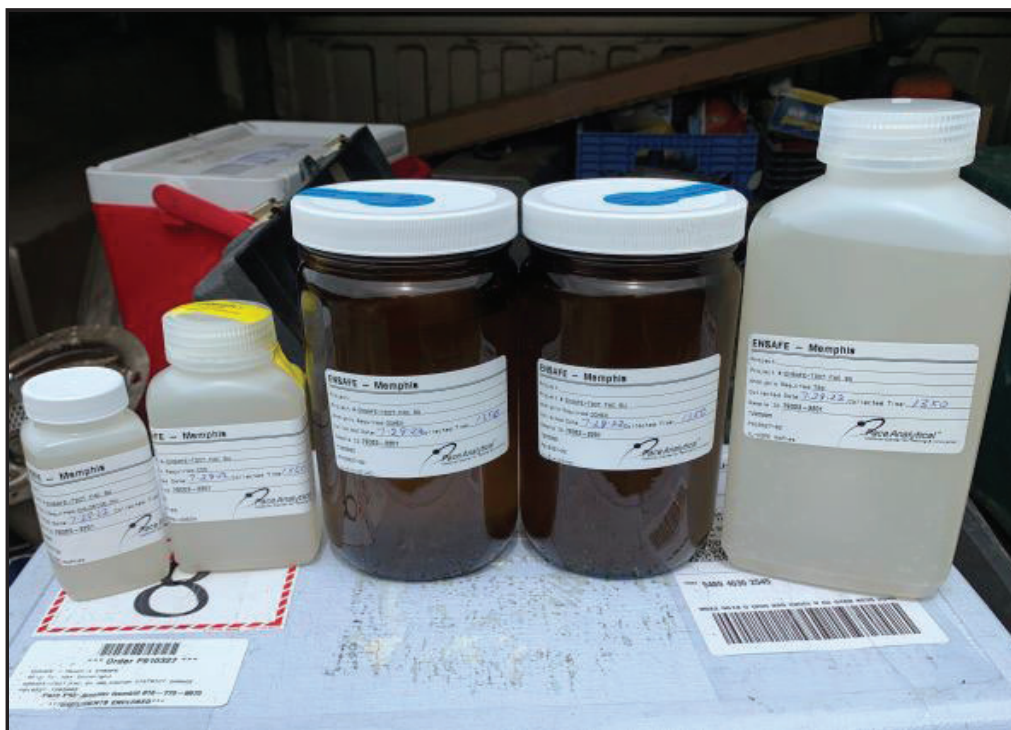
**Photograph 4**

**Note:** View of the storm water sample collected from Outfall 79-D-03.
