**Re: Tennessee Department of Transportation Facility Monitoring Results
Clarksville District Garage**

Attachments:
Photographic Log

Clarksville District Garage

Region 3
Outfall 63-D-02

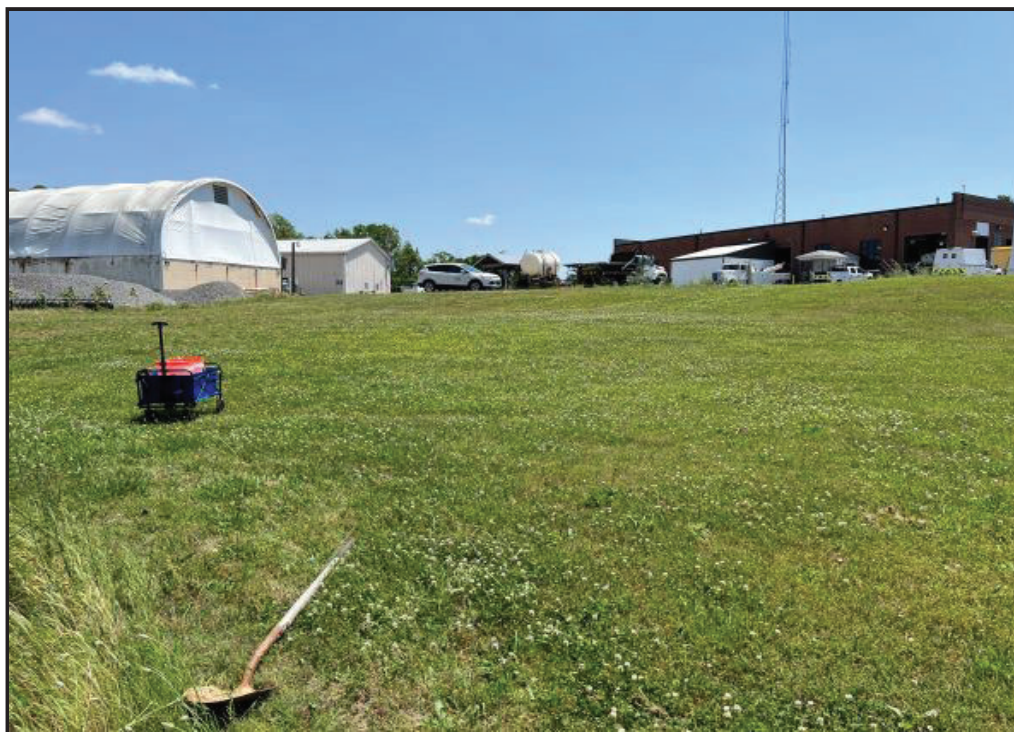
Photograph 1

Note: View upslope of Outfall 63-D-02. The collected storm water sample exceeded the action levels for chloride and chemical oxygen demand (COD). Decaying vegetation is the likely source of COD in the storm water sample.

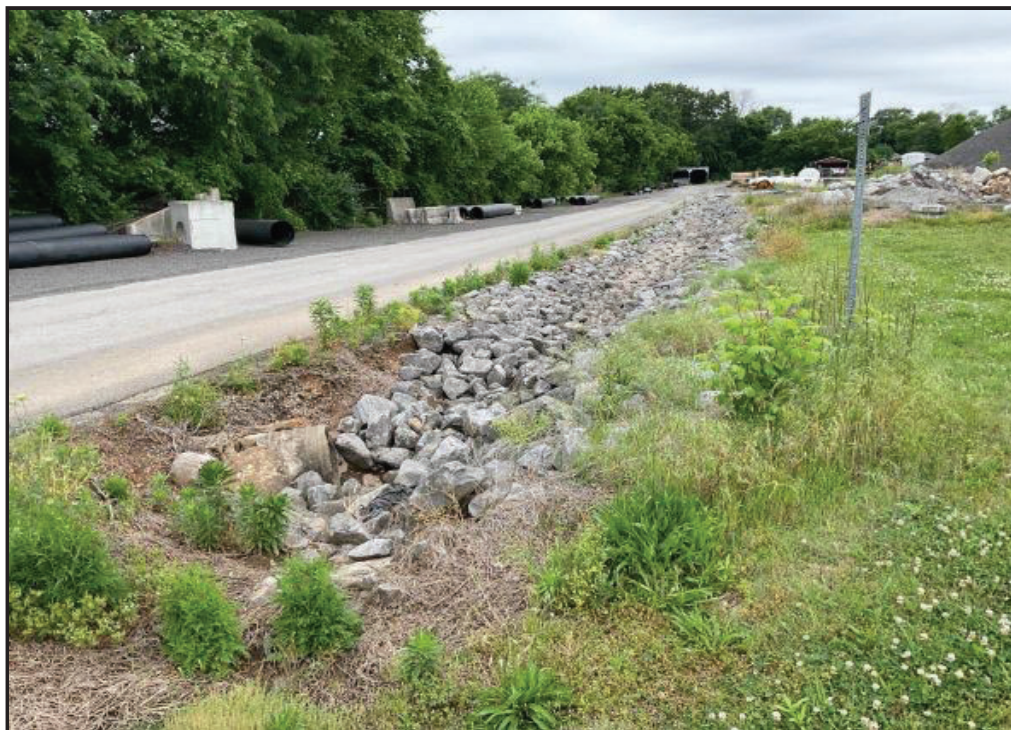
Photograph 2

Note: View of the riprapped ditch line which discharges at Outfall 63-D-02. Stagnant water from the ditch line could be a possible source of COD.

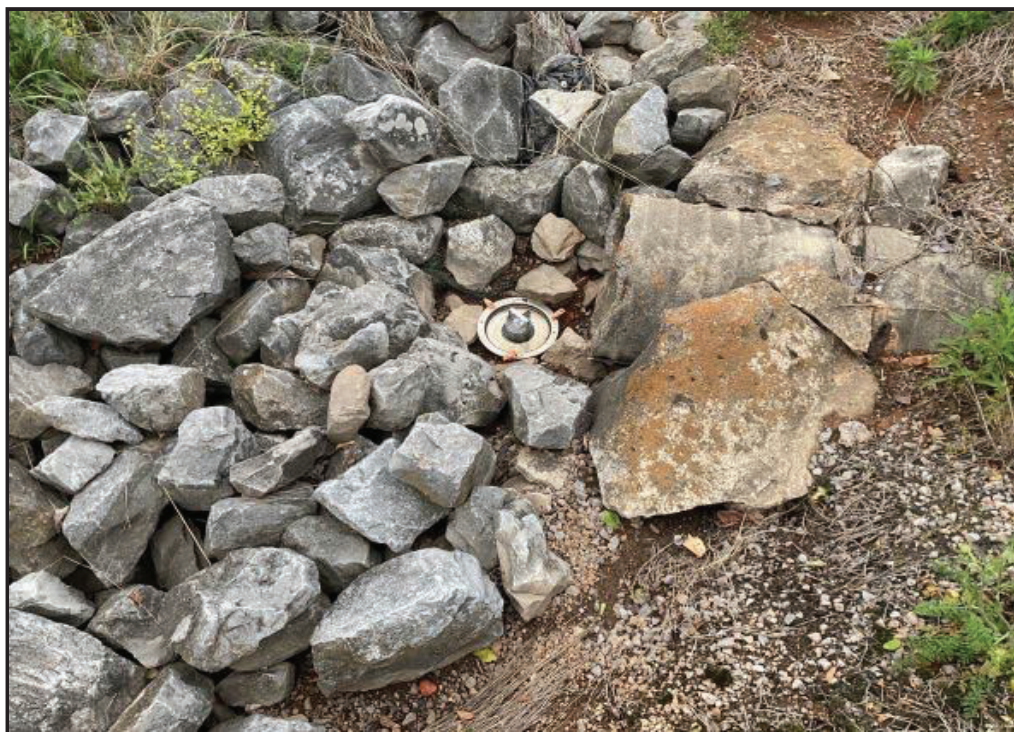
Photograph 3

Note: View of the storm water sampler installed at the inlet of the culvert at Outfall 63-D-02.

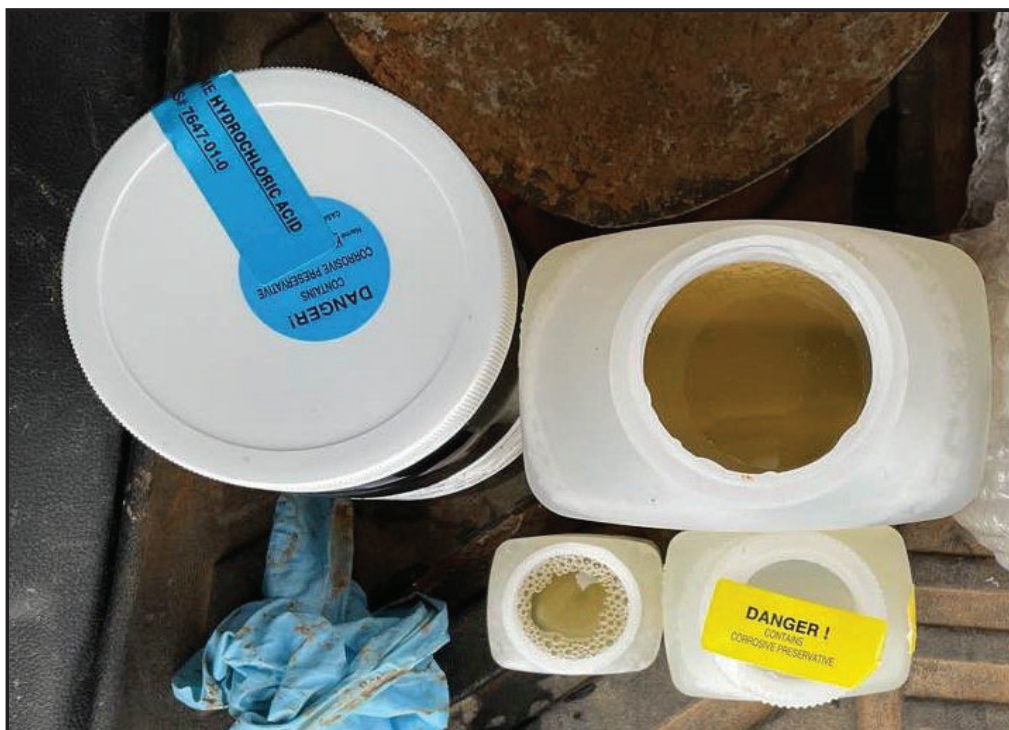
Photograph 4

Note: View of the storm water sample collected at Outfall 63-D-02. There was no observable cause for high COD levels due to facility operations.
