**Re: Tennessee Department of Transportation Facility Monitoring Results
Cookeville District Garage**

Photographic Log

Cookeville District Garage

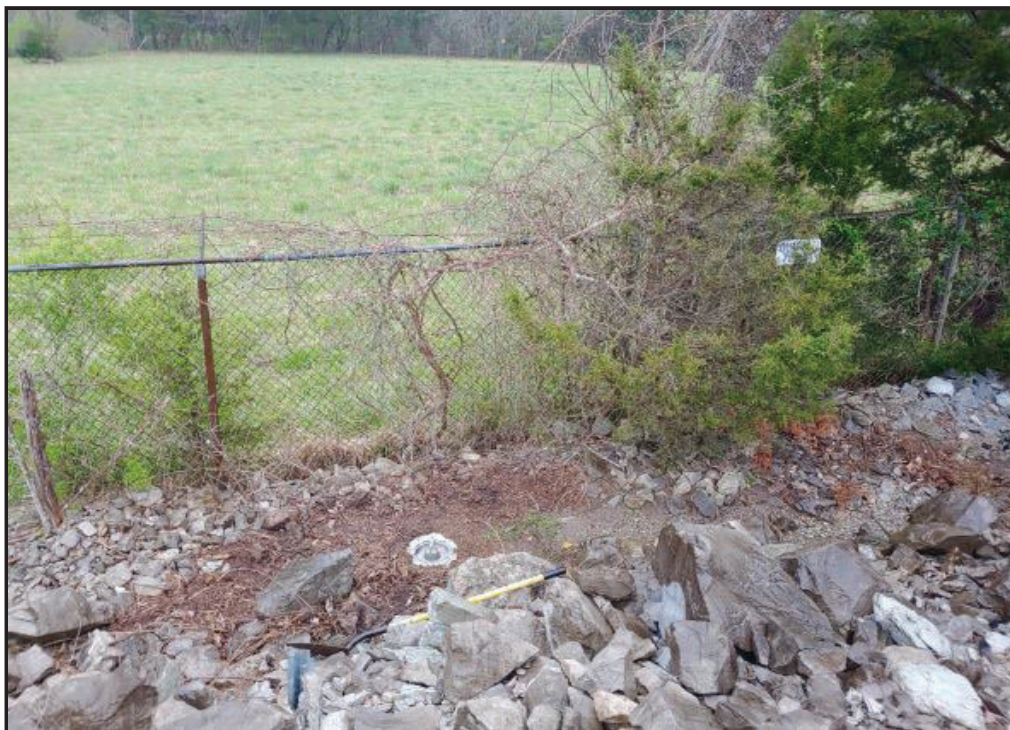
Photograph 2

Note: View looking offsite from Outfall 71-D-01. There was a thick layer of cedar tree needles on the ground around the sampler installation. Decaying vegetation can cause chemical oxygen demand levels to rise. No sediment stains or deposits were observed at the Outfall or beyond.

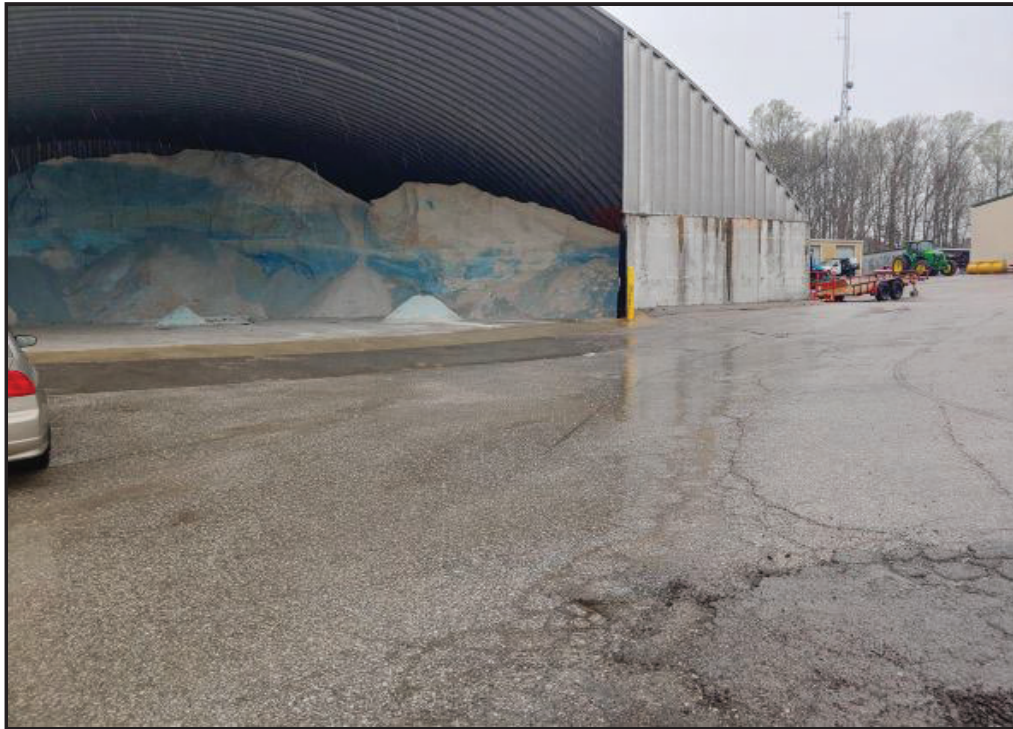
Photograph 3

Note: Salt is being kept under cover and back from the entrance of the shed. Some salt-staining had been observed in front of the shed before the rain event occurred and was the likely cause of the elevated chloride levels in the storm water that discharges at Outfall 71-D-02.

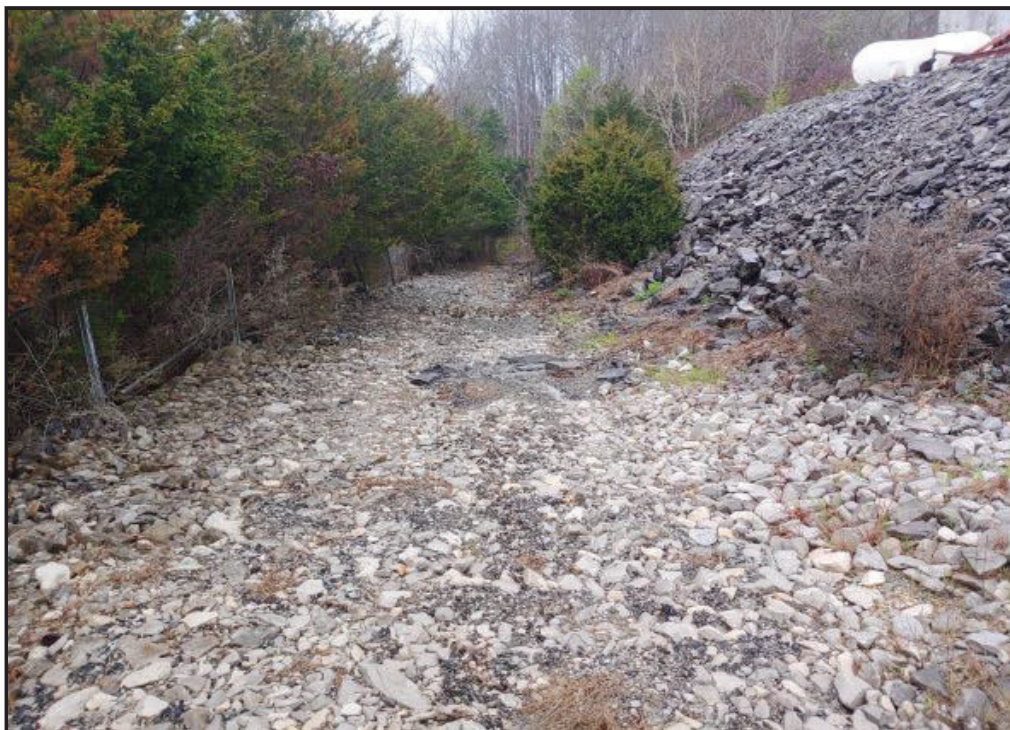
Photograph 4

Note: View of the riprap-lined ditch leading to Outfall 71-D-02. Due to difficulties getting a sampler installed in the riprap, a storm water sample was collected by hand at the beginning of the rain event from approximately this location. The sample tested high for chloride, but levels may have been reduced by dilution once the storm water made it to the discharge point.
