**Re: Tennessee Department of Transportation Facility Monitoring Results
Dickson County I-40 Eastbound Salt Shed**

Dickson County I-40 EB Salt Shed

Region 3
Outfall 22-S-02

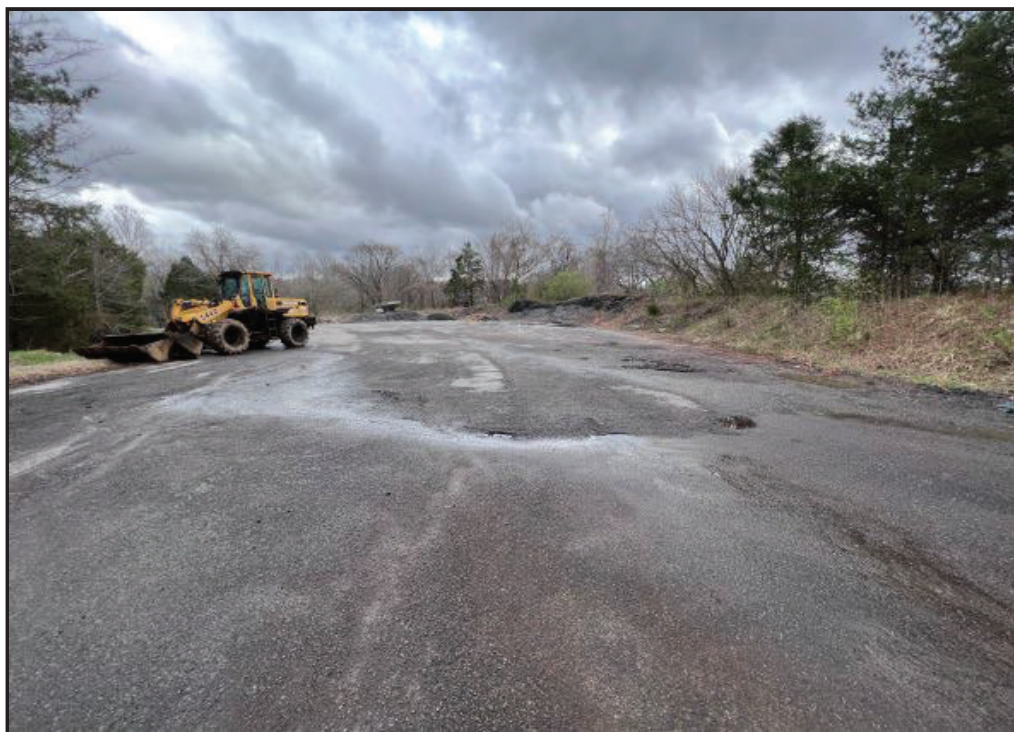
Photograph 1

Note: View of the paved lot from the front of the salt shed. Loading operations have been ongoing and there was some salt-staining visible on the pavement.

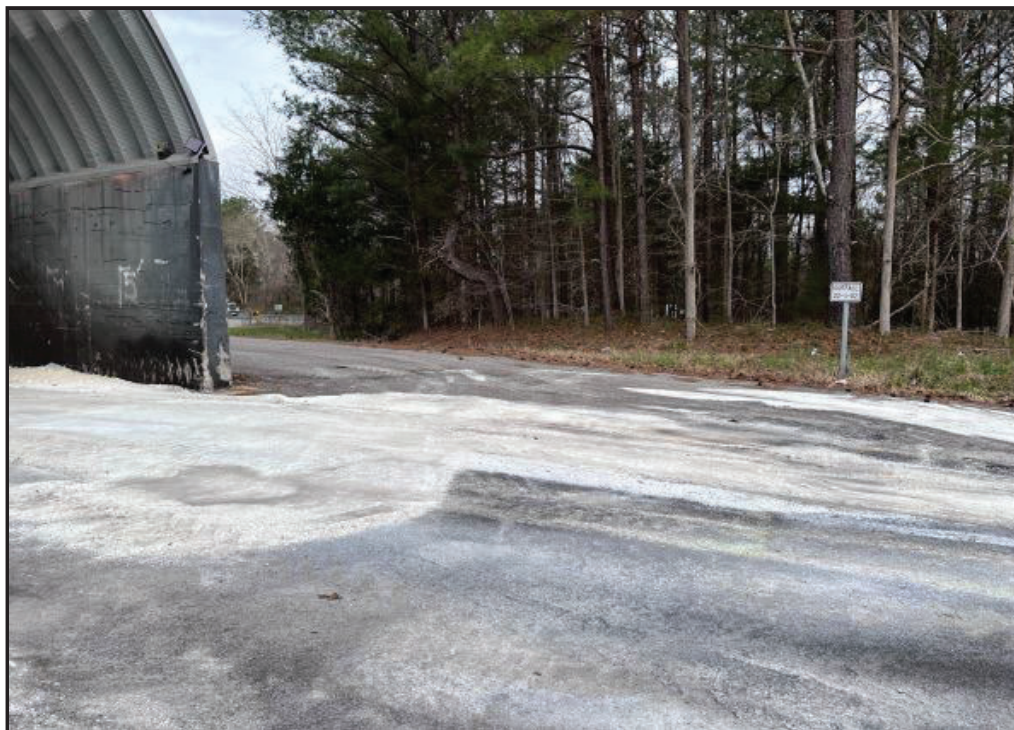
Photograph 2

Note: View of salt in front of the shed, leftover from loading operations. Salt has been pushed back into the shed with the loader but a sweeper or flat shovels and brooms needs to be used to minimize the amount of salt left outside. TDOT Standard Environmental Procedures requires salt to be under cover prior to the next rain event.

to storm water. Salt had been delivered and loaded into the shed, but additional actions are needed (using a sweeper or flat shovels/brooms) to ensure all salt is stored in the shed and not exposed to stormwater. One hole was also observed in the salt shed roof and should be repaired. TDOT currently has a vendor, under contract, working their way across the state to repair damaged roofing on salt sheds. TSS exceeded the action level, but the source is believed to have been from the hole dug to install the sampler. There was no erodible stockpiled material onsite and no active erosion or sediment deposits were observed. Please see the attached photo log.

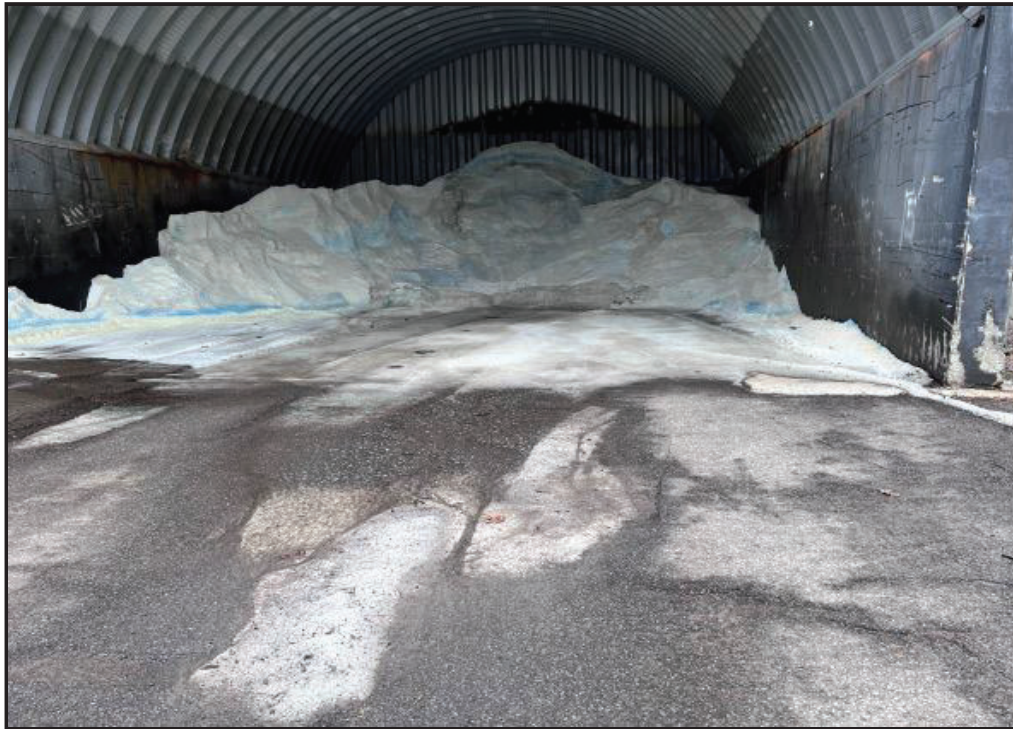
Photograph 3

Note: There is visible evidence of surface water coming into contact with salt at the entrance of the shed. Additional efforts need to be made to keep stockpiled salt away from stormwater, this may include building a berm or redirecting the stormwater in another manner. There is also a small hole in the roof (visible in top right of the photo) that should be repaired.

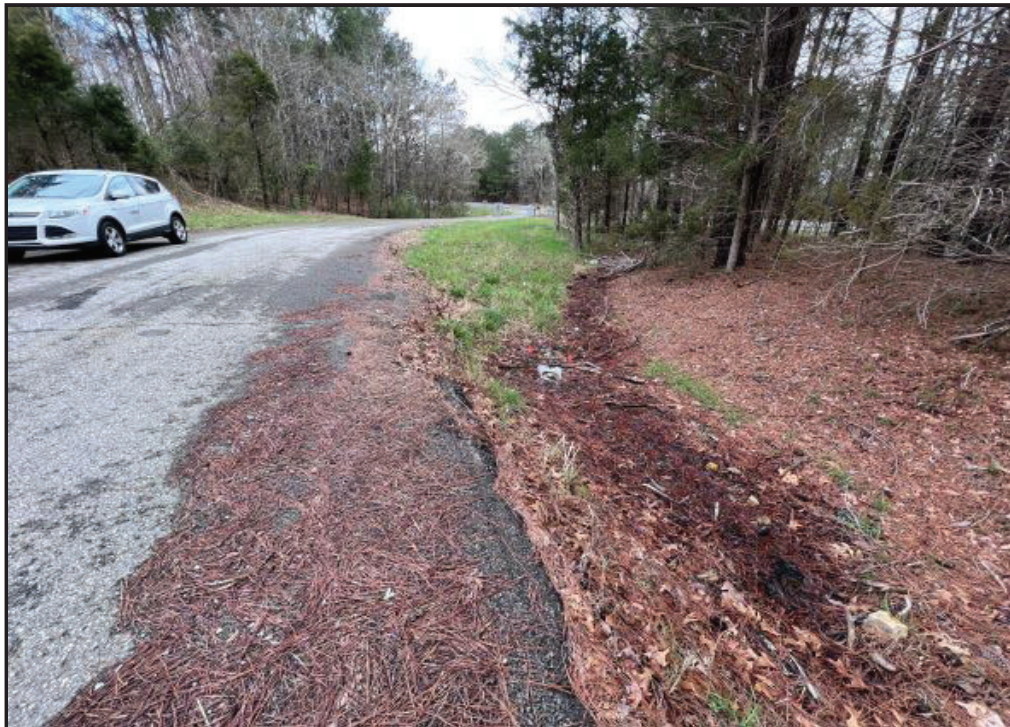
Photograph 4

Note: View of the ditch running along the paved drive, discharging at Outfall 22-S-02. The storm water sample exceeded action levels for total suspended solids and chloride. There was no erodible material being stockpiled or active erosion observed at the site. The higher levels of total suspended solids likely came from the ground disturbance necessary to install the sampler.
