**Re: Tennessee Department of Transportation Facility Monitoring Results
Hickman County Garage**

Photographic Log

**Hickman County
Garage**

**Region 3
Outfall 41-C-01**

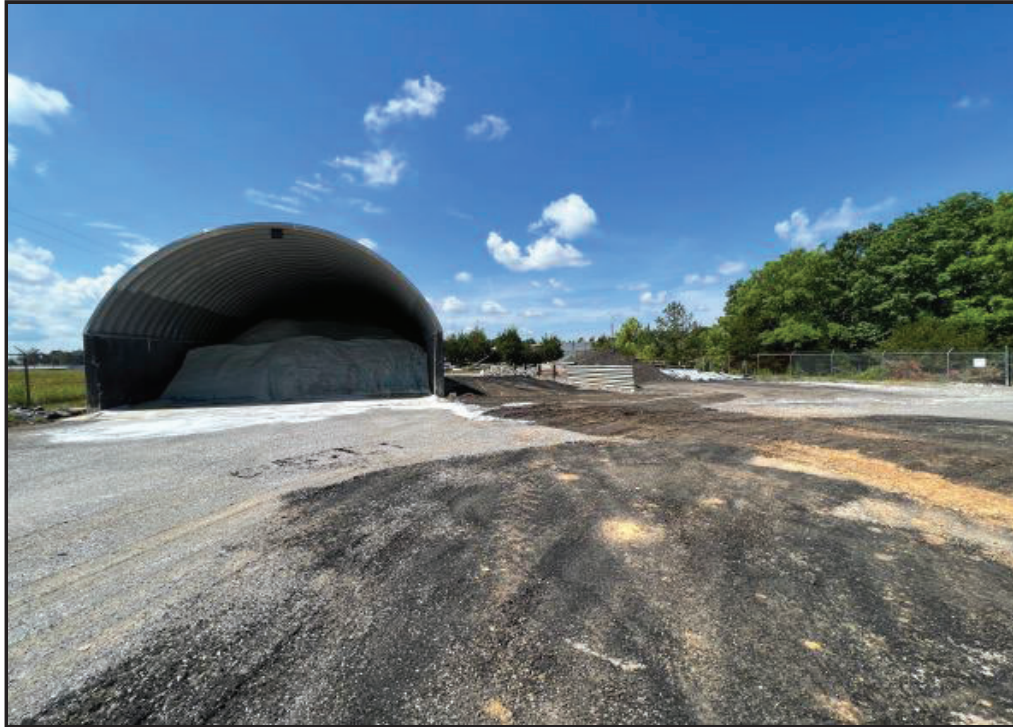
Photograph 1

Note: View of the entrance of the salt shed and visible salt-staining outside of it migrating toward Outfall 41-C-01. The collected storm water sample measured lower for chloride than the previous year, but still exceeded the action level. The lot needs to be regraded so that surface runoff flows away from the shed entrance.

entrance, into the shed, and back out carrying dissolved salt with it. In order to correct this issue, the facility should regrade the pavement in front of the shed to ensure water flows away from the entrance during heavy rain events. All salt should be stored a minimum of 5 feet back from the entrance and any salt deposits outside of the shed should be swept up per TDOT's Standard Environmental Procedure. The ECO will be following up with the facility once the surface grade has been corrected. Please see the attached photo log.

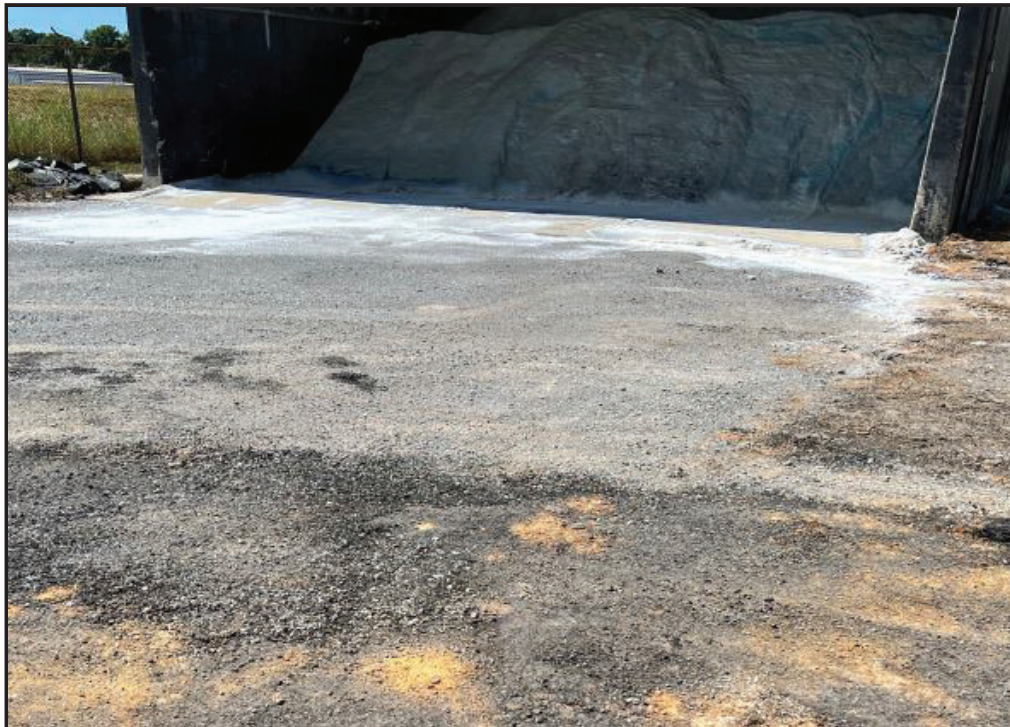
Photograph 2

Note: View of entrance of the shed. There is visible salt-staining that should be swept and several deposits of salt that need to be shoveled back into the shed. The grade of the pavement in front of the shed will be adjusted to ensure storm water flows away from the entrance. Per TDOT's Standard Environmental Procedure, salt should be stored in a way that prevents it from coming in contact with storm water.

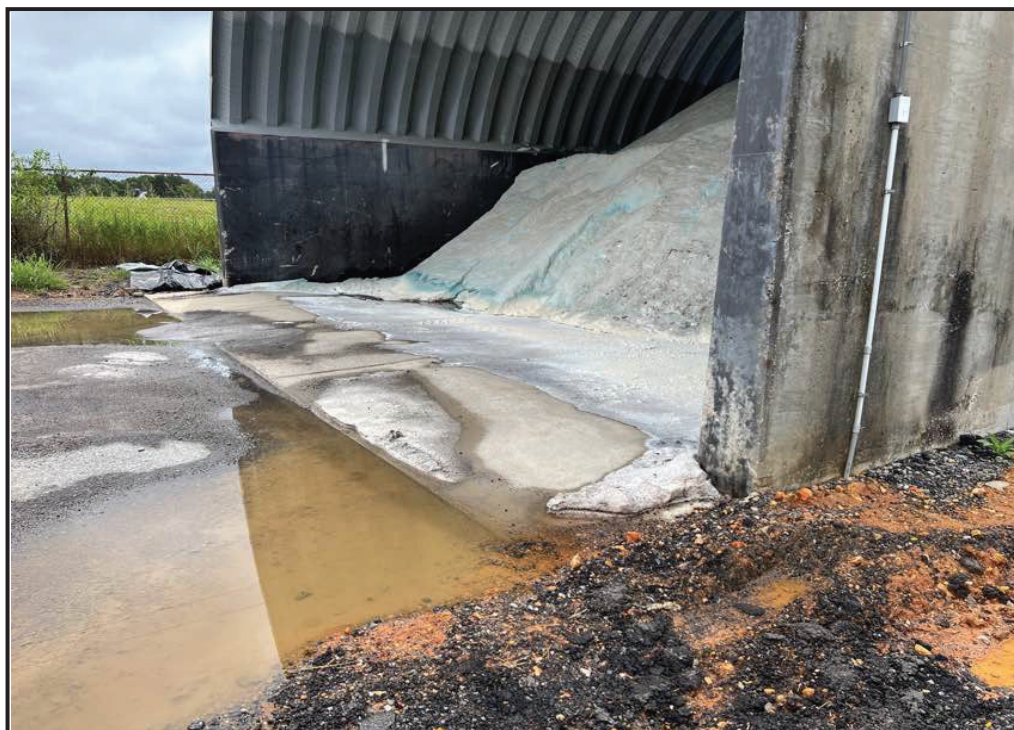
Photograph 3

Note: View of the shed entrance after the rain event. The surface grade of the lot needs to be modified to prevent storm water from entering the shed.

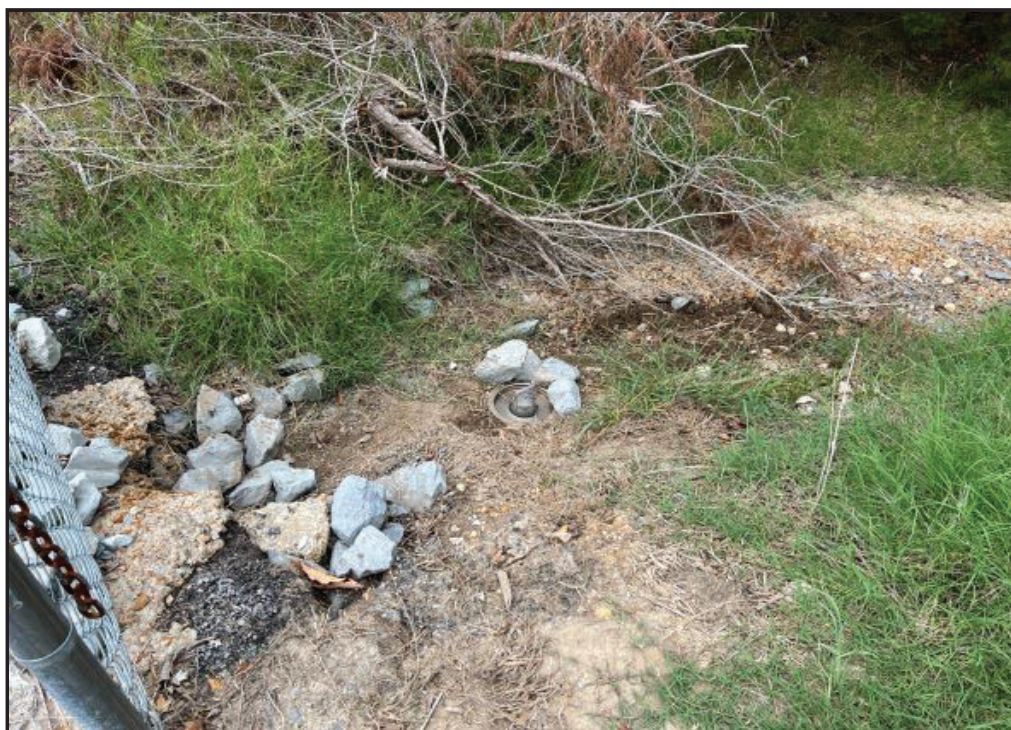
Photograph 4

Note: View of the storm water sampler installed at Outfall 41-C-01. Elevated chloride levels in storm water runoff appears to have caused a "grass kill" and prevented vegetation from growing back.
