**Re: Tennessee Department of Transportation Facility Monitoring Results
Morristown District Garage**

Morristown District Garage

Region 1
Outfall 32-D-01

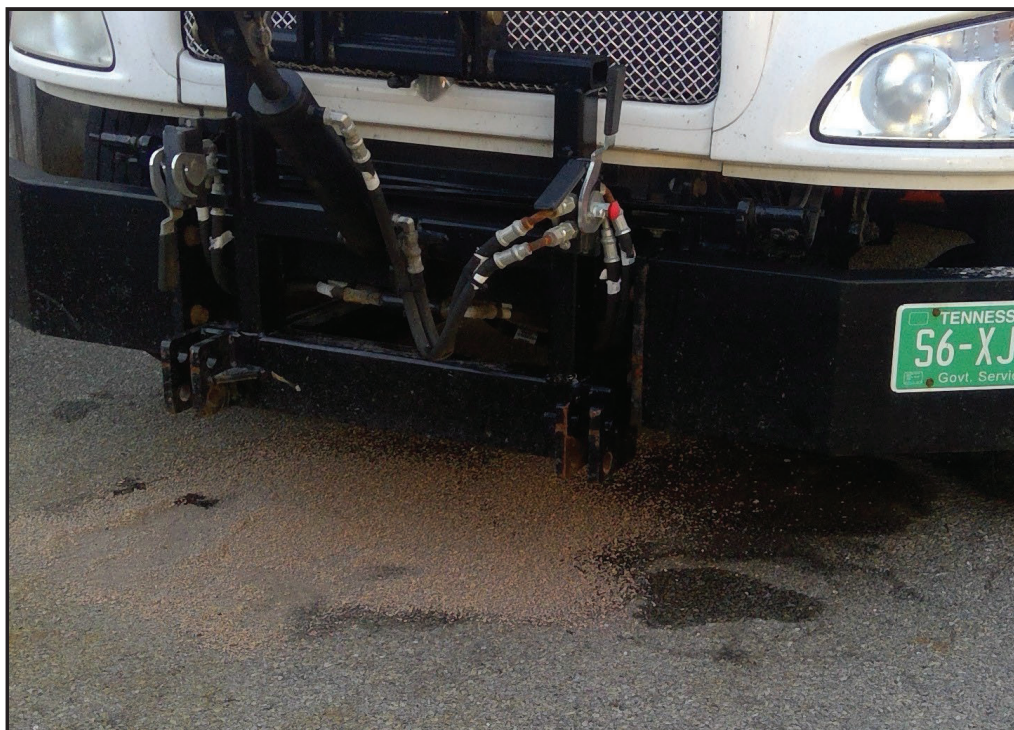
Photograph 1

Note: View of one of several active equipment leaks observed at the facility. The collected storm water sample exceeded the action level for chemical oxygen demand (COD). Petroleum can cause COD levels to increase in storm water runoff. Ensure leaks are repaired when possible. Absorbents used on leaks should be swept up.

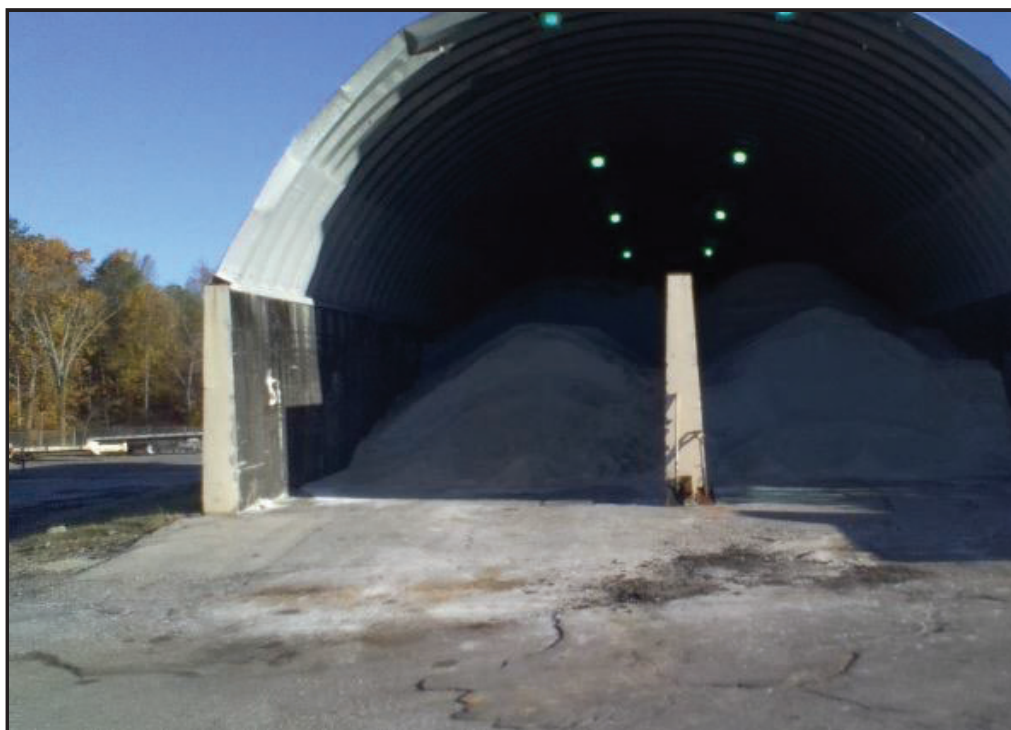
Photograph 2

Note: View of the salt shed entrance. Salt appears to be stored properly and no storm water has been coming into contact. The storm water sample collected at Outfall 32-D-01 exceeded the action level for chloride.

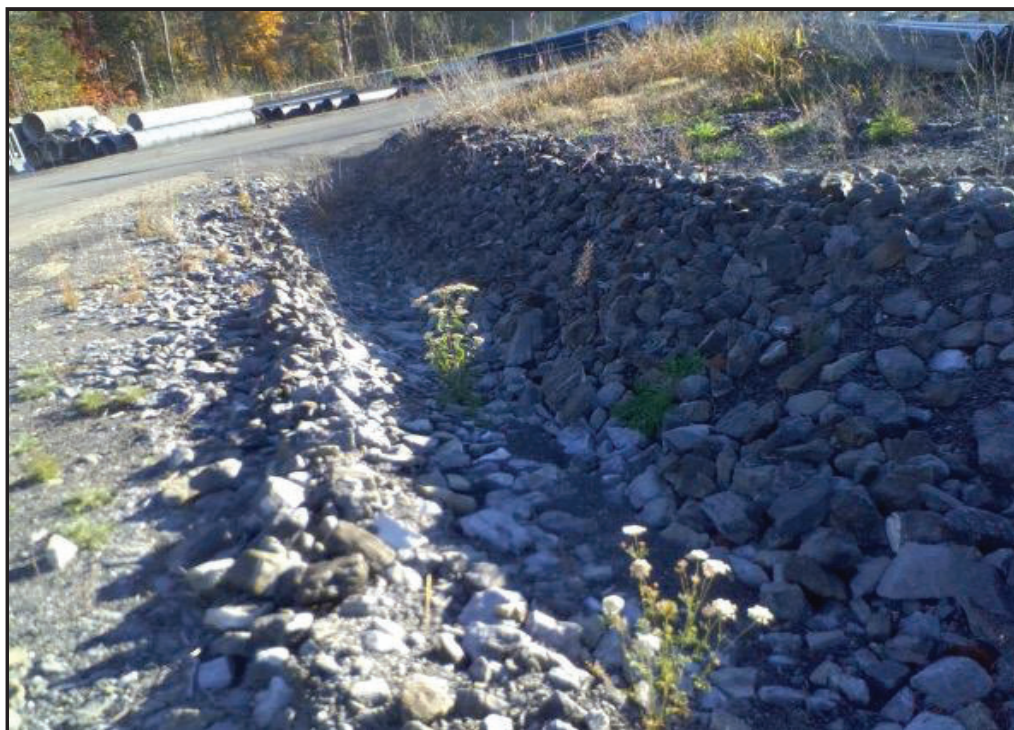
Photograph 3

On April 1, 2022, EnSafe Inc., consultants to the TDOT Environmental Compliance Office (ECO), conducted analytical monitoring of the storm water discharge from the Morristown District Garage in Hamblen County, Tennessee, according to the methods and requirements of the SFMP. The final laboratory analytical report from this sampling event was received on April 8, 2022. Samples were acquired from the principal outfall, Outfall 32-D-01, and lab results included a value for COD of 561 milligrams per liter (mg/L), which exceeds the action level concentration of 120 mg/L specified in the SFMP. The sample also yielded a measured chloride concentration of 5,210 mg/L, which exceeds the action level concentration of 1,200 mg/L. Several active leaks were observed around the facility, which can be a source for elevated COD. Equipment should be repaired and absorbents used on oil leaks so that it is not a source of COD. There were no obvious signs for why chloride levels were high. It is suspected that salt or brine may have settled

Note: View of the riprap-lined ditch that discharges at Outfall 32-D-01. The storm water sample tested high for COD and chloride. It is possible that there are high chloride levels due to past issues with salt-handling which allowed salt-laden water to deposit in the ditch line. Further investigation into the source of the chlorides is recommended.

out in the riprap ditch leading to the outfall. Site personnel should continue to follow the TDOT Standard Environmental Procedures for salt-handling and minimize the chances that salt or brine will come in contact with storm water. Please see the attached photo log.

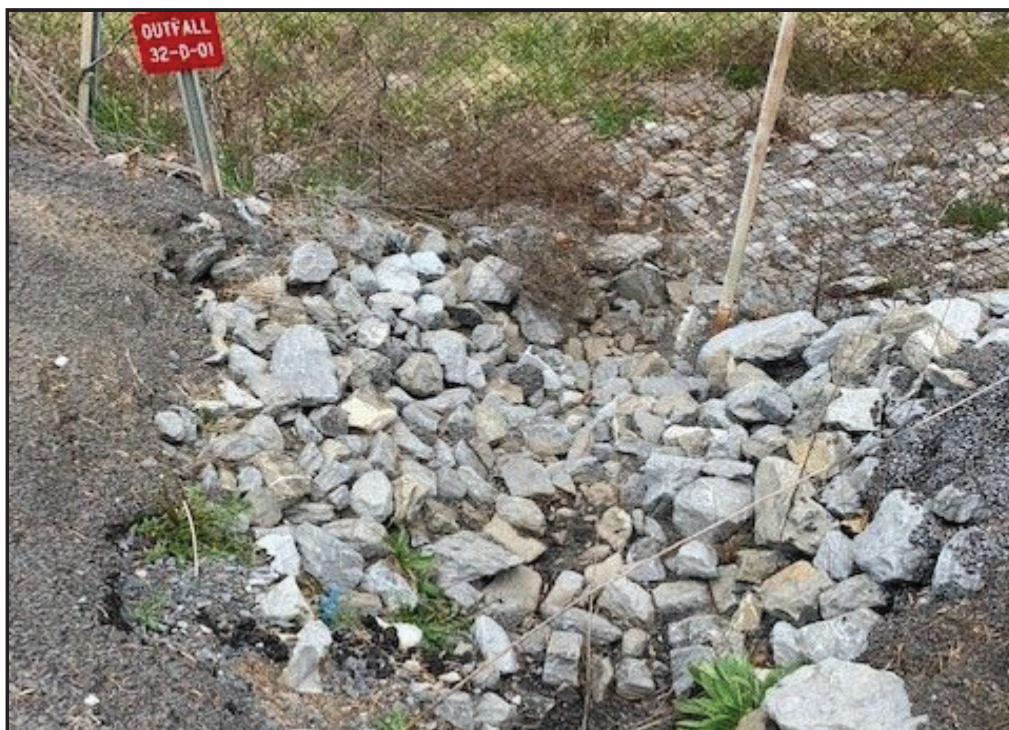
Photograph 4

Note: View of riprapped outlet protection at Outfall 32-D-01.
