STATE OF TENNESSEE
DEPARTMENT OF ENVIRONMENT AND CONSERVATION
DIVISION OF WATER RESOURCES

Re: **Notice of Violation**
 Compliance Evaluation Inspection (CEI)
 Iskiwitz Metal Company
 Tennessee Multi-Sector Storm Water Permit (TMSP) Tracking Number TNR054012
 Shelby County

Site Name: Iskiwitz Metal Company
Tracking No: TNR054012
Location: 604 Marble Avenue, Memphis, TN 38107
Date of Inspection: June 9, 2016
Inspector(s): Maylynne Wilbert (DWR)
Onsite contact(s): Jamie B. Iskiwitz (Vice President)

Photographic Log

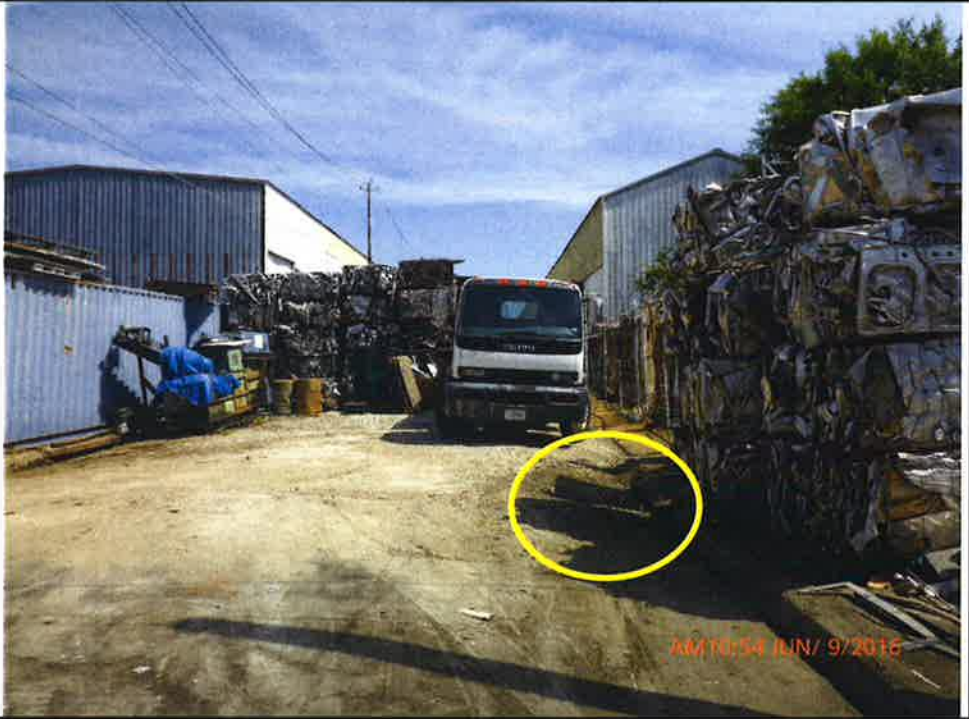
Photo No. 1	Date 6/9/2016

Description <p>Storm water from the facility flows northward into the storm drain located near the northern boundary of the property and is designated as Outfall SW1.</p> <p>Outfall SW1 is denoted by the yellow circle.</p>

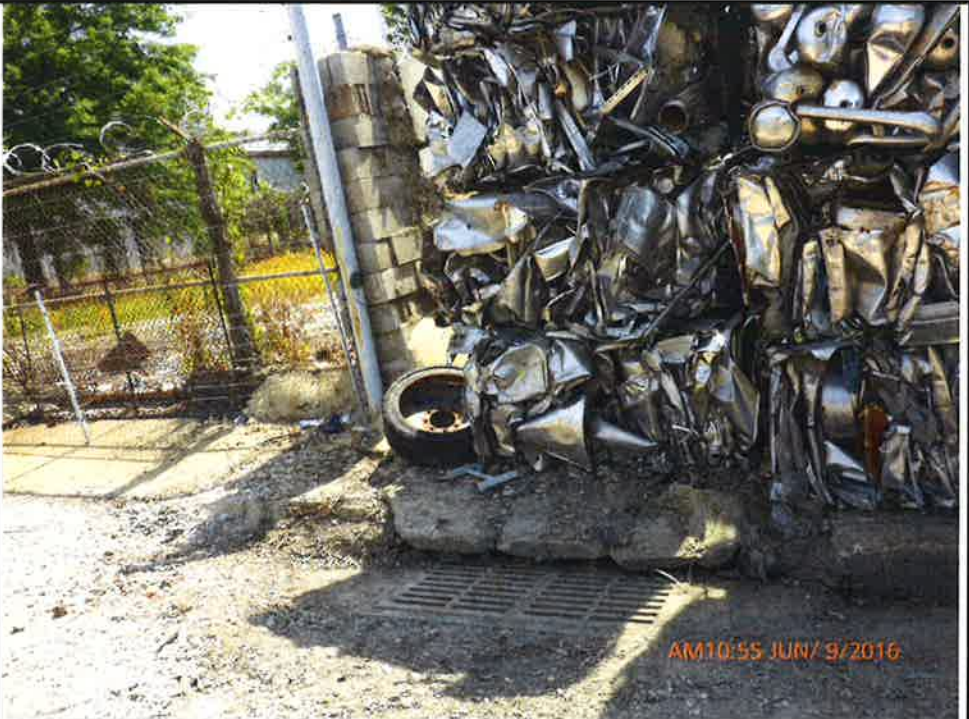
Photo No. 2	Date 6/9/2016

7. At the time of the inspection, no discharge was observed at Outfall SW1 or any of the other observed storm drains. Stockpiles of bailed scrap metal were observed adjacent to the outfall. Although no metal debris was observed inside the storm drain at the time of the inspection, the Division recommends that the bailed materials be stored in an area not in close proximity to the storm drain to ensure that small pieces of scrap metal don't migrate into the drain

Description <p>Close-up view of Outfall SW1.</p> <p>Stockpiles of bailed scrap metal were observed adjacent to the outfall. Although no metal debris was observed inside the storm drain at the time of the inspection, the Division recommends that the bailed materials be stored in an area not in close proximity to the storm drain to ensure that small pieces of scrap metal don't migrate into the drain.</p>

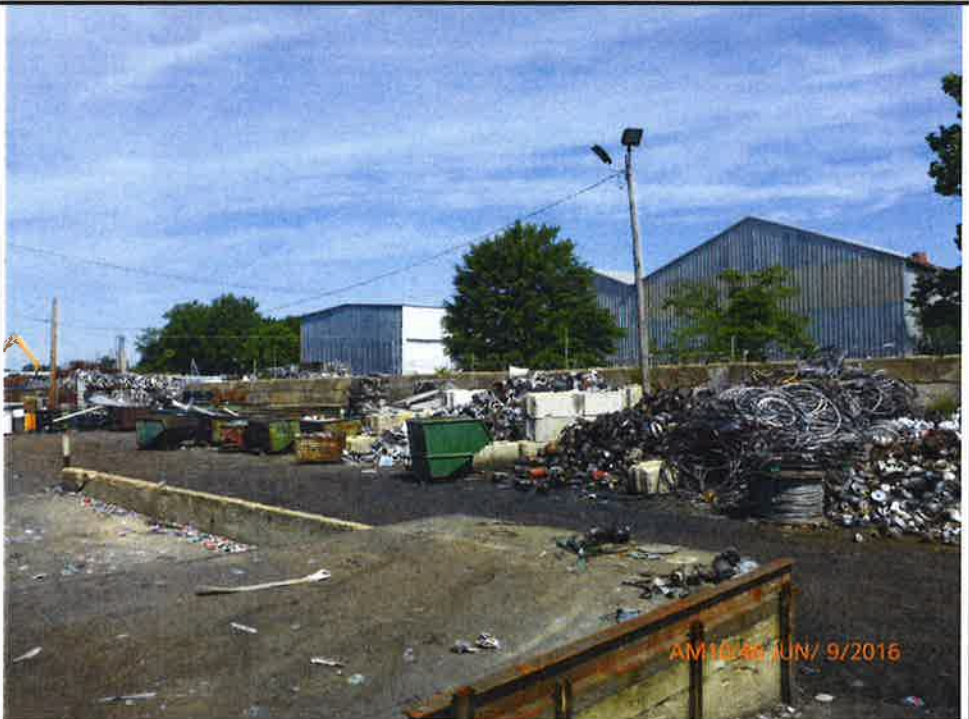
Photo No. <div style="text-align: center;">4</div>	Date <div style="text-align: center;">6/9/2016</div>

- Metal scrap materials both bailed and un-bailed were observed north of the site (photos 3-5). Metal scrap materials, sediment, and other debris were observed near two storm drains located in these areas, and accumulated sediment and debris was observed in the storm drains (photos 6-9). According to Mr. Iskiwitz, the storm drains are cleaned out 2-3 times per year. The Division requires that appropriate best management practices (BMPs) be implemented in these areas to prevent pollutants from entering the storm drains. Additionally, due to the condition of the storm drains at the time of the inspection, the Division recommends that the drains be cleaned more than 2-3 times per year.

Description View of metal scrap materials facing northwest.

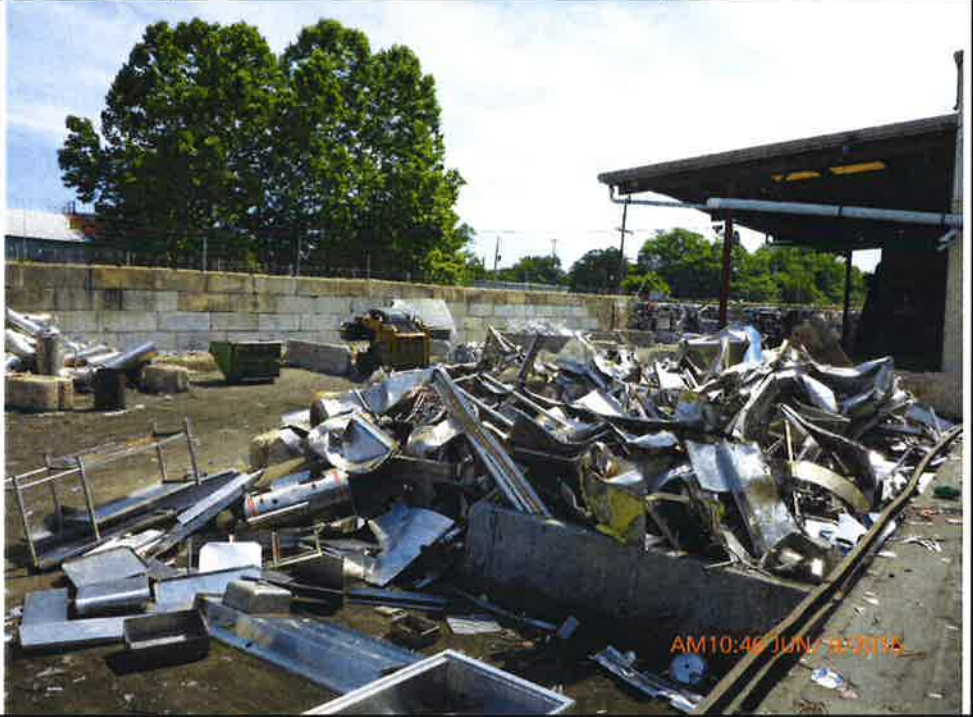
Facility Name: Iskiwitz Metal Company		Site Location: 604 Marble Avenue, Memphis, TN 38107	Permit No.: TNR054012
Photo No. <div style="text-align: center;">5</div>	Date <div style="text-align: center;">6/9/2016</div>

Description View of metal scrap materials facing northeast.

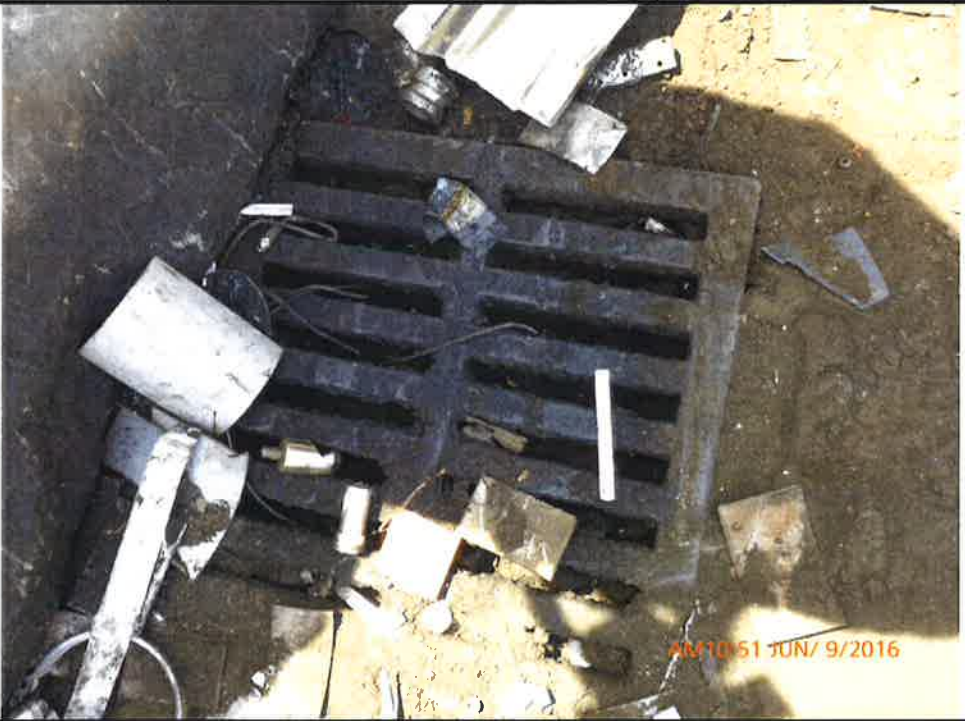
Description Close-up view of SD1. Accumulated sediment and debris was observed within the storm drain at the time of the inspection.
