STATE OF TENNESSEE  
**DEPARTMENT OF ENVIRONMENT AND CONSERVATION**  
**DIVISION OF WATER RESOURCES**

Re:    Compliance Evaluation Inspection  
      Archer Daniels Midland (ADM) Company  
      NPDES Number TN0000281  
      Shelby County

**Compliance Inspection for Individual NPDES Permit**

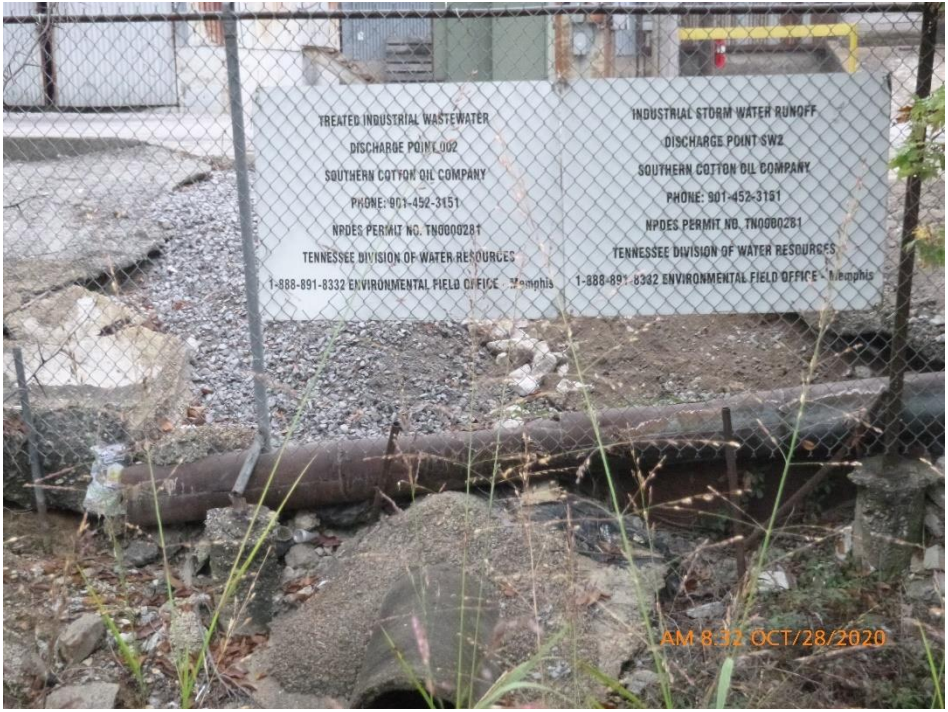
At the time of the inspection, no discharge was observed at Outfall 002, which is also the same physical discharge point as storm water Outfall SW2 (photo 1).

The sign designating Outfall 002/SW2 was in place as required by the NPDES permit (photo 1). The information on the sign was consistent with the requirements of the NPDES permit.

As mentioned in this CEI report, Outfall SW2 is the same physical discharge point as Outfall 002. Outfall SW2 is a culvert that receives sheet flow of storm water runoff from the south side of the old seed storage tank farm area, from the old boiler shop area, and from the west side of the railcar loading area. At the time of the inspection, no discharge was observed at Outfall SW2 (photo 1). The sign designating Outfall 002/SW2 was in place as required by the NPDES permit (photo 1). The information on the sign was consistent with the requirements of the permit.

| <b>Description</b><br>At the time of the inspection, no discharge was observed at Outfall 002, which is also same physical discharge point as storm water Outfall SW2. The sign designating Outfall 002/SW2 was in place. The information on the sign was consistent with the requirements of the permit. | | | |

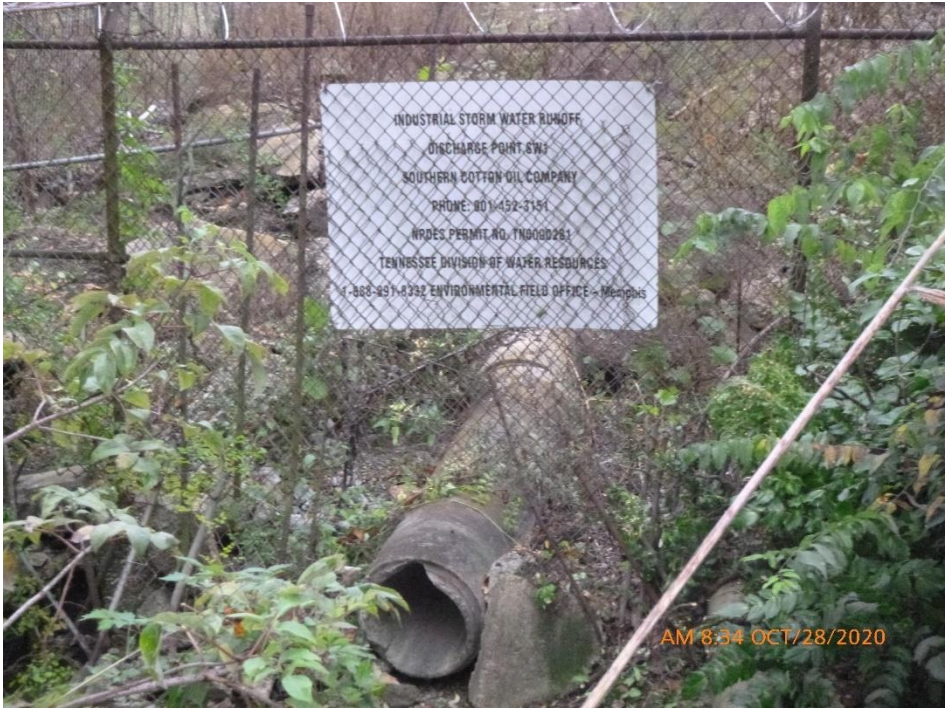
Outfall SW1 is a culvert that receives sheet flow of storm water runoff from the north end of the seed storage houses, from the west side of the preparation plant, and from the tank 8 pad area. At the time of inspection, no discharge was observed at Outfall SW1 (photo 2). The sign designating Outfall SW1 was in place as required by the NPDES permit (photo 2). The information on the sign was consistent with the requirements of the permit.

| <b>Description</b><br>View Outfall SW1. SW1 is a culvert that receives sheet flow of storm water runoff from the north end of the seed storage houses, from the west side of the preparation plant, and from the tank 8 pad area. At the time of the inspection, no discharge was observed. The information on the sign was consistent with the requirements of the permit. | | |

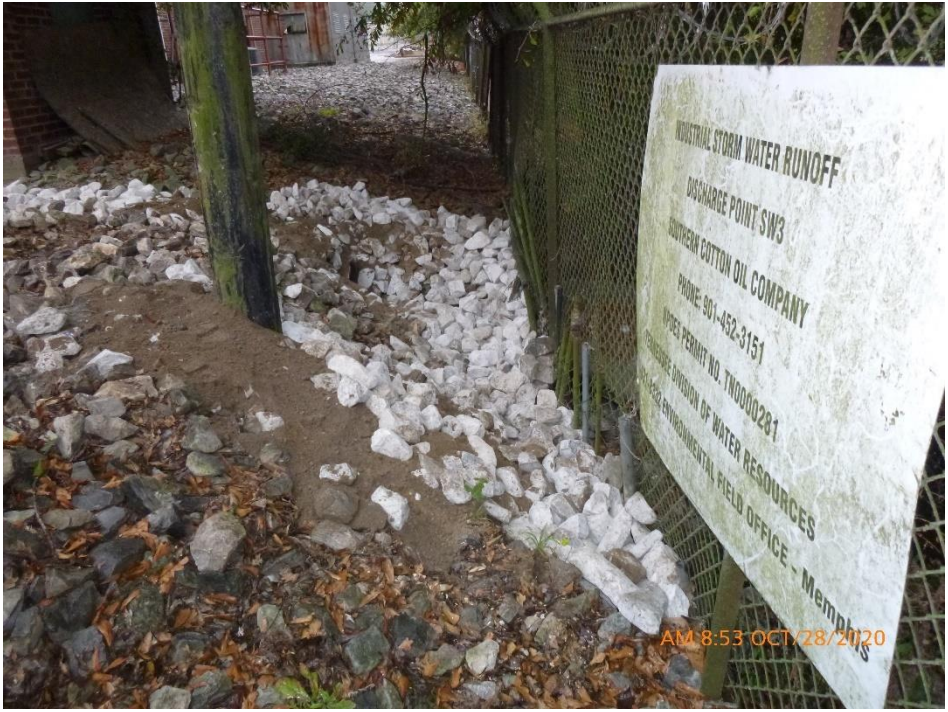
Outfall SW3 is a culvert that receives sheet flow of storm water runoff from the western and southern areas of seed house 4, northern areas of seed house 5 and 6, roof run off from the lint room area, roof run off from the cleaning room area, roof runoff from the bath house area, roof runoff from the lab area, and roof run off from the mill building. At the time of the inspection, no discharge was observed at Outfall SW3 (photo 3). The sign designating Outfall SW3 was in place as required by the NPDES permit (photo 3). The information on the sign was consistent with the requirements of the permit.

| <b>Description</b><br>View of Outfall SW3. SW3 is a culvert that receives flow of storm water runoff from the western and southern areas of seed house 5 and 6, roof runoff from the lent room area, roof runoff from the cleaning room area, roof runoff from the bath house area, roof runoff from the lab area, and roof runoff from the mill building. At the time of the inspection no discharge was observed. The information on the sign was consistent with the requirements of the permit. | | | |

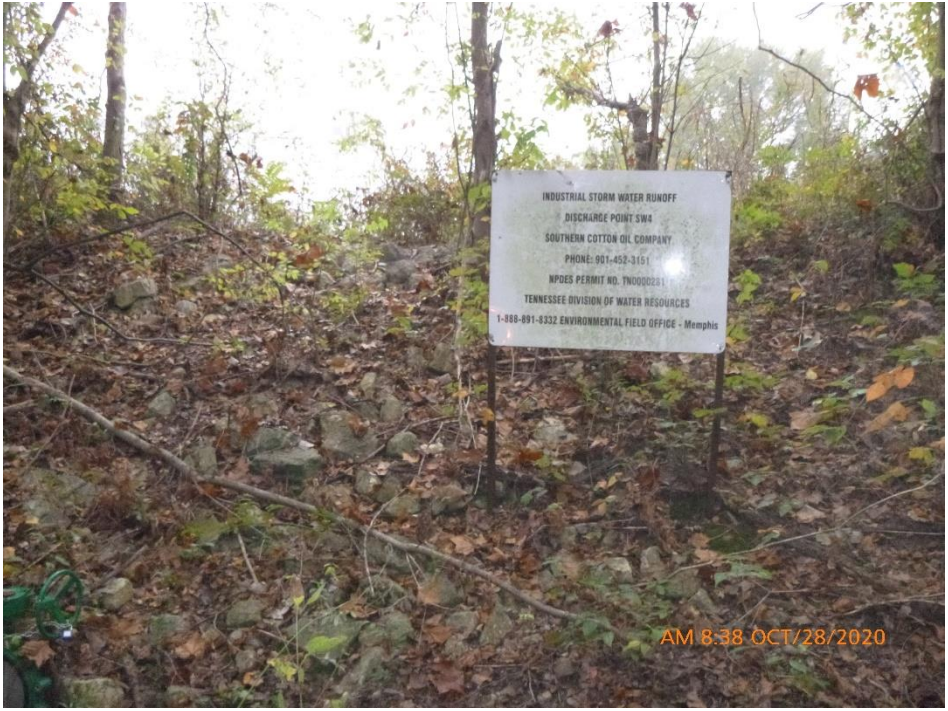
Outfall SW4 is a culvert that receives sheet flow of storm water runoff from the northern area of the extraction plant and preparation plant, from the solvent storage areas, rail unloading areas, tank farm areas, and from the north side of tank 8. According to Mr. Sarwat, storm water runoff at Outfall SW4 continues to flow approximately 500 feet north over a grassy terrain into an oil/water separator retention pond. At the time of the inspection, no discharge was observed at Outfall SW4; algae build-up was observed inside the culvert (photo 4). The sign designating Outfall SW4 was in place as required by the NPDES permit (photo 4). The information on the sign was consistent with the requirements of the permit.

| <b>Description</b><br>View of Outfall SW4. SW4 is a culvert that receives sheet flow of storm water runoff from the northern area of the extraction plant and preparation plant, from the solvent storage areas, rail farm areas, and from the north side of tank 8. At the time of the inspection, no discharge was observed. The information on the sign was consistent with the requirements of the permit. | | |

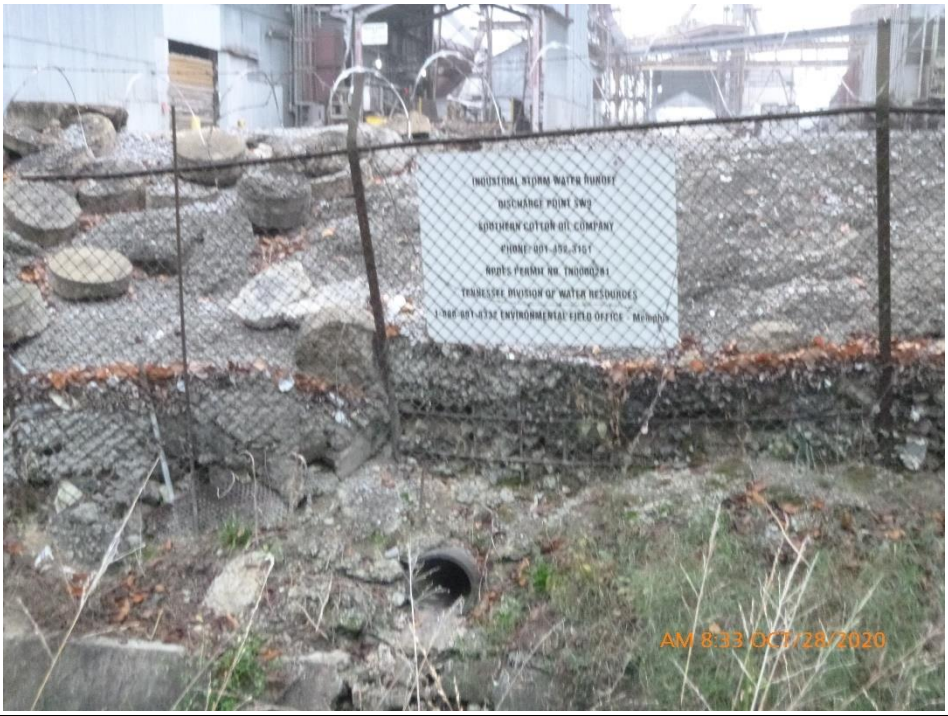
Outfall SW9 is a culvert that receives sheet flow of storm water runoff from the south side of the seed storage houses. At the time of the inspection, no discharge was observed at Outfall SW9 (photo 5). The sign designating Outfall SW9 was in place as required by the NPDES permit (photo 5). The information on the sign was consistent with the requirements of the permit.

| <b>Description</b><br>View of Outfall SW9. SW9 is a culvert that receives sheet flow of storm water runoff from the south side of the seed storage houses. At the time of the inspection there was no discharge observed. The information on the sign was consistent with the requirements of the permit. | | | |
