Asbestos Neshap Report

**419 Eagle Bend Road
Clinton, Tennessee 37716**

April 04, 2024

RE: Asbestos Neshap Report
419 Eagle Bend Road
Clinton, Tennessee 37716

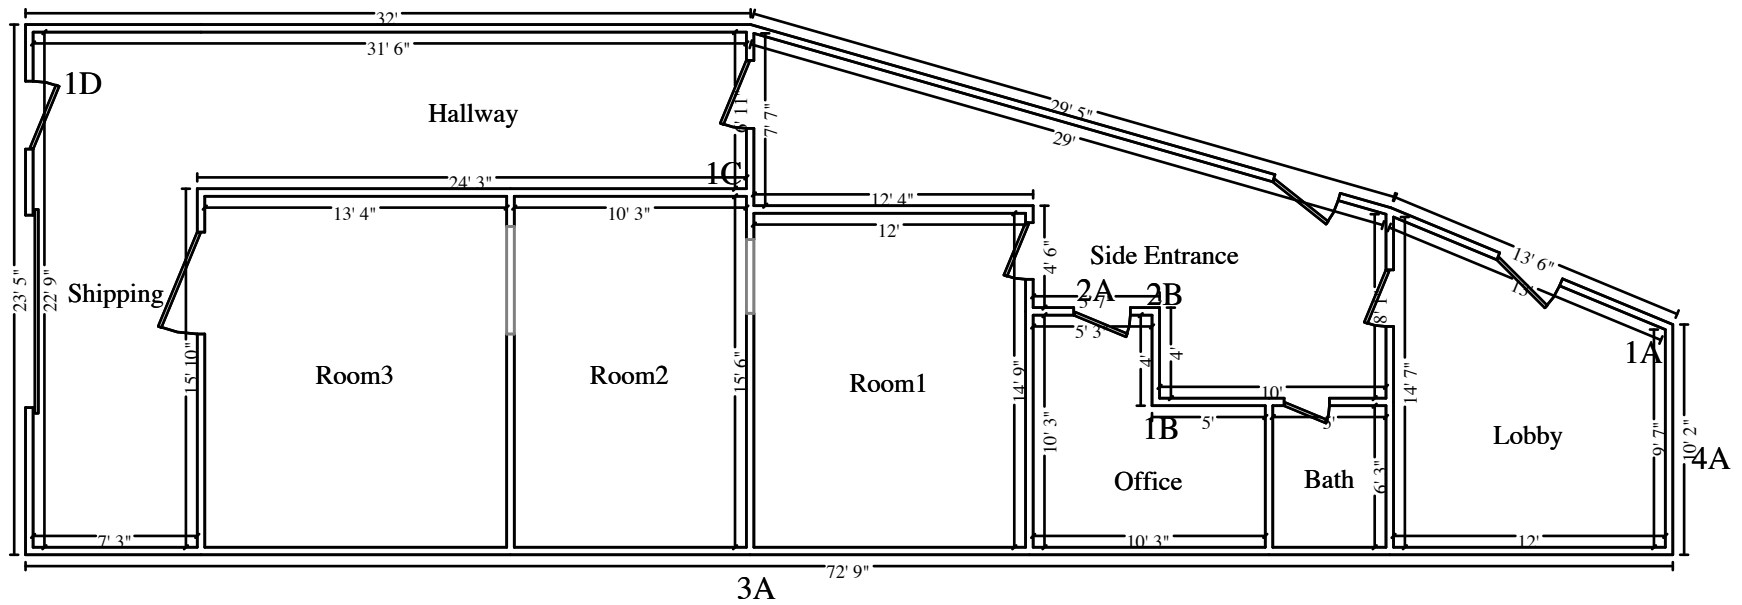
Main Level

Laboratory analysis confirmed the absence of asbestos containing materials in the tested areas of the structure. See attached drawing identifying both rooms and sample collection locations
