Supplemental Inspection Information

DATE OF INSPECTION: 4/28/2022

FACILITY NAME: Yellow Creek Stone Quarry

NPDES PERMIT NUMBER: TN0070661

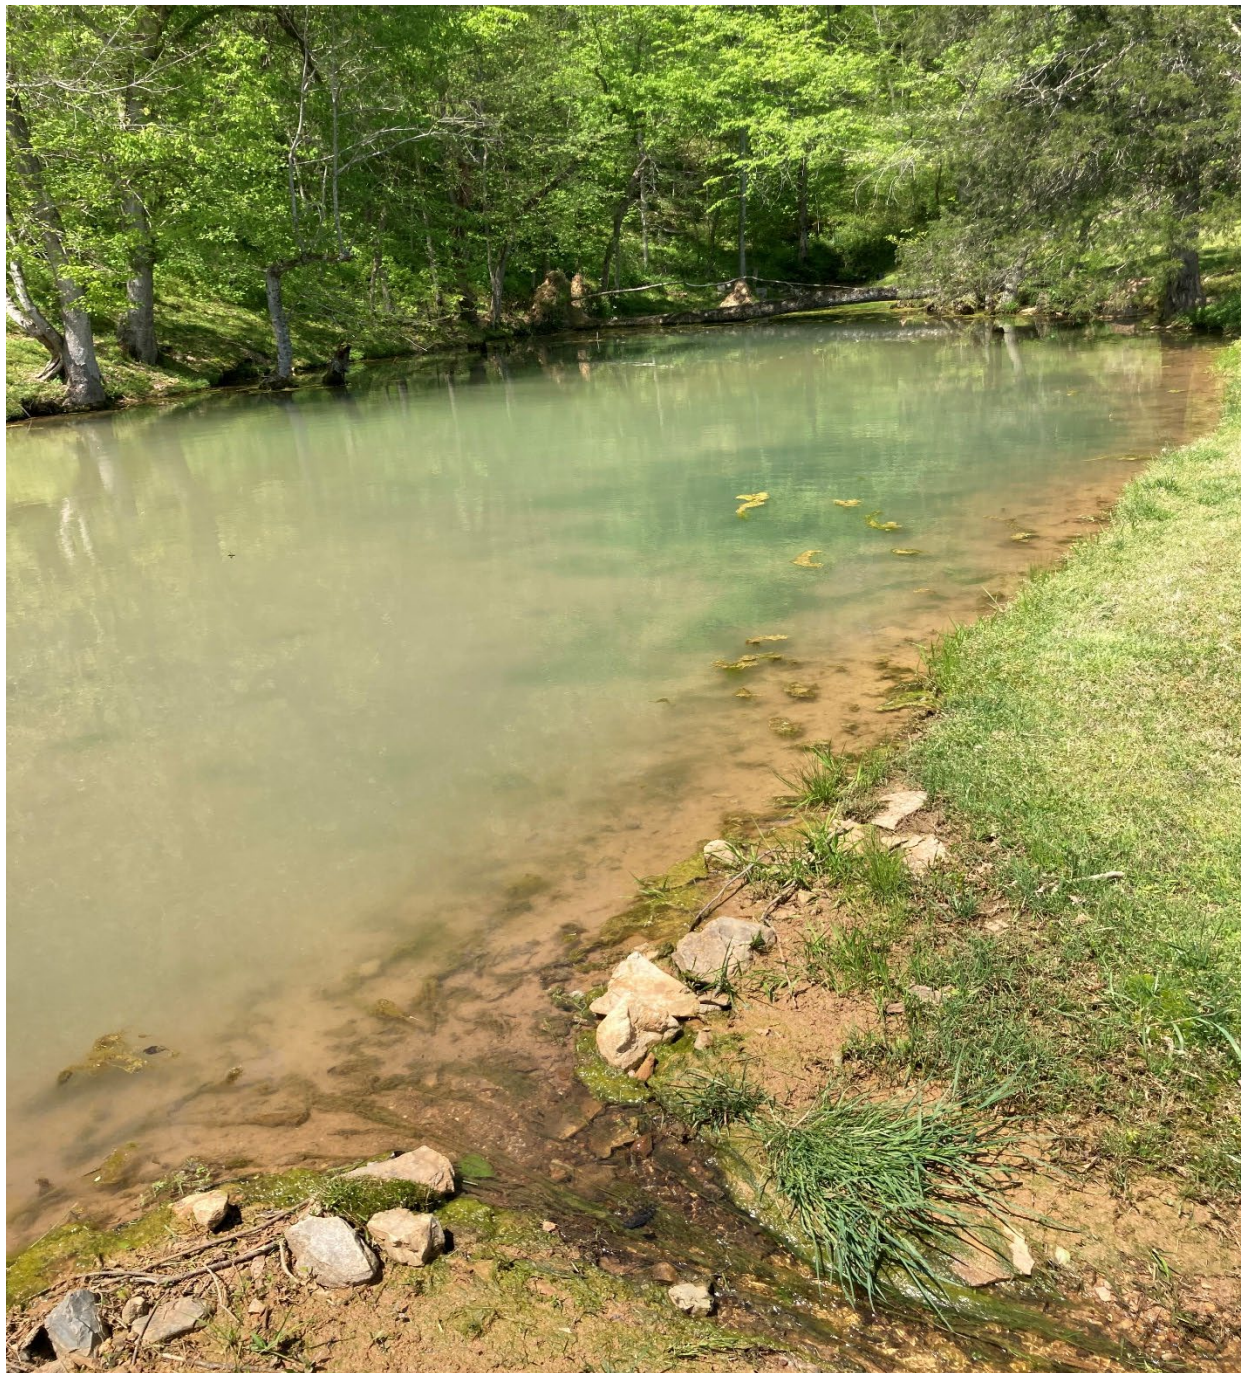
The spring fed pond below the quarry appeared to be turbid (photo 1); however, the spring water entering the pond was clear (photo 2). A potential conduit from the quarrying operation to the pond was identified (photo 3). It is recommended that the facility direct stormwater drainage away from this area and install BMPs, such as silt fencing and straw wattles, around this area to prevent sediment laden water from entering this potential conduit. It was also recommended that the facility stabilize the cleared land in this area with seed and straw or rock to prevent stormwater from accumulating large sediment loads. Additionally, allowing more littoral zone aquatic vegetation to grow along the pond shoreline may help trap and process sediment that enters the pond.

Photo 1: Spring fed pond below the Yellow Creek Stone Quarry. Pond appeared quite turbid for not receiving any significant rain for the past 6 days.

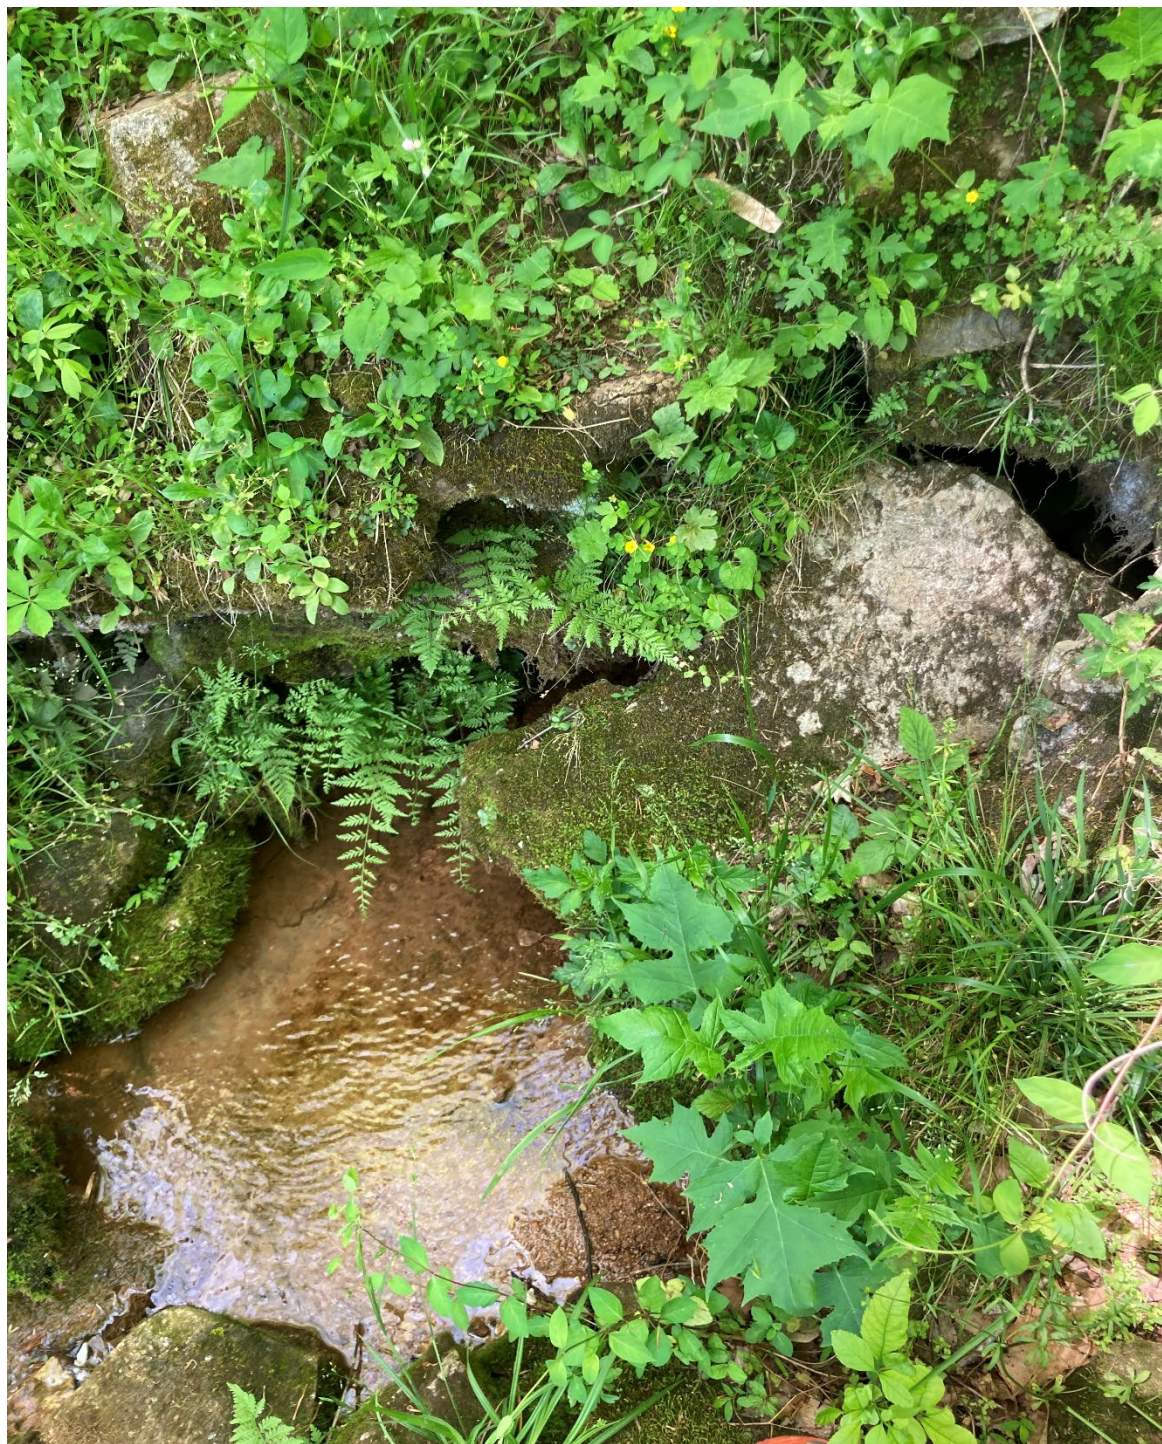
Photo 2: Spring water entering the pond below the Yellow Creek Quarry.

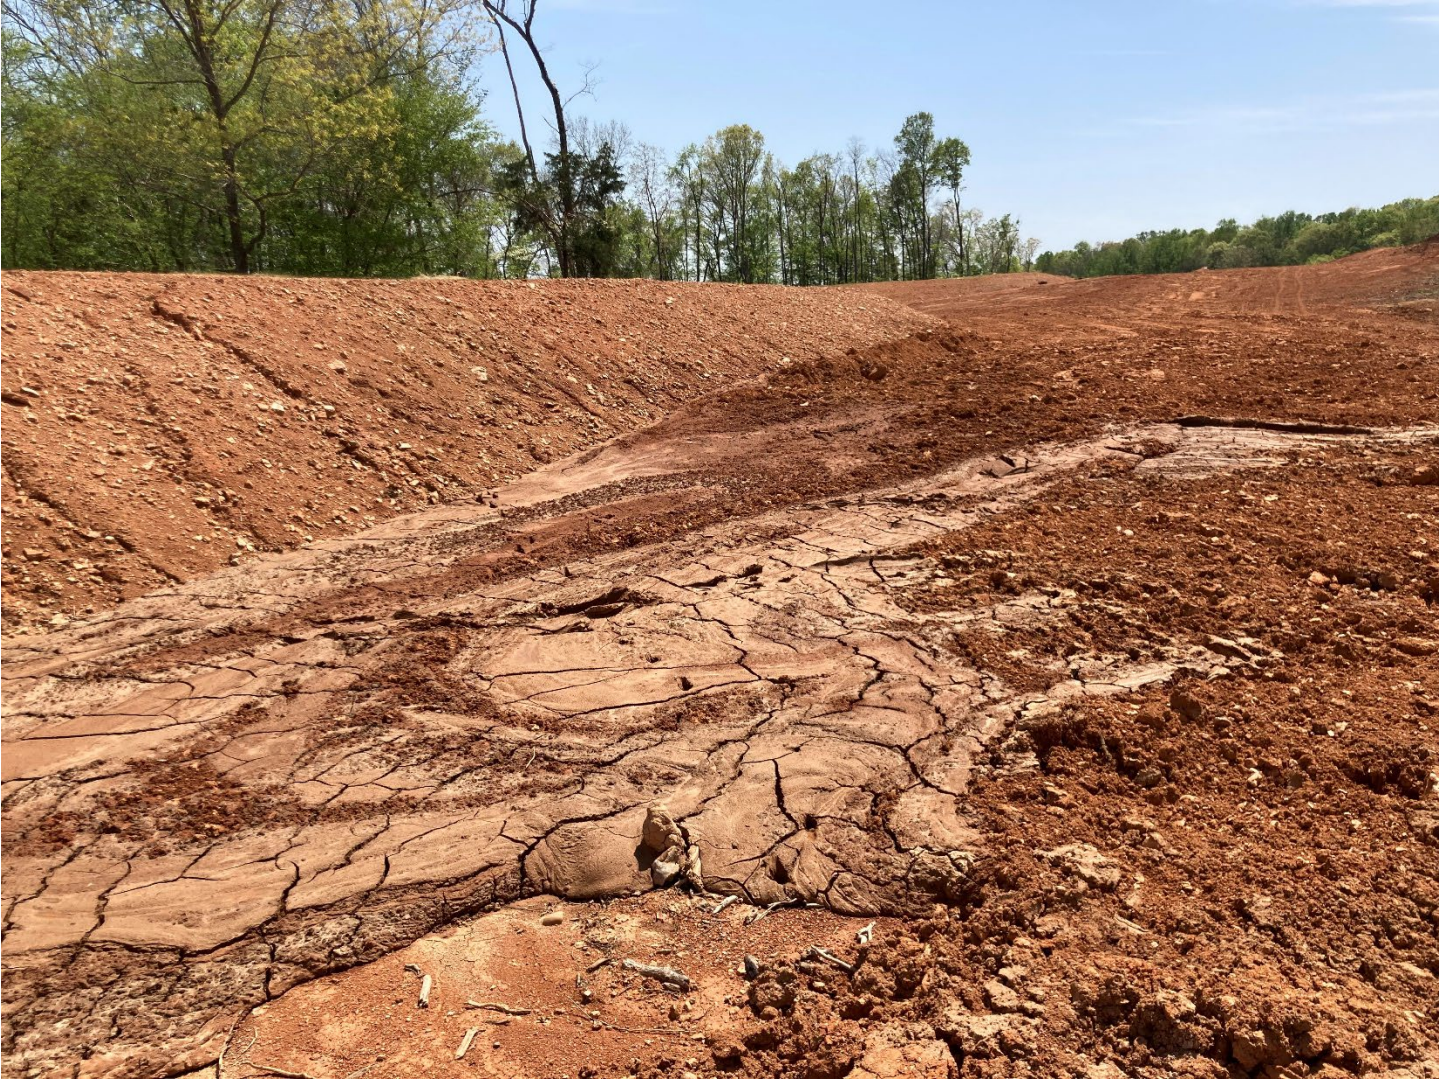
Photo 3: Area of potential conduit to spring and pond below Yellow Creek Quarry. Stormwater drainage from disturbed area pools here behind the berm and slowly infiltrates through the berm or potentially into the spring. The facility needs to redirect this drainage into the mine pit or sediment basin, stabilize the disturbed area that they are not immediately expanding into, and protect this area with BMPs to prevent sediment laden water from draining into this potential conduit.

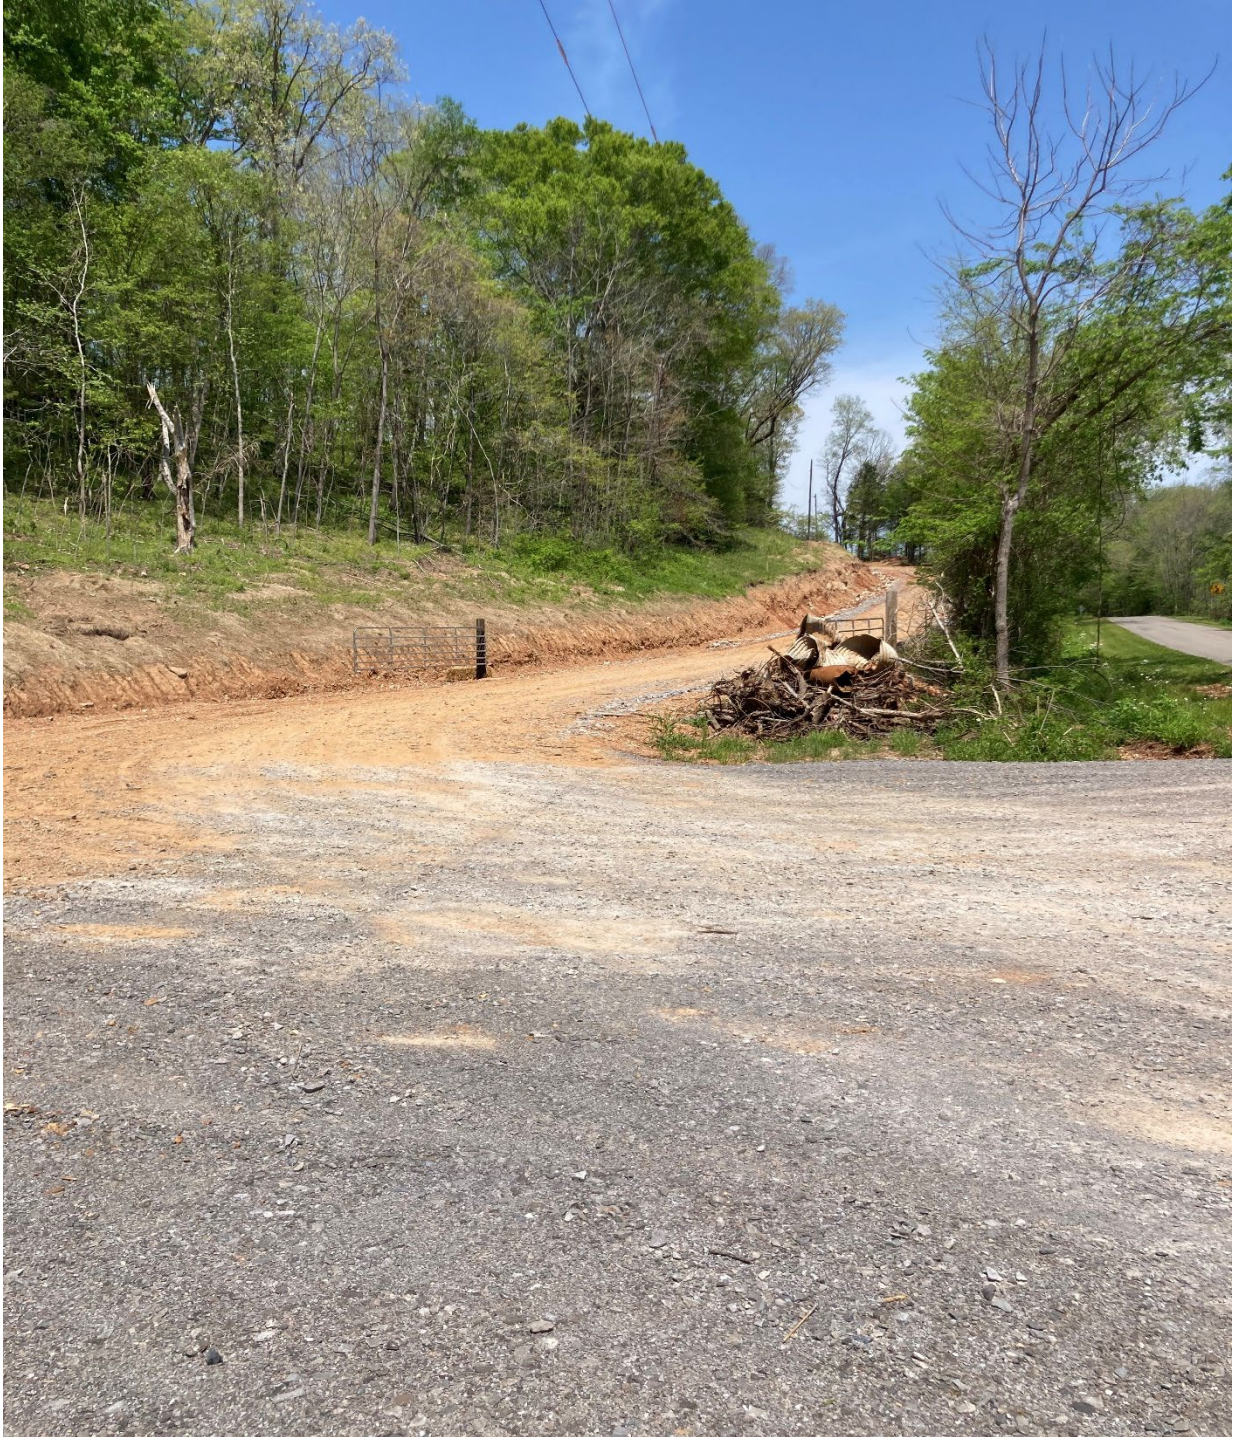
Photo 4: Tracking pad at the entrance of the facility.

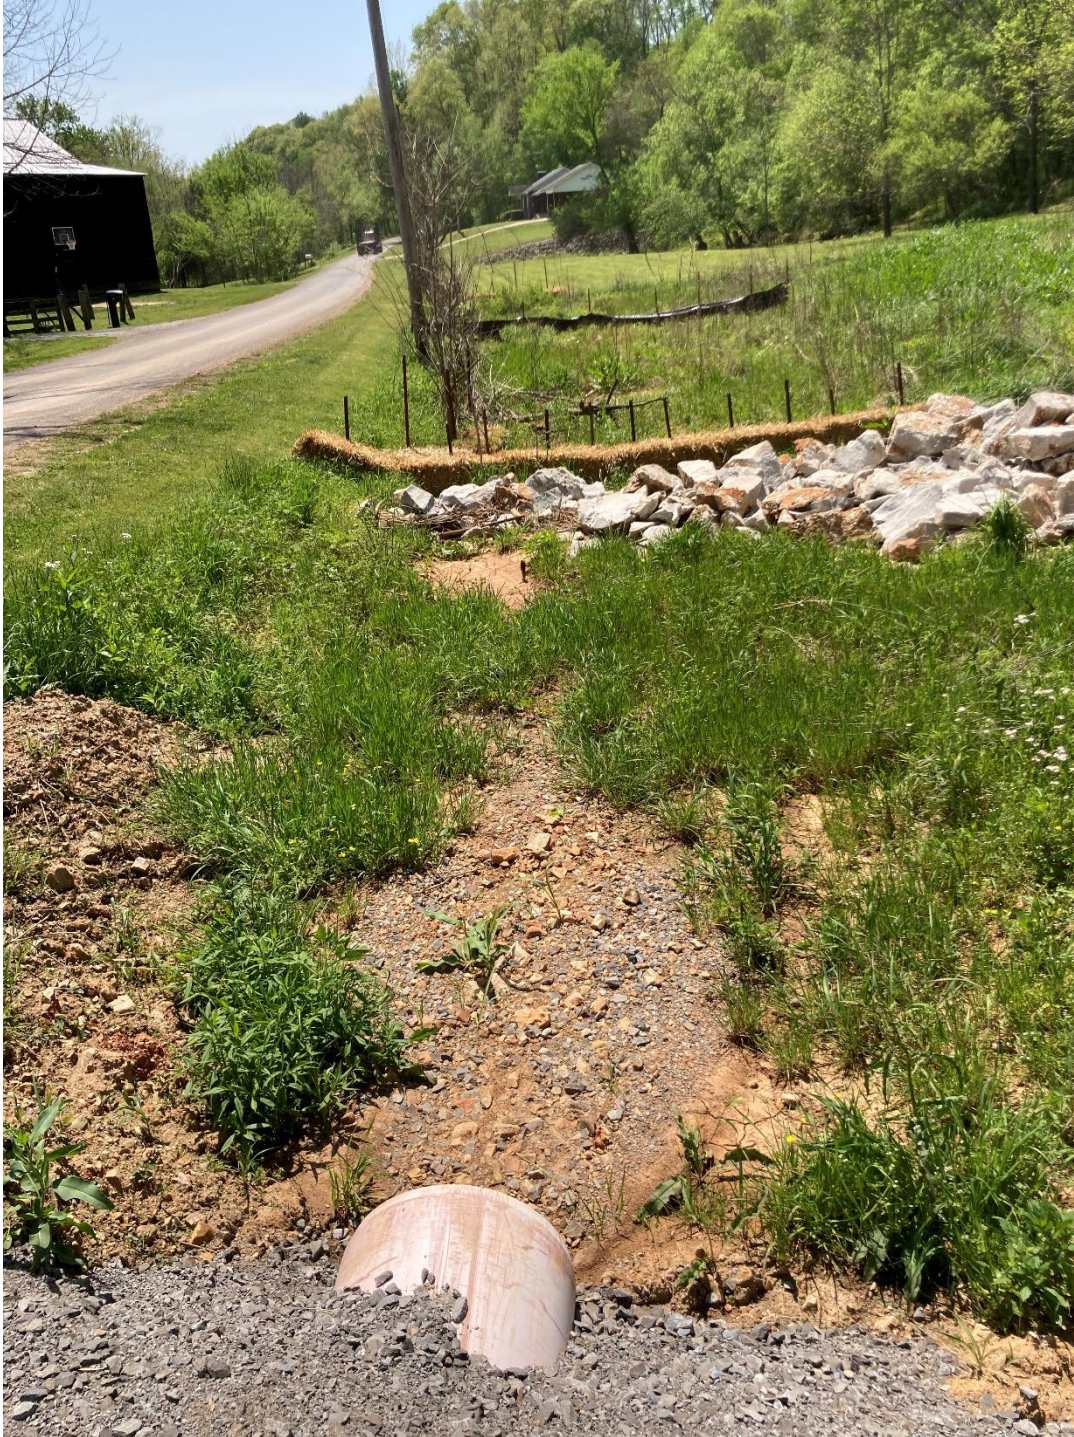
Photo 5: Road ditch culvert at the facility entrance and a series of BMPs below the culvert.

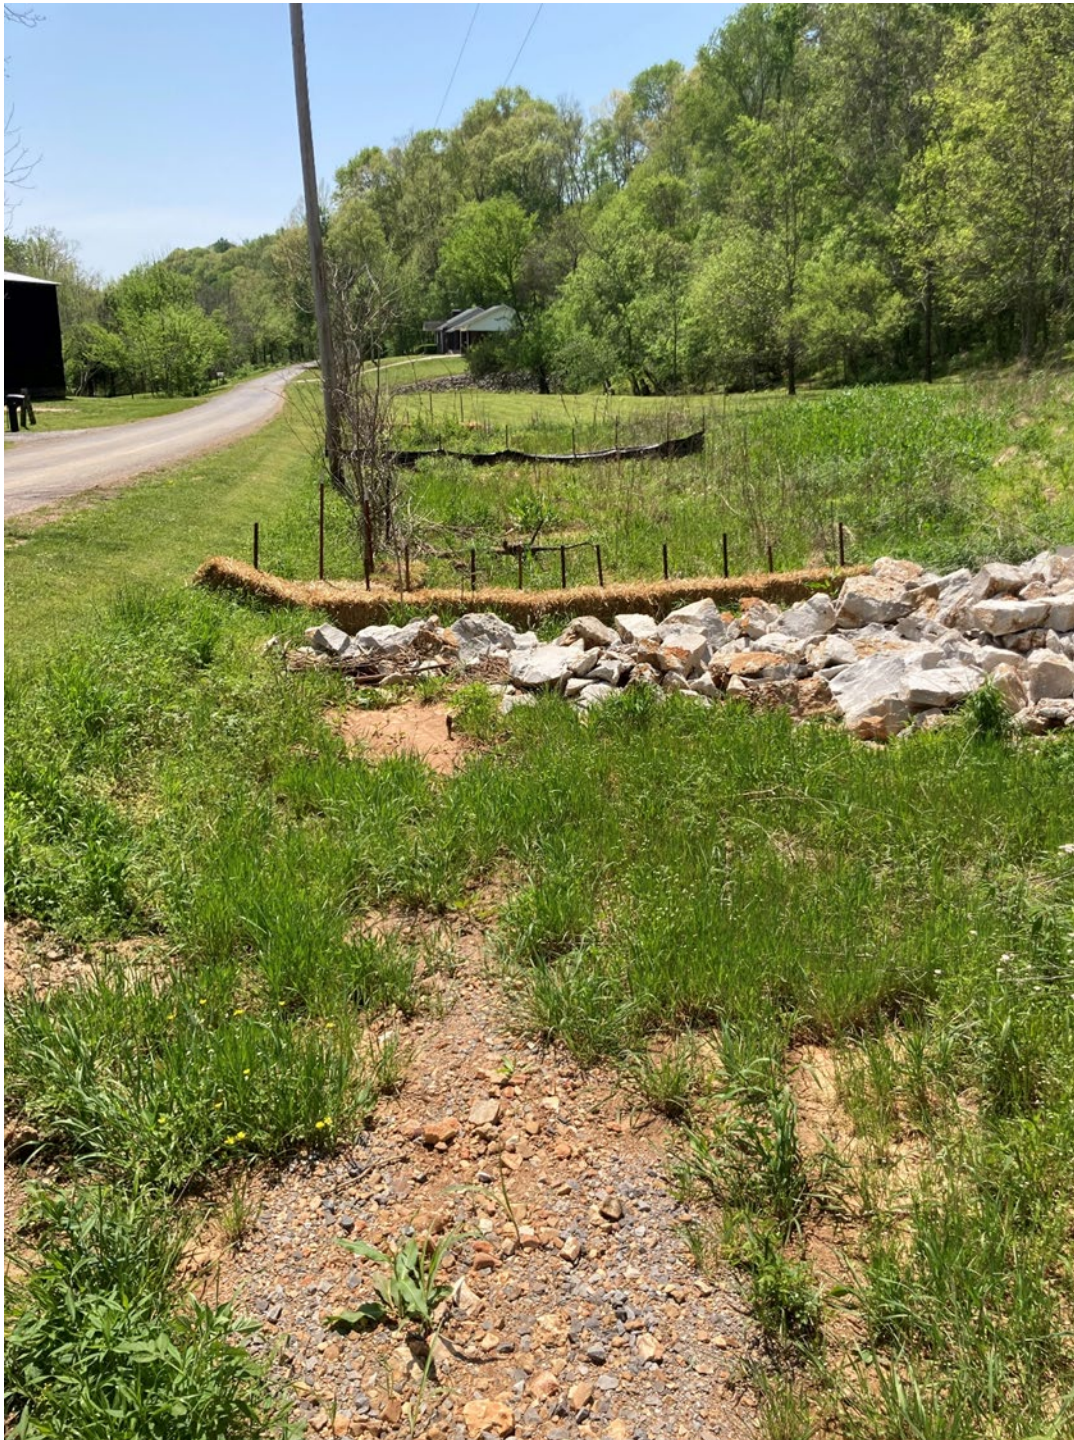
Photo 6: Series of BMPs at the facility entrance to treat stormwater before it leaves the site.

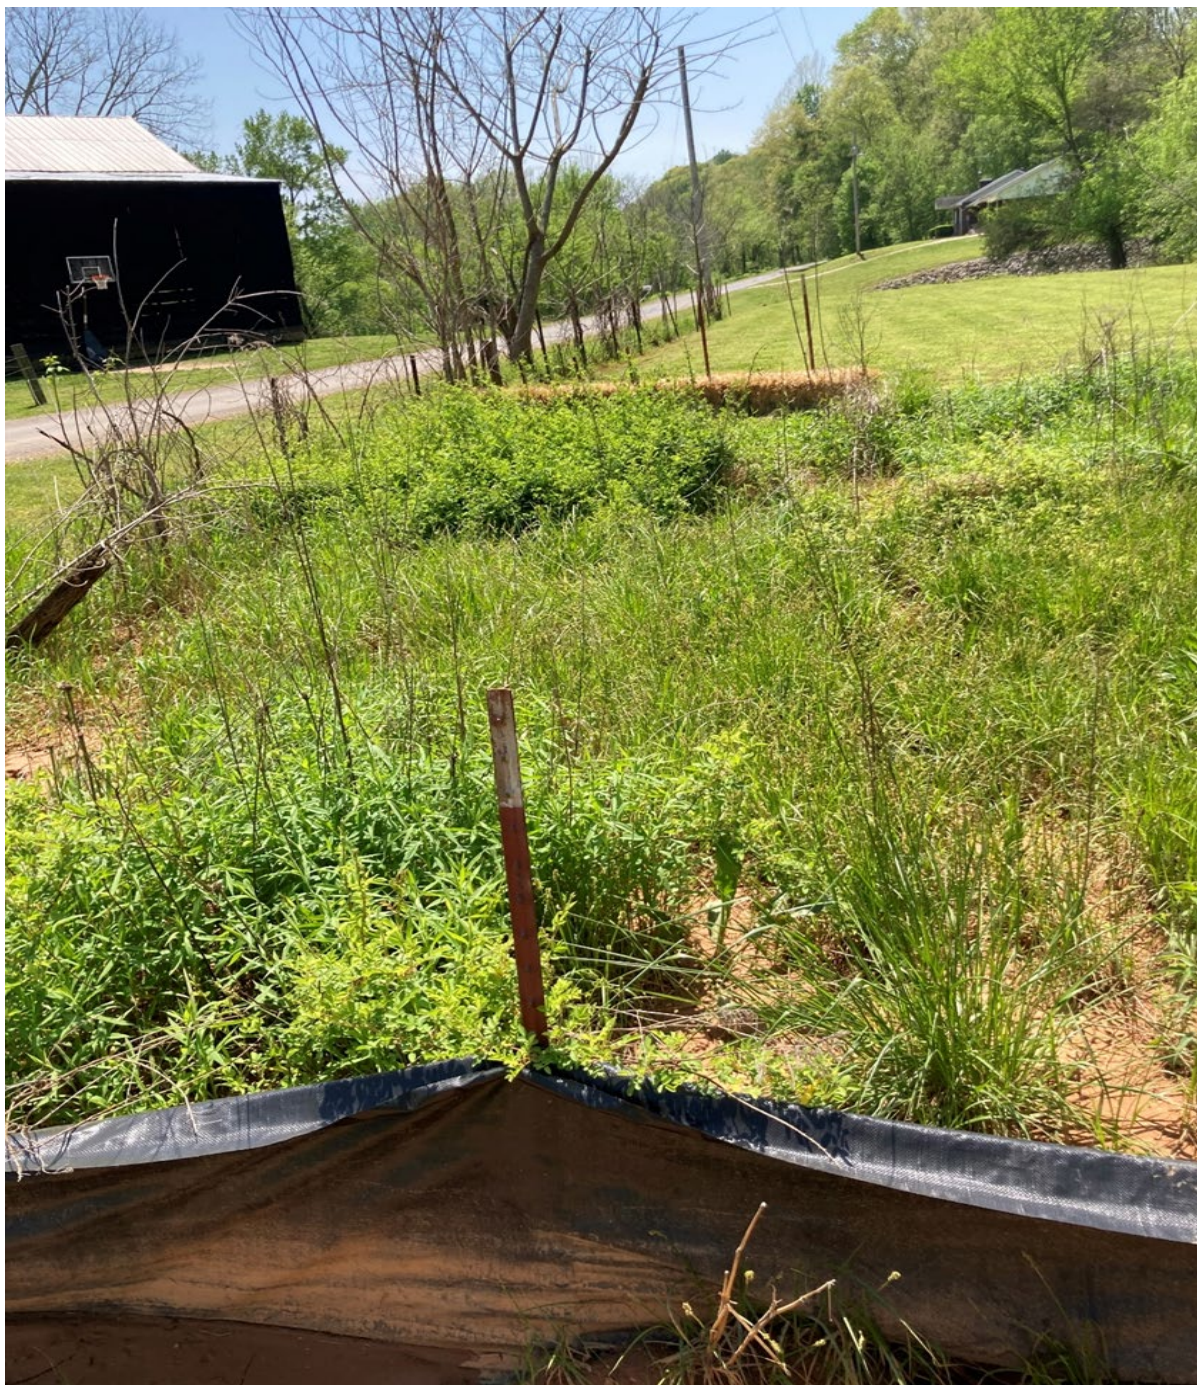
Photo 7: Series of BMPs at the facility entrance to treat stormwater before it leaves the site.

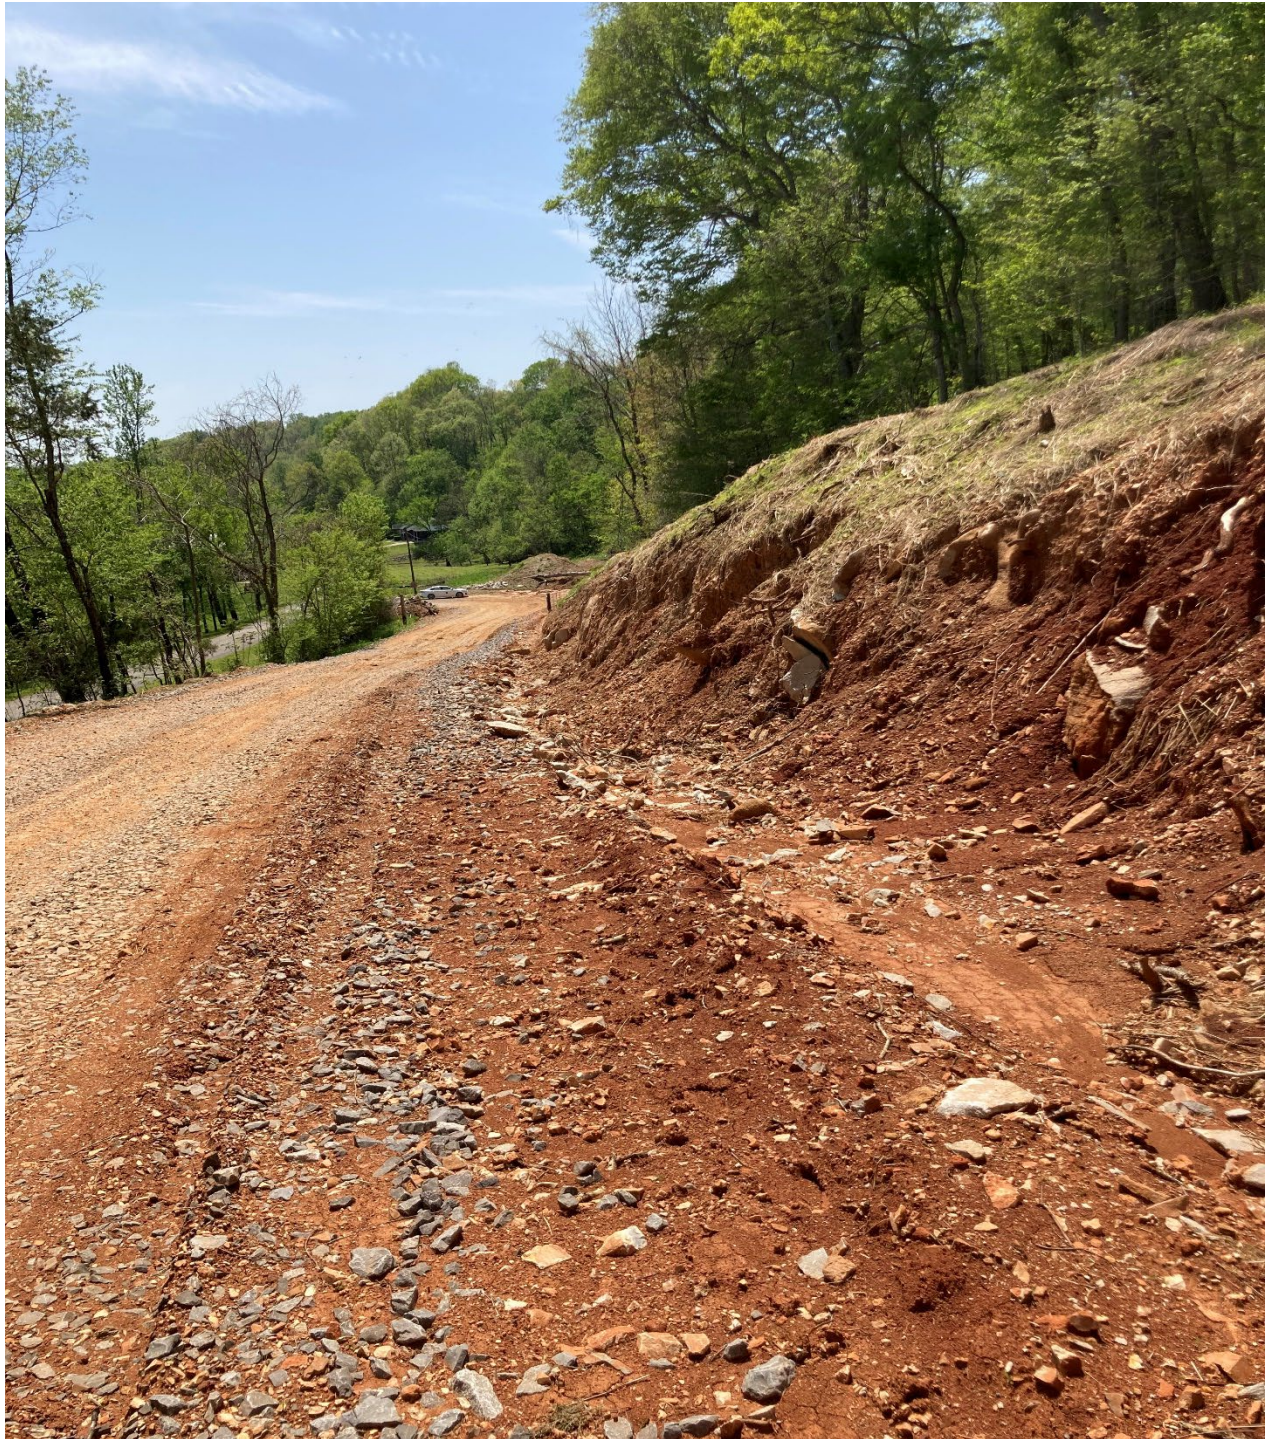
Photo 8: Large amounts of unstabilized soil at the upper portion of the driveway.

The facility appears to have installed an adequate tracking pad (photo 4) and BMPs are in place below the quarry entrance to manage stormwater runoff (photos 5-7). However, large areas of unstabilized soil were observed along the western and northern portions of the driveway that needs to be stabilized (photos 8-10). Additional BMPs such as check dams and sumps need to be installed along the driveway and roadway ditches, and unstabilized soil should be seeded and strawed.

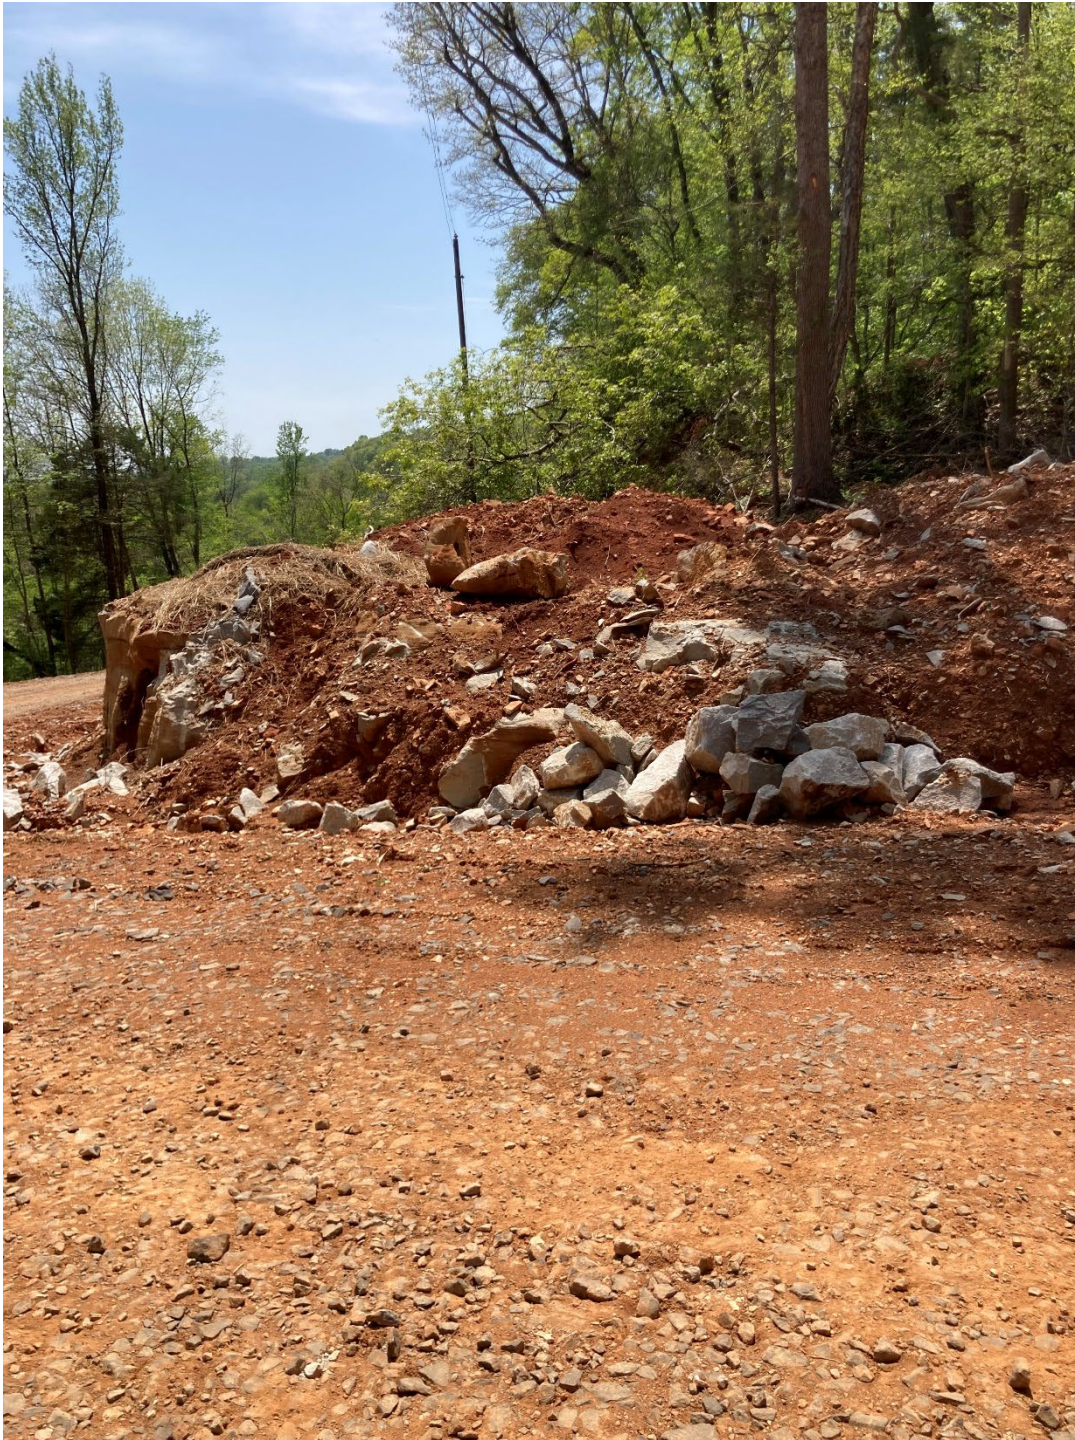
Photo 9: Large amounts of unstabilized soil at the upper portion of the driveway.

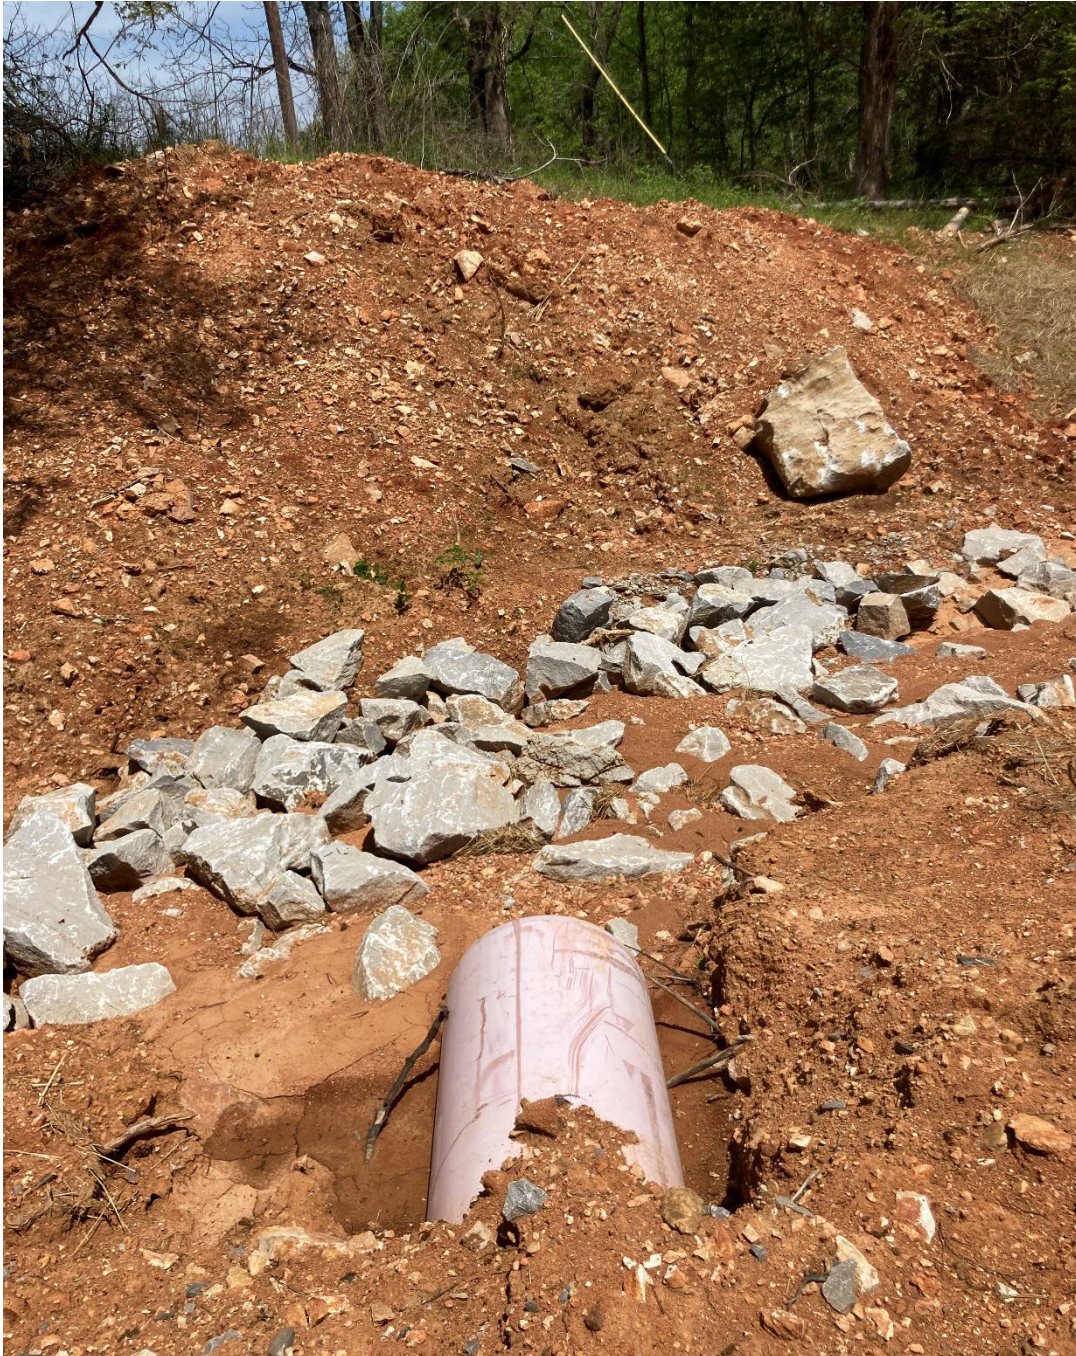
Photo 10: Large amounts of unstabilized soil at culvert at upper portion of driveway.

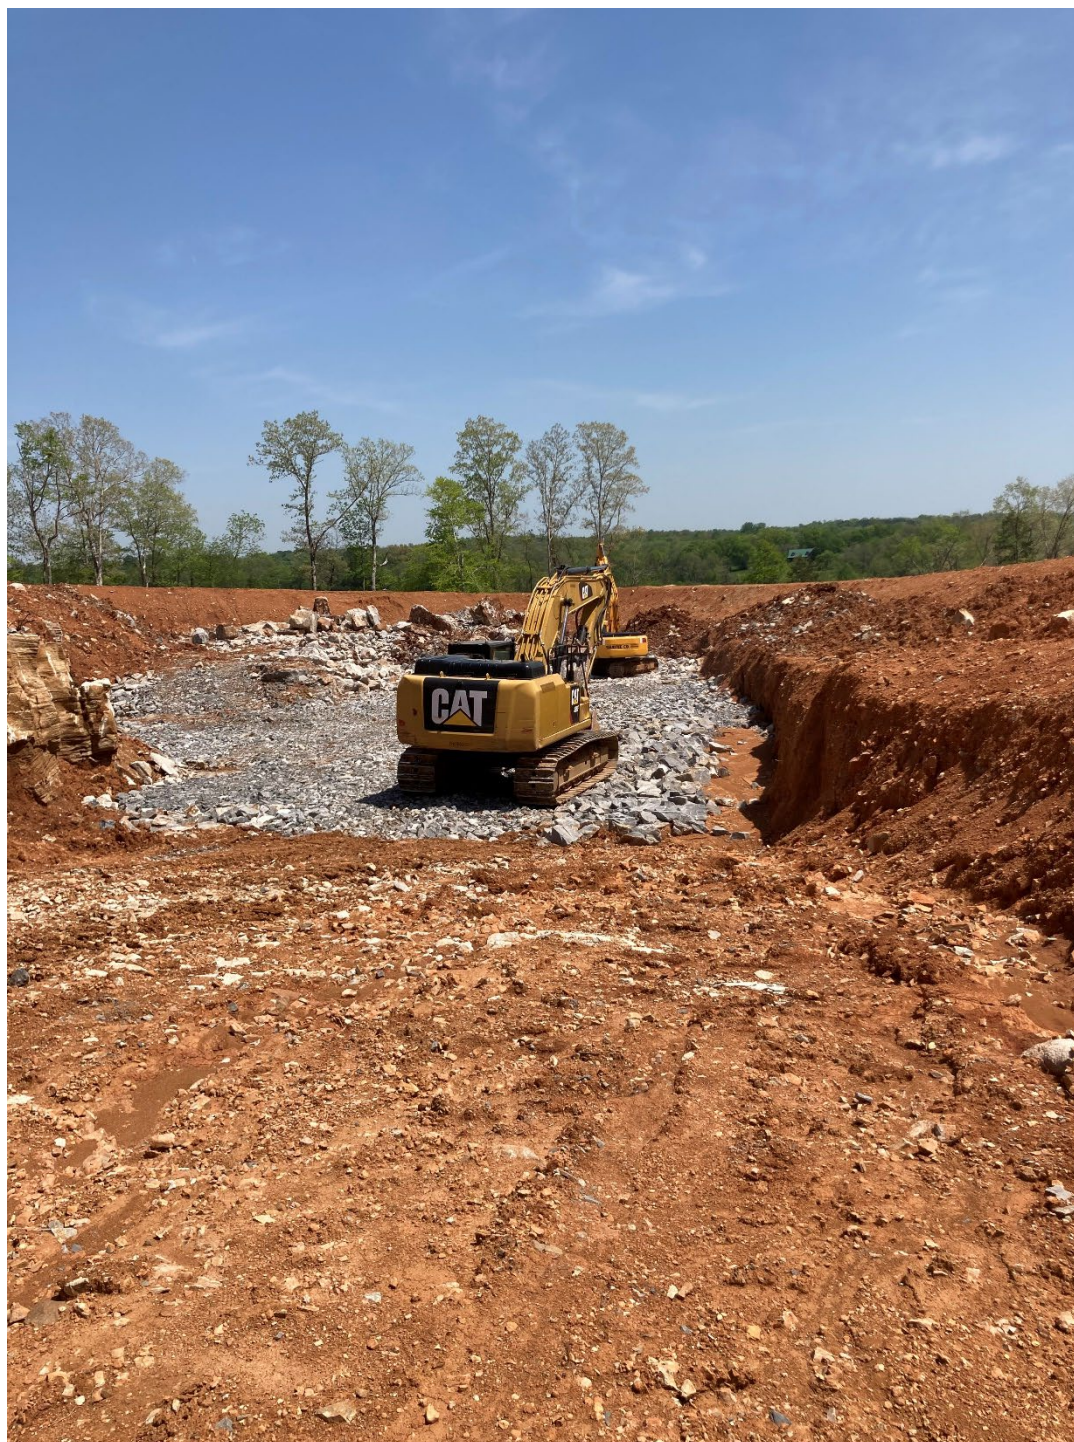
Photo 11: Development of the mine pit.

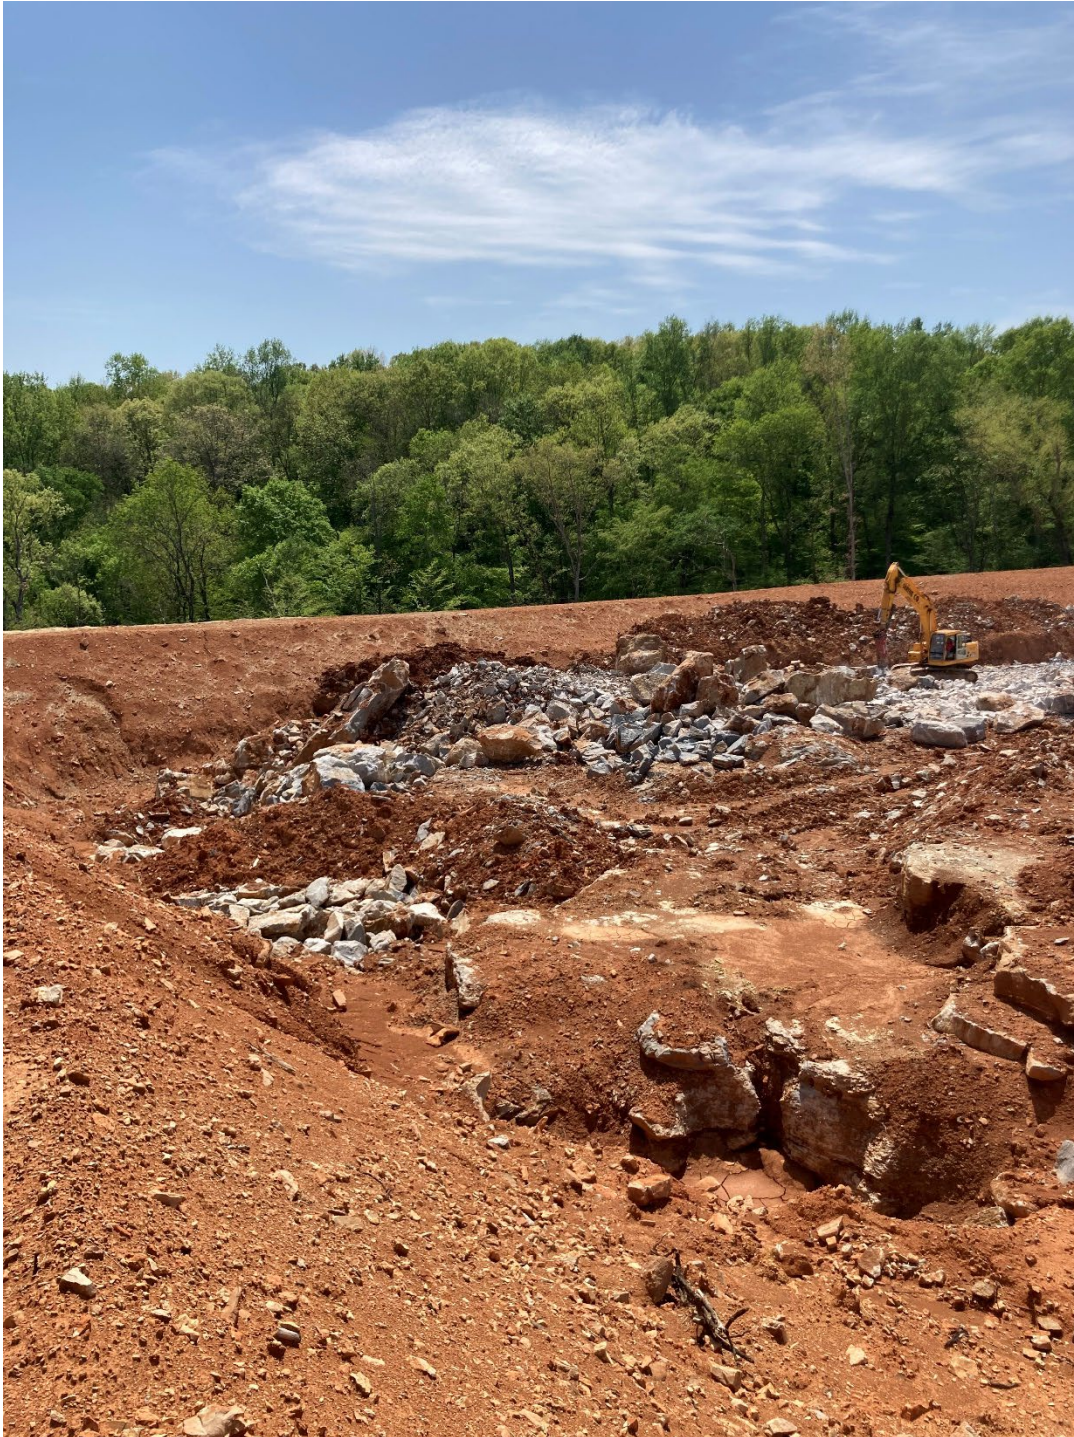
Photo 12: Development of the mine pit.

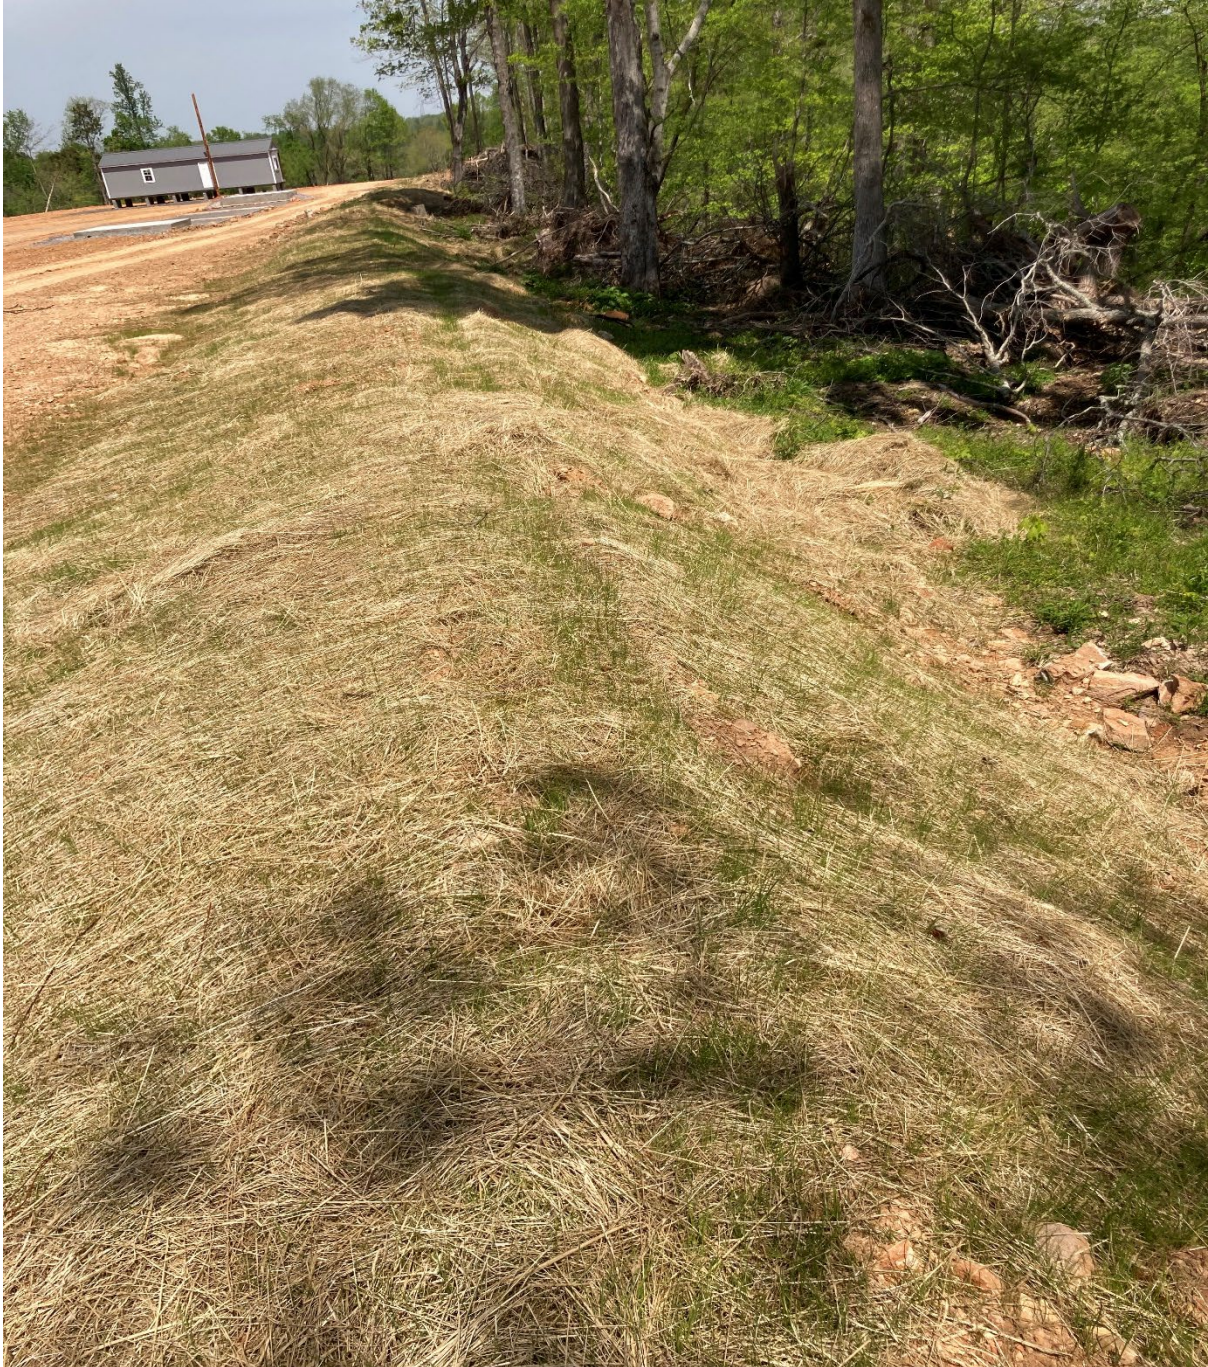
Photo 13: Photo of scale pad, scale house and outslope berm.

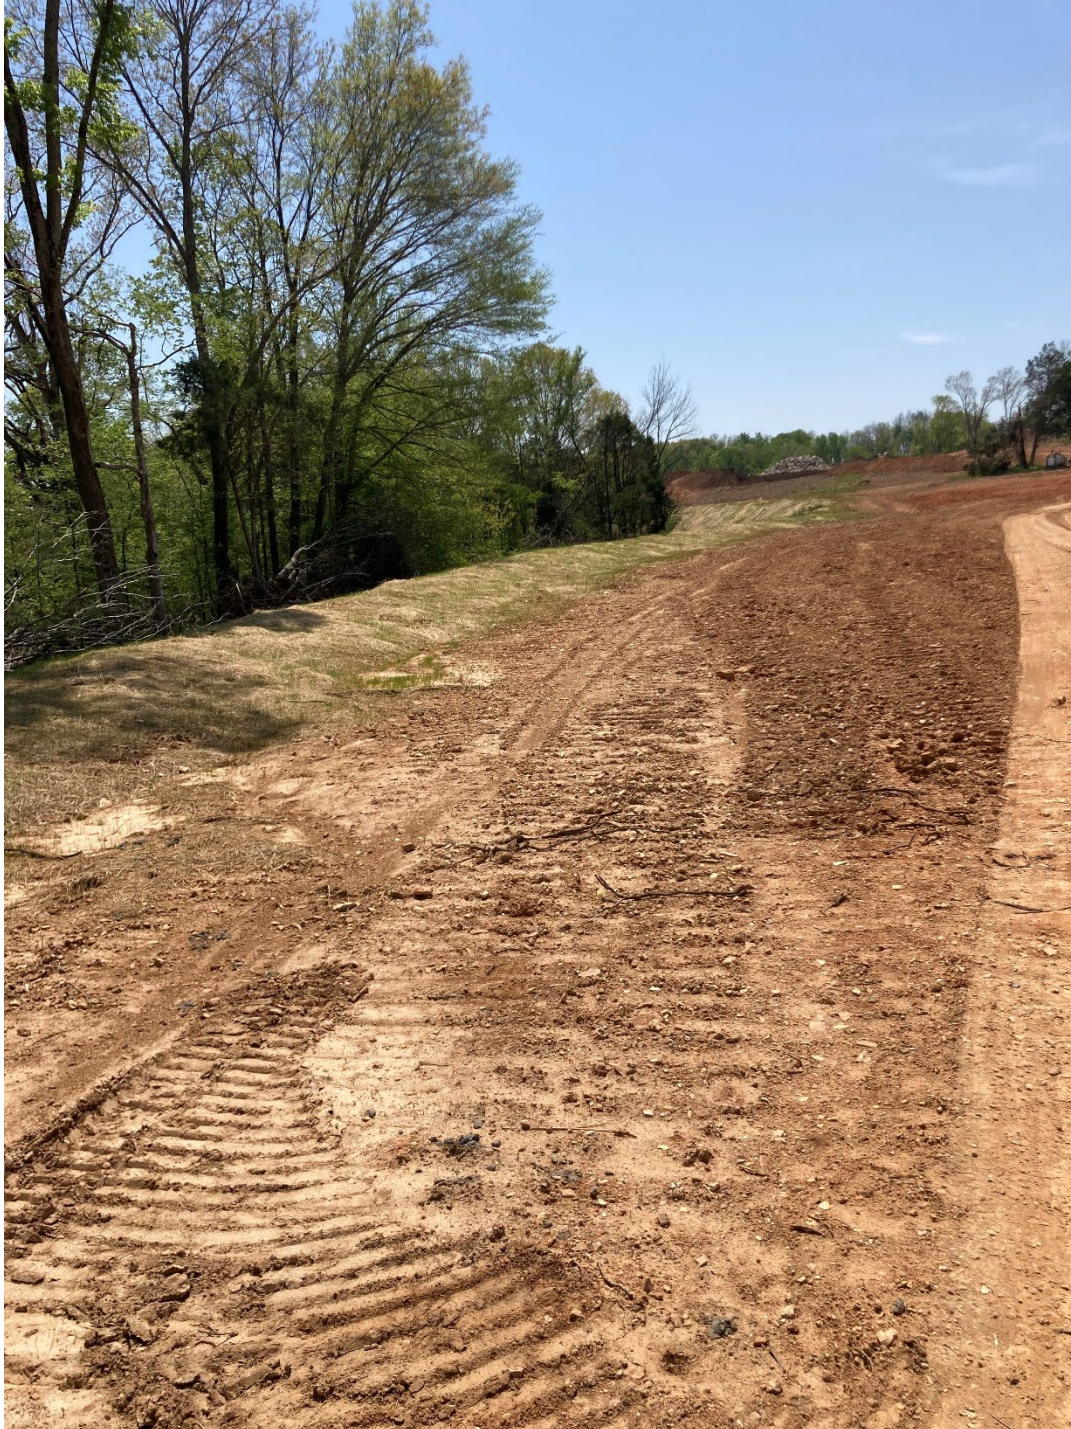
Photo 14: Photo of stabilized berms at the edge of the disturbed area.
