Supplemental Inspection Information

DATE OF INSPECTION: 4/28/2022

FACILITY NAME: Yellow Creek Stone Quarry

NPDES PERMIT NUMBER: TN0070661

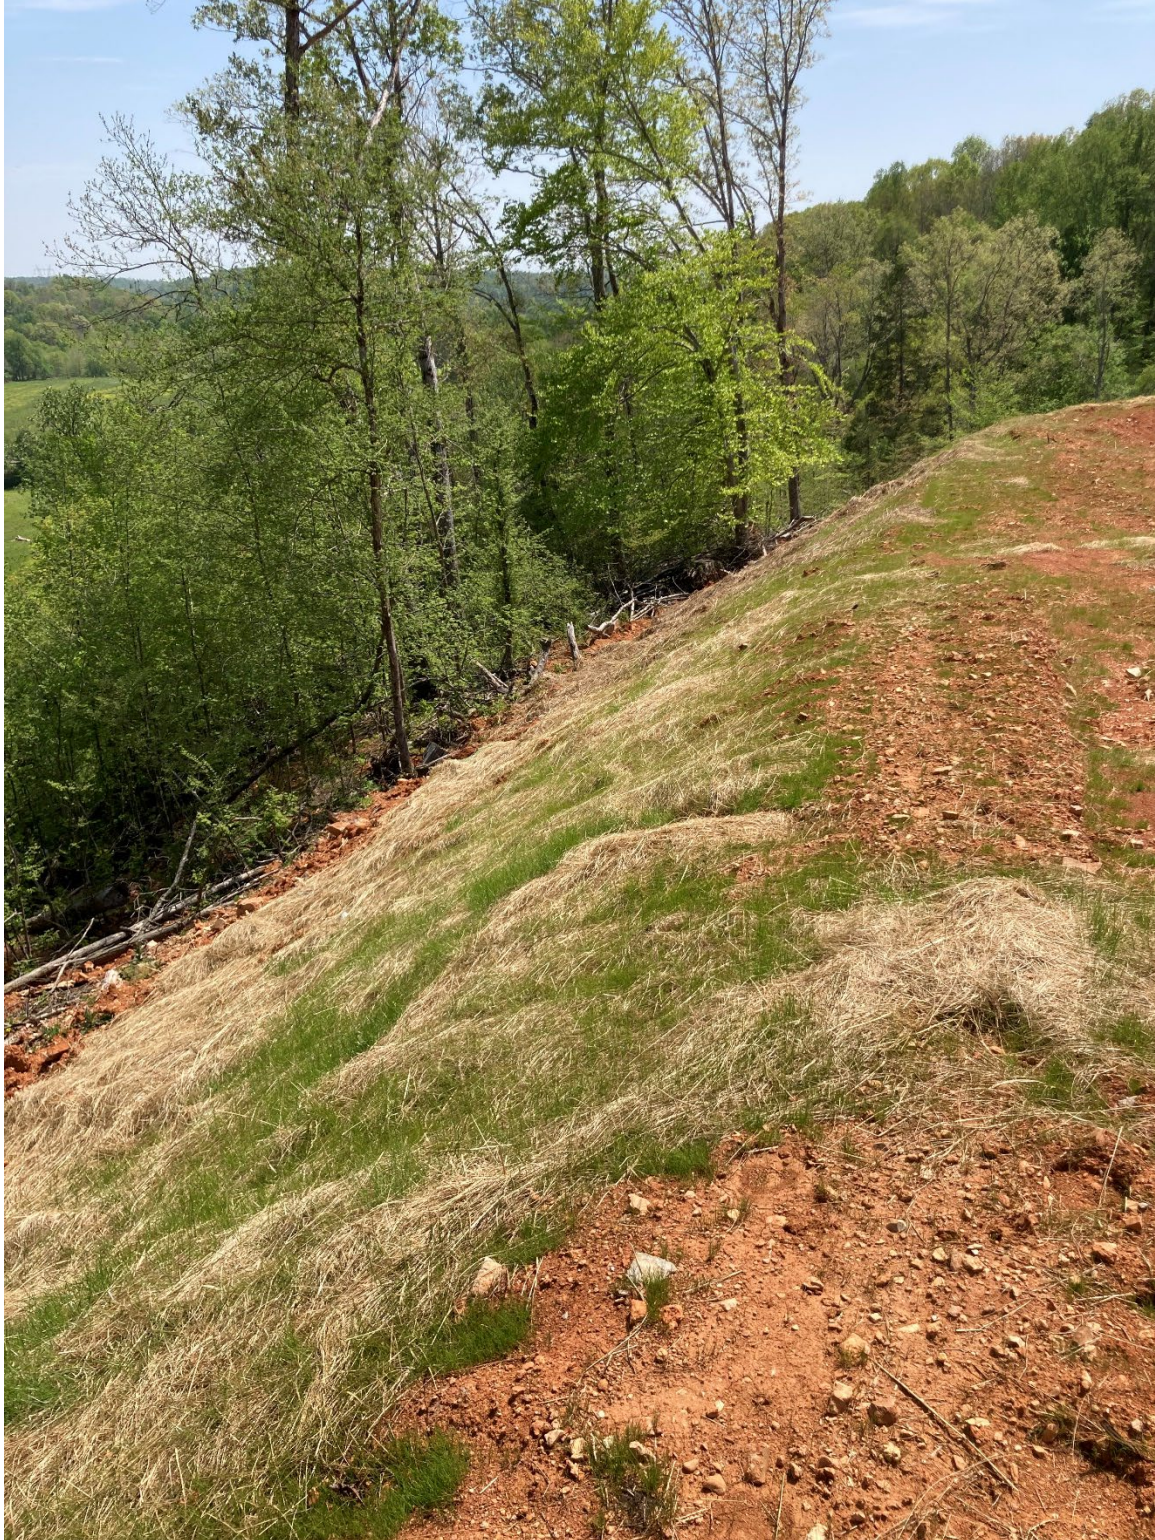
Photo 15: Photo of stabilized berm at the mine pit, note this berm could use more seed and straw.

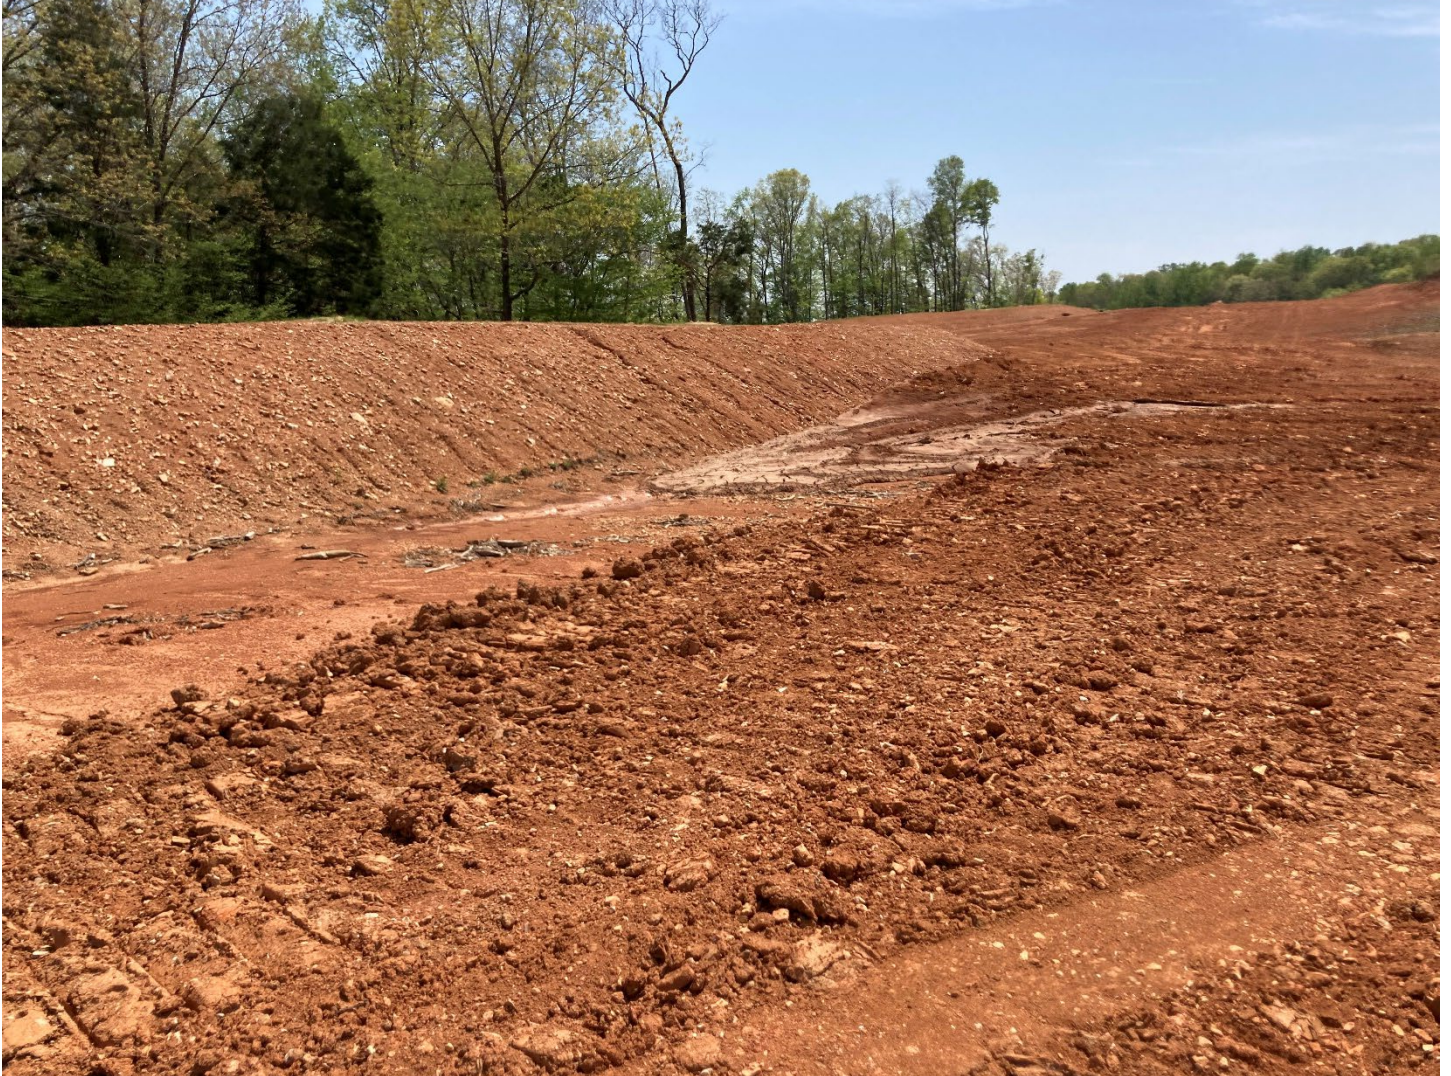
amount of unstabilized, disturbed area that did not drain to the pit or treatment basin (photos 16) and instead infiltrated through the berms. The facility needs to direct stormwater and process water into the mine pit or treatment basin and seed or otherwise stabilize the disturbed areas where mining activity is not occurring.

Photo 16: Large amount of disturbed area that does not drain to the mine pit or sediment basin. This area needs to be regraded to drain to the pit or treatment basin or be seeded or rocked if the facility does not plan to expand to this area soon.

We request that within 30 days of receiving this report; the facility make improvements to the BMPs along the driveway and roadway ditches, direct stormwater drainage from disturbed areas to either the mine pit or sediment basin and stabilize any disturbed areas the facility is not actively using or planning on expanding into within the first year of operation. Please provide photos documenting the completion of this work to Chris Pracheil at christopher.pracheil@tn.gov or TDEC.mining@tn.gov.
