**QUALITY ASSURANCE  
MONTHLY SITE  
ASSESSMENT REPORT**

Airfield Modernization Program  
Runway 5L-23R Reconstruction  
Project 2 / Project 3

## QUALITY ASSURANCE SITE ASSESSMENT

## **AIRFIELD MODERNIZATION PROGRAM RUNWAY 5L-23R RECONSTRUCTION**

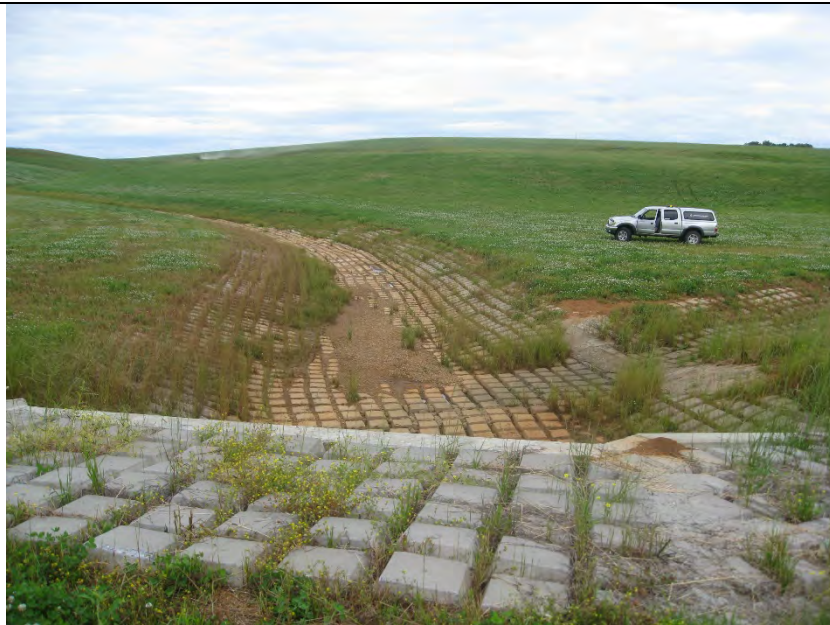
Photo 1  
Sta. 111+56 RT  
(Line LB)  
NLET 01  
Project 2

North Lateral End Treatment 01 (Outfall A).

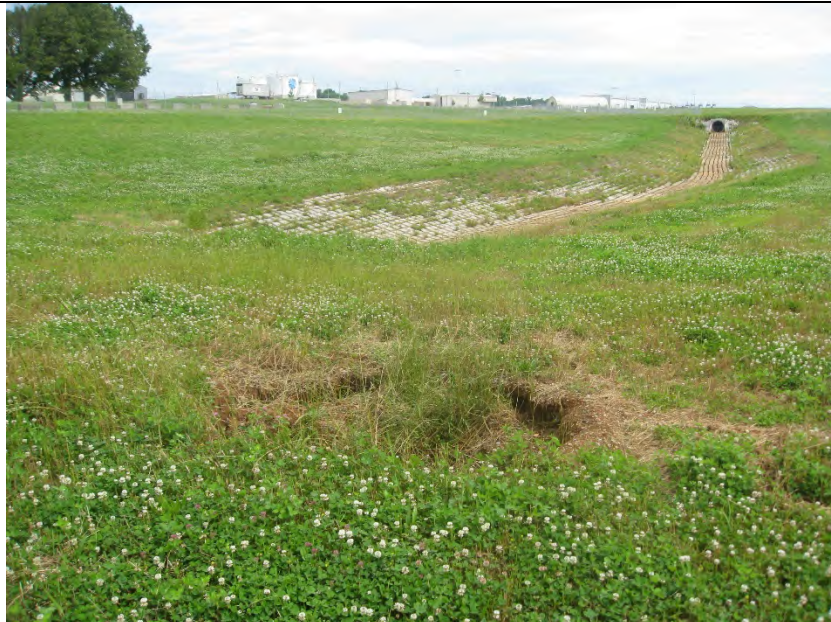
Photo 8  
Sta. 117+00  
(Line LB)  
Project 2

Above the Guard Lateral Ditch (Outfall B).  
Construction fall out present. Recommend coordinating remediation with CHA.

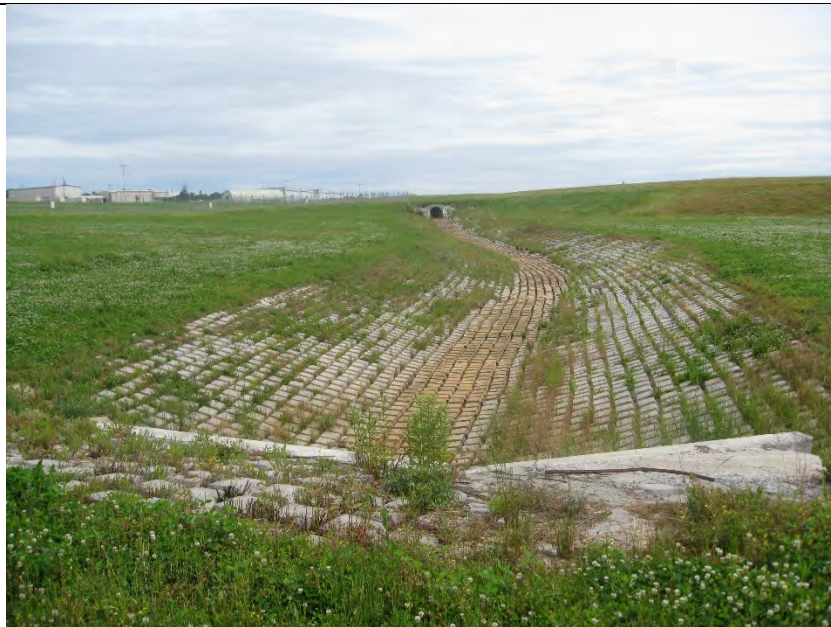
Photo 9  
Sta. 117+00  
(Line LB)  
Project 2

Guard Lateral Ditch (Outfall B).

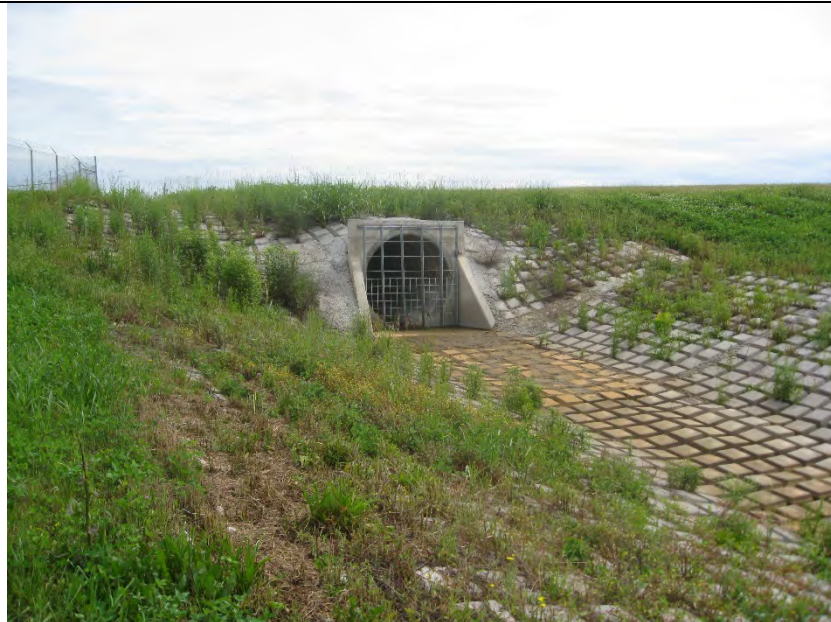
Photo 10  
Sta. 117+00 (RT)  
Project 2

78" culvert in the Guard Lateral Ditch. Clear flow observed at beginning of Site Assessment.

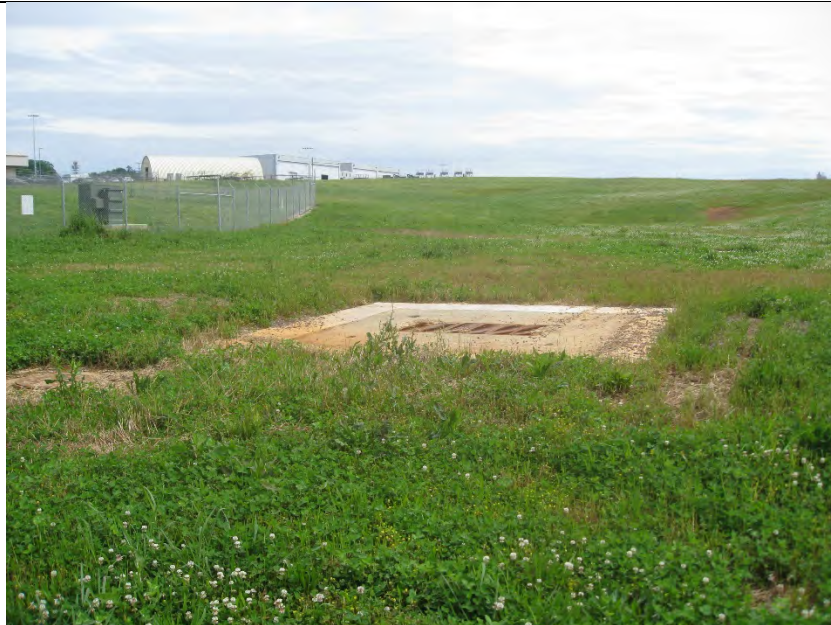
Photo 11  
Sta. 287+21 LT  
(RW 5L-23R)  
Structure 124  
Project 3

Structure 124.  
Recommend stabilizing remaining bare areas.

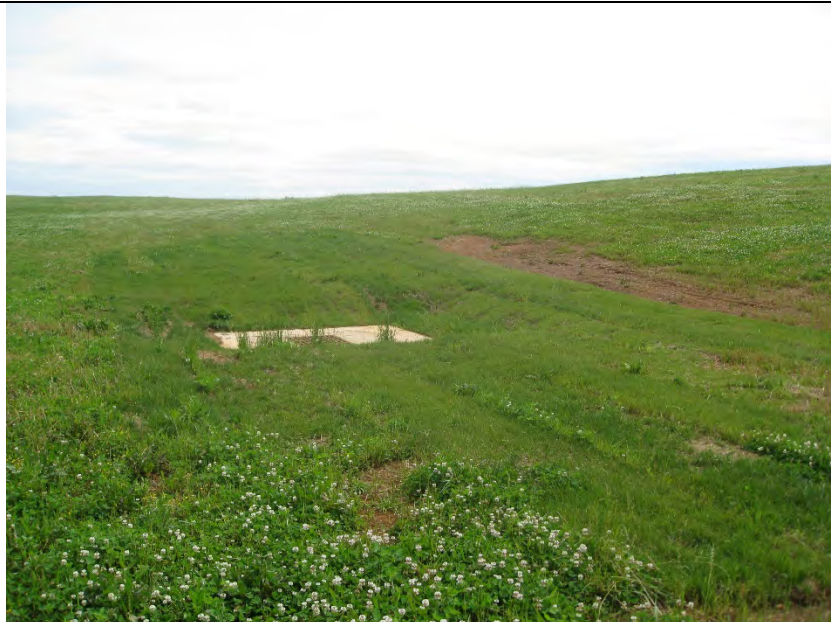
Photo 12  
Sta. 289+13 LT  
(RW 5L-23R)  
Structure 122  
Project 3

Structure 122.  
Recommend stabilizing remaining bare areas.

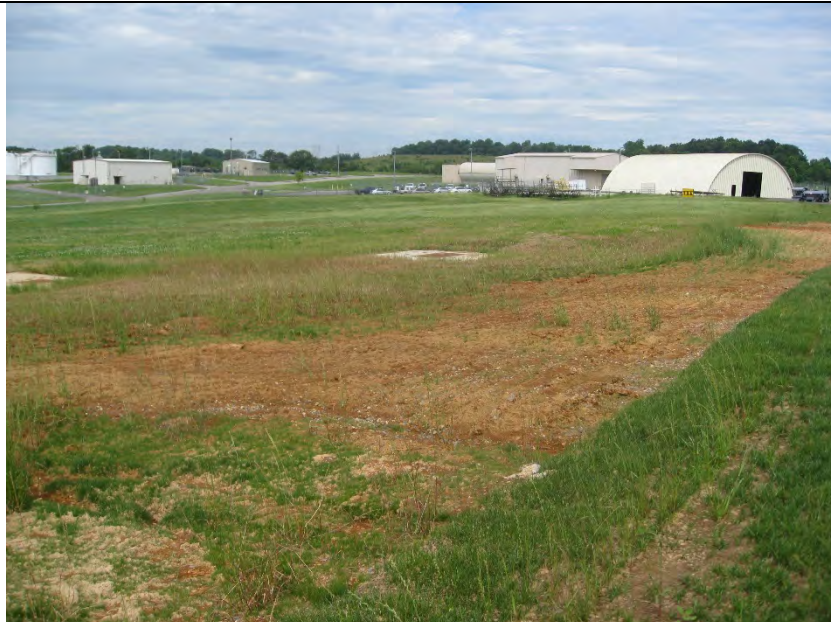
Photo 16  
Sta. 294+31 LT  
(RW 5L-23R)  
Structure 118  
Project 3

Area adjacent to Structure 118.  
Recommend stabilizing remaining bare areas.

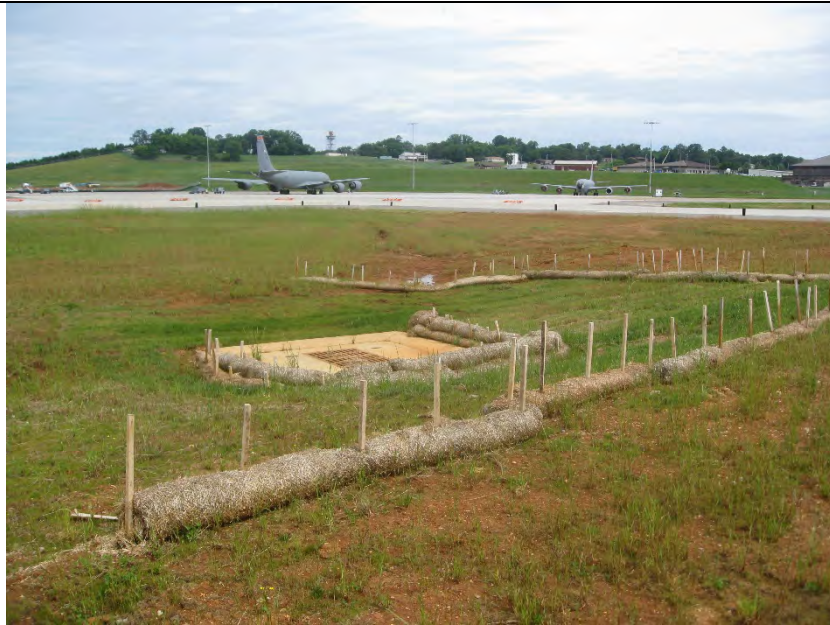
Photo 17  
Sta. 298+71 LT  
(RW 5L-23R)  
Structure 116  
Project 3

Structure 116.  
Recommend stabilizing bare areas.

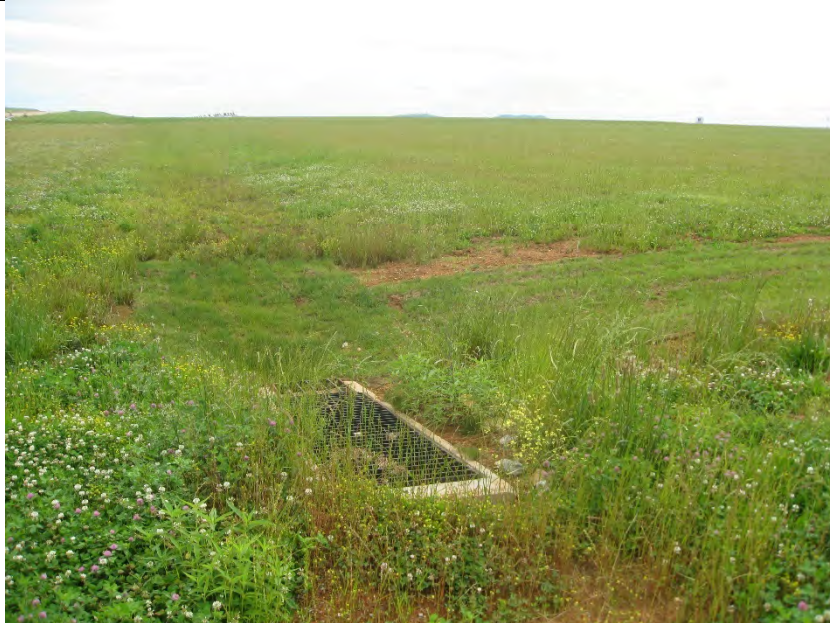
Photo 23  
Sta. 314+48 LT  
(RW 5L-23R)  
ES Endwall 108  
Project 3

Enhanced Swale Endwall 108.  
Recommend stabilizing remaining bare areas.

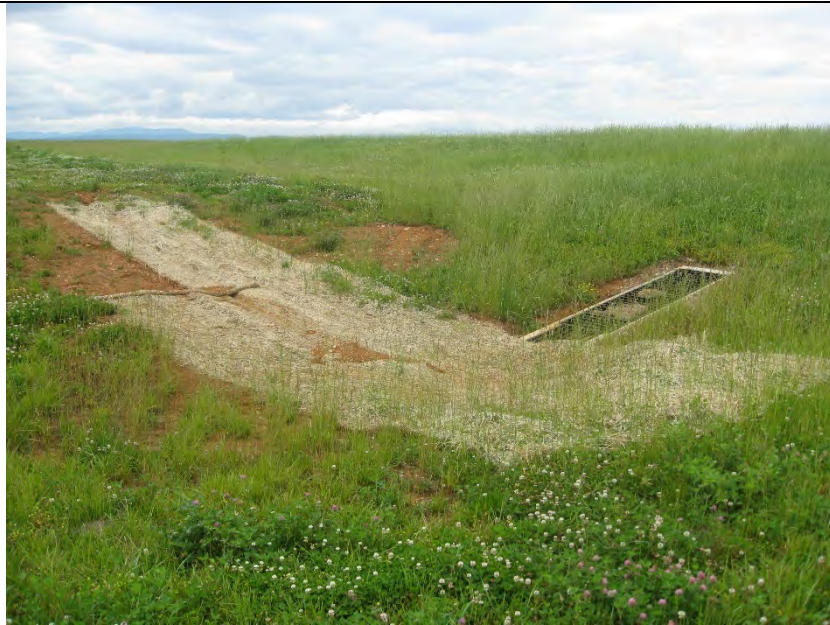
Photo 35  
Sta. 347+31 LT  
(RW 5L-23R)  
ES Endwall 102  
Project 3

Enhanced Swale Endwall 102.  
Recommend stabilizing remaining bare areas.

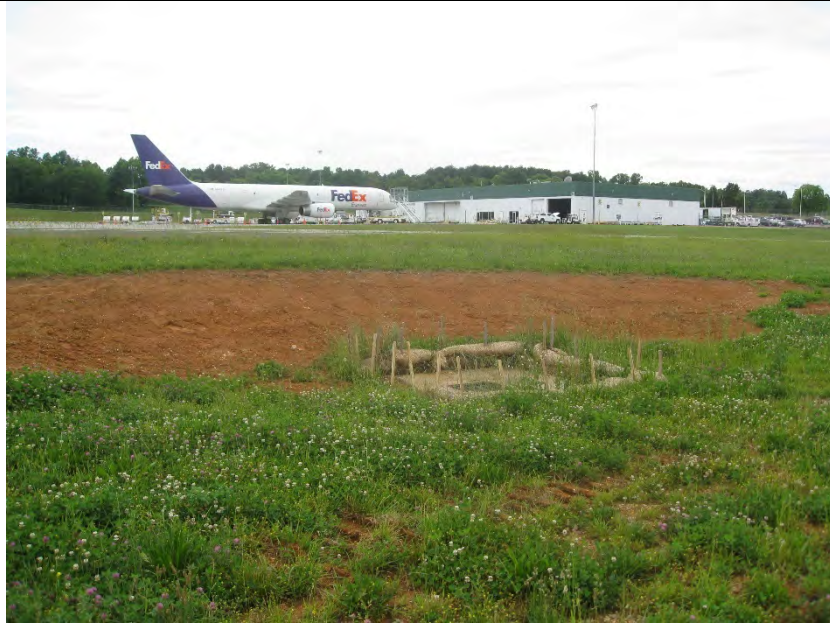
Photo 43  
Sta. 677+00 RT  
(RW 5L-23R)  
Existing Structure  
Project 4

Structure south of Taxiway "G".  
Slopes recently regraded.  
Recommend stabilizing bare areas.

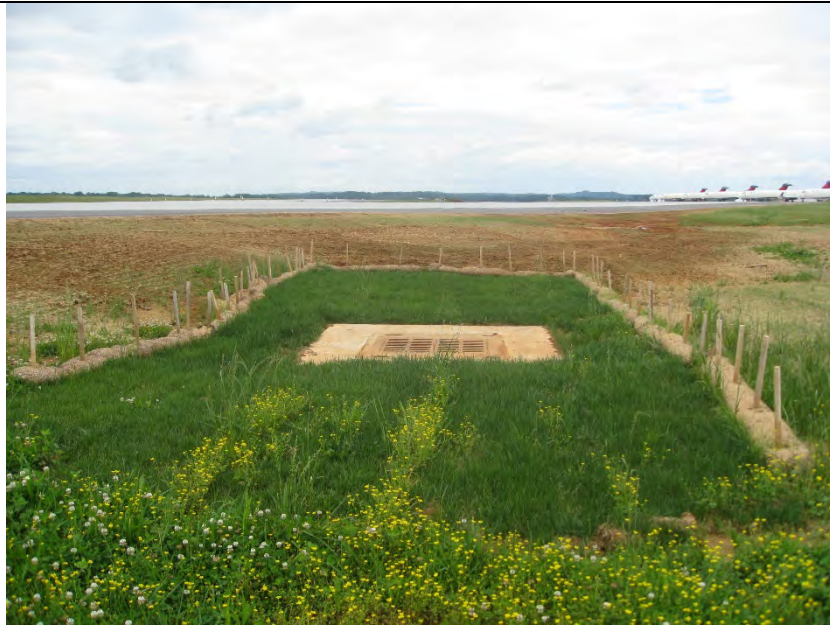
Photo 51  
Sta. 365+69 RT  
(RW 5L-23R)  
Structure 300  
Project 4

Structure 300.  
Recommend stabilizing bare areas.

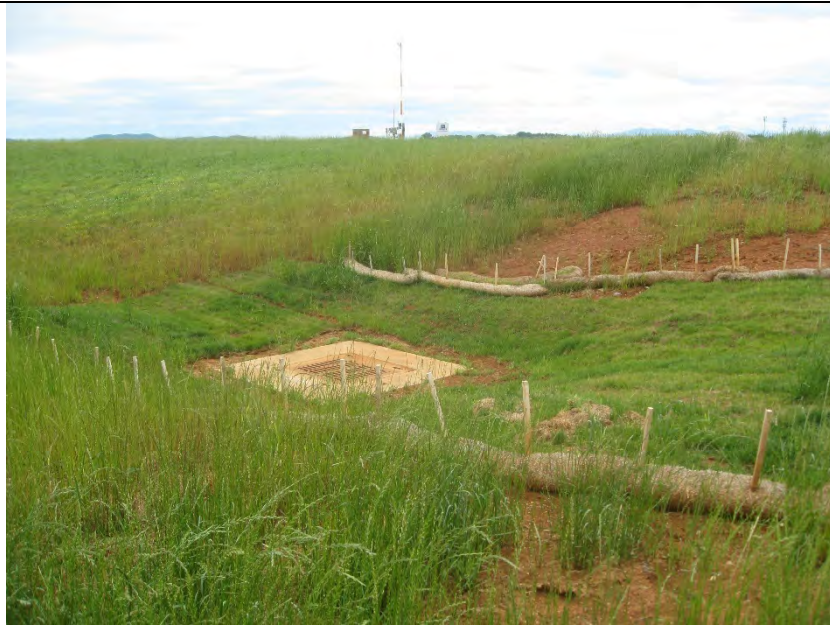
Photo 57  
Sta. 347+26 RT  
(RW 5L-23R)  
Structure 22  
Project 4

Structure 22.  
Sediment tubes recently relocated to edge of sod. Recommend stabilizing bare areas.

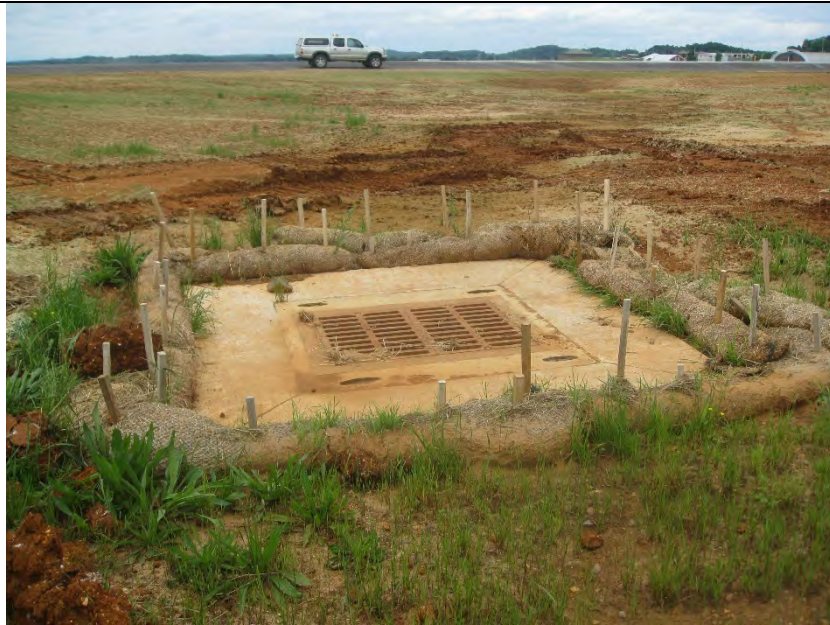
Photo 59  
Sta. 347+26 RT  
(RW 5L-23R)  
Structure 202  
Project 4

Structure 202.  
Shoulders recently stabilized.  
Recommend stabilizing remaining bare areas.

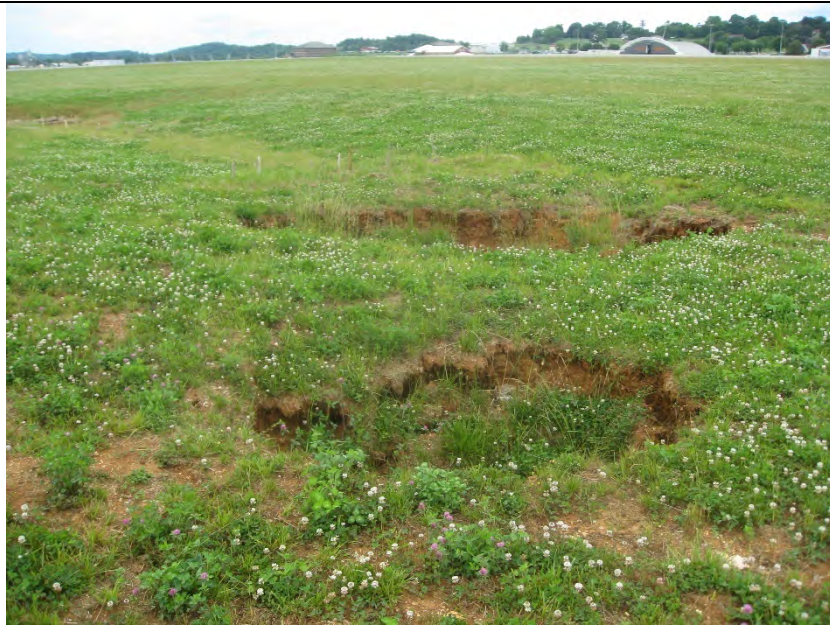
Photo 61  
Sta. 341+86 RT  
(RW 5L-23R)  
Project 4

Construction fallout on Storm Line 2 between structures 204 and 206.  
Recommend coordinating remediation with CHA.

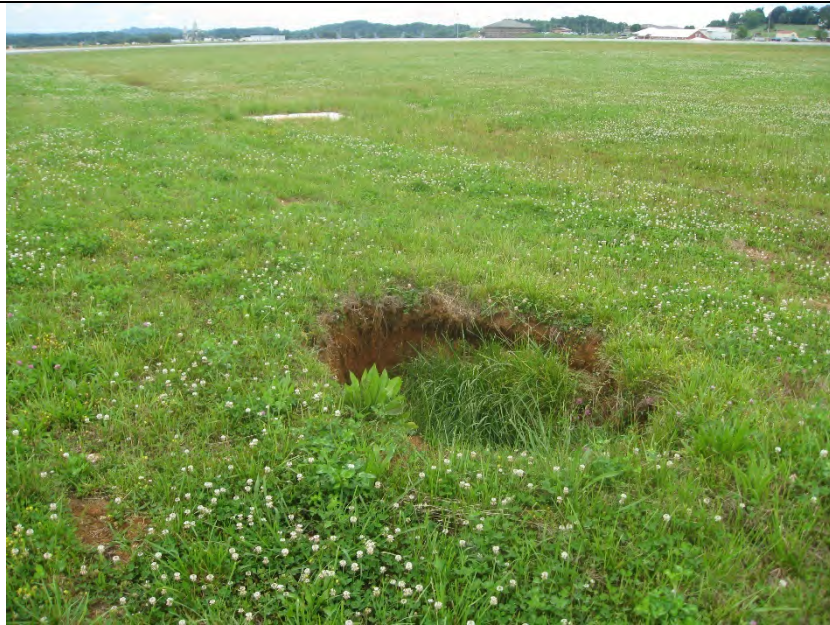
Photo 63  
(RW 5L-23R)  
Project 4

Construction fallout on Storm Line 2 between structures 206 and 208.  
Recommend coordinating remediation with CHA.

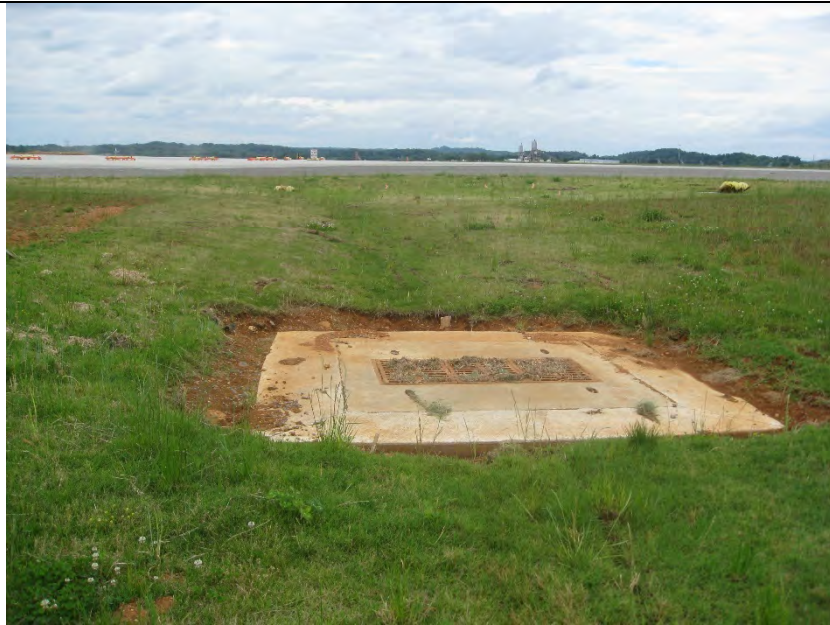
Photo 65  
Sta. 329+86 RT  
(RW 5L-23R)  
Structure 210  
Project 3

Structure 210.  
Recommend stabilizing bare areas above sediment tubes.

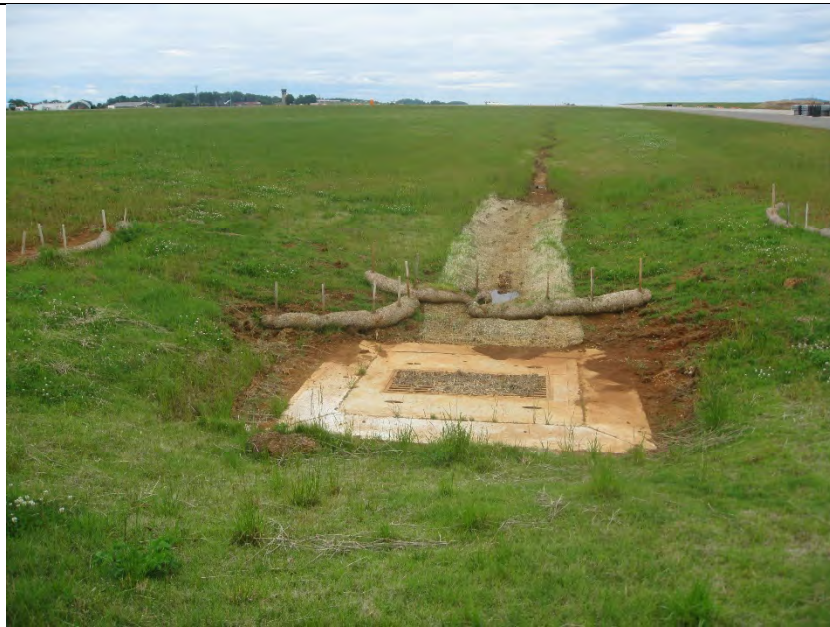
Photo 69  
Sta. 301+87 RT  
(RW 5L-23R)  
Structure 218  
Project 3

Structure 218.  
Erosion control blanket recently added.  
Recommend stabilizing bare areas.  
Recommend removing sediment from top of structure.

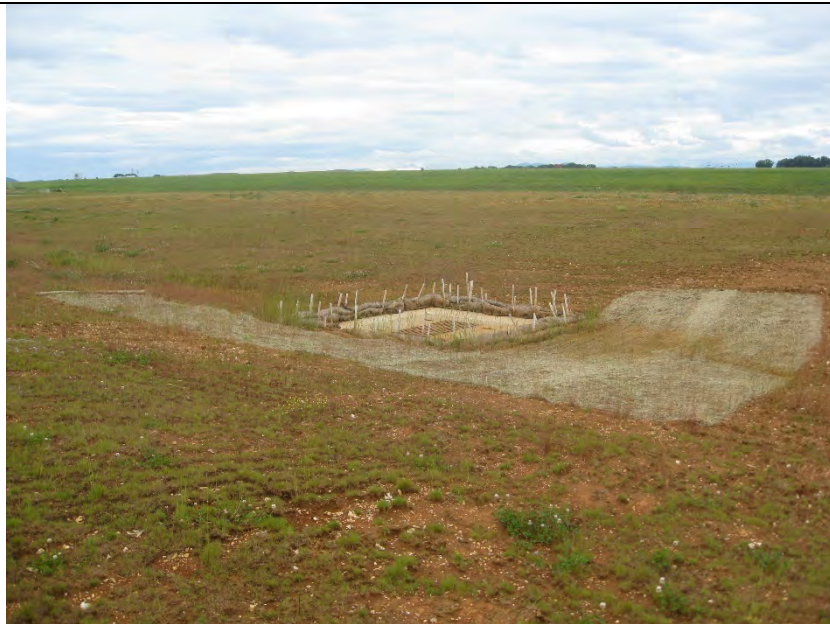
Photo 70  
Sta. 296+83 RT  
(RW 5L-23R)  
Structure 220  
Project 2

Structure 220.  
Recommend stabilizing remaining bare areas.

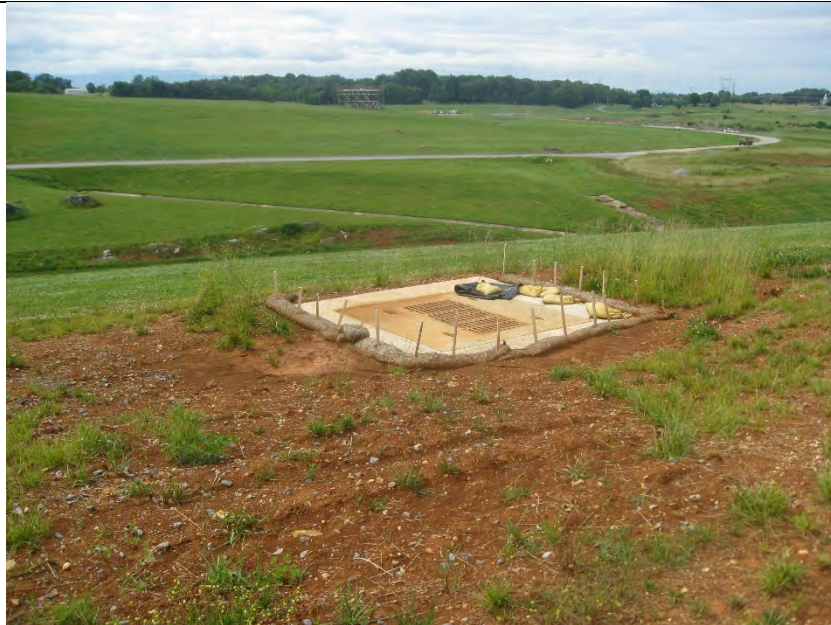
Photo 73  
Sta. 290+26 RT  
(RW 5L-23R)  
Structure 222  
Project 2

Structure 222.  
Recommend removing inlet protection.  
Recommend stabilizing bare areas.

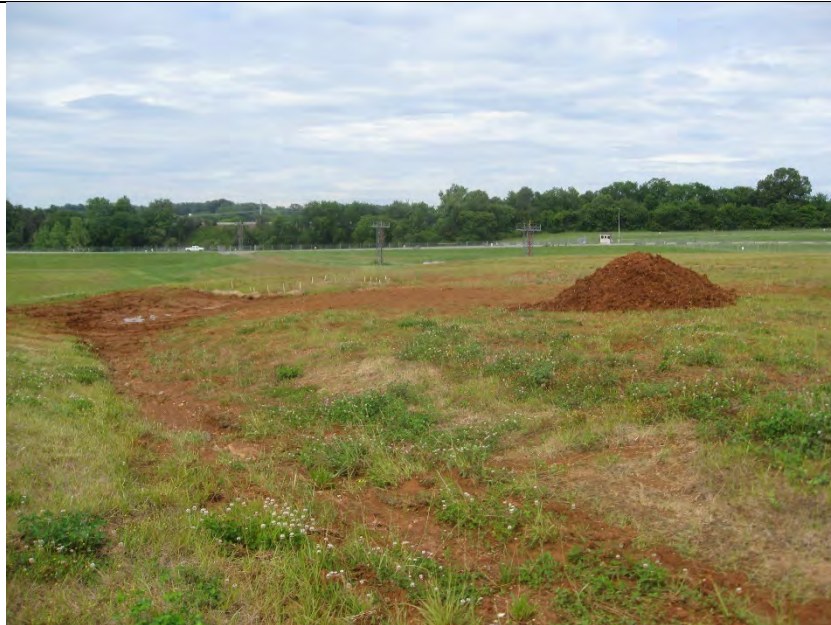
Photo 75  
Sta. 290+26 RT  
(RW 5L-23R)  
Structure 600 Ditch  
Project 2

Structure 600 ditch.  
Sediment recently removed from ditch line and stock piled.  
Recommend stabilizing bare areas.

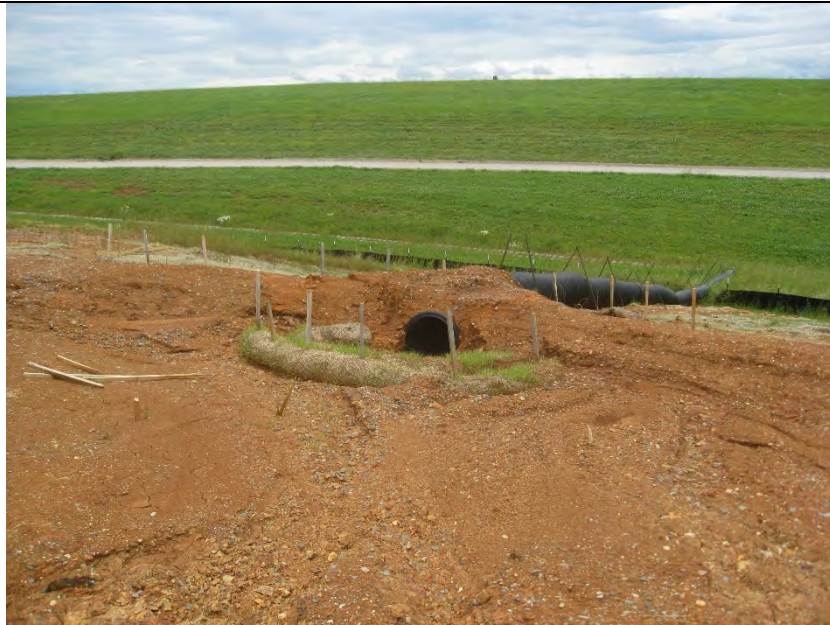
Photo 87  
Sta. 302+54  
(RW 5L-23R)  
Project 2

Soil stockpile area next to haul road at Taxiway B.  
Berm recently reworked.  
Recommend reinstalling sediment tubes to wrap around front of slope drain and tie into berms.

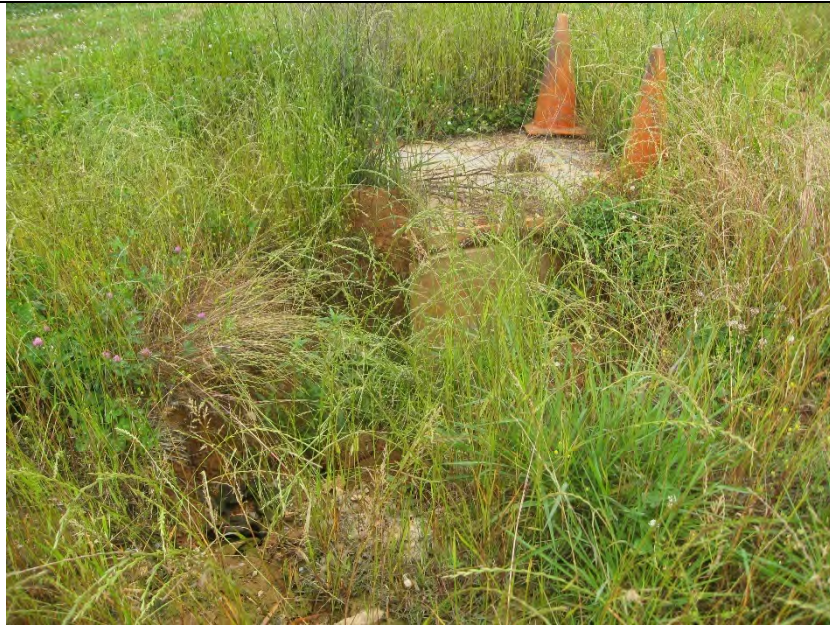
Photo 99  
Sta. 284+00 LT  
(RW 5L-23R)  
Project 2

Existing vault at old Liberty street.  
Construction fallout present. Recommend coordinating with CHA on remediation.

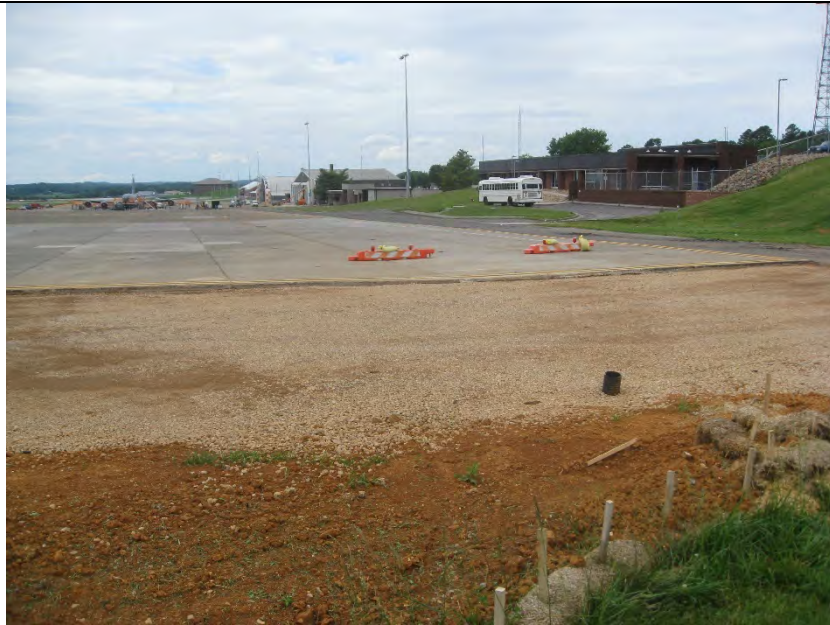
Photo 103  
(Repair TWY Lighting)  
Sheet EC2.1.7

Existing structure at Upper Apron.  
Base stone recently installed. Area appears to be stable.  
Recommend continuing to monitor for possible sediment migration and/or color contrasted water entering apron storm structures.

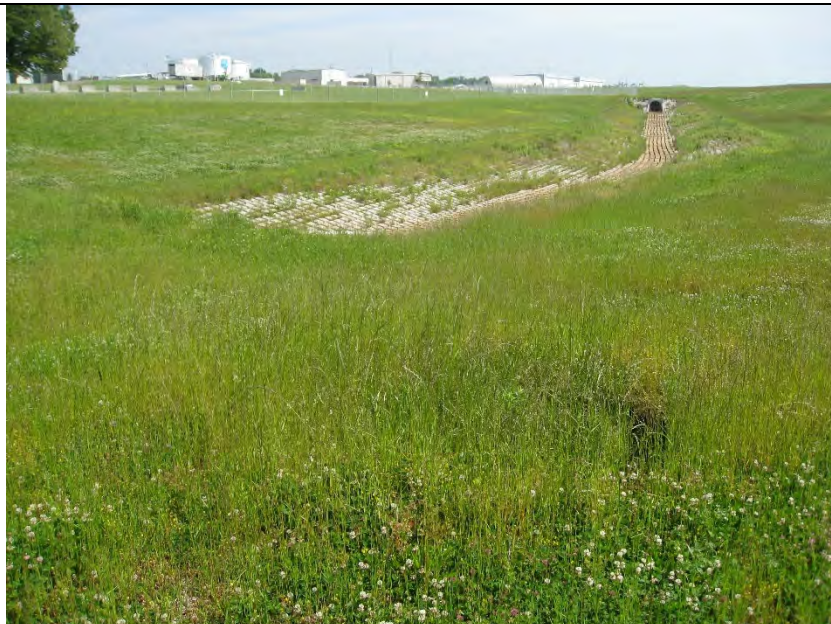
Photo 8  
Sta. 117+00  
(Line LB)  
Project 2

Above the Guard Lateral Ditch (Outfall B).  
Construction fall out present. Recommend coordinating remediation with CHA.

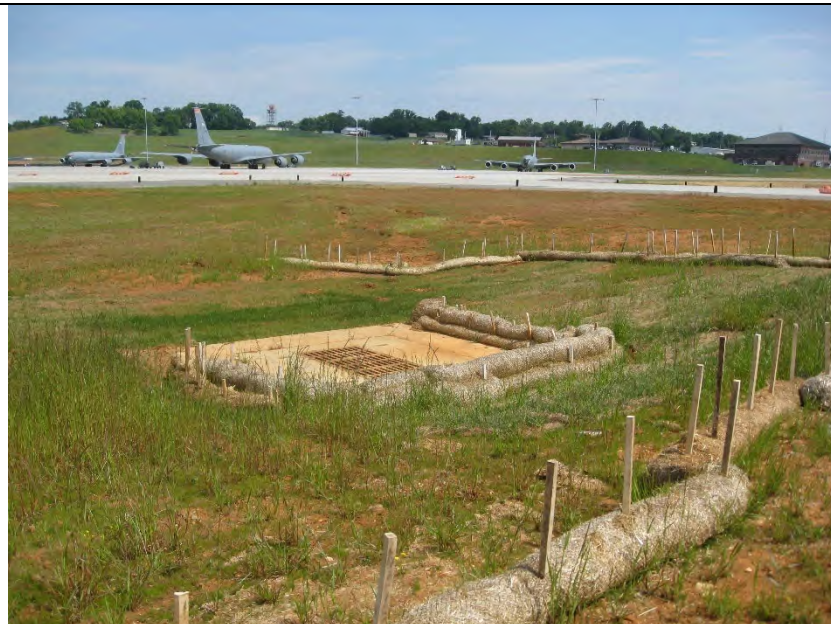
Photo 16  
Sta. 298+71 LT  
(RW 5L-23R)  
Structure 116  
Project 3

Structure 116.  
Recommend stabilizing bare areas.

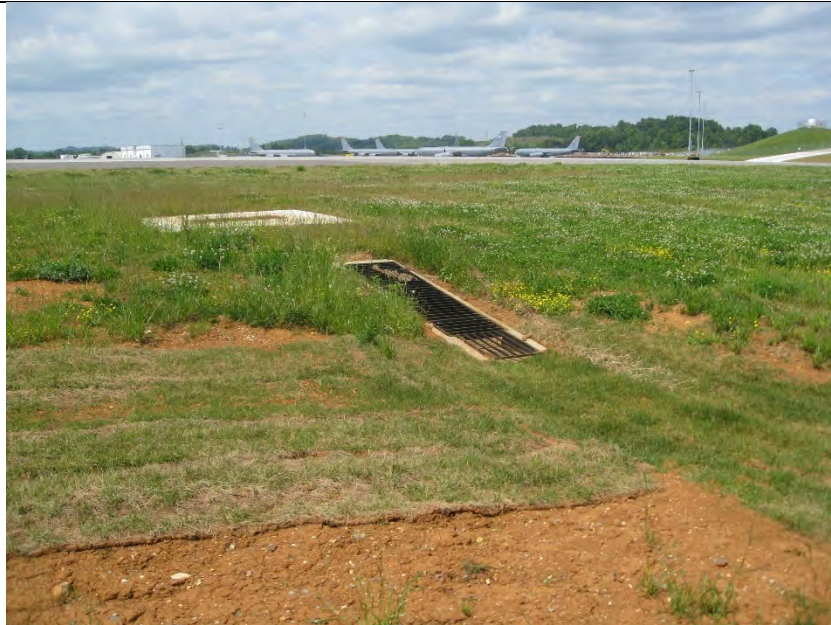
Photo 21  
Sta. 314+48 LT  
(RW 5L-23R)  
ES Endwall 108  
Project 3

Enhanced Swale Endwall 108.  
Recommend stabilizing remaining bare areas.

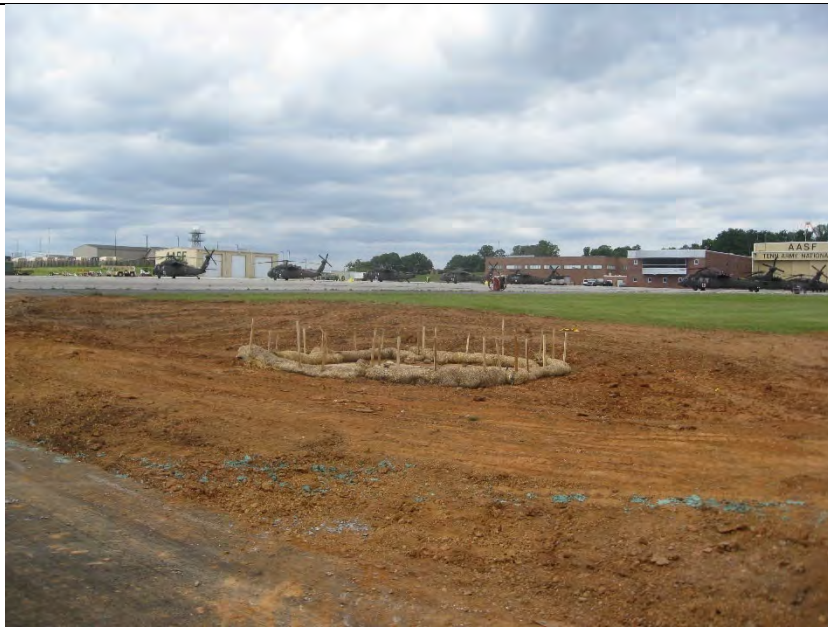
Photo 45  
Sta. 676+00 RT  
(RW 5L-23R)  
Project 4

New structure recently placed.  
Sediment tubes recently installed.  
Area recently backfilled.  
Recommend stabilizing remaining bare areas.

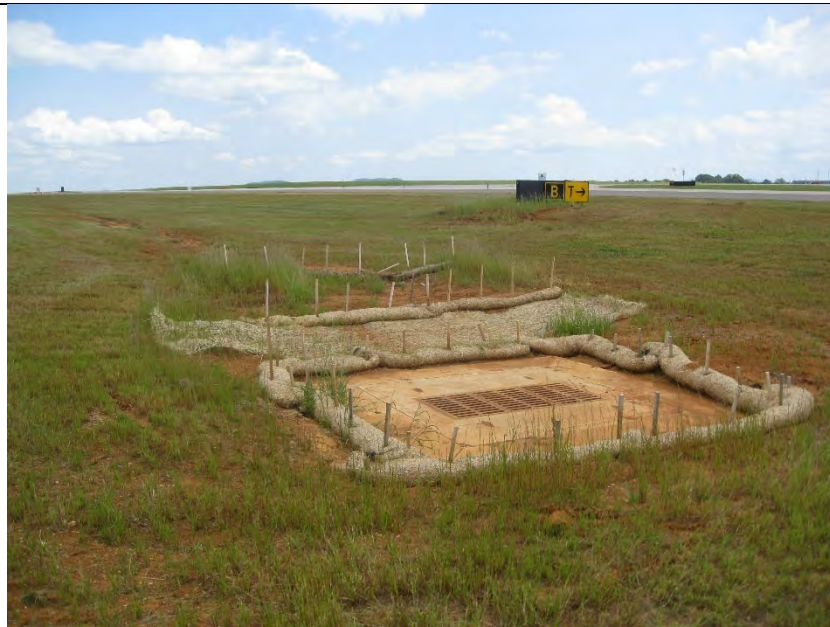
Photo 65  
Sta. 321+73 RT  
(RW 5L-23R)  
Structure 212  
Project 3

Structure 212.  
Sediment recently removed.  
Recommend stabilizing remaining bare areas.

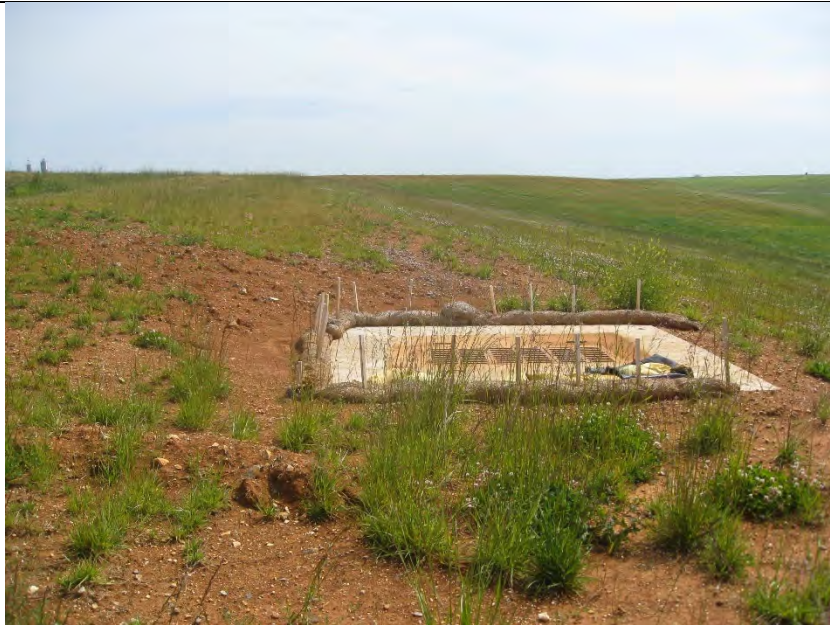
Photo 71  
Sta. 290+26 RT  
(RW 5L-23R)  
Structure 222  
Project 2

Structure 222.  
Recommend removing inlet protection.  
Recommend stabilizing bare areas.

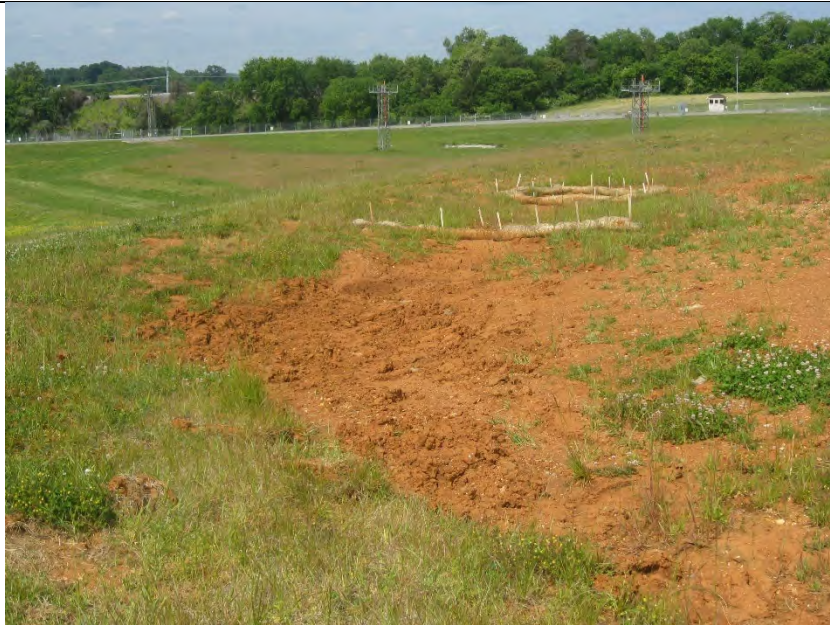
Photo 73  
Sta. 290+26 RT  
(RW 5L-23R)  
Structure 600 Ditch  
Project 2

Structure 600 ditch.  
Sediment continues to accumulate due to erosion of ditch line from storm events  
(see previous photo)  
Recommend stabilizing bare areas.

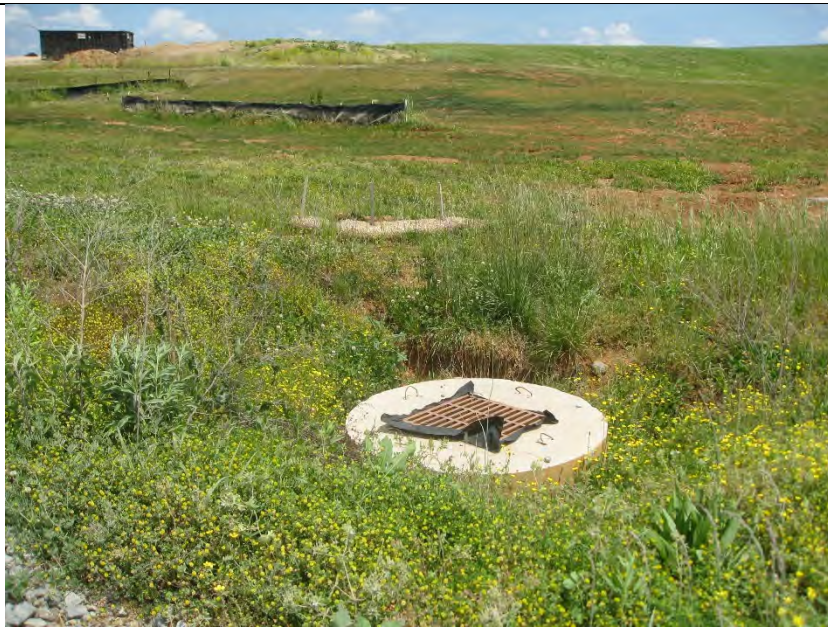
Photo 81  
Sta. 37+25 RT  
Proposed Haul Route  
Project 3

Inlet structures along haul road.  
Recommend stabilizing bare areas.

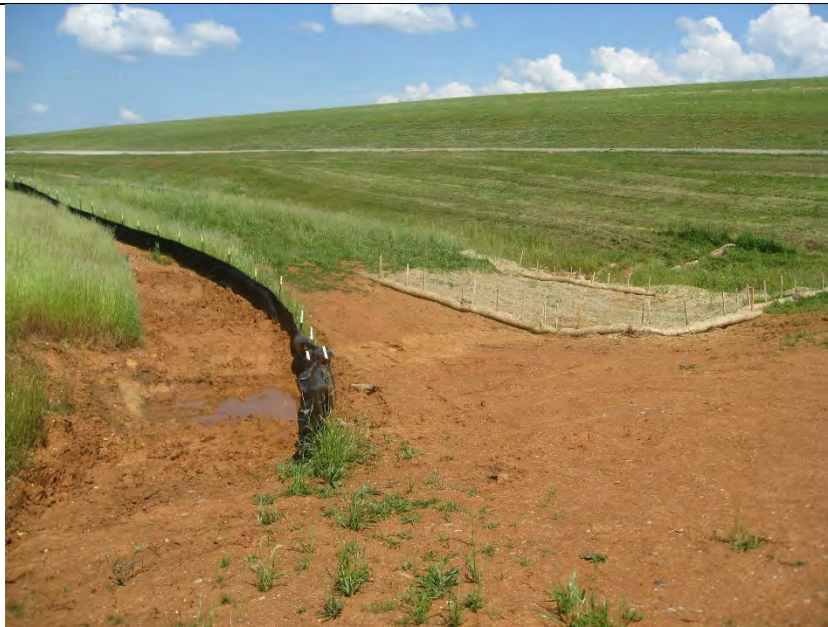
Photo 83  
Sta. 302+54  
(RW 5L-23R)  
Project 2

Above North Lateral Endwall 100.  
Sediment tubes and sediment recently removed.  
Recommend stabilizing remaining bare areas

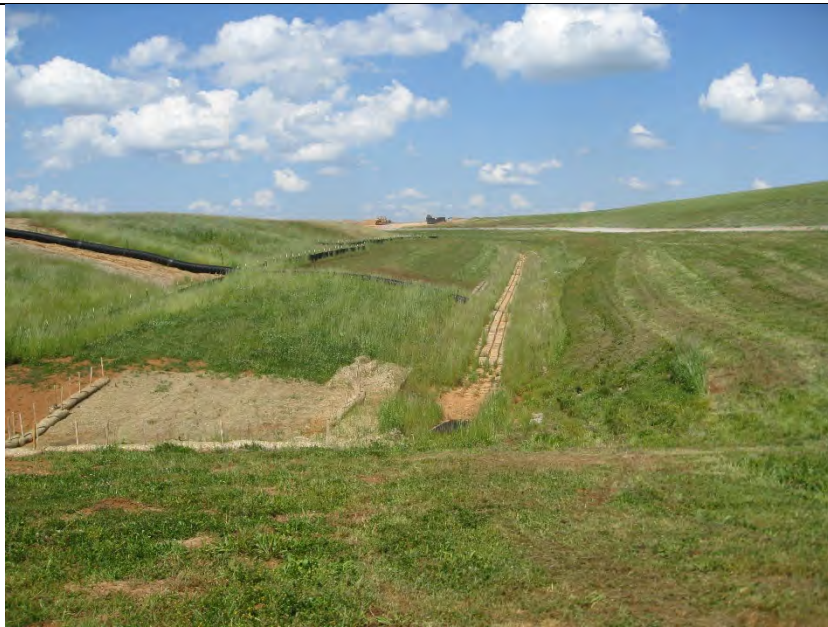
Photo 85  
Sta. 302+54 to Sta. 313+50  
(RW 5L-23R)  
Project 2

North Lateral Endwall 100.  
Recommend stabilizing remaining bare areas

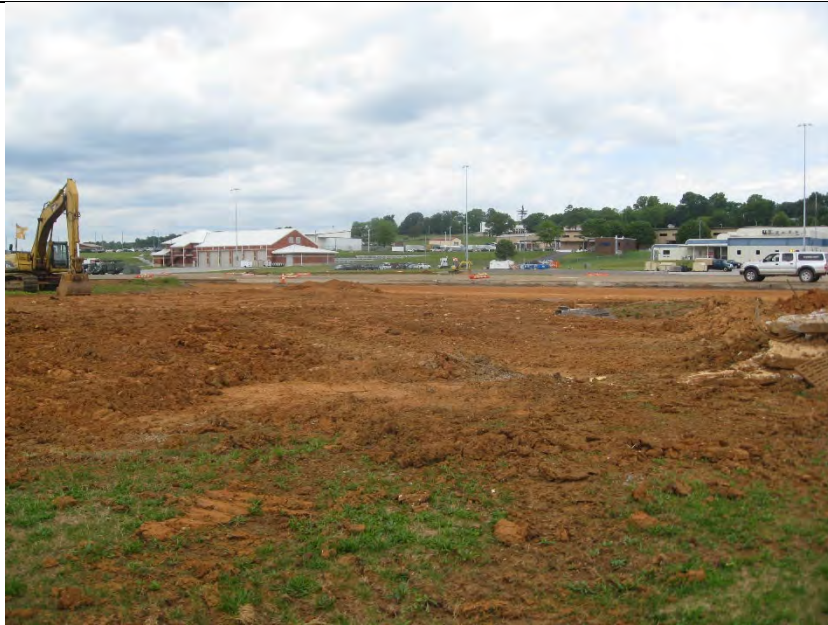
Photo 101  
(Repair TWY Lighting)  
Sheet EC2.1.6

Existing remaining Taxiway G4 recently demolished.  
Existing trench drain recently removed.  
Recommend stabilizing bare areas once activities are complete or remain inactive for longer than 14 days.
