**QUALITY ASSURANCE  
MONTHLY SITE  
ASSESSMENT REPORT**

Airfield Modernization Program  
Runway 5L-23R Reconstruction  
Project 2 / Project 3

## QUALITY ASSURANCE SITE ASSESSMENT

## **AIRFIELD MODERNIZATION PROGRAM RUNWAY 5L-23R RECONSTRUCTION**

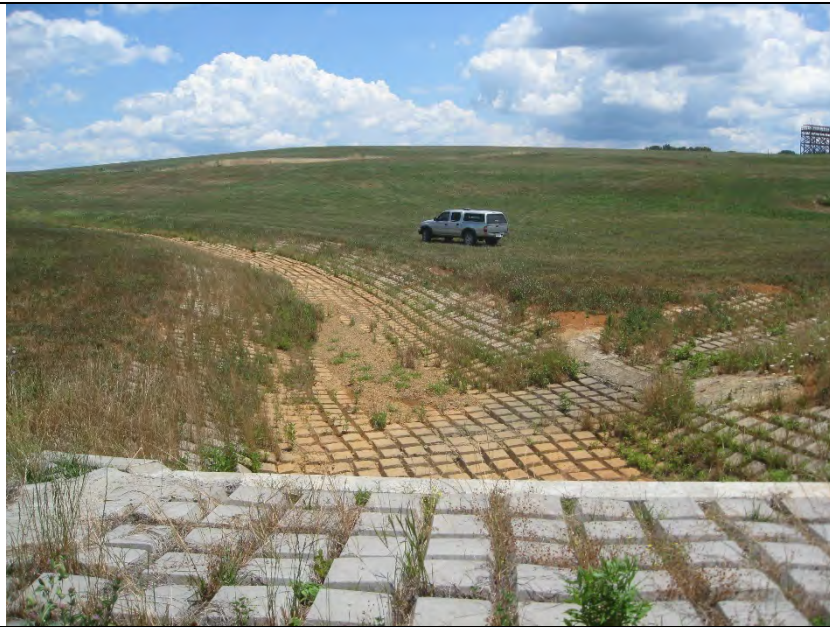
Photo 1  
Sta. 111+56 RT  
(Line LB)  
NLET 01  
Project 2

North Lateral End Treatment 01 (Outfall A).

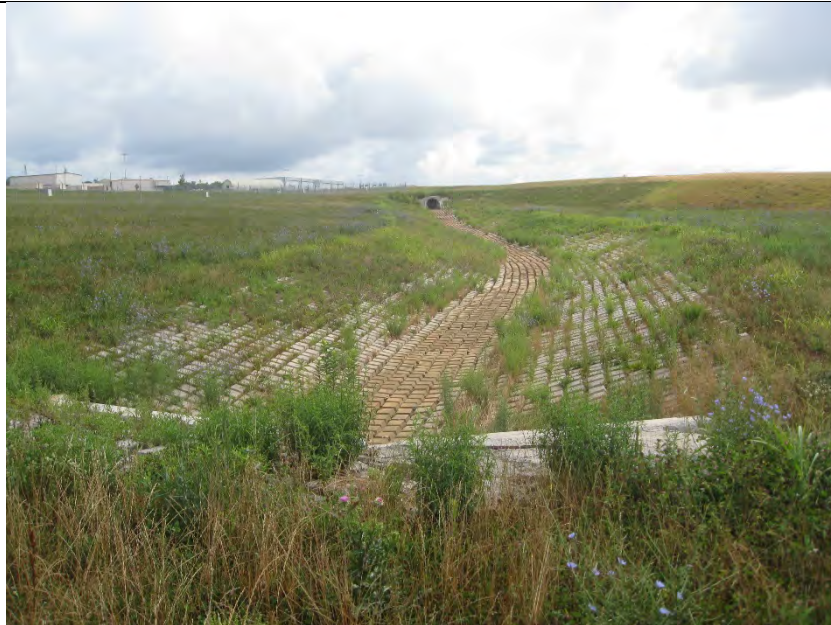
Photo 7  
Sta. 117+00  
(Line LB)  
Project 2

Guard Lateral Ditch (Outfall B).

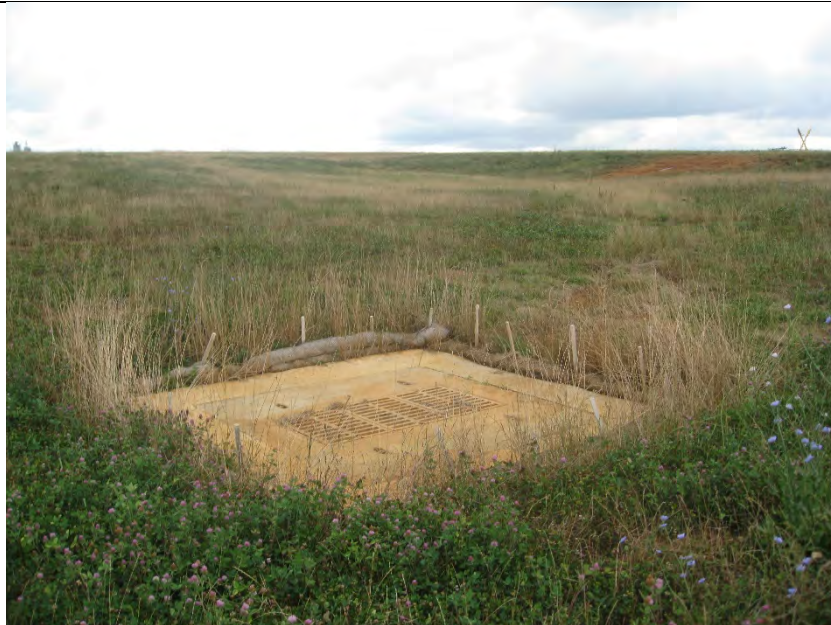
Photo 11  
Sta. 291+51 LT  
(RW 5L-23R)  
Structure 120  
Project 3

Structure 120.

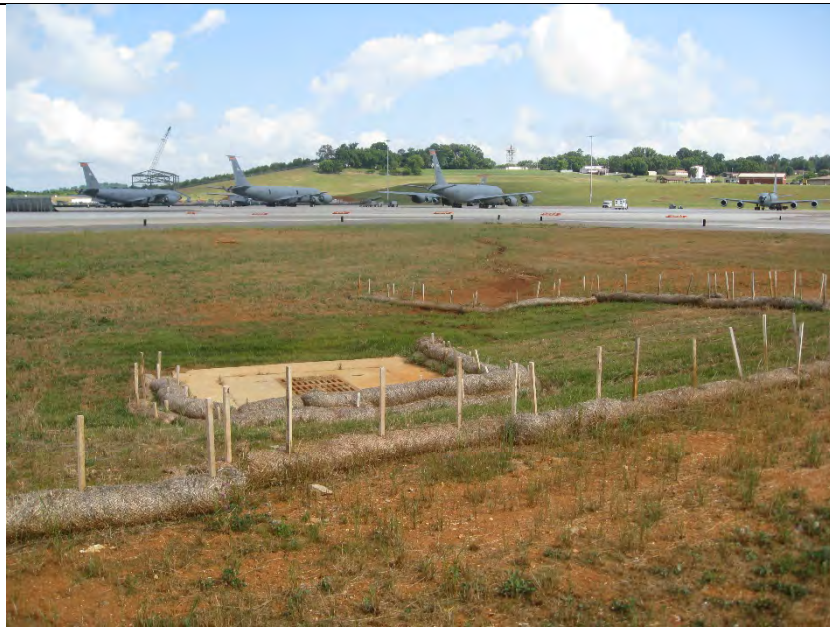
Photo 13  
Sta. 298+71 LT  
(RW 5L-23R)  
Structure 116  
Project 3

Structure 116.  
Recommend stabilizing bare areas.

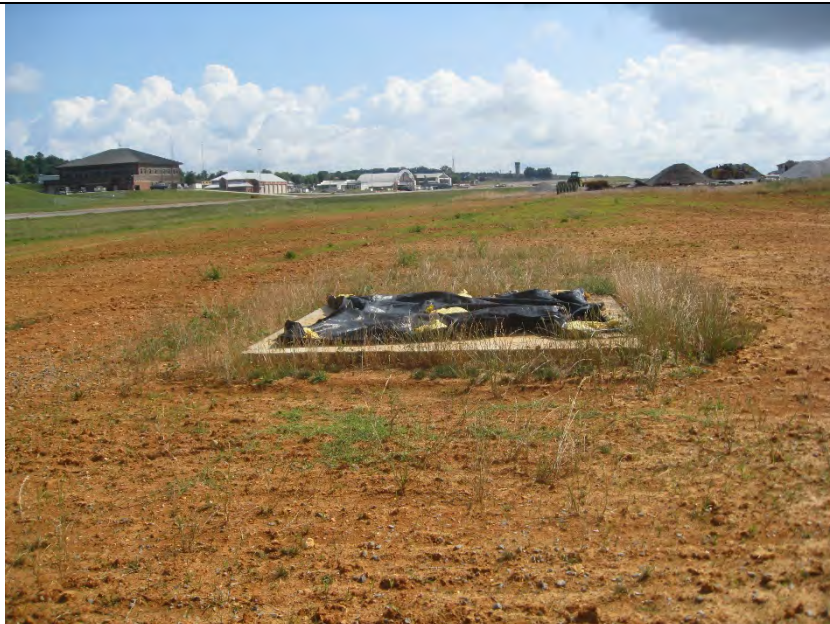
Photo 14  
Sta. 302+54 LT  
(RW 5L-23R)  
Structure 114  
Project 3

Structure 114.  
Bare areas recently stabilized.

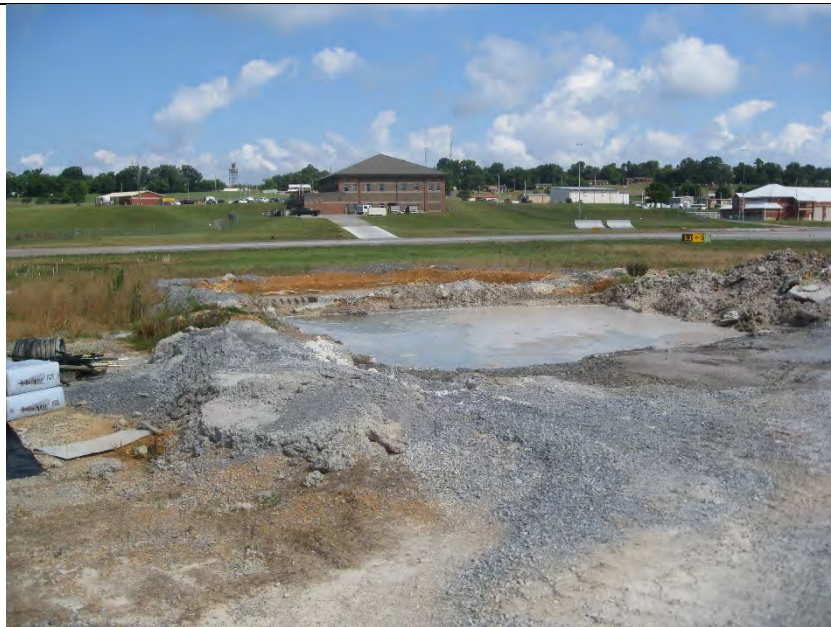
Photo 17  
Concrete washout area  
Project 3

Concrete washout area.  
Washout area appears to be in use again.  
Recommend reinstalling proper signage per the permit.

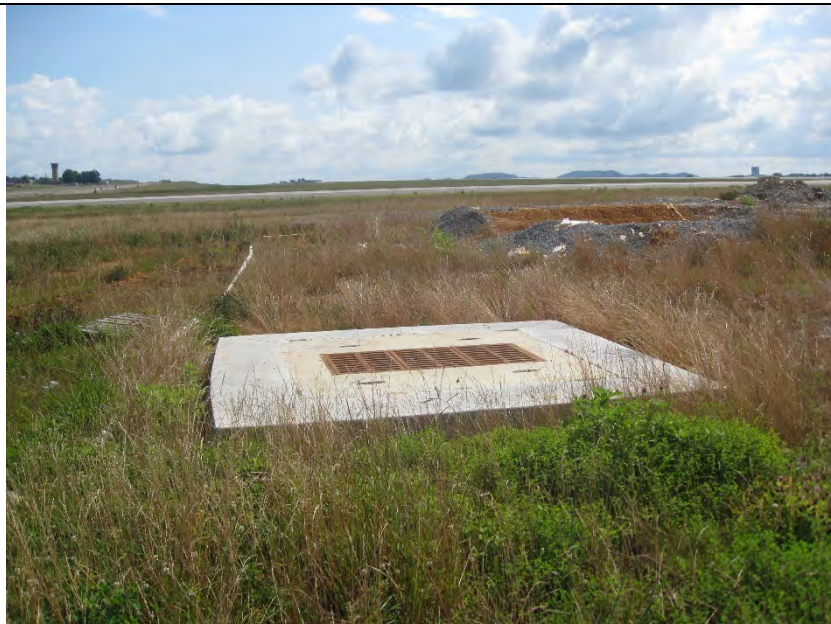
Photo 18  
Sta. 310+00 LT  
(RW 5L-23R)  
Project 3

Structure 112

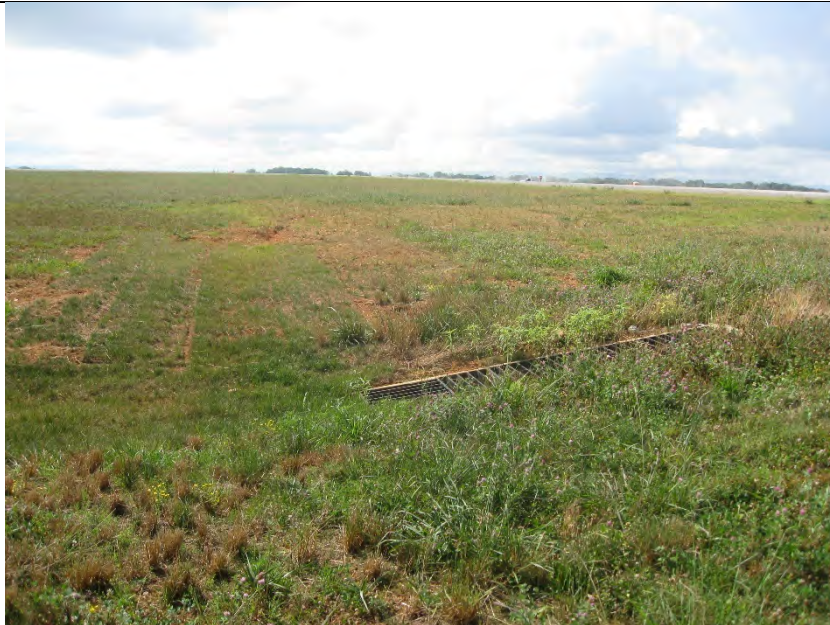
Photo 19  
Sta. 314+48 LT  
(RW 5L-23R)  
ES Endwall 108  
Project 3

Enhanced Swale Endwall 108.  
Recommend stabilizing remaining bare areas.

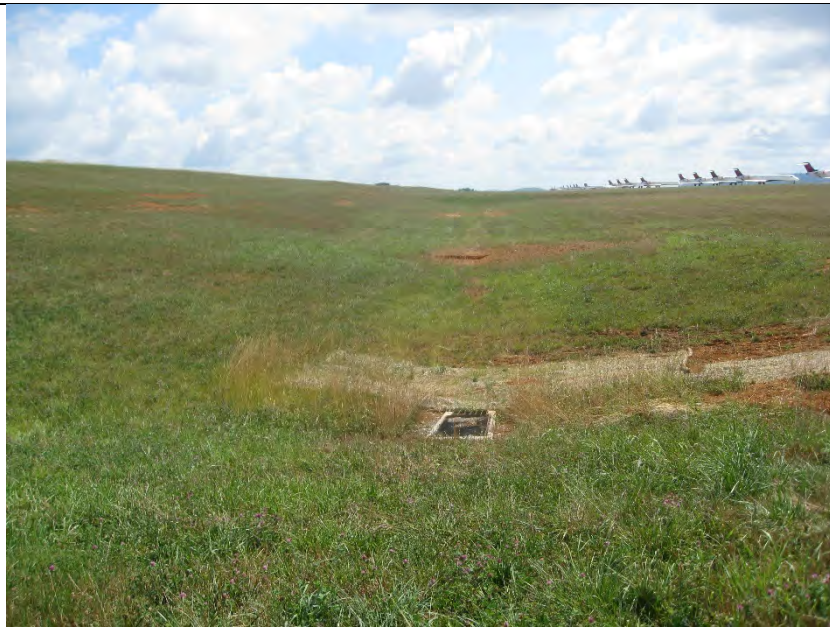
Photo 31  
Sta. 347+31 LT  
(RW 5L-23R)  
ES Endwall 102  
Project 3

Enhanced Swale Endwall 102.  
Recommend stabilizing remaining bare areas.

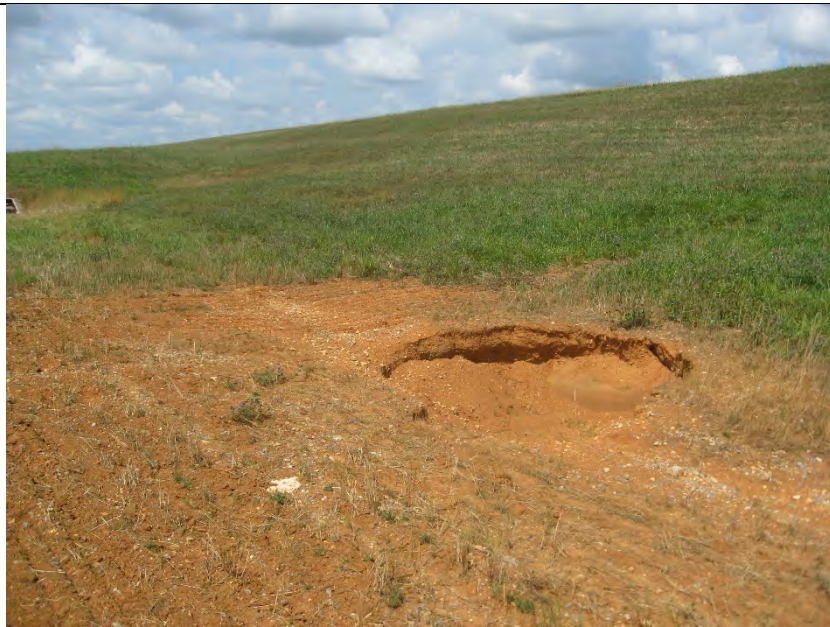
Photo 33  
Sta. 341+50 LT  
(RW 5L-23R)  
ES Endwall 102  
Project 3

Construction fallout on Storm Line 1 between ES Endwall 102 and 100.  
Coordinate remediation with CHA.

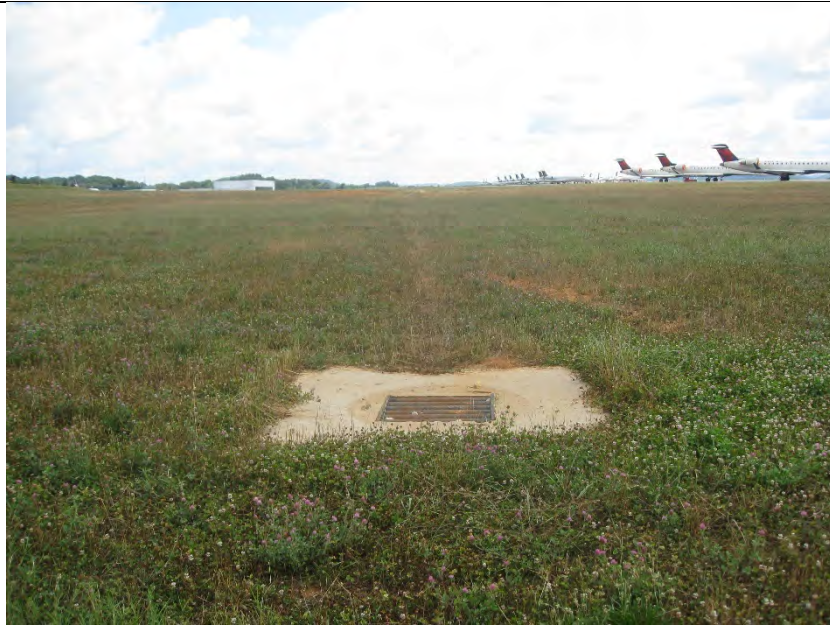
Photo 37  
Sta. 363+35 LT  
(RW 5L-23R)  
Existing Structure  
Project 2

Existing Structure.

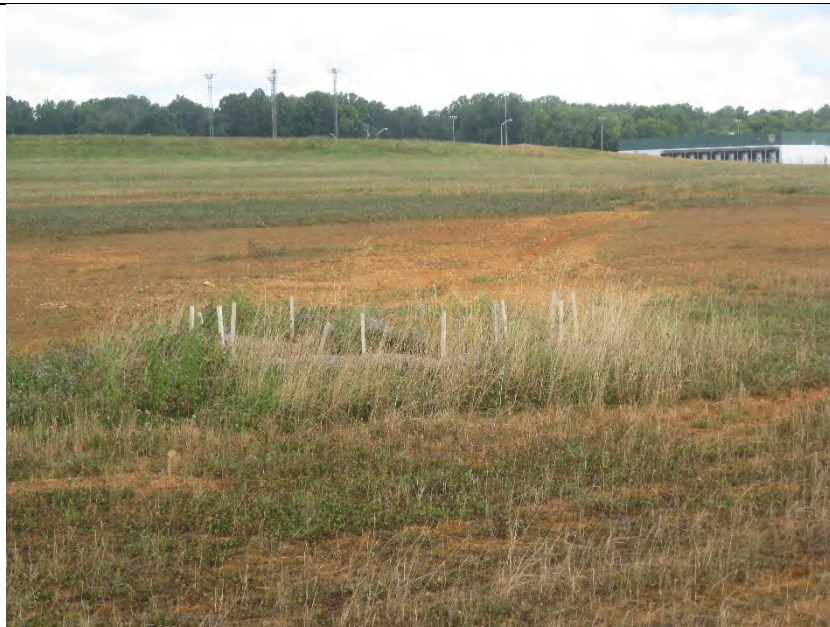
Photo 39  
Sta. 369+11 LT  
(RW 5L-23R)  
Existing Structure  
Project 2

Existing Structure.  
Recommend stabilizing bare areas.

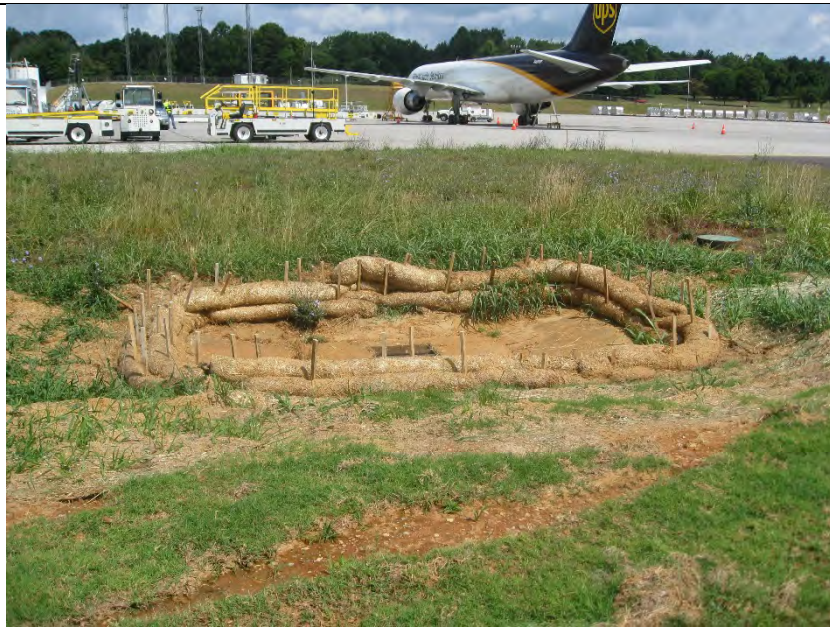
Photo 41  
Sta. 677+00 RT  
(RW 5L-23R)  
Project 4

Structure between Taxiway G and UPS Facility.

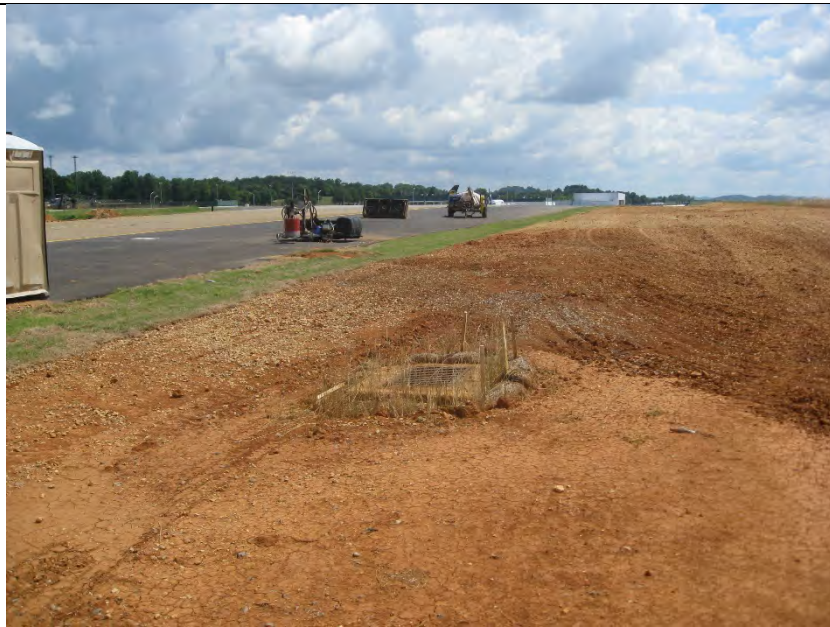
Photo 43  
(RW 5L-23R)  
Existing Structure  
Project 4

Existing structure south of Taxiway G  
Area recently regraded, recommend stabilizing bare areas.

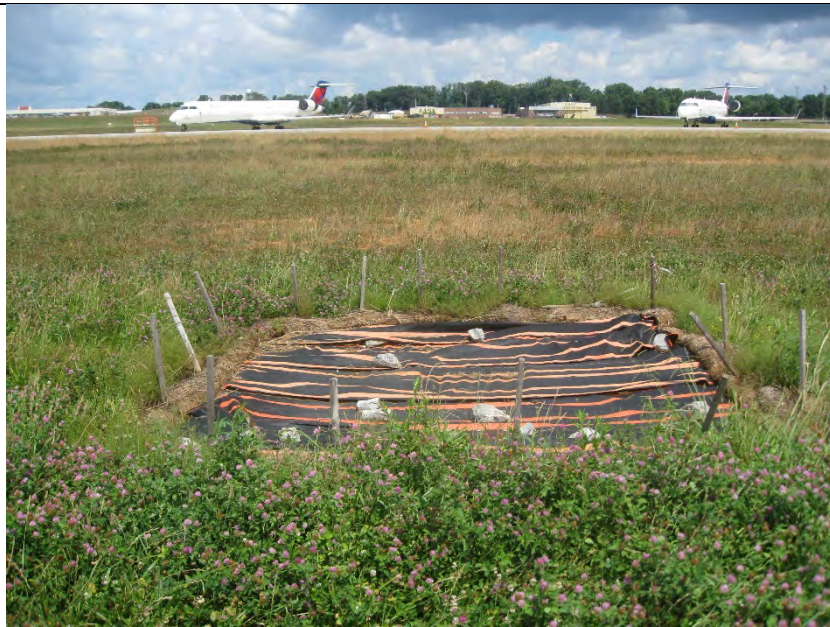
Photo 47  
Sta. 366+89 RT  
(RW 5L-23R)  
Outfall C  
Project 4

Recommend removing filter fabric from this structure to allow sampling for DMR.  
(Outfall C).

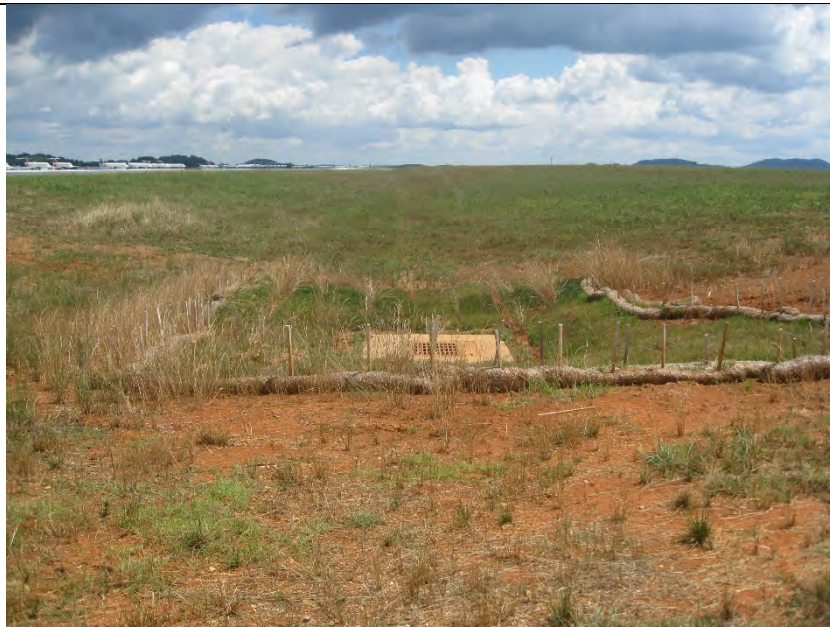
Photo 53  
Sta. 347+26 RT  
(RW 5L-23R)  
Structure 22  
Project 4

Structure 22.  
Sediment tubes recently relocated to edge of sod. Recommend stabilizing bare areas.

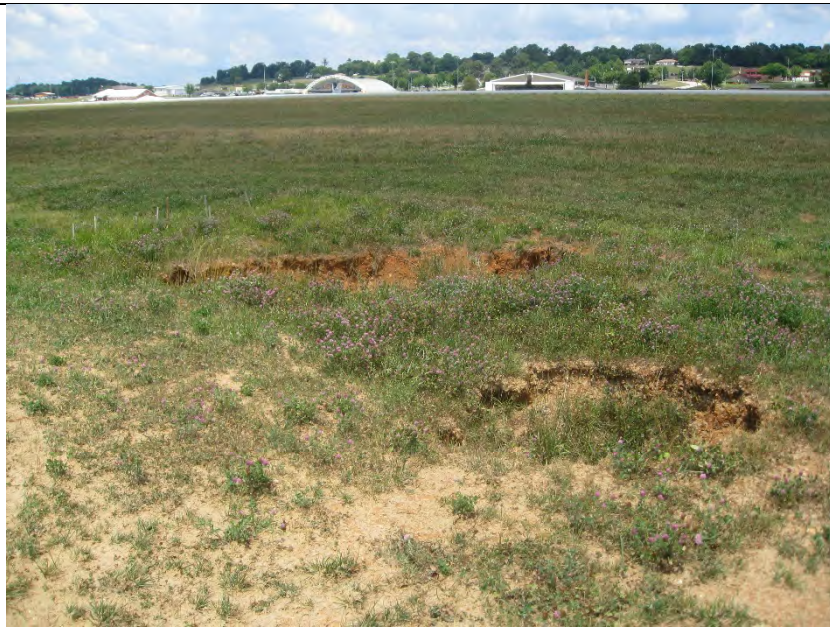
Photo 57  
Sta. 341+86 RT  
(RW 5L-23R)  
Project 4

Construction fallout on Storm Line 2 between structures 204 and 206.  
Recommend coordinating remediation with CHA.

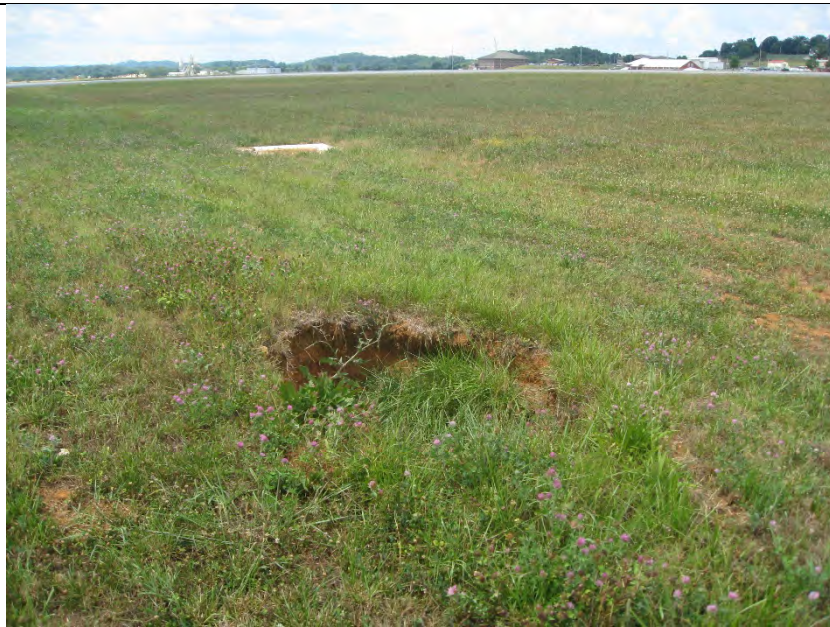
Photo 59  
(RW 5L-23R)  
Project 4

Construction fallout on Storm Line 2 between structures 206 and 208.  
Recommend coordinating remediation with CHA.

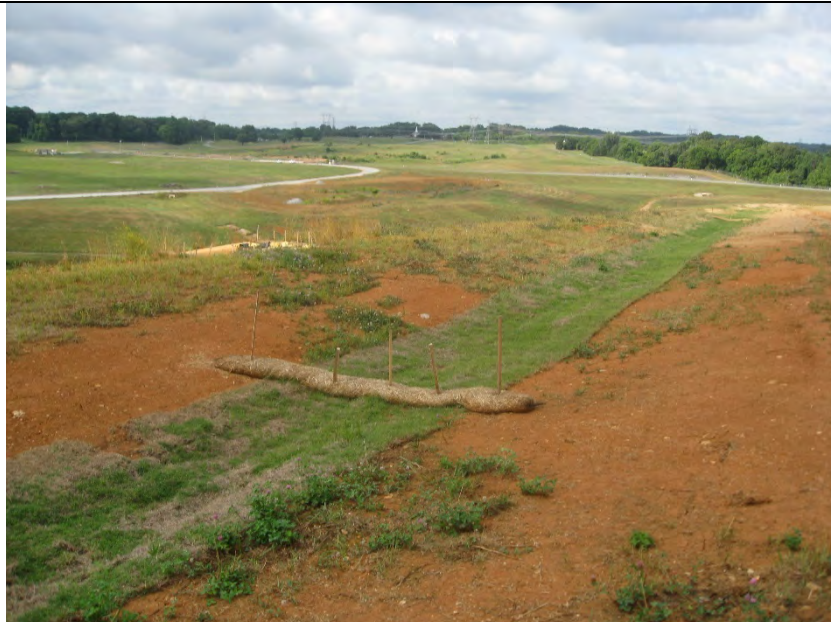
Photo 68  
Sta. 290+26 RT  
(RW 5L-23R)  
Structure 600 Ditch  
Project 2

Structure 600 Ditch.  
Ditch recently regraded and sod applied.  
Recommend stabilizing remaining bare areas.

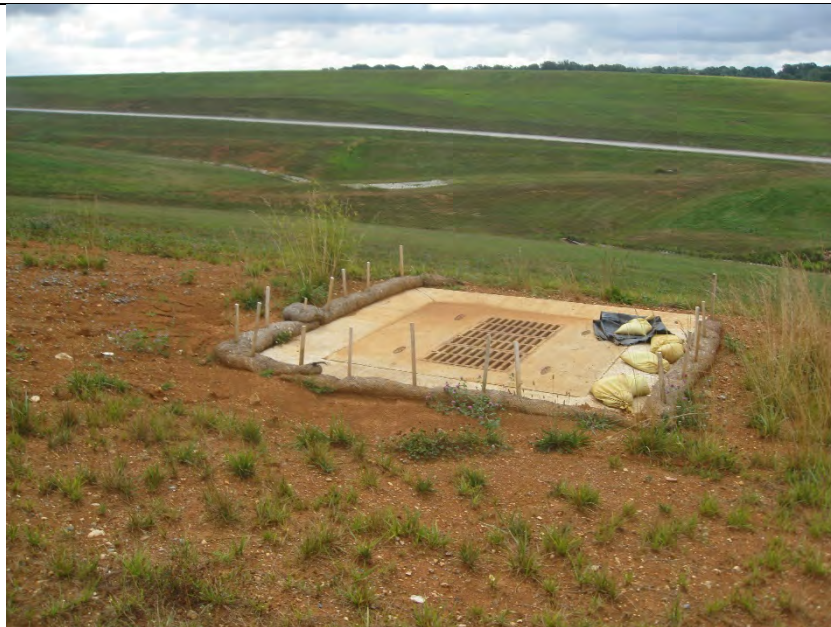
Photo 69  
Sta. 290+26 RT  
(RW 5L-23R)  
Structure 222  
Project 2

Structure 222.  
Recommend removing inlet protection.  
Recommend stabilizing bare areas.

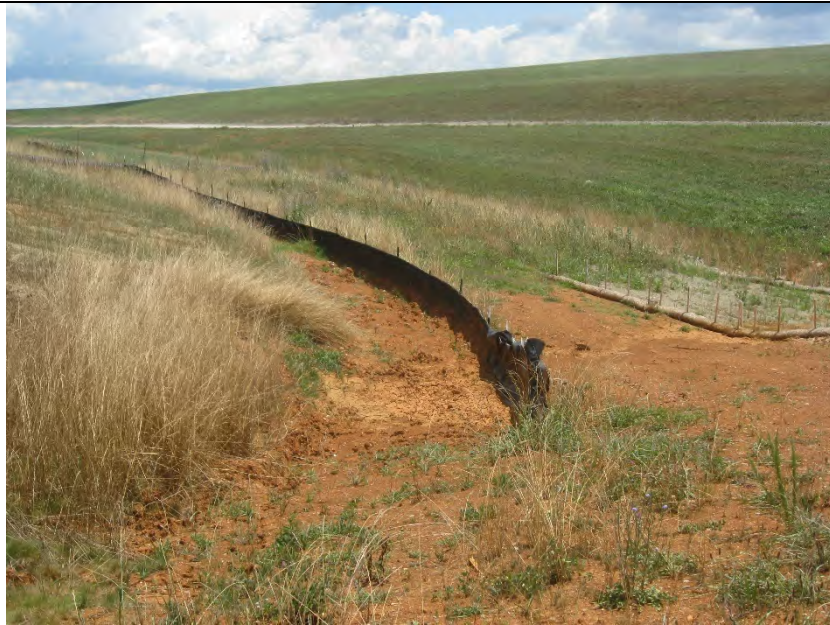
Photo 79  
Sta. 302+54  
(RW 5L-23R)  
Project 2

Above North Lateral Endwall 100.  
Erosion control blanket and sediment tubes recently added.  
Recommend stabilizing bare areas.

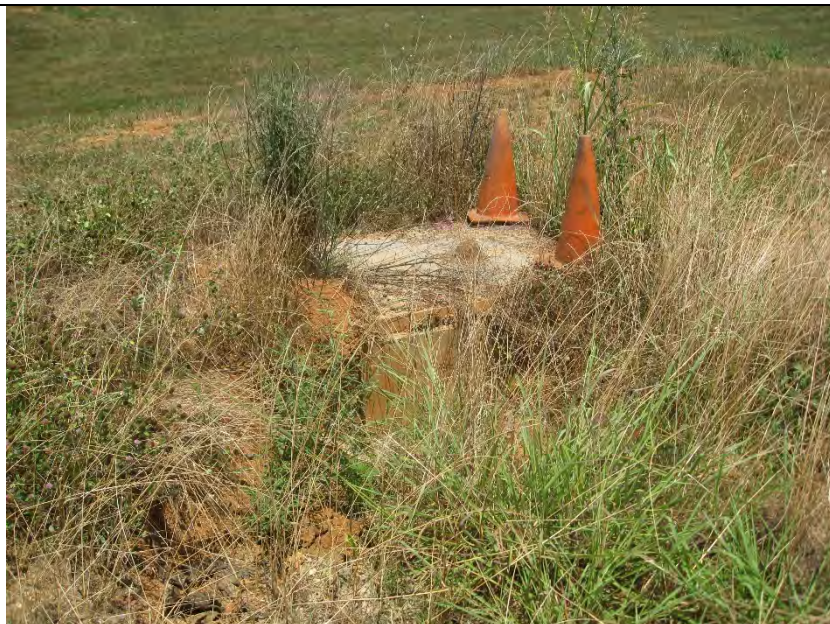
Photo 92  
Sta. 284+00 LT  
(RW 5L-23R)  
Project 2

Existing vault at old Liberty street.  
Construction fallout present. Recommend coordinating with CHA on remediation.

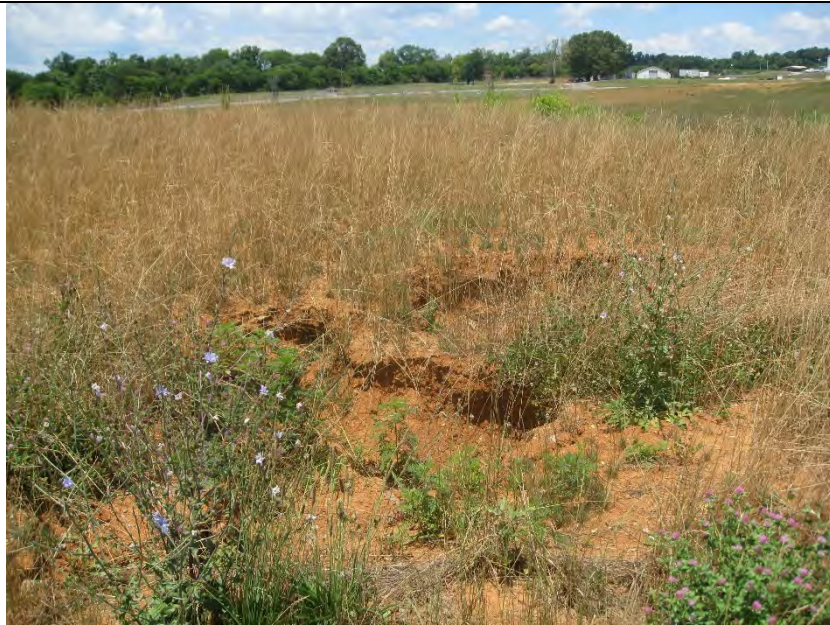
Photo 93  
Sta. 284+00 LT  
(RW 5L-23R)  
Project 2

Previous soil stockpile at old Liberty Street.  
Construction fallout present. Recommend coordinating with CHA on remediation.

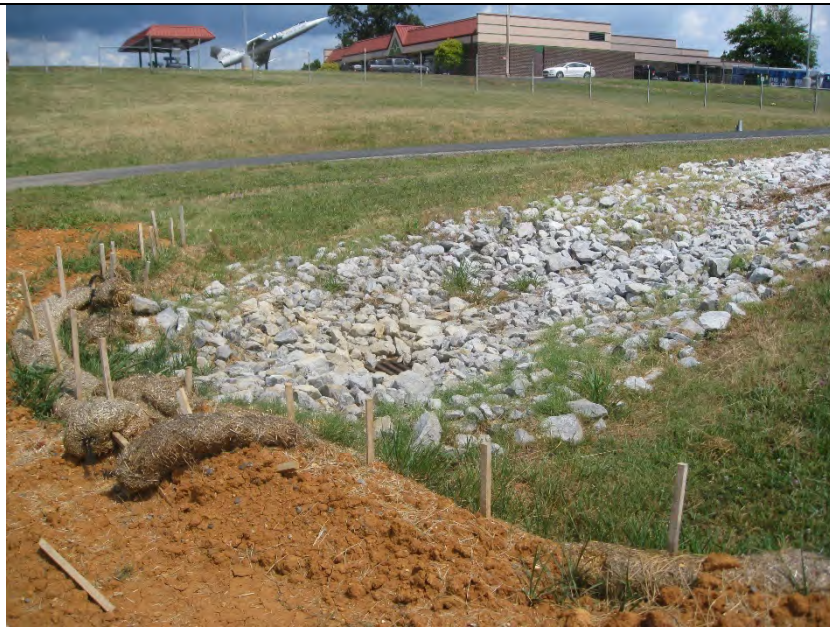
Photo 95  
(Repair TWY Lighting)  
Sheet EC2.1.7

Existing structure at Upper Apron.  
Base stone recently installed. Area appears to be stable.  
Recommend continuing to monitor for possible sediment migration and/or color contrasted water entering apron storm structures.

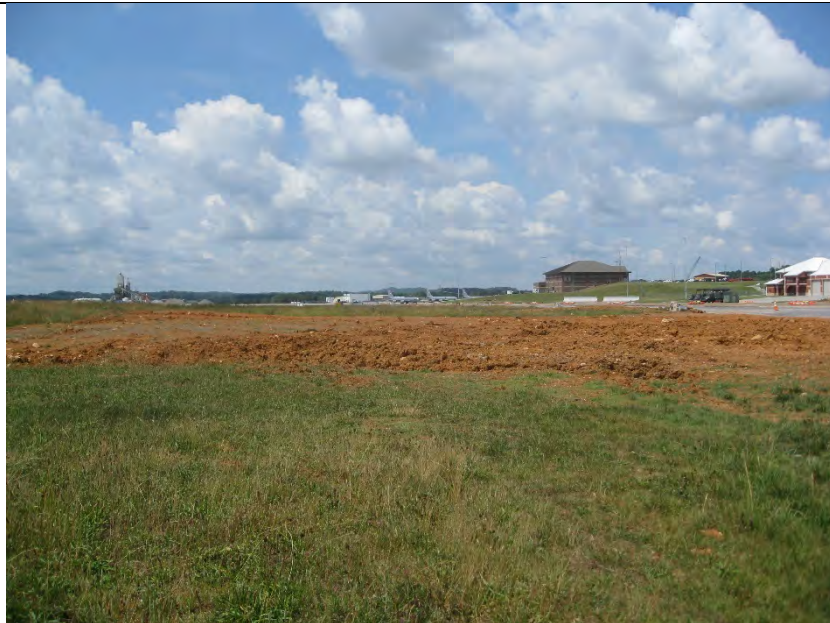
Photo 96  
(Repair TWY Lighting)  
Sheet EC2.1.6

Existing remaining Taxiway G4 recently demolished.  
Trench drain recently demolished.

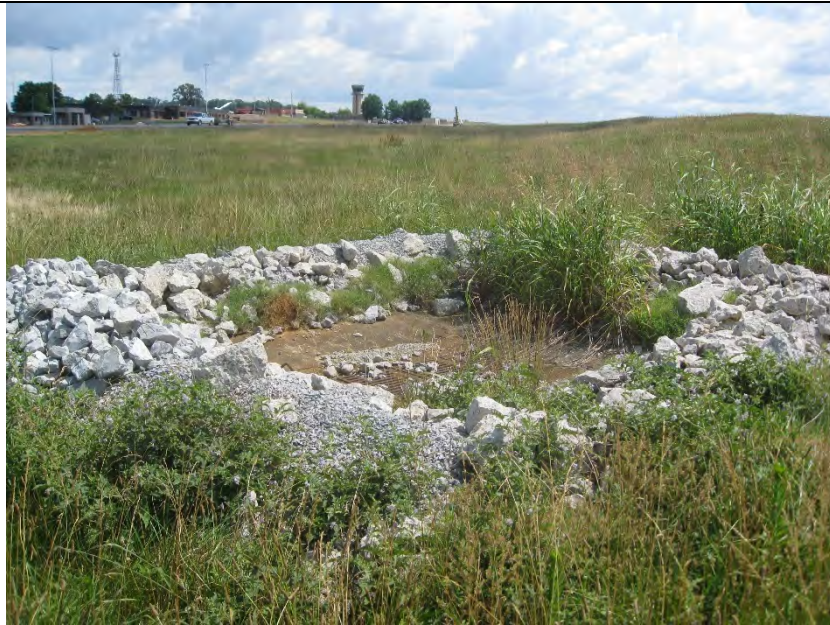
Photo 97  
(Repair TWY Lighting)  
Sheet EC2.1.6

Existing structure adjacent to Taxiway G4 being demolished.  
Original inlet protection from Project 2 in place and appears to be properly functioning.

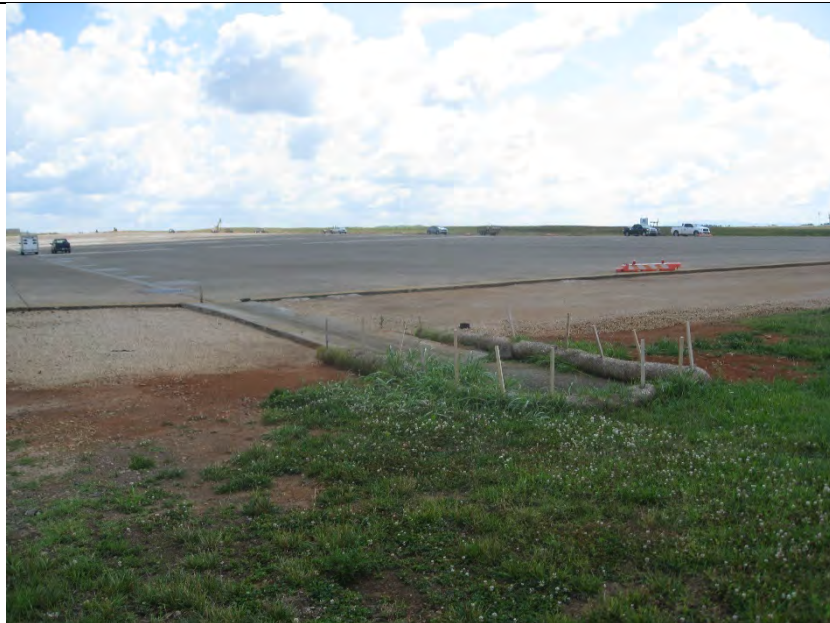
Photo 98  
(Repair TWY Lighting)  
Sheet EC2.1.5

Existing structure at Upper Apron.  
Newly installed underdrain recently backfilled and sediment tubes reinstalled.

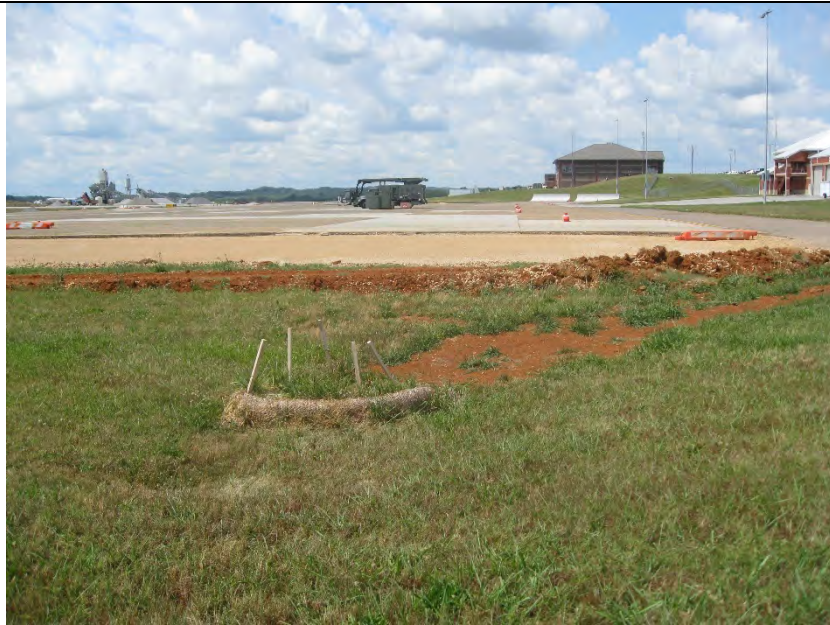
Photo 99  
(Repair TWY Lighting)  
Sheet EC2.1.5

Existing structure at Upper Apron.  
Newly installed underdrain recently backfilled.

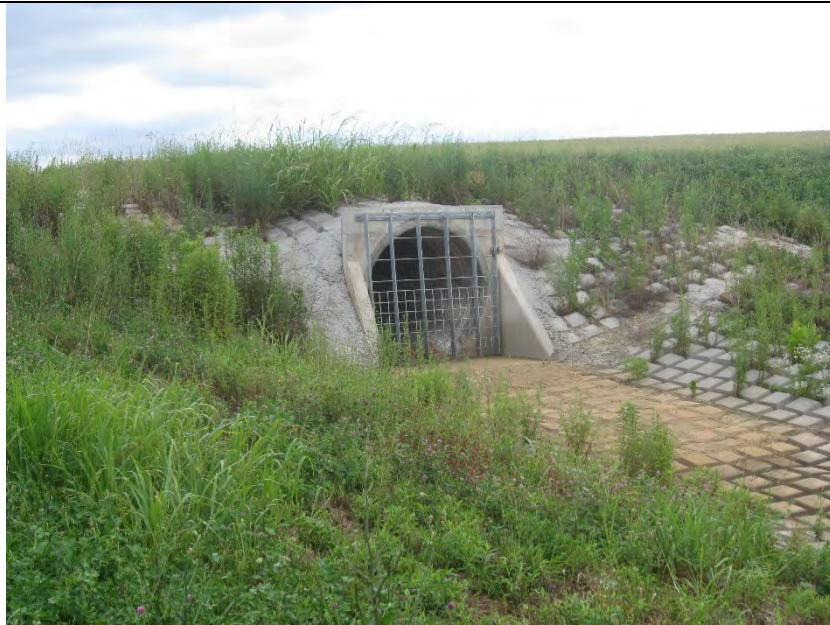
Photo 9  
Sta. 117+00 (RT)  
Project 2

78" culvert in the Guard Lateral Ditch. Clear flow observed at beginning of Site Assessment.

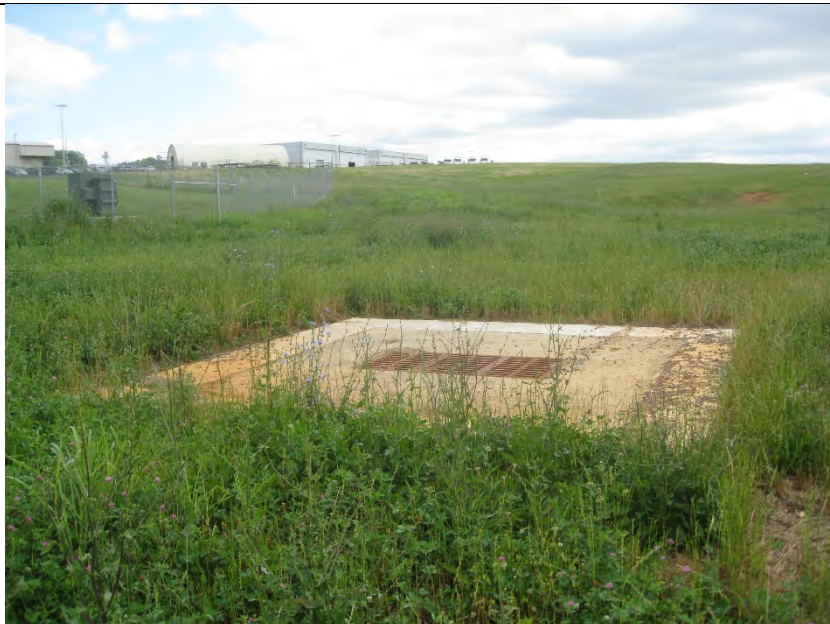
Photo 10  
Sta. 287+21 LT  
(RW 5L-23R)  
Structure 124  
Project 3

Structure 124.  
Recommend stabilizing remaining bare areas.

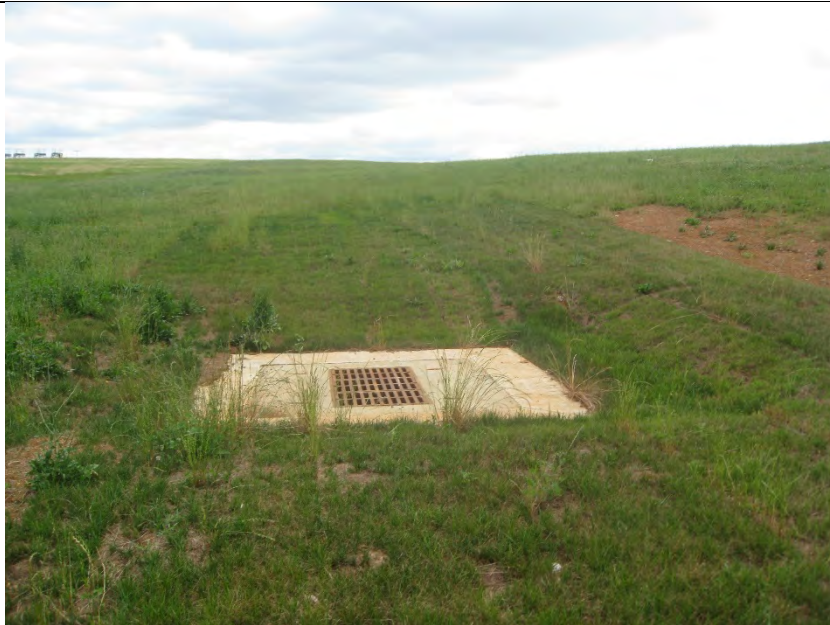
Photo 11  
Sta. 289+13 LT  
(RW 5L-23R)  
Structure 122  
Project 3

Structure 122.  
Recommend stabilizing remaining bare areas.

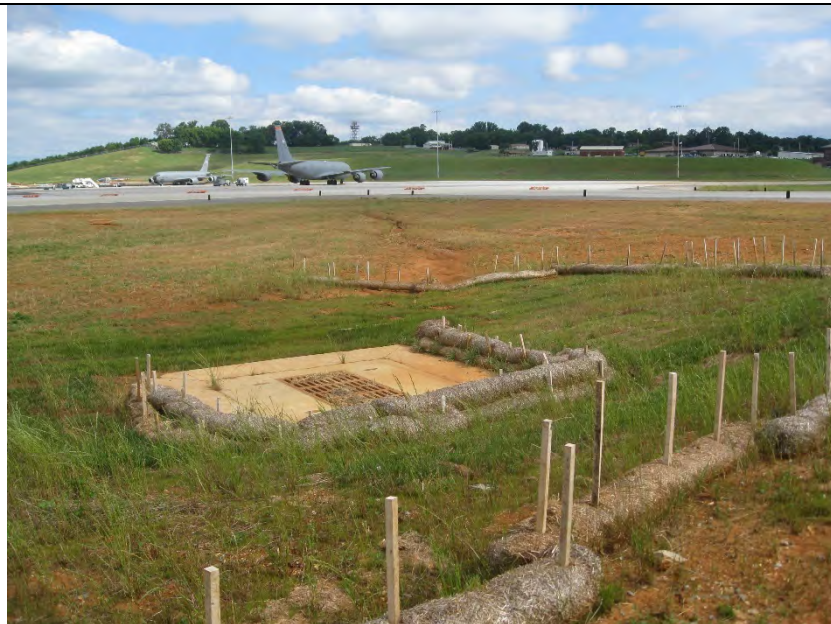
Photo 14  
Sta. 298+71 LT  
(RW 5L-23R)  
Structure 116  
Project 3

Structure 116.  
Recommend stabilizing bare areas.

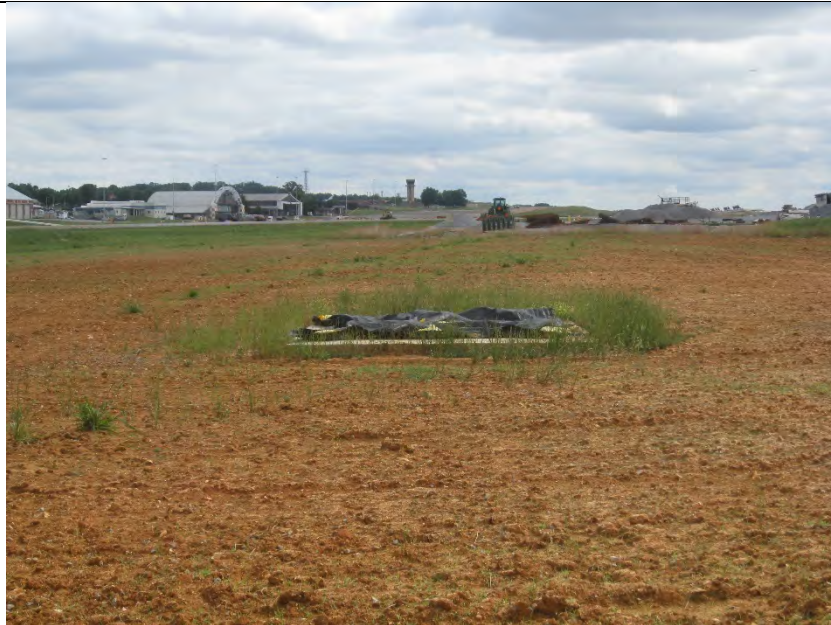
Photo 15  
Sta. 302+54 LT  
(RW 5L-23R)  
Structure 114  
Project 3

Structure 114.  
Bare areas recently stabilized.

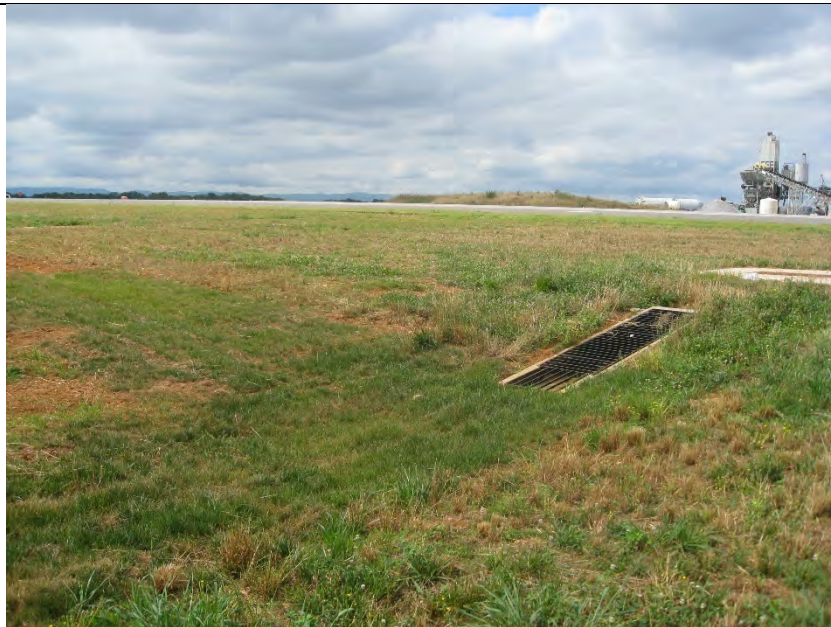
Photo 19  
Sta. 314+48 LT  
(RW 5L-23R)  
ES Endwall 108  
Project 3

Enhanced Swale Endwall 108.  
Recommend stabilizing remaining bare areas.

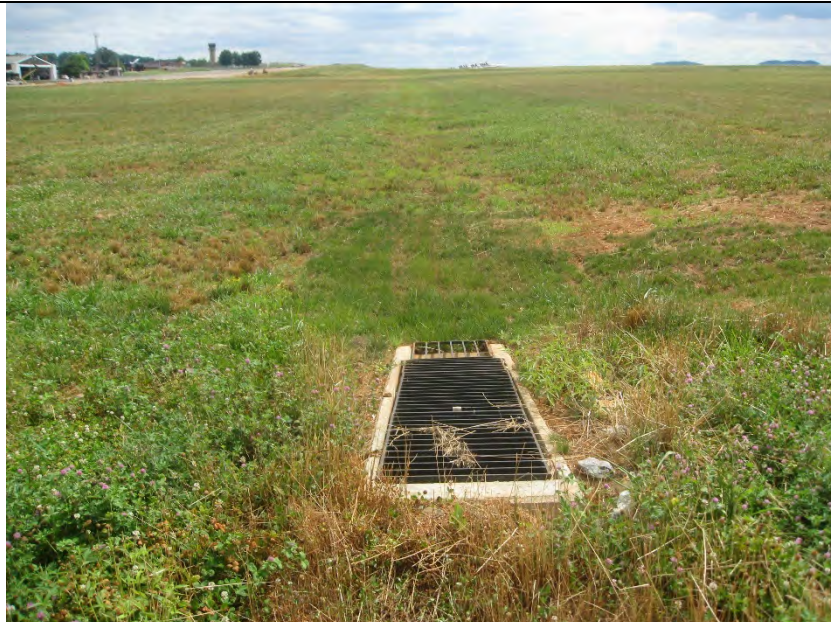
Photo 20  
Sta. 314+48 LT  
(RW 5L-23R)  
ES Endwall 108  
Project 3

Enhanced Swale Endwall 108.  
Recommend stabilizing remaining bare areas.

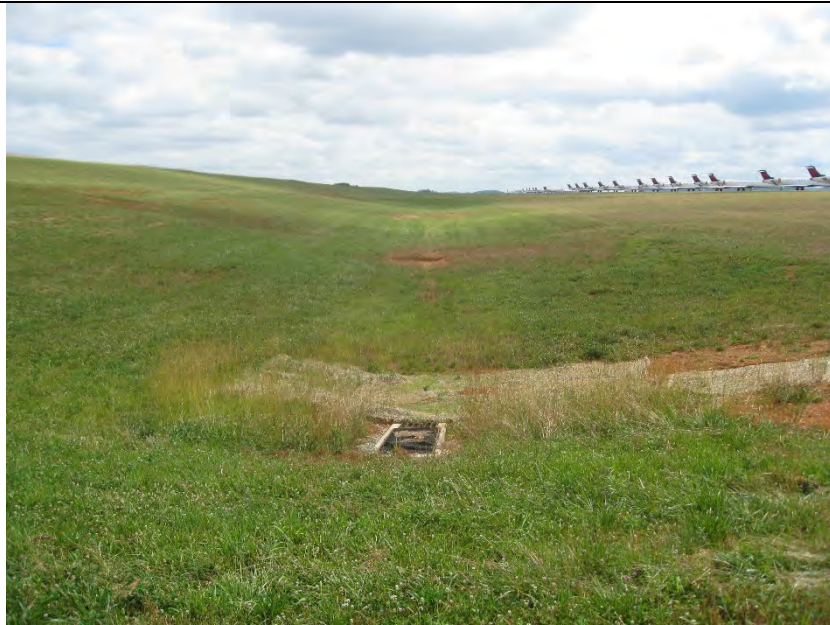
Photo 31  
Sta. 347+31 LT  
(RW 5L-23R)  
ES Endwall 102  
Project 3

Enhanced Swale Endwall 102.  
Recommend stabilizing remaining bare areas.

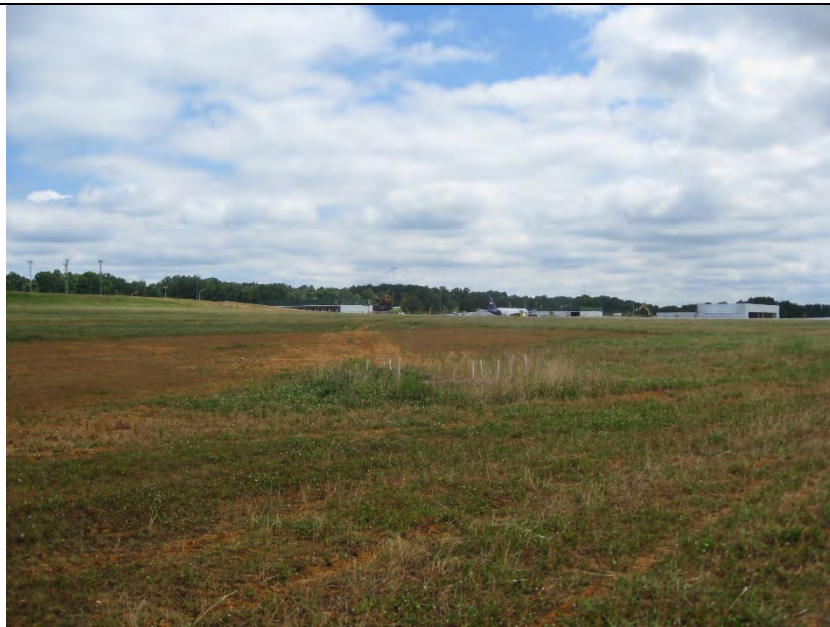
Photo 39  
Sta. 369+11 LT  
(RW 5L-23R)  
Existing Structure  
Project 2

Existing Structure.  
Recommend stabilizing bare areas.

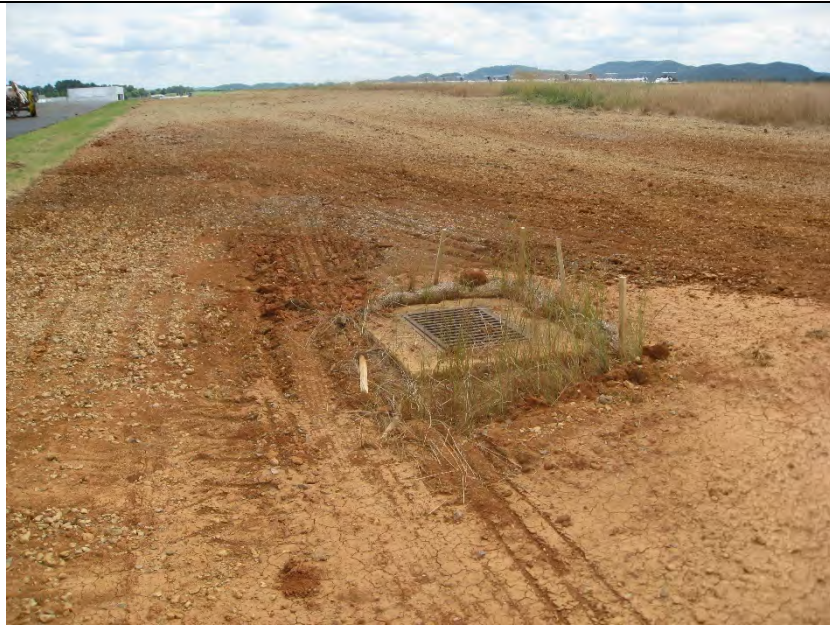
Photo 43  
(RW 5L-23R)  
Existing Structure  
Project 4

Existing structure south of Taxiway G  
Area recently regraded, recommend stabilizing bare areas.

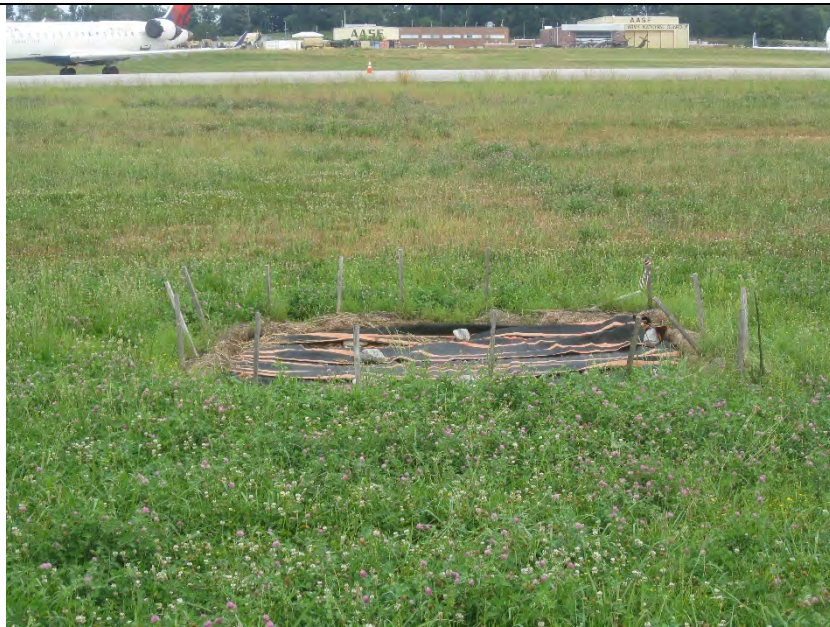
Photo 47  
Sta. 366+89 RT  
(RW 5L-23R)  
Outfall C  
Project 4

Recommend removing filter fabric from this structure to allow sampling for DMR.  
(Outfall C).

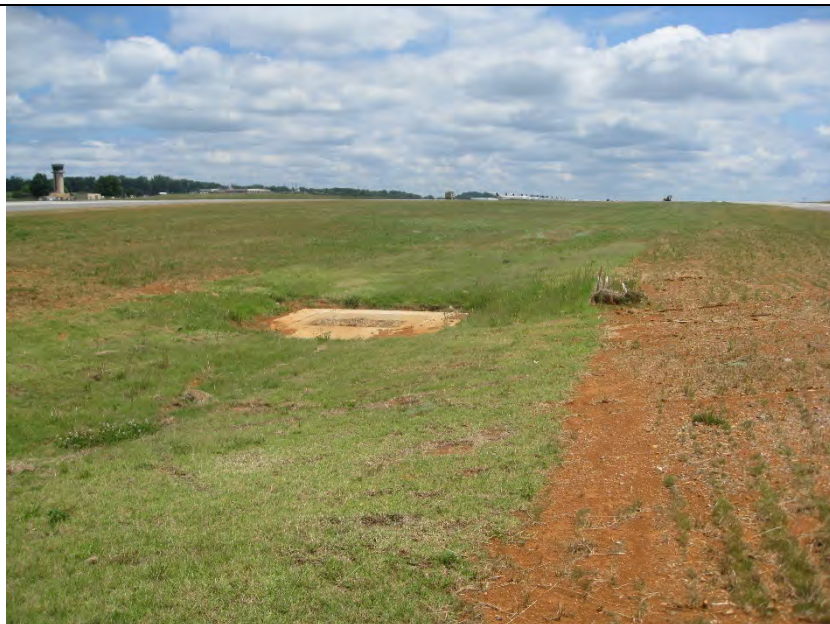
Photo 62  
Sta. 329+86 RT  
(RW 5L-23R)  
Structure 210  
Project 3

Structure 210.  
Recommend stabilizing bare areas above sediment tubes.

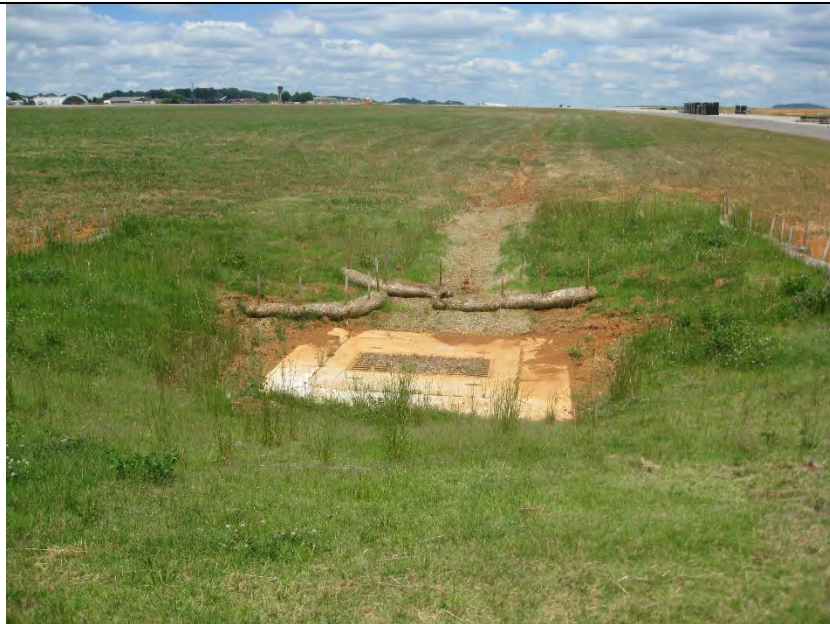
Photo 66  
Sta. 301+87 RT  
(RW 5L-23R)  
Structure 218  
Project 3

Structure 218.  
Erosion control blanket recently added.  
Recommend stabilizing bare areas.  
Recommend removing sediment from top of structure.
